Building Inspection Report

Inspection Date: Thu, 12 Mar 2026

Property Address: 907/311 Hume Hwy, Liverpool NSW 2170,
Australia

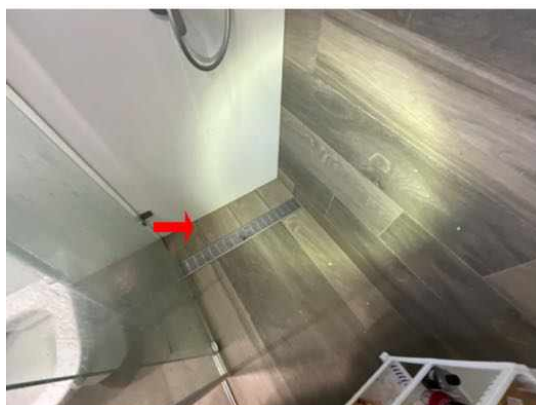
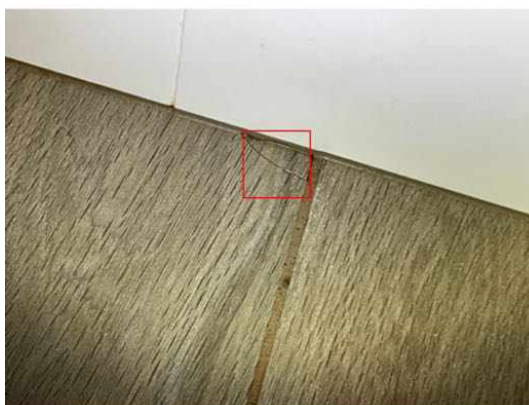
Defects 3.01

Building: Main Building
Location: Ensuite
Finding: Wet area tiles - Cracked or damaged
Information: Cracking was evident to the tiling in this area at the time of inspection. While the cracking appears to be minor, this area is frequently exposed to water, allowing potential for water penetration into adjoining sections of walls or flooring.

If left unmanaged, water penetration to these areas may lead to subsequent water damage, which is likely necessitate repair work to affected building elements.

A bathroom specialist should be appointed to determine the integrity of the bathroom waterproofing membrane. If the membrane was found to be intact then relatively minor works to replace the cracked tiles should be carried out to ensure no further damage occurs. The re-application of silicone and grouting throughout remaining tile work is also advised, to further protect the area against water penetration.

- Replace the cracked ensuite tile

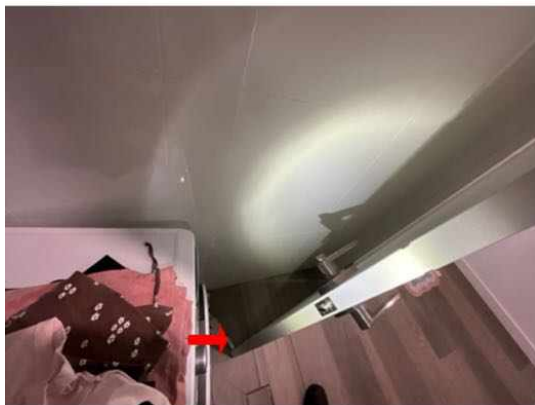
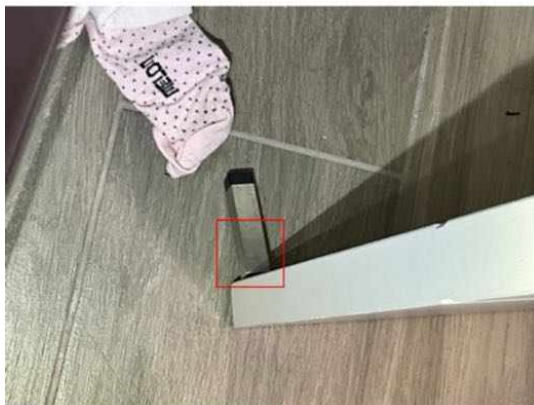
Defects 3.02

Building: Main Building
Location: Laundry

Finding: Building element - Damaged

Information: Doorstop in this area was found to have been damaged at the time of inspection. Breakage occurs generally when the building materials have either aged and decayed, or as a result of damage (accidental or deliberate).

Repair and/or replacement of broken elements is advised to ensure that additional secondary defects do not arise as a consequence. Such works are necessary, as all building elements play a key role in the operation and function of the overall structure and its performance.

A general handyman should be appointed to repair or replace the affected building element prior to any subsequent damage being caused.

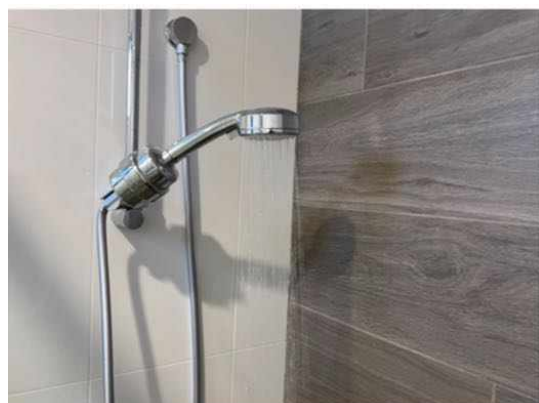
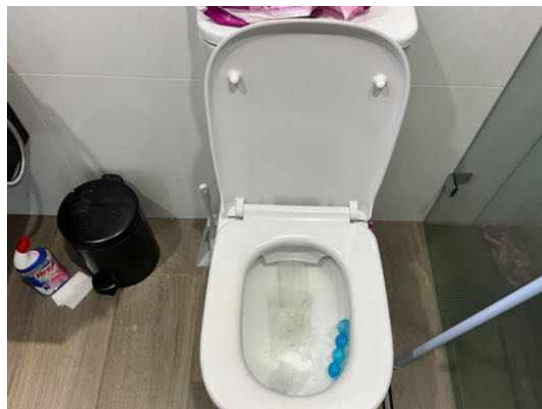
Location: All Wet Areas

Finding: Waterproofing

All taps, mixers and toilets were tested for operation, except for those obstructed. The waterproofing to the shower recess was assessed by checking the walls in and around the shower recess for varying moisture content. There were no significant variations across the tested areas. No sign of recent water damage was evident upon a visual inspection of the surrounding walls, where the visual nature of the inspection was possible.

Consequently, there is no conclusive evidence of any current shower recess leakage other than those which may have already been mentioned earlier in this report. It is reasonable to assume the shower waterproofing is sound. Note that if the shower is not used, or has not been used for some time, moisture readings would not vary significantly and this can lead to erroneous results. It is not possible under the visual inspection criteria (under which a prepurchase inspection is carried out) to categorically determine if there are leaks. If a more accurate assessment is required, a special purpose inspection should be requested. Alternatively, the assumption should be made that the shower may leak.

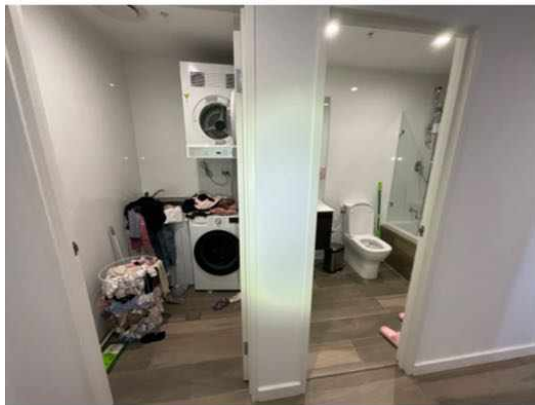
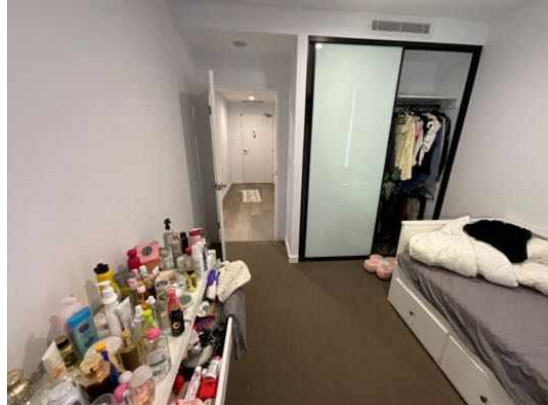
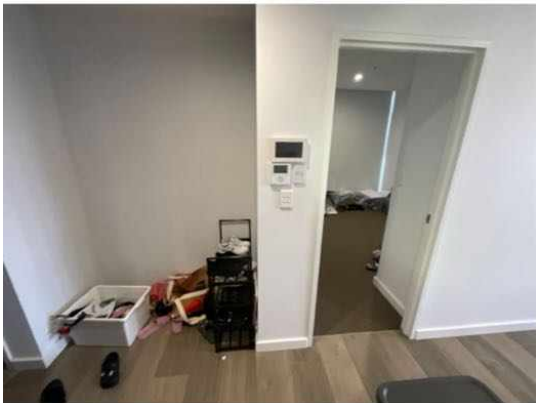
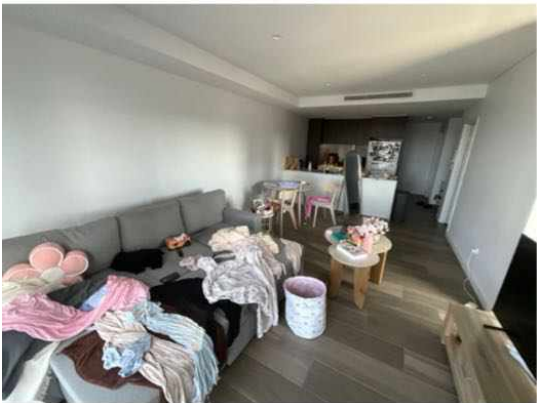
Building: Main Building
 Location: All Areas
 Finding: Additional Photos - Obstructions and Limitations
 Information:

These photographs are an indication of the obstructions and limitations which impeded full inspection of the property at the time of inspection. These obstructions can hide an array of defects and should be removed to allow full inspection to be carried out. A re-inspection is recommended once the areas are made accessible.
