Building and Timber Pest Inspection Report

Inspection Date: Thu, 26 Mar 2026

Property Address: 131 Mywee Rd, Strathmerton VIC 3641,
Australia

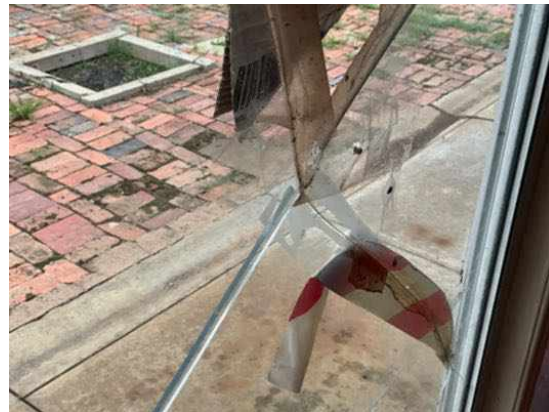
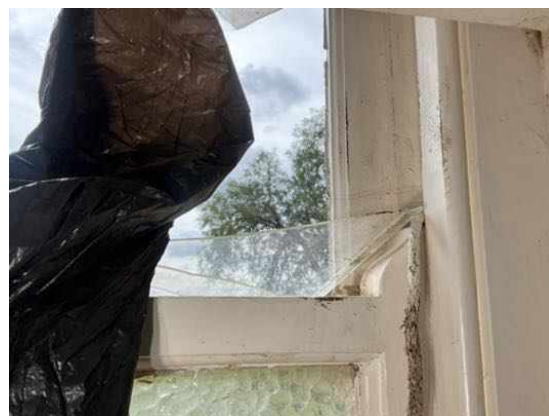
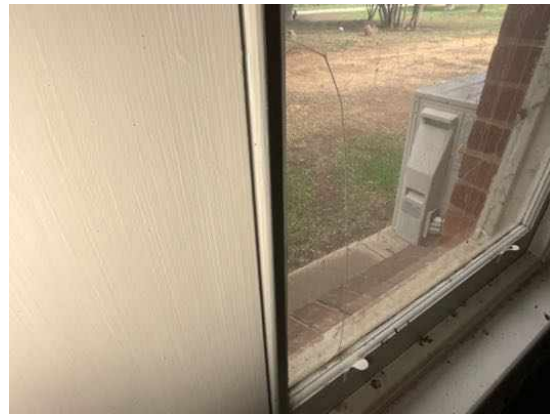
Building: Building 1
Location: Family Room, living, store room
Finding: Window - Cracked
Information: Cracks were identified in the window in this area. Cracking in windows is generally the result of impact damage, and is likely to develop further when left unmanaged.

The likelihood of this windowpane further cracking and shattering is increased exponentially, providing a safety hazard in the area. The cracked window also impairs the weather tightness of the building, creating potential for minor water leaks.

A qualified glazier is required to repair the window as soon as possible. Depending on the extent of the cracking, replacement of the window may be required. Please be advised that any persons coming into contact with the cracked window should do so with due caution to avoid any personal injury that may ensue.

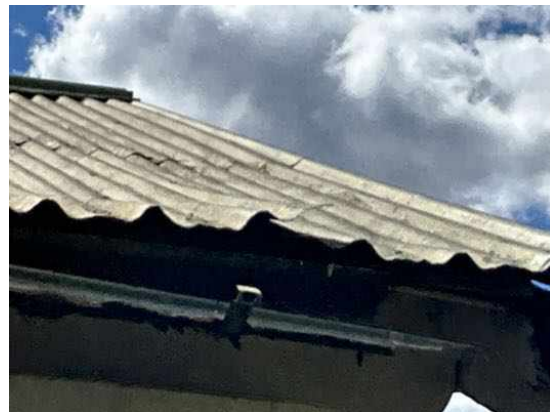
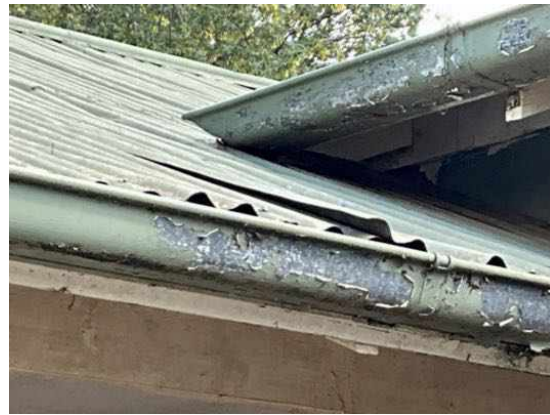
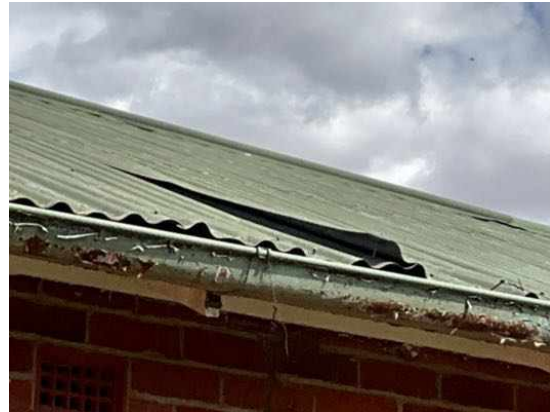
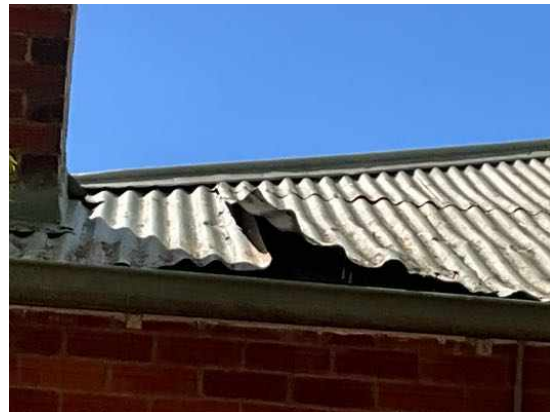
Finding 2.01

Building:	Building 1
Location:	Roof Exterior
Finding:	Roof sheets - Loose
Information:	Upon inspection of the exterior roof covering, it was noted that numerous roof sheets have become loose from their original fixings. It is suspected that this defect has developed as a result of a lack of adequate maintenance, but may also have been caused by inappropriate fixings being used in the construction process.

Loose roof sheeting detracts from the weather tightness of the roof covering, making the internal roofing structure susceptible to water penetration and subsequent damage. If left unaddressed, it is likely that secondary damage to associated building elements will develop, potentially necessitating remedial works to these structures.

A roofing restoration contractor should be appointed to advise on rectification options and on the cost of repair. It is advised that remedial works be performed as soon as possible to prevent any further damage.

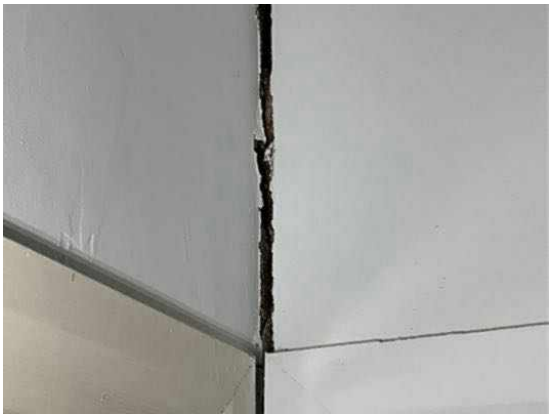
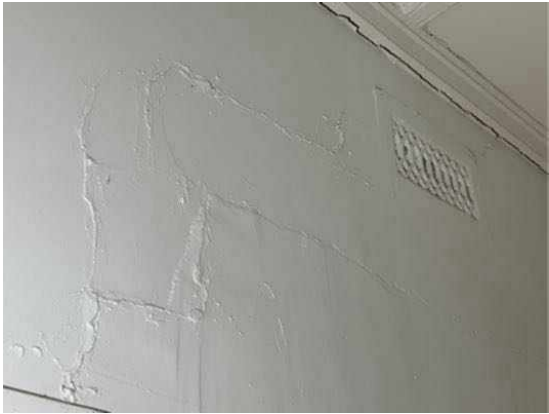
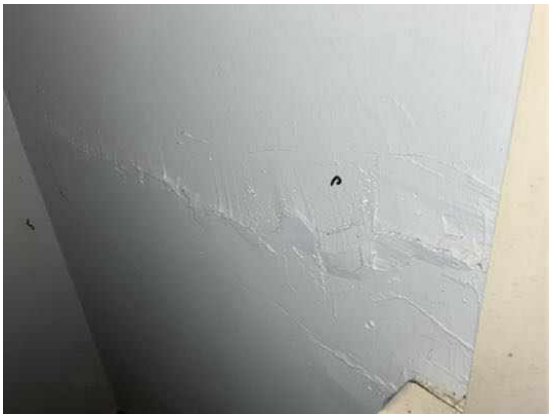
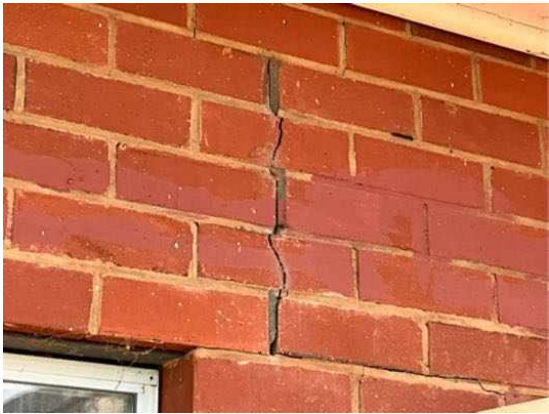
Finding 2.02

Building:	Building 1
Location:	brickwork of external walls
Finding:	Brickwork - Cracking [Repair required]
Information:	Major cracking was identified to the brickwork in this area. Cracks of this type are likely to have been caused by minor expected movement of building elements, but may also have a structural cause that is more significant.

A crack of this size may be repaired by extensive filling. Additionally, further remedial works to associated building elements, such as eave sheeting or external door frames, is likely to be required.

A qualified bricklayer should be contacted immediately to estimate and perform repair and restoration works. Consultation with a structural engineer may be required where structural instability is found to be the underlying cause of the cracking.

Always contact a building inspector should cracks widen, lengthen, or become more numerous.

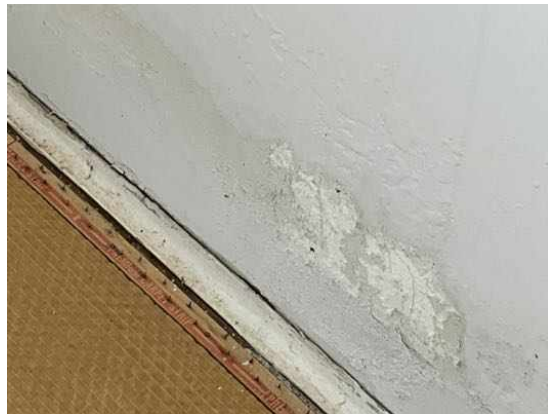
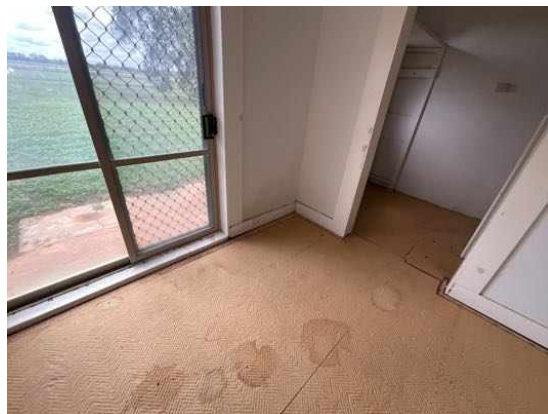
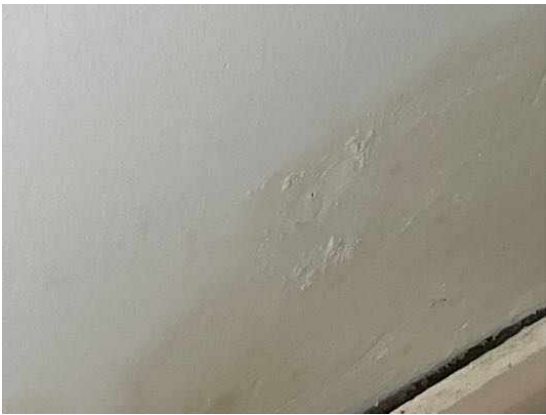
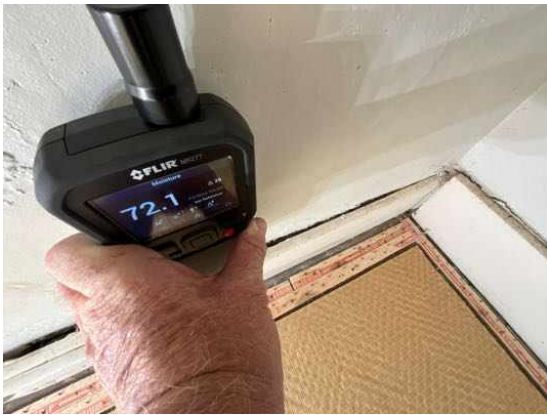
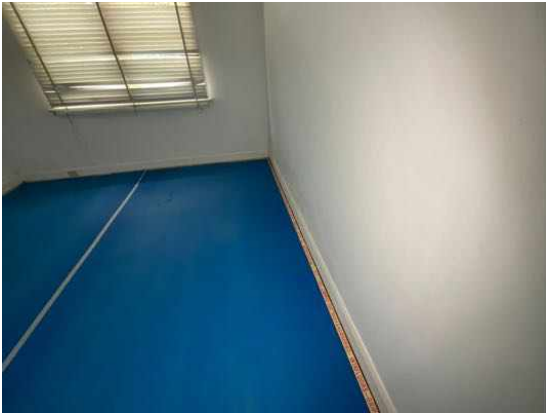
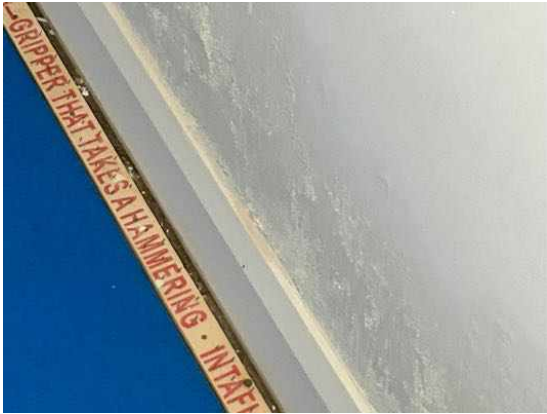
Finding 2.03

Rising damp is generally managed by the installation of a damp proof course during construction. A Damp Proof Course (DPC) is an impermeable barrier at the base of the wall above ground level. However, many 19th Century buildings have no damp course installed, or the materials have failed. The DPC may have been omitted as a

consequence of poor workmanship, or it may have been bridged where materials built up against the side of the house allow moisture ingress above the DPC level.

The first step in addressing rising damp is to diagnose the cause. The identified cause should be addressed first before addressing the appearance and other defects which have resulted from the rising damp. If the original cause is not resolved, further cases of damp are likely to ensue, resulting in secondary defects.

Consultation with a qualified plumber is advised immediately to identify the cause of the damp and perform remedial works as required.

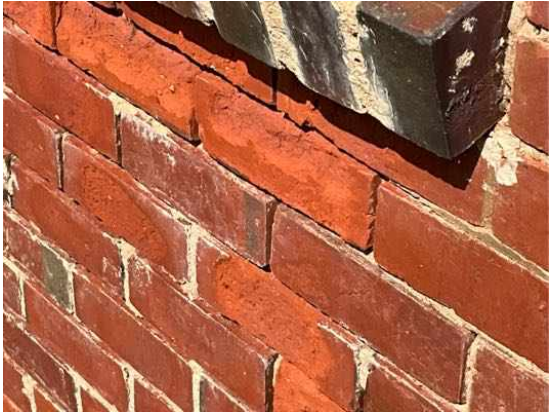
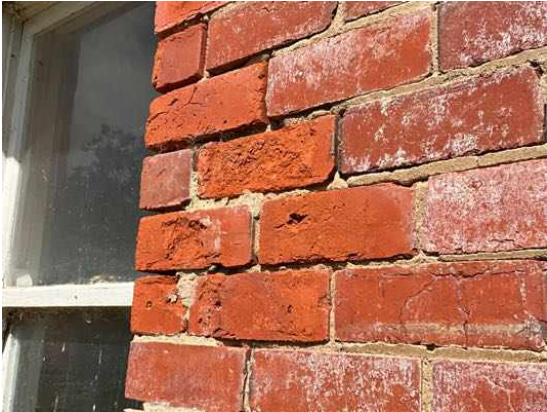
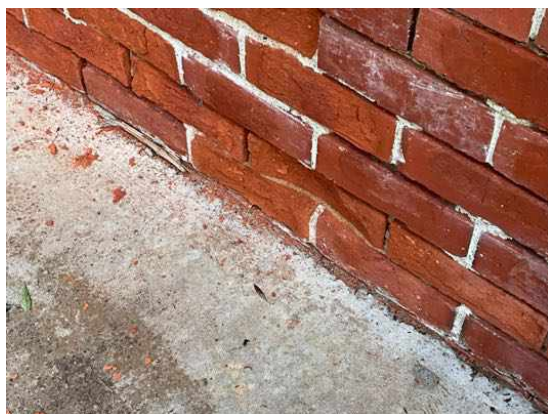
Finding 2.04

Building: Building 1
Location: External brickwork
Finding: Brickwork - Deterioration
Information: Deterioration was evident to sections of the brickwork in this area at the time of inspection. Commonly referred to as brick corrosion or erosion, the bricks are aged and likely to have been affected by a variety of factors, including weather exposure, damage, salt-based deterioration, and more.

Overtime, these factors can affect the bricks, causing them to become brittle and appear corroded or eroded. The mortar in the brickwork may also become powdery, further detracting from the structural integrity of the brickwork. If left unmanaged, potential implications include further deterioration of the building materials, the development of secondary defects, and potential development of structural instability of the wall.

Where this degree of damage has already occurred, you should consult a Building Surveyor or Engineer to seek advice regarding the structural stability and load bearing capabilities of the wall. Such consultation is always required prior to performing any remedial works on the affected brickwork.

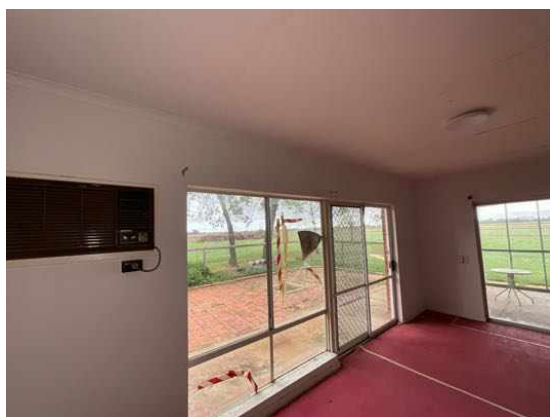
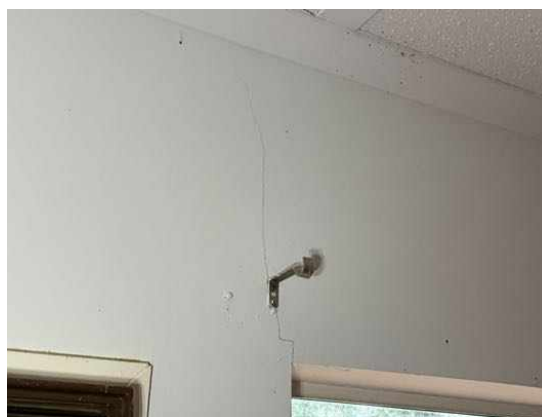
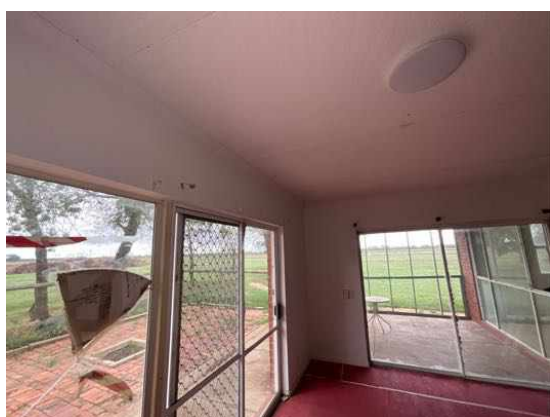
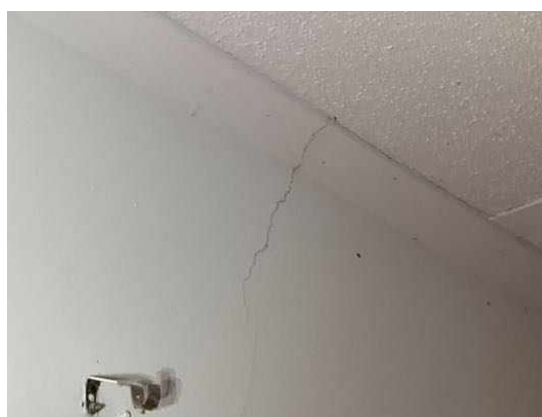
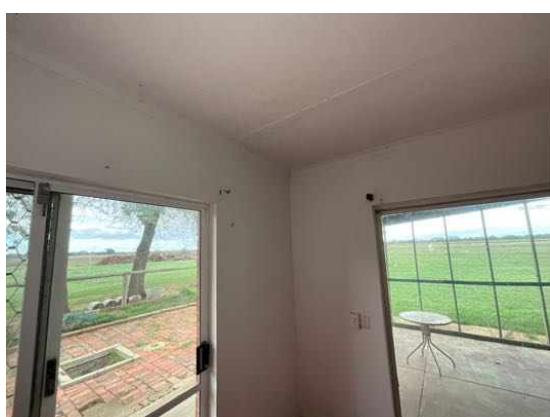
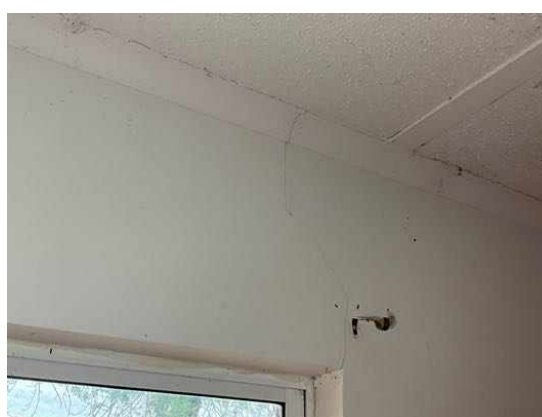
Finding 3.01

Building:	Building 1
Location:	Family Room
Finding:	Cracking - Damage Category 2 - Noticeable (up to 5mm)
Information:	Noticeable cracks are a common occurrence as a result of many primary defects. Such causes may include age, general wear and tear, expected building movement, general expansion/contraction of building materials in different weather conditions, and/or minor failings in the installation or application of building materials.

Noticeable cracks may result in minor sticking or jamming of associated doors and windows, which require easement. However, noticeable cracks are easily filled and repaired. A plasterer can be consulted to install an expansion joint at this point to allow for this movement during different weather conditions.

Monitoring of all cracking should be conducted frequently. Always contact a building inspector should cracks widen, lengthen, or become more numerous. Additionally, your building inspector should also be contacted if associated building elements such as doors and windows become more difficult to operate over time.

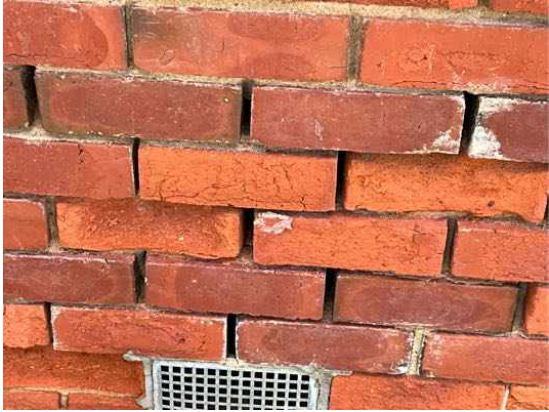
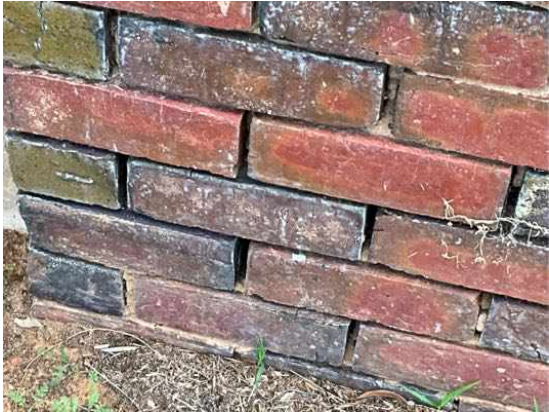
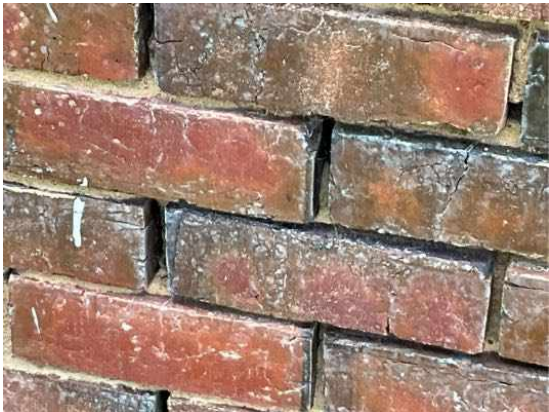
Finding 3.02

Building:	Building 1
Location:	Brickwork
Finding:	Brickwork - Deteriorated mortar
Information:	Mortar, or 'bedding', is the material which fills joints and intersections between bricks in masonry walls and structures. Sections of mortar in this brickwork were identified as having deteriorated, which is generally expected for a property of this age and condition.

Mortar may deteriorate as a result of age of building materials, minor movement of bricks, or frequent exposure to weathering. Mortar should be replaced to ensure that

bricks remain in their intended location and to prevent gaps, which would allow water or moisture ingress and secondary damage as a result.

Mortar deterioration can be addressed by a bricklayer where areas of deterioration are localised and easily accessible. Alternatively, appointment of a registered builder is advised, to repoint large areas of decaying mortar. Where secondary structural defects have become evident, consultation with a structural engineer may be required.

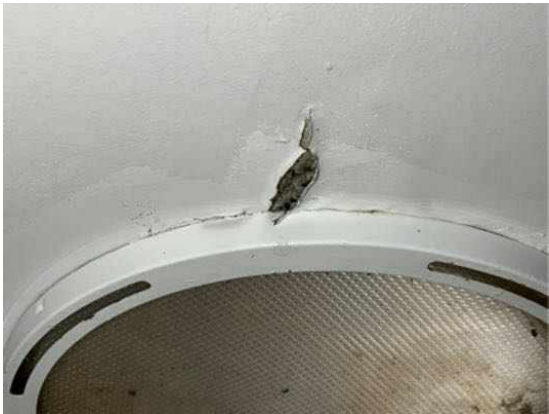
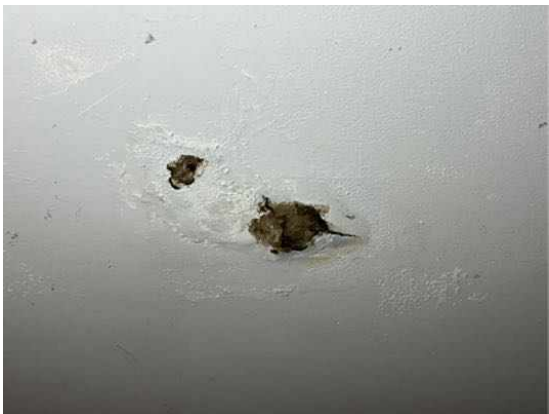
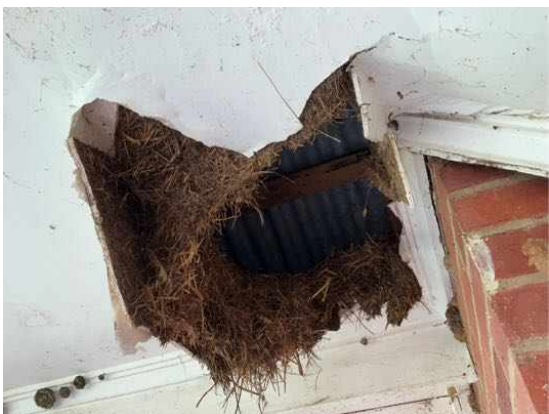
Finding 3.03

Building: Building 1
Location: Family Room, bathroom, laundry, entry

Finding: Ceiling - Water damaged

Information: Water damage to the ceiling lining is generally an indication of excessive moisture being present in the roof void, usually via a leak to the roof covering.

Where water damage is evident to the ceiling, the primary requirement is to identify and rectify the source of the leak. A roofing plumber should be appointed as soon as possible to identify the leak and perform rectification works as necessary, ensuring the water damage is restricted.

Once the leak is repaired, consultation with relevant tradespeople, including plasterers and painters, is advised. Rectification works may include replacement of ceiling lining or minor repainting, depending on the extent of the damage.

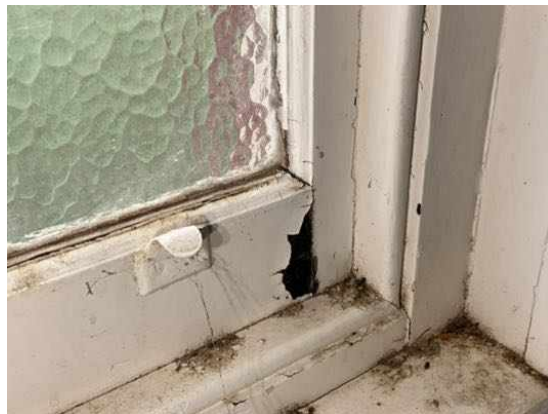
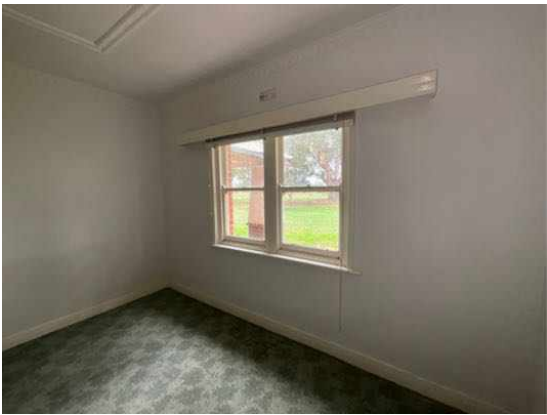
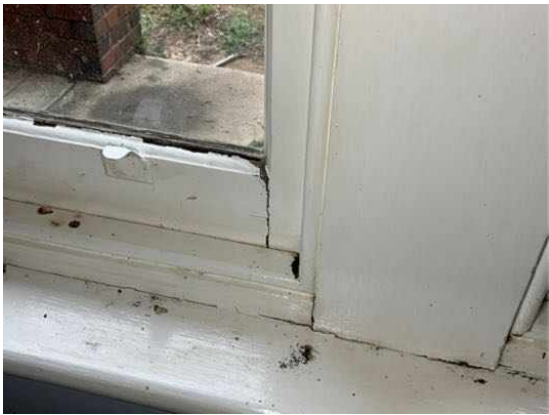
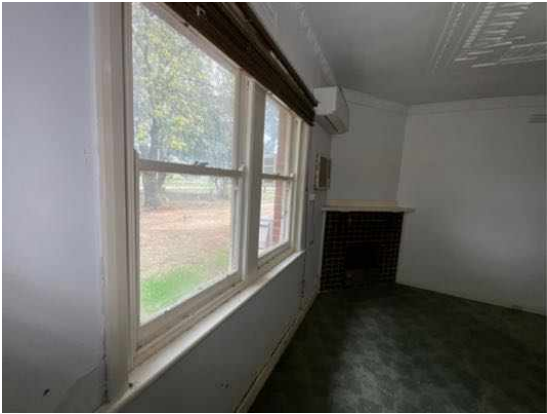
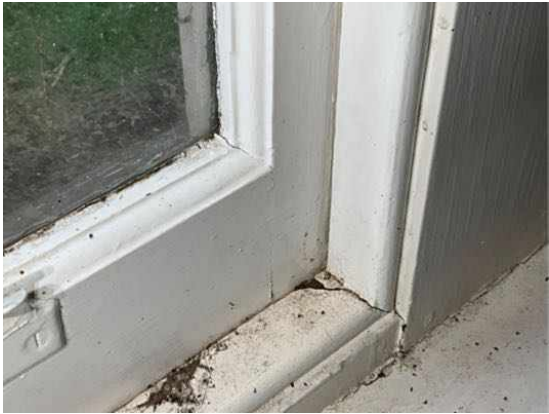
Finding 3.04

Building: Building 1
 Location: Most timber windows
 Finding: Window - Binding/jamming
 Information: Binding and/or jamming of this window is evident during standard operation. This defect inhibits the functionality of the affected window as well as creating potential for secondary defects to associated building elements, such as damage to the frame.

A window that binds to the associated frame may have several causes, ranging from minor defects, such as poor installation or deteriorated hinges, through to major structural issues, such as damage to framing structures.

Where binding/jamming appears to indicate major structural issues, a registered builder specialising in re-stumping should be appointed to provide an estimate on the cost of rectification.

For minor causes, a qualified carpenter, general handy person or window specialist should be appointed to perform minor rectification works at client discretion.

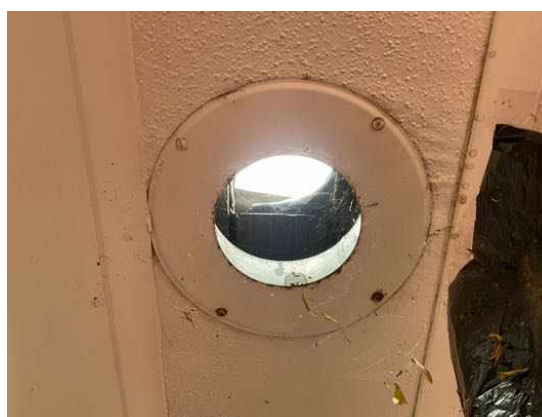
Building:	Building 1
Location:	Family Room
Finding:	Installation - substandard or incomplete
Information:	The installation of this building element appears to have been completed to a substandard level of workmanship or is incomplete. Generally substandard repairs or installation are related to poor workmanship, the use of inappropriate materials, or a failure to complete installation to a suitable standard.

Where installation is substandard and/or incomplete, the client should contact the responsible trade to undertake rectification. Unfinished and substandard building works are likely to degrade more quickly and may create potential for secondary defects to associated building elements.

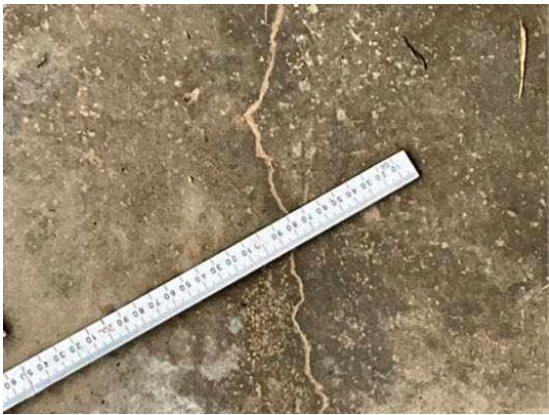
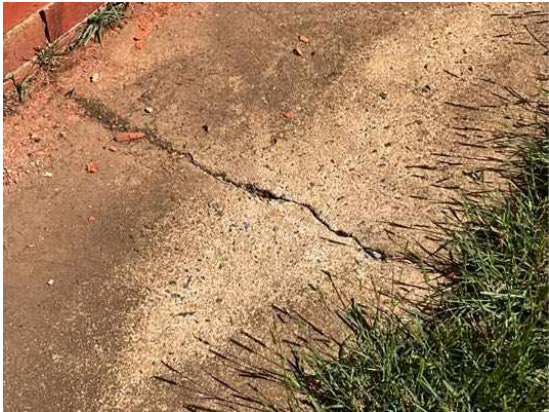
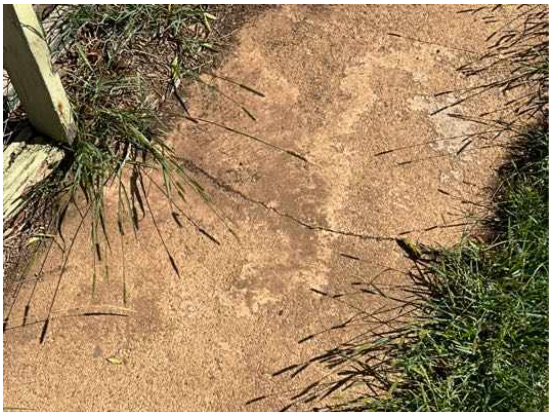
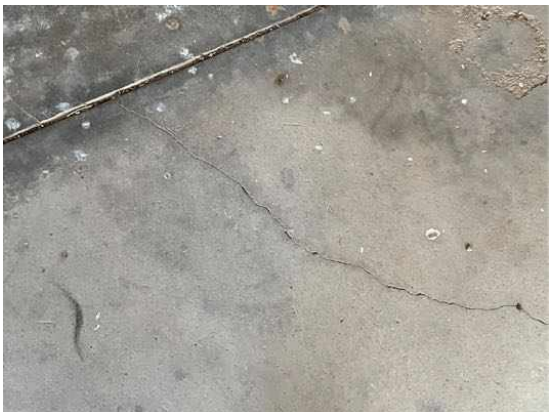
Building:	Building 1
Location:	All External Areas
Finding:	Cracking - External Concrete Paving Damage Category 2 - Distinct (less than 3mm)
Information:	Distinct cracks were identified in external concrete paving. Distinct cracks are generally found in older concrete paving, and may also present as a trip hazard as consequence of an uneven or curved surface.

General age and expected deterioration of the paved areas is a common cause of this type of cracking. However, expansion and contraction of the slab may also have occurred due to environmental factors. Such factors include variable moisture and weather conditions, the presence of trees and their roots having a settling or lifting affect on the soil, or the effect of load bearing, e.g. heavy vehicles over a sustained period of time.

Cracking to this degree may also be due to poor original installation of the concrete. Factors such as poor compaction of the sub surface and/or inadequate reinforcing of the slab may create cracking and other secondary defects.

Repairs are likely to be required to prevent further cracking and to reduce hazards associated with cracking, such as tripping. Monitoring of all cracking should be conducted frequently. Always contact a building inspector should cracks widen, lengthen, or become more numerous.

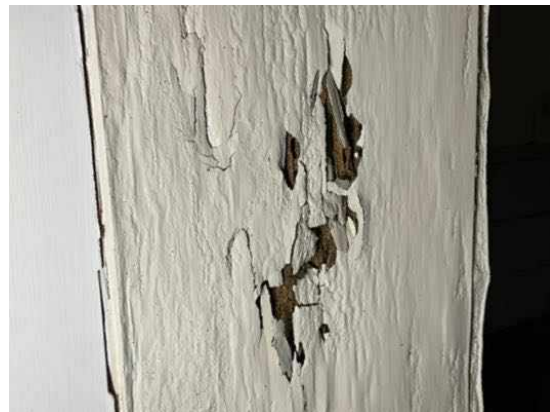
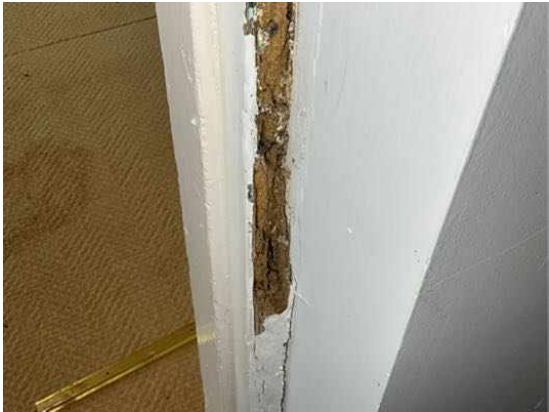
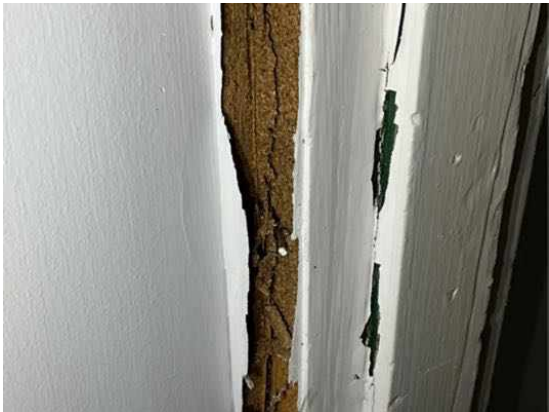
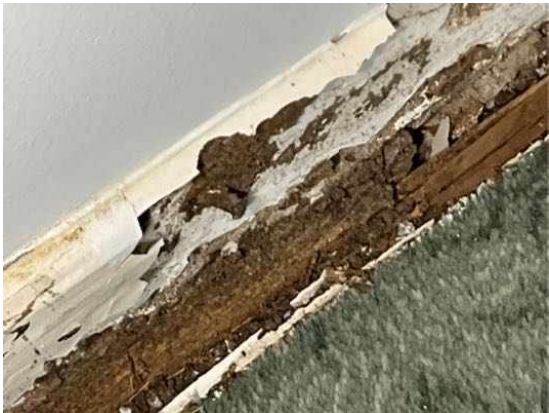
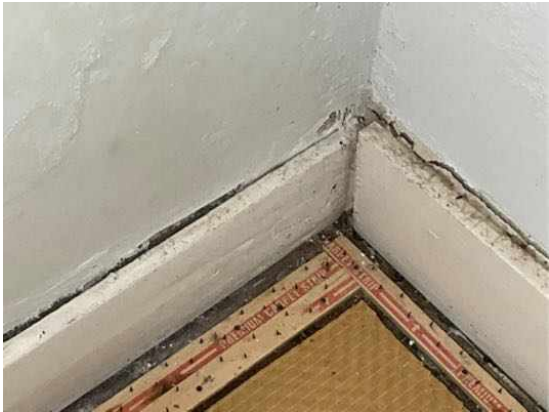
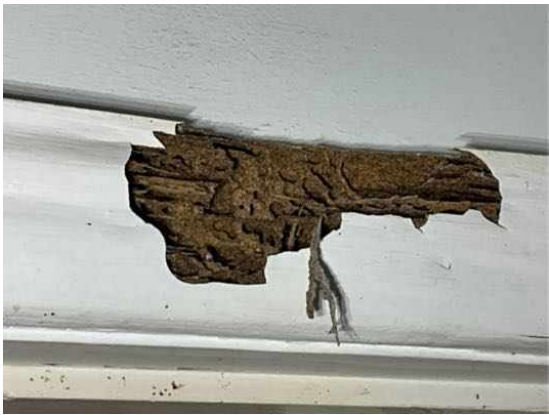
Building:	Building 1
Location:	Most internal areas
Finding:	Evidence of termite damage - structural
Information:	Despite no live termite or timber pest activity being identified, previous termite damage was found in this area. This damage is considered to be structural in nature. Such damage creates a potential safety hazard, and is likely to worsen and cause further damage to adjoining building materials.

If left unattended, this damage creates an unsafe environment and is likely to lead to the need for major structural works.

A building contractor should be appointed immediately to advise on options to prevent further damage and repair all affected building materials. Until such time, caution should be taken by all people coming into contact with these building elements and this area.

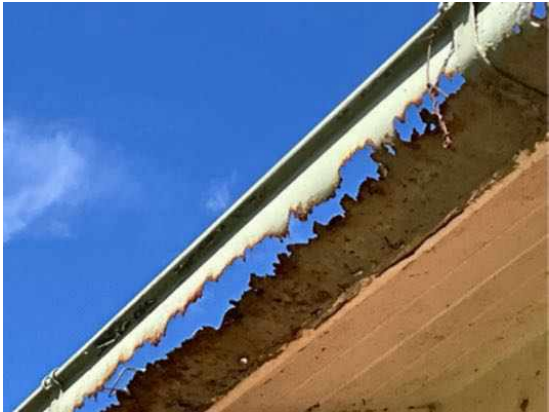
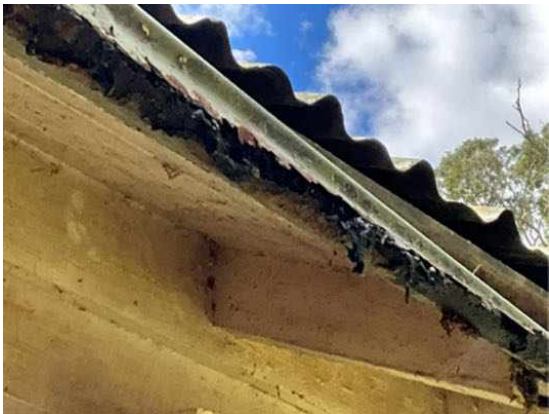
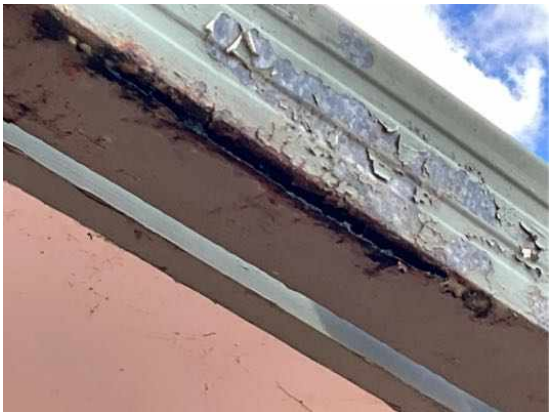
Finding 6.01

Building: Building 1
Location: Eaves
Finding: Gutters- Deteriorated
Information: The guttering and some downpipes have deteriorated.

Although not a major problem now, they will deteriorate further if left for an extended period.

Sagging can be seen in the gutter.

A Licensed Plumber should be engaged as soon as possible to advise on any repairs or maintenance that may be required.

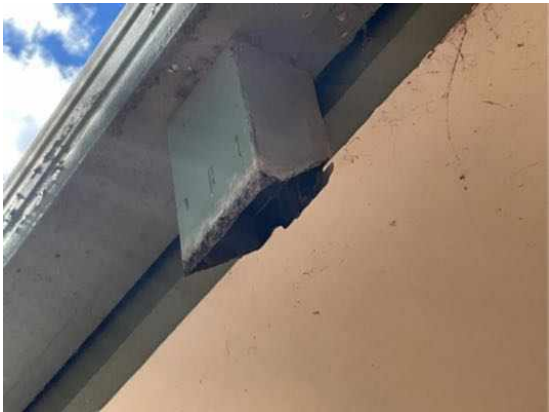
Finding 6.02

Building: Building 1
Location: Yard - Back, side
Finding: Stormwater drain - Not connected
Information: The roof plumbing is not adequately connected to stormwater drainage on the site. This disconnection negatively impacts the functional capacity of the roof plumbing.

Where roof plumbing doesn't drain adequately, the area at the base perimeter can become excessively damp, potentially creating an environment that is susceptible to rust and corrosion of surrounding building elements, as well as attracting termites and other pests.

It is highly recommended that a plumber be appointed to further inspect the area and to install adequate drainage equipment where necessary.

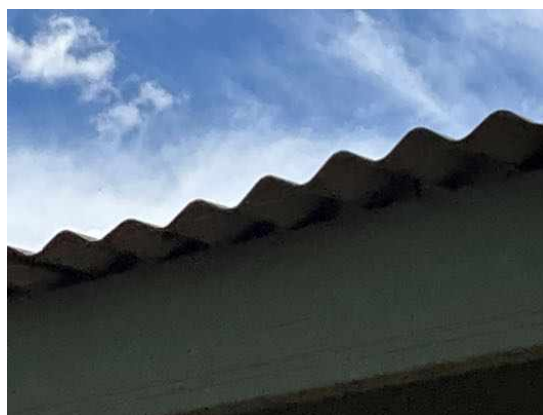
Finding 6.03

Building: Building 1
 Location: Alfresco
 Finding: Guttering Missing
 Information: The Guttering in this area was missing at the time of inspection. Guttering, Downpipes and Stormwater drainage are vital to protect the integrity of the structure and to prevent an environment conducive to Timber Pest attack.

A Plumber should be contacted as soon as possible to replace and connect to drainage the missing Guttering.

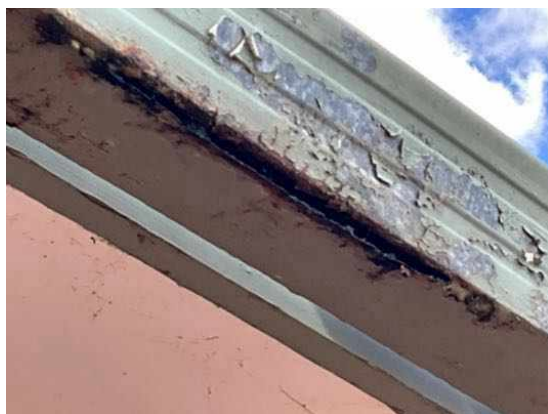
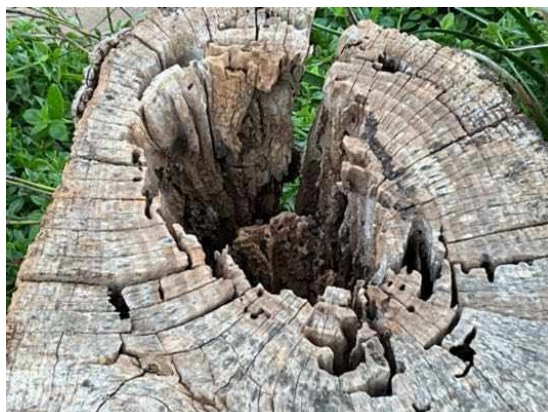
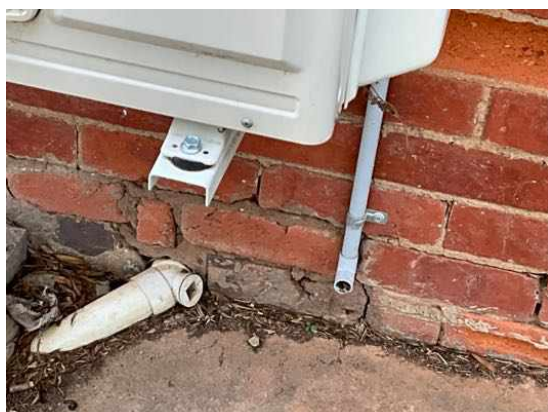
Building: Building 1
 Location: All External Areas
 Finding: Termite Management System - no evidence of a chemical installation
 Information: The application of a post-construction chemical termite barrier is highly recommended for all properties, particularly if live termite activity has been found on the site previously. Such barriers are highly effective in preventing termite attack on any timber building elements throughout the property.

The client may consider gaining further advice from a pest controller as to the costs and procedures involved with this application. It is recommended that obtaining such advice be a short-term priority.

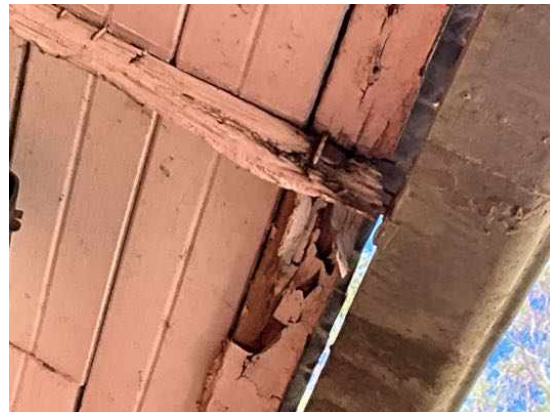
Finding 7.01

Building:	Building 1
Location:	Eaves
Finding:	Fungal decay - present (localised)
Information:	Fungal decay also known as wood decay or wood rot generally refers to the deterioration of timber elements when in contact with excessive levels of moisture for a prolonged period of time.

The development of fungal decay is accelerated by temperatures in the range of 5degreeC to 40degreeC as well as the presence of oxygen. Generally fungal decay develops on timber elements that are in use in an external environment which are exposed to rain penetration.

In this case although the affected timber element is in a decaying state the extent of any visible damage appears to be localised to a specific area and is yet to spread to other parts of the building element or affect adjoining structures. The fungal decay is therefore likely to be of a relatively superficial nature with minimal impact on the structural integrity or tensile strength of the timber element.

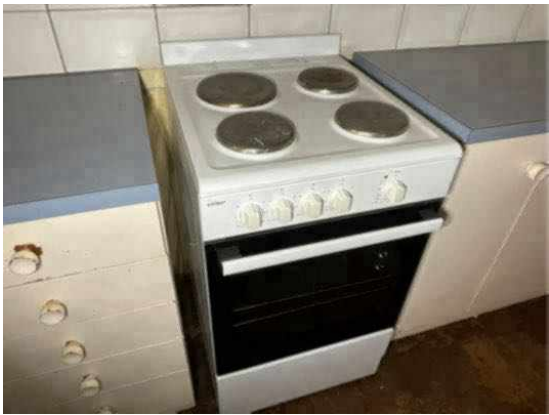
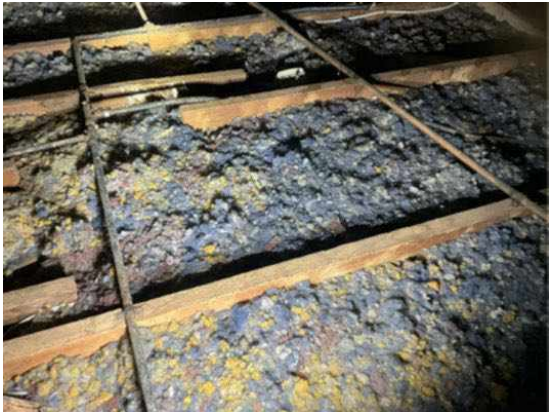
Building: Building 1
Location: All Areas
Finding: Additional Photos - Obstructions and Limitations
Information: These photographs are an indication of the obstructions and limitations which impeded full inspection of the property at the time of inspection. These obstructions can hide an array of defects and should be removed to allow full inspection to be carried out. A re-inspection is recommended once the areas are made accessible.
