## Building Inspection Report

Inspection Date: Wed, 4 Feb 2026

Property Address: 26 Dowling St, COLAC, VIC, 3250, Australia

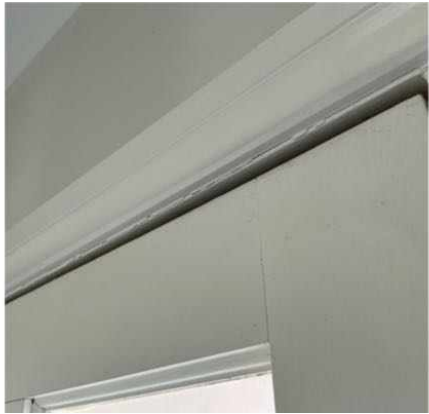
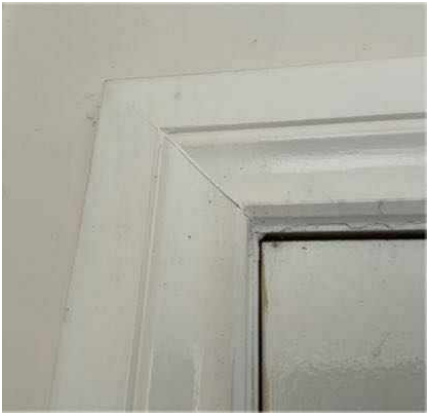
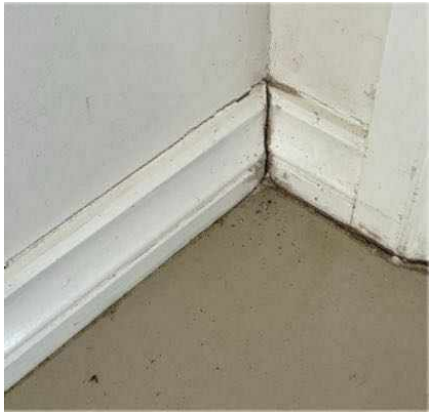
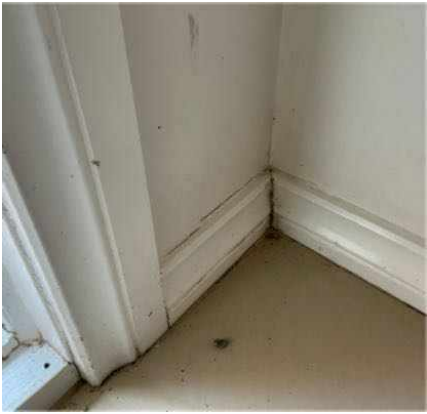
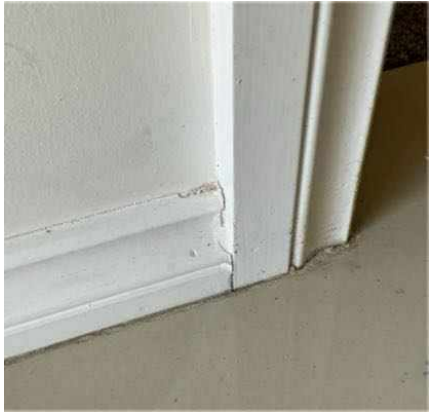
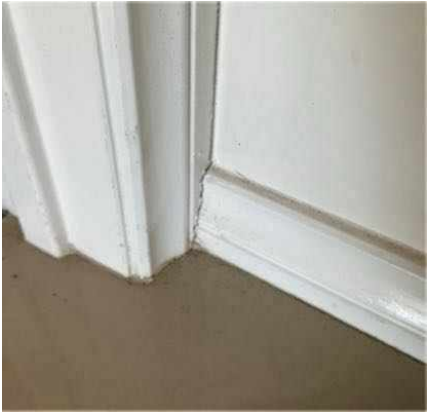
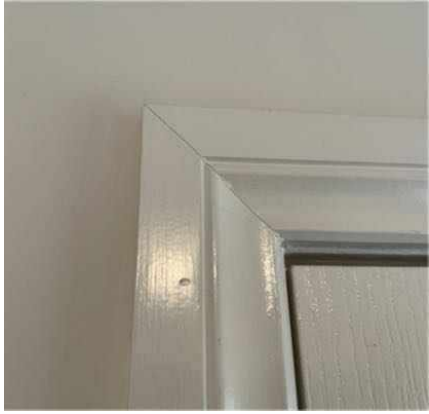
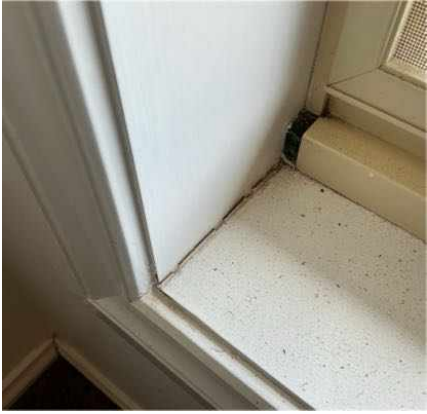
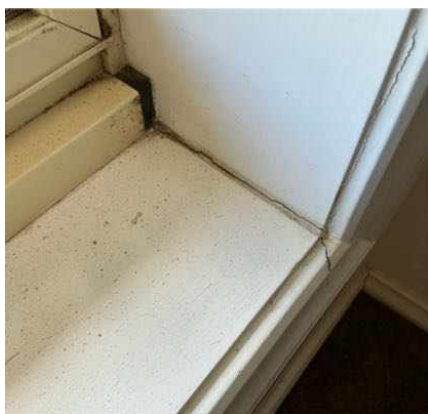
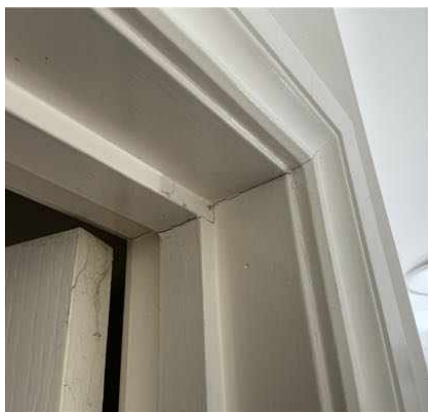
### Defects 3.01

Building:	Main Building
Location:	All Internal Areas
Finding:	Cracking to Painted Architraves and Skirting Boards
Information:	Cracks were observed opening up in various sections of the painted architraves and skirting boards. These cracks may be associated with minor building movement, timber shrinkage, or inadequate surface preparation prior to painting.

- Aesthetic presentation is compromised by visible cracking.
- Potential ongoing movement may lead to further deterioration or require repeated maintenance.
- May indicate underlying workmanship or preparation issues.

This condition is not uncommon following recent painting, particularly in timber joinery, and is typically considered a maintenance item unless associated with significant structural movement.

- Engage a qualified painter or builder to assess the extent of cracking and undertake necessary repairs, which may include filling, sanding, and repainting affected areas.
- Monitor for any signs of worsening or recurring movement over time.

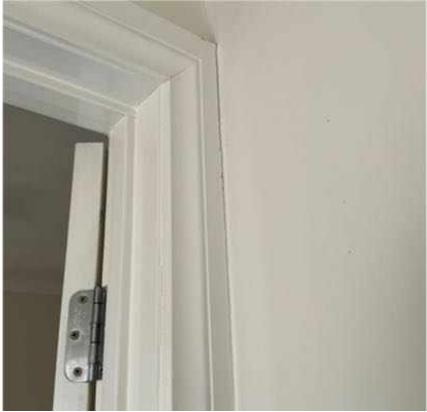
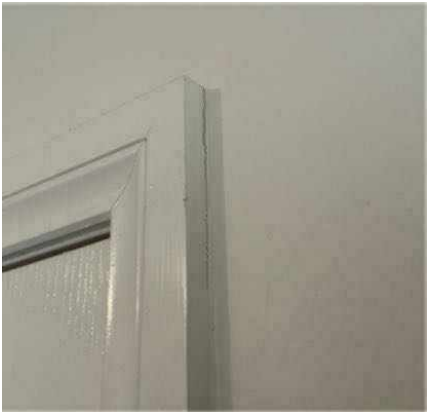
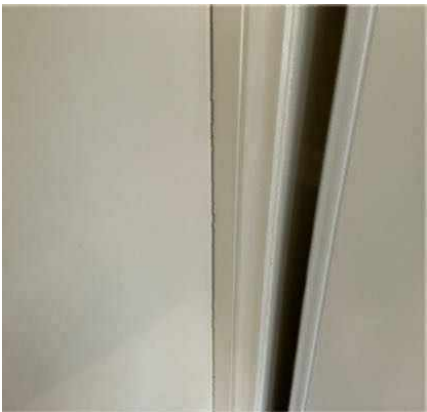
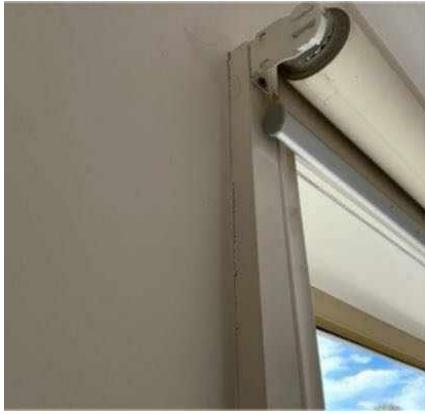
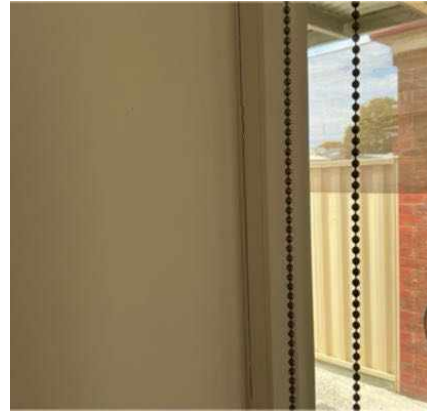
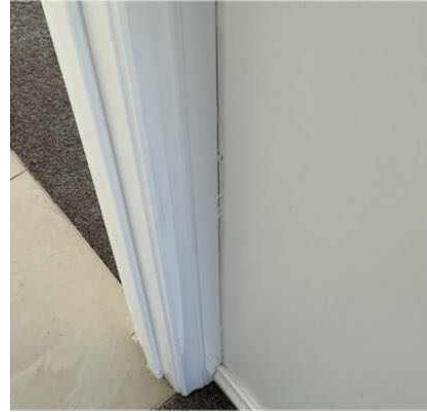
### Defects 3.02

Building:	Main Building
Location:	All Internal Areas
Finding:	Cracking Between Architrave and Wall Junction
Information:	During the inspection, cracking and separation were observed between the architrave and the adjoining wall surface. This condition is commonly caused by normal building movement, minor frame shrinkage, or seasonal expansion and contraction of materials. In some cases, movement may also be influenced by additional loads from attached fittings such as blinds or curtain brackets.

- Cracking detracts from the appearance of internal finishes.
- Minor separation may continue with seasonal changes or building movement.
- Unsealed gaps can collect dust or allow minor moisture staining over time.

The condition appears cosmetic and is typical of normal building movement. It can be readily repaired through routine maintenance and repainting.

- Ensure that any attached fittings are adequately supported to reduce future stress on trim components.

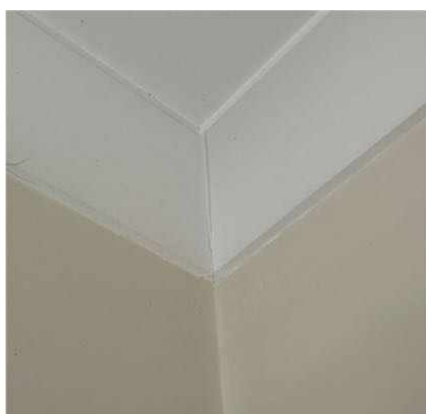
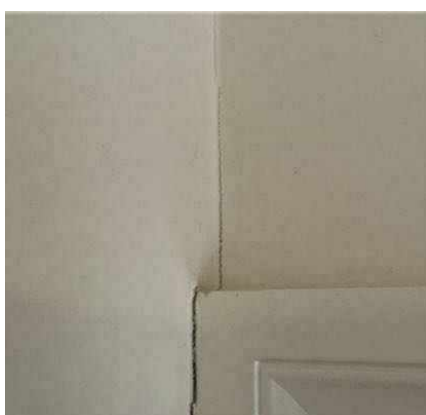
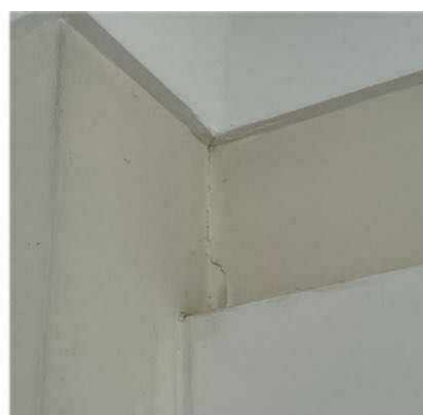
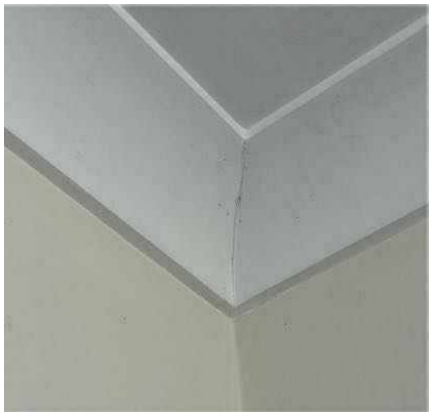
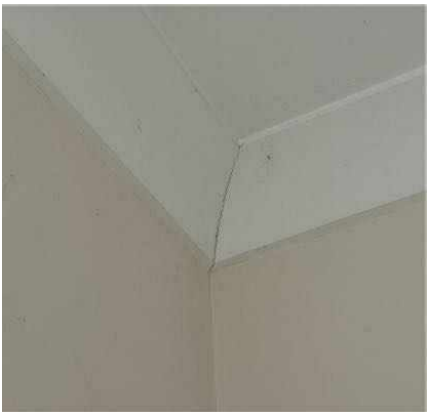
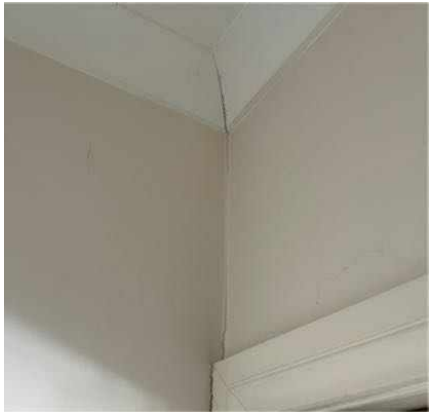
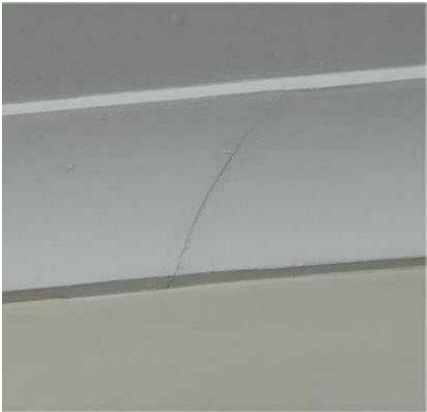
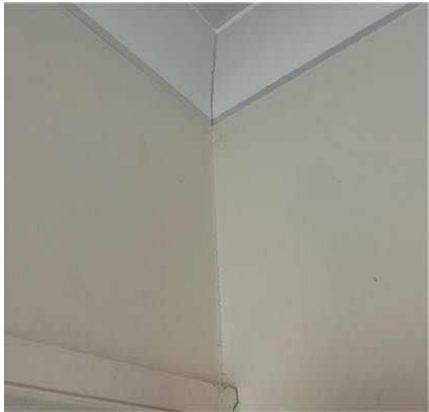
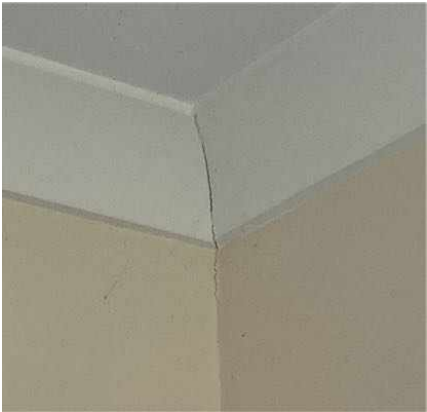
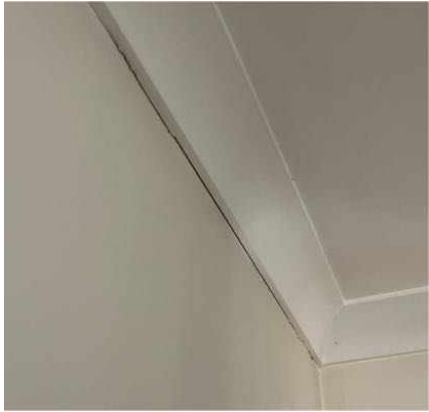
### Defects 3.03

Finding: Cracking to Internal Wall Linings

Information: Cracking was observed to internal wall linings during the inspection. These types of cracks are generally considered common and are typically the result of natural building movement, age-related wear, thermal expansion and contraction, or minor installation-related issues in plasterboard or supporting framing members.

The cracking noted is typical of minor building movement and does not currently present as structural. Regular monitoring and cosmetic repair will assist in preserving the internal presentation and allow early intervention if future issues arise.

- Engage a qualified plasterer to repair cracks and consider installing expansion joints if necessary to accommodate ongoing building movement.
- Arrange for repainting by a qualified painter following any plaster repairs.
- Monitor cracks over time for signs of progression (e.g. widening, lengthening, or new cracks forming).
- If deterioration continues or operational issues with doors/windows arise, seek further assessment from a building inspector or structural engineer.

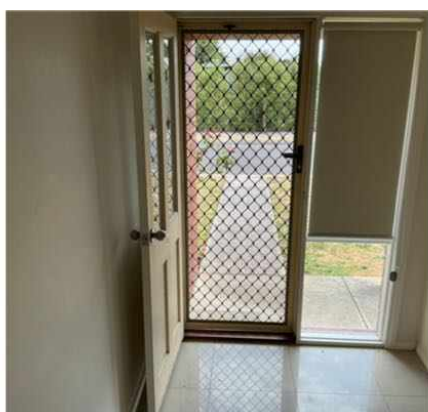
Defects 3.04

Building: Main Building  
 Location: Entry  
 Finding: Missing Bottom Door Seal to External Door  
 Information: During the inspection, it was noted that a bottom door seal had not been installed to one or more external perimeter doors. These seals—such as Raven or similar weather seals—are commonly used in conjunction with perimeter seals to improve the weather-tightness and energy efficiency of the dwelling.

- Gaps at the base of external doors can allow drafts, moisture, dust, insects, and noise to enter the home.
- The absence of door seals can reduce the thermal efficiency of the property and negatively impact the overall energy rating.
- Poorly sealed doors may lead to higher heating and cooling costs due to loss of conditioned air.

- After settlement, engage a competent handyman or carpenter to install bottom and perimeter door seals where missing.
- Select door seals that are compliant with energy efficiency requirements and appropriate for the type of door and threshold.
- Ensure proper installation to maximise effectiveness and longevity.

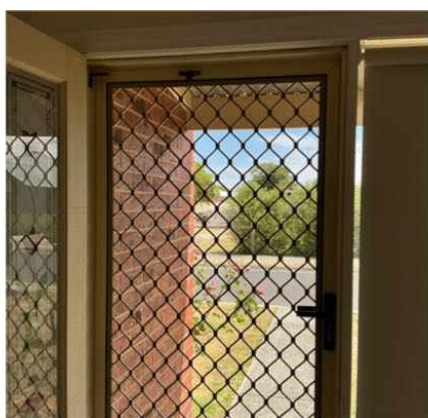
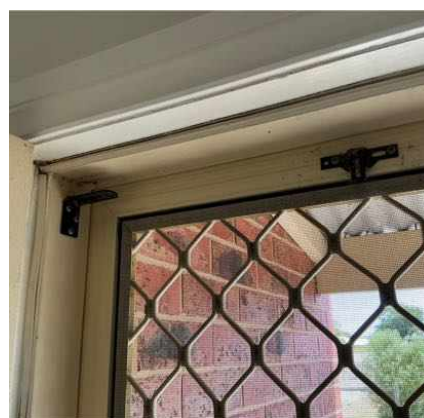
### Defects 3.05

Finding: Security Door – Missing Pneumatic Door Closer (Gas Strut)  
Information: During the inspection, it was observed that the external security door is missing the pneumatic door closer (commonly referred to as a gas strut). As a result, the door does not self-close in a controlled manner and relies entirely on manual operation.

The absence of the door closer affects the intended function of the security door, particularly in controlling door movement and preventing slamming caused by wind or user operation. Over time, this may contribute to increased wear on hinges, fixings, and the door frame.

- Reduced functionality of the security door due to lack of controlled self-closing action.
- Increased likelihood of the door slamming, which may cause damage to hinges, fixings, or surrounding frames.
- Potential safety concern where the door may swing freely in windy conditions.
- Additional maintenance or repair costs if damage occurs over time.

- Install a suitable pneumatic door closer compatible with the existing security door.
- Ensure the closer is correctly adjusted to allow smooth, controlled closing without slamming.
- Have installation carried out by a suitably qualified tradesperson if required.

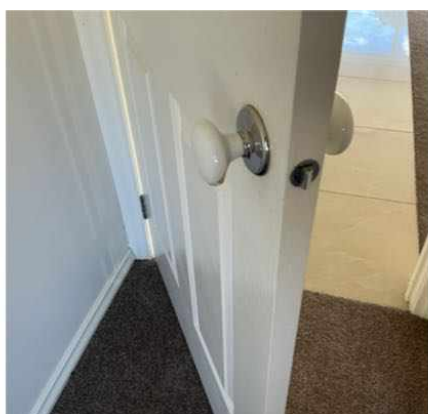
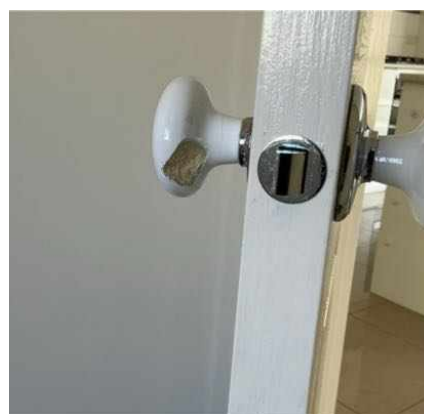
### Defects 3.06

Building: Main Building  
Location: Bedroom  
Finding: Damaged Internal Door Handle  
Information: During the inspection, damage was observed to one or more internal door handles. The damage includes visible chipping and surface deterioration to the handle finish, exposing the underlying material. This condition detracts from the overall presentation of the dwelling and indicates the handle has been subject to impact or poor handling. While the door remains operable at the time of inspection, the damaged finish may worsen with ongoing use.

- Reduced visual presentation and perceived finish quality of the interior.
- Potential for further deterioration of the handle surface with continued use.
- Possible discomfort or minor injury risk if sharp or rough edges develop.

In its current condition, the damaged door handle is considered a defect that should be addressed to maintain an acceptable standard of finish and usability within the dwelling.

- Replace the damaged door handle with a new, matching unit to restore appearance and functionality.
- Check other internal door hardware for similar damage or defects and rectify as required.
- Ensure replacement hardware is securely fixed and operates smoothly.

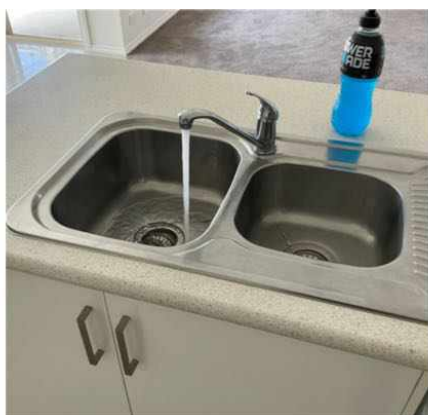
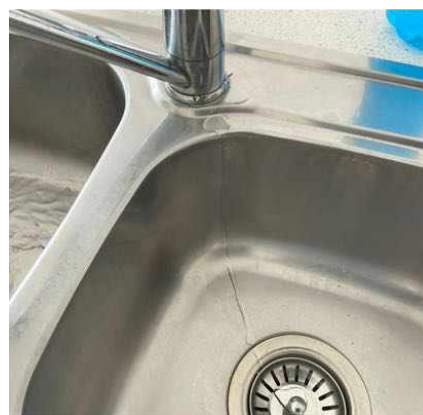
### Defects 3.07

Finding: Kitchen Mixer Tap Leak at Neck  
 Information: The kitchen mixer tap was observed to be leaking from the neck when in use. Water was discharging from the upper section of the fitting rather than solely from the spout, indicating failure of the internal seals or cartridge.

- Continued leakage may worsen over time, leading to increased water wastage.
- Moisture ingress into the bench or cabinetry below could cause swelling, deterioration, or mould development.
- Functionality of the mixer will be further compromised if left unresolved.

- Engage a licensed plumber to service or replace the mixer tap.
- Inspect the cabinetry and surrounding surfaces for signs of moisture damage and repair if required.

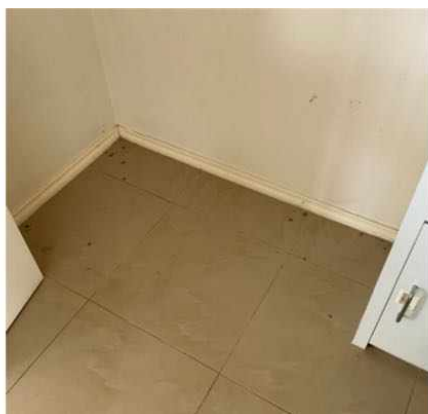
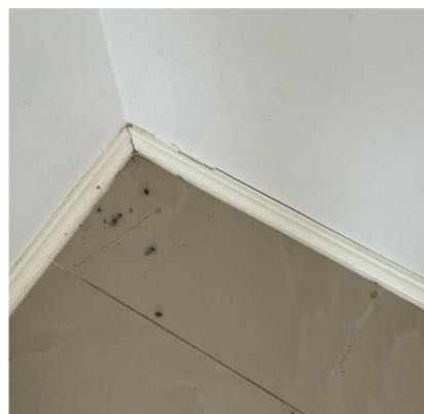
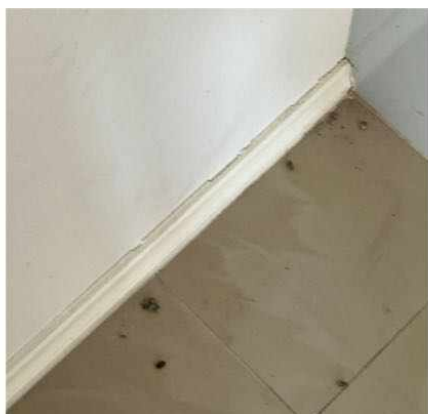
### Defects 3.08

Building: Main Building  
 Location: Laundry  
 Finding: Separation of Skirting Board from Wall Linings – European Laundry  
 Information: During the inspection, separation was observed between the skirting boards and the adjacent wall linings within the European laundry. The skirting boards are pulling away from the wall in several locations, with visible gaps along the top edge and at corner junctions. This condition is inconsistent with an acceptable standard of finish and may be associated with moisture-related movement or elevated humidity levels typically present in laundry environments, as well as inadequate fixing or sealing at the time of

- Gaps between skirting boards and wall linings detract from the overall finish and presentation of the internal space.
- In a laundry environment, separation may be exacerbated by higher moisture or humidity levels, contributing to material movement over time.
- Gaps can allow dirt, debris, and moisture to accumulate behind the skirting, increasing the risk of further deterioration.

- Refix the affected skirting boards to ensure they are securely fixed and flush with the wall linings.
- Seal the junction between the skirting boards and wall linings with an appropriate flexible sealant and repaint as required to achieve a consistent finish.
- Ensure the laundry area is adequately ventilated to minimise ongoing moisture and humidity-related movement.

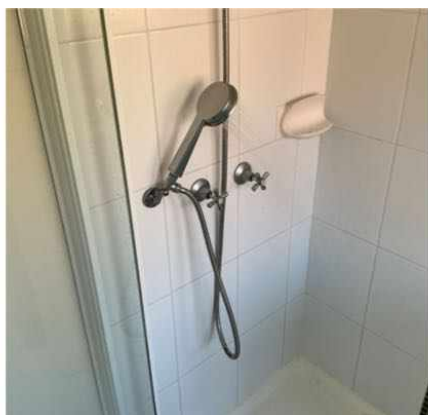
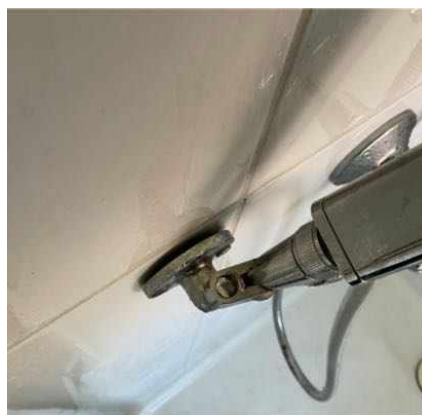
### Defects 3.09

Building:	Main Building
Location:	Bathroom
Finding:	Loose Hand-Held Shower Bracket – Shower
Information:	AreaDuring the inspection, the wall-mounted bracket supporting the hand-held shower head was observed to be loose and inadequately secured to the wall lining. Movement was evident at the fixing point, indicating that the bracket is not firmly anchored to a suitable substrate behind the wall finish.

The loose shower bracket is considered a defect. Rectification is recommended to prevent water ingress, restore proper function, and reduce the risk of ongoing

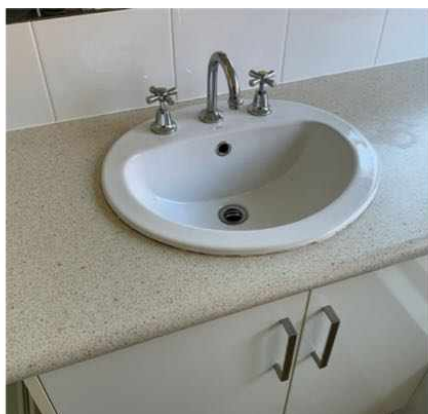
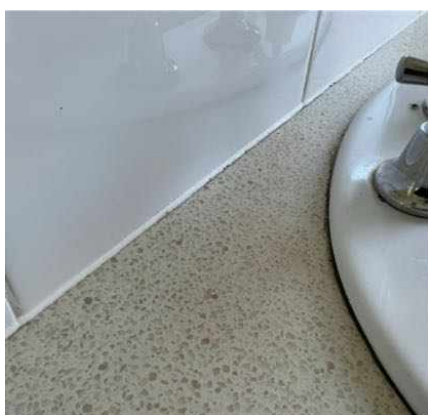
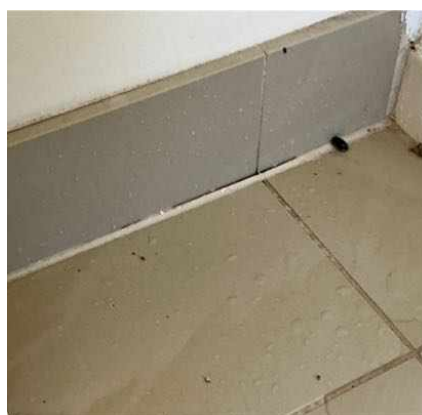
### Defects 3.10

Building:	Main Building
Location:	Bathroom
Finding:	Deteriorated Sealant and Caulking – Bathroom
Information:	During the inspection, the sealant to tiled junctions in the bathroom was found to be significantly deteriorated, with visible cracking, separation, and areas of missing caulking. This condition is typically caused by general ageing, exposure to moisture, and differential movement between adjacent surfaces such as wall tiles, vanity units, benchtops, and skirting boards. The failure of these joints compromises the waterproofing integrity of the wet areas.

The condition of the sealant and caulking requires attention to prevent further deterioration and to maintain waterproofing performance in all wet areas.

- Engage a qualified trade to remove failed sealant and reapply with mould-resistant, flexible waterproof caulking.
- Inspect adjacent grout lines for similar deterioration and re-grout as required.
- Repair or replace any skirting boards or fixtures already affected by water damage.
- Ensure wet areas are adequately ventilated to prevent premature sealant degradation.

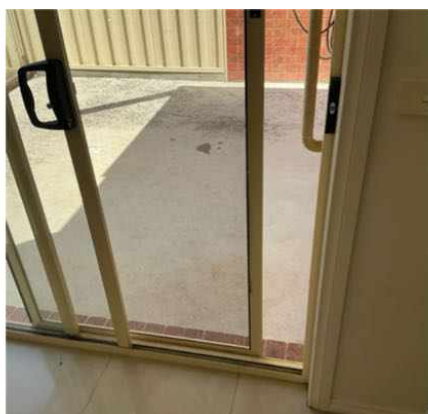
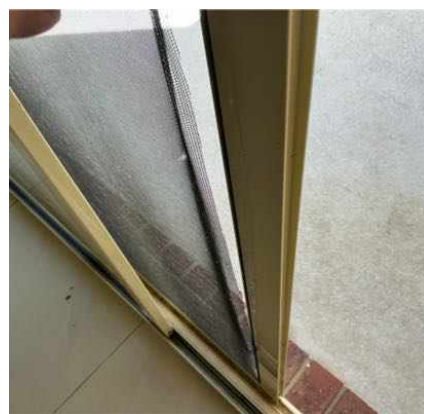
### Defects 3.11

Building:	Main Building
Location:	Sliding Door
Finding:	Damaged Flyscreen Mesh to Sliding Door
Information:	During the inspection, the flyscreen mesh to the sliding door was observed to be damaged and partially pulled free from the frame edge. The mesh is no longer fully retained within the edge channel, resulting in visible gaps and loss of proper tension. This condition indicates deterioration or failure of the mesh retention system.

The flyscreen mesh is defective due to damage and detachment from the frame edge. Rectification is recommended to restore effective insect screening and acceptable presentation.

- Replace the damaged flyscreen mesh and resecure it correctly within the frame retention channel.
- Confirm the frame and spline (or equivalent retention system) are in suitable condition to securely hold the replacement mesh.
- Test operation after repair to ensure the mesh remains properly tensioned and retained.

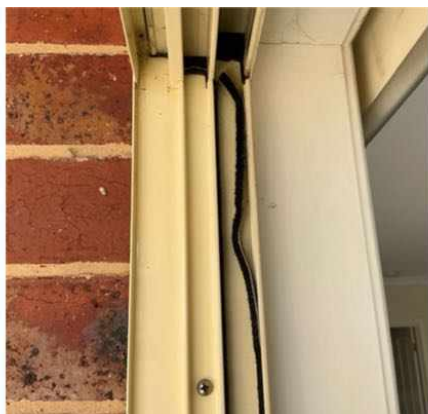
### Defects 3.12

Building:	Main Building
Location:	Sliding Door
Finding:	Sliding Door – Deteriorated / Dislodged Felt Weather Seal
Information:	During the inspection, the felt weather seal to the sliding door was observed to be displaced and no longer seated correctly within the door frame. The seal appears partially detached and uneven, reducing its effectiveness as a barrier between the internal and external environments.

While this issue is not structural, rectification is recommended to restore the intended weatherproofing, functionality, and performance of the sliding door.

- Refit or replace the felt weather seal to ensure it is continuous, secure, and correctly aligned.
- Confirm the door operates smoothly after rectification without binding or excessive gaps.
- Use manufacturer-compatible replacement seals where applicable.

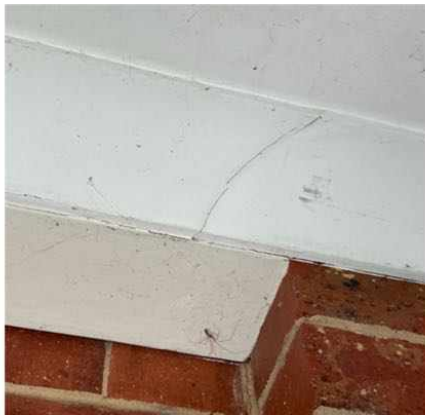
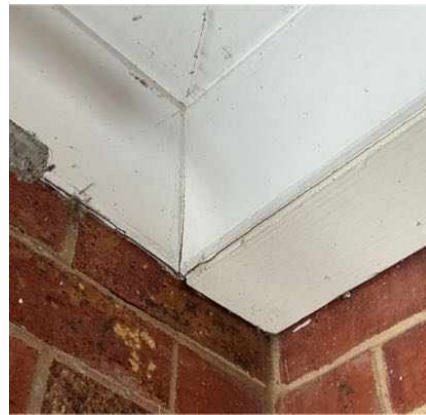
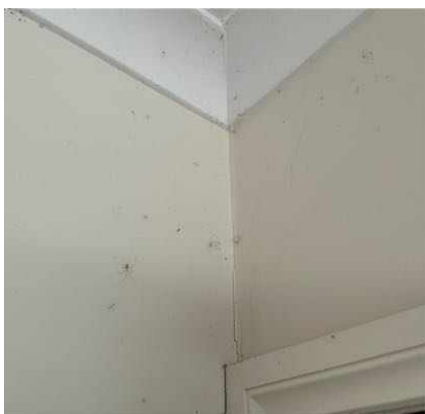
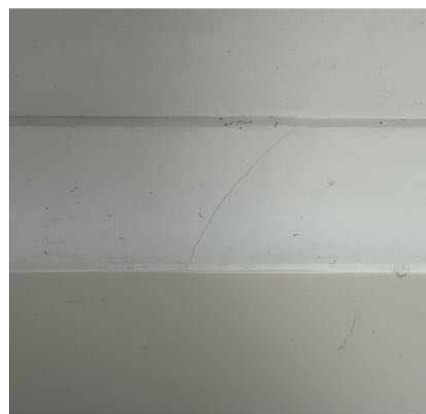
### Defects 3.13

Building:	Garage
Location:	Garage
Finding:	Cracking to Internal Wall Linings
Information:	Cracking was observed to internal wall linings during the inspection. These types of cracks are generally considered common and are typically the result of natural building movement, age-related wear, thermal expansion and contraction, or minor installation-related issues in plasterboard or supporting framing members.

The cracking noted is typical of minor building movement and does not currently present as structural. Regular monitoring and cosmetic repair will assist in preserving the internal presentation and allow early intervention if future issues arise.

- Arrange for repainting by a qualified painter following any plaster repairs.
- Monitor cracks over time for signs of progression (e.g. widening, lengthening, or new cracks forming).
- If deterioration continues or operational issues with doors/windows arise, seek further assessment from a building inspector or structural engineer.

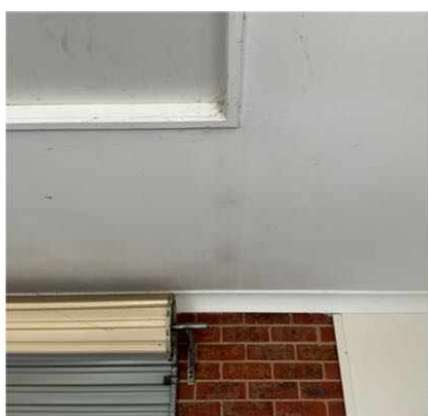
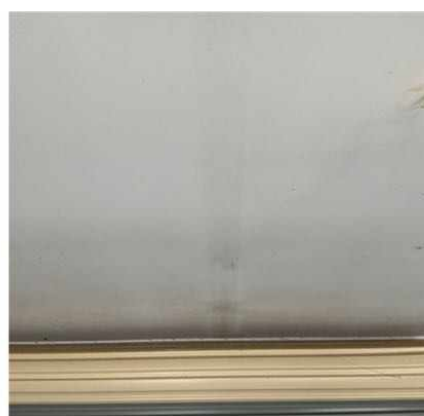
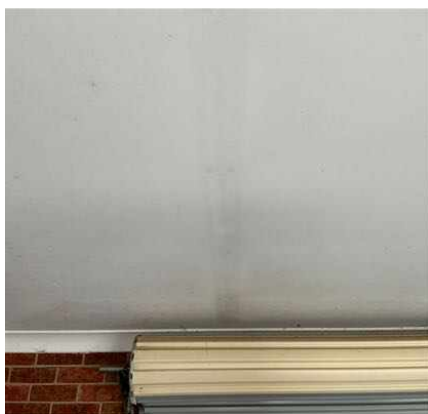
Based on the inspection at the time, the observed markings appear consistent with thermal and environmental effects rather than a structural or moisture-related failure.

- Monitor the ceiling for any changes, including spreading stains or signs of moisture.
- If appearance is a concern, cleaning and repainting may improve the visual condition.
- Improving insulation and ventilation above the garage ceiling may help reduce temperature differentials and limit recurrence.

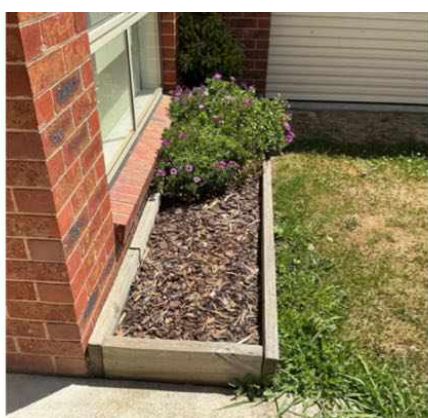
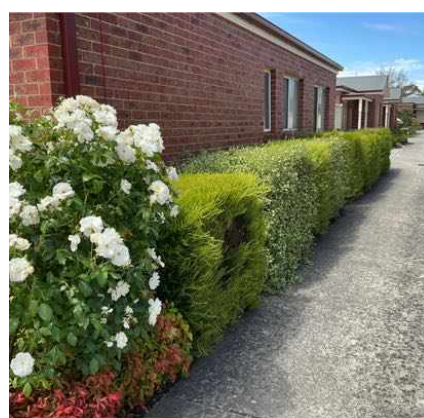
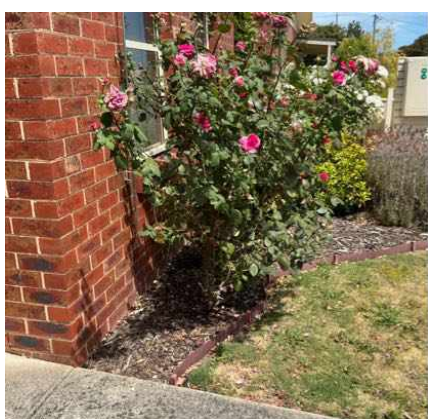
To prevent deterioration of building elements and maintain proper ventilation and drainage, garden beds must be modified to ensure adequate clearance and separation from the dwelling.

- Ensure vents are unobstructed and free of soil, vegetation, or leaf litter to enable adequate airflow
- Consider installing edging or root barriers to separate planting areas from the dwelling perimeter
- Regularly clear and maintain drainage paths to prevent water pooling at the base of the building

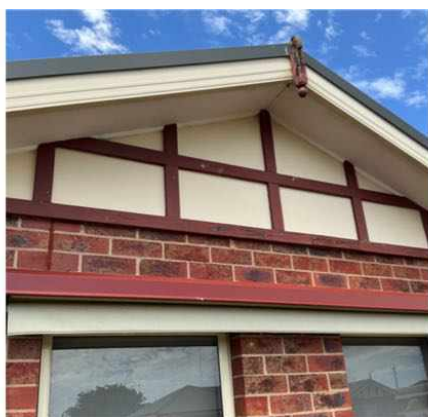
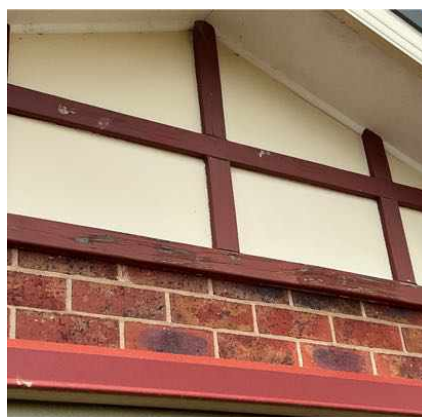
### Defects 3.18

Building:	Main Building
Location:	Front Gable
Finding:	Deteriorated External Paintwork
Information:	During the inspection, multiple external areas—including timber window frames, fascias, guttering, veranda components, and other fixtures—were noted to have deteriorated, incomplete, or missing paintwork. While often considered cosmetic, the lack of adequate surface protection significantly increases the risk of weather-related

Although primarily maintenance-related, deteriorated paintwork can accelerate material failure if left unattended. Prompt rectification will improve both durability and presentation.

- Engage a qualified painter to assess and repaint all affected areas using appropriate exterior-grade, weather-resistant coatings.
- Prior to painting, ensure damaged or decayed materials are repaired or replaced by licensed tradespersons.
- Incorporate repainting into a comprehensive post-settlement exterior maintenance plan to protect materials and preserve the home's appearance.
- Schedule routine inspections and touch-ups every few years to maintain surface protection and extend the lifespan of external finishes.

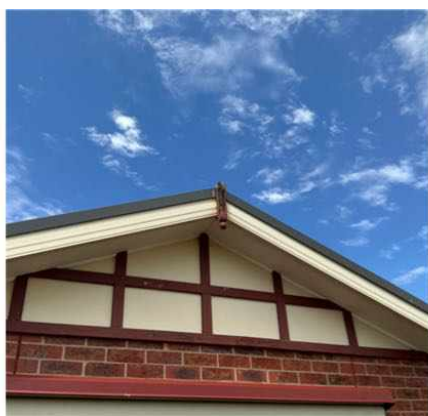
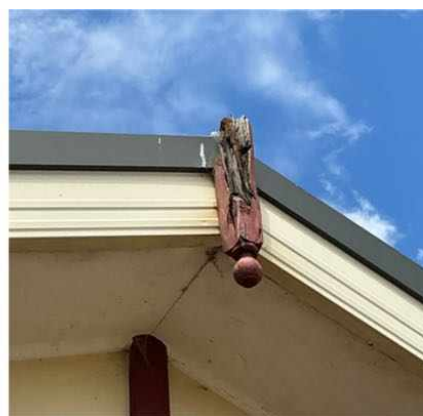
**Defects 3.19**

Building:	Main Building
Location:	Front Gable
Finding:	Deteriorated Decorative Finial to Gable End
Information:	During the inspection, the decorative timber finial located at the gable end was observed to be incomplete, with the upper portion missing and the remaining timber exhibiting advanced decay. The exposed timber shows clear signs of weathering and rot, likely due to prolonged exposure to moisture and the absence of adequate protective coatings. The deteriorated condition indicates the element is no longer performing as intended and is continuing to degrade.

In summary, the gable-end finial is incomplete and affected by timber decay. Remedial works are recommended to address the deterioration, prevent further damage, and restore the integrity and appearance of the gable end.

- Remove the remaining decayed finial and assess the condition of the underlying fixing point and adjacent timber.
- Replace the finial with a new, appropriately detailed element or make good the gable end to a durable, weather-resistant finish.
- Ensure all exposed timber is properly sealed, painted, or otherwise protected to reduce future moisture ingress and decay.

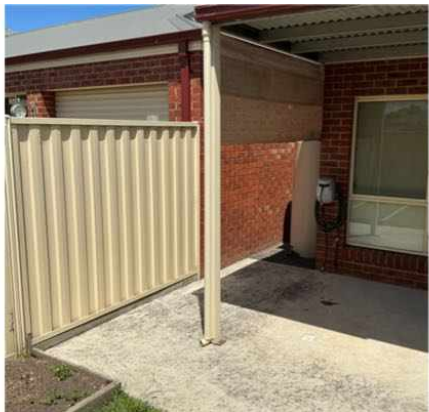
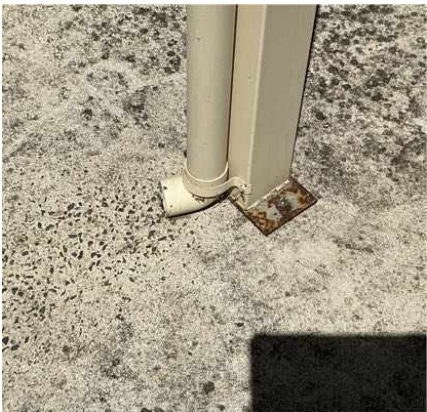
## Defects 3.20

Building:	Main Building
Location:	Pergola
Finding:	Disconnected Downpipes – Inadequate Stormwater Management
Information:	During the inspection, it was observed that multiple downpipes are not connected to a compliant stormwater drainage system. Roof runoff is discharging directly onto the ground adjacent to the structure, which undermines effective site drainage and may contribute to future moisture-related concerns.

Effective stormwater discharge is critical in preventing long-term structural and environmental issues. Rectification should be prioritised to mitigate potential damage and ensure regulatory compliance.

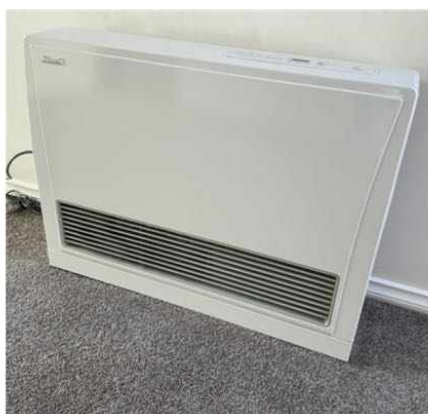
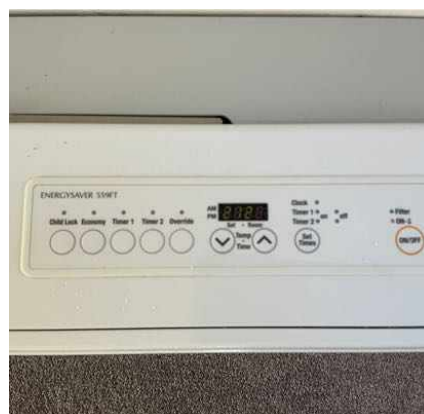
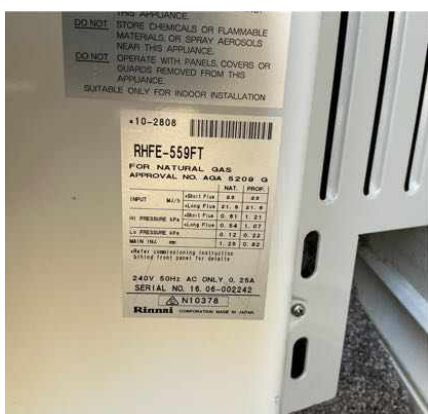
### Noted Item

Building: Main Building  
 Location: Living Room  
 Finding: Servicing and Safety of Gas Wall Heaters  
 Information: It is strongly advised that all gas wall heaters within the property are regularly serviced and maintained by a licensed and registered plumber. Over time, gas appliances can become inefficient or develop faults, which may lead to serious safety hazards such as carbon monoxide leaks, fire risk, or poor combustion efficiency.

While a visual assessment of gas appliances is included in this report, their operation, compliance, and safety can only be verified by a licensed plumbing professional. A qualified inspection and servicing should be treated as a priority to ensure occupant safety.

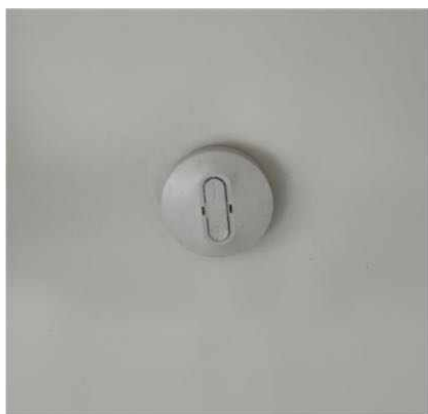
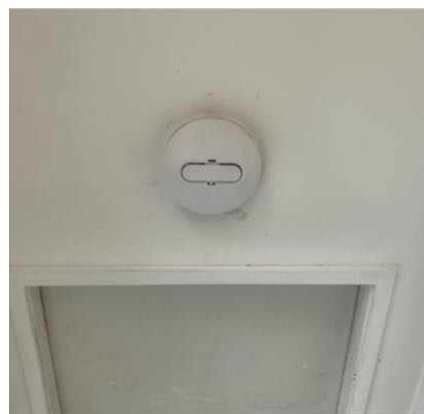
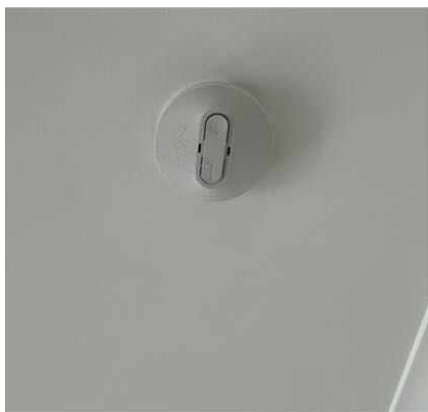
**Noted Item**

Ensuring smoke detectors meet current requirements is essential to protect future occupants and comply with legal obligations following possession of the property.
