## Building Inspection Report

Inspection Date: Fri, 6 Mar 2026

Property Address: 1 Walsh St, West Melbourne VIC 3003,  
Australia

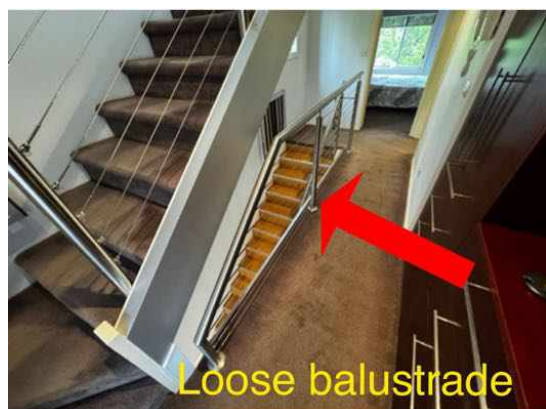
## Defects 1.02

Building: Main Building  
 Location: Hallway > Level 2  
 Finding: Staircase Balustrade – Loose Section  
 Information: The staircase balustrade located in the Level 2 hallway was observed to be slightly loose on one side during inspection, while the opposite side appeared to be firmly fixed. Balustrades are critical safety elements designed to prevent falls from elevated areas such as staircases and landings.

Any looseness or movement in a balustrade can compromise its effectiveness and presents a potential safety risk to occupants. If the balustrade is subjected to force, it may fail to perform as intended and increase the risk of injury from a fall.

- Loose staircase balustrade (Level 2):

A section of the internal staircase balustrade on Level 2 was observed to be loose on one side, presenting a potential fall hazard for occupants if not rectified.

It is recommended that the balustrade be inspected and securely fixed by a qualified builder or carpenter to ensure it is rigid and compliant with safety requirements for stair balustrades.

Immediate – Rectification is recommended as soon as practicable due to the potential fall hazard associated with loose balustrading.

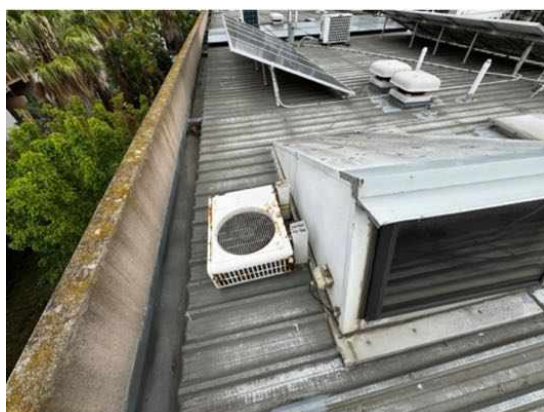
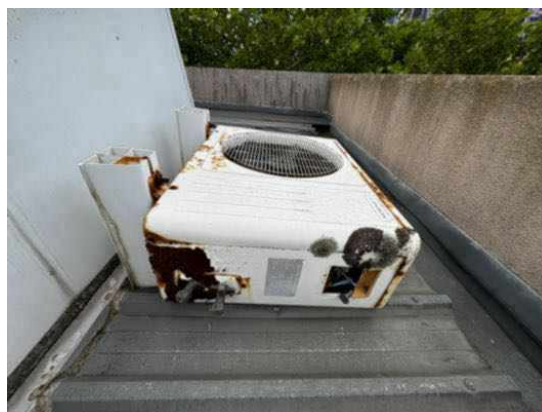
## Defects 1.03

Building: Main Building  
 Location: Roof Exterior > Rear  
 Finding: Disused Air Conditioner Condenser Unit – Unsecured on Roof  
 Information: An old and disused air conditioner condenser unit was observed on the roof lying flat on its back and visibly corroding. The unit appears to have been left behind following the installation of a newer air conditioning system and was not removed from the rooftop.

At the time of inspection, the condenser unit appeared to be unsecured and simply resting on the roof surface, with no visible fixings or restraints. Loose or unsecured equipment on roof areas may shift during high winds or severe weather conditions, potentially causing damage to the roof covering or falling from height. This condition therefore presents a potential safety hazard and may also contribute to premature deterioration of the roof surface if left in place.

- Unsecured disused air-conditioning condenser on roof:

An old and redundant air-conditioning condenser unit was observed lying unsecured on the roof and showing signs of corrosion. The unit appears to have been abandoned following installation of a replacement system and may shift during adverse weather conditions, posing a potential safety risk and risk of damage to the roof covering.

It is recommended that the redundant condenser unit be safely removed from the roof by a qualified contractor or HVAC technician. If the unit is to remain in place for any reason, it should be properly secured to an appropriate mounting system in accordance with manufacturer and installation requirements.

Immediate, as unsecured equipment on roof areas poses a potential safety risk and may cause damage to the building during adverse weather conditions.

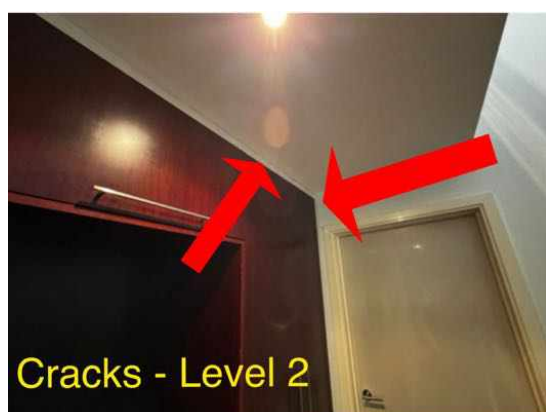
### Defects 2.01

Building:	Main Building
Location:	All Areas > All Areas
Finding:	Structural Movement – Cracking to Walls and Floor Level Variations
Information:	Cracking was observed to several areas of the building, both internally and externally, across multiple levels of the townhouse. The cracking was most prominent on Level 2, where plaster cracking was visible to both ceilings and walls within the north and south bedrooms. Minor cracking was also observed on Level 1, while the ground floor garage showed cracking to the blockwork on the east side of the building, including diagonal hairline cracking through sections of the masonry.

found to have floor level variations of up to 25mm over spans of approximately 4 metres, which indicates noticeable deviation within relatively short distances.

Additionally, evidence of previous repair work was observed to the external concrete wall on the east side of the building facing the footpath. The area appeared patched and repainted, suggesting earlier crack repairs had been carried out.

Given the extent of cracking observed across multiple levels, the measurable variation in floor levels, and the separation noted at the balcony junction, the condition is considered a Major Defect under the principles of AS 4349.1–2007 as it indicates possible structural movement that may affect the stability or serviceability of building elements.

These conditions indicate suspected structural movement, and it is recommended that the property be assessed by a qualified structural engineer to determine the cause and appropriate remediation.

It is strongly recommended that a qualified structural engineer be engaged to assess the building structure, identify the cause of the movement, and determine whether structural remediation or monitoring is required. The engineer should specifically assess the balcony separation, floor level variations, and cracking patterns throughout the building.

Further structural investigation recommended in the short term due to the extent of movement observed.

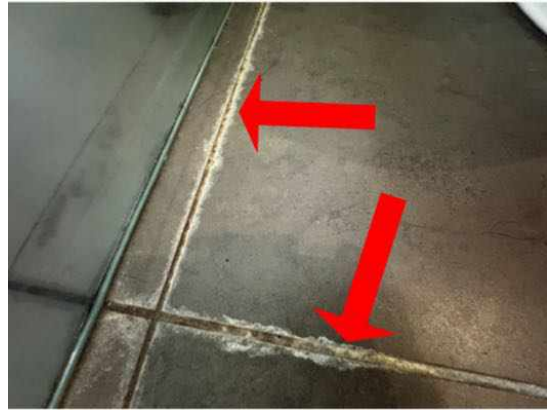
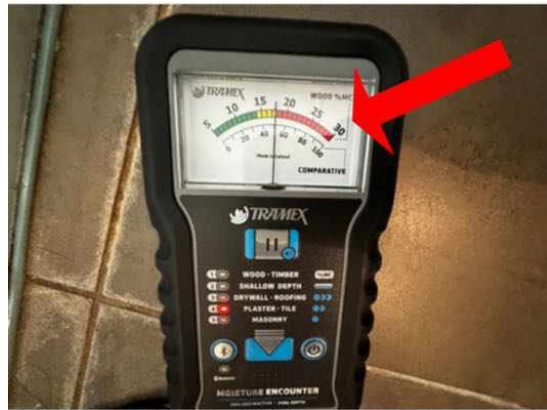
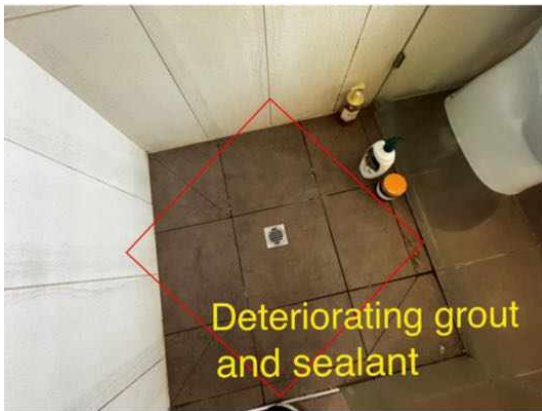
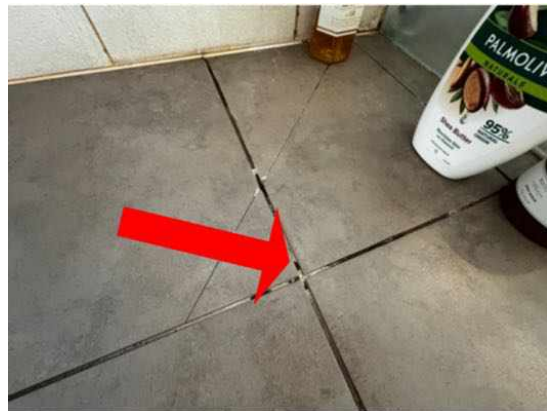
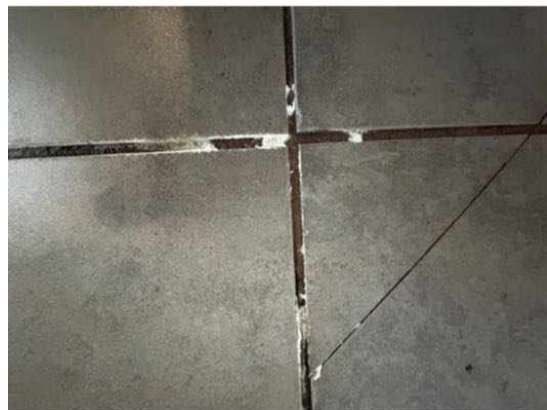
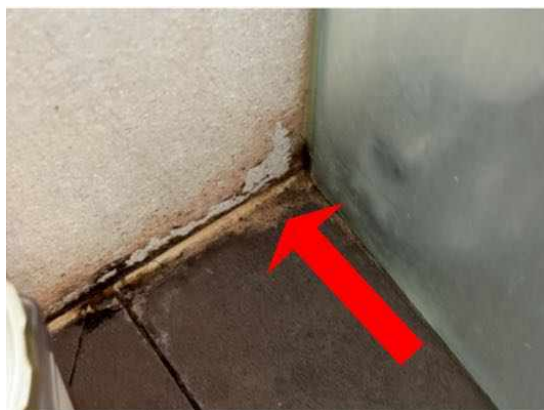
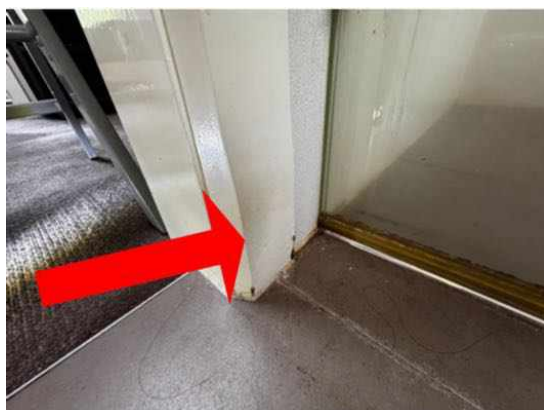
Defects 2.02

Building: Main Building  
Location: Ensuite - Master > Level 3  
Finding: Wet Area Moisture Ingress – Level 3 Ensuite Shower Area  
Information: Elevated moisture levels were detected to the floor tiles in the Level 3 ensuite bathroom, particularly around the external perimeter of the shower screen. Moisture readings were obtained using a moisture meter and were concentrated mainly in areas outside the shower enclosure.

Visible efflorescence was observed on the floor tiles adjacent to the shower screen, indicating prolonged moisture migration through the tile or grout system. Additionally, the architrave to the door jamb directly adjacent to the shower screen showed visible signs of moisture damage, including swelling and early deterioration of the timber element.

The condition of the grout and sealant within the shower enclosure was poor, with heavily deteriorated joints noted during inspection. Deterioration of grout and sealant can allow water to bypass the tiled surface and migrate into surrounding building elements.

It was also noted that no visible water stop could be identified beneath the shower screen threshold during the inspection. Without a visible water stop, water can escape the wet area and migrate into adjoining floor areas. The compliance of the waterproofing system within this bathroom could not be verified, as the waterproofing membrane is concealed beneath the tiled surface.

Given the presence of elevated moisture readings, efflorescence, deterioration of timber joinery, and degraded grout and sealant conditions, this defect is considered a Major Defect under the principles of AS 4349.1–2007, as it indicates ongoing moisture ingress that may lead to concealed damage to floor substrates, framing and surrounding building elements.

It is recommended that a licensed plumber or waterproofing specialist undertake further investigation to determine the source of the moisture ingress. This may require invasive inspection of the shower base and waterproofing system. Rectification works may include repair or replacement of grout and sealants, installation of a compliant water stop if missing, and potential remediation of the waterproofing system if found to be defective. Damaged architraves and adjacent building elements should be repaired once the moisture issue has been resolved.

Immediate – Rectification is recommended as soon as practicable to prevent further moisture migration and potential deterioration of concealed structural and finishing elements.

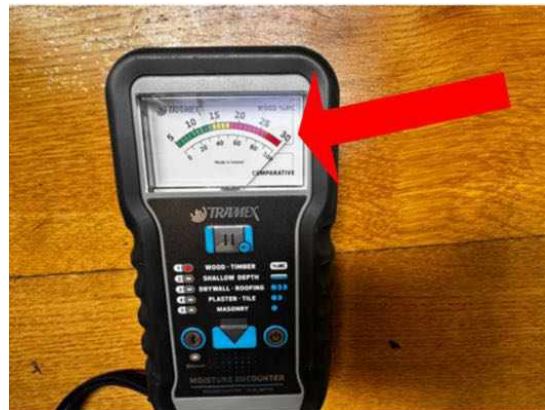
## Defects 2.03

Building:	Main Building
Location:	Kitchen > Level 1
Finding:	Timber Floor Moisture Damage – Kitchen Courtyard Door
Information:	Elevated moisture levels were detected to the timber floorboards in the kitchen area directly in front of the door leading to the external courtyard. Moisture testing was conducted using a moisture meter, which returned high readings to the timber flooring immediately behind the door threshold.

Visible signs of moisture damage were also observed to a small section of the timber flooring in this location, including deterioration and discolouration of the floorboards. The pattern and location of the moisture damage suggest that water may be entering beneath the door during rainfall events. However, other possible causes such as inadequate door sealing, drainage issues at the external threshold, or other moisture ingress sources cannot be ruled out at this stage.

Timber flooring exposed to ongoing moisture can deteriorate over time, leading to swelling, warping and potential damage to the underlying subfloor or surrounding building elements.

It is recommended that the courtyard door threshold and external drainage conditions

be assessed to determine whether rainwater is entering beneath the door. Improvements may include installing or replacing door seals, adjusting the door threshold, or improving external drainage away from the doorway. Damaged timber flooring should be repaired or replaced once the moisture source has been identified and rectified.

Immediate – Investigation and rectification are recommended as soon as practicable to prevent further moisture ingress and deterioration of the timber flooring and surrounding building elements.

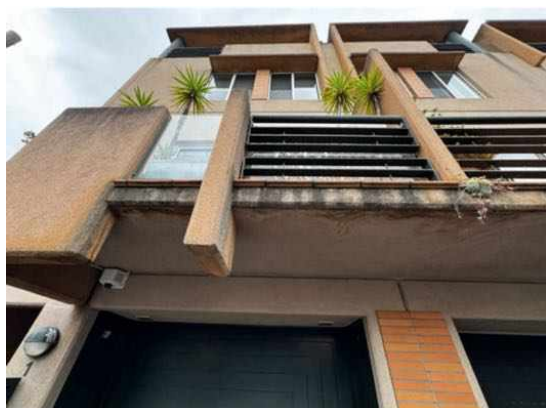
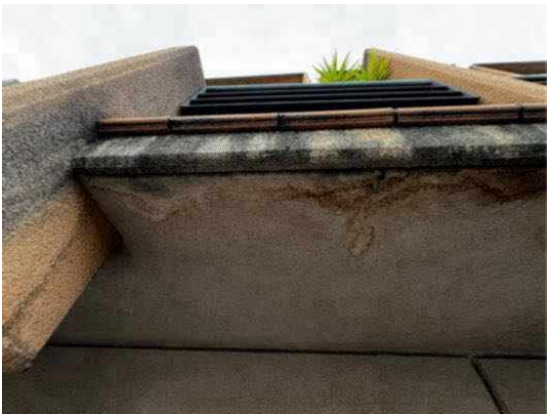
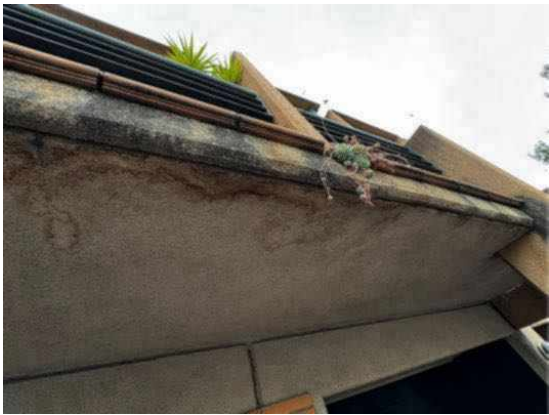
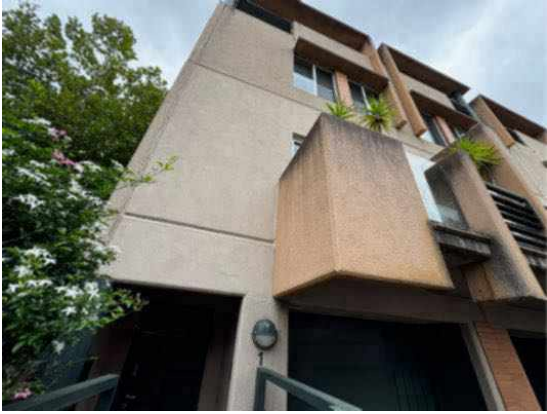
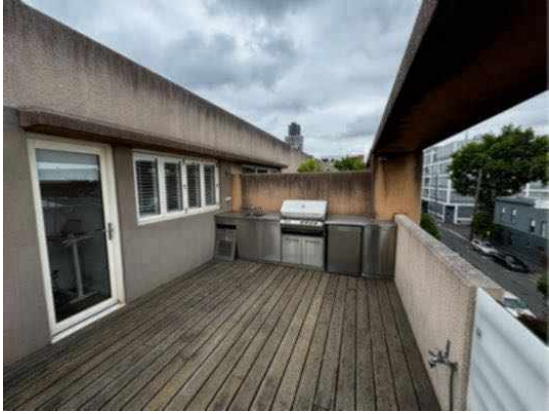
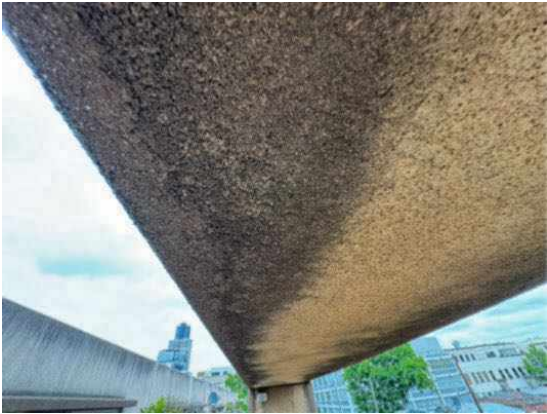
### Defects 3.01

Building: Main Building  
 Location: All Areas > All Areas  
 Finding: External Defects – Concrete Walls, Steel Columns and Terrace Kitchen Junctions  
 Information: The following external defects were observed during the inspection:

Accumulation of dirt, grime, mould and moisture staining was observed to the external

concrete panel walls, including areas around balconies and terrace spaces. The staining appears consistent with prolonged exposure to weather conditions combined with a lack of routine maintenance and cleaning.

Peeling paint was observed to the steel columns supporting the top floor terrace. Deterioration of protective paint coatings can expose steel elements to moisture, potentially leading to corrosion over time if not maintained.

The outdoor kitchen located on the top floor terrace was observed to have gaps at junction points where the kitchen structure meets the surrounding walls. These junctions require sealing with an appropriate flexible sealant to prevent moisture ingress.

Additionally, pipe penetrations beneath the outdoor kitchen bench were observed to have visible gaps, with sections of the wall cavity clearly visible. Although located beneath the bench, these penetrations should be sealed to prevent potential moisture ingress and to reduce the risk of pest entry into the building envelope.

It is recommended that the external concrete surfaces be professionally cleaned to remove mould and grime. Steel columns should be prepared and repainted with an appropriate protective coating to prevent corrosion. Junctions around the outdoor kitchen and pipe penetrations should be sealed with suitable exterior-grade sealant to close gaps and protect the building envelope.

Maintenance recommended in the short to medium term.

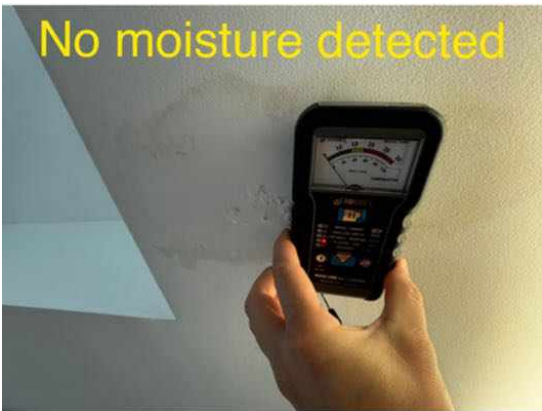
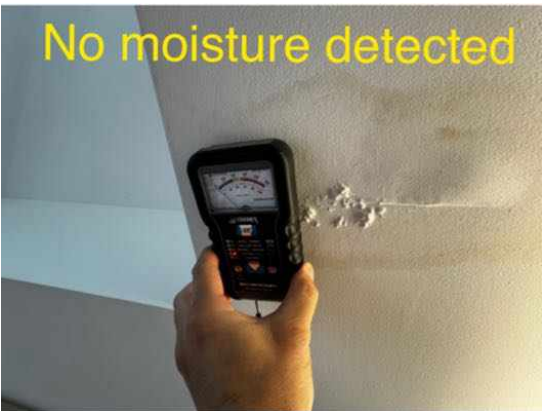
### Defects 3.02

Building:	Main Building
Location:	Bedroom - Master > Level 3
Finding:	Roof Leak – Reported Historical Moisture Damage to Level 3 Bedroom Ceiling
Information:	Evidence of moisture damage was observed to the ceiling of the bedroom on Level 3 on the south side of the building. The damage consisted of visible staining and deterioration to sections of the plaster ceiling lining.

According to the tenant, the damage was caused by a previous roof leak, which has reportedly been repaired. Moisture testing was undertaken using a moisture meter in the affected ceiling areas and no elevated moisture readings were detected at the time of inspection, suggesting that the leak is not currently active.

Inspection of the roof above the affected area revealed that several sections of the metal roof sheeting had previously been repaired using sealant where dents and damage to the roof sheets were present. Sealant-based repairs are typically considered temporary in nature and their long-term effectiveness cannot be guaranteed. The durability of these repairs is therefore uncertain.

It is recommended that the previously repaired roof sheet areas be periodically monitored, particularly during and after rainfall events, to ensure that water ingress does not recur. If leaks return, a licensed roofing contractor should be engaged to undertake permanent repairs, which may include replacement of damaged roof sheets. Once the roof is confirmed to be watertight, the internal ceiling plaster damage should be repaired and repainted.

Monitoring recommended in the short to medium term, particularly following rainfall events. Internal repairs may be undertaken once the roof is confirmed to be fully watertight.

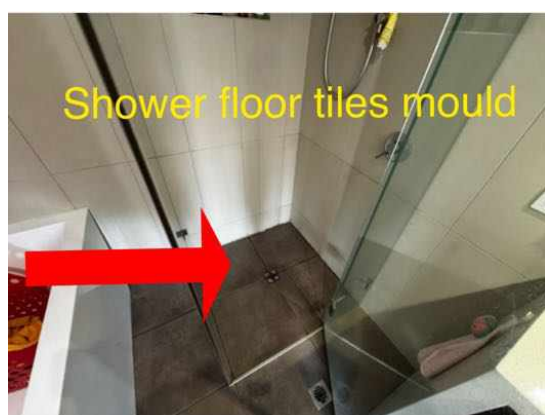
Defects 3.03

Building: Main Building  
Location: Ensuite - Other > Level 2  
Finding: Ensuite Shower – Mould Build-Up to Floor Tiles  
Information: Mould build-up was observed on the floor tiles within the ensuite shower on Level 2. The mould appears consistent with a lack of regular cleaning and maintenance within the shower enclosure.

Accumulation of mould, dirt and grime can retain moisture on tiled surfaces and within grout lines. Over time, this condition may accelerate the deterioration of grout joints and sealants at wall-to-floor junctions and around tiled surfaces. Deteriorated grout and sealant can eventually allow moisture to penetrate behind tiled finishes and potentially affect surrounding building elements.

At the time of inspection, the condition appeared superficial and related to hygiene and maintenance rather than a structural or waterproofing failure.

It is recommended that the affected shower area be thoroughly cleaned using appropriate mould-removal products. Grout joints and sealant lines should be inspected following cleaning and repaired or replaced if deterioration is identified. Ongoing regular cleaning and ventilation of the bathroom is recommended to prevent recurrence.

Maintenance recommended in the short to medium term as part of routine upkeep.

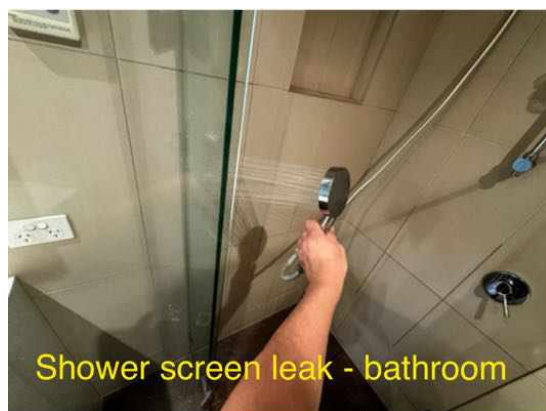
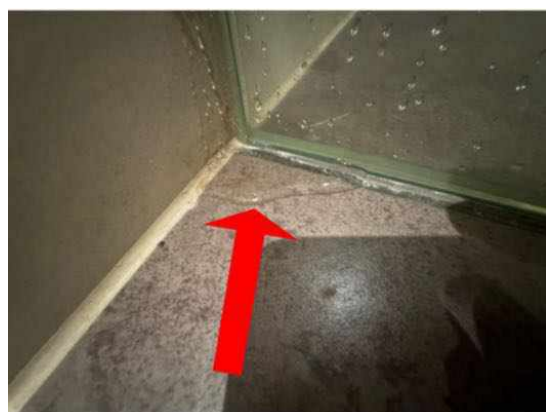
### Defects 3.04

Building: Main Building  
 Location: Bathroom > Level 2  
 Finding: Shower Screen Leakage – Level 2 Main Bathroom  
 Information: A minor leak was identified to the shower screen in the Level 2 main bathroom during testing. A water test was conducted using the shower rose, and when water was directed toward the wall and shower screen junction, a small amount of water was observed leaking from the corner of the shower screen onto the bathroom floor tiles.

The leak appears to be associated with deteriorated or failed sealant at the junction between the wall tiles and the shower screen frame. Sealant at these junctions forms part of the water containment system of the shower enclosure, and deterioration can allow water to escape the enclosure during use.

At the time of inspection, the leak appeared minor in nature; however, if left unaddressed it may allow ongoing moisture exposure to surrounding floor areas and adjacent building elements.

It is recommended that the affected junctions be cleaned and re-caulked using an appropriate waterproof sanitary-grade sealant to ensure a watertight seal. The shower should be retested after resealing to confirm the leak has been rectified.

Maintenance recommended in the short term to prevent potential moisture-related deterioration.

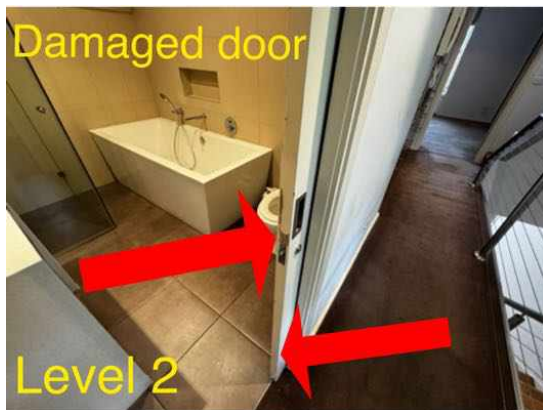
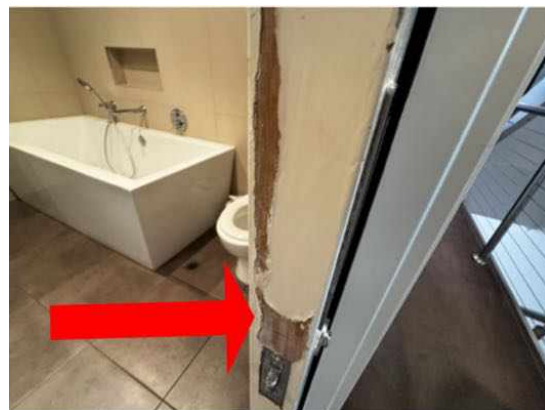
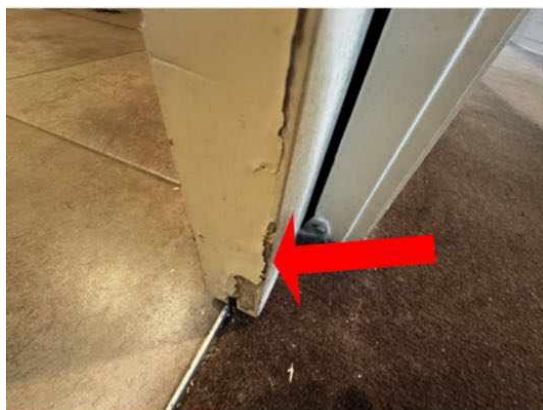
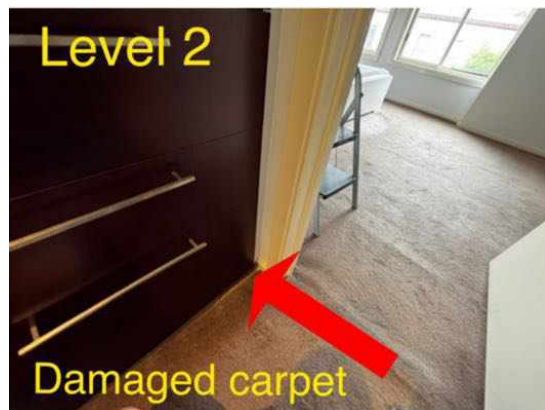
### Defects 3.05

Building:	Main Building
Location:	All Areas > All Areas
Finding:	Minor Internal Defects – Doors, Carpet and Garage Wall
Information:	The following internal defects were observed during the inspection:

A damaged door to the Level 2 main bathroom was noted. Sections of paint were peeling and the door surface appeared to be delaminating. This condition is consistent with deterioration of the door finish and may be related to prolonged exposure to moisture or general wear and tear.

Damage to the carpet was observed in the Level 2 hallway, where a narrow strip of carpet abutting joinery was lifting and separating from the join. The defect appears related to poor adhesion or wear and may worsen with continued foot traffic.

Damage was also observed to the garage wall near the floor-to-wall junction on the right-hand side of the laundry area. The damage appeared consistent with historical moisture exposure. Moisture testing was conducted using a moisture meter and no

elevated readings were detected at the time of inspection, suggesting the condition is likely historical and not currently active.

These defects are considered cosmetic or minor maintenance items.

It is recommended that the bathroom door be repaired or replaced as required. The affected carpet section should be re-secured or replaced to prevent further deterioration. The damaged garage wall area should be repaired and repainted as part of routine maintenance, and the area monitored for any signs of recurring moisture.

Maintenance recommended in the short to medium term as part of routine upkeep.
