Building and Timber Pest Inspection Report

Inspection Date: Fri, 13 Mar 2026

Property Address: 169 Wallarah Rd, Gorokan NSW 2263, Australia

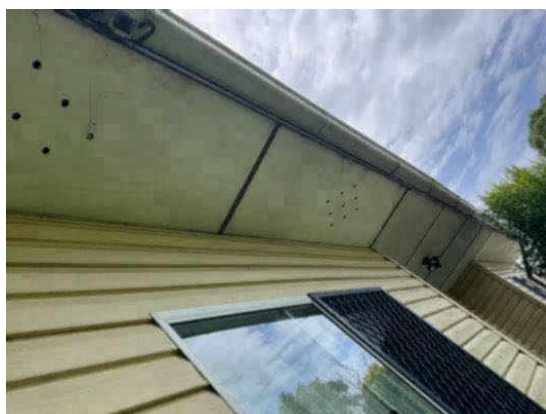
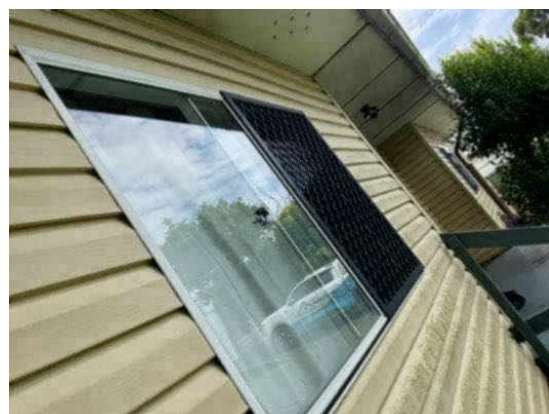
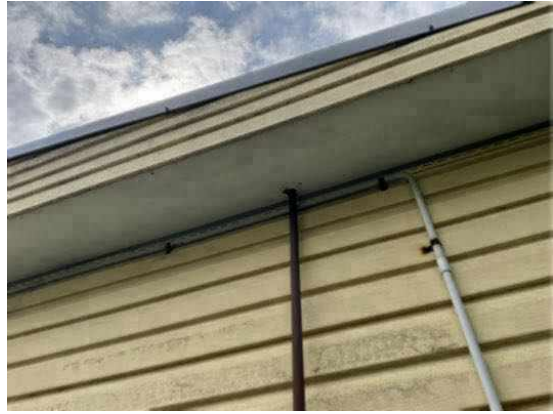
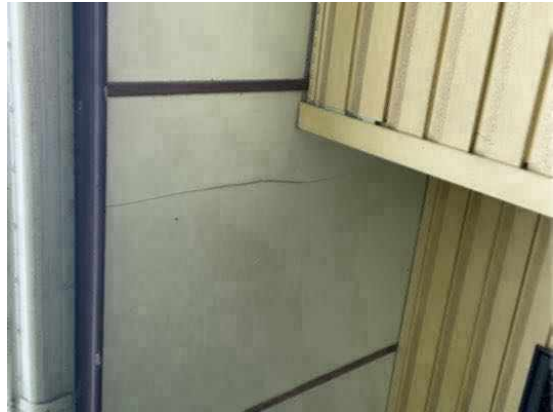
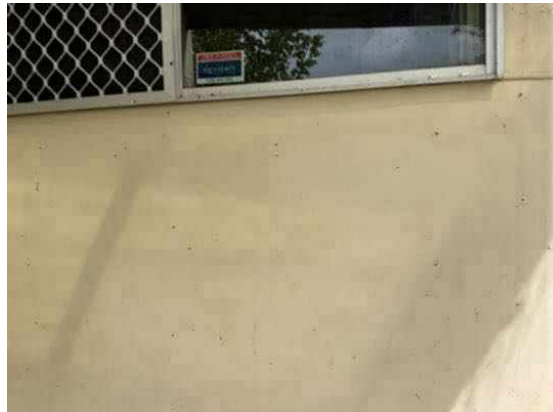
Building: Main Building
Location: All Areas
Finding: Asbestos - Suspected ACM Identified on Site
Information: Reporting on Asbestos is outside the Scope of this Report. This suspected defect is highlighted as a caution only. We suspect, based on our experience in the building industry, that there is a higher risk of the identified building element containing asbestos.

As Asbestos Reporting is outside the scope of this report, we advise that you consider a separate Asbestos Inspection and Condition Audit, which can include the taking of samples for definitive confirmation of the presence of Asbestos.

In the interim, the client is advised to act with caution, especially when considering any damage to building materials general wear and tear renovations extensions demolition and general maintenance activities due to the suspected presence of Asbestos.

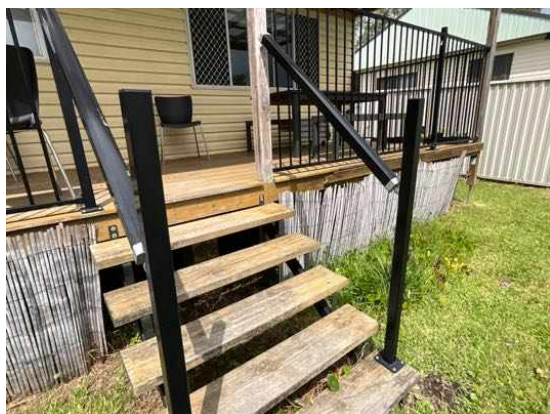
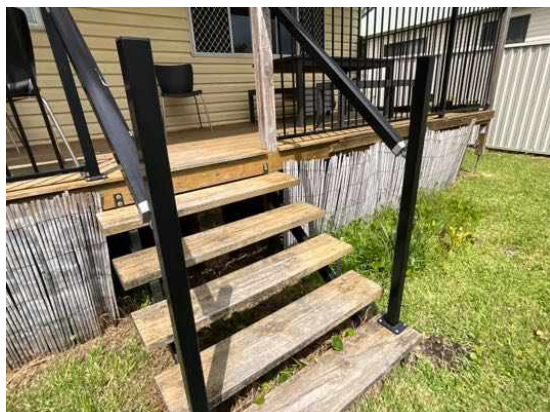
External timber structures are also constantly exposed to weather deteriorates in an exhilarate manner, ongoing assessments are required.

It is highly recommended that a structural engineer further, assess the external timber balcony or a deck to inform the client of its load capacity.

Regular maintenance inspections by competent practitioners is needed.

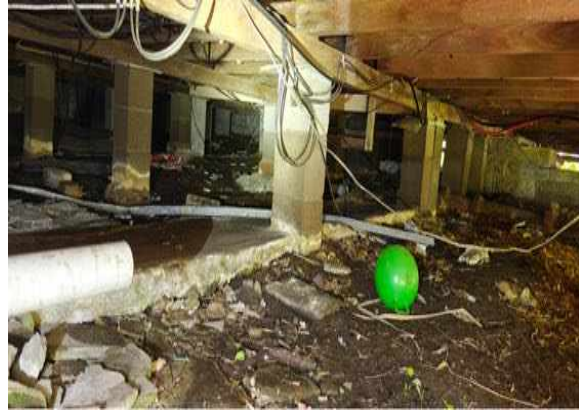
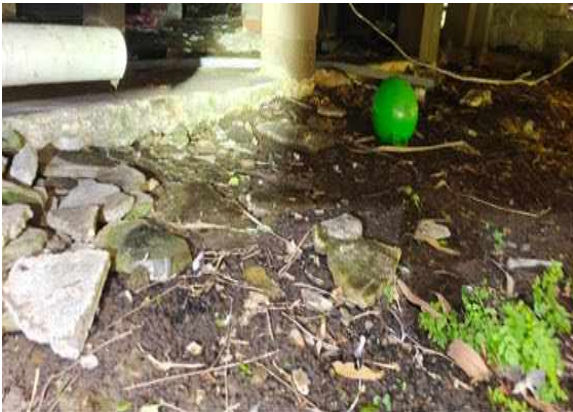
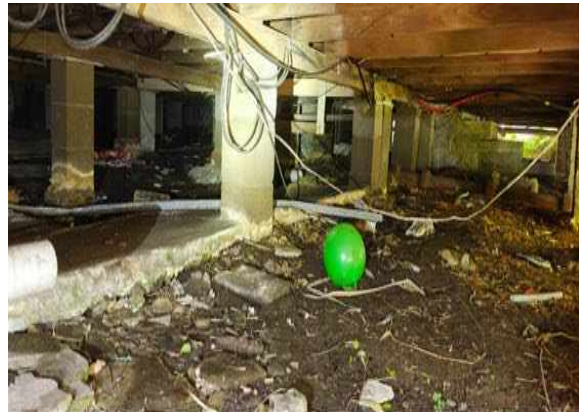
Finding 1.03

Building:	Main Building
Location:	Subfloor
Finding:	Mould - Present
Information:	Mold growth is present throughout the property, primarily due to inadequate ventilation. Poor airflow and moisture accumulation within the house have created ideal conditions for mold to thrive.

- **Health Hazards**: Mold growth can pose serious health risks to occupants, particularly those with allergies, asthma, or other respiratory conditions. Prolonged exposure to mold spores can cause respiratory issues, skin irritation, and other allergic reactions.
- **Structural Damage**: Mold can degrade building materials over time, leading to rot and weakening of the structural components such as timber, drywall, and insulation, which can result in costly repairs.
- **Decreased Property Value**: The presence of mold can significantly reduce the value of the property, as it indicates underlying moisture and ventilation issues that need addressing.

A licensed mold remediation specialist should be engaged to remove the mold and treat affected areas. In addition, a ventilation expert or builder should assess and improve the house's ventilation system, possibly installing exhaust fans, vents, or mechanical ventilation systems to ensure adequate airflow and prevent future mold growth.

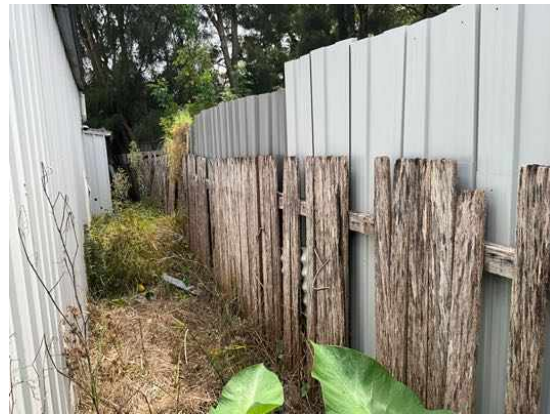
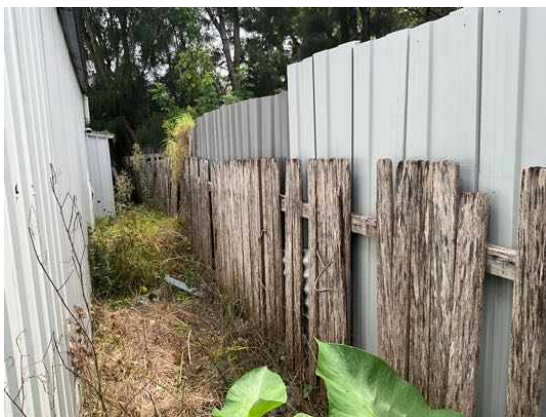
Building: Main Building
Location: Fencing
Finding: Fencing - Deteriorated
Information:

It was noted at the time of inspection that sections of the fencing throughout the property have deteriorated. Typically fencing deteriorates due to age and or wear, rot and or rust which is generally expected for a structure of this age, due to prolonged exposure to weather conditions. Sometimes inadequate installation or maintenance can be to blame.

If left unattended, it is likely that further damage will occur. It is suspected that repair of several elements of the fencing may be required however replacement may be a consideration of the client also.

A licensed fencing contractor should be appointed to provide further advice and perform rectification works as necessary.

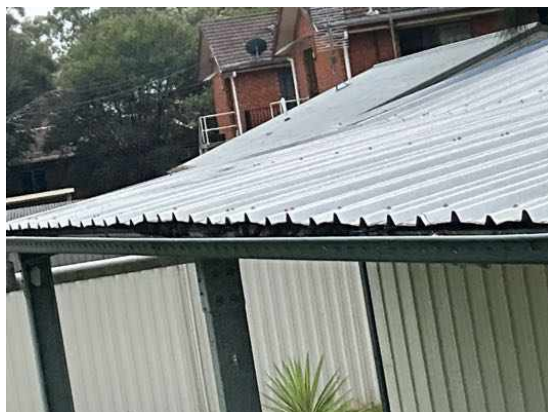
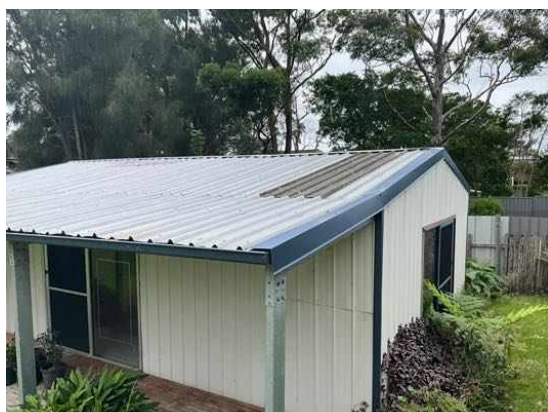
Finding 2.02

Building:	Main Building
Location:	Shed
Finding:	Roof Weathered - metal roof sheeting
Information:	The roof sheeting shows visible weathering, surface oxidation, and deterioration of fastener washers. Some sheet overlaps appear uneven and may not provide adequate weatherproofing at joints near the dormer. The sealant and flashing junctions also show signs of age and deterioration.

Prolonged weather exposure and rusting can lead to corrosion, potential roof leaks, and reduced lifespan of the sheeting. Deteriorated fasteners may allow water ingress, particularly around joints and penetrations.

Engage a licensed roofing contractor to inspect and maintain the affected areas. Replace rusted screws and washers, resecure loose or uneven sheets, and apply protective roof coating or repainting as required. Check flashings and sealants to ensure watertightness.

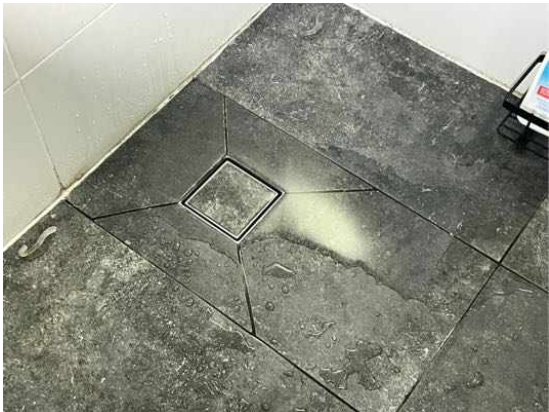
Finding 2.03

Building:	Main Building
Location:	Bathroom
Finding:	Shower base - Water pooling
Information:	Evidence of water pooling around the floor waste in the shower recess was noticed at the time of inspection. It is suspected that this excessive moisture is attributed to insufficient fall in the shower floor tiles.

This pooling is Major & considered unsatisfactory, as standard tiling practices would not permit this situation to occur. Pooling water around floor wastes can create a slip hazard in extreme cases and create conditions that are conducive to mould growth over time. Where left unmanaged, the degradation of sealant and grouting is also likely

to occur, possibly necessitating further repair works.

Remedial works may involve some sections of tiling and flooring repair and replacement. A tiling contractor or bathroom specialist should be appointed to provide further advice on reparation options and to perform works as necessary.

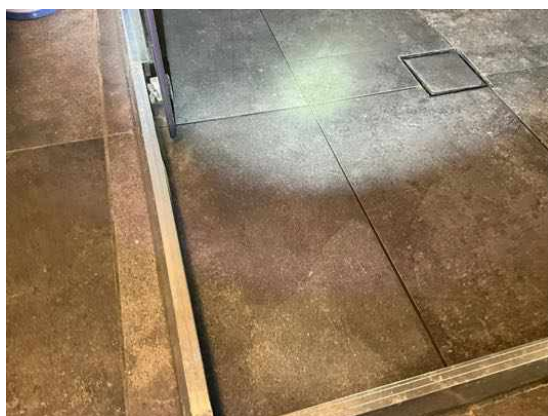
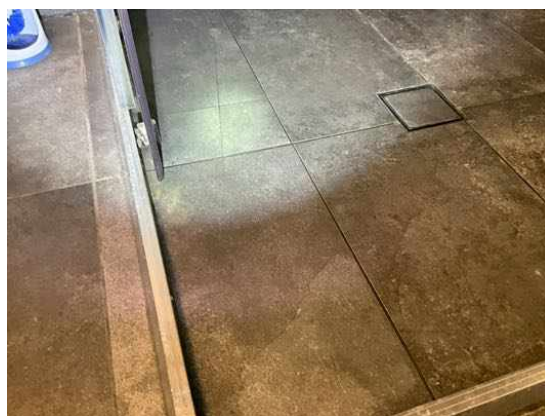
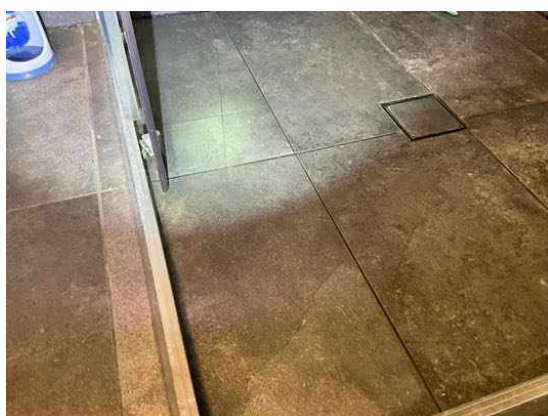
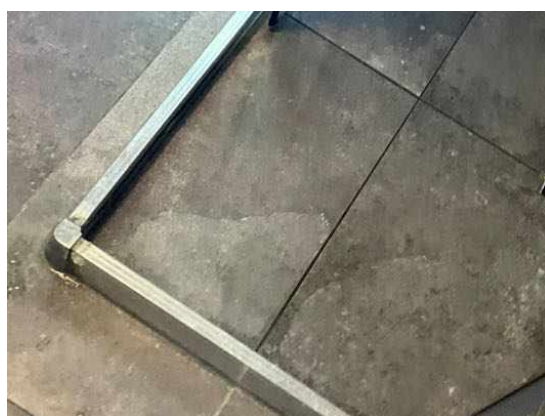
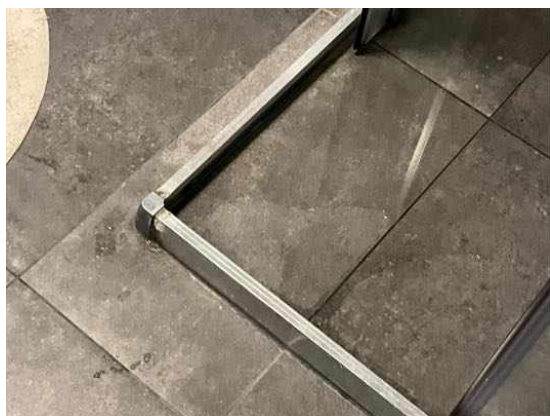
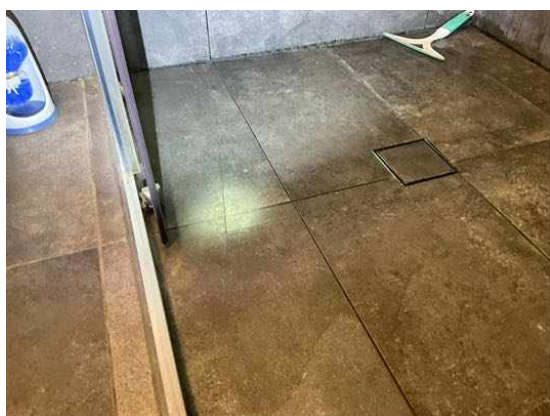
Finding 2.04

Building: Main Building
Location: Bathroom / Laundry
Finding: Shower base - Water pooling
Information: Evidence of water pooling around the floor waste in the shower recess was noticed at

the time of inspection. It is suspected that this excessive moisture is attributed to insufficient fall in the shower floor tiles.

This pooling is Major & considered unsatisfactory, as standard tiling practices would not permit this situation to occur. Pooling water around floor wastes can create a slip hazard in extreme cases and create conditions that are conducive to mould growth over time. Where left unmanaged, the degradation of sealant and grouting is also likely to occur, possibly necessitating further repair works.

Remedial works may involve some sections of tiling and flooring repair and replacement. A tiling contractor or bathroom specialist should be appointed to provide further advice on reparation options and to perform works as necessary.

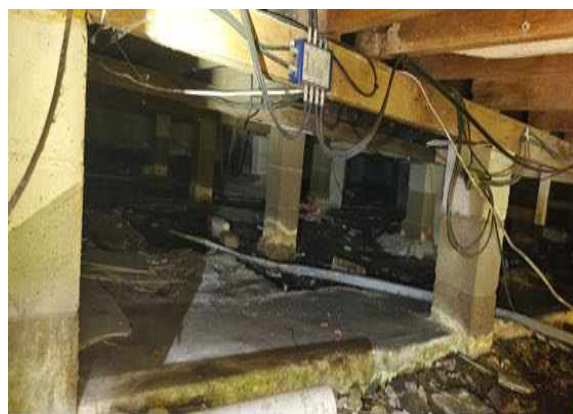
Building:	Main Building
Location:	Subfloor
Finding:	Rising Damp - Subfloor
Information:	Rising damp has been identified in the subfloor area. This condition is characterized by moisture seeping upward through the foundation and into the subfloor structures. The presence of dampness has been confirmed by visible signs such as discoloration, efflorescence, and potential mold growth on the lower sections of walls and subfloor timbers.

1. Structural Damage: Prolonged exposure to moisture can weaken the structural integrity of timber and masonry, potentially leading to rot, decay, and compromised load-bearing capacity.
2. Health Hazards: Damp conditions can foster the growth of mold and mildew, which can cause respiratory issues, allergies, and other health problems for the occupants.
3. Decreased Property Value: Rising damp can significantly reduce the property's value and appeal to potential buyers.
4. Increased Energy Costs: Damp conditions can make it more challenging to heat or

1. Identify and Address the Source: A thorough inspection should be conducted to identify the source of the rising damp. This could involve checking for inadequate drainage, poor waterproofing, or damage to the damp-proof course (DPC).

2. Improve Drainage: Ensure that the property has adequate drainage systems in place to divert water away from the foundation. This may involve installing or repairing gutters, downpipes, and surface drains.

3. Damp-Proofing: Implement appropriate damp-proofing measures such as the installation or repair of a damp-proof course or damp-proof membrane. In some cases, chemical damp-proofing injections may be necessary.

4. Ventilation: Improve subfloor ventilation to reduce moisture buildup. This could involve installing additional vents or fans to promote air circulation.

5. Repair Damaged Areas: Replace or repair any timber or masonry that has been damaged by rising damp.

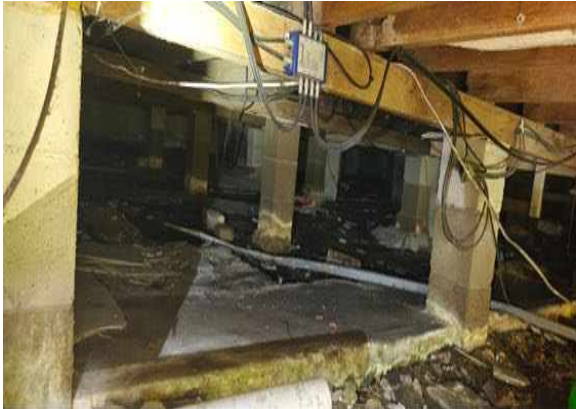
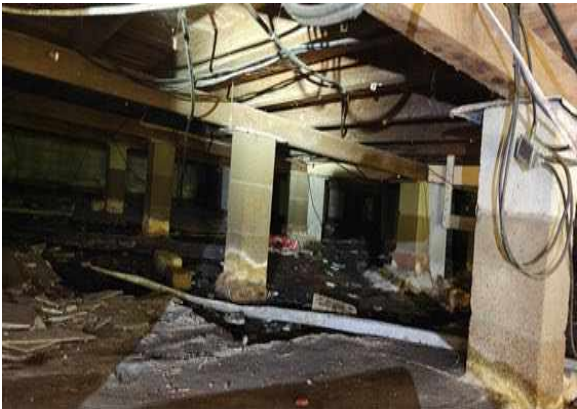
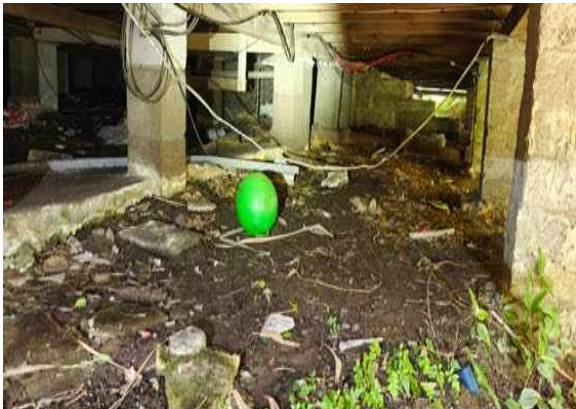
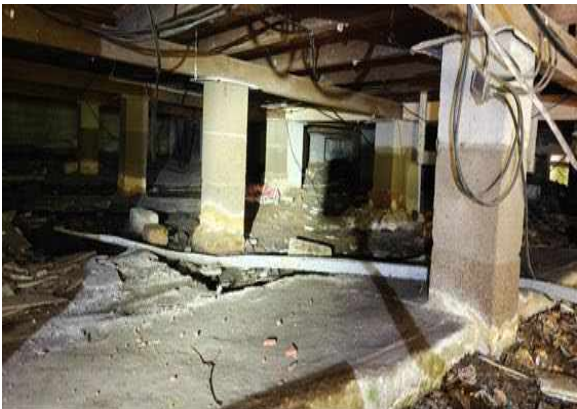
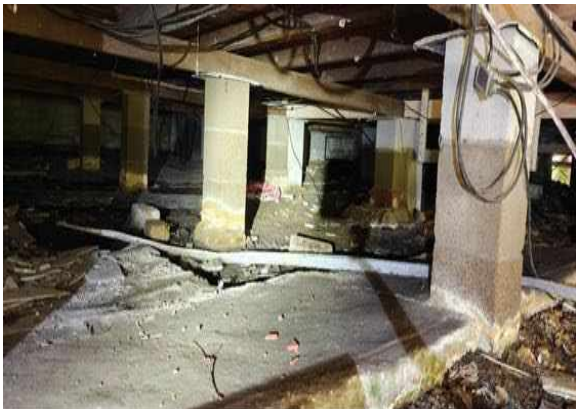
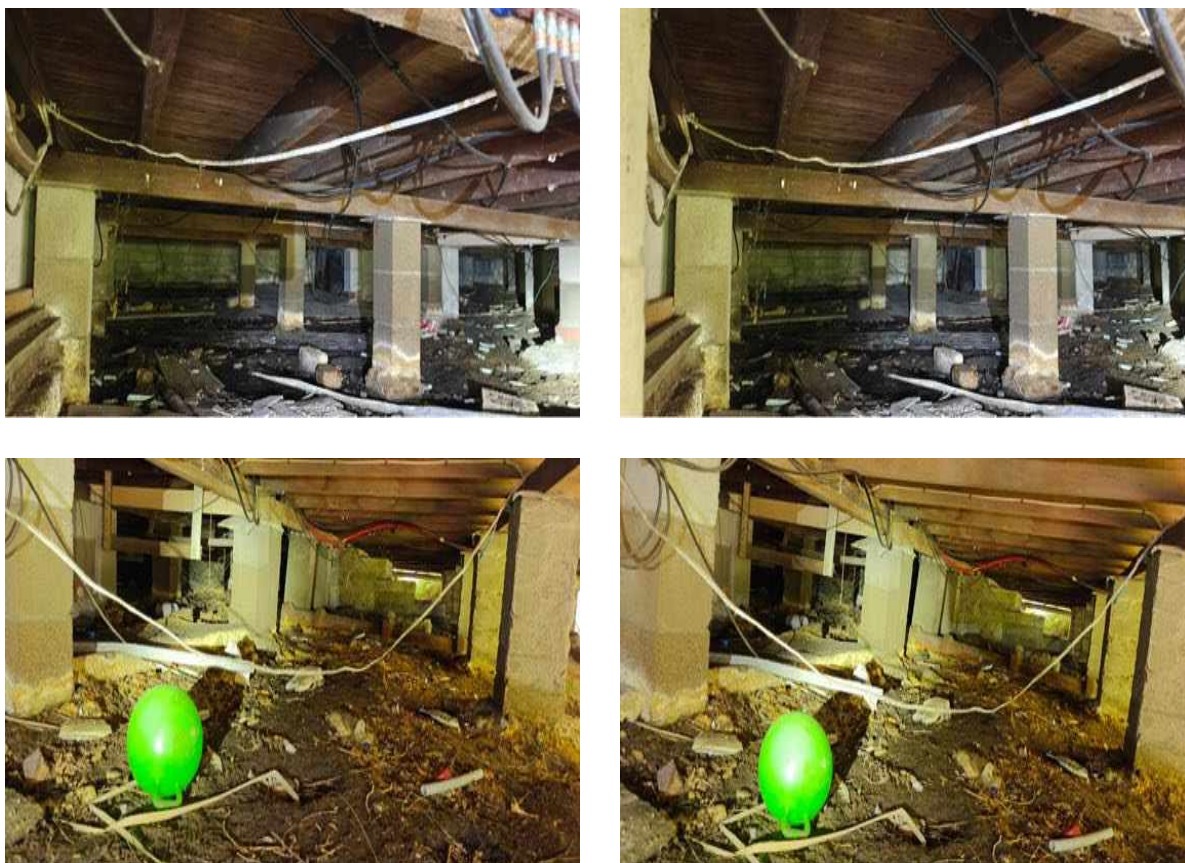
Finding 2.07

Finding: Subfloor - Site drainage - Inadequate

Information: The site exhibits poor drainage under the subfloor, leading to several critical issues. Water accumulates and does not properly drain away from the subfloor area, creating a hazardous condition.

1. Frequent water pooling and stagnation under the subfloor.
2. Risk of subfloor structural damage due to prolonged moisture exposure.
3. Potential for mold and mildew growth, compromising indoor air quality and a potential of Termite attack.
4. Safety hazard for occupants due to slippery surfaces and potential electrical hazards.

The poor site drainage under the subfloor poses a significant safety risk to the occupants, as it can lead to structural damage and health hazards.

This issue requires immediate attention and rectification. A licensed and experienced plumber or licensed builder specialising in drainage and foundation work should be engaged to assess the problem and implement necessary drainage solutions, such as improved grading, installation of drainage systems, and moisture barrier enhancements. Regular maintenance and inspections should also be scheduled to prevent future occurrences. Water damage and secondary defects are likely to occur if left unmanaged.

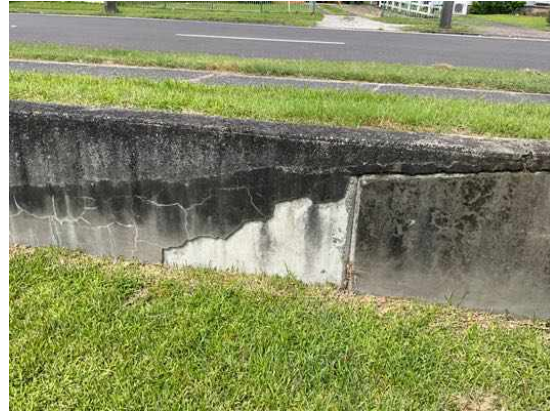
Finding: Cracking - rendered surface

Information: Cracking observed along the vertical and diagonal plane of the rendered surface. The cracks appear as fine to moderate-width cracks, indicating potential shrinkage or movement within the substrate.

According to AS 4349.1-2007 Inspection of Buildings and the Guide to Standards and Tolerances 2017 cracks up to 1mm wide are considered an acceptable tolerable limit for plaster and render finishes in the absence of other symptoms (such as displacement or water ingress). Cracks between 1mm and 5mm wide may require repair depending on their cause and severity.

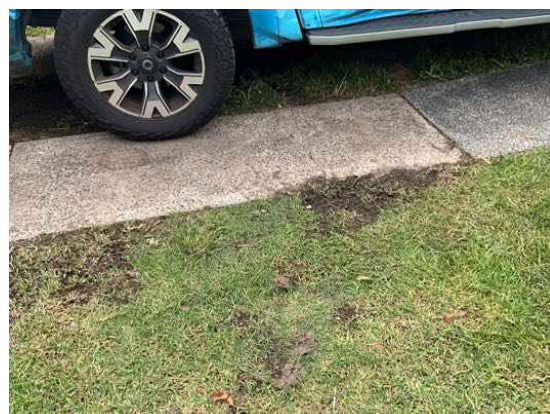
Finding 3.03

Building:	Main Building
Location:	Yard - Front
Finding:	Water pooling - poor surface drainage
Information:	Surface drainage

Surface water drainage is defective if it is not in accordance with the requirements of the Building Code of Australia.

Such water pooling also increases the risk of termite activity and the development of fungal decay in the area.

Consult a Licensed Plumber regarding the cost of potential site drainage rectification works.

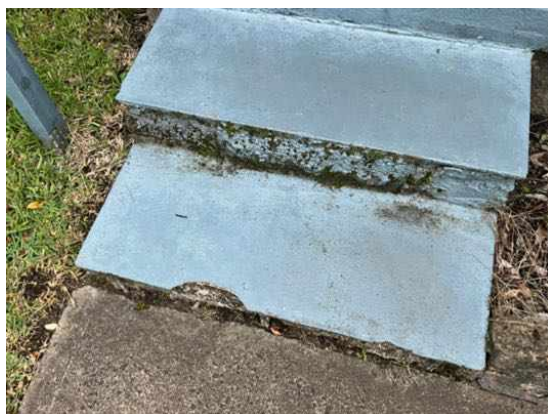
Finding 3.04

Finding: Step crack

Information: A defect has been identified in the front elevation of the property, specifically involving a crack in the step. The step crack poses a safety concern and diminishes the aesthetic appeal of the property.

The cracked step poses a significant safety risk for occupants and visitors, increasing the likelihood of accidents or injuries. Additionally, the visual impact on the property's front elevation can lead to a negative perception and potential decrease in property value.

A licensed contractor or construction professional specializing in structural repairs should be engaged to assess and fix the broken step. The property owner or manager should take immediate action to address the safety and aesthetic concerns.

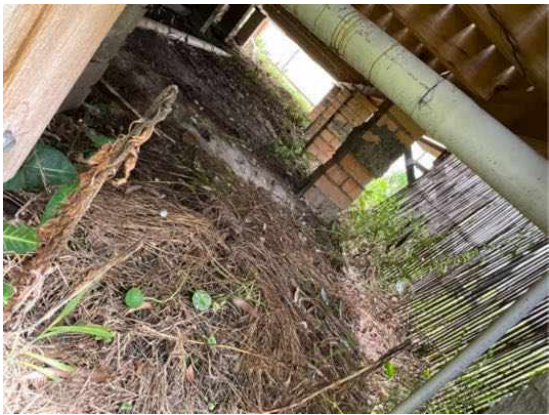
Finding 3.05

Building:	Main Building
Location:	Deck
Finding:	Poor workmanship
Information:	The structure exhibits signs of poor workmanship, evident in various aspects of construction and finishing.

Risk: Poor workmanship poses a range of risks, including compromised structural integrity, potential safety hazards, and a decreased lifespan of the structure. It may also lead to aesthetic and functional issues.

Resolution: A qualified contractor or construction professional should be consulted to assess and address the poor workmanship. They can implement corrective measures to ensure structural soundness, safety, and overall quality of the construction.

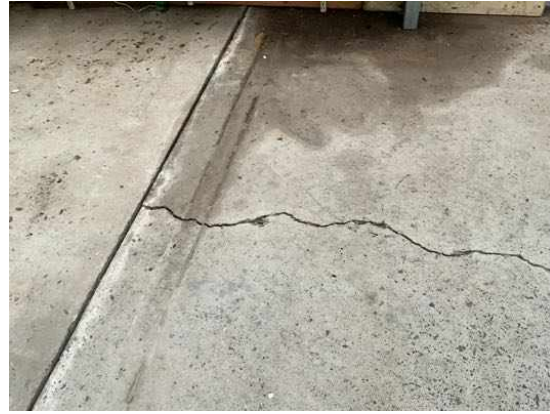
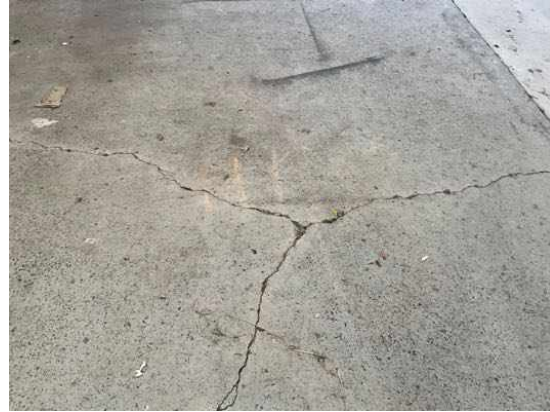
Finding 3.06

Building: Main Building
Location: All Areas
Finding: Noticeable Cracking in Concrete Slab
Information: Noticeable cracking has been observed in the concrete slab, failing to meet the required construction and quality standards.

- Cracks are visible on the surface and may extend through the depth of the slab.

- Evidence of improper curing or inadequate reinforcement leading to cracking.

- Compromised structural integrity of the slab, potentially leading to failure under load.
- Water ingress through cracks, causing corrosion of reinforcement and further weakening the structure.
- Potential trip hazards and aesthetic issues, reducing the overall value and safety of the property.
- Increased maintenance and repair costs due to ongoing deterioration.

- A structural engineer should be engaged to assess the extent of the cracking and recommend appropriate repair methods.
- A licensed contractor or concrete repair specialist should carry out the recommended repairs under the guidance of the structural engineer.

A detailed inspection should be conducted post-repair to confirm compliance with the required standards and to ensure that the structural integrity of the concrete slab has been restored.

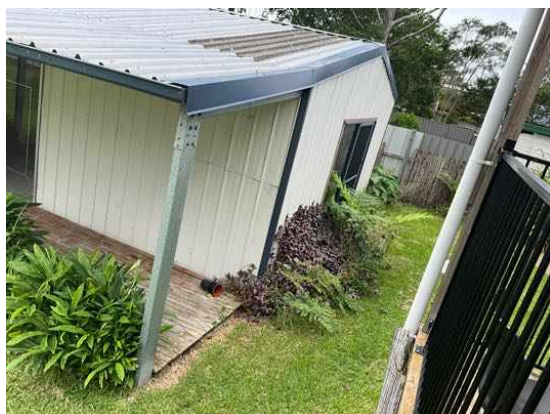
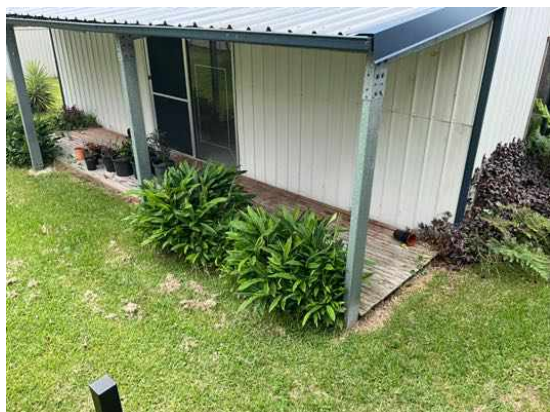
Finding 6.04

Building:	Main Building
Location:	All Areas
Finding:	Dense vegetation around a property can increase the risk of termite infestation
Information:	The presence of dense vegetation around a property can increase the risk of termite infestation, as it provides a conducive environment for them. To address this, consider maintaining a clear space between the vegetation and your home. If you suspect a termite issue, it's advisable to consult with a licensed pest control professional for inspection and treatment.

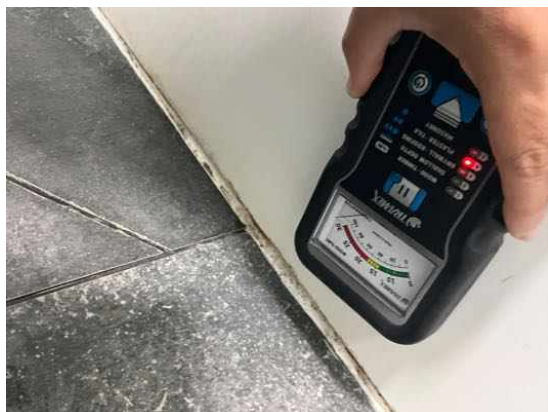
Finding 6.05

Building:	Main Building
Location:	Bathroom
Finding:	Excessive moisture - Conducive to Timber pest
Information:	Excessive moisture can attract termites and produce conditions that promote fungal growth and wood decay.

If mould growth has been found there may be environmental biological or health issues involved. In these cases an appropriately qualified inspector should also be contacted.

Prior to any remedial works being performed a qualified plumber should be appointed to further inspect the property and to identify the cause of the excessive moisture. Works to remove affected building elements may then be necessary and should be performed by an appropriate tradesperson.

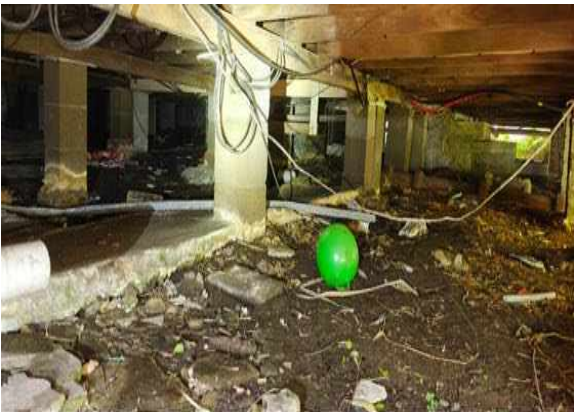
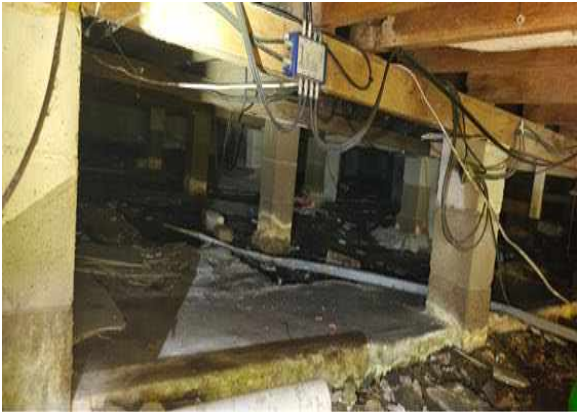
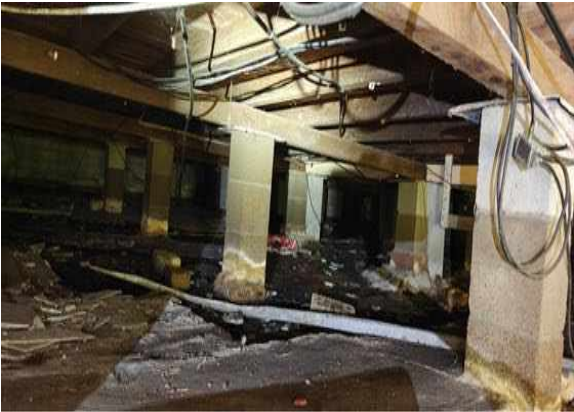
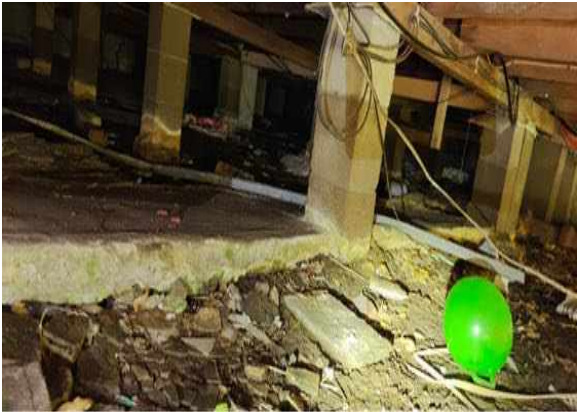
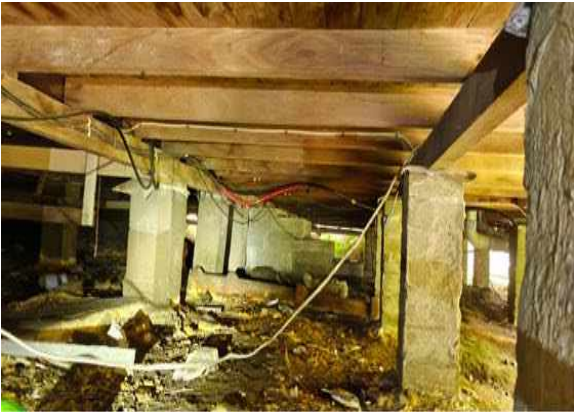
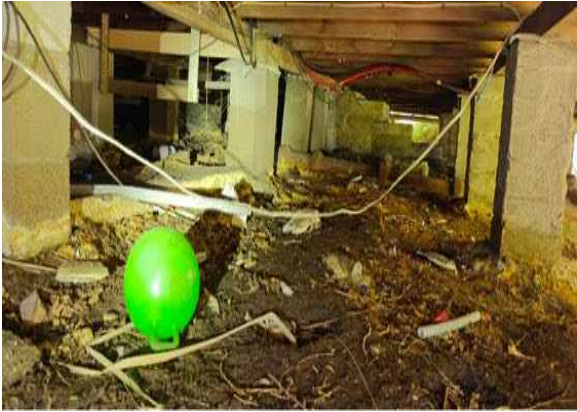
Finding 6.06

Building:	Main Building
Location:	Bathroom / Laundry
Finding:	Excessive moisture - Conducive to Timber pest
Information:	Excessive moisture can attract termites and produce conditions that promote fungal growth and wood decay.

Risk: The combination of poor ventilation, inadequate drainage, water stains significantly increases the risk of timber pest infestations. Termites are attracted to moist environments and can thrive in subfloors with high humidity levels and water damage. The lack of proper ventilation and drainage exacerbates moisture retention, providing an ideal habitat for timber pests to establish colonies and cause extensive damage to the subfloor structure. Additionally, water stains indicate previous or ongoing moisture issues, which further attract timber pests and contribute to the deterioration of timber materials.

A licensed pest control professional specializing in timber pest management should be consulted to assess the extent of the infestation and develop a comprehensive treatment plan. They can implement strategies to eliminate existing timber pests, such as termites and prevent future infestations by addressing underlying moisture issues. Additionally, a qualified plumber or builder may be needed to improve subfloor ventilation, enhance site drainage, repair water-damaged areas. Regular inspections and maintenance are essential to ensure ongoing protection against timber pests and maintain the structural integrity of the subfloor.
