# Building and Timber Pest Inspection Report

Inspection Date: Tue, 13 Jan 2026

Property Address: 3/42 Gilchrist St, Shepparton VIC 3630,  
Australia

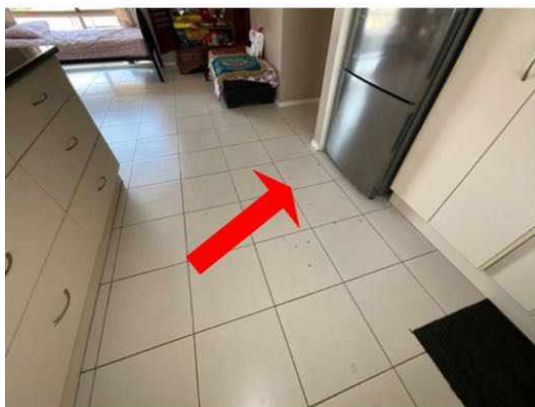
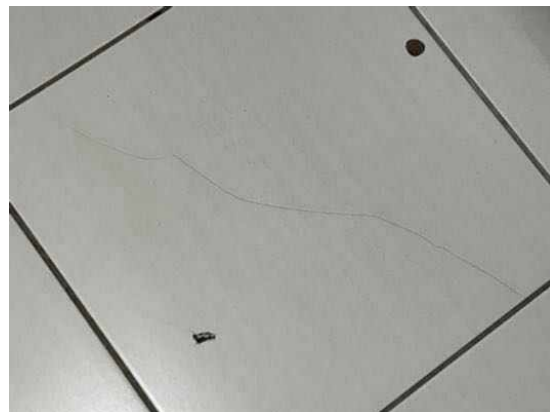
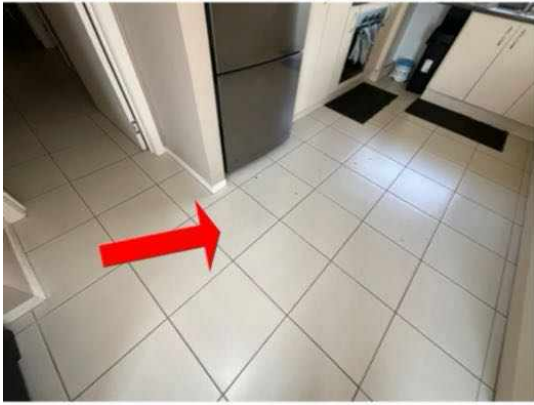
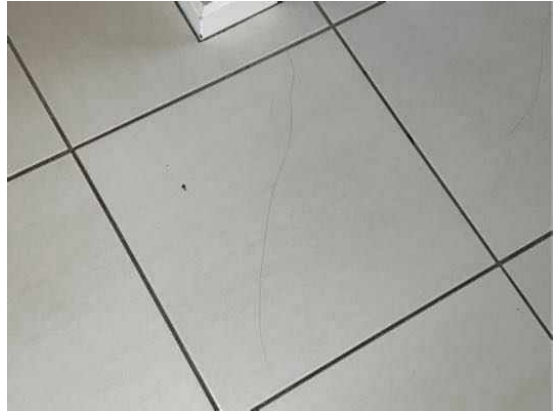
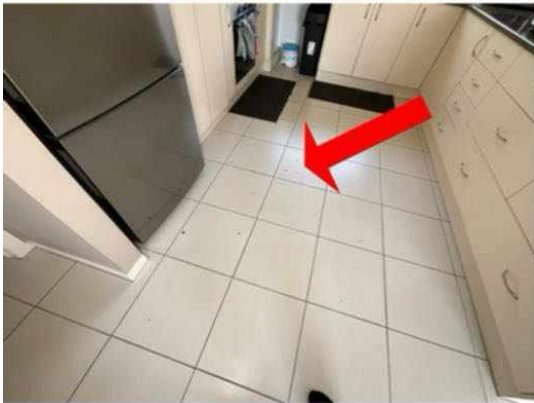
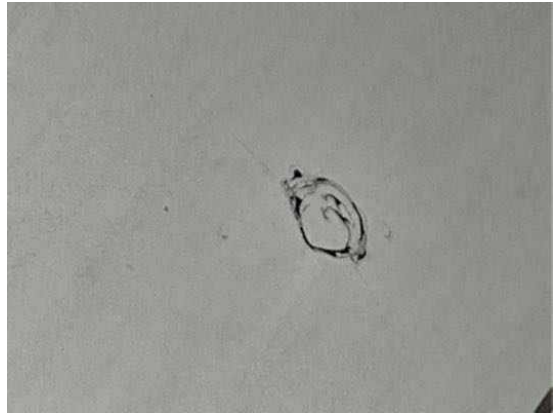
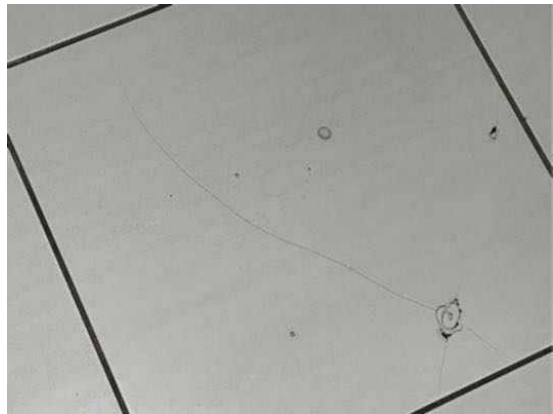
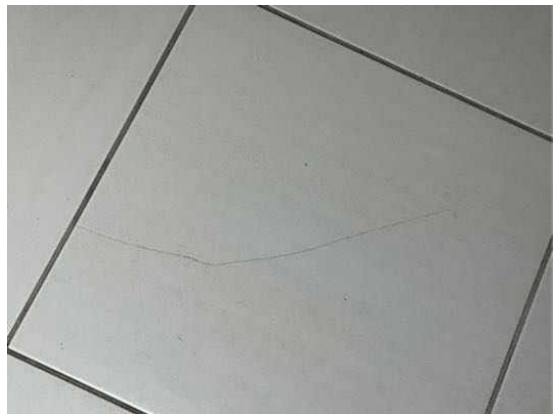
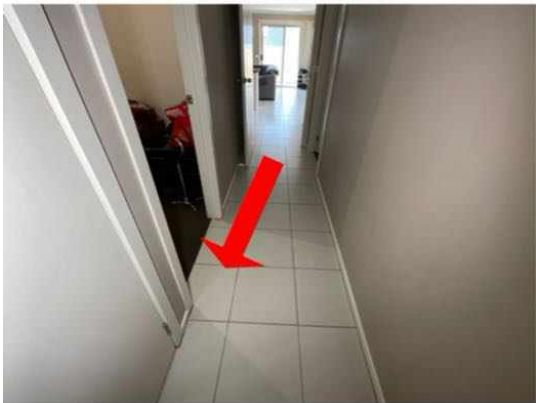
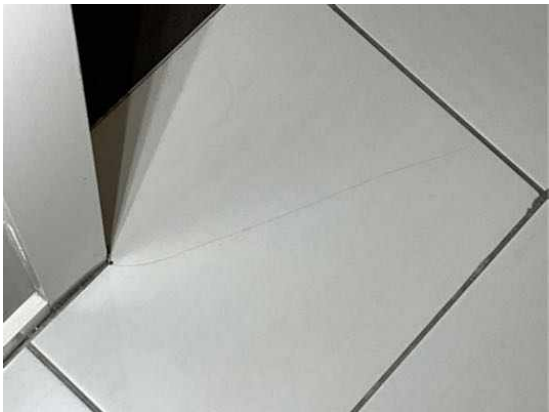
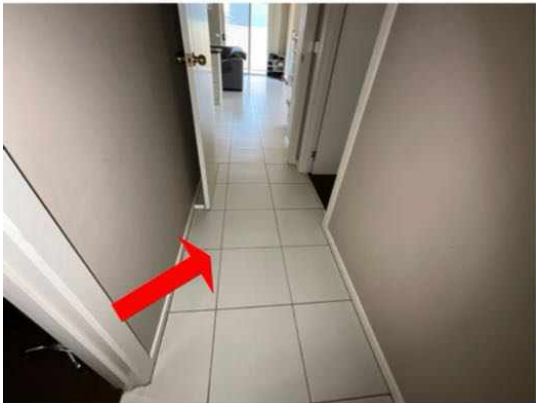
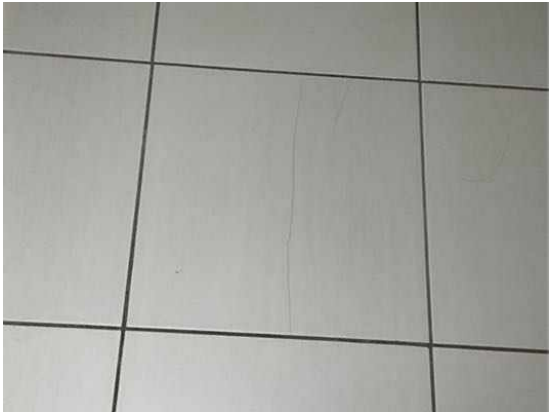
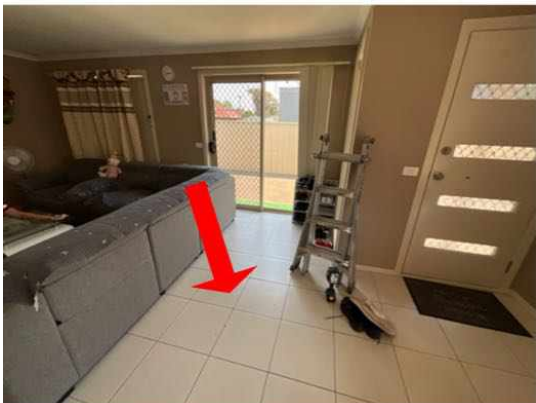
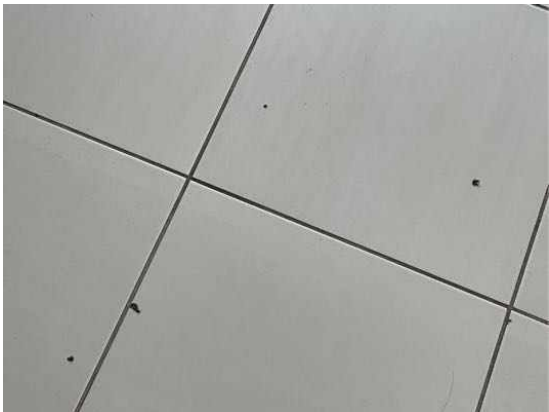
#### Finding 3.01

Building:	Building 1
Location:	Kitchen, hall, living
Finding:	Cracked floor tiles
Information:	Cracking in the floor tiles was evident in this area at the time of inspection. It is suspected that this cracking has occurred as a result of minor settlement or impact damage.

Cracked tiles throughout the household detract from the overall appearance of the affected areas however it is unlikely to create or lead to any secondary defects.

While not considered a matter of urgency, replacement of cracked floor tiles is recommended at the clients discretion. A tiling contractor may be appointed to perform these works. Where cracks become more numerous, contact a licensed building inspector for further investigation.

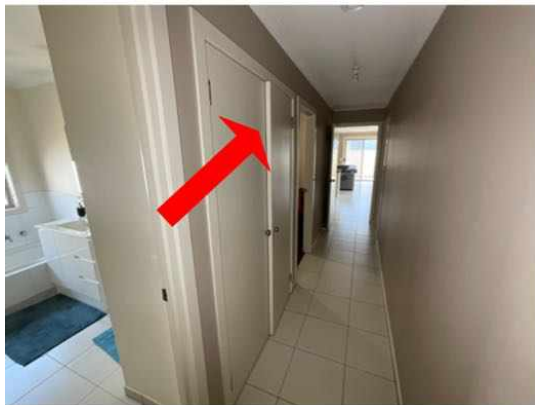
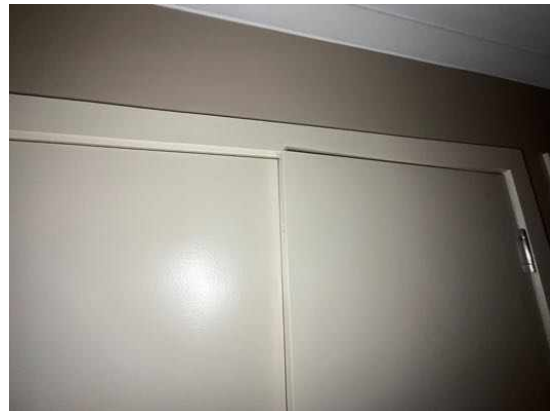
**Finding 3.02**

Building: Building 1  
Location: Hall  
Finding: Door- Binding  
Information: Binding and/or jamming of this door is evident during standard operation. This defect inhibits the functionality of the affected door as well as creating potential for secondary defects to associated building elements, such as damage to the floor covering.

A door that binds to flooring or to the associated door frame may have several causes, ranging from minor defects, such as poor installation of the door or deteriorated hinges, through to major structural issues, such as damage to subfloor structures.

A qualified carpenter or general handyperson should be appointed to perform minor rectification works at client discretion.

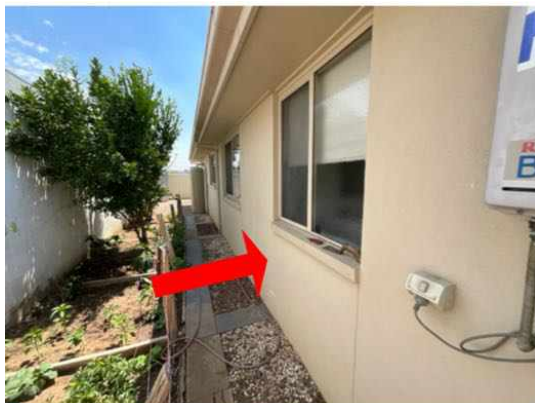
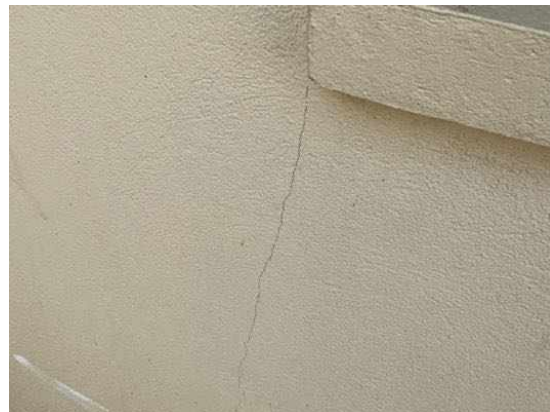
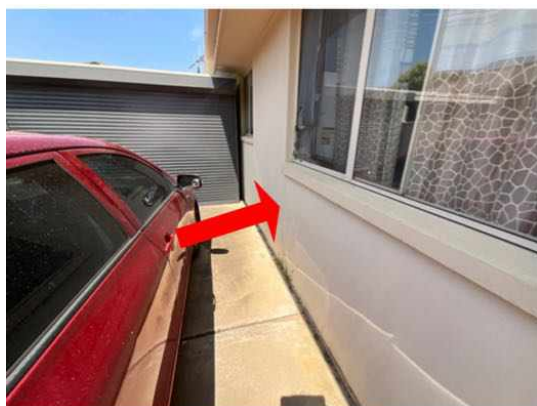
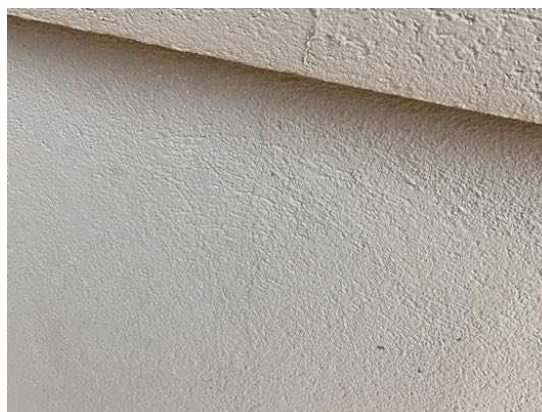
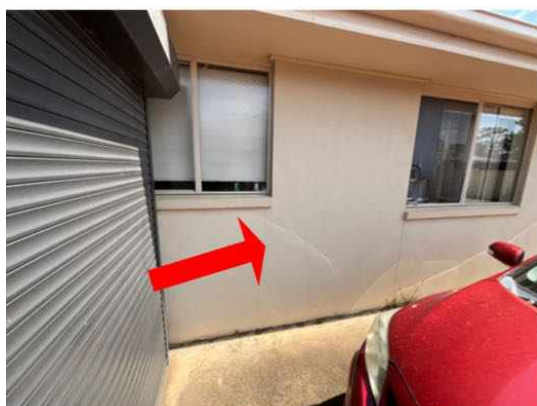
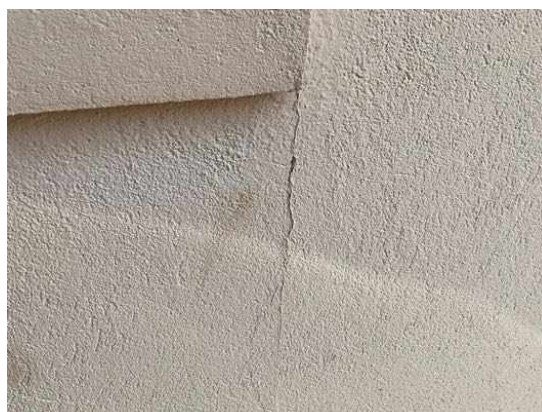
### Finding 3.03

Building: Building 1  
 Location: Yard - Side, front wall  
 Finding: Render- Cracking  
 Information: Cracking to the render in this area was identified at the time of inspection.

This type of cracking is often consistent with general dilapidation of the property, and may continue to develop if left unmaintained.

Frequent monitoring should be carried out to identify any further damage.

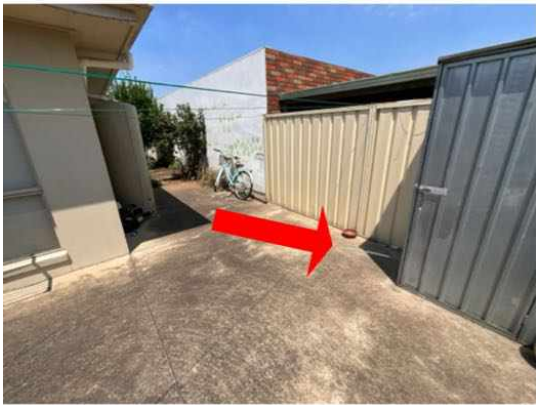
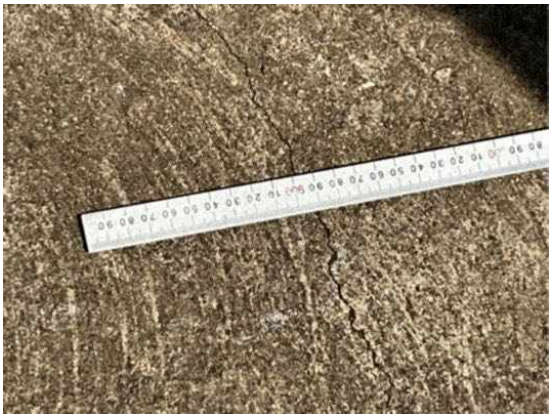
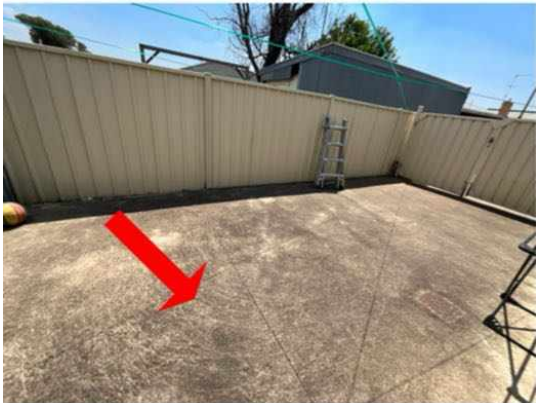
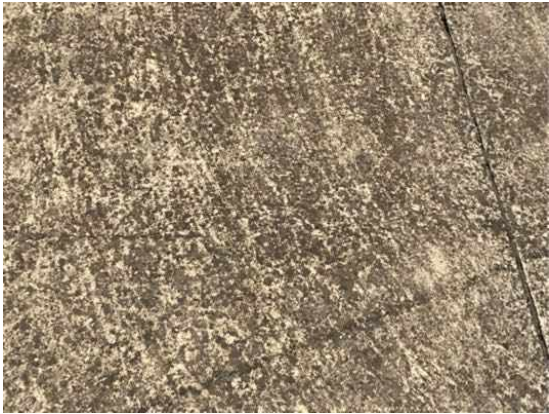
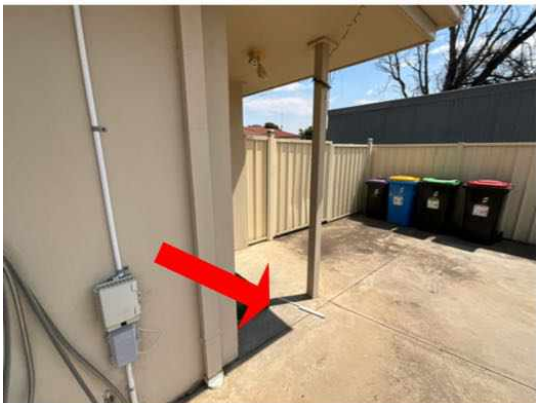
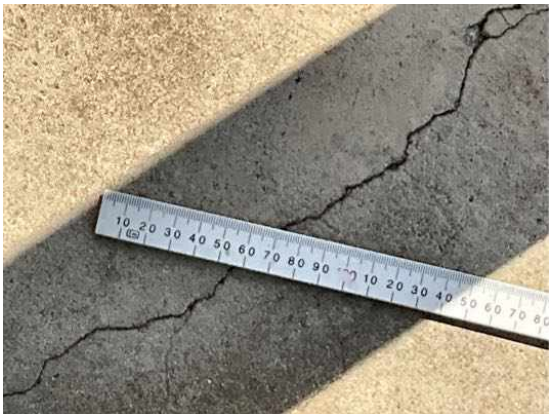
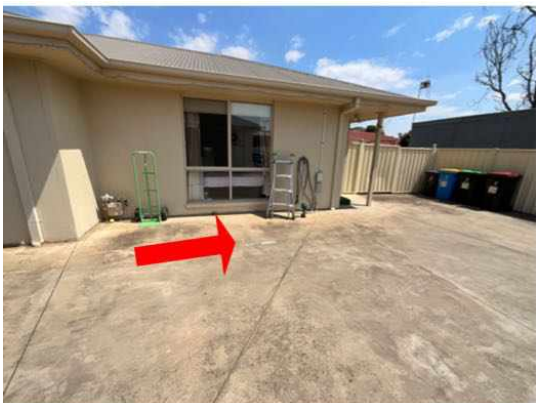
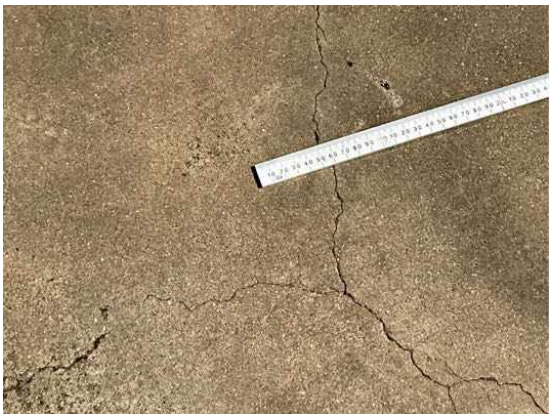
### Finding 3.04

Building:	Building 1
Location:	Yard - Back, driveway area
Finding:	Cracking - External Concrete Paving Damage Category 1 - Fine (less than 2mm)
Information:	Fine cracks were identified in external concrete paving. Although fine cracks are quite noticeable, they are often only considered to be an appearance defect, and usually do not indicate any structural damage. To be considered a Category 1 or fine crack, the crack is found to be less than 2mm in width.

Generally the cause of a hairline crack in existing concrete paving such as driveways and pathways is indicative of the expansion and contraction of the concrete. Such causes are generally due to environmental factors, such as moisture levels, weather conditions, root systems of nearby trees or the soil types on which they are laid.

Fine cracks may also be due to poor original installation of the concrete. Factors such as poor compaction of the sub surface and/or inadequate reinforcing of the slab may create cracking and other secondary defects.

Monitoring of all cracking should be conducted frequently. Always contact a building inspector should cracks widen, lengthen, or become more numerous.

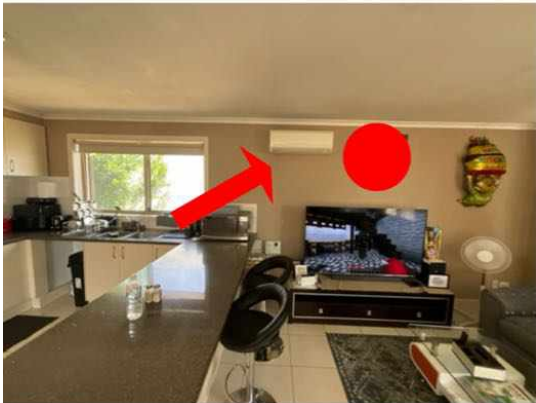
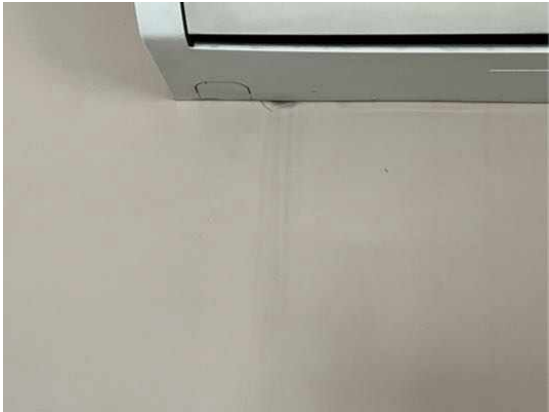
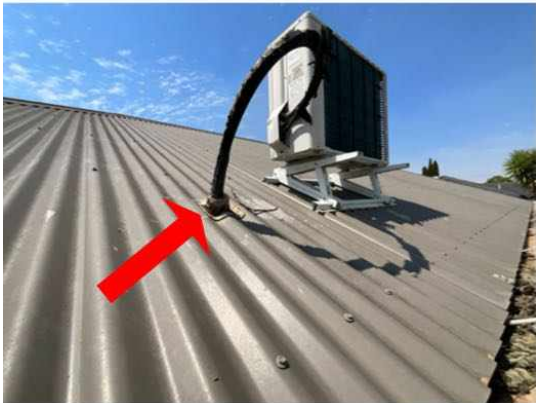
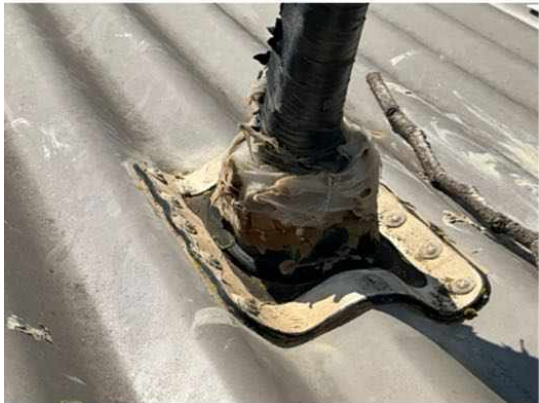
### Finding 6.01

Building: Building 1  
Location: Roof Exterior  
Finding: Air conditioner leak  
Information: The penetration through the roof for the aircon appears to be allowing a leak during strong rain events. Water marks can be seen on the living room wall internally.

The drain system for the head unit should have external clear drainage. The drain pipe from the internal head unit should be cleaned out, as a first step.

An Aircon specialist should be contacted soon to restore the area and prevent further deterioration.

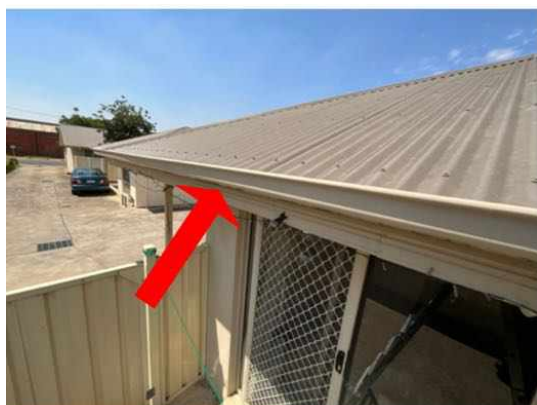
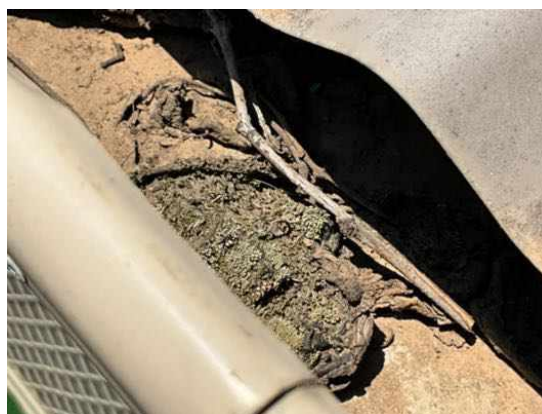
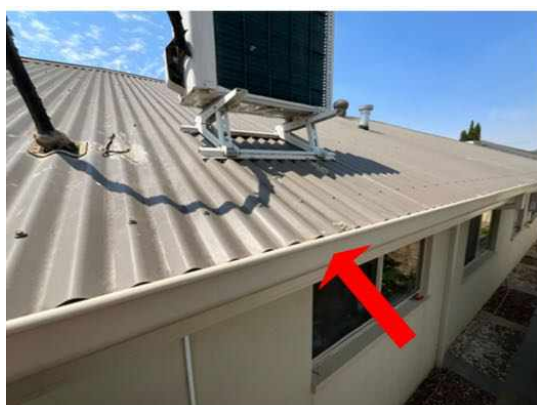
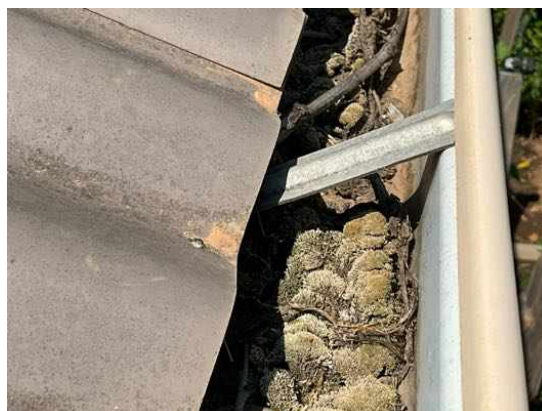
## Finding 6.02

Building:	Building 1
Location:	Eaves
Finding:	Gutters- Blocked
Information:	Roof plumbing structures, such as guttering and downpipes, should be free of all debris to prevent blockages. Blockages of the guttering and downpipes will lead to pooling and accumulated water overflows, which is likely to subsequently flood eaves and exterior walls.

Blocked gutters are likely to lead to high levels of moisture in the affected areas. Such moisture will not only cause rust and decay of the associated building materials, but can also provide conditions that are conducive to termite and timber pest activity. Blockages in gutters should therefore be removed immediately to ensure dry conditions are maintained.

Consult a Licensed Plumber for further specific advice on remedial works that may be required. In the interim, it is highly advised that blocked gutters be removed by the homeowner or a general handyperson as a matter of urgency.

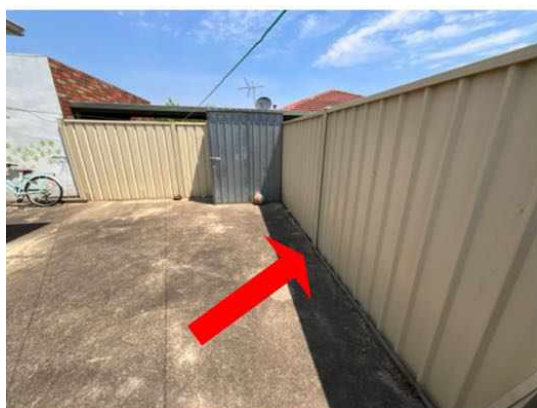
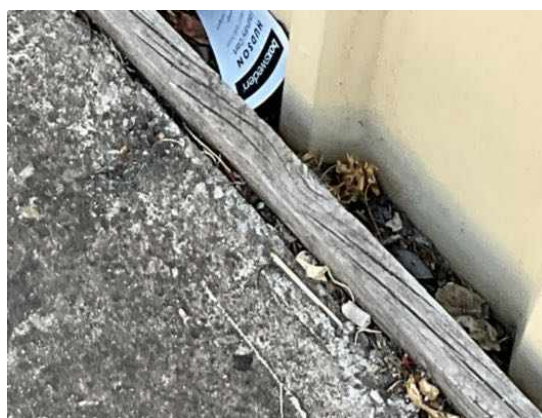
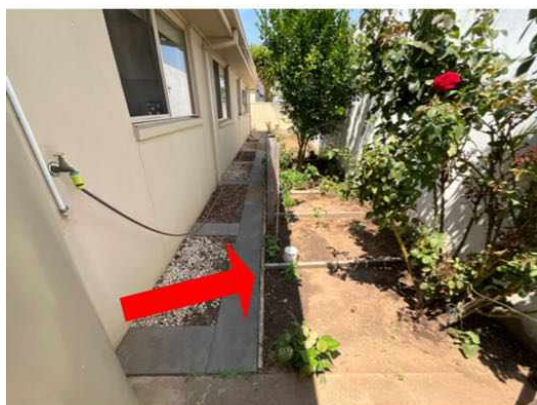
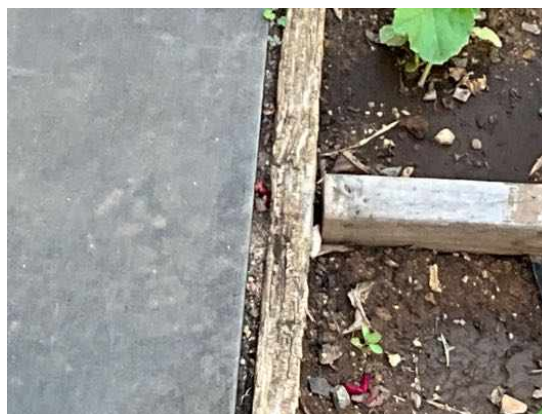
## Finding 6.03

Building:	Building 1
-----------	------------

Location: Yard - Back

Finding: Untreated or non-durable timbers in a hazardous environment

Information: To reduce the risk of timber pest attack it is essential that timber used in a hazardous environment (e.g. in direct contact with the ground or frequently exposed to damp conditions) is of sufficient durability and/or is adequately preservative treated.

Untreated timbers in direct contact with the ground are likely to develop severe wood rot and/or fungal decay if left unattended creating attraction for subterranean termites to infest the timbers from surrounding areas.

If untreated or non-durable timbers are found to be in a hazardous environment it is highly advised that replacement of these building elements be performed as soon as possible to aid the protection of the property against termite / timber pest attack.

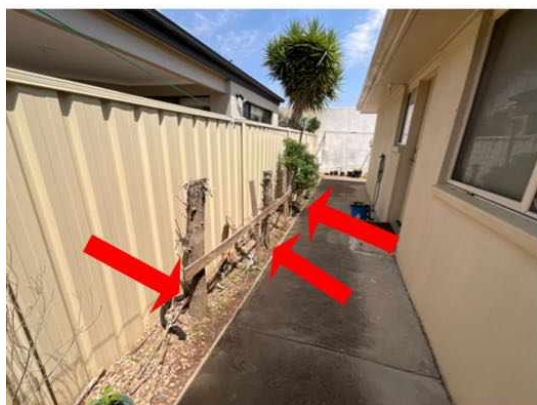
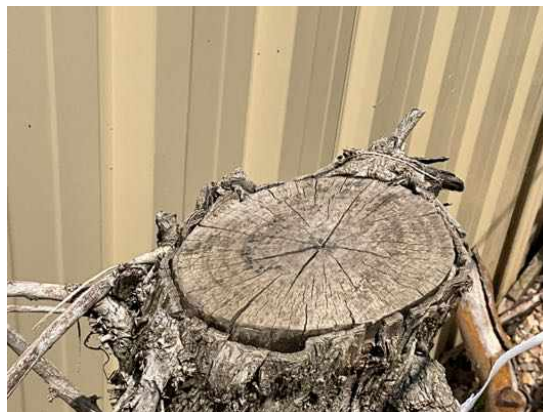
### Finding 6.04

Building: Building 1

Location: Yard - Side

Finding: Tree Stump in Ground

Information: Any tree stumps in the yard not removed during the tree removal process provides the opportunity for Termite infestation and is likely to be subject to decay from damp conditions against the stump.

All tree stumps should be removed by professional tree removal services where possible. Meanwhile regular inspections are advised to identify any termite activity in the areas identified.

Services for tree stump removal should be contacted as soon as possible to reduce the risk of timber pest attack.

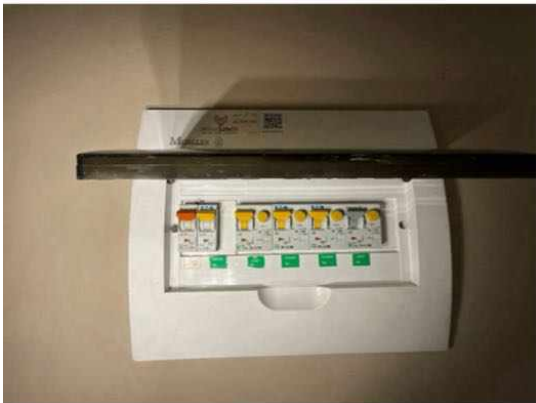
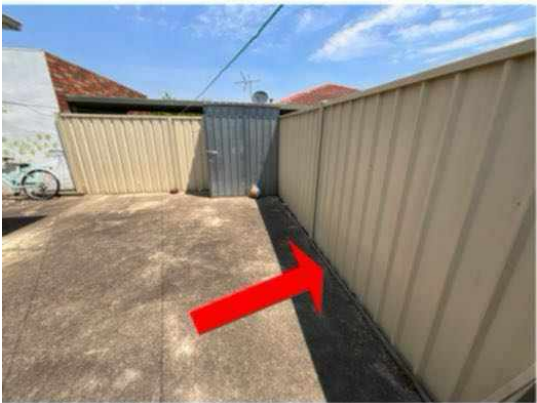
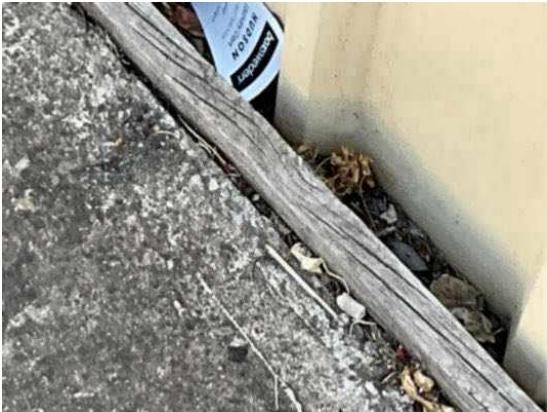
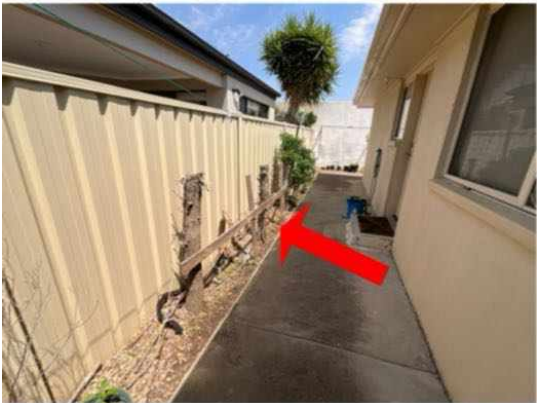
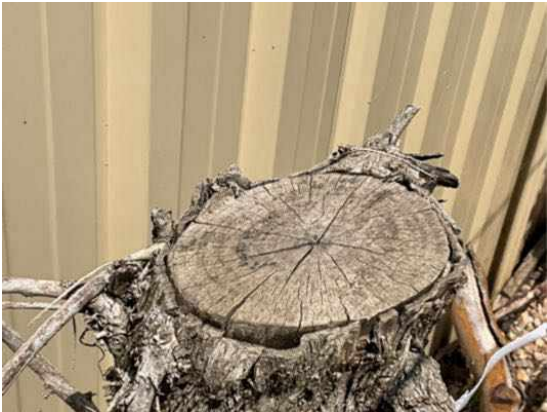
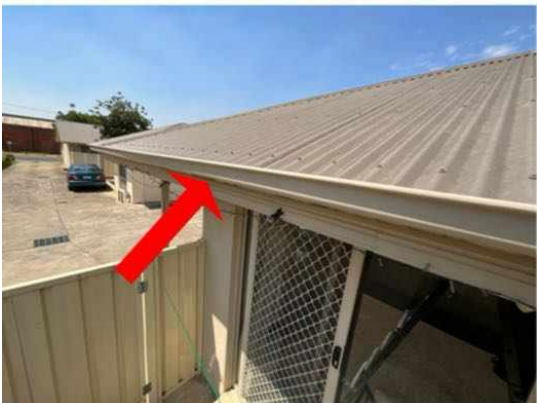
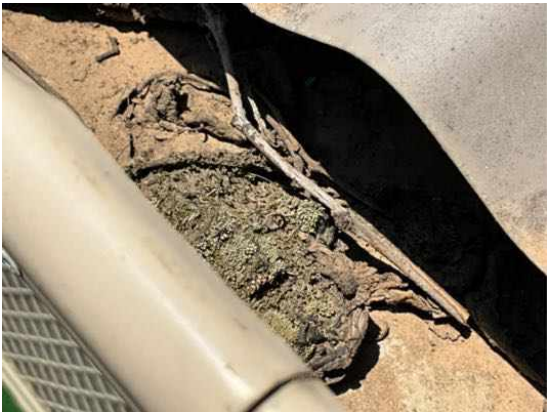
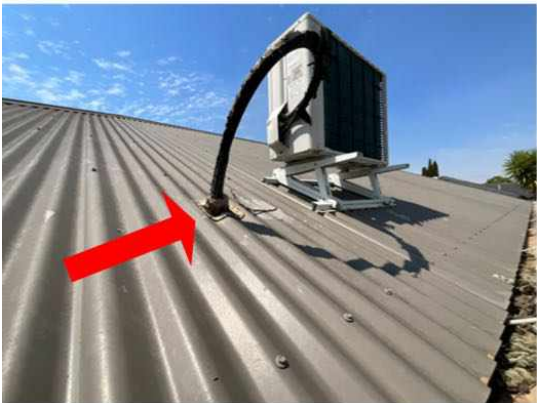
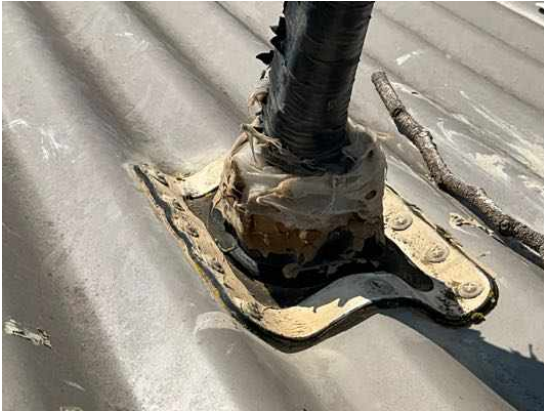
### Finding 6.05

Building:	Building 1
Location:	All External Areas
Finding:	Termite Management System - no evidence of a chemical installation
Information:	The application of a post-construction chemical termite barrier is highly recommended for all properties, particularly if live termite activity has been found on the site previously. Such barriers are highly effective in preventing termite attack on any timber building elements throughout the property.

A durable notice should be placed in the switchboard unit to indicate current termite barriers. At the time of inspection, it appeared as though no termite management system has been installed, with no evidence to suggest preventative works taking place.

The client may consider gaining further advice from a pest controller as to the costs and procedures involved with this application. It is recommended that obtaining such advice be a short-term priority.

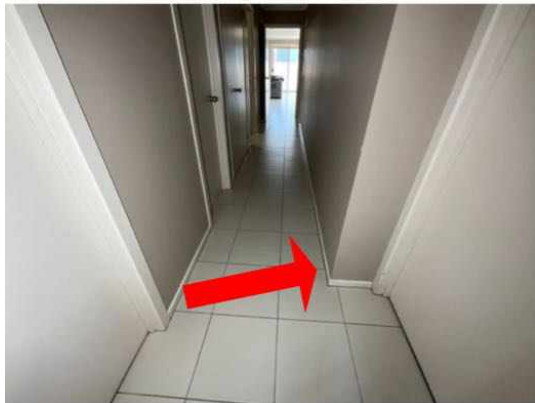
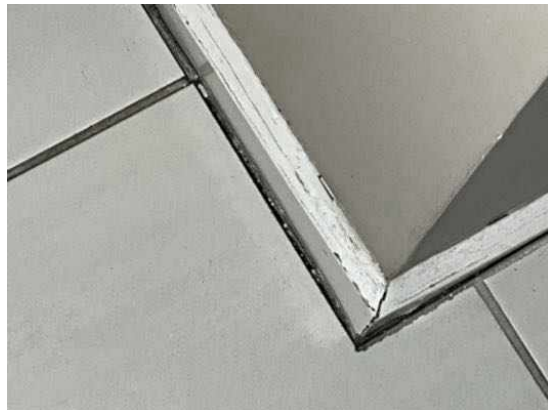
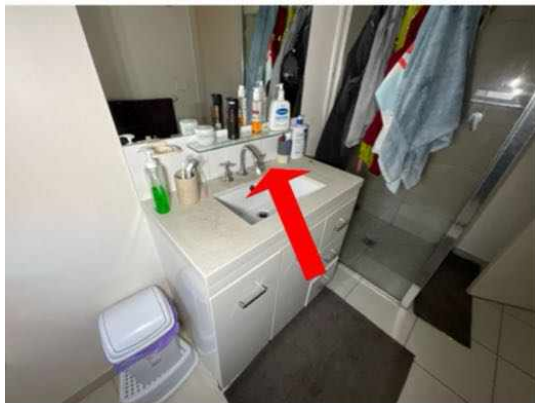
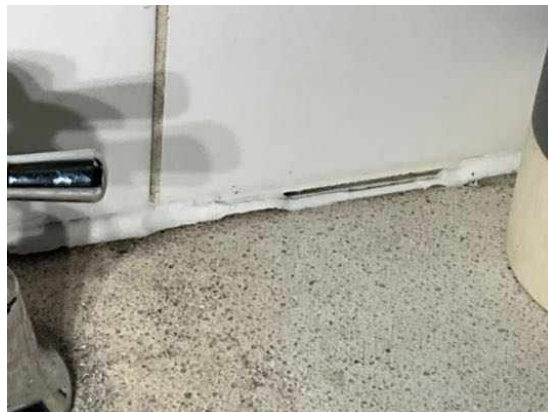
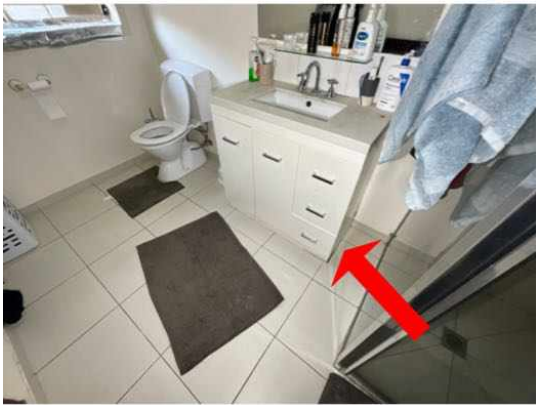
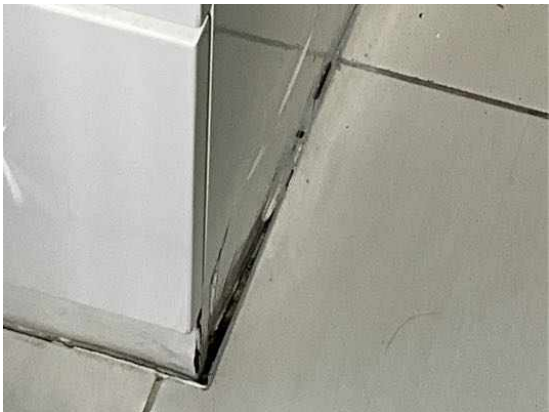
Building: Building 1  
Location: Hall, ensuite,  
Finding: Inadequate sealant or Grout  
Information: This area has a lack of effective Sealant or Grout. This is allowing the ingress of water to the structure inside the wall.

The presence of water encourages Termite attack, Mould and Fungal Decay.

A Tiler or General Handy person must be contacted as soon as possible to effect repairs and prevent further deterioration.

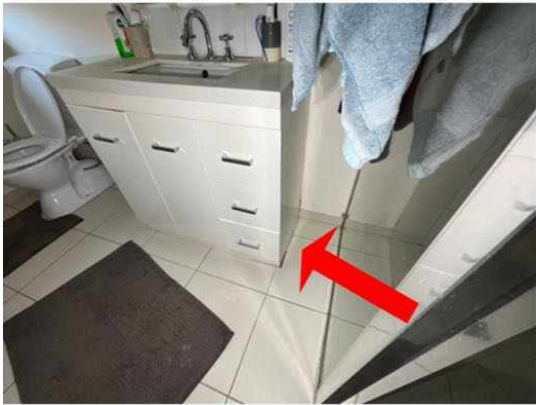
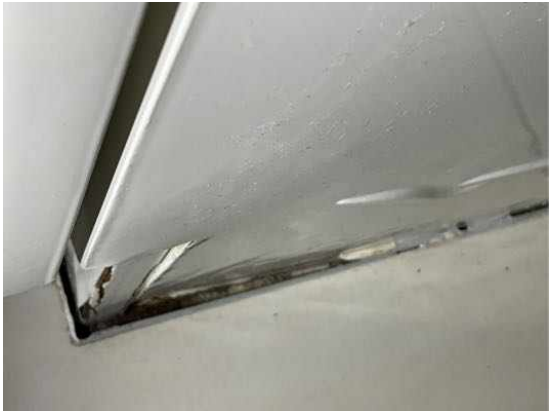
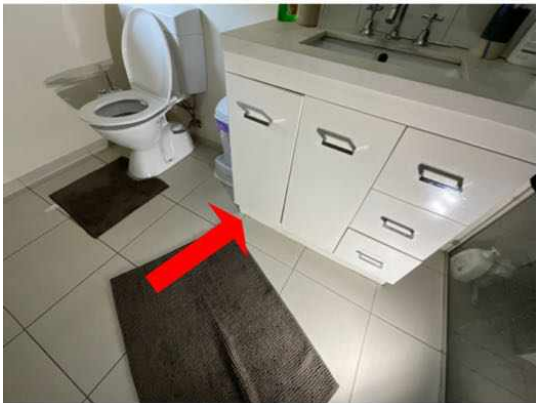
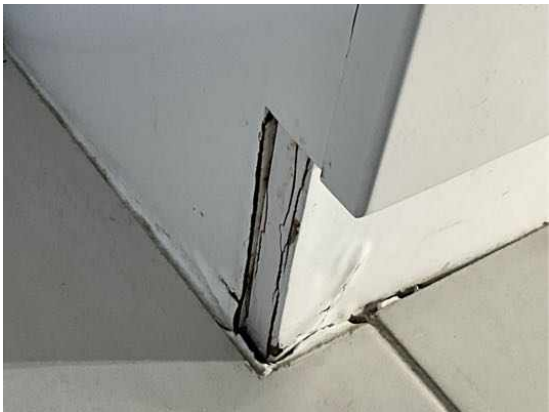
Building: Building 1  
Location: Ensuite  
Finding: Cabinets- moisture affected.  
Information: The structure of the Cabinets in this area was found to be deteriorating due to the effects of excessive moisture. Replacement of any damaged board materials is recommended. Parts of the Cabinetry not badly damaged or swollen may be re-sealed or painted.

The source of the moisture must be identified and rectified before repairs and replacement is carried out. The services of a Cabinet maker or General Handy Person should be sought at the discretion of the owner.
