# Building and Timber Pest Inspection Report

Inspection Date: Thu, 29 Jan 2026

Property Address: 211 Woods Rd, Yagoona NSW 2199,  
Australia

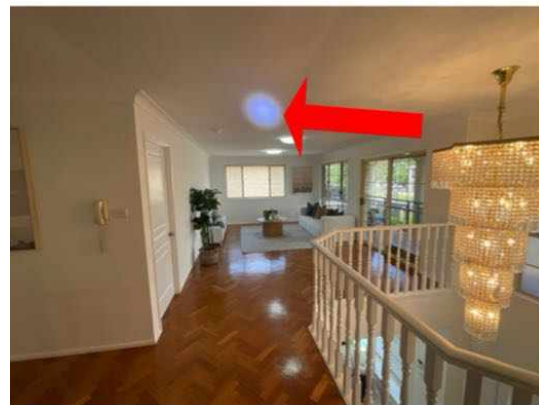
Finding: Ceiling - Water stained

Information: Water staining to ceiling linings in this area was evident at the time of inspection. Water staining indicates that surfaces have been exposed to excessive moisture over time. The minerals and other elements in the water lead to staining, which may graduate to corrosion and deterioration if left unmanaged.

While mostly an appearance defect, water staining can be indicative of more serious defects, which may be currently concealed by interior ceilings.

Where water staining is active, a licensed plumber must be consulted to identify the cause of the staining and to provide advice on any reparation works that may be required. Replacement of any damaged structures is advised.

Conversely, where water staining is old and inactive, affected building materials may be repaired or replaced at client discretion.

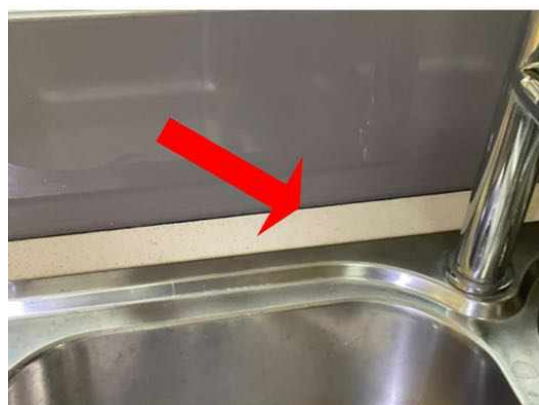
Building:	Main Building
Location:	Kitchen
Finding:	Sealant and grouting - Missing or damaged
Information:	It was noted on inspection that sealant or grout is degraded to the tiled shower alcove and or other areas of the bathroom.

Different materials and floor areas move at different rates, generally causing cracking to grout or sealant at this point. A flexible sealant is required to allow for expected expansion and contraction, while keeping the joint water tight and protective of all associated building materials.

There appears to be excessive mould to the sealant and grout which will likely require scraping out and replacement.

Flexible and mould resistant materials should be applied to affected areas to prevent any subsequent water damage that is likely to occur. Regular maintenance and replacement of damage or missing or damaged sealant and grout is highly recommended to the wet areas, as this is a regular wear and tear defect. Sealant and grouting in areas that come into regular contact with water should be maintained for the long term care of your property.

A sealant specialist or tiling contractor should be appointed to complete these works as soon as possible

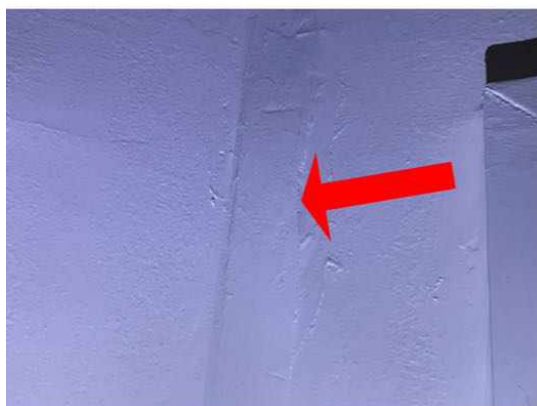
Building:	Main Building
Location:	All Internal Areas
Finding:	Paint finish - Substandard
Information:	The paint finish in this area was found to have been completed to a substandard level. Substandard painting is generally classified as an appearance defect. However, the substandard appearance may also be indicative of poor surface preparation and substandard workmanship.

If this applies, further areas of poor and incomplete finishes could develop over time. Furthermore, substandard paint finishes in areas exposed to moisture, e.g. external areas or wet areas, could lead to deterioration of underlying building materials.

Substandard paint finishes should be sanded back, filled, leveled and repainted, as applicable. Where inadequate paint protection has led to the deterioration of the associated building element, repair and/or replacement of this building element may be required.

A painting contractor should be appointed as soon as possible to perform necessary works to aid the appearance of the affected area and to ensure that the area is protected against further deterioration. Alternatively, the homeowner following manufacturer instructions may be able to provide this service.

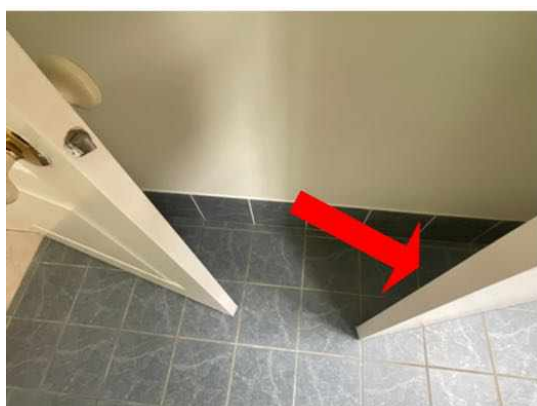
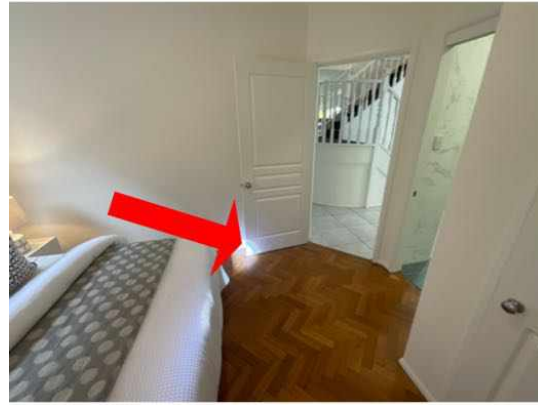
Building:	Main Building
Location:	All Internal Areas
Finding:	Door stop - Missing
Information:	The door stop is missing or is inadequate to stop the door handle from damaging the wall. Although some building elements may seem irrelevant or unnecessary, all building elements play a key role in the operation and function of the overall structure and its performance.

Re-installation or replacement of the door stop is advised as soon as possible to prevent any subsequent damage to the door or associated structures. A general handyman may be appointed to perform these works at client discretion.

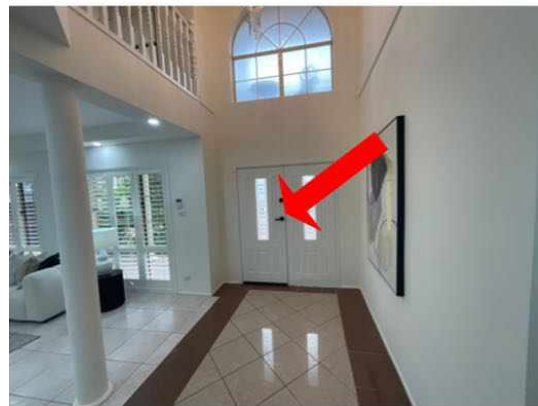
### Finding 3.06

Building:	Main Building
Location:	Entry
Finding:	Fitting (door handle) - Loose
Information:	The fitting in this area is loose and requires adjustment to tighten.

If left unmanaged, the fitting may further deteriorate, causing potential for the development of other minor secondary defects.

A relevant tradesperson should be appointed to perform these rectification works at discretion of the client.

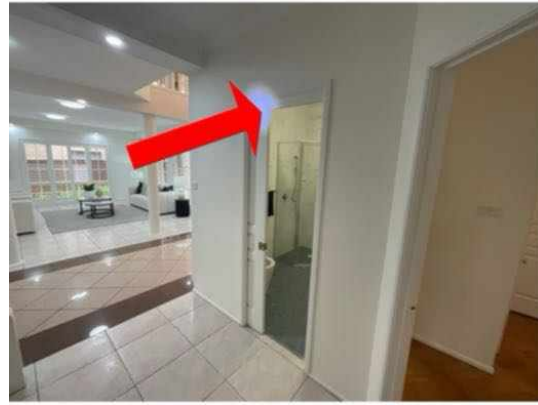
### Finding 3.07

Building:	Main Building
Location:	Bathroom > Ground Level
Finding:	Cavity Sliding door - defect
Information:	Most of cavity sliding doors may have a ball bearing type system that runs along the track and this system may get the defects by installation and some other impacts.

The qualified carpenter should be nominated to repair the matter.

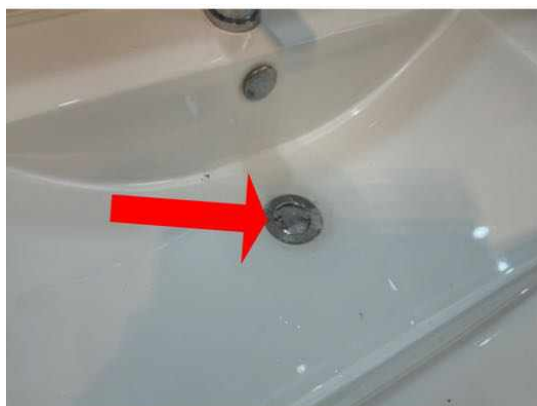
Building:	Main Building
Location:	Ensuite > Ground Level
Finding:	Internal drains (vanity) - Blockages
Information:	Vanity drains throughout the property have blocked at the time of the inspection. Vanity drains are vital in removing the water in the vanity bowl and should be fully functional. Minor blockages create potential for the development of moisture damage over time.

All vanity drains should be assessed by the building contractor and cleared or replaced where applicable.

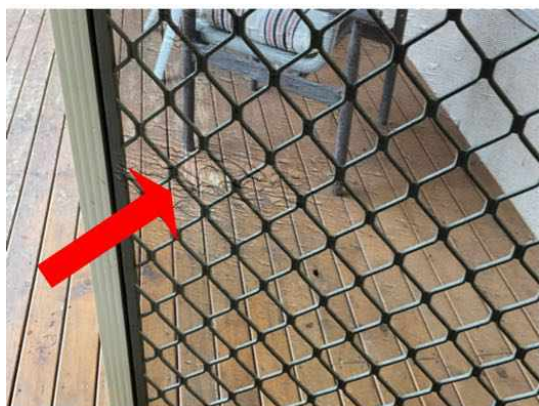
Finding: Flyscreens - Damaged

Information: Flyscreens were found to be damaged to the windows in this area at the time of inspection. This damaged building element detracts from the operational state of the window. Where not replaced, damaged flyscreens allow pest and insect ingress into the adjoining room/s. It is advised that all damaged building elements be replaced in order to ensure the full function of all building structures. A general handyperson may be appointed to replace flyscreens at the discretion of the client.

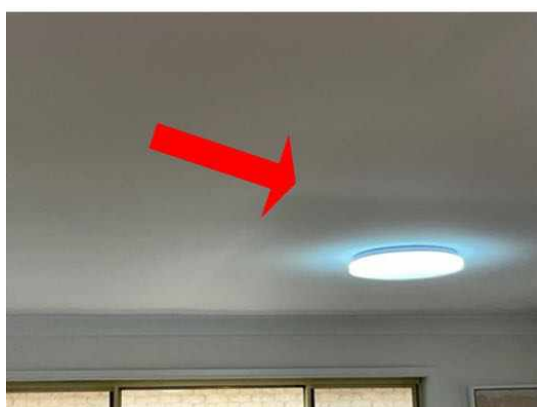
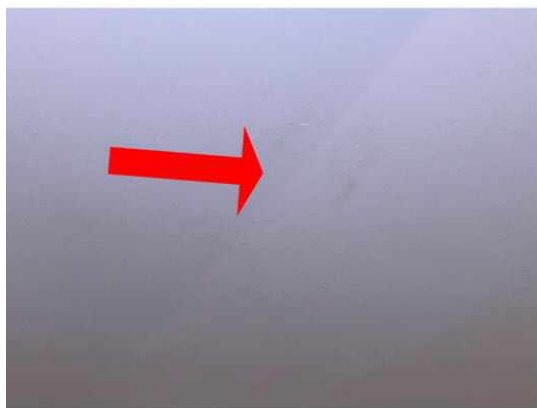
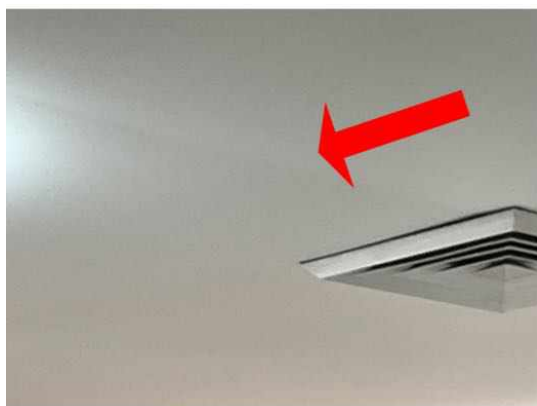
Information: Sections of the ceiling were found to be sagging at the time of inspection. Sagging to the fixed ceiling structure generally indicates that the building materials have swollen, due to contact with water, or that fixings (e.g. nails or glue) have become loose and require reattachment.

Where minor sagging is evident, comparatively minor works, such as re-gluing of ceiling sheets, may be required. Such works may be performed by relevant tradespeople, such as plasterers and painters. Where excessive moisture has caused the roofing structure to swell and sag, the source of the water leak should primarily be identified prior to any remedial works being performed.

In some cases, sagging ceiling linings may also indicate that there are structural issues, causing surfaces to warp, twist or sag. Where sagging appears to be major, appointment of a structural engineer is advised to further inspect the property and identify the source and rectification works required.

The appropriate action should be taken by the client as soon as possible to ensure that any potential further damage is limited.

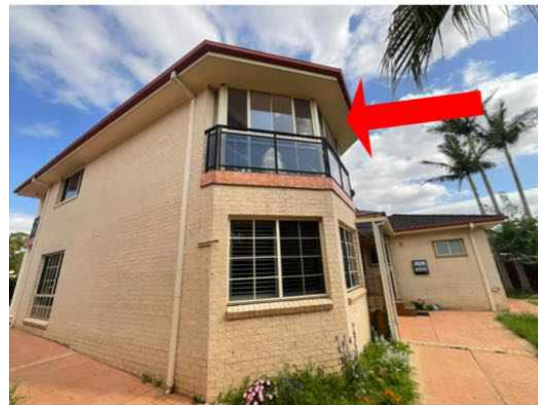
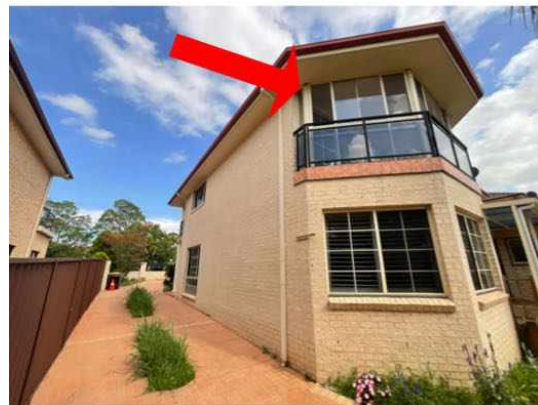
### Finding 3.19

Building:	Main Building
Location:	All External Areas
Finding:	Building element - Rusted or corroded
Information:	This building element shows evidence of rusting and corrosion, which is likely to have

Where possible, the use of galvanized (treated) metals or aluminium coated metals aid in rust prevention, as does regular general maintenance. Rust formation can be controlled with coatings, such as paint, that isolate the iron from the environment.

Rusting and corrosion should be managed by ideally removing or limiting the affected surface from exposure to moisture. A registered builder may be appointed to replace any building elements that have been severely affected by rust or water damage.

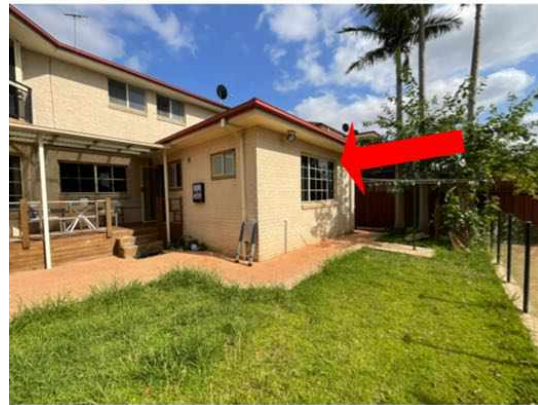
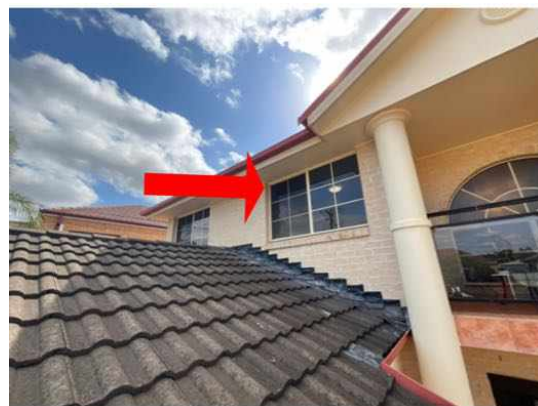
### Finding 3.20

Building:	Main Building
Location:	All External Areas
Finding:	Window - Gap
Information:	A significant gap was identified between the brick and window frame in this area. Where large gaps to the head appear, it may indicative of a variety of defects, ranging from uneven framework, sagging hinges or uneven flooring.

A gap to the head of the window may also indicate movement of the foundation of the property, which is a common occurrence and does not indicate structural damage.

A qualified tradesmen should be appointed to perform remedial works to restore the window to a fully operational level.

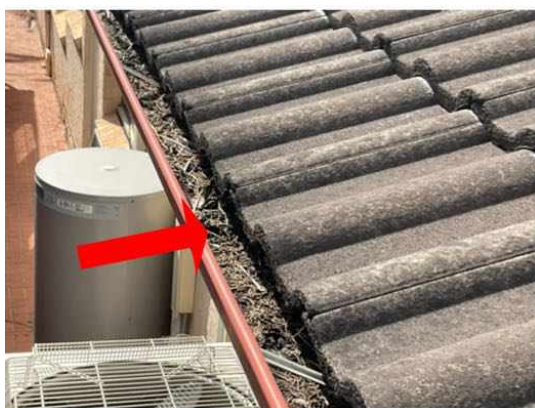
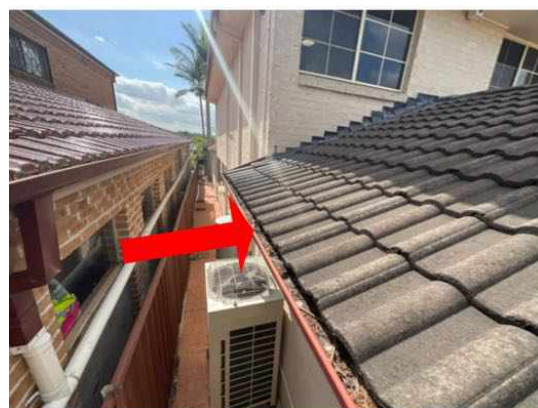
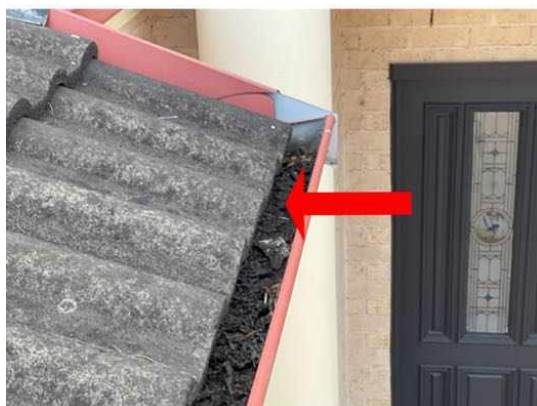
### Finding 3.23

Building:	Main Building
Location:	Roof Exterior

Blocked gutters are likely to lead to high levels of moisture in the affected areas. Such moisture will not only cause rust and decay of the associated building materials, but can also provide conditions that are conducive to termite and timber pest activity. Blockages in gutters should therefore be removed immediately to ensure dry conditions are maintained.

Consult a Licensed Plumber for further specific advice on remedial works that may be required. In the interim, it is highly advised that blocked gutters be removed by the homeowner or a general handyperson as a matter of urgency.

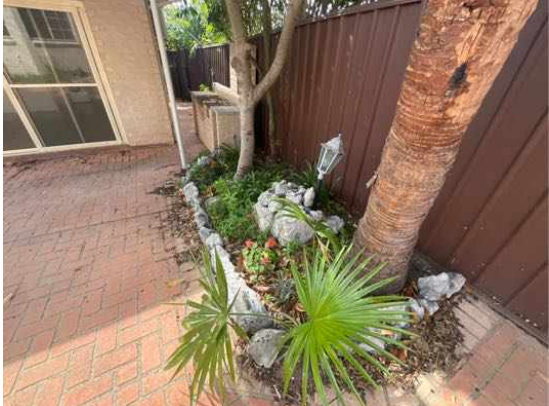
**Finding 6.01**

Building: Main Building  
 Location: All Areas  
 Finding: Garden Beds - Conditions Conducive to Termites  
 Information: Garden beds were found to be evident in the garden area. These garden beds can include untreated timber, and with a combination of moisture from watering hosing can make conditions conducive to termite activity and termite ingress.

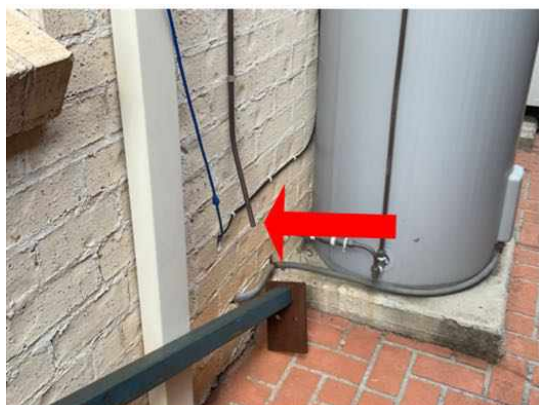
## Finding 6.02

Building:	Main Building
Location:	All Areas
Finding:	HWS Overflow - Not Connected
Information:	The Hot Water System (HWS) overflow was found to be disconnected from storm water drainage and is creating excessive moisture in the surrounding area.

These damp conditions can lead to secondary defects such as rot, rust or corrosion of associated building elements, the formation of fungal decay, or even the creation of potential slip hazards. When coupled with poor site drainage, pooling of water may also attract termite activity to this area.

It is highly recommended that a licensed plumber be appointed to connect the HWS overflow in order to prevent such an environment from being created. These minor works should be carried out as soon as possible.
