Building Inspection Report

Inspection Date: Wed, 1 Apr 2026

Property Address: Unit 3 1 Carlyle st, Croydon VIC 3138,
Australia

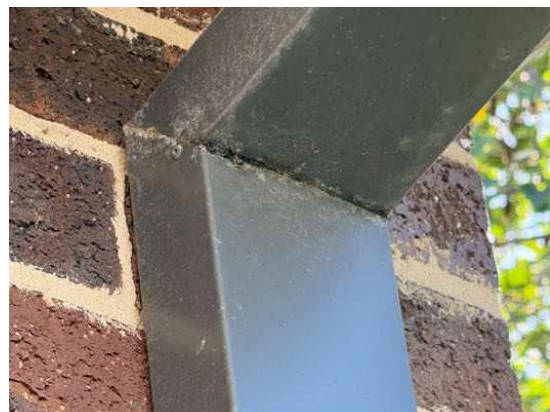
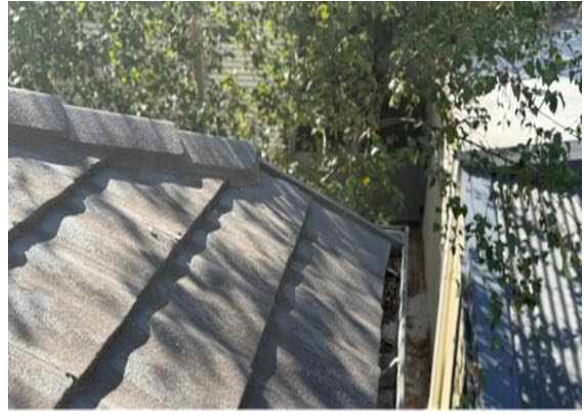
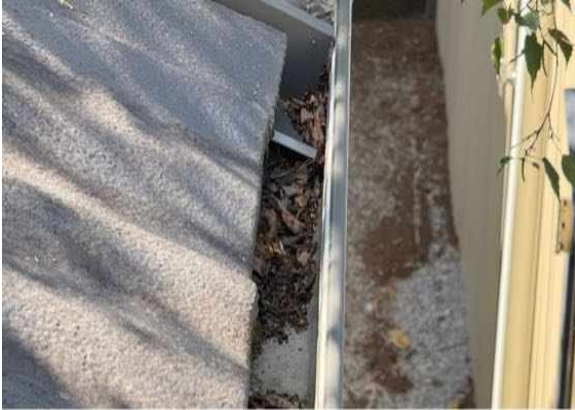
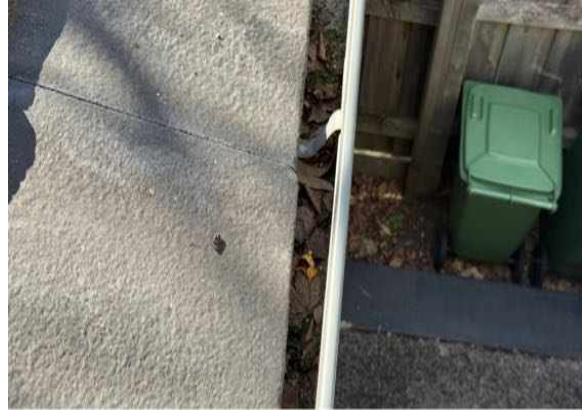
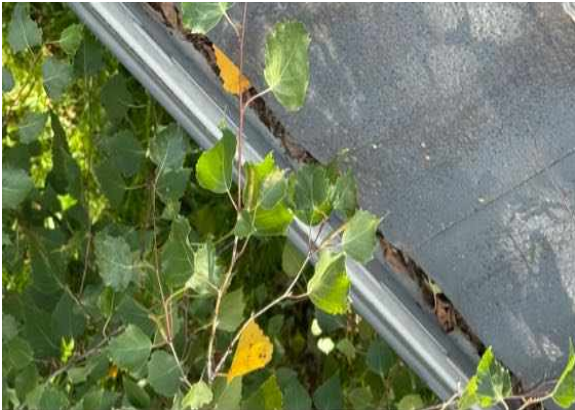
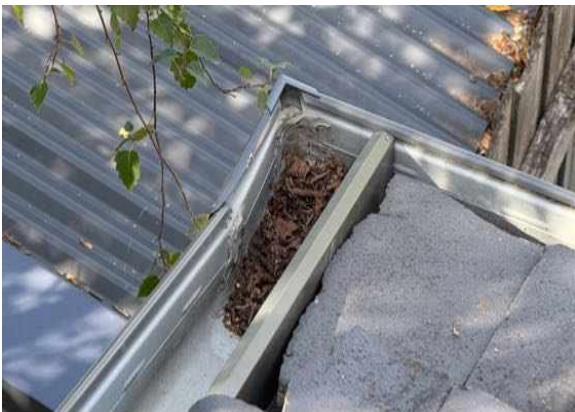
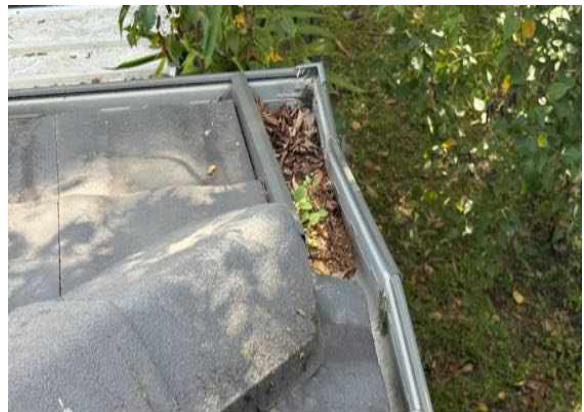
Defects 3.01

| Finding: | Gutters - minor blockages |
| Information: | Roof plumbing structures, such as guttering and downpipes, should be free of all debris to prevent blockages. Blockages of the guttering and downpipes will lead to pooling and accumulated water overflows, which is likely to subsequently flood eaves and exterior walls and entering internal areas. |

Blocked gutters are likely to lead to high levels of moisture in the affected areas. Such moisture will not only cause rust and decay of the associated building materials, but can also provide conditions that are conducive to termite and timber pest activity. Blockages in gutters should therefore be removed immediately to ensure dry conditions are maintained.

It is recommended that blocked gutters be cleaned and leaf matter and debris be removed by a relevant tradespersons as a priority.

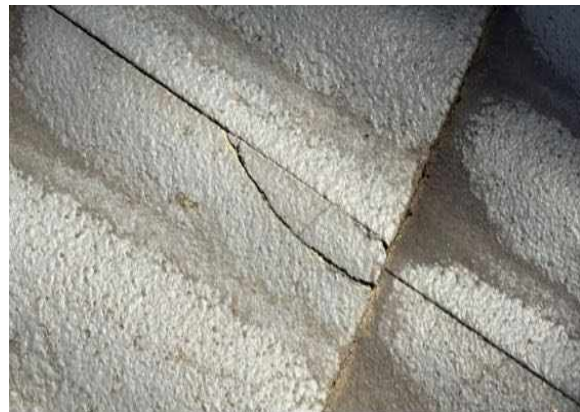
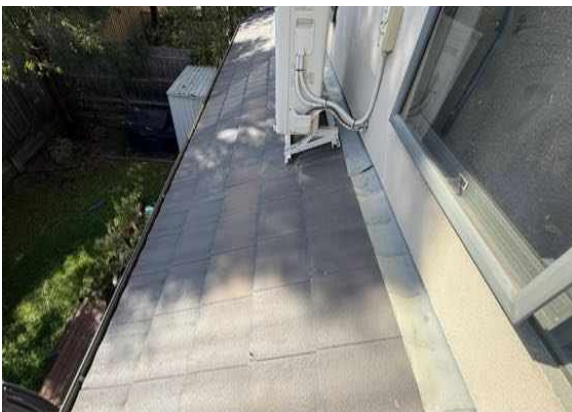
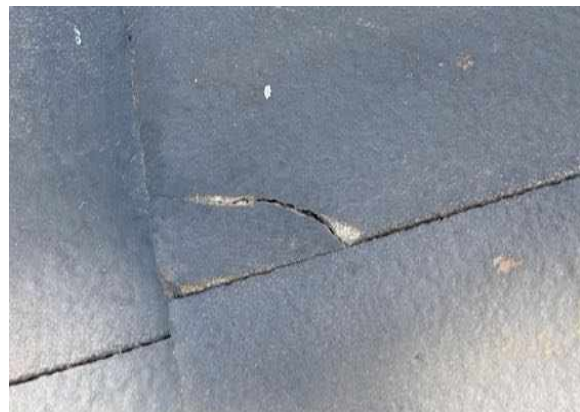
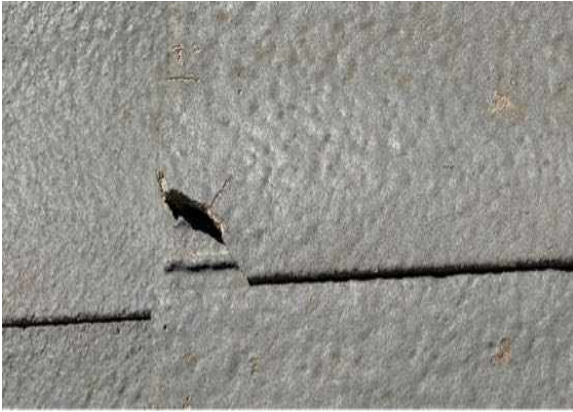
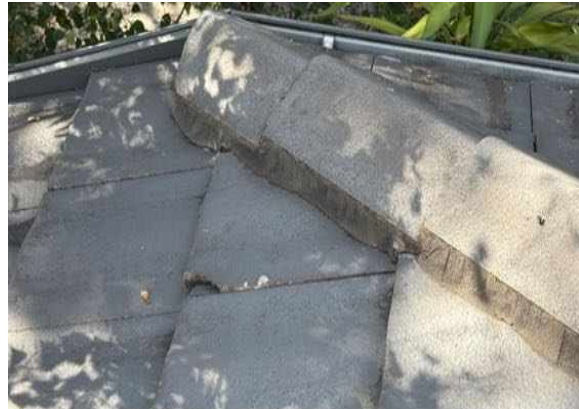
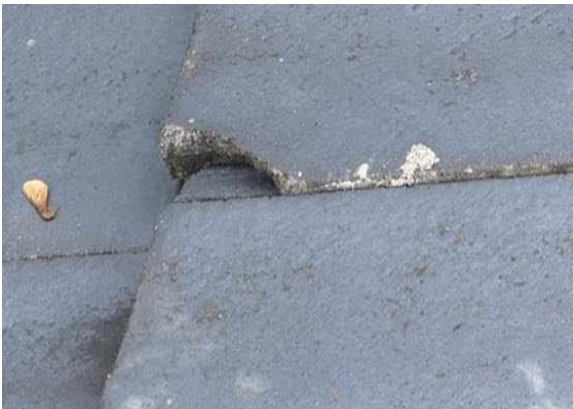
Defects 3.02

Building: Building 1
Location: All Areas > All Areas
Finding: Roof tiles - some broken edges or chipped
Information: Upon inspection of the exterior roof covering, a few of the roof tiles showed some small broken off or chipped roofing tiles were observed. Broken and friable roof tiles are generally the result of getting a bit brittle overtime, plus normal weathering of what is essentially a concrete porous material.

Over time the roof tiles can get brittle, will further deteriorate and are likely to lead to water penetration via the roof into the ceiling space, causing secondary damage to ceiling linings, insulation and roof structures. Where broken or chipped roof tiles are left unmanaged they are also likely to lead the roof not being watertight, creating the potential for secondary damage. Replacement of any broken or chipped roof tiles is required and should be performed by a roofing contractor as soon as possible. This can be carried out by a roof tiling company or a qualified roof tiler.

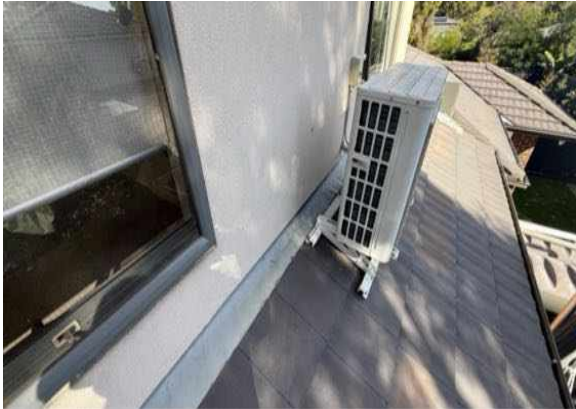
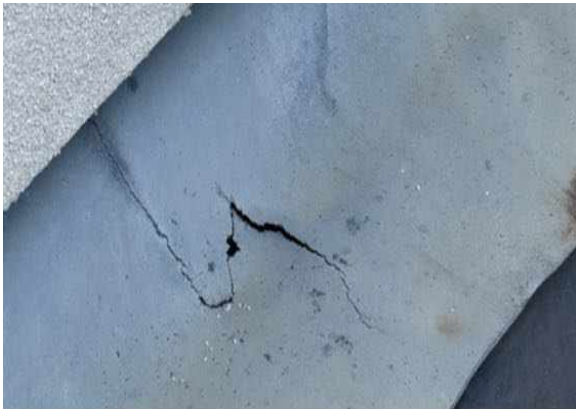
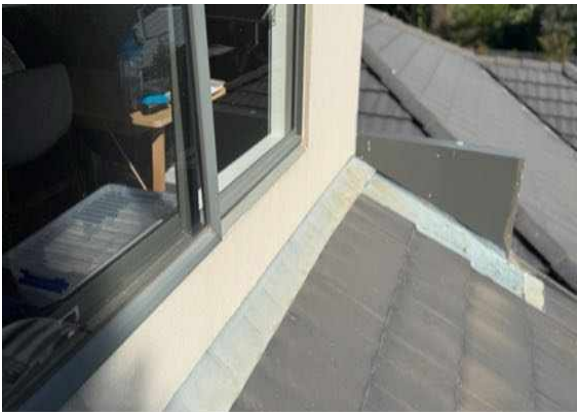
Defects 3.03

| Finding: | Roof flashings above the rear living room |
| Information: | The roof flashing above the rear lining room were observed to be showed cracks in the wall to roof flashings, these are not currently sealed adequately. The flashing in this section of the roofing appears to be good expect for these cracks, these are suspected to have been caused at the time of installation and construction of the unit. This roof flashing needs to be sealed immediately or rectified as soon as possible in the short term future to ensure it is weather proof and water tightness remains in this area. |

Metal and other material flashings are applied to seals and intersections between roof coverings and building elements. They are designed to aid in weatherproofing of roof joins. Left unmanaged moisture damage in this area may be eminent, failure to perform these works may result in water damage and accelerated deterioration of other associated roof and building elements. A roofing plumber should be appointed immediately or as soon as possible to restore these flashings to a fully operational state.

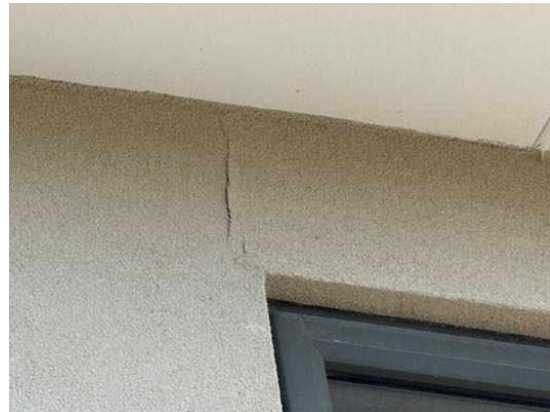
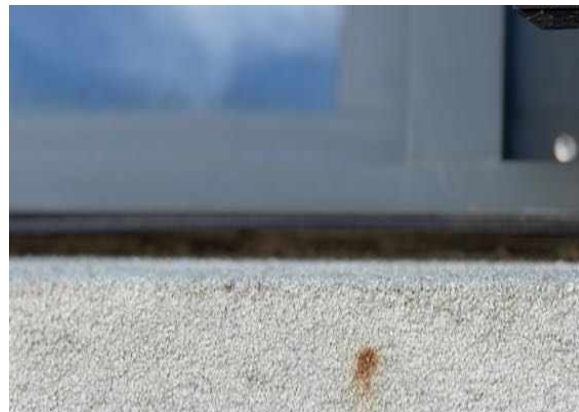
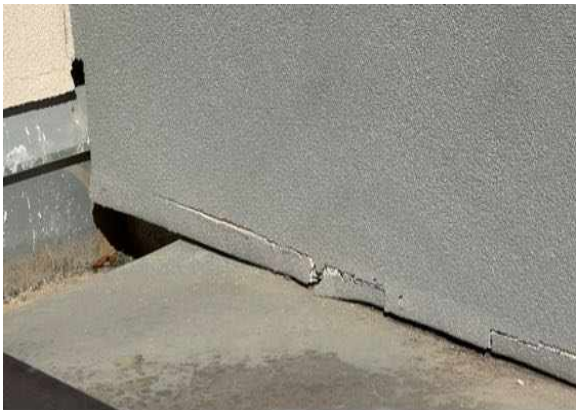
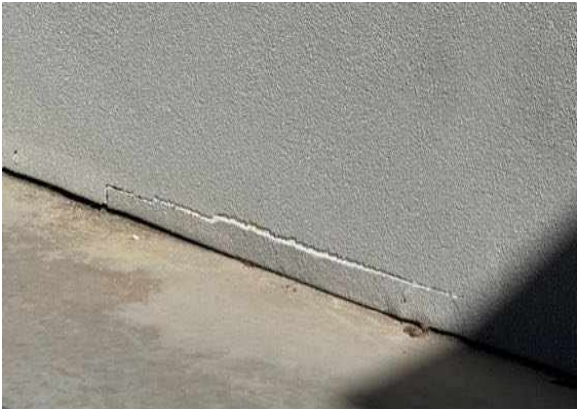
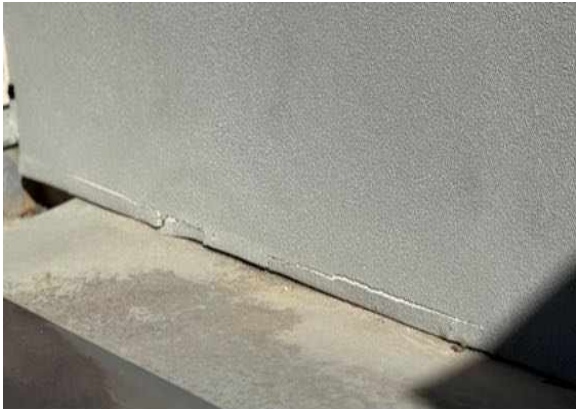
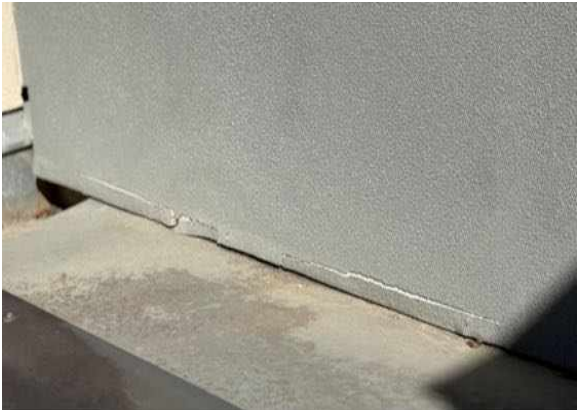
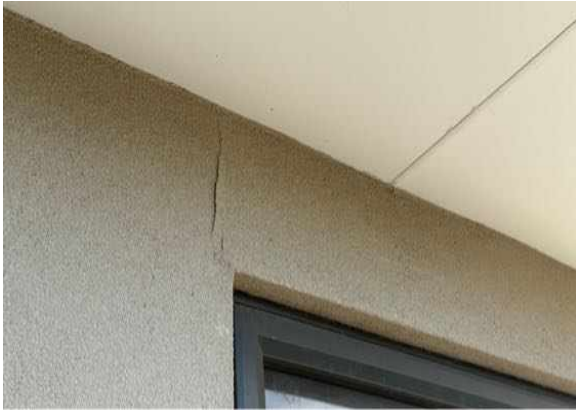
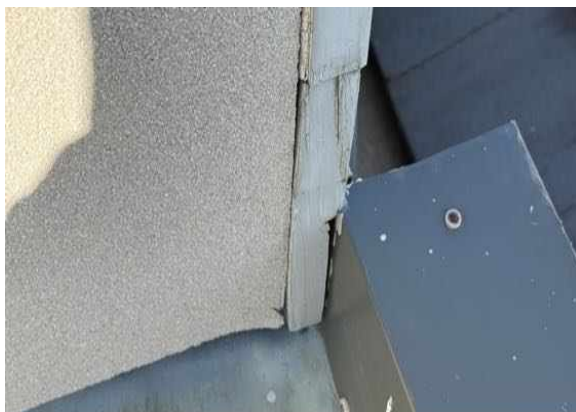
Defects 3.04

Finding: Cracks to exterior rendered surfaces

Information: It has been observed that numerous cracks to the rendered surfaces has occurred throughout the external areas. The degree of damage is described as numerous minor cracks which are generally less than 1- 3mm in width. In the future the client may consider some repair and remedial works to seal these areas to ensure water and moisture cannot enter into the internal areas behind the rendered surfaces.

This type of cracking is considered to be from normal movement from expansion and contraction at the many stress points throughout the exterior of the home. However they will still required the client to monitor to ensure they do not become larger and deteriorate, if these cracks and or defects were to further deteriorate, it is considered a defect that requires rectification in the short term future. Always contact your relevant building or tradesperson should cracks widen, lengthen, or become more numerous.

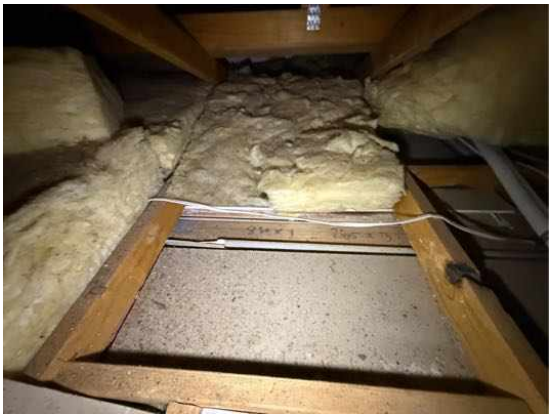
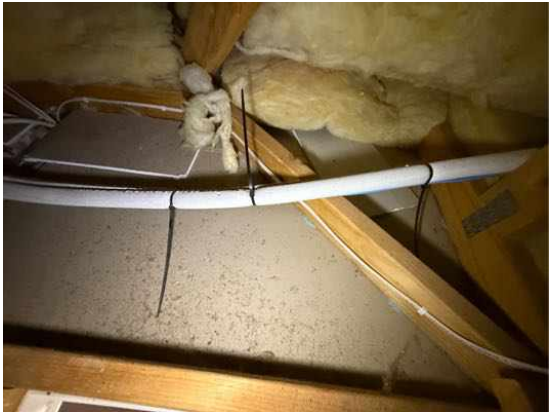
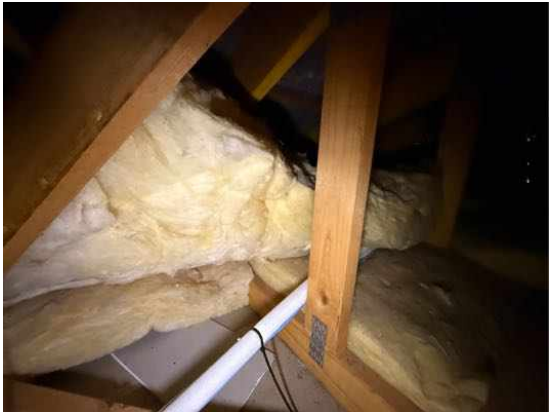
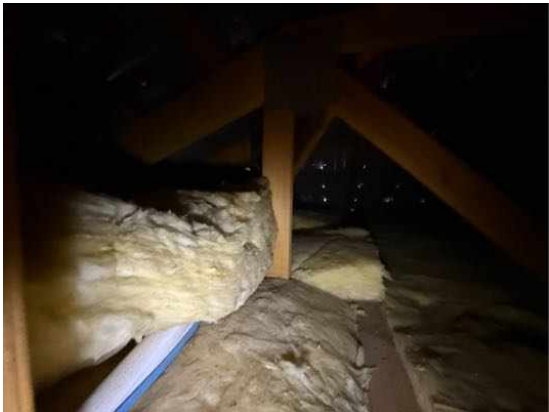
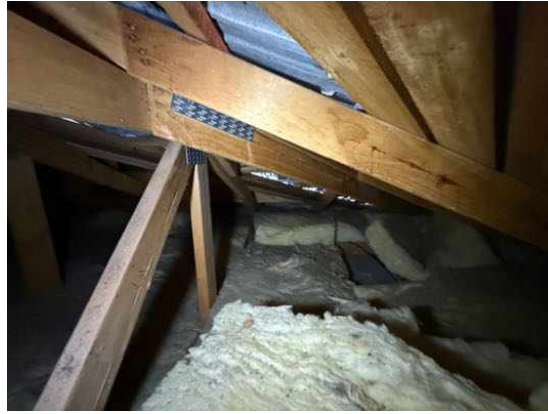
Defects 3.05

| Finding: | Insulation - poorly installed - missing or moved |
| Information: | Some areas of the roof insulation in the roof space is suspected to have been poorly installed, missing or have been moved from their original position. Insufficient insulation will result in a comparatively higher cost to heat and cool a property as there is a lack of Insulation (or uneven coverage of insulation) which works as a barrier to heat transfer. This helps to keep out unwanted heat in summer and preserves warmth inside your home in winter. It can also help soundproof your home from unwanted airborne noise transfer. |

Example - Where there is a gap in coverage totaling 5% there is a potential for up to 50% of the energy efficiency to escape. Caution should always be exercised when accessing the roof void. Do not attempt to stand on the framework and especially be aware that there is a potential for electric shock if contact is made with exposed or faulty electrical wiring.

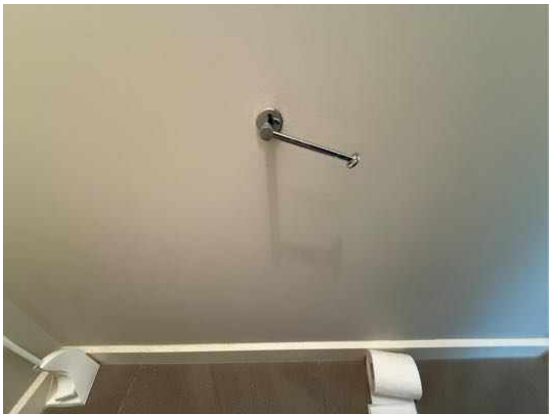
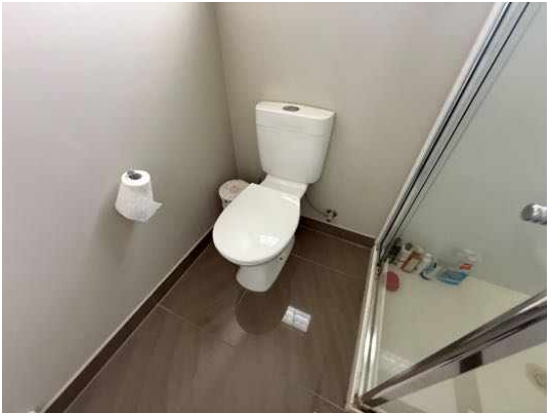
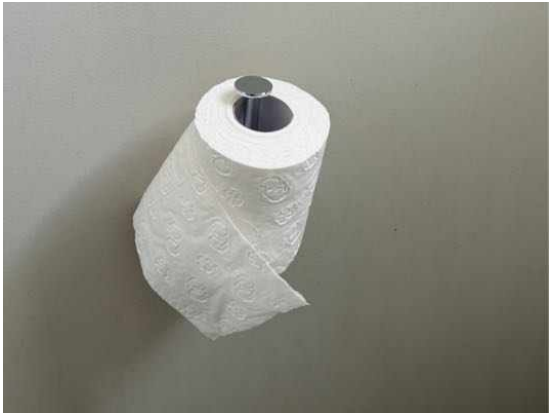
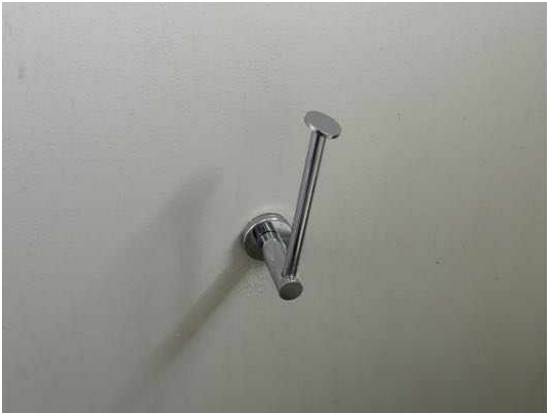
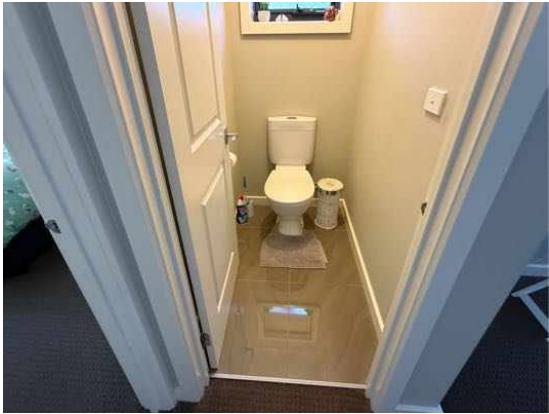
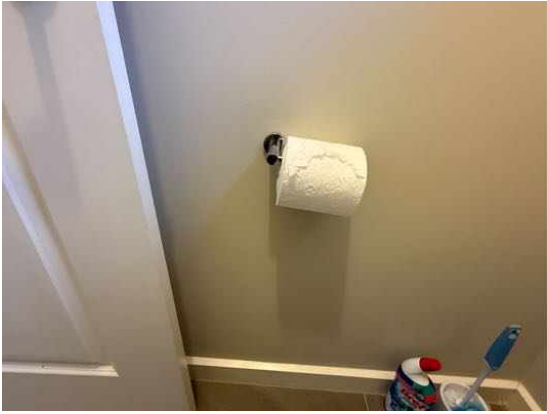
Defects 3.08

| Finding: | Toilet roll holders - Loose |
| Information: | The toilet roll holders and towel rail were found to be loose at the time of inspection. While not a major operational defect, function can deteriorate if the problem is left unmanaged. It is recommended that some remedial works to rectify the loose toilet roll holders and towel rails to its original fixing. If these cannot be be rectified to function as intended, client is recommended to renew. A qualified carpenter may be required to perform these works. |

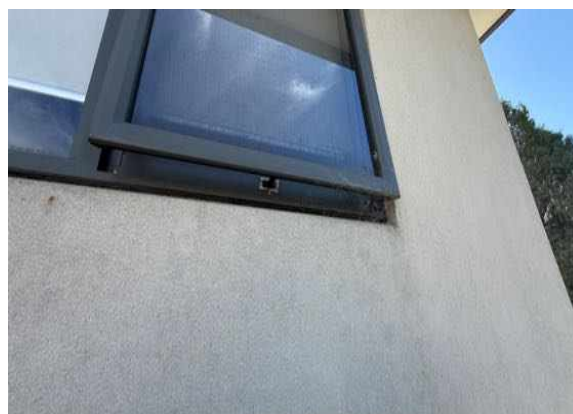
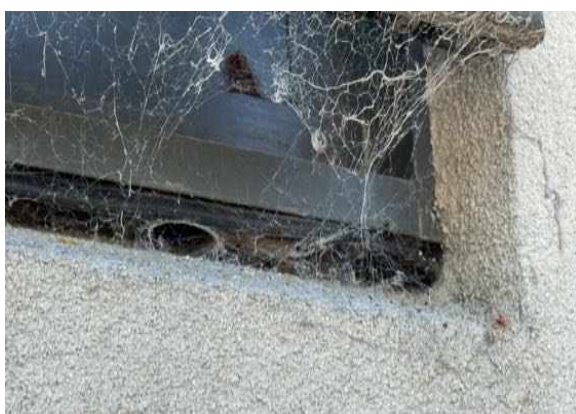
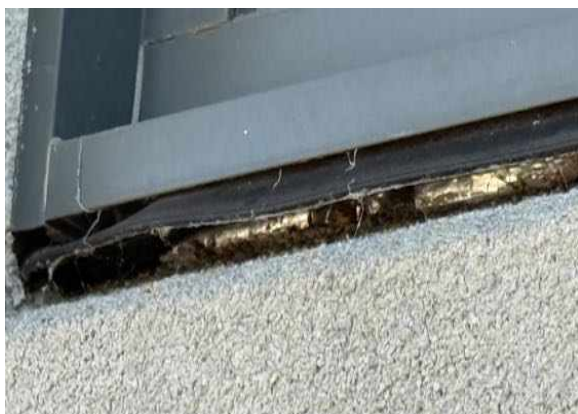
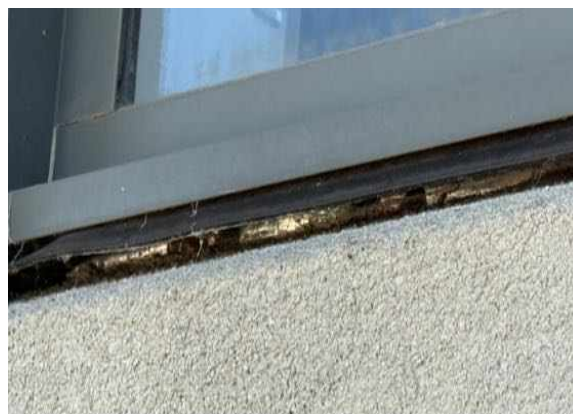
Defects 3.09

| Finding: | Gaps between the bottom of the aluminium window frames and sills |
| Information: | <p>At the time of the inspection some aluminium windows were showing gaps to the bottom of the windows between aluminium window frames and sills. All windows with gaps to the exterior perimeter should be filled with a good quality sealant, aluminium angle or flat. It is recommended that for the large gaps, firstly you may need a backing rod (Cylindrical foam) in the gap to take up the bulk of the space, this should prevent the sealant from falling through any gaps. If a colour matched colourbond aluminium angle is used, the tradesperson must ensure that this will match the exterior window colour as close as possible, then apply a sealant to ensure a good, wind and weather tight seal and rivet to the window frame. The installer or tradespersons must be capable and competent to ensure a good quality sealant finish. A good quality sealant, should be used, for the small gaps. The installer must ensure that the sealant used is mildew and mould resistant and fit for purpose.</p> |

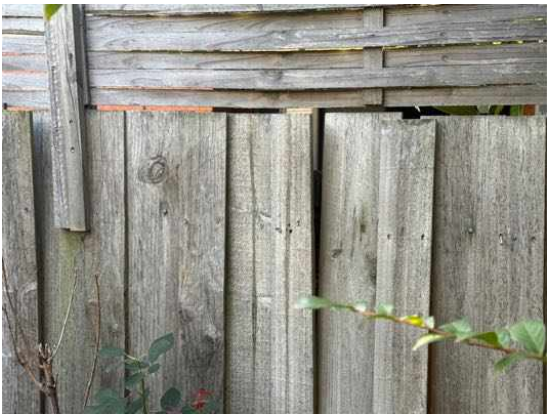
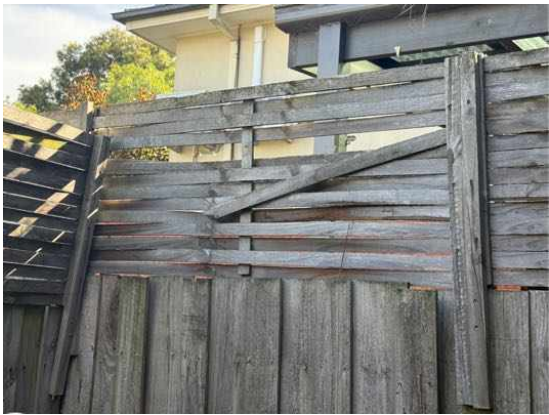
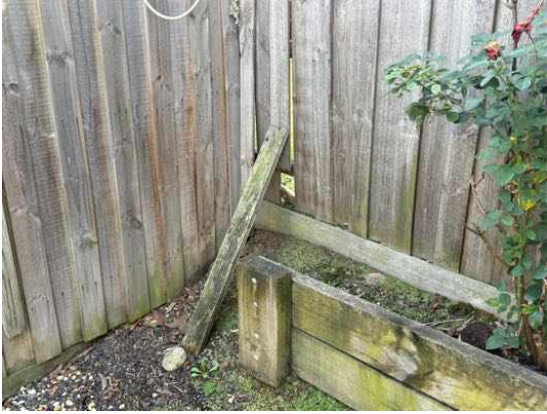
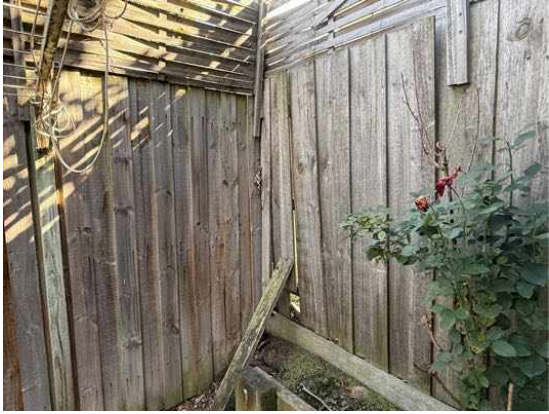
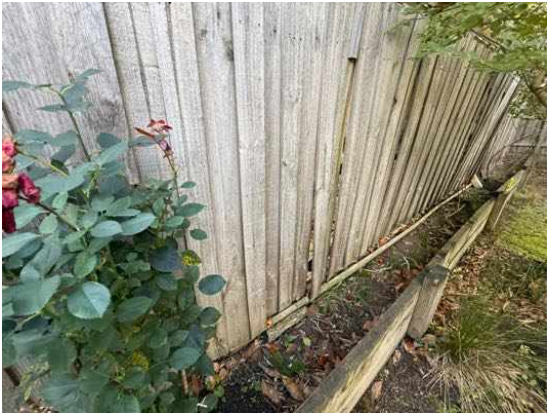
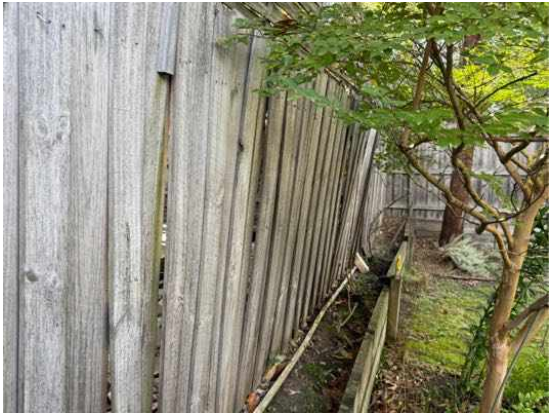
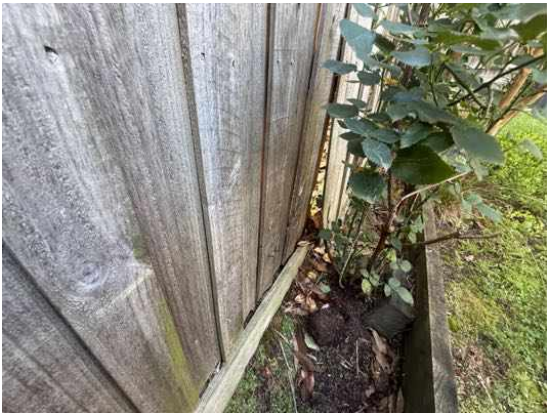
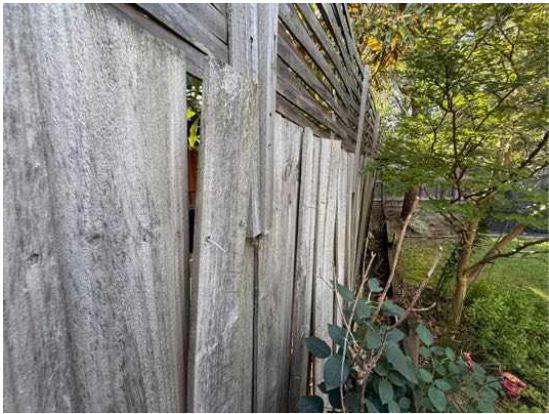
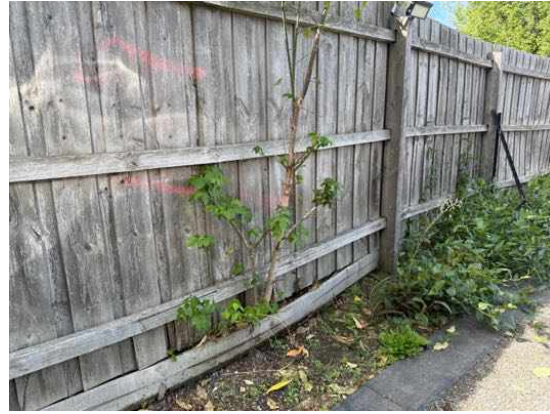
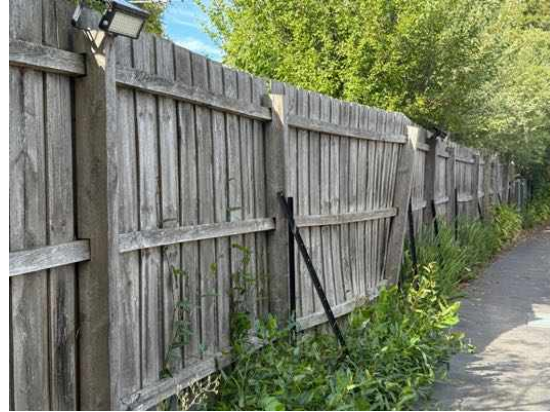
Defects 3.10

| Finding: | Post and rail fences |
| Information: | Post and rail fences showed damage and deterioration at the time of the inspection. This deterioration is suspected to have developed over a prolonged period of time due to frequent weather exposure, which is expected in a property of this age and condition. |

Left unmanaged, further deterioration is likely to develop further, necessitating in extensive repair or replacement areas of the timber fences, this will depend on the age and deterioration and or wood rot, further damage is suspected of occur.

To maintain the condition of the external timber building elements, any affected areas should be substituted as soon as possible with pre-treated replacements. A qualified fencing contractor should be appointed to repair and replace post and rail fencing where deemed to be necessary.

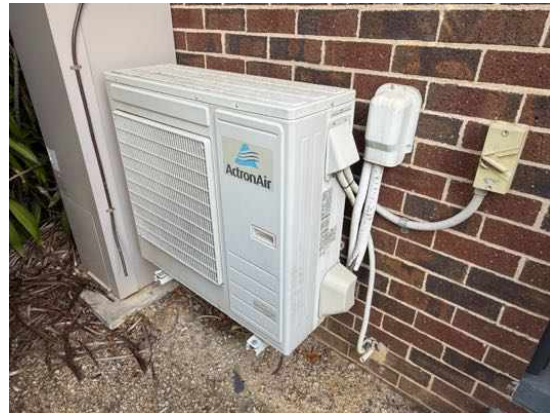
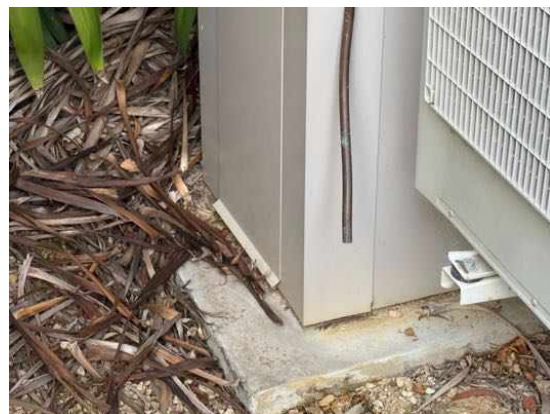
Defects 3.11

| Finding: | HWS and air-conditioning overflows not connected |
| Information: | The Hot Water System (HWS) and external air-conditioning units showed that the overflow pipes not to be connected to any form of storm water drainage system and may in the future create excessive moisture in the surrounding area, as these units as they get aged, deteriorated and particularly during their use. These damp conditions can lead to secondary defects such as rot, rust or corrosion of associated and adjoining building elements, as well as the formation of fungal decay and even the creation of potential slip hazards for occupants. When coupled with poor site |

drainage, pooling of water may also attract termite activity to these areas. It is highly recommended that a licensed plumber be appointed to connect the HWS and air-conditioning overflows in order to prevent such an environment from being created. These remedial works should be carried out as soon as possible.

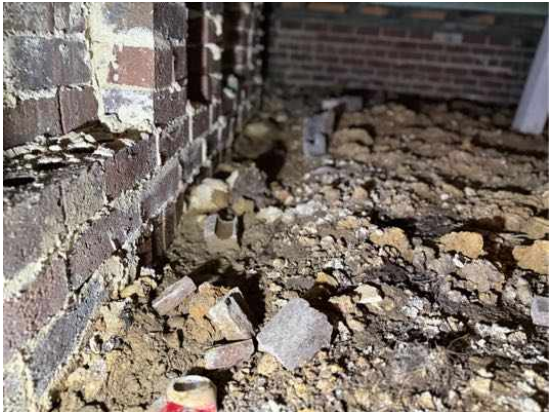
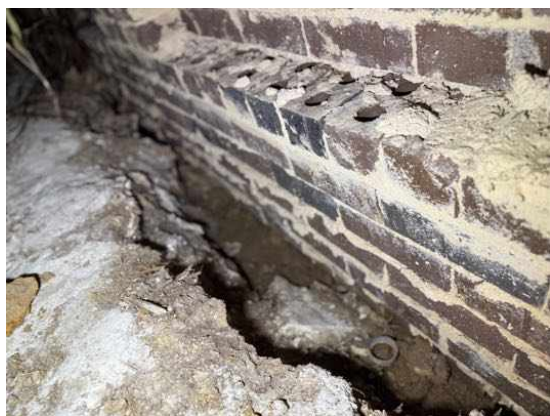
Defects 3.12

Building: Building 1
 Location: All Areas > All Areas
 Finding: Subfloor moisture travelling around the subfloor foundations
 Information: At the time of the inspection to the subfloor areas, moisture was observed to be travelling around the subfloor foundations in some of the rear areas in the subfloor. It is

Where roof plumbing doesn't drain adequately, the exterior areas at the base perimeter can become excessively moist and damp, moving through and under the home creating an environment that is making the foundations susceptible to heaving and other building elements and materials to moisture damage, wood rot, rust and corrosion, as well as attracting termites and other pests to these areas. It is highly recommended that a plumber be appointed to further inspect the exterior and subfloor areas and to install adequate drainage and equipment where deemed to be necessary.

recommended that the client appoint a Registered drainage plumber to provide adequate drainage to alleviate as much moisture from entering the subfloor as possible. A plumbing contractor should be instructed to add the necessary site drainage such as agriculture drainage and rectify any drainage not adequately working or connected to stormwater drainage on the site. Any disconnection or drainage problems can negatively impact the functional capacity of the site drainage system.

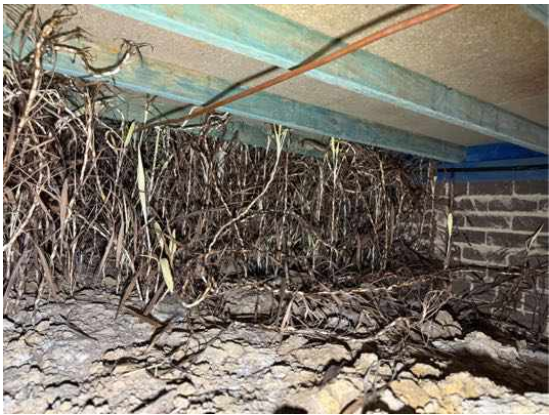
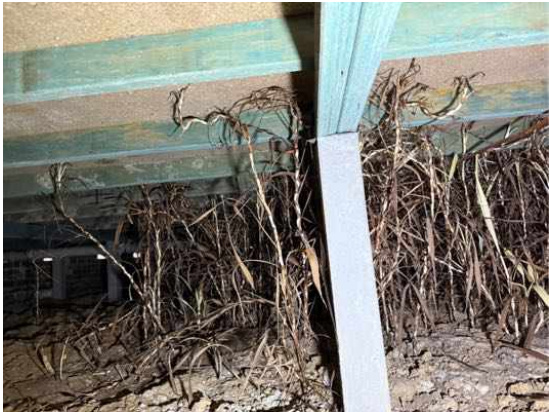
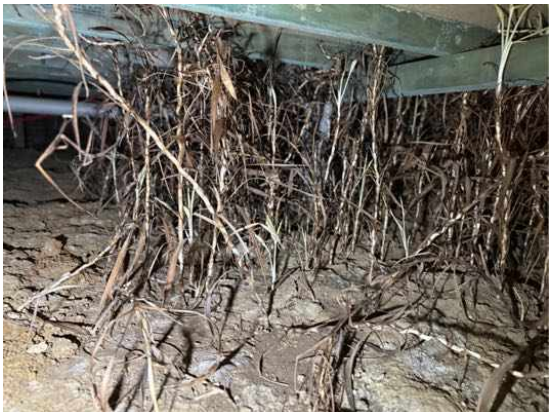
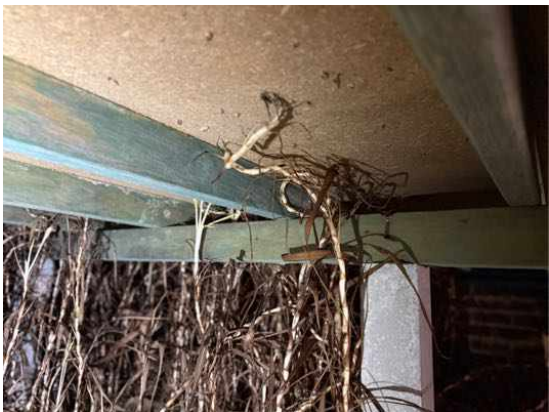
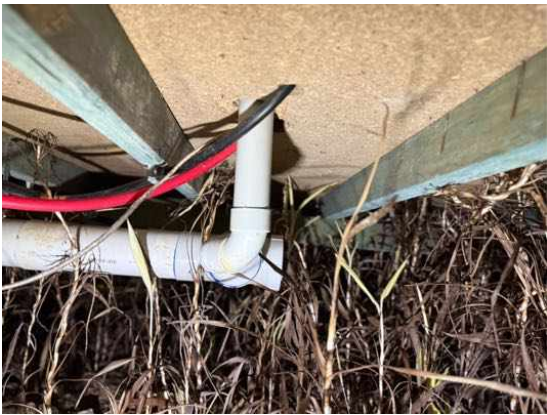
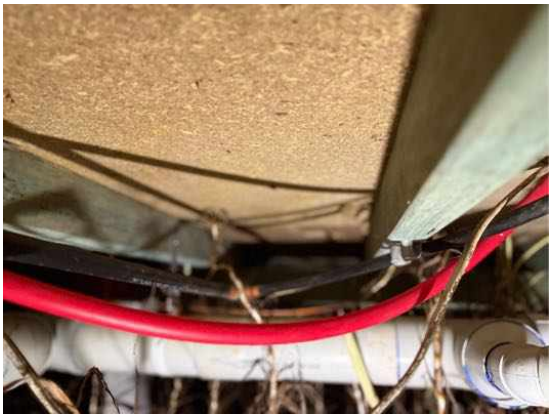
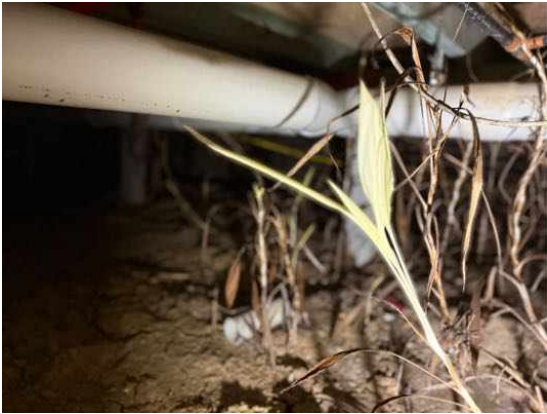
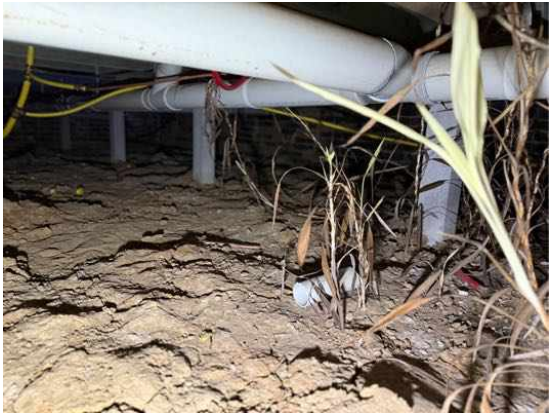
Defects 3.13

| Finding: | Subfloor - Long grass growing |
| Information: | An excessive amount of long grass was found in the subfloor area at the time of inspection. The grass in this area creates potential for concealed pest entry and may also make the area susceptible to termite activity. A clear and empty subfloor will be better ventilated and easier to maintain in a dry condition. The removal of this grass is considered important in minimising the risk of unwanted insect and pest activity. |

This grass is recommended to be removed and killed off as soon as possible. Depending on the location and amount, the homeowner may elect to undertake this task. Alternatively there are a large number of subcontractors that could undertake these works.

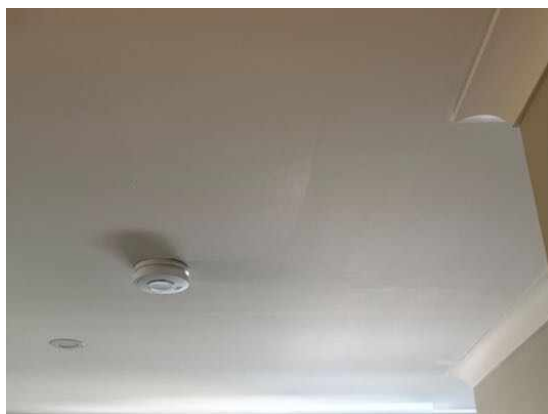
Building: Building 1
Location: All Areas > All Areas
Finding: Smoke detectors and alarms
Information: Reporting on Smoke Detectors or Alarms, including hard wired smoke detection systems and their legislative requirements, is outside the Scope of this Report. Please note that this defect is highlighted as a caution only. We suspect, based on our experience in the building industry, that smoke detectors are sometimes get overlooked, or they may be in a poor condition, so we recommend that they always should be addressed prior to occupation to improve occupant safety.

Always ensure sufficient working and suitable smoke detectors are installed prior and during to occupying any building. Additionally, it is advised that all smoke detectors be tested by the homeowner on a monthly basis.

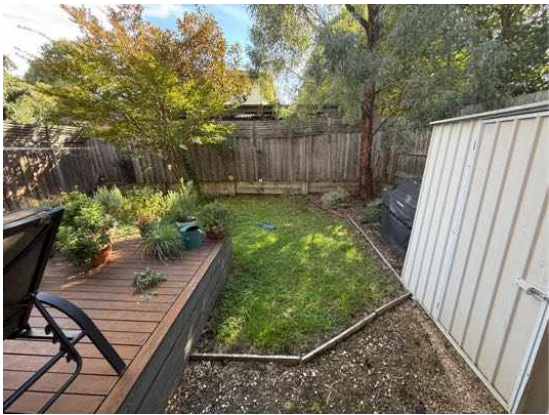
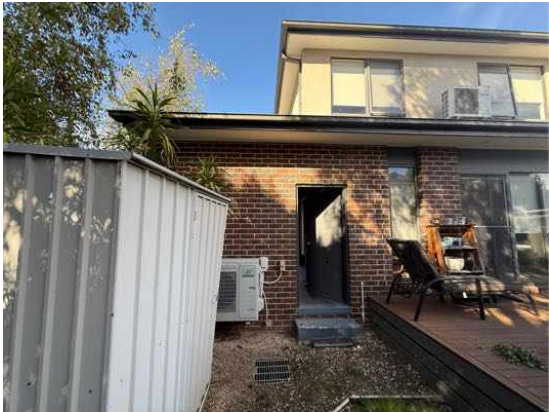
Building: Building 1
 Location: All Areas > All Areas
 Finding: Trees - close trees
 Information: Overhanging trees often result in excessive amounts of leaf matter and debris accumulating in gutters. Blockages of the guttering and downpipes will lead to pooling and accumulated water overflows, which is likely to subsequently flood eaves and exterior walls. Blocked gutters are likely to lead to high levels of water and moisture sitting in the gutters, which can cause rust and decay of the associated building materials, but can also provide conditions that are conducive to termite and timber pest activity. Blockages in gutters should be clean and kept clean at all times to ensure dry conditions are maintained.

Gutters are a critical part of the building's management of storm water and rain. It is therefore important that they be kept clear to prevent secondary damage to associated building elements, including exterior and interior walls, ceiling linings and any adjoining building elements. Where gutters are blocked, pooling of rainwater is likely to occur, fast-tracking rust and corrosion of the roof plumbing elements. A gutter guard can be beneficial in these situations to reduce the regular maintenance that will be required. But the client will still have to periodically provide maintenance and cleaning of gutter guard of any debris which may rest on top of the filter or the finer material through the top.

It is therefore highly recommended that any overhanging trees and branches be removed as soon as possible to prevent any future damage. Such works should be performed by the homeowner; however, appointment of a landscape contractor or an arborist may be required and highly recommended.

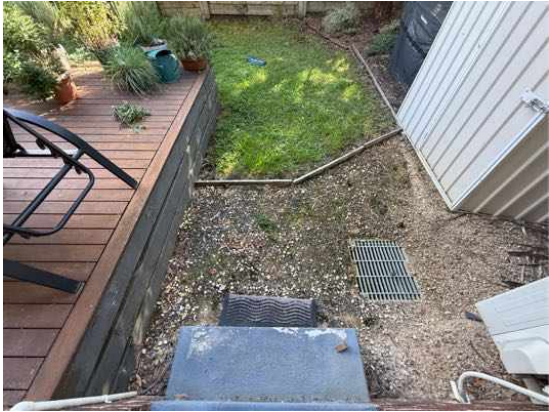
Building: Building 1
Location: All Areas > All Areas
Finding: Rear timber exposed to harsh weather conditions
Information: Rear external deck timbers that are frequently exposed to harsh weather conditions require adequate protection in order to maintain their condition and protection. Where timbers have not been painted or treated adequately, general deterioration is likely to occur at an accelerated rate. If left unattended, replacement of these timbers is likely to be necessary in the future. Adequate treatment of these timbers is a must and required if these deck timbers are to remain in a good condition. In the future client may elect to appoint a painting contractor to ensure deck are remains in a good condition.
