# Building and Timber Pest Inspection Report

Inspection Date: Mon, 30 Mar 2026

Property Address: 12 Marsanne St, Shepparton VIC 3630,  
Australia

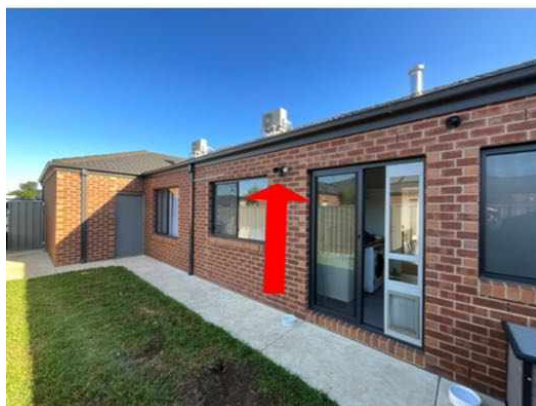
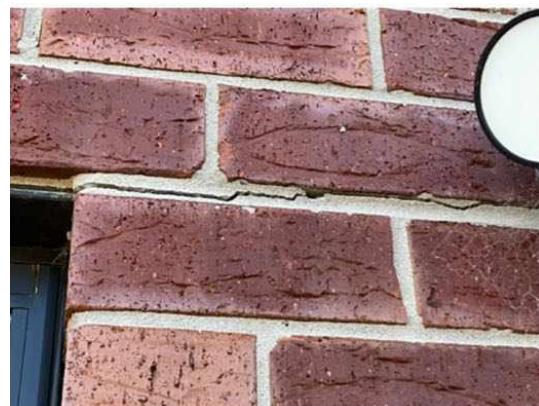
#### Finding 3.01

Building: Building 1  
 Location: Yard - Side  
 Finding: Brickwork - Cracking [Fine]  
 Information: Although fine cracks are quite noticeable, they are often only considered to be an appearance defect and usually do not indicate any structural damage. Generally, the cause of a fine crack is indicative of a separation between brickwork and mortar throughout the structure, but single bricks may also show cracks of this nature.

Cracking of this nature can generally be repaired with minor filling and should be conducted by a qualified bricklayer.

Always contact a building inspector should cracks widen lengthen or become more numerous.

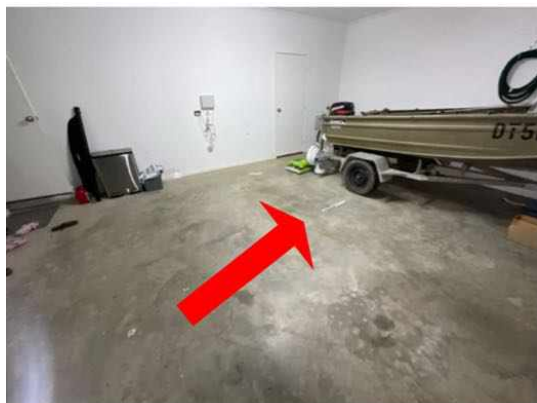
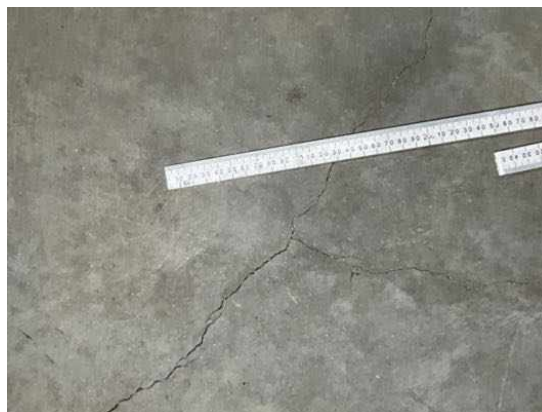
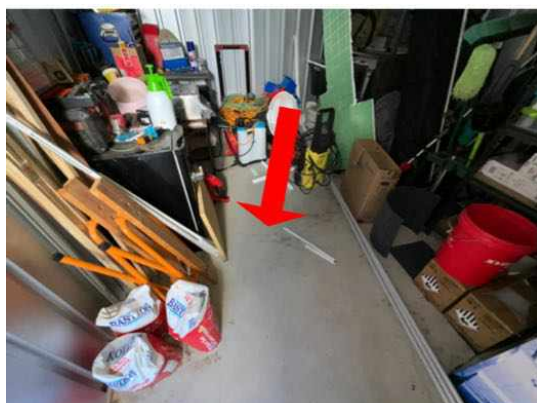
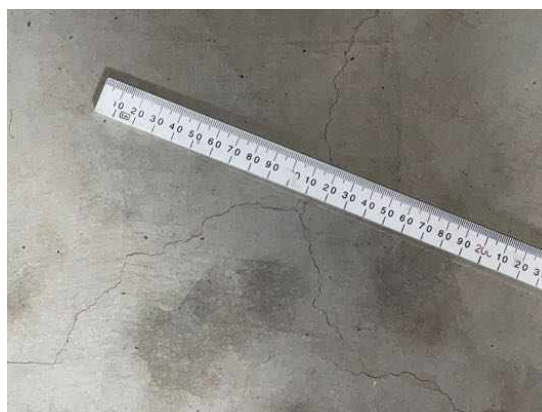
#### Finding 3.02

Building: Building 1  
 Location: Garage, shed  
 Finding: Crack in concrete slab - Category 1  
 Information: A crack coded as Category 1 was identified in the slab. A Category 1 crack is

described as a fine but noticeable crack, with the slab at an otherwise reasonable level.

To be considered Category 1, the approximate width of the crack is less than 1.0mm, or a less than 10mm change in offset when a 3m straight edge is placed over the defect.

Category 1 cracks should be monitored for a period of 12 months. At the end of the monitoring period, identified cracks that are rated greater than Category 2 are considered defects, and require rectification.

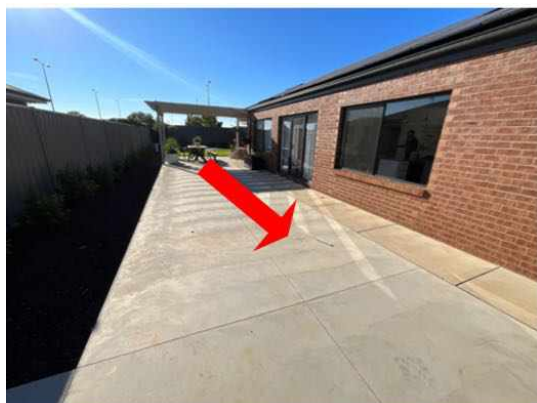
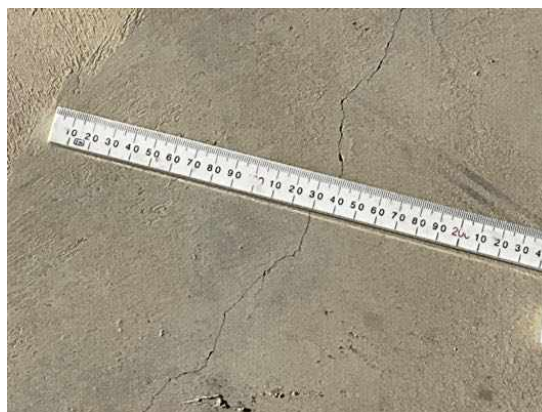
### Finding 3.03

Building:	Building 1
Location:	Yard - Back
Finding:	Cracking - External Concrete Paving Damage Category 1 - Fine (less than 2mm)
Information:	Fine cracks were identified in external concrete paving. Although fine cracks are quite noticeable, they are often only considered to be an appearance defect, and usually do not indicate any structural damage. To be considered a Category 1 or fine crack, the crack is found to be less than 2mm in width.

Generally the cause of a hairline crack in existing concrete paving such as driveways and pathways is indicative of the expansion and contraction of the concrete. Such

causes are generally due to environmental factors, such as moisture levels, weather conditions, root systems of nearby trees or the soil types on which they are laid.

Fine cracks may also be due to poor original installation of the concrete. Factors such as poor compaction of the sub surface and/or inadequate reinforcing of the slab may create cracking and other secondary defects.

Monitoring of all cracking should be conducted frequently. Always contact a building inspector should cracks widen, lengthen, or become more numerous.

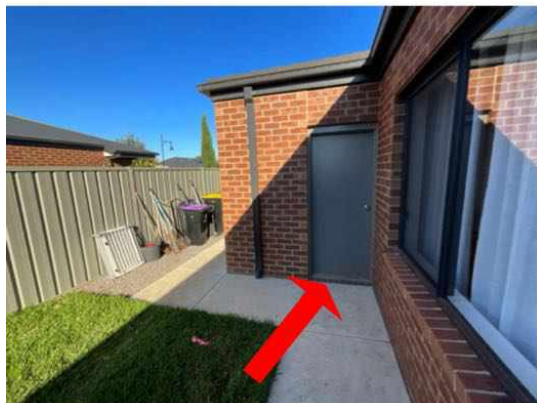
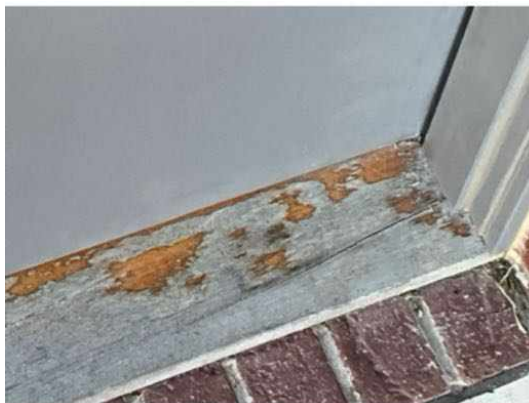
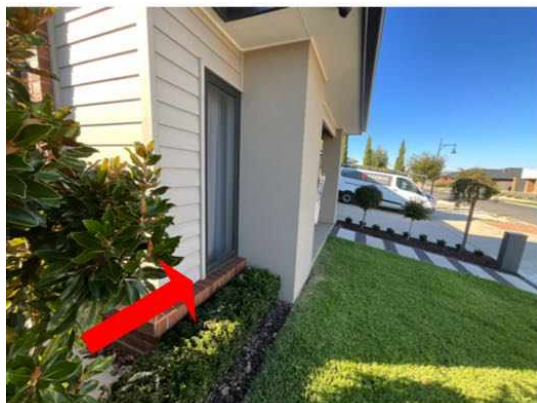
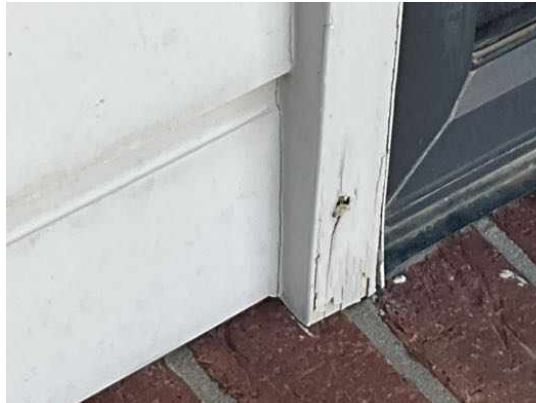
### Finding 6.01

Building: Building 1  
 Location: Garage, front wall  
 Finding: Timber - exposed to weather  
 Information: External timbers that are frequently exposed to harsh weather conditions require adequate protection in order to maintain their condition. Where timbers have not been painted or treated adequately, general deterioration is likely to occur at an accelerated rate.

If left unattended, replacement of these timbers is likely to be necessary in the short-term future. Adequate treatment of these timbers is required as soon as possible by a painting contractor or general handyman.

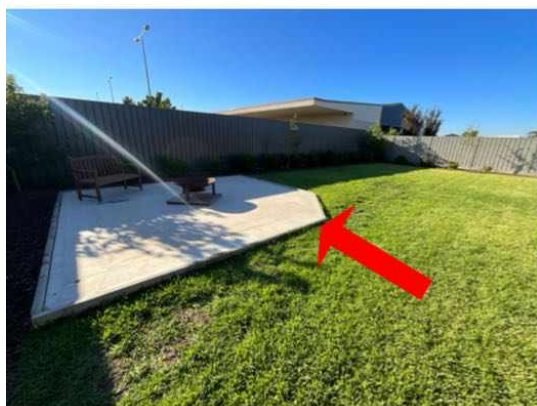
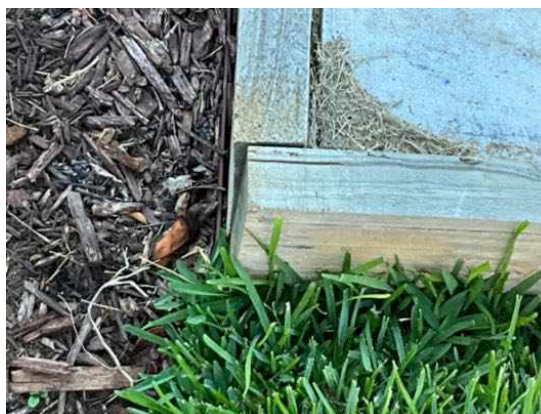
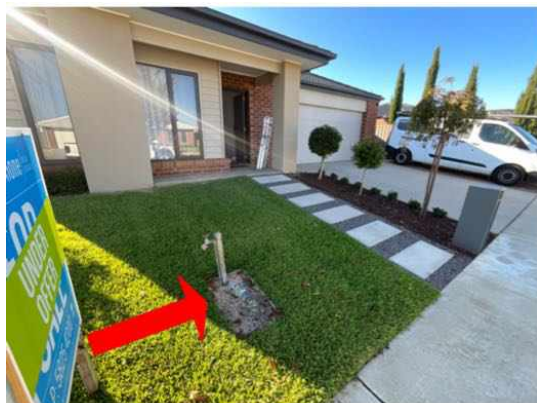
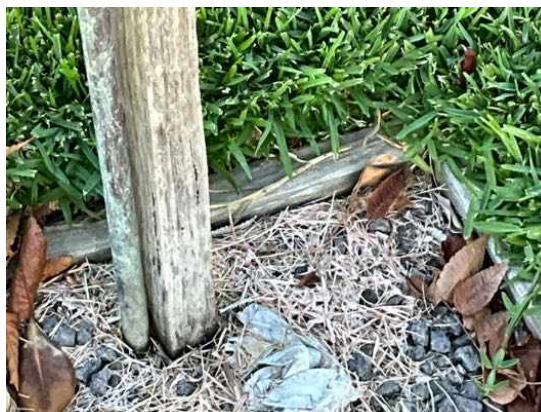
### Finding 6.02

Building:	Building 1
Location:	Yard - Back, front
Finding:	Untreated or non-durable timbers in a hazardous environment
Information:	To reduce the risk of timber pest attack it is essential that timber used in a hazardous environment (e.g. in direct contact with the ground or frequently exposed to damp conditions) is of sufficient durability and/or is adequately preservative treated.

Untreated timbers in direct contact with the ground are likely to develop severe wood rot and/or fungal decay if left unattended creating attraction for subterranean termites to infest the timbers from surrounding areas.

If untreated or non-durable timbers are found to be in a hazardous environment it is highly advised that replacement of these building elements be performed as soon as possible to aid the protection of the property against termite / timber pest attack.

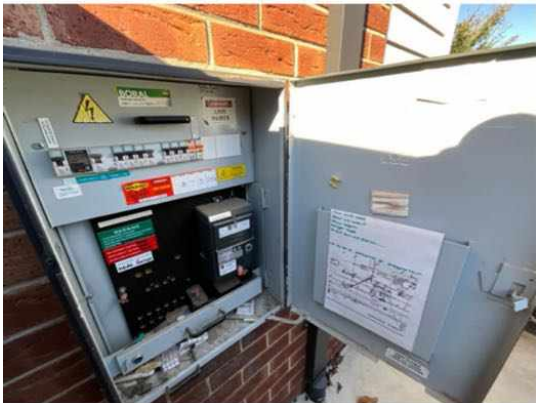
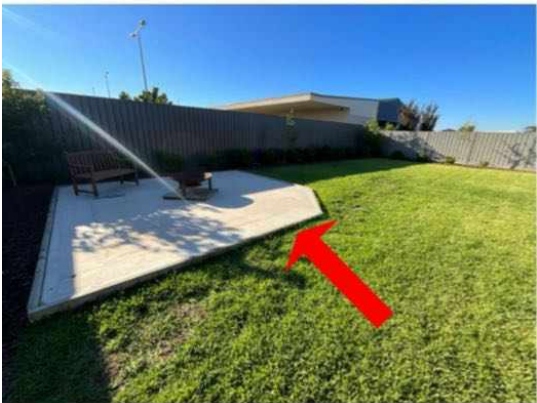
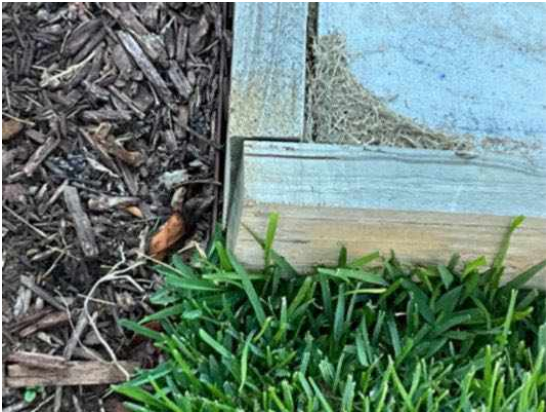
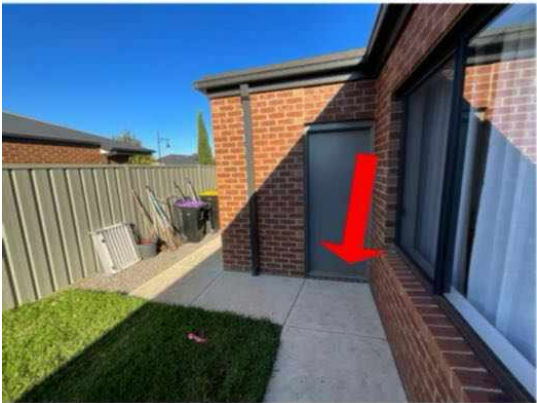
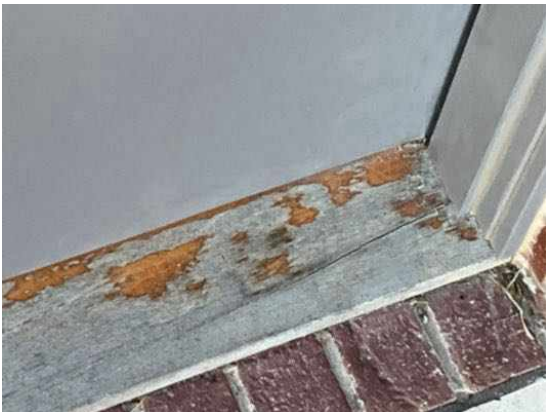
### Finding 6.03

Building:	Building 1
Location:	All External Areas
Finding:	Termite Management System - no evidence of a chemical installation
Information:	The application of a post-construction chemical termite barrier is highly recommended for all properties, particularly if live termite activity has been found on the site previously. Such barriers are highly effective in preventing termite attack on any timber building elements throughout the property.

A durable notice should be placed in the switchboard unit to indicate current termite barriers. At the time of inspection, it appeared as though no termite management system has been installed, with no evidence to suggest preventative works taking place.

The client may consider gaining further advice from a pest controller as to the costs and procedures involved with this application. It is recommended that obtaining such advice be a short-term priority.

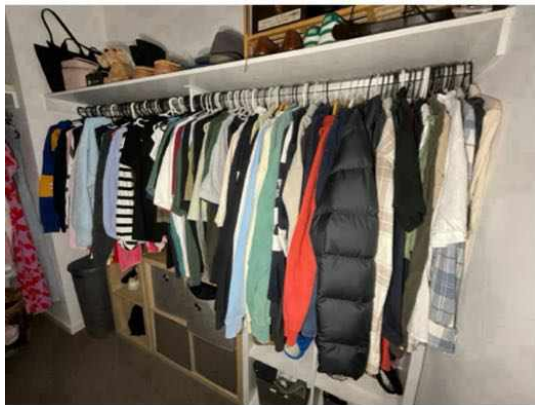
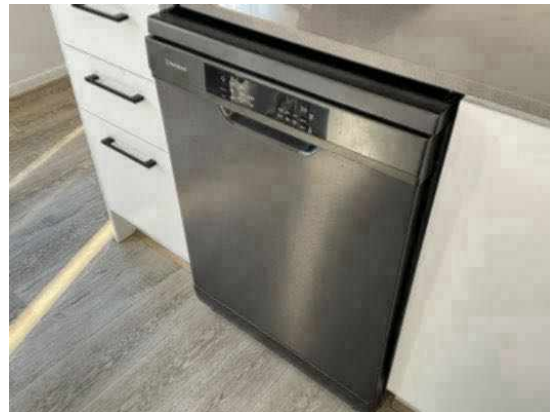
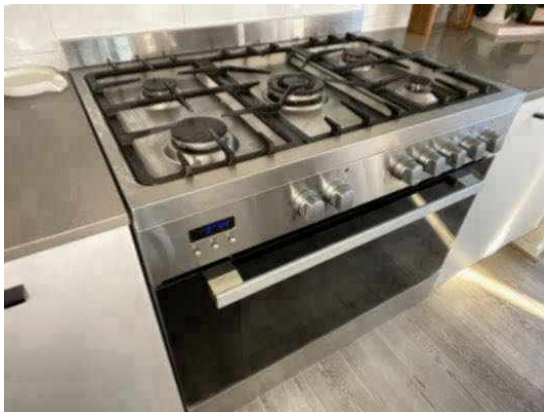
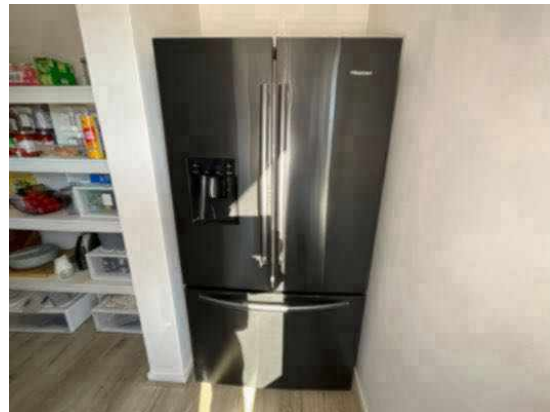
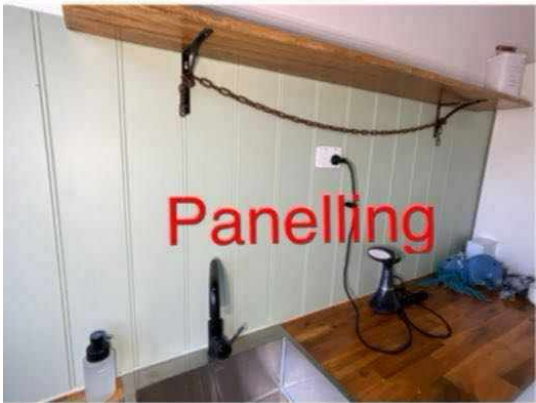
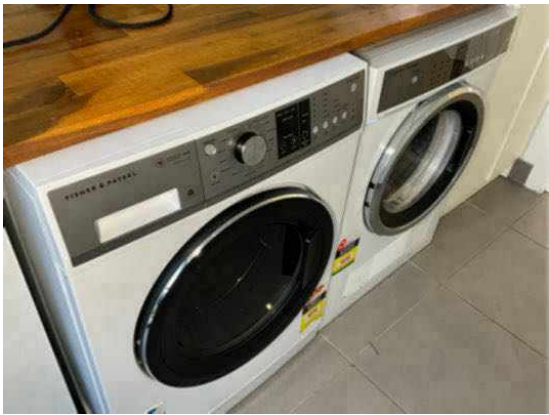
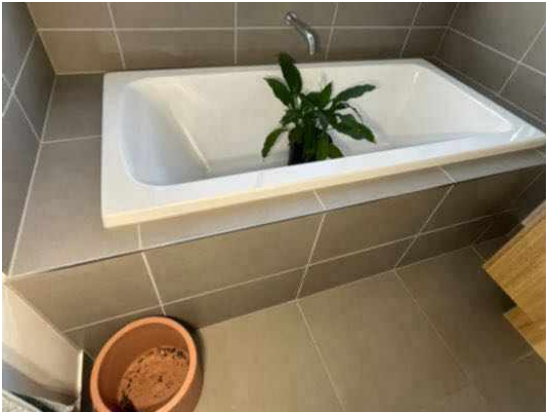
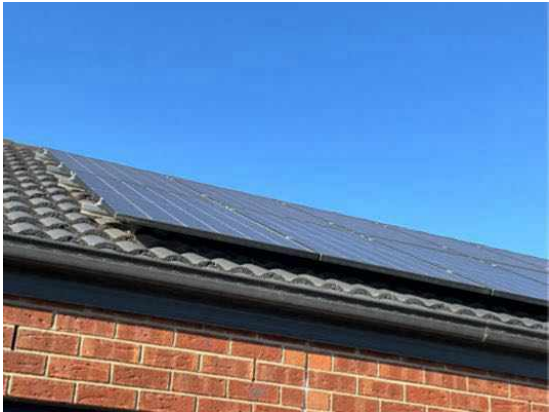
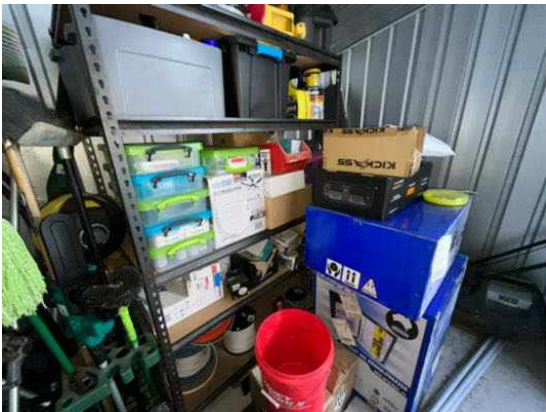
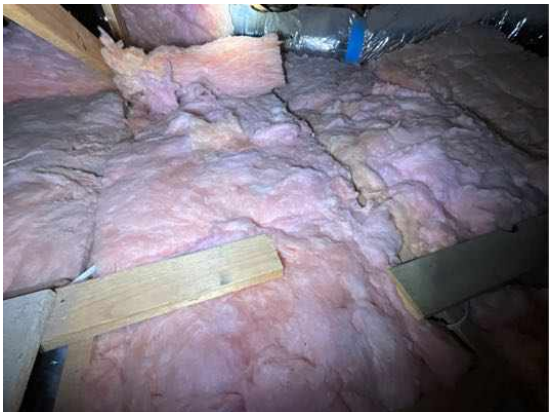
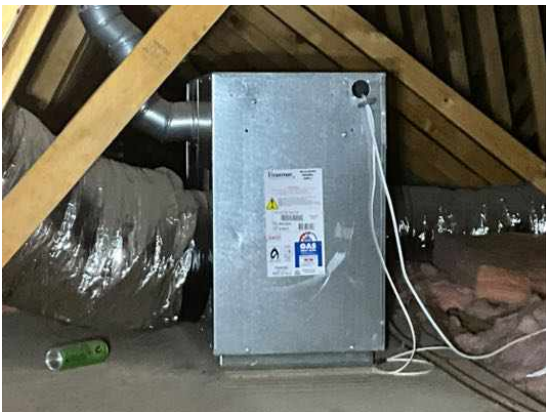
#### Noted Item

Building: Building 1  
Location: All Areas  
Finding: Additional Photos - Obstructions and Limitations  
Information: These photographs are an indication of the obstructions and limitations which impeded full inspection of the property at the time of inspection. These obstructions can hide an array of defects and should be removed to allow full inspection to be carried out. A re-inspection is recommended once the areas are made accessible.
