# Building Inspection Report

Inspection Date: Fri, 23 Jan 2026

Property Address: 26 Murdoch Ct, Sunbury VIC 3429,  
Australia

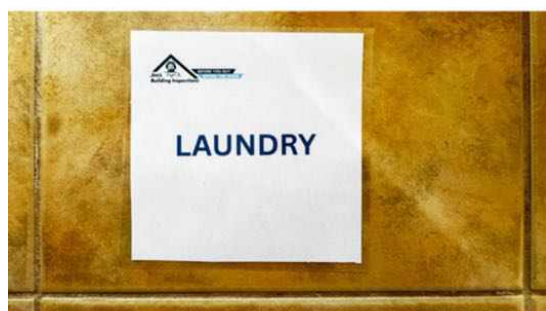
### Defects 3.04

Building:	Main Building
Location:	All Areas >
Finding:	Fittings - Loose
Information:	Fittings were observed to be loose and inadequately secured to walls in this area, moving when light pressure was applied. This reduces usability and may cause further damage if not addressed.

Common causes include incorrect or inadequate fixings, use of anchors unsuitable for the wall type, movement of the wall or timber substrate, wear from repeated use, or improper installation.

If left unresolved, loose fittings may detach, damage wall finishes, or cause progressive deterioration of both fittings and surrounding surfaces.

When practical, a qualified carpenter or experienced handyman should be engaged to securely refix or replace all loose fittings using appropriate fixings and methods for the wall type. The fittings should be monitored over time to ensure they remain secure.

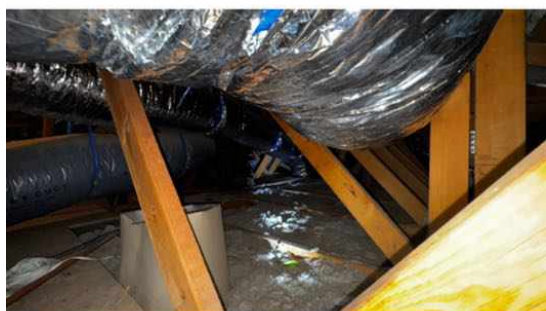
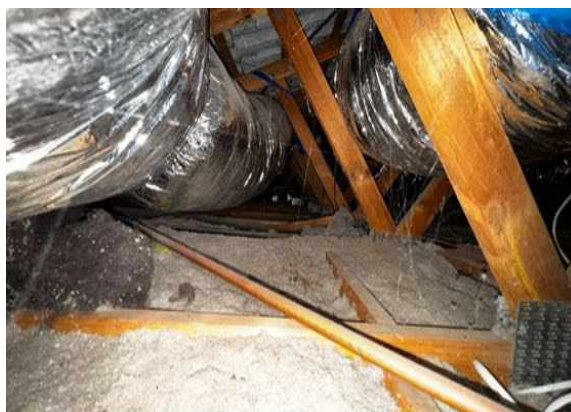
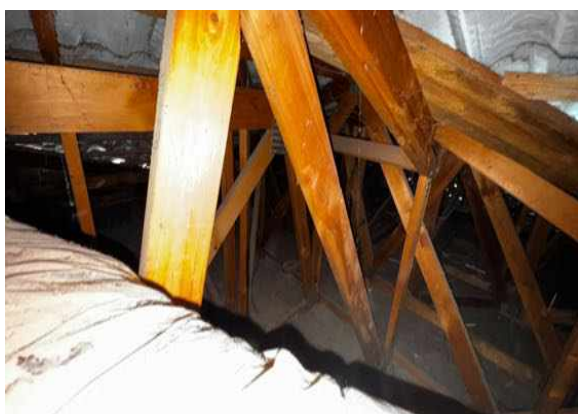
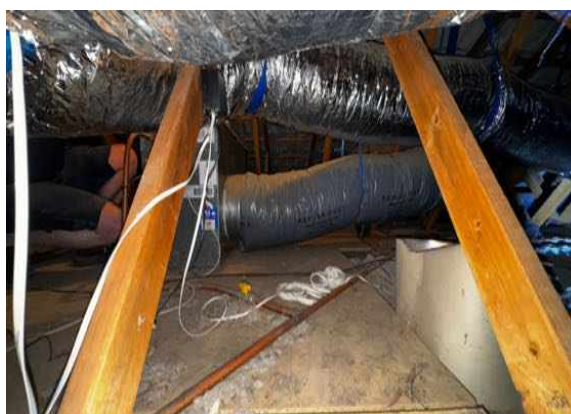
### Defects 3.09

Building: Main Building  
 Location: Roof Void  
 Finding: Roof Void - Limited Access  
 Information: Limited access to the roof void was present due to facts including but not limited to, limited access, insulation, Air condition Unit & ducting, obstructions or placement of

NOTE: Unless all insulation is removed from the roof space a full inspection is never possible, timber pest or termite activity and/or damage may not be visible.

A visual inspection was carried out from accessible areas only, recommend installing another access hatch in a more accessible area for a re-inspection.

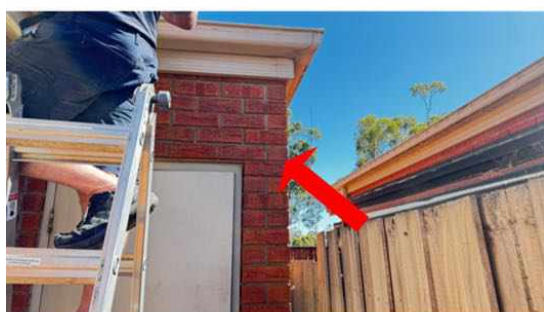
### Defects 3.10

Building:	Main Building
Location:	All External Areas >
Finding:	External Walls - Minor Cracking To Wall Claddings
Information:	Minor cracking was observed to the external walls in this area. The cracking appeared superficial and did not indicate significant structural movement; however, such cracking can allow moisture ingress if left unaddressed.

The cracking is likely due to building movement or minor settlement.

When practical, a registered builder should assess and repair the cracking, which may include sealing and repainting. The area should be monitored, and any increase in

cracking or signs of movement should be further investigated immediately by a Structural Engineer.

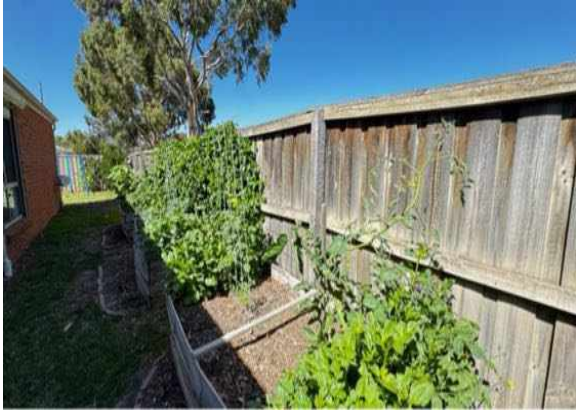
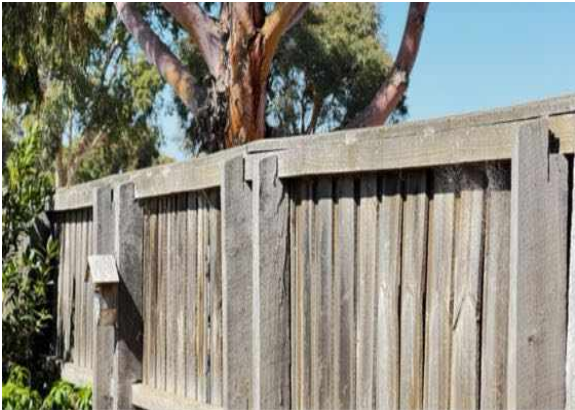
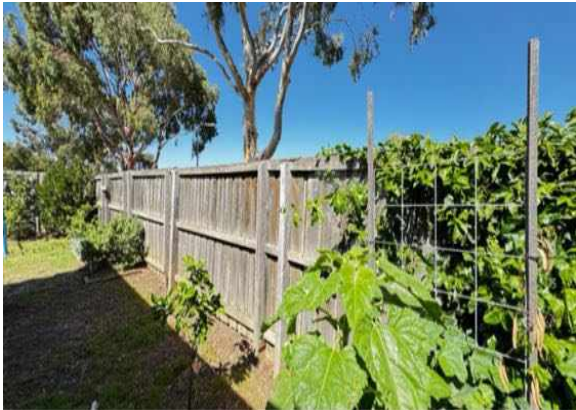
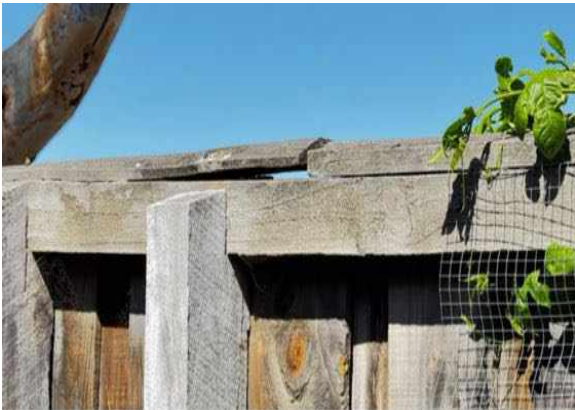
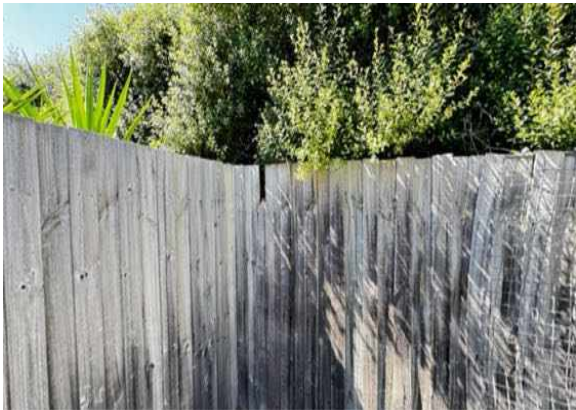
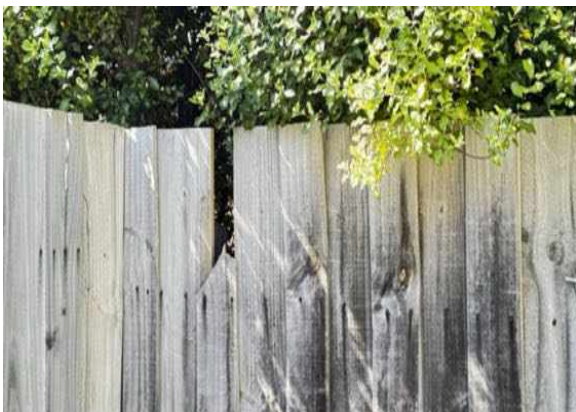
## Defects 3.12

Information: Timber fencing was inspected and deterioration was observed in this area. Deteriorated fencing can compromise structural stability, reduce privacy, and may allow pest ingress or accelerated decay if left unaddressed.

Possible causes include age-related timber decay, prolonged exposure to moisture or sunlight, poor maintenance, or impact damage.

When practical, a qualified carpenter or fencing specialist should be engaged to repair or replace affected sections, and a qualified painter should be engaged to restore protective finishes. Prompt rectification will maintain structural performance, improve appearance, and extend the lifespan of the fencing.

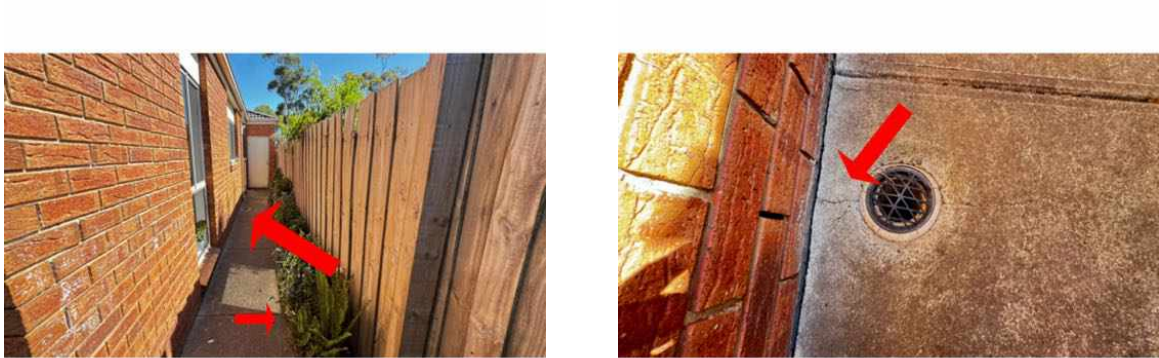
### Defects 3.13

Building:	Main Building
Location:	All External Areas >
Finding:	Paving - Minor Cracking
Information:	The external paved areas were visually inspected. Minor cracking, uneven surfaces, and general wear were observed in this area. These defects do not currently affect structural safety but may reduce durability, appearance, and safe pedestrian access.

This may be caused by age-related deterioration of concrete, pavers, or other materials, soil movement or settlement beneath paved surfaces, tree root intrusion or erosion, or inadequate original installation or sub-base compaction.

A qualified landscaper should be engaged as soon as possible to repair or resurface sections as required. Rectification will restore even surfaces, reduce trip hazards, and improve the serviceability and appearance of the paved areas.

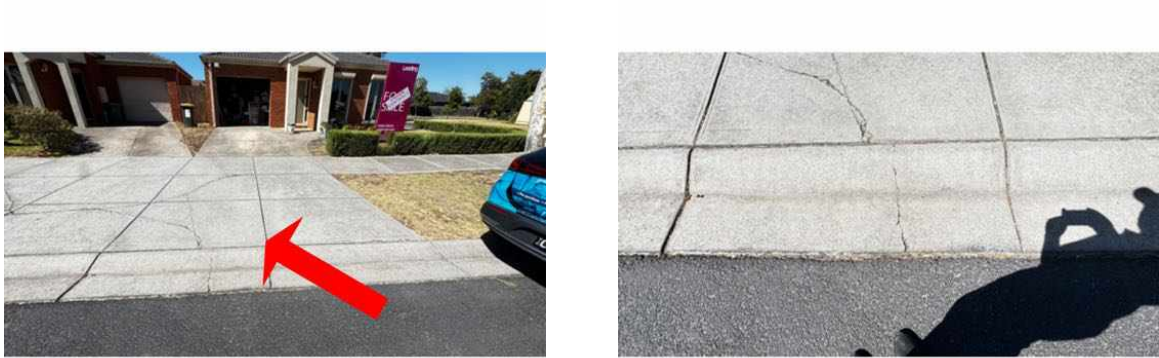
**Defects 3.14**

Building: Main Building  
Location: Driveway >  
Finding: Driveway - Minor Cracking & Surface Imperfections  
Information: The external driveway was visually inspected. Minor cracking, surface settlement, and minor unevenness was observed in this area. While these defects do not currently compromise structural safety, they may affect long-term durability, appearance, and vehicle access.

These issues may be caused by age-related wear, soil movement or settlement beneath the driveway, possible tree root intrusion, or inadequate original construction or reinforcement.

A qualified concreter should be engaged when practical to repair or resurface affected areas. Prompt rectification will restore a smooth surface, improve appearance, and prevent further deterioration.

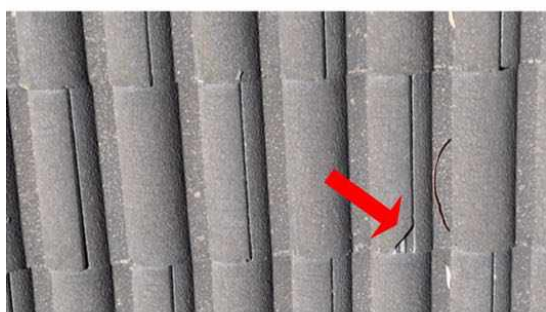
**Defects 3.16**

Building: Main Building  
Location: Roof Exterior  
Finding: Roof Plumbing - Roof Tiles Cracked  
Information: Roof tiles in this area are cracked and may no longer provide full protection. The issue is observed across the roof surface where damaged tiles are present.

This has likely occurred due to impact, weathering, or poor installation. Cracked tiles may allow water to penetrate, causing leaks, water damage to internal structures, or deterioration of surrounding tiles.

A licensed roof plumber is required to inspect and repair or replace the cracked tiles in this area. This should be rectified immediately to prevent water ingress and further damage.

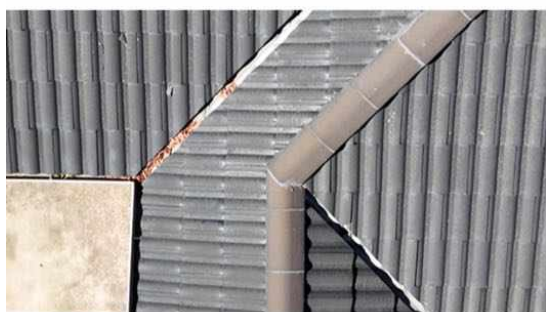
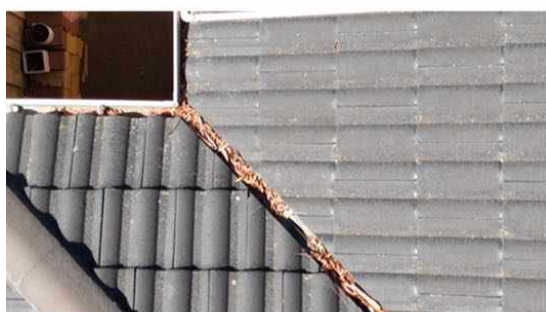
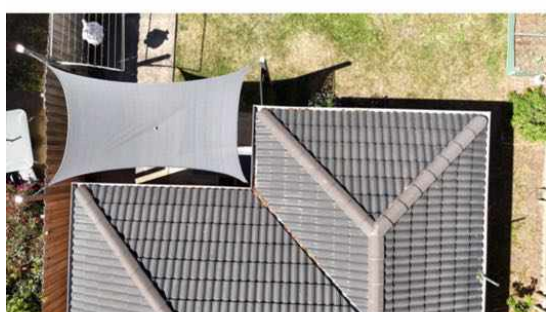
### Defects 3.17

Building:	Main Building
Location:	Roof Exterior
Finding:	Roof Plumbing - Gutters Blocked
Information:	Gutters in this area are blocked and not allowing water to flow freely. The issue is observed along the gutter runs where leaves, debris, or other obstructions have accumulated.

This has likely occurred due to lack of maintenance or build-up of debris over time. Blocked gutters may cause water to overflow, damage the roof, walls, or foundations, and increase the risk of erosion or water ingress.

A licensed roof plumber or competent handy man is required to inspect and clear the blocked gutters in this area. This should be rectified immediately to ensure water drains correctly and to prevent potential damage to the building.

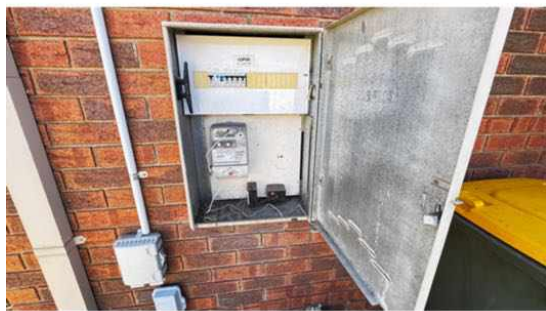
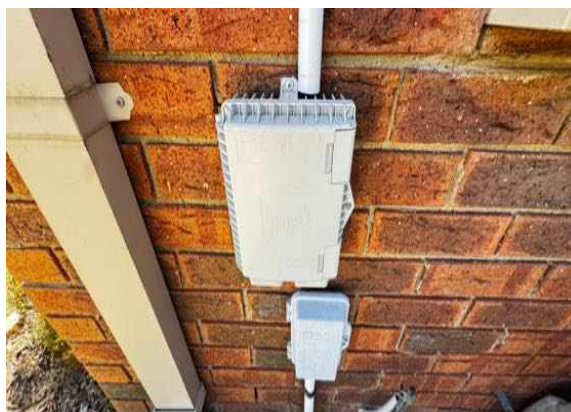
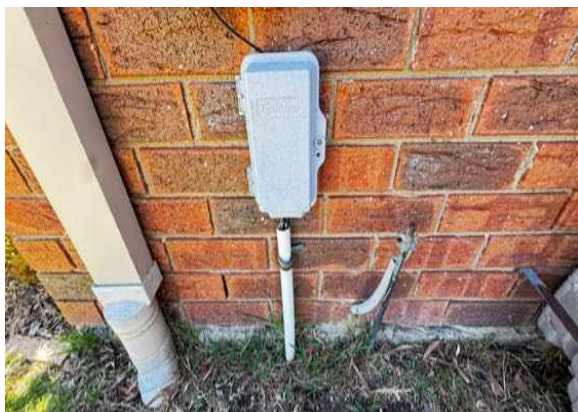
Building: Main Building  
Location: >  
Finding: Electrical - Switch Board Location  
Information: For your information, the main electrical switchboard was visually inspected. No intrusive testing or detailed electrical assessment was performed as part of this inspection.
