Building Inspection Report

Inspection Date: Thu, 12 Mar 2026

Property Address: 1901/311 Hume Hwy, Liverpool NSW 2170,
Australia

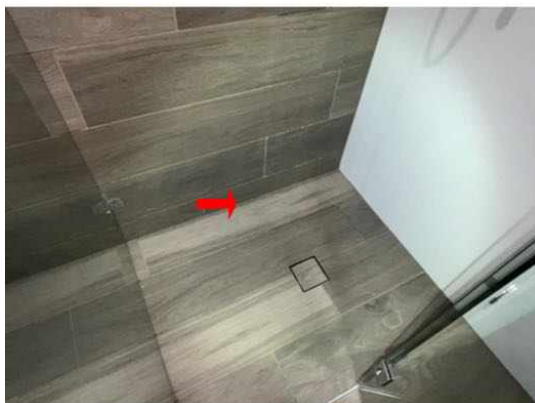
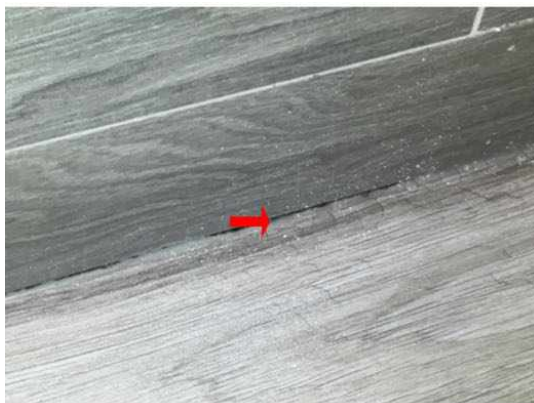
Defects 3.01

Building: Main Building
Location: Ensuite
Finding: Sealant and grouting - Missing or damaged
Information:

It was noted on inspection that sealant or grout is degraded to this area.

Different materials and floor areas move at different rates, generally causing cracking to grout or sealant at this point. A flexible sealant is required to allow for expected expansion and contraction, while keeping the joint water tight and protective of all associated building materials.

Flexible and mould resistant materials should be applied to affected areas to prevent any subsequent water damage that is likely to occur. Regular maintenance and replacement of damage or missing or damaged sealant and grout is highly recommended to the wet areas, as this is a regular wear and tear defect. Sealant and grouting in areas that come into regular contact with water should be maintained for the long term care of your property.

A sealant specialist should be appointed to complete these works as soon as possible.
