Building and Timber Pest Inspection Report

Inspection Date: Tue, 27 Jan 2026

Property Address: 10 Cowdroy Ave, Cammeray NSW 2062, Australia

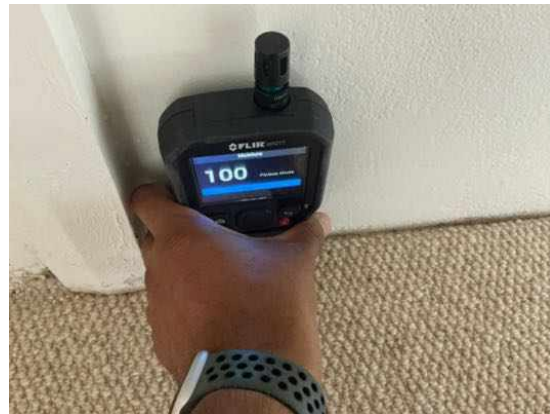
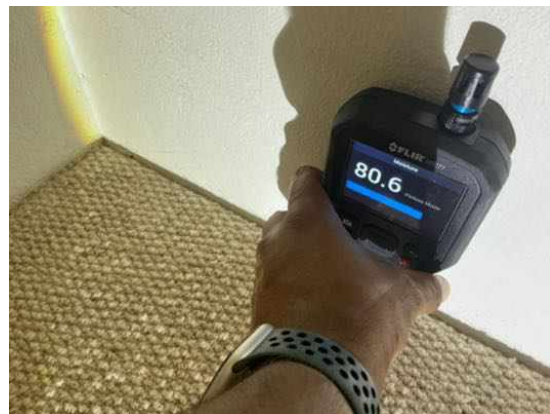
Building:	Main Building
Location:	Bedroom 4, Rumpus
Finding:	Rising Damp / Excessive Moisture to Internal Walls
Information:	At the time of inspection, excessive moisture readings were recorded to internal wall surfaces, particularly at low-level areas, with a subfloor space located on the opposite side of the affected walls. Moisture meter readings were significantly elevated, indicating active moisture ingress consistent with rising damp.

This condition is typically caused by the upward movement of ground moisture through porous building materials such as masonry and mortar via capillary action. Contributing factors may include the absence, deterioration, or bridging of the damp-

proof course (DPC), as well as elevated external ground levels, inadequate subfloor ventilation, or poor site drainage adjacent to the affected walls.

If left unrectified, rising damp can lead to progressive deterioration of wall linings, plaster, paint finishes, and internal timbers, and may also create conditions favourable for mould growth. Prolonged damp conditions are also considered conducive to termite activity, increasing the overall risk to the structure.

It is strongly recommended that the client engage a qualified waterproofing to carry out appropriate remedial works.

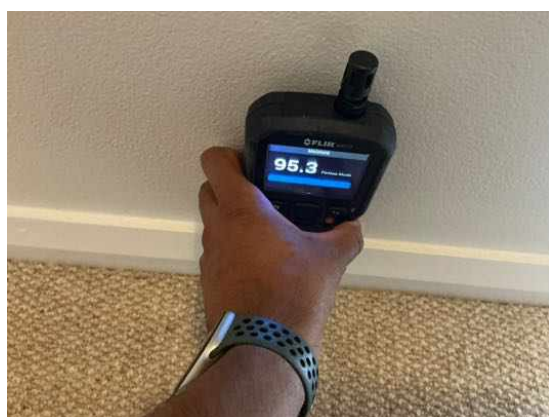
Building:	Main Building
Location:	Level 2 Bathroom
Finding:	Shower Damp - Adjacent Bathroom
Information:	At the time of inspection, shower damp was observed on the wall adjacent to the shower in the bathroom.

This issue, likely caused by deteriorated grout, failed waterproofing, or leaking pipes within or behind the wall, allows moisture to penetrate and accumulate, compromising the wall's integrity. The presence of dampness creates an environment conducive to mould growth, timber decay, and potential structural deterioration if left unaddressed, posing health risks to occupants, such as respiratory problems, allergies, and skin

irritation. Additionally, prolonged moisture exposure could lead to further damage to surrounding building materials, including paint, plaster, and any timber elements, increasing repair costs over time.

It is strongly recommended that the client engage a qualified plumber or waterproofing specialist to which may involve resealing the shower area, replacing damaged grout, or repairing any leaks. To prevent future issues, maintaining sealants and grout in good condition and operating the bathroom exhaust fan during and after showering for at least 20-30 minutes to remove excess humidity is advised.

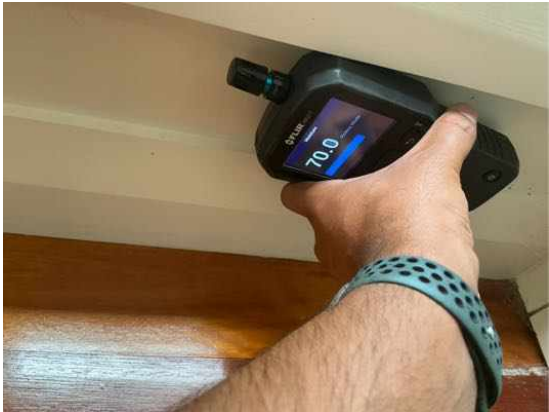
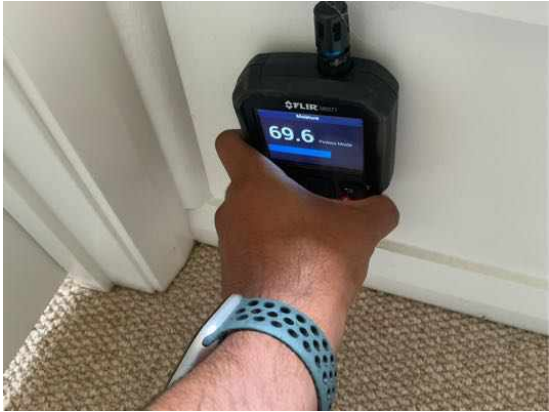
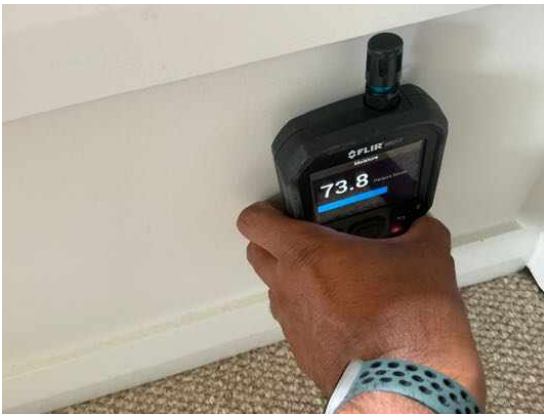
Building:	Main Building
Location:	Kitchen
Finding:	Moisture Readings to Internal Walls and Minor Flooring Damage
Information:	At the time of inspection, minor elevated moisture readings were recorded to sections of internal walls, particularly around window areas. No visible signs of active water ingress, staining, mould growth, or deterioration to wall linings were observed at the time of inspection. The moisture readings may be attributable to minor gaps or inadequate sealing around window frames, allowing limited moisture ingress during wet weather conditions.

In addition, minor damage was noted to sections of the kitchen flooring. This damage appears localised and consistent with minor moisture exposure or general wear and tear. No structural concerns were identified in relation to this issue at the time of inspection.

It is advised that these areas be monitored over a 12-month period. Should signs of moisture recurrence occur in the future—such as bubbling, staining, softening of wall linings, or further deterioration to flooring—further investigation by a suitably qualified trade may be required. At the time of inspection, no immediate remedial action is considered necessary.

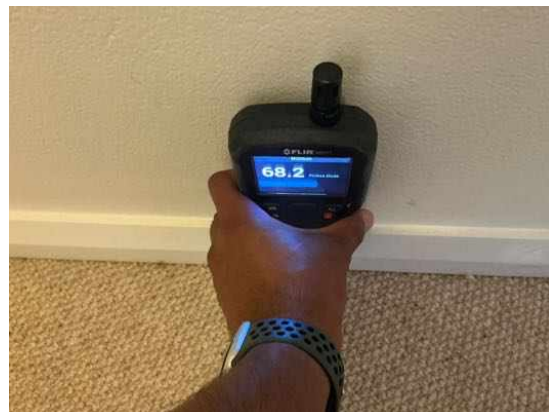
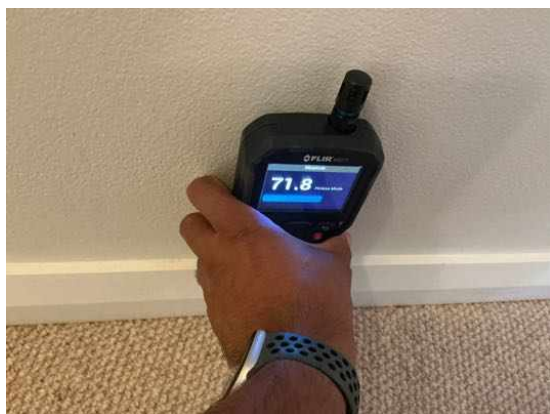
Finding 3.04

Finding: Excessive Moisture - Walls

Information: At the time of inspection, elevated moisture readings were recorded to sections of internal walls, with a subfloor area located on the opposite side. These readings are consistent with early signs of rising damp, where moisture travels upward through porous building materials. Contributing factors may include subfloor moisture conditions or the condition of the damp-proof course (DPC).

No significant visible damage was observed at the time of inspection. The area should be monitored, and if moisture levels increase or visible signs such as staining or bubbling paint develop, assessment by a suitably qualified waterproofing specialist is recommended.

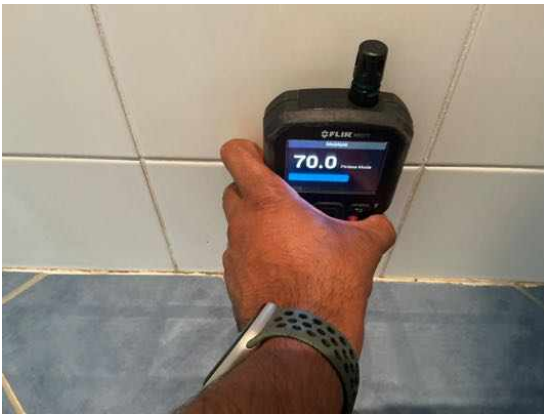
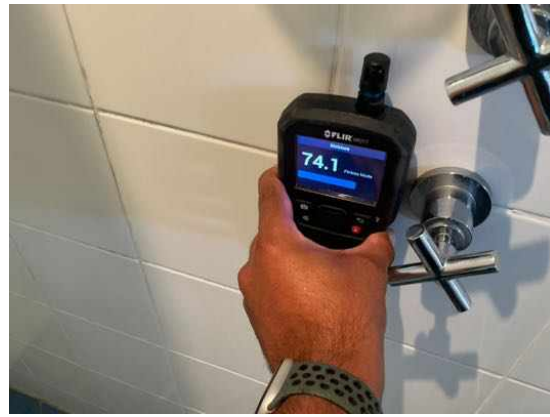
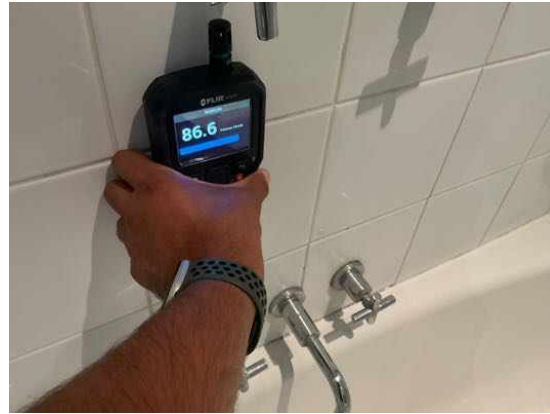
Finding: Excessive Moisture - Shower Damp

Information: At the time of inspection, excessive moisture was noted within the shower area, which is a common issue in wet areas due to the continual exposure to water. This condition is typically caused by moisture seeping through grout lines and settling behind tiles, resulting in localised high-moisture zones. Provided there is no evidence of water staining or elevated moisture readings on the opposite side of the wall, this is considered a minor defect.

However, persistently damp conditions may act as conducive conditions for termite activity, as termites are strongly attracted to moisture-rich environments. It is recommended that the client ensures regular use of the exhaust fan and maintains adequate ventilation after shower use to promote drying and reduce long-term moisture build-up, thereby also reducing the risk of attracting termites.

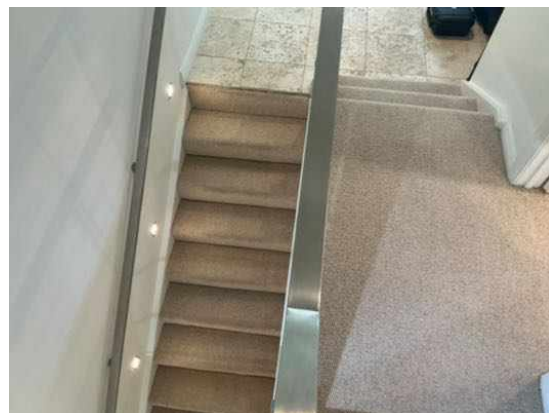
Information: A bouncy floor was noted at this area during the inspection. Several factors could be contributing to this issue. One potential cause is insufficient structural support, such as undersized or improperly spaced floor joists, which may result in excessive flexing when weight is applied. Over time, this can lead to a bouncy or springy sensation underfoot. Another possibility is that the subfloor may not be securely fastened to the joists, causing movement between the layers of the floor system. Additionally, wear and tear on the structural components, such as floorboards or beams, could cause degradation or warping, further contributing to the issue. If the floor structure is compromised, it may also indicate settlement or movement in the building itself, which can affect the alignment and stability of the stairs and floors.

It is recommended that a flooring specialist or qualified building professional assess the condition of the floor and stairs. They may recommend reinforcing the joists, securing the subfloor, or addressing any structural shifts to ensure the safety and stability of the floor and staircase.

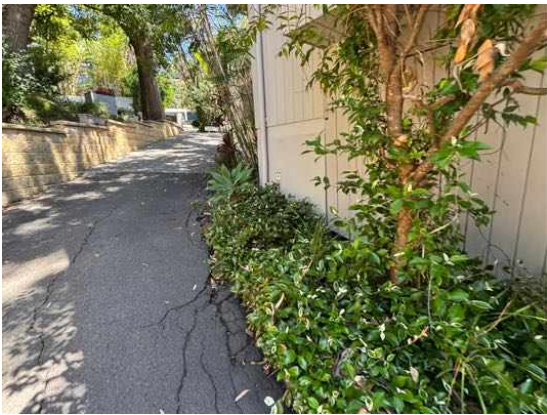
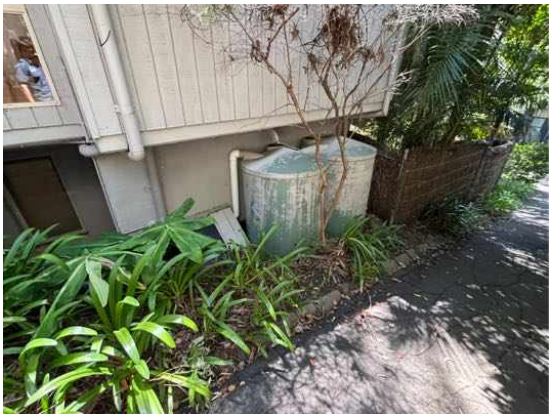
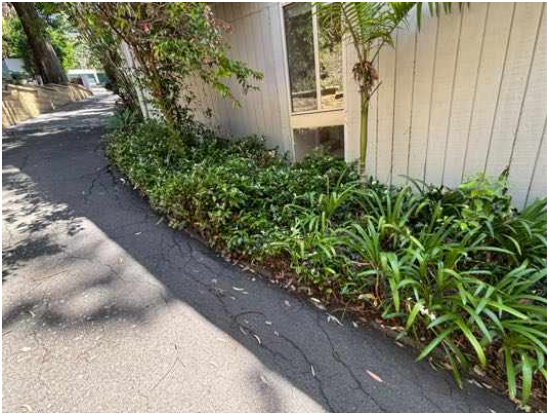
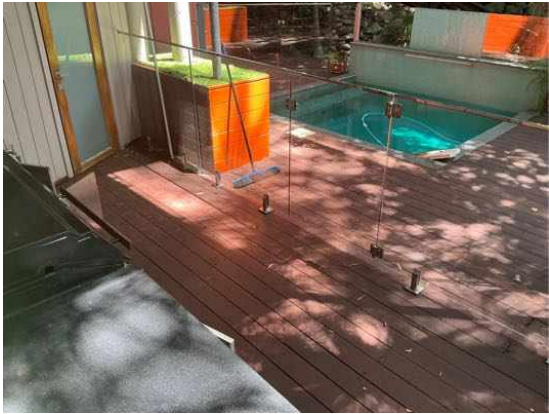
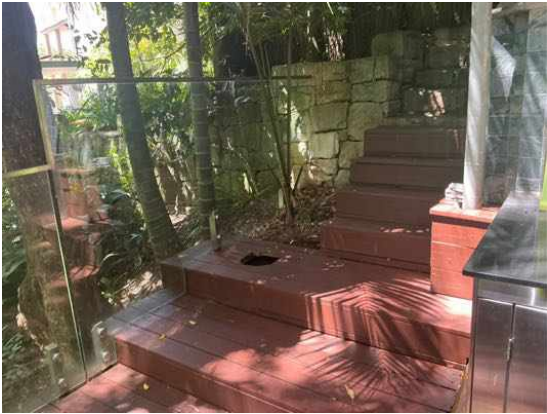
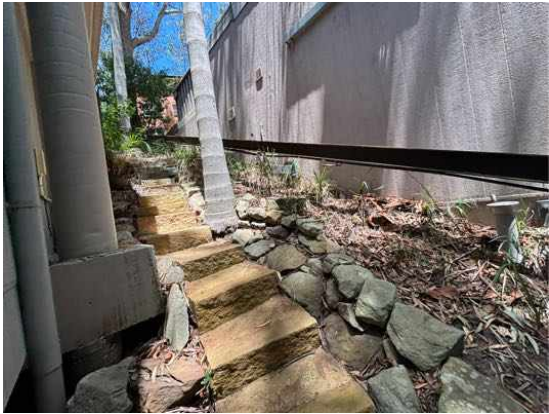
Therefore, it is strongly recommended that the obstructions be removed and a re-inspection be scheduled once the affected areas are made fully accessible. This will ensure a complete evaluation of the property's exterior and provide the client with a clear understanding of any potential issues that may have been concealed during the initial inspection.

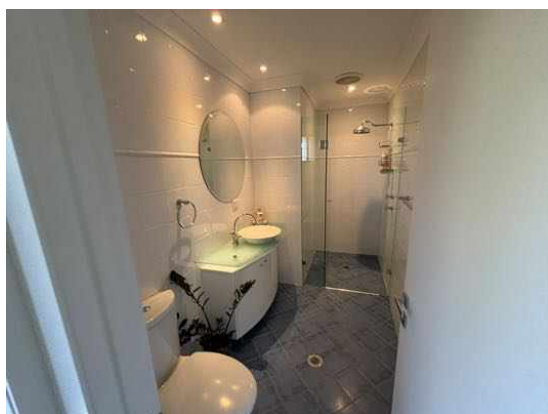
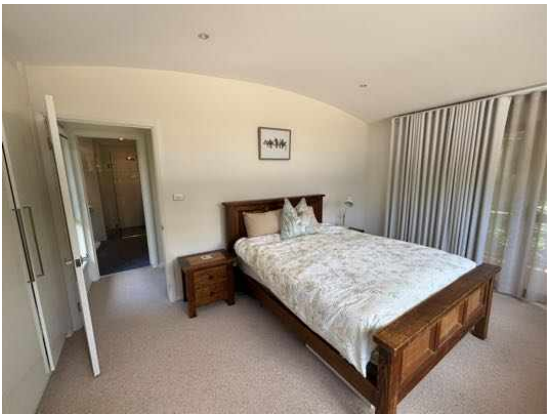
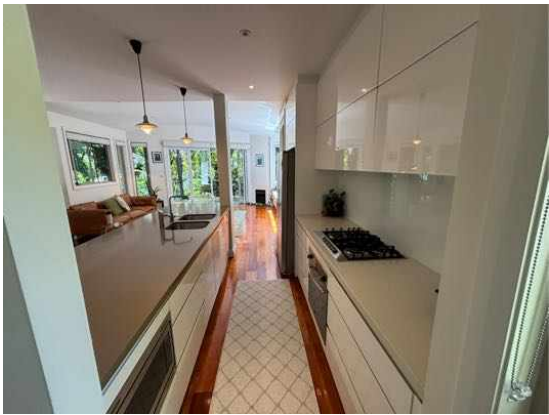
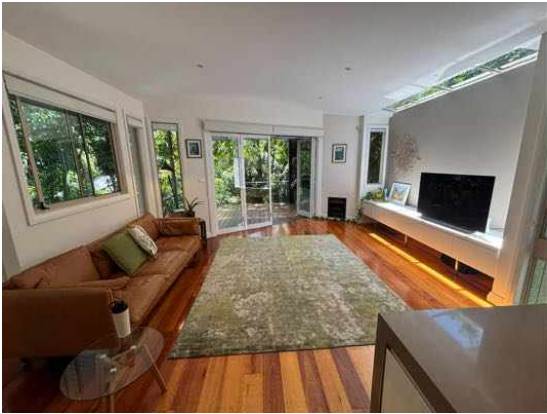
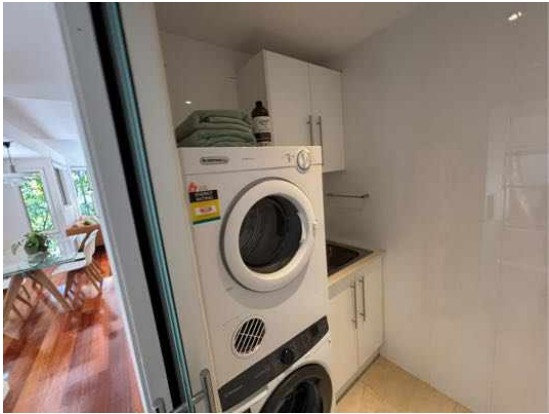
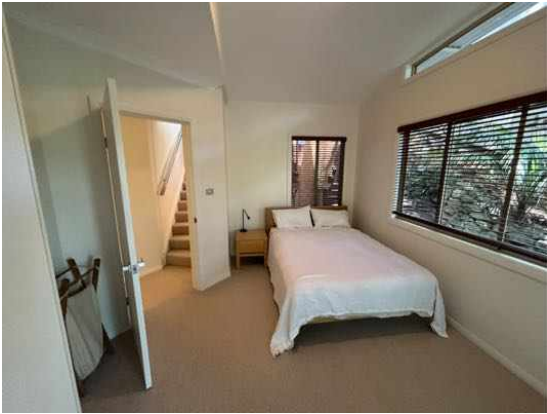
Building:	Main Building
Location:	All Internal Areas
Finding:	Obstructions and Limitations - Internal Areas
Information:	The accompanying photographs provide clear evidence of the obstructions and limitations that restricted a comprehensive inspection of the internal areas of the property at the time of assessment. These obstructions, which may include furniture, personal belongings, stored items, or structural elements such as wall coverings and built-ins, significantly hindered the ability to thoroughly evaluate these areas. It is important to note that such obstructions can potentially conceal a wide array of defects, ranging from hidden structural damage, water leaks, pest infestations, or

It is highly recommended that all obstructions be cleared to facilitate a complete and thorough inspection of the internal areas. Once the obstructions have been removed and full access is available, a re-inspection should be carried out to ensure that any previously concealed issues can be properly identified and rectified. This follow-up inspection will provide a more accurate assessment of the property's internal condition and help the client make informed decisions about any necessary repairs or maintenance.

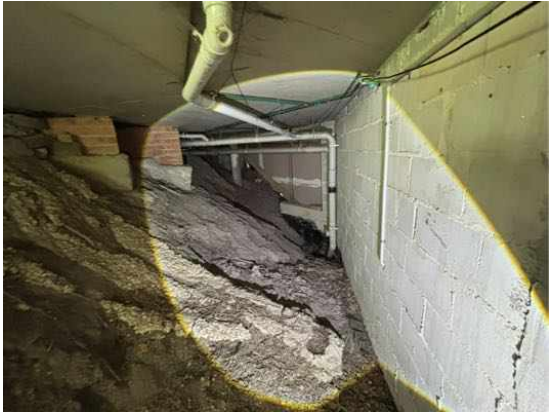
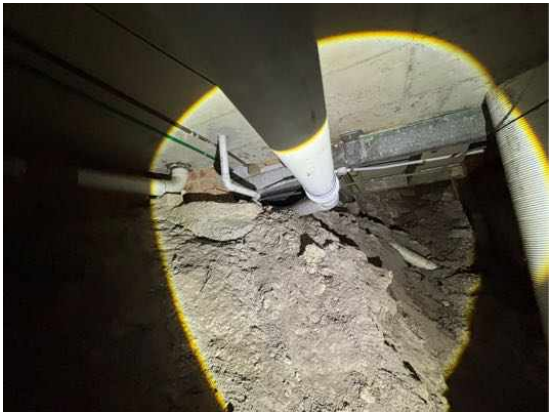
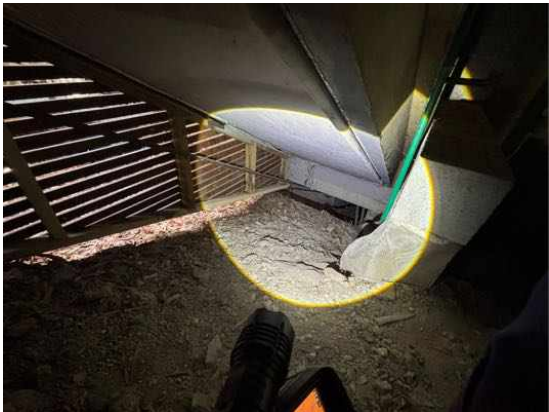
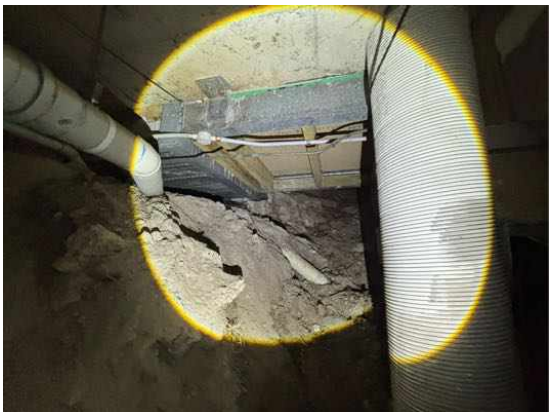
Building: Main Building
 Location: Subfloor
 Finding: Obstructions, Limitations, and General Subfloor Condition
 Information: The attached photographs illustrate the obstructions and access limitations that restricted a full inspection of the subfloor area of the main property at the time of assessment. Items such as stored materials, construction debris, low-hanging services, and insulation impeded movement and visibility within key sections of the subfloor. In addition, the limited crawl height further restricted safe access to inspect critical structural components.

While no major concerns were identified in the accessible areas, a full and unobstructed inspection is necessary to properly assess the overall condition of the subfloor. It is recommended that obstructions be removed and access improved where possible. Once adequate clearance is provided, a re-inspection should be arranged to ensure that any concealed defects can be identified and addressed accordingly. This will assist in providing a more comprehensive understanding of the

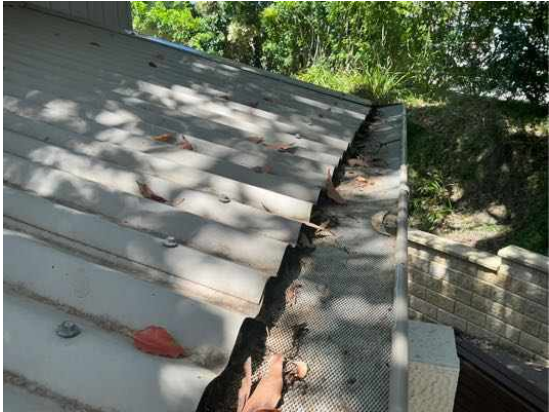
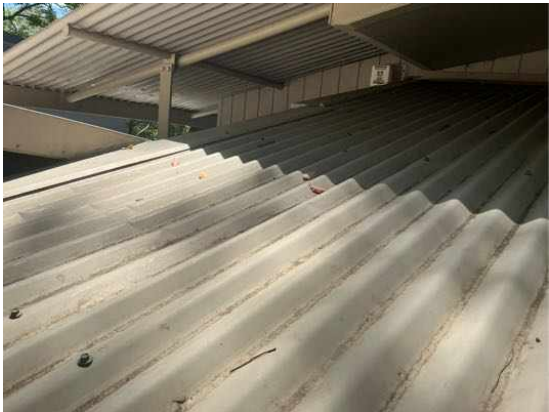
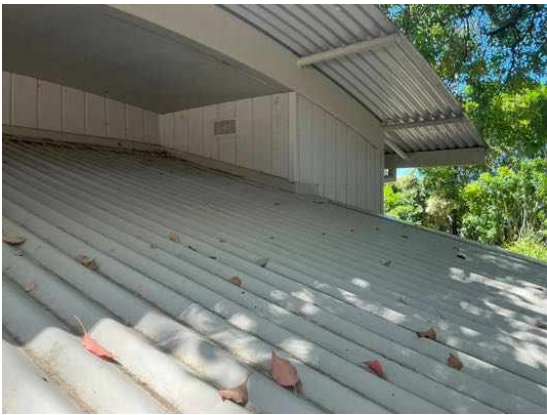
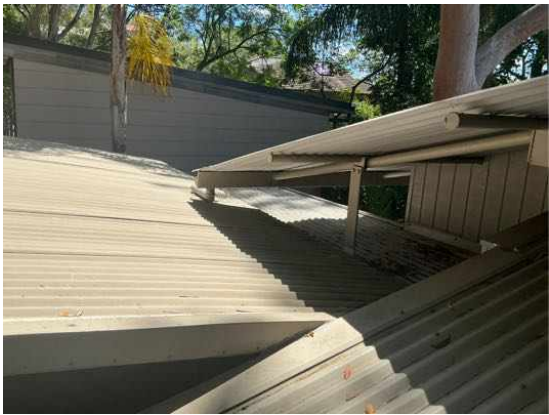
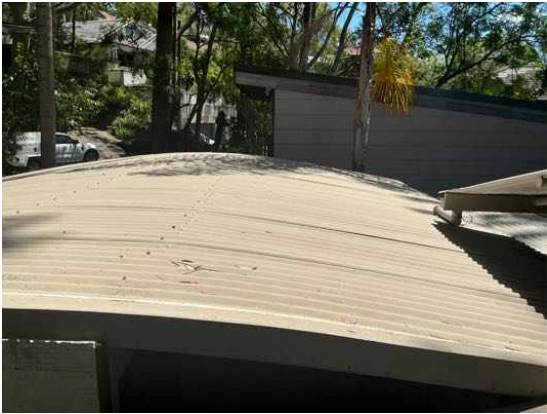
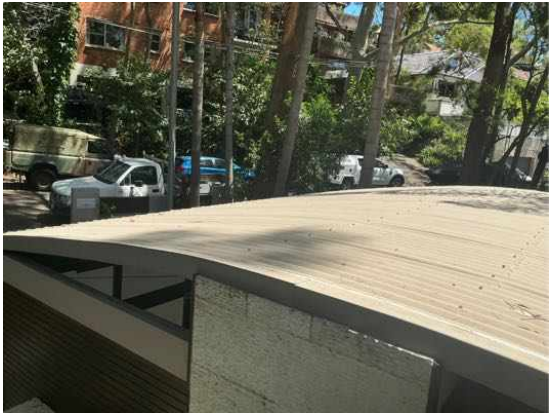
Building: Main Building
Location: Roof Exterior
Finding: Additional Roof Photos

Information: As part of the information provided, please note that the attached roof photos represent the condition of the roof at the time of inspection. These photos are for visual reference only and do not constitute a detailed roofing assessment. Any defects or issues identified with the roof are mentioned separately in the defect statements. It is strongly recommended that the client engage a qualified roofer to conduct a thorough inspection of the roof, ensuring that any potential issues, such as leaks, structural integrity, or wear and tear, are properly identified and addressed.
