Building and Timber Pest Inspection Report

Inspection Date: Thu, 5 Mar 2026

Property Address: 2 Fiedler St, Huntly VIC 3551, Australia

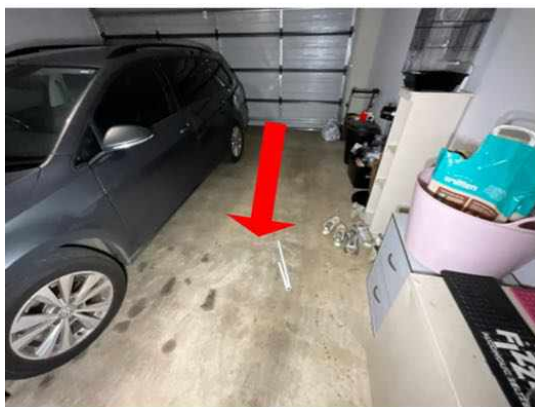
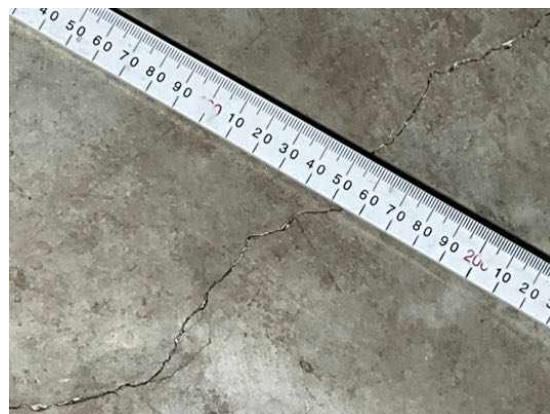
Finding 3.01

Building: Building 1
Location: Garage
Finding: Crack in concrete slab - Category 1
Information: A crack coded as Category 1 was identified in the slab. A Category 1 crack is described as a fine but noticeable crack, with the slab at an otherwise reasonable level.

To be considered Category 1, the approximate width of the crack is less than 1.0mm, or a less than 10mm change in offset when a 3m straight edge is placed over the defect.

Category 1 cracks should be monitored for a period of 12 months. At the end of the monitoring period, identified cracks that are rated greater than Category 2 are considered defects, and require rectification.

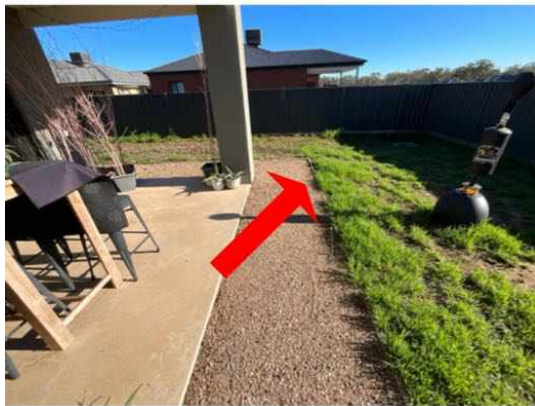
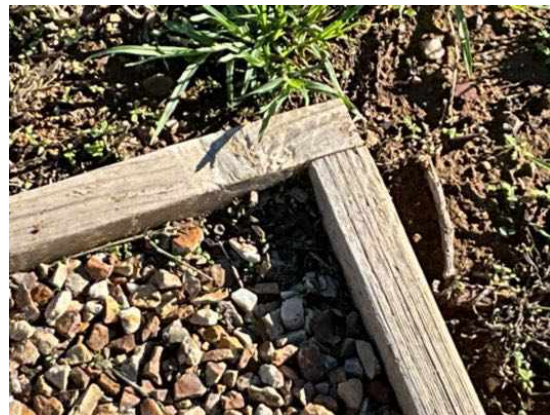
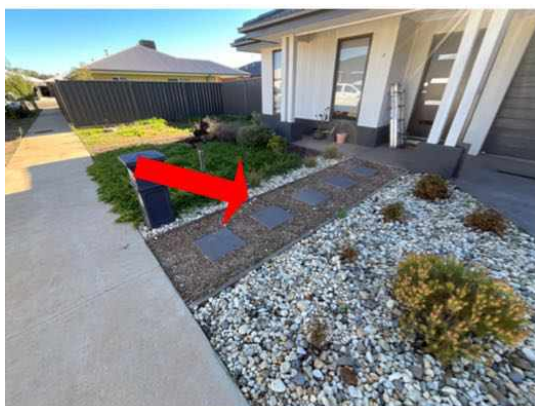
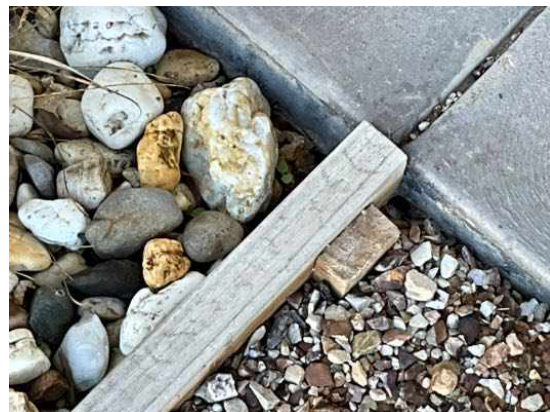
Finding 6.01

Building: Building 1
 Location: Yard - Back, front
 Finding: Untreated or non-durable timbers in a hazardous environment
 Information: To reduce the risk of timber pest attack it is essential that timber used in a hazardous environment (e.g. in direct contact with the ground or frequently exposed to damp conditions) is of sufficient durability and/or is adequately preservative treated.

Untreated timbers in direct contact with the ground are likely to develop severe wood rot and/or fungal decay if left unattended creating attraction for subterranean termites to infest the timbers from surrounding areas.

If untreated or non-durable timbers are found to be in a hazardous environment it is highly advised that replacement of these building elements be performed as soon as possible to aid the protection of the property against termite / timber pest attack.

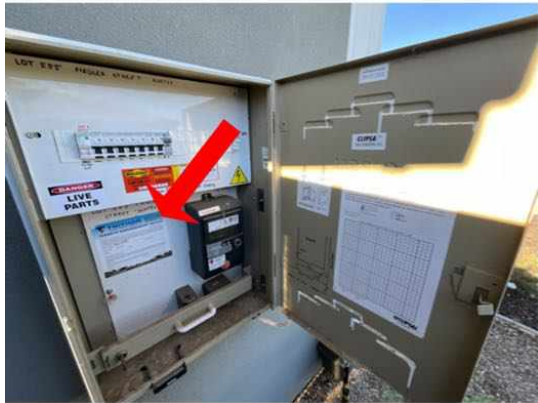
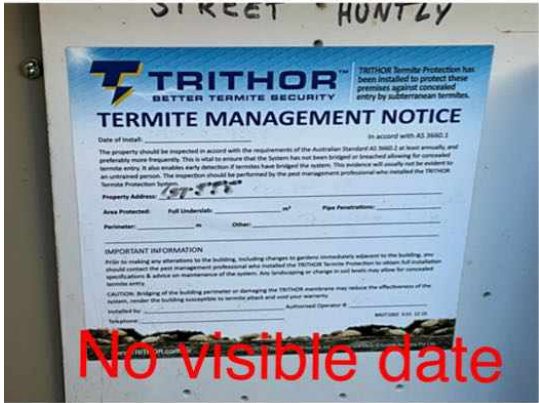
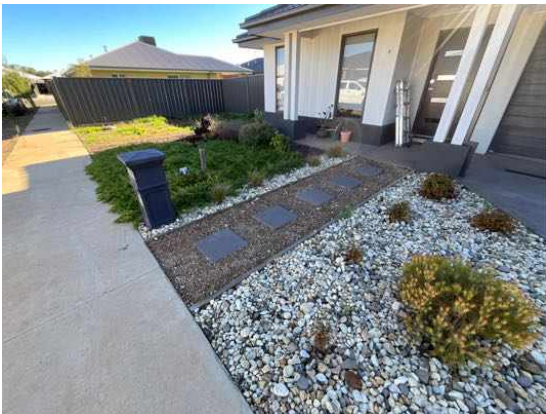
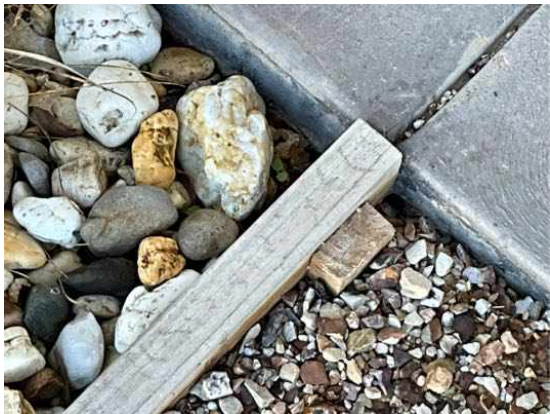
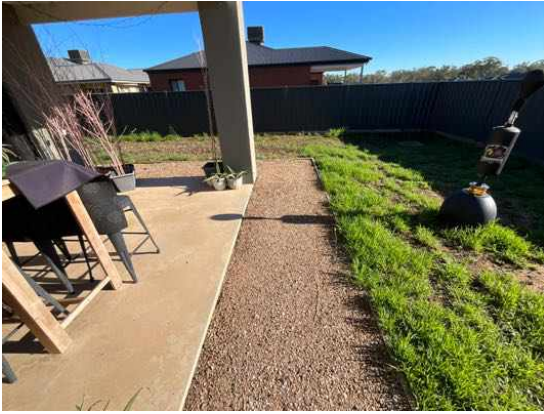
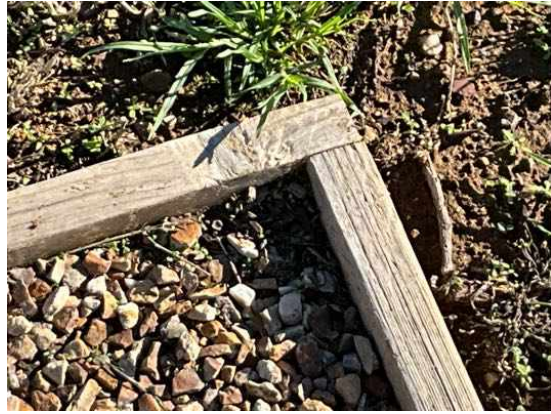
Finding 6.02

Building: Building 1
 Location: All External Areas
 Finding: Termite Management System- evidence of a chemical installation
 Information: The application of a post-construction chemical termite barrier is highly recommended for all properties, particularly if live termite activity has been found on the site previously. Such barriers are highly effective in preventing termite attack on any timber building elements throughout the property.

A durable notice has been placed in the switchboard unit to indicate current termite barriers. At the time of inspection, it appeared as though a termite management system has been installed. The recency of any treatment cannot be determined.

The client may consider gaining further advice from a pest controller as to the costs and procedures involved with this application. It is recommended that obtaining such advice be a short-term priority.

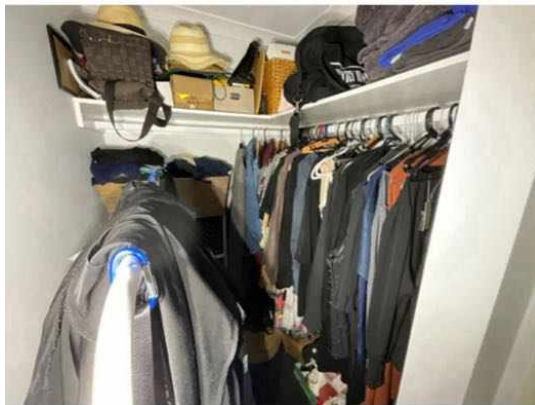
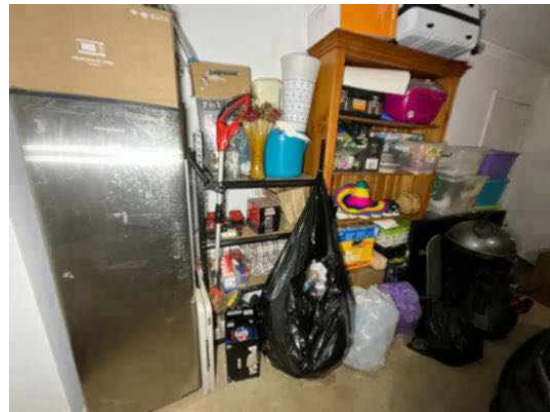
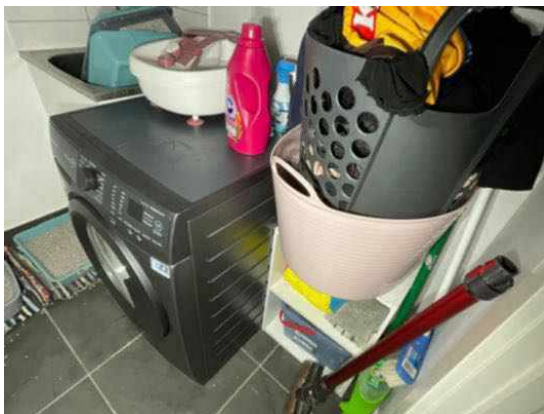
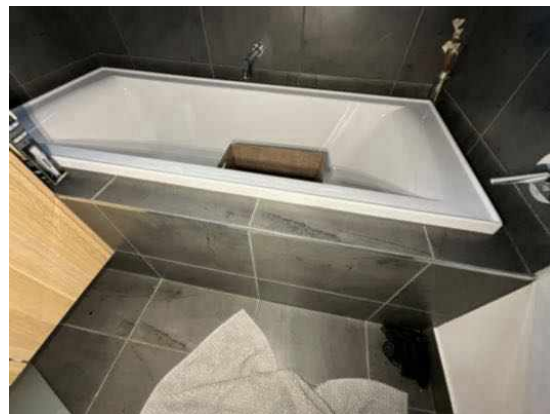
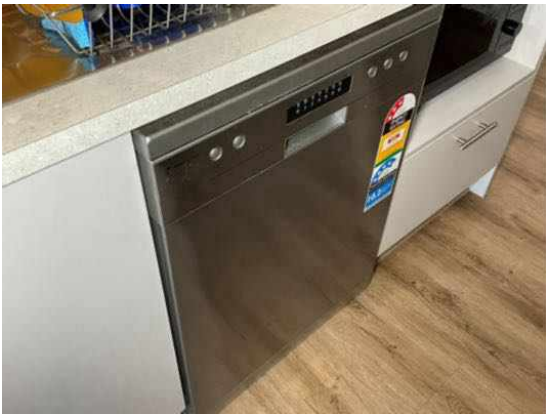
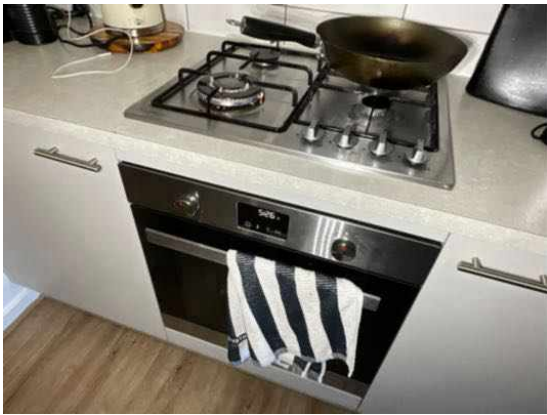
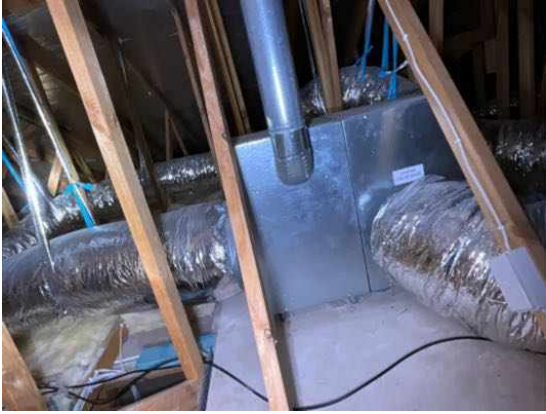
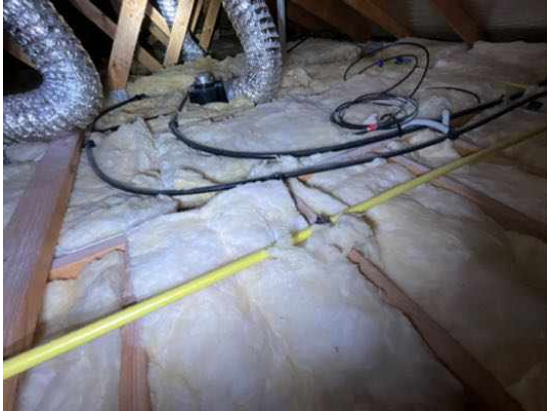
Noted Item

Building: Building 1
Location: All Areas
Finding: Additional Photos - Obstructions and Limitations
Information: These photographs are an indication of the obstructions and limitations which impeded full inspection of the property at the time of inspection. These obstructions can hide an array of defects and should be removed to allow full inspection to be carried out. A re-inspection is recommended once the areas are made accessible.
