Building and Timber Pest Inspection Report VR

Inspection Date: Wed, 21 Jan 2026

Property Address: 5 Evadne St, Graceville QLD 4075, Australia

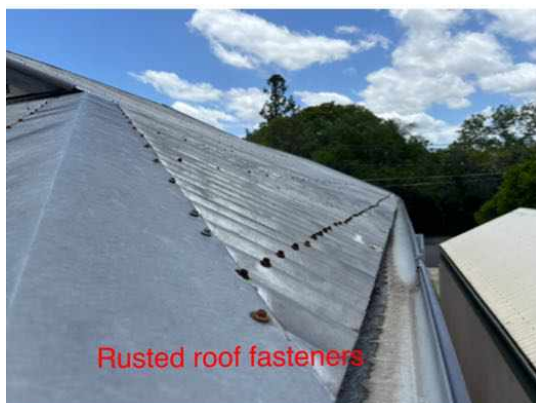
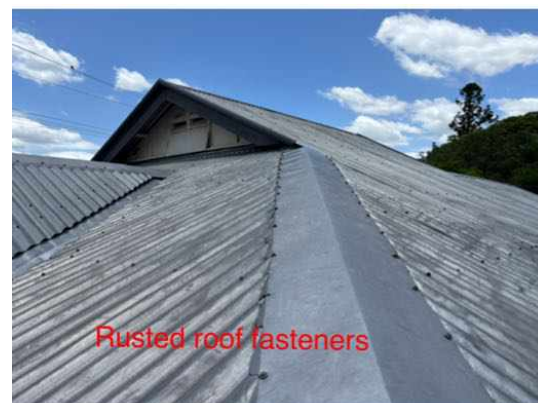
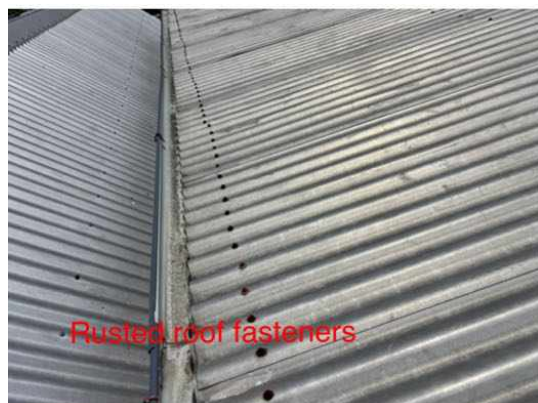
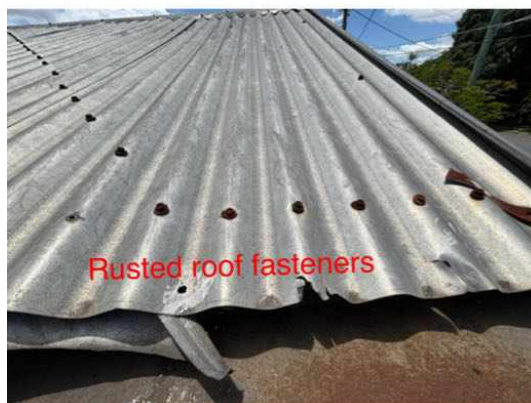
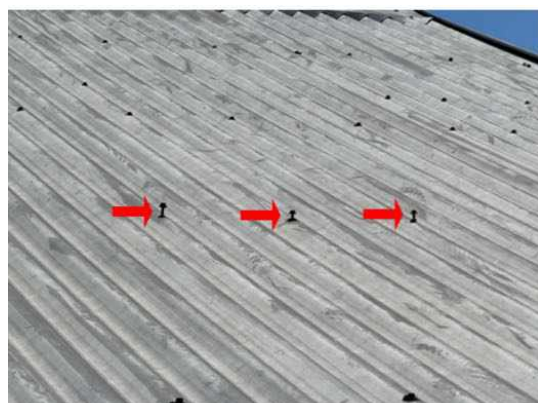
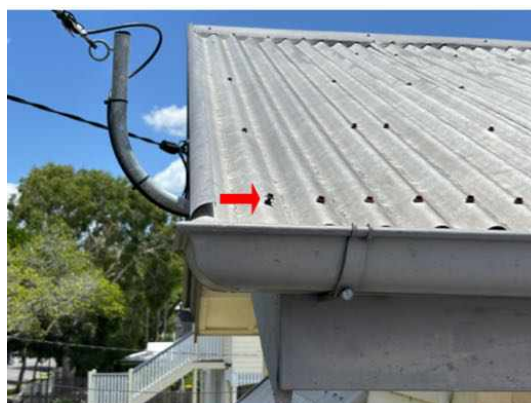
Finding 3.01

Building: Main Building
 Location: Roof Exterior
 Finding: Metal roof covering - Weathered
 Information: Upon inspection of the exterior roofing, the majority of the metal roof sheets were considered to be in a fair condition. While weathering of the metal roof sheets is consistent with the age of the property, maintenance works are required.

The majority of the roof fasteners were rusting and several roof fasteners have worked loose. The loose roof fasteners and the rusted roof fasteners need to be replaced as a matter of urgency. The rusted roof fasteners need to be replaced to avoid the rust transferring to the metal roof sheets. Rust on the roof sheeting will be a major defect.

Where left unmanaged, deteriorating metal roof sheets are likely to lead to a number of secondary defects, including minor water leaks and weather exposure to internal roofing structures.

Roofing fasteners were found to be rusting and several fasteners have worked loose.

Consultation with a roofing contractor is highly advised to gain advice on cost of remedial works that may be required in the short to medium term. Remedial works are likely to increase the longevity of the exterior roofing structure.

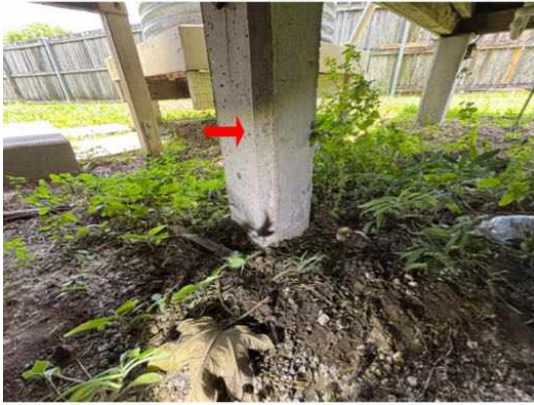
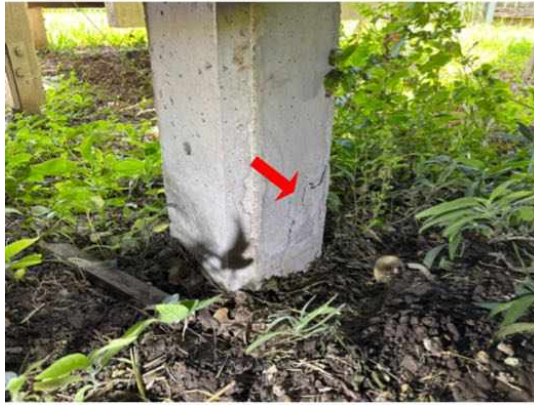
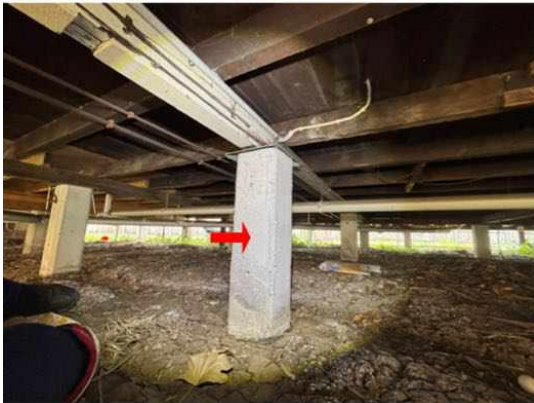
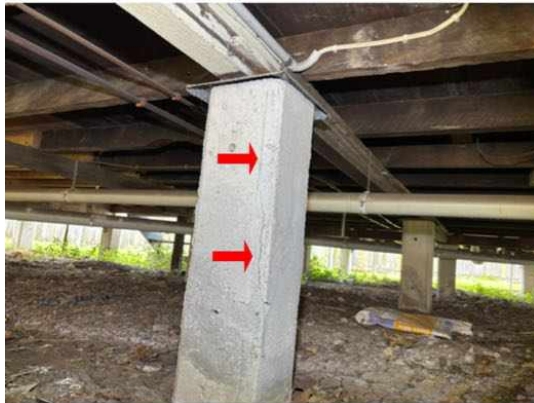
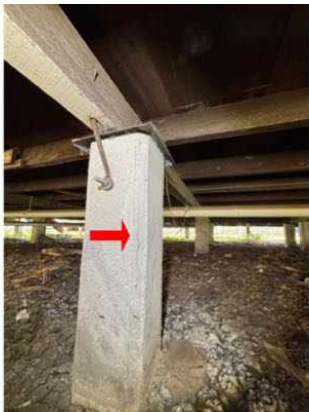
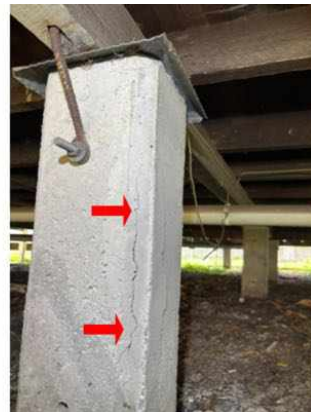
Finding 3.02

Building:	Main Building
Location:	Subfloor
Finding:	Concrete Stumps - Spalling
Information:	Three concrete stumps to the subfloor structure were found to be affected by spalling, indicating that their structural integrity has been affected. Spalling refers to concrete deterioration and threatens the building's supportive structure.

The cause of spalling can range from inferior quality concrete, improper concrete curing, chemical reactions to alkaline in the soil, or corrosion of steel reinforcement within the concrete, which is commonly known as concrete cancer. The stumps are failing in their structural purpose, likely leading to a range of major and minor defects. Further damage to the stumps and structure may be imminent if left unattended.

Three concrete stumps in the subfloor area have started to spall.

An appointment with a registered builder specialising in re-stumping is required immediately to assess the condition of the concrete stumps and provide advice on remedial works. This defect should not be left unmanaged.

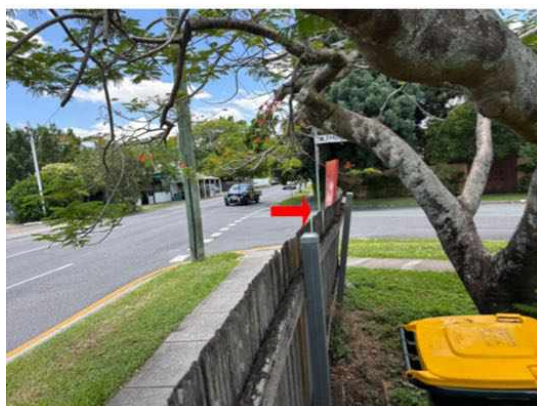
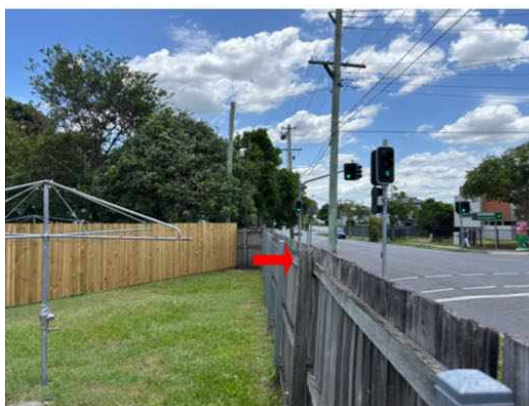
Finding 3.03

Building:	Main Building
Location:	Side yard
Finding:	Boundary fence - deteriorating
Information:	At the time of the inspection, it was noted that the right hand side boundary fence was deteriorating. This may be due to the age of the materials and general weathering.

A fencing contractor should be engaged to assess the fence and provide a solution to rectify this issue. This can be done at the clients discretion.

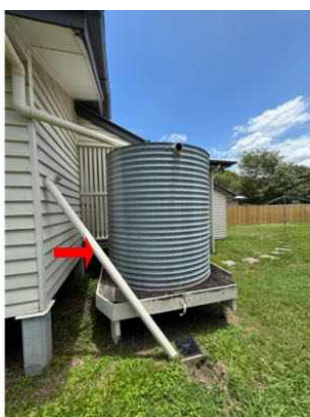
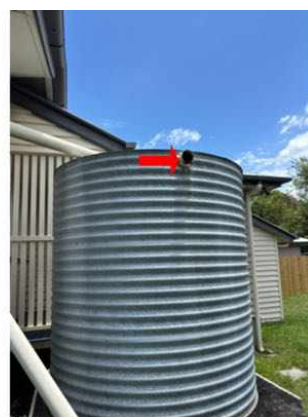
Finding 3.04

Building:	Main Building
Location:	Side yard
Finding:	Exterior - tank overflow disconnected.
Information:	At the time of the inspection, it was noted that the tank overflow has become disconnected.

A licensed plumber should be engaged to reconnect the tank overflow.

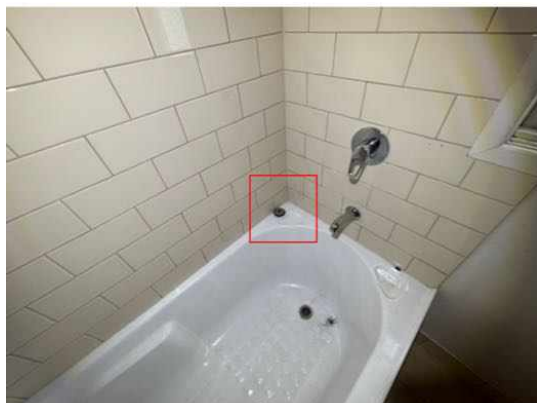
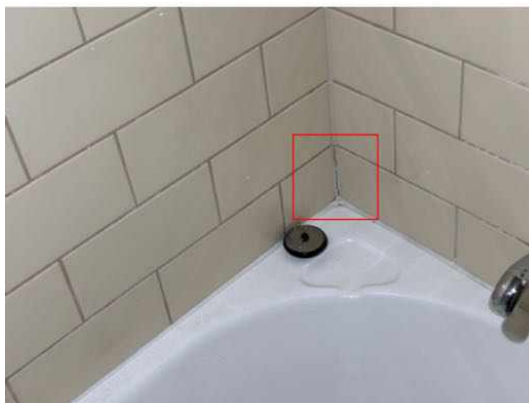
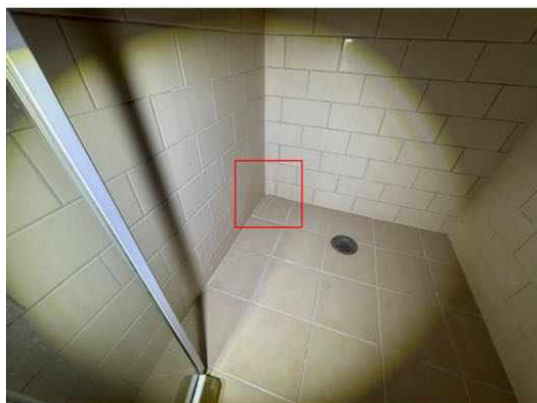
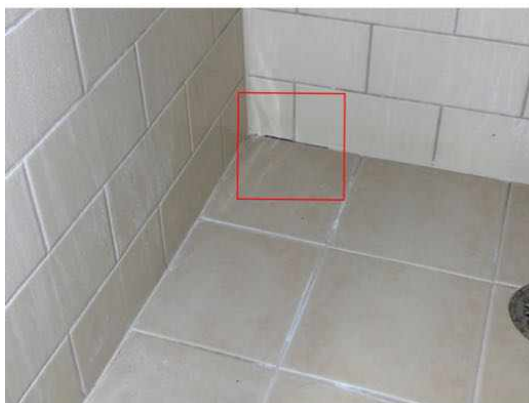
Finding 3.05

Building:	Main Building
Location:	Bathroom
Finding:	Bathroom - sealant deteriorating
Information:	At the time of the inspection it was noticed that the sealant in the bathroom was deteriorating.

Sealant is used in tiled areas to prevent moisture from entering the wall cavity and causing damage to the building elements. A moist environment in the wall cavity may also be a conducive condition for termite activity.

If it is not addressed, damage to building elements will occur and would require invasive works to rectify any damage.

A building maintenance professional or sealant applicator should be appointed to replace all sealant as a matter of urgency.

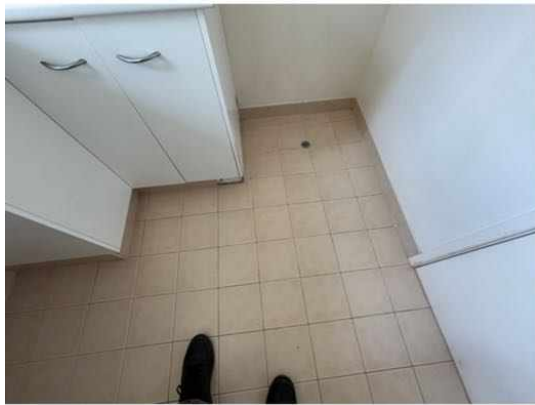
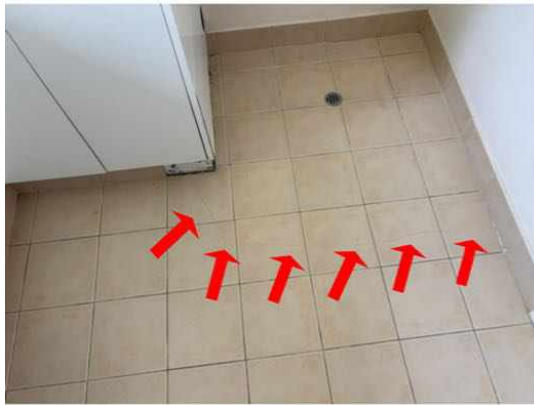
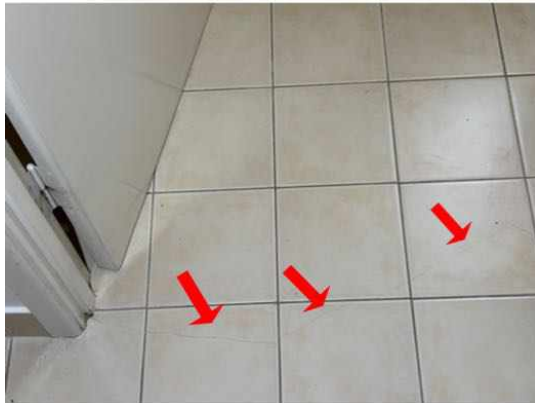
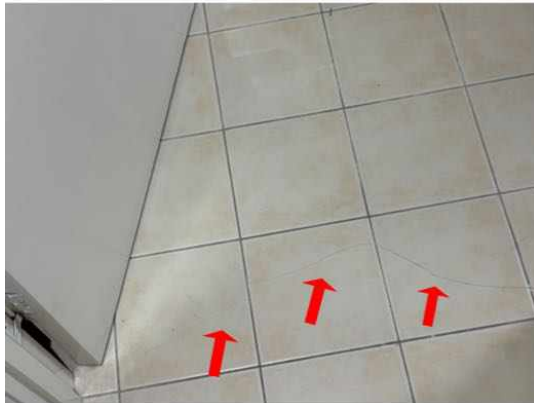
Finding 3.06

Building:	Main Building
Location:	All Internal Areas
Finding:	Laundry and bathroom - cracked floor tiles
Information:	At the time of the inspection it was noted that several tiles were cracked on the laundry and bathroom floors. This appears to be purely an aesthetic issues and could be attended to at the clients discretion. The tiles may have cracked because they are drummy and something has been dropped on them.

A tiler or building maintenance professional would be able to carry out the necessary works.

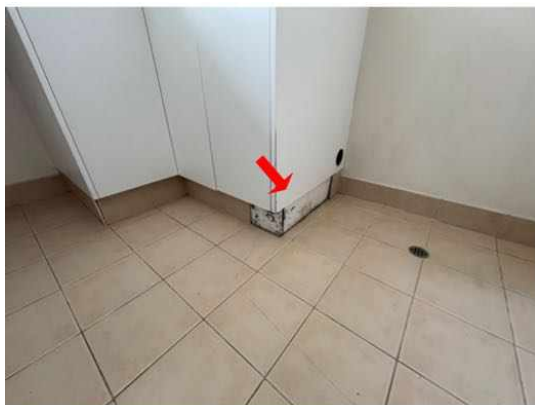
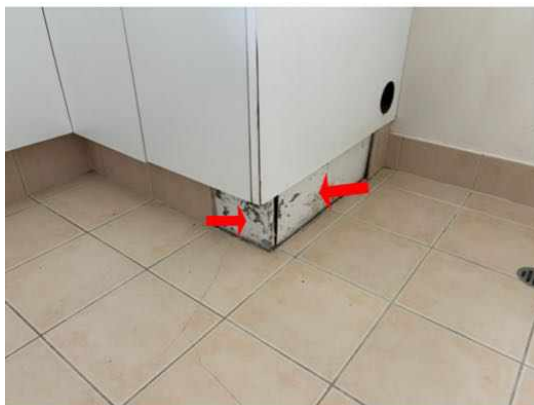
Finding 3.07

Location: Laundry

Finding: Laundry - skirt tiles missing

Information: At the time of the inspection, it was noted that skirt tiles were missing from the base of the laundry cabinetry. This may be due to the adhesive failing.

A building maintenance professional or tiler could be engaged to replace the missing skirt tiles. This can be done at the clients discretion.

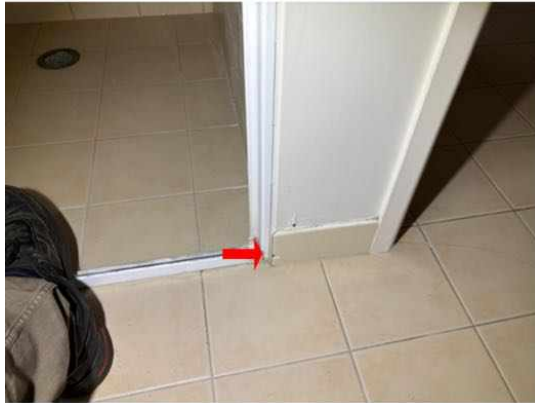
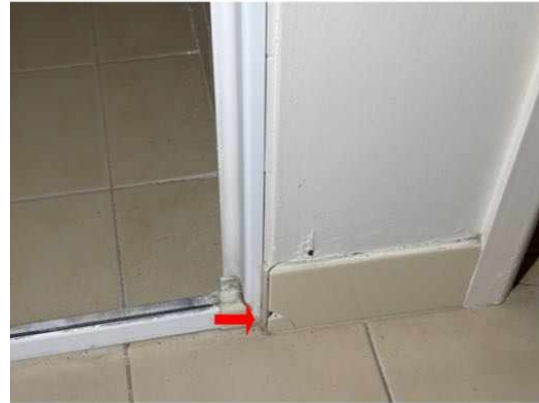
Finding 3.08

Building: Main Building
 Location: Bathroom
 Finding: Bathroom - cracked skirt tile
 Information: At the time of the inspection, it was noted that a skirt tile in the bathroom was cracked. This can be seen as an aesthetic issue.

A building maintenance professional or tiler could be engaged to replace the cracked skirt tile. This can be done at the clients discretion.

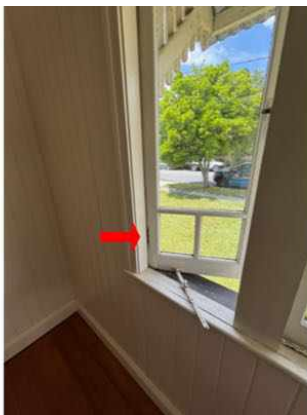
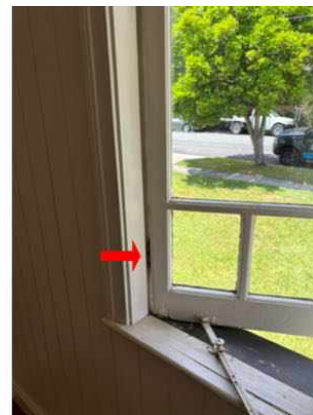
Finding 3.09

Building: Main Building
 Location: Front bedroom
 Finding: Front bedroom - window hinge loose
 Information: At the time of the inspection, it was noted that the bottom hinge to a window in the front bedroom was loose. The functionality of this window is affected. This may be due to general wear and tear.

A building maintenance professional could be engaged to re-secure the affected hinge. This can be done at the clients discretion.

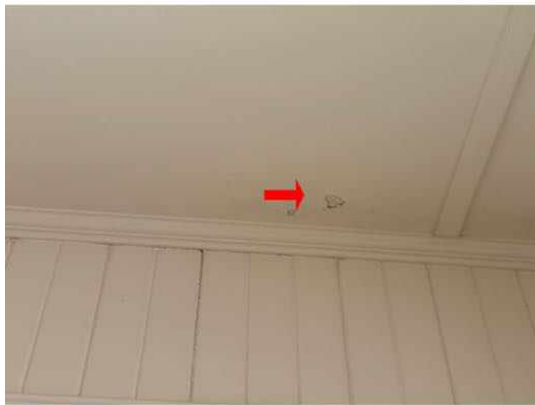
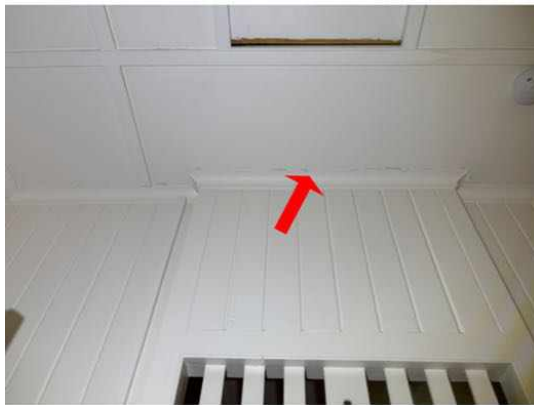
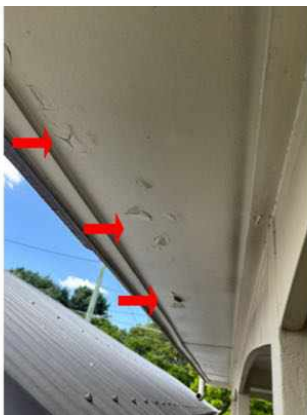
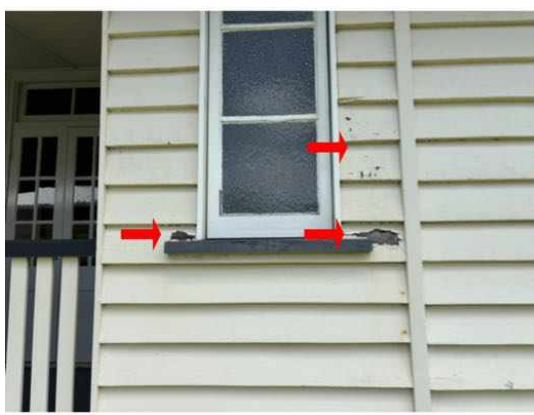
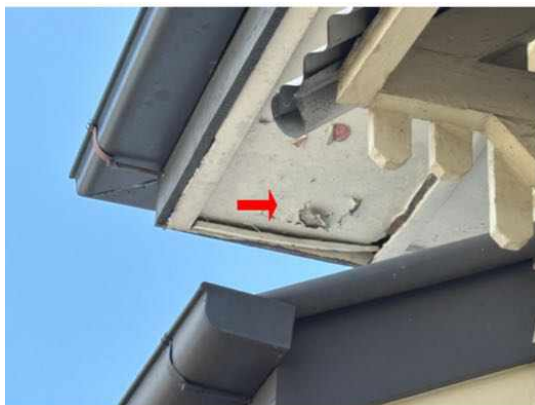
Finding 3.10

Location: All Areas

Finding: Paint peeling

Information: At the time of the inspection, it was noted that the paint was peeling in several areas around the dwelling as depicted in the attached photographs.

Peeling paint can be caused by moisture, poor preparation or age. There was no evidence of moisture found.

A painter or building maintenance professional could be engaged to rectify this issue. This can be done at the clients discretion.

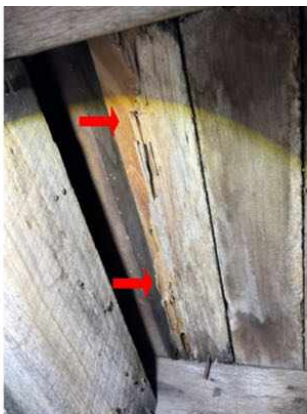
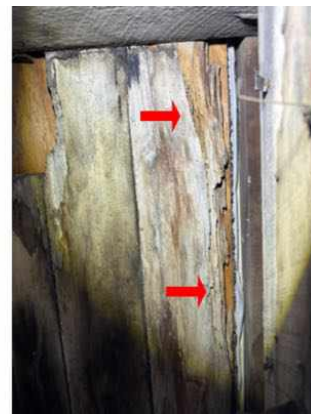
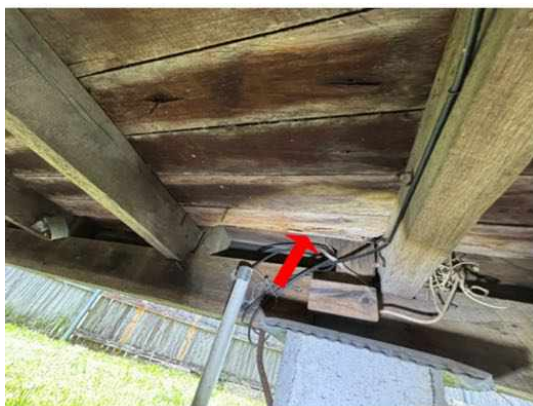
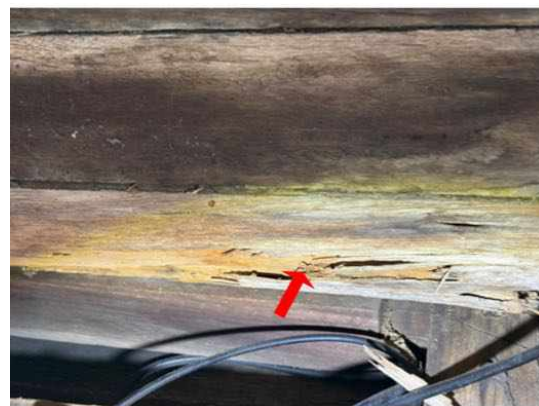
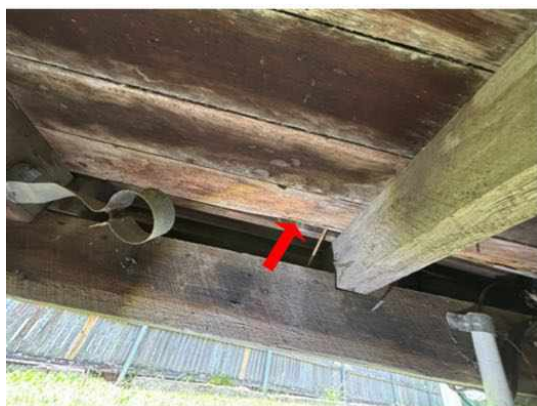
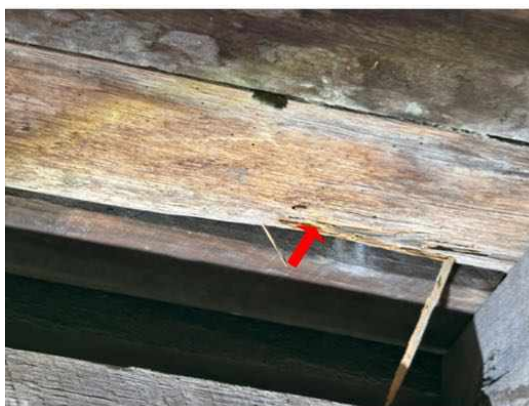
Finding 5.01

Building: Main Building
Location: Subfloor
Finding: Evidence of past termite damage
Information: At the time of the inspection, it was noted that there was evidence of past termite damage in the subfloor area under the bathroom.

Evidence of past termite damage was found in the subfloor under the bathroom.

It is advised that the area be visually inspected frequently to ensure that the condition of affected building materials does not worsen.

A building contractor may be appointed to provide a further invasive inspection if further damage is evident.

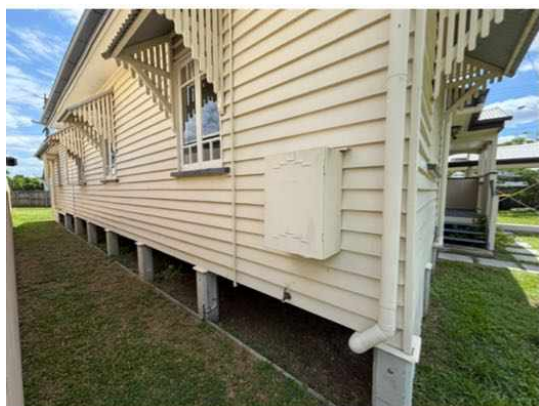
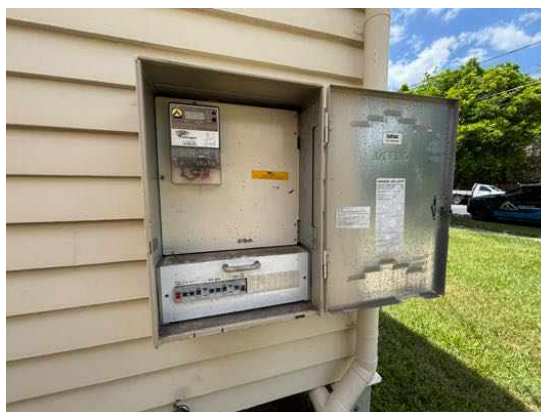
Finding 6.01

Building:	Main Building
Location:	All External Areas
Finding:	Termite Management System - no evidence of a chemical installation
Information:	At the time of the inspection, no evidence of a chemical termite management system was found. There is no durable notice in the meter box. A physical termite barrier in the form of metal ant caps was found in the subfloor area. Metal ant caps are designed to expose concealed termite activity.

A durable notice should be placed in the switchboard unit to indicate current termite barriers. At the time of inspection, it appeared as though no termite management system has been installed, with no evidence to suggest preventative works taking place.

No evidence of a chemical termite treatment system was found during the inspection. No durable notice was found in the meter box or in the kitchen sink cabinet. A physical termite barrier in the form of metal ant caps was found on the top of the concrete stumps. Metal ant caps are designed to expose concealed termite activity.

The application of a post-construction chemical termite barrier is highly recommended for all properties, particularly if live termite activity has been found on the site previously. Such barriers are highly effective in preventing termite attack on any timber building elements throughout the property.

The client may consider gaining further advice from a pest controller as to the costs and procedures involved with this application. It is recommended that obtaining such advice be a short-term priority.

A termite and timber pest technician should be engaged to provide a suitable chemical termite treatment system to suit this style of building.

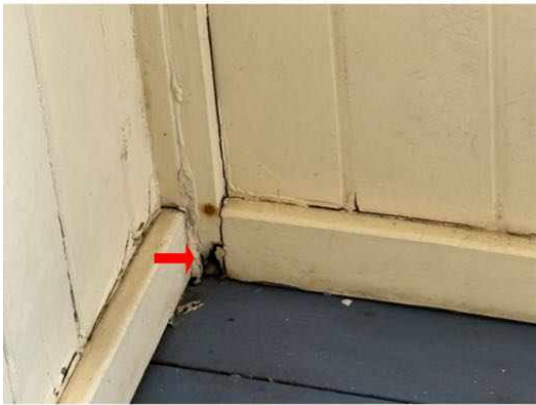
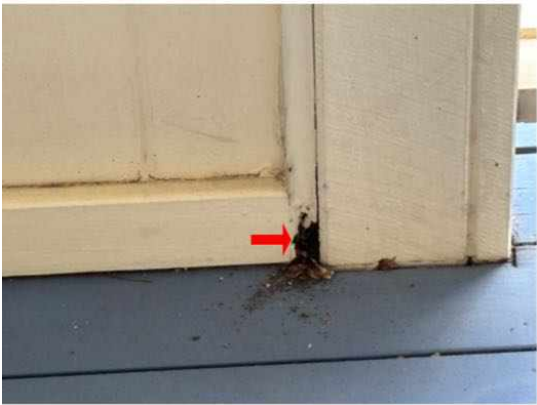
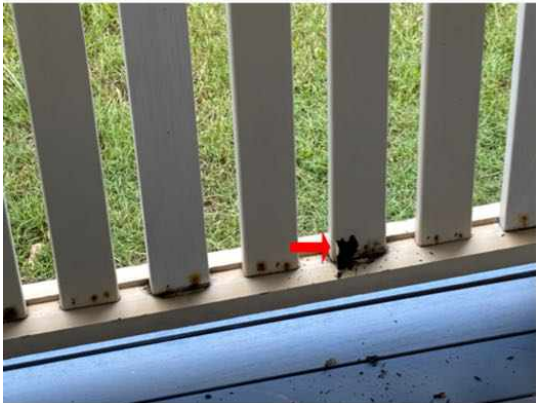
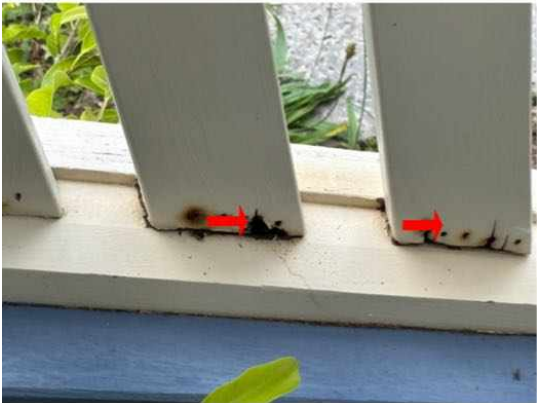
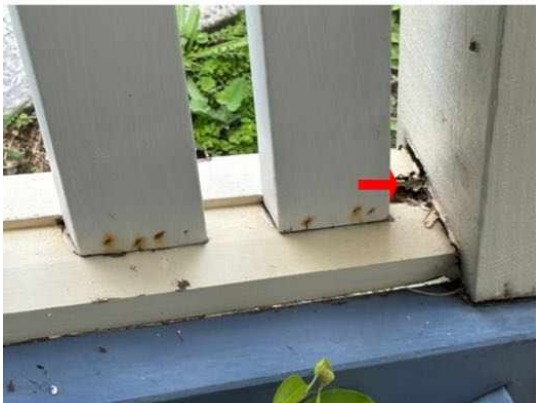
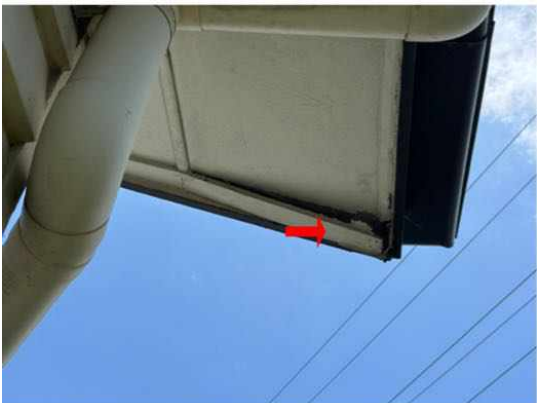
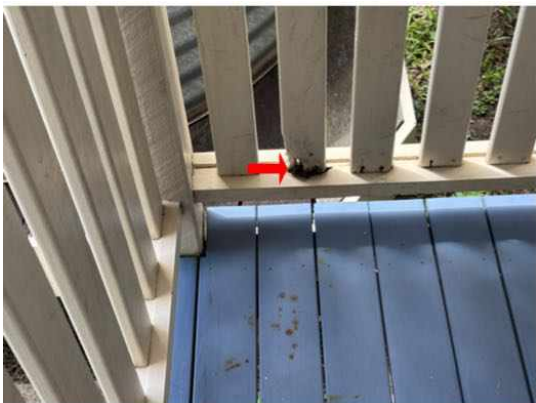
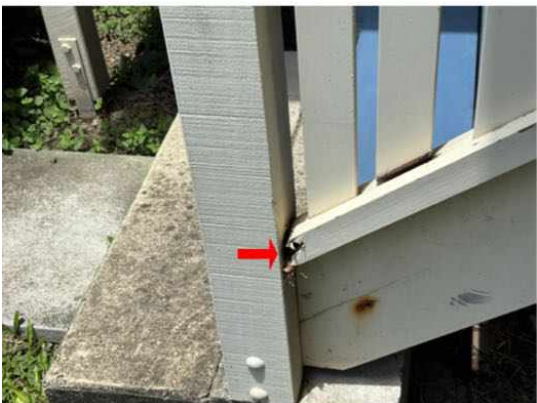
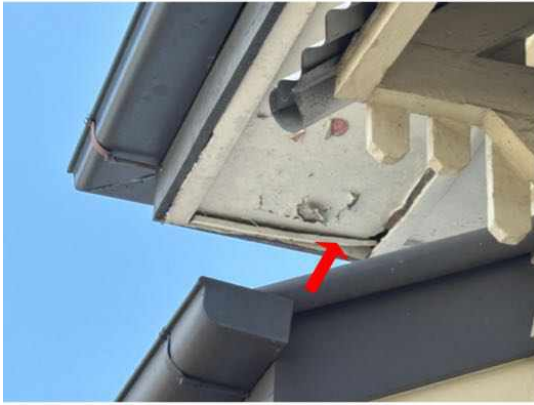
Finding 7.01

Building:	Main Building
Location:	All External Areas
Finding:	External areas - wood rot
Information:	At the time of the inspection, it was noted that there was evidence of wood rot to several timber building elements as depicted in the attached photographs. This may be due to the age of the timber building elements and general weathering.

This building element shows evidence of wood rot. Wood rot, also known as Fungal Decay, occurs when timbers and other cellulose building materials are exposed to damp conditions on an ongoing basis.

Wood rot is often associated with general damp problems and is evidenced by a 'musty' smell or mould and mildew occurring on surfaces. If left unmanaged, damp conditions can lead to further health problems and the decay of timbers will continue.

Early intervention and regular maintenance, particularly of exterior timbers, will prolong the useful life of these building elements. Prior to any works being performed, the cause of the moisture that has created the visible wood rot should be identified and addressed in a suitable manner. Replacement of affected timbers may then be a necessary step in protecting surrounding building elements from such deterioration.

A qualified carpenter or registered builder may also be required to replace affected building materials.

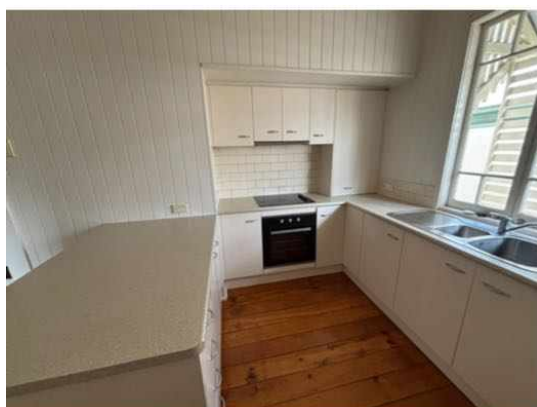
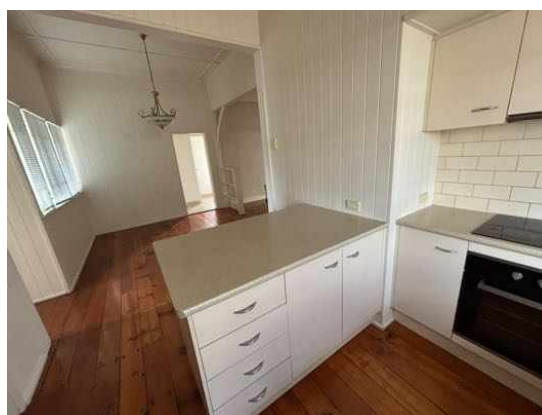
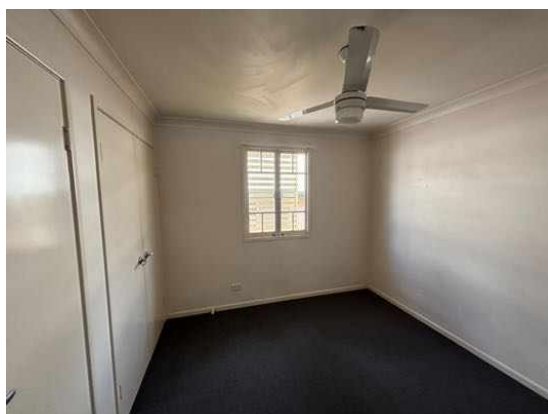
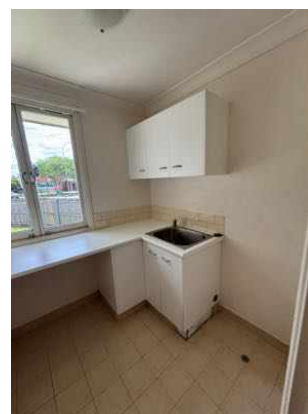
Noted Item

Building:	Main Building
Location:	All Internal Areas
Finding:	Obstructions and Limitations - Internal areas
Information:	These photographs are an indication of the obstructions and limitations which impeded full inspection of the property of the internal areas at the time of inspection. These obstructions can hide an array of defects and should be removed to allow full inspection to be carried out. A re-inspection is recommended once the areas are made accessible.

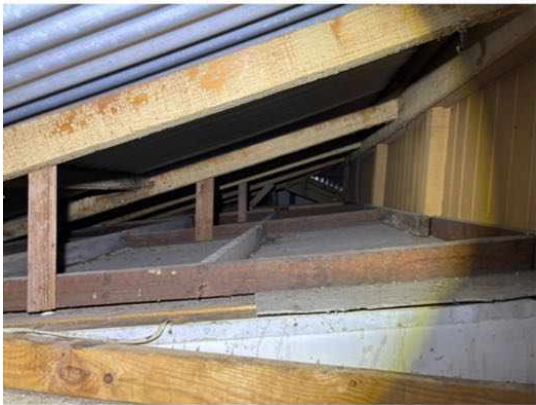
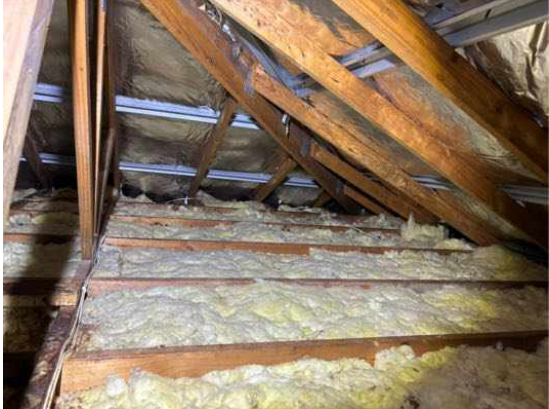
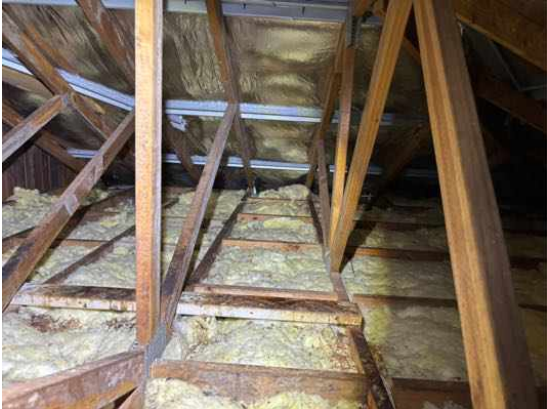
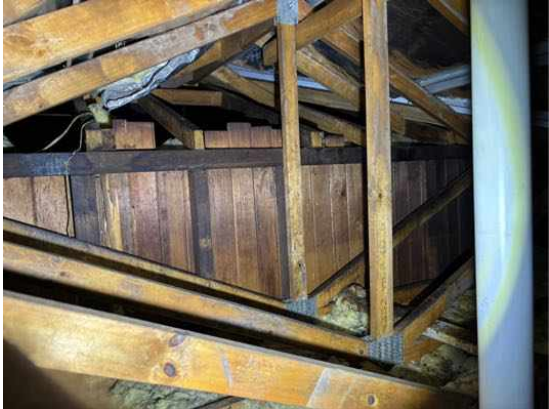
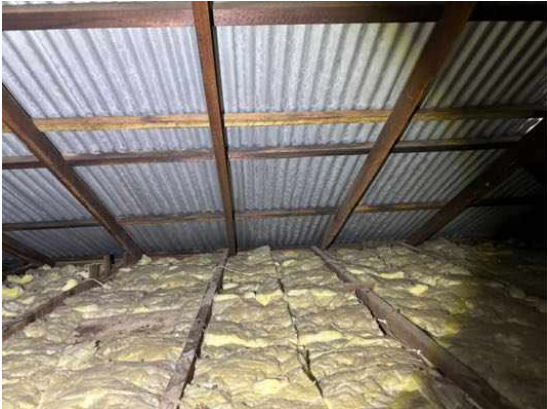
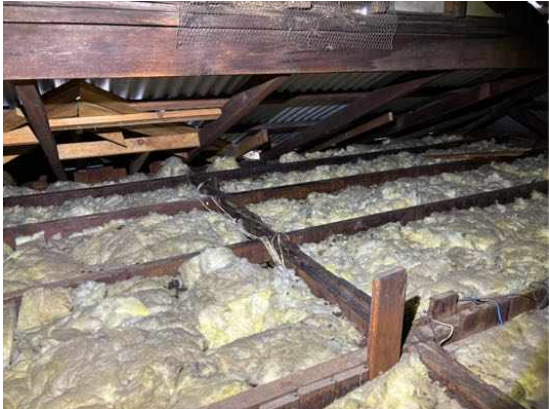
Noted Item

Building:	Main Building
Location:	Roof Void
Finding:	Obstructions and Limitations - Roof cavity
Information:	These photographs are an indication of the obstructions and limitations which impeded full inspection of the property of the roof cavity

at the time of inspection. These obstructions can hide an array of defects and should be removed to allow full inspection to be carried out. A re-inspection is recommended once the areas are made accessible.
