Building and Timber Pest Inspection Report

Inspection Date: Wed, 8 Apr 2026

Property Address: 189 Slopes Road, North Richmond NSW
2754

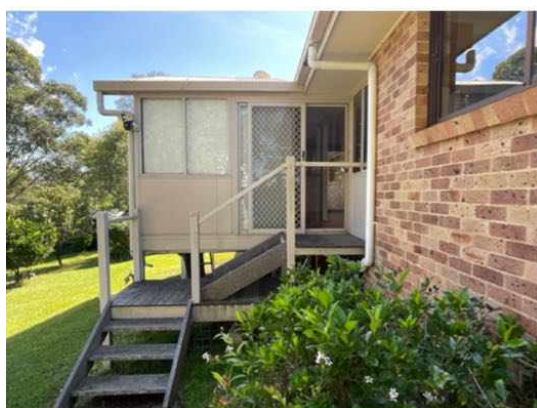
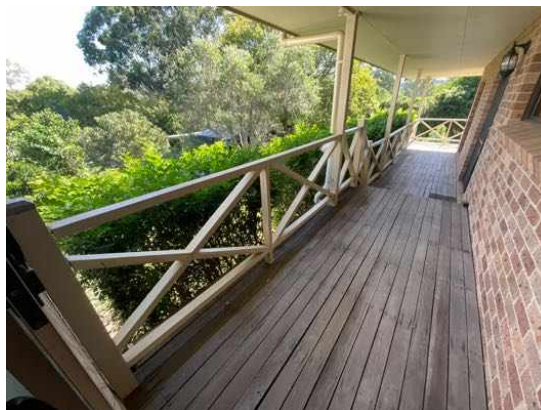
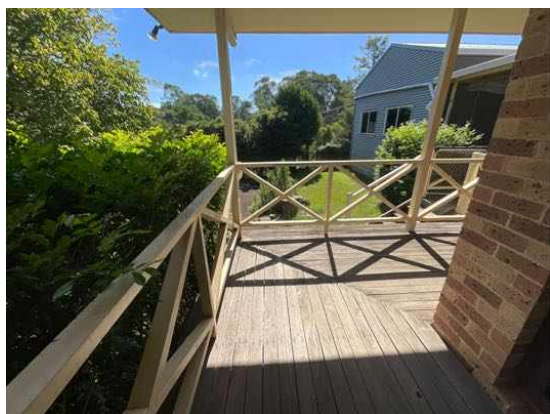
Building:	Main Building
Location:	Stairs & Landing - Rear
Finding:	Inadequate Stairwell Balustrades – Safety Hazard.
Information:	Balustrade – Safety Hazard

Although balustrades may not have been required at the time of original construction (as is often the case with older buildings), their absence does not meet current safety expectations and is considered hazardous.

According to the National Construction Code (NCC), barriers or balustrades are required where a change in level exceeds 1 metre. The current condition would be considered non-compliant by modern standards.

It is strongly recommended that a licensed builder or stair manufacturer be engaged to supply and install compliant balustrades in accordance with current NCC requirements as a priority, to reduce the risk of injury.

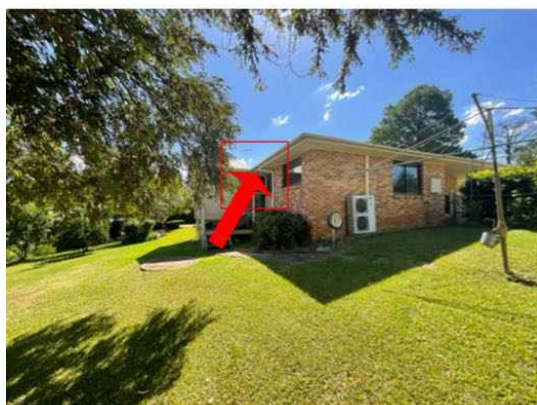
Building: Main Building
 Location: Rear Elevation
 Finding: Minor Defect – Roof Plumbing (Downpipes / Stormwater Connection).
 Information: Observation:

At the time of inspection, sections of the roof plumbing system were observed to be inadequately connected to the stormwater drainage system. In particular, downpipes were not properly sealed at their connection points, with visible gaps, damage and/or incomplete junctions noted. The condition of these connections suggests that stormwater discharge may not be effectively captured or directed into the drainage system.

Unsealed or poorly connected downpipes can result in water leakage or overflow during periods of rainfall, particularly where surface drains are obstructed or inadequately maintained. This may lead to water pooling at the base of the structure and adjacent areas. Prolonged exposure to excess moisture in these locations can contribute to subfloor dampness, increased risk of timber decay, and conditions conducive to pest activity. In addition, ongoing moisture exposure may lead to deterioration of masonry elements, including brickwork and mortar joints. While considered a minor defect at the time of inspection, failure to address this issue may result in more significant moisture-related problems over time.

It is recommended that a licensed plumber be engaged to carry out a detailed assessment of the roof drainage system. All downpipe connections should be properly sealed and securely connected to an approved stormwater disposal system. Any defective components should be repaired or replaced as required to ensure efficient collection and discharge of roof water away from the building. Regular maintenance, including clearing of surface drains and inspection of stormwater connections, is also advised to minimise the risk of blockage, overflow, and water accumulation near the structure.

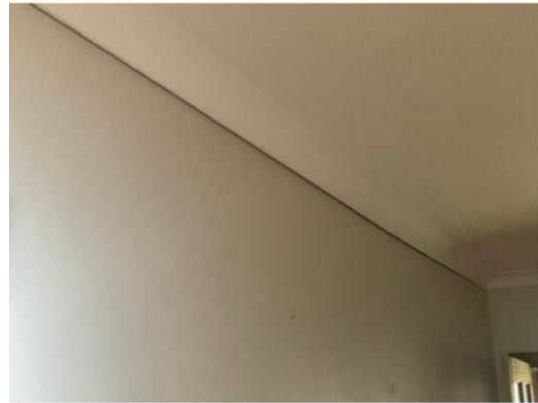
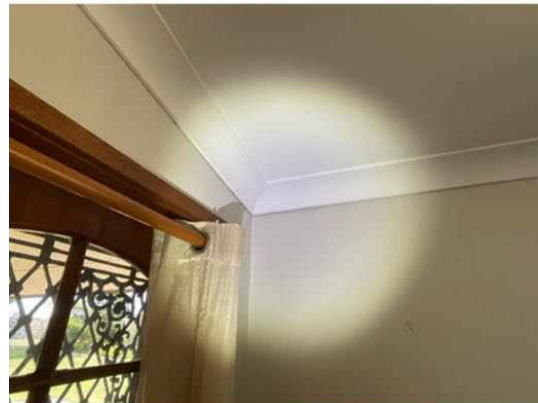
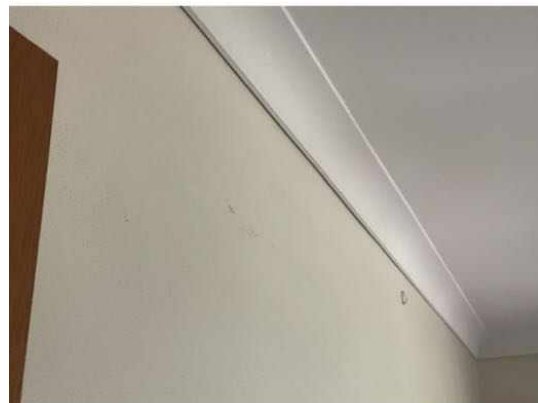
Finding 3.02

Building:	Main Building
Location:	Hallway & Bedrooms
Finding:	Minor Defect – Cornice Cracking / Detachment.
Information:	Observation:

Cracking and/or localised detachment of cornices were observed in the noted areas. The defects appear to be limited to the junction between the wall and ceiling linings and are typical of minor movement, material shrinkage, or age-related deterioration.

In most cases, cracking or minor separation of cornices is considered an aesthetic defect and does not generally indicate structural failure. However, where detachment is present, there is a risk of progressive loosening over time, which may result in sections becoming unstable or further deterioration of the finish if left unaddressed.

Repairs are recommended to re-secure and reinstate affected cornice sections, which may include re-gluing, fastening, and patching as required. These works are generally considered minor maintenance and can be undertaken by a qualified plasterer or relevant tradesperson.

Prompt attention is advised to prevent further movement or damage and to maintain the overall presentation and integrity of the internal finishes. Regular monitoring of the affected areas is also recommended as part of ongoing maintenance.

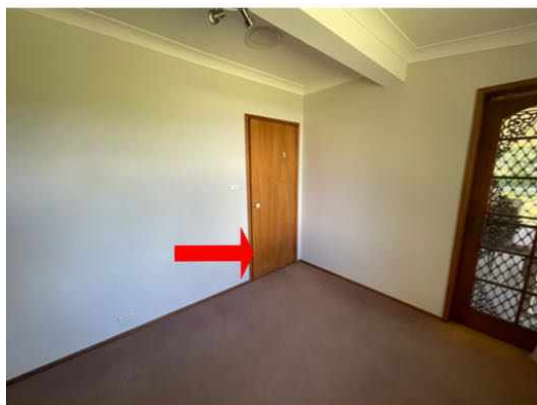
Finding 3.03

Location: Bedroom
Finding: Door - Binding and/or Jamming.
Information: Functional Defect Identified

Binding and/or jamming of this door was observed during standard operation and appeared to be rubbing or binding. This issue impairs the normal functionality of the door and may lead to secondary damage to adjacent building elements, such as scuffing or tearing of floor coverings, or stress to door hardware and framing.

- Poor door installation
- Worn, damaged, or misaligned hinges
- Swelling or warping of materials
- Differential movement in the building structure (e.g. due to settlement, subfloor deflection, or foundation issues)

- If the issue appears to be related to major structural movement, it is recommended that a registered builder with experience in re-stumping or subfloor repairs be engaged to assess the extent of the movement and provide a quotation for necessary remedial works.
- Where the issue is minor in nature, a qualified carpenter or general handyperson may be appointed to carry out corrective works at the client's discretion.

Prompt assessment and remediation are advised to prevent further deterioration or related damage.

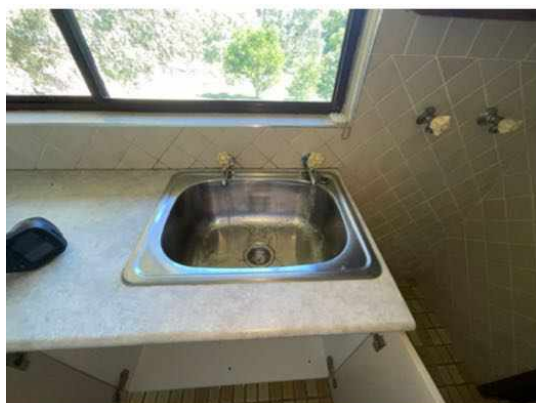
Finding 3.04

Building: Main Building
 Location: Laundry
 Finding: Sealant to splash back - Degraded or Missing.
 Information: Observation

During the inspection, it was noted that the sealant to the splashback areas is either missing or has significantly degraded. This condition exposes junctions between different materials, such as tiles and countertops, to potential water ingress. Over time, movement between dissimilar materials can cause cracking of grout and deterioration of sealant, particularly when regular maintenance has not been carried out.

The absence or degradation of flexible sealant increases the risk of water penetrating underlying building materials. This may lead to moisture-related damage, including timber decay, corrosion of fixtures, mould growth, and potential damage to cabinetry or wall substrates. Failure to maintain sealant in wet areas can result in ongoing water ingress and accelerated deterioration of associated building components.

A flexible, mould-resistant sealant should be applied to all affected junctions to restore water tightness and accommodate expected expansion and contraction of materials. Regular inspection and maintenance of sealant in areas exposed to water is recommended as part of ongoing property care. Works should be undertaken by a qualified sealant specialist or experienced tiling contractor to ensure proper preparation and application, reducing the likelihood of future water damage.

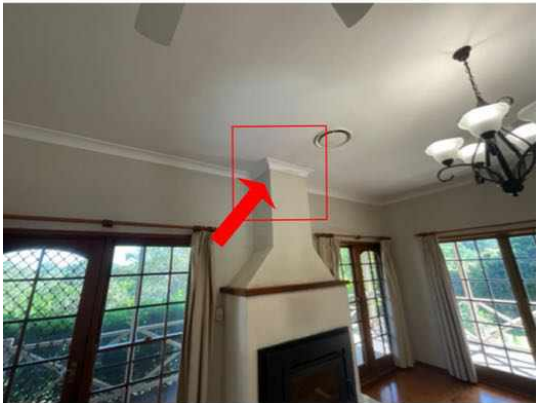
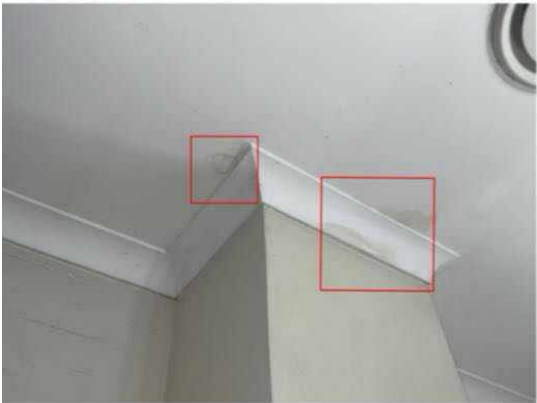
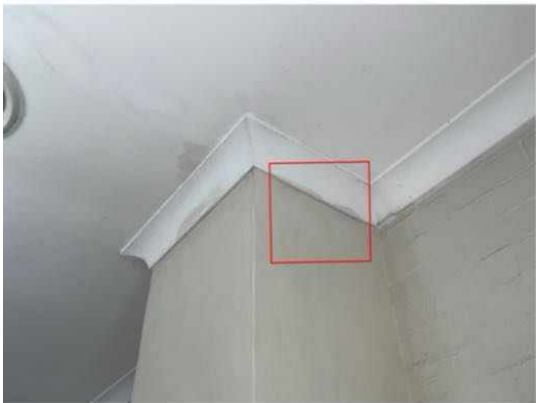
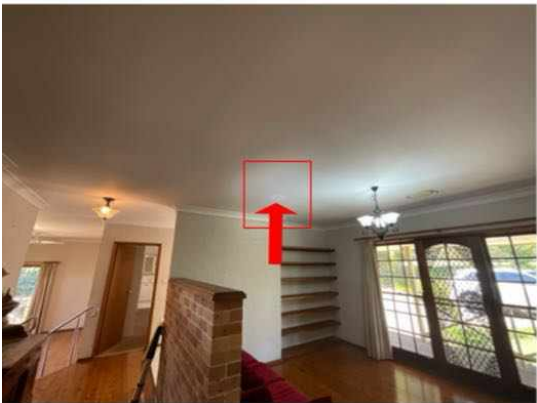
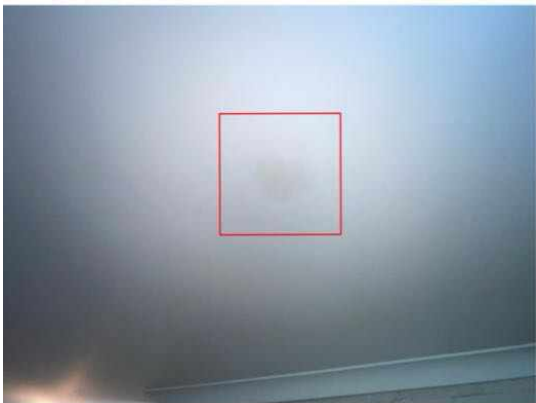
Finding 3.05

Building: Main Building
 Location: Living Rooms
 Finding: Ceiling - Water stained.

Water staining was noted to ceiling linings in the inspected area(s) at the time of the inspection. These stains present as discoloured or patchy areas and may suggest a history of moisture ingress, most commonly associated with roof leaks or plumbing issues.

Water staining is typically the result of prolonged exposure to moisture, which allows minerals and other contaminants carried by the water to accumulate on surfaces, leaving visible marks. If ongoing or left untreated, moisture ingress can lead to more serious issues such as:

Where the staining is still active (i.e., the leak continues during rainfall), this may indicate a current and unresolved roofing issue. In such cases, prompt attention is required to prevent further internal damage.

- Where the staining is active or suspected to be active during wet weather, a qualified roofing specialist should be engaged to conduct a more detailed inspection. Their investigation should focus on identifying the exact source of moisture ingress and advising on necessary repairs to the roof coverings, flashings, penetrations, or associated components.
- Where the staining appears to be historical (i.e., dry and showing no recent progression), reparation of affected ceiling materials (such as repainting or patching) may be carried out at the client's discretion, subject to confirmation that the source of the leak has been effectively addressed.

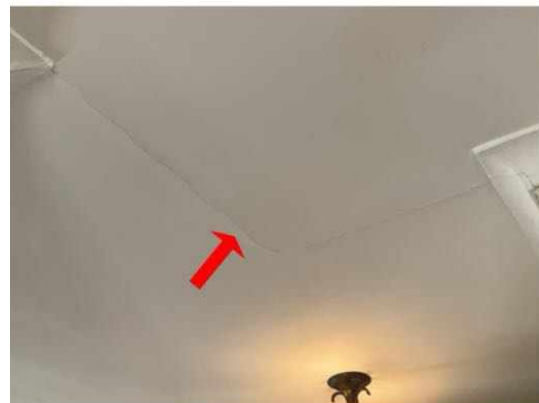
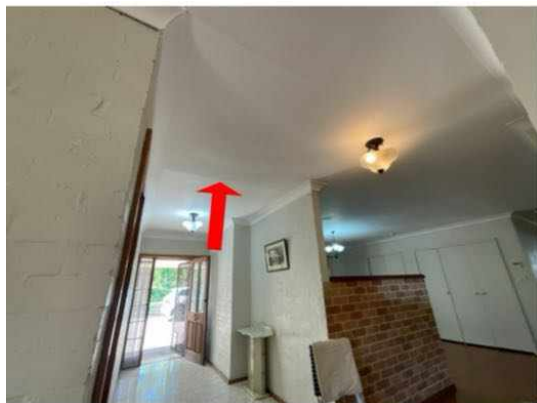
Finding 3.06

Building: Main Building
Location: All Internal Areas
Finding: Minor Defect – Ceiling & Wall Cracking (Internal).
Information: Observation:

Cracking was observed to the internal ceilings and/or wall linings within the nominated

areas. The cracking appears to be minor in width and extent, consistent with typical patterns associated with material movement and settlement. Contributing factors may include timber frame movement, shrinkage during the drying process, and seasonal moisture fluctuations affecting building materials.

Cracking of this nature is common in buildings of similar age and construction and is generally considered an aesthetic or cosmetic defect, rather than an indication of structural failure. However, without full access to concealed areas, the possibility of underlying contributing factors cannot be entirely excluded.

Repairs can typically be undertaken as part of routine maintenance, including:

- Minor filling of cracks
- Sanding and surface preparation
- Repainting to achieve a uniform finish

In areas subject to ongoing movement, the installation of a control/expansion joint may assist in managing future cracking and reducing recurrence.

Works may be carried out at the client's discretion by a qualified plasterer, painter, or competent handyman.

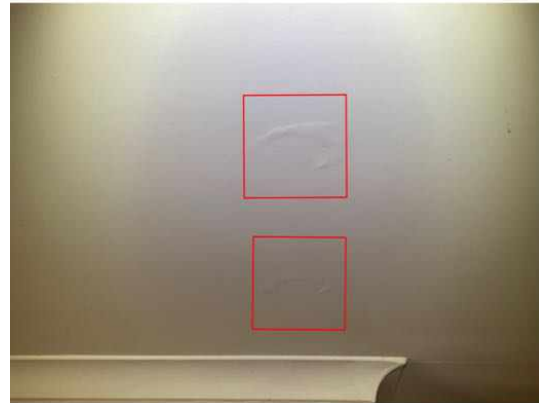
Finding 3.07

Building:	Main Building
Location:	Living Rooms
Finding:	Minor Defect – Popped Nails to Internal Ceiling.
Information:	Observation:

Nails and screws rely on frictional resistance within the substrate to maintain fixing integrity. Over time, due to natural ageing, minor structural movement, and material shrinkage, these fixings can loosen and back out.

If left unaddressed, this condition may lead to progressive loosening of ceiling sheets, increasing the risk of sheet movement, surface cracking, or localised sagging, and may contribute to the development of secondary defects.

It is recommended that the affected areas be re-secured by re-fastening or replacing the loosened fixings, and making good the surface finish as required. This may include:

Prompt attention is advised to maintain the stability and integrity of the ceiling linings

and to prevent further deterioration. Ongoing monitoring is also recommended as part of routine property maintenance.

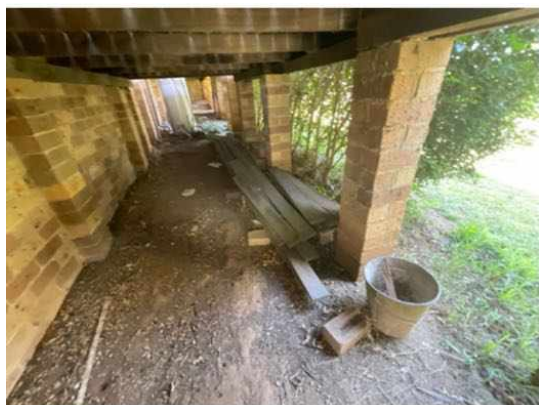
Building:	Main Building
Location:	Subfloor
Finding:	Subfloor - Excessive moisture conducive conditions..
Information:	Observation:

Excessive moisture was noted in the subfloor area during the inspection in particular under the laundry. Elevated moisture levels were evident within the soil and surrounding buildings elements. These conditions create an environment that is highly conducive to timber pest activity, particularly subterranean termites, as well as fungal growth and mould formation.

As part of an integrated termite management approach, reducing conducive conditions is essential. The elimination of potential attractants and concealment zones is a key preventative measure and is considered significantly more effective than addressing termite infestation after it has occurred.

Ongoing routine timber pest inspections are recommended in accordance with Australian Standards to monitor for any future activity.

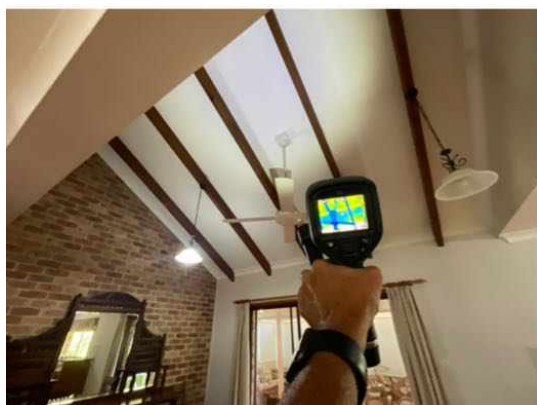
At the time of the inspection, no abnormalities indicating live termite activity were observed. However, it's important to note that various factors—such as obstructions, ambient temperature, and wall material/thickness—can impact the accuracy of thermal readings. In cases where surfaces are visually restricted or obstructed, a comprehensive thermal scan may not always be feasible.

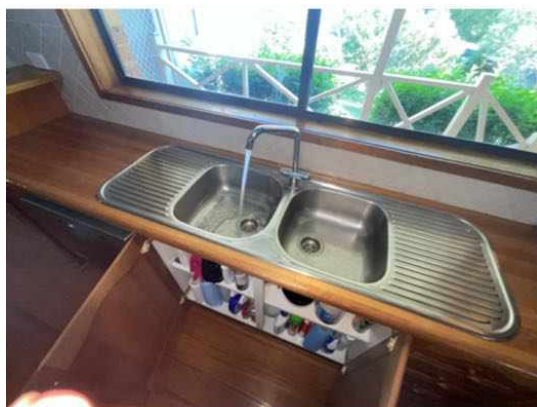
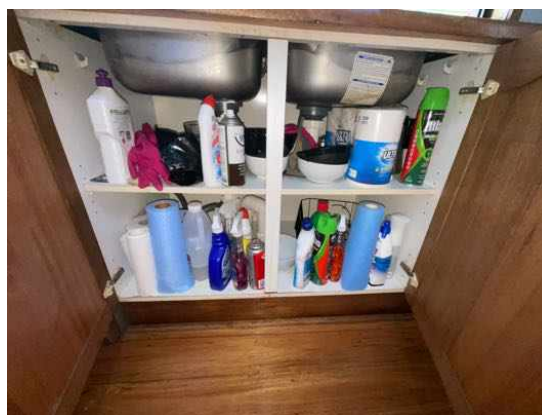
Building: Main Building
 Location: Kitchen
 Finding: Kitchen Sink – Overall Condition & Recommendations.
 Information: Observations:

- Further monitoring and testing are recommended once the tap(s) are in constant use, to identify any drainage issues or signs of slow leaks not evident during the limited inspection.
- For long-term property care, it is advised that sealant and grouting in water-exposed areas be regularly inspected and maintained.
- It is recommended that the stored items beneath the sink be removed to allow for a full re-inspection of the plumbing and cabinetry, ensuring no concealed defects are present.

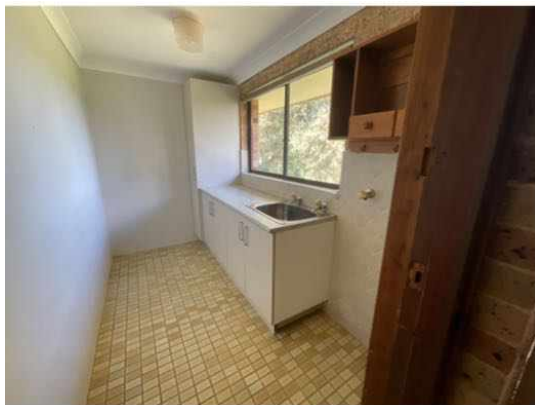
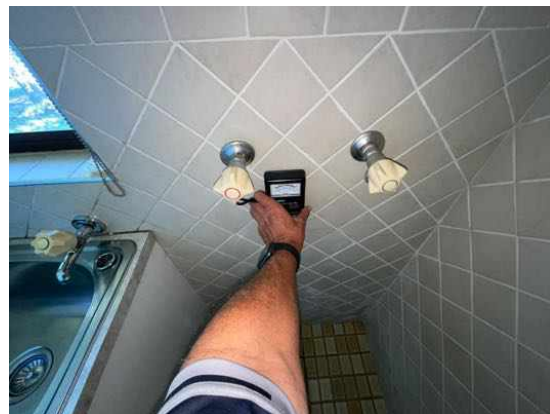
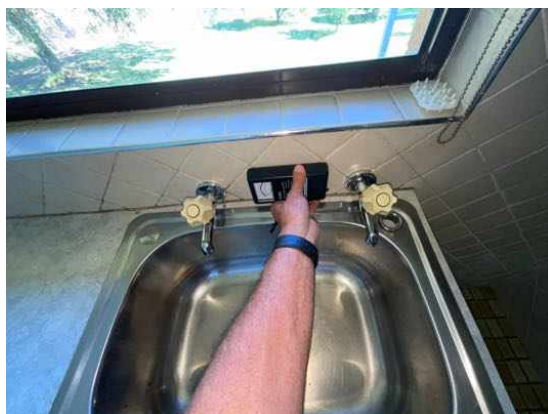
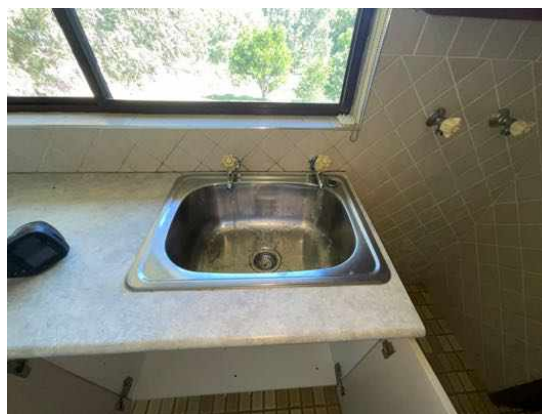
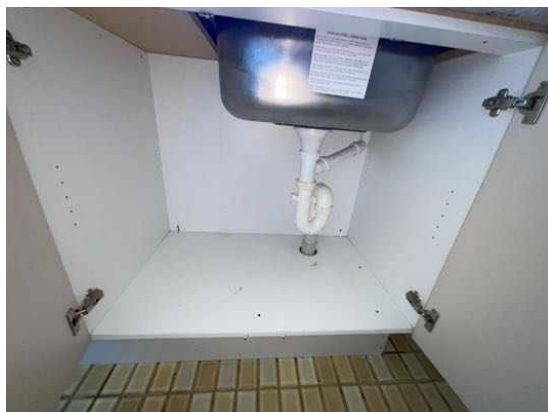
Building: Main Building
 Location: Laundry
 Finding: Laundry - Taps/Plumbing/Drainage.
 Information: Observation: Laundry Tub – Taps, Plumbing, and Cabinetry

- Further monitoring or testing is recommended once the taps are placed into regular use, to ensure no leaks develop over time and that the drainage system continues to perform adequately.
- Flexible and mould-resistant sealant should be applied to junctions between the basin and the wall to prevent water ingress that may lead to damage.
- Regular maintenance and prompt replacement of missing or deteriorated sealant is highly recommended, as this is a common wear-and-tear issue.
- Sealant and grouting in wet areas should be maintained as part of the long-term care and upkeep of the property.
- Where required, a sealant specialist or qualified tiling contractor should be appointed to carry out remedial sealing works.
