# Building and Timber Pest Inspection Report

Inspection Date: Wed, 01 Apr 2026

Property Address: 24 Flinders St, Matraville NSW 2036,  
Australia

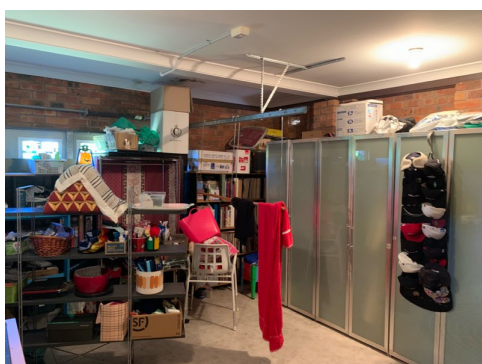
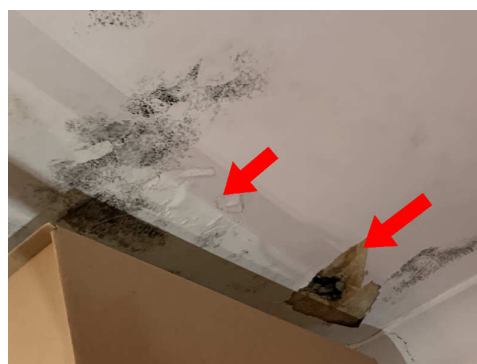
Finding: Ceiling - Water damaged

Information: Water damage to the ceiling lining is generally an indication of excessive moisture being present in the roof void, usually via a leak to the roof covering.

Where water damage is evident to the ceiling, the primary requirement is to identify and rectify the source of the leak.

A roofing plumber should be appointed as soon as possible to identify the leak and perform rectification works as necessary, ensuring the water damage is restricted.

Once the leak is repaired, consultation with relevant tradespeople, including plasterers and painters, is advised. Rectification works may include replacement of ceiling lining or minor repainting, depending on the extent of the damage.

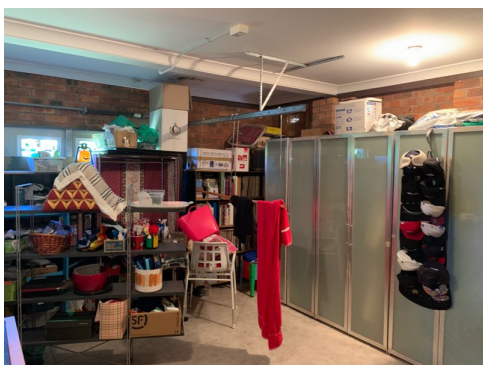
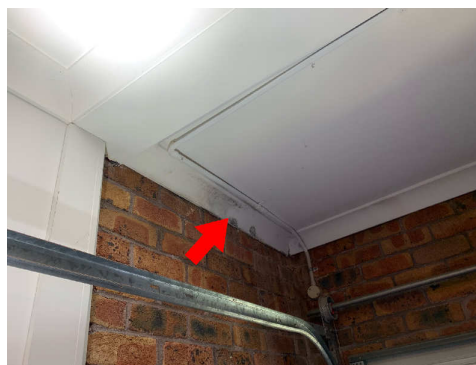
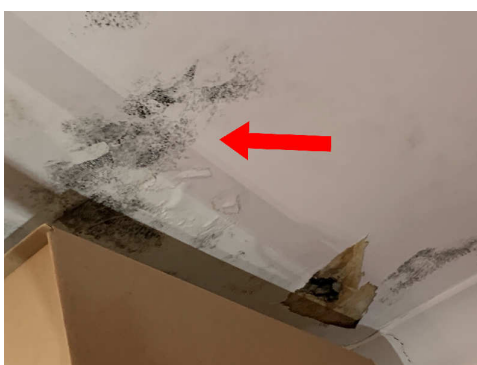
#### Finding 2.02

Where evidence of mould growth was noted, there may be environmental, biological or health issues associated with the report. A specialist inspection by a suitably qualified environmental health inspector is warranted, where mould is extensive or where any queries regarding air quality spores or other related issues apply.

Generally, the client is advised to ensure that the general environment is free of moisture and humidity to aid in the prevention of mould formation and development.

Any mould found during the inspection should be cleaned immediately by a cleaning contractor or the homeowner as applicable.

Please note that severely affected building elements may require replacement by a registered builder or qualified carpenter.

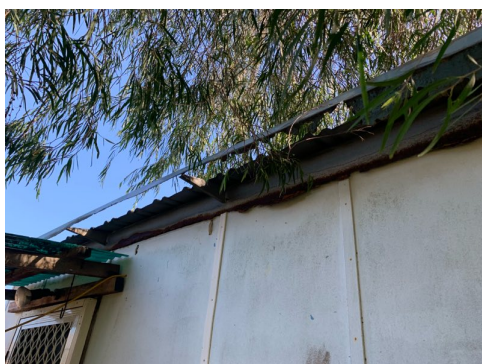
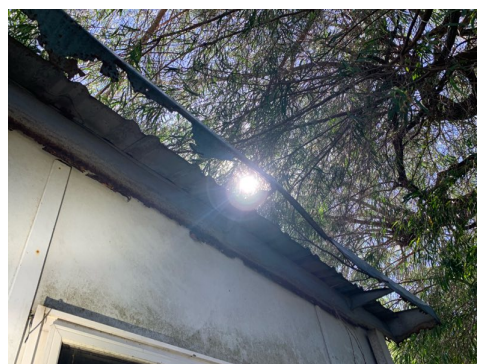
**Finding 2.03**

Finding: Roof plumbing - Rusted or corroded  
 Information: The roof plumbing has areas of rust and corrosion. It is suspected that this has been caused by blockages, resulting in pooling or standing water, that have prematurely rusted elements of the roof plumbing.

Rusted roof plumbing will generally develop holes and leaks that can affect other building elements with poor drainage of storm water. Poorly drained roof areas will also lead to damp conditions surrounding the base perimeter of the building which, if left unmanaged, can lead to a range of secondary building defects.

Repair and/or replacement of rusted roof plumbing is highly required in order to reinstate the roof drainage system to a fully operational level. To further maintain these areas, gutters should be cleaned frequently, allowing the avoidance of any partial blockages.

A licensed plumber or specialist roof restoration company should be appointed to undertake these works. It is advised that such works be completed as soon as possible to prevent any further damage and deterioration.

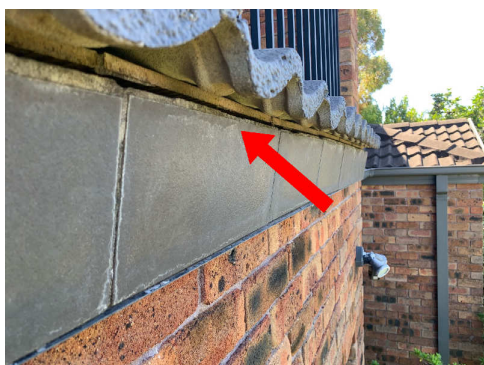
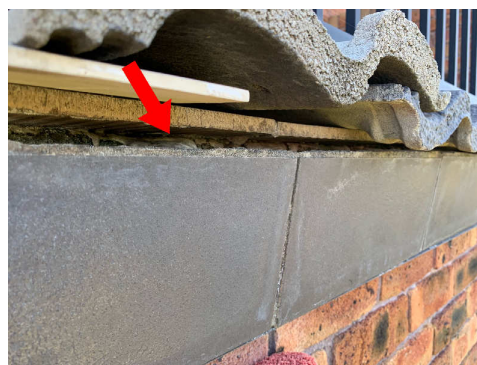
#### Finding 2.04

Building: Main Building  
 Location: Exterior walls - front  
 Finding: Balcony edge tiles - Drummy / loose (Note: Suspect this is the cause of water penetration through to the garage ceiling)

Information: Drummy tiled areas were identified at the time of inspection. The term 'drummy' refers to tiles that have become detached from their fixing, despite otherwise being in relatively good condition. Such defects are generally caused by physical or moisture damage to the area. Drummy tiled areas may also be a direct result of poor workmanship during the construction process.

Tiled areas may swell and shrink with changes in air humidity if the area has sustained moisture damage.

Any exposure to moisture is capable of causing tiled areas to become drummy and/or cracked over a prolonged period of time. Drummy tiled areas generally require removal and replacement of affected tiles, with adequate sealant and grouting.

Specialist trades are available for these types of services. A registered builder may be required to undertake works if damage is extensive or if secondary building defects have resulted.

Otherwise, it is advised that a tiling contractor be appointed to perform works as necessary. Immediate action is recommended to ensure that no further damage is sustained in the affected area.

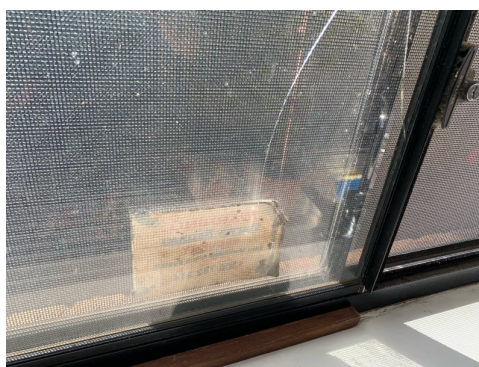
### Finding 3.01

Building:	Main Building
Location:	Kitchen
Finding:	Window - Cracked

Information: Cracks were identified in the window in this area. Cracking in windows is generally the result of impact damage, and is likely to develop further when left unmanaged.

The likelihood of this windowpane further cracking and shattering is increased exponentially, providing a safety hazard in the area. The cracked window also impairs the weather tightness of the building, creating potential for minor water leaks.

A qualified glazier is required to repair the window as soon as possible. Depending on the extent of the cracking, replacement of the window may be required. Please be advised that any persons coming into contact with the cracked window should do so with due caution to avoid any personal injury that may ensue.

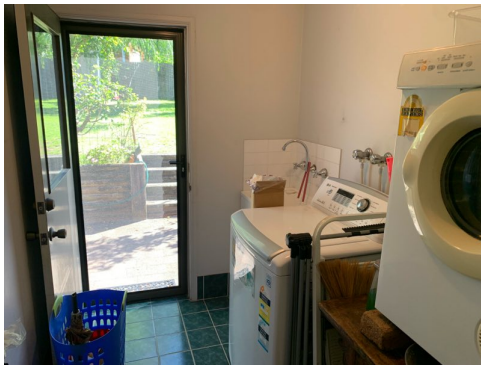
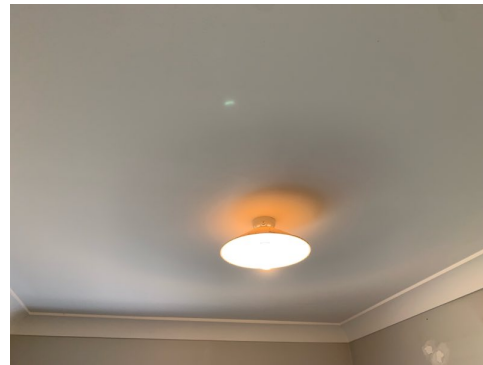
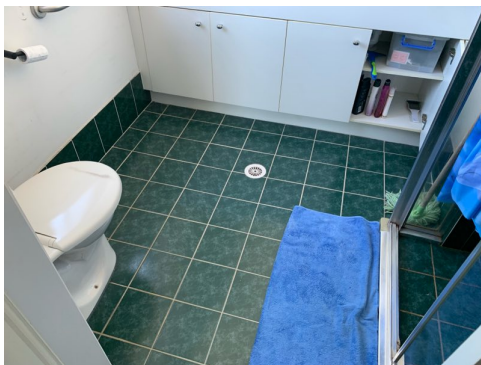
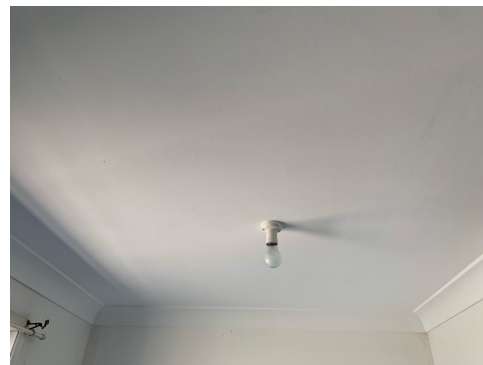
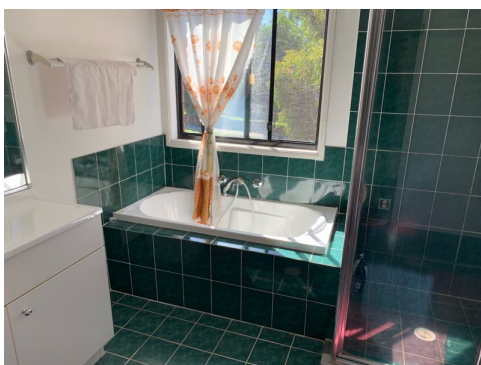
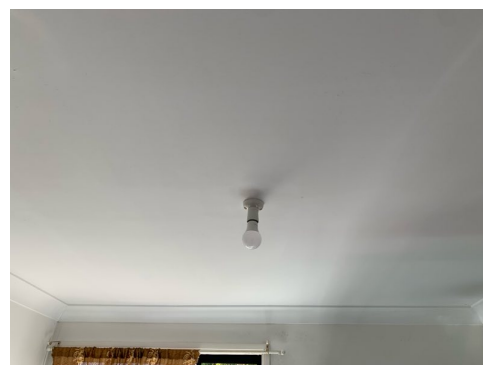
### Finding 3.02

Finding: Exhaust fan - Missing

Information: An exhaust fan has not been installed in this area. Missing exhaust fans may lead to the development of more significant defects such as moisture damage to surrounding building materials from inadequate ventilation.

Inadequate ventilation in internal areas creates an environment that is conducive to the formation and development of mould and other respiratory hazards.

It is advised that a licensed electrician be appointed to retrospectively install an exhaust fan.

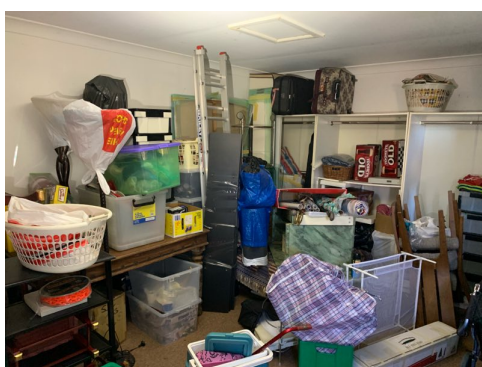
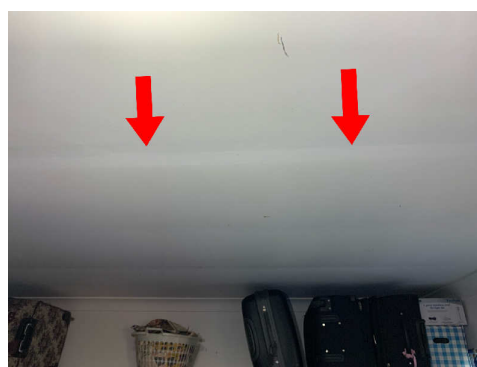
**Finding 3.03**

Information: Numerous popped nails were identified in the internal ceiling at the time of inspection. Nails and screws hold simply by the friction between them and the surface they are applied to. Over time, the nails and screws can back out, which is often a result of general ageing and deterioration of the building structure.

If left unmanaged, the ceiling sheets may become loose and unstable, increasing the rate of deterioration of the internal ceiling and creating potential for the development of secondary defects.

Re-fastening of popped nails will help to maintain the stability of the internal ceiling and associated building elements. Such minor works will also help to improve the appearance of the affected area and secure the ceiling sheets, so as to prevent the onset of ceiling sagging. These works should be performed by a qualified carpenter or plasterer at client discretion.

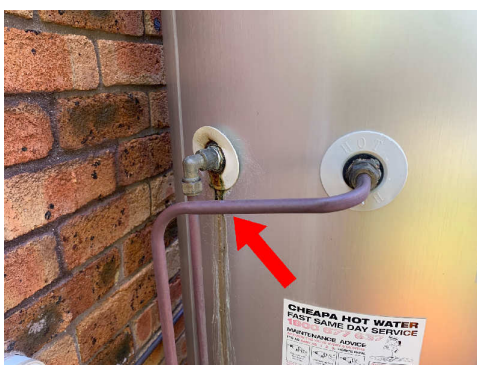
### Finding 3.05

Finding: Hot water unit - Leak

Information: The external hot water unit shows evidence of a minor leak and general deterioration. Such a leak is expected of a building element of this age and with this level of exposure to excessive moisture.

While the hot water unit is still fully operational, any leaks should be identified and rectified by a licensed plumber as soon as possible. Prevention of further deterioration will delay the need for replacement of the unit in the near future.

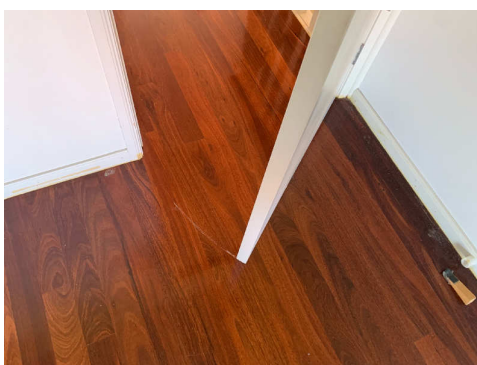
### Finding 3.06

Information: Binding and/or jamming of this door is evident during standard operation. This defect inhibits the functionality of the affected door as well as creating potential for secondary defects to associated building elements, such as damage to the floor covering.

A door that binds to flooring or to the associated door frame may have several causes, ranging from minor defects, such as poor installation of the door or deteriorated hinges, through to major structural issues, such as damage to subfloor structures.

For minor causes, a qualified carpenter or general handyperson should be appointed to perform minor rectification works at client discretion.

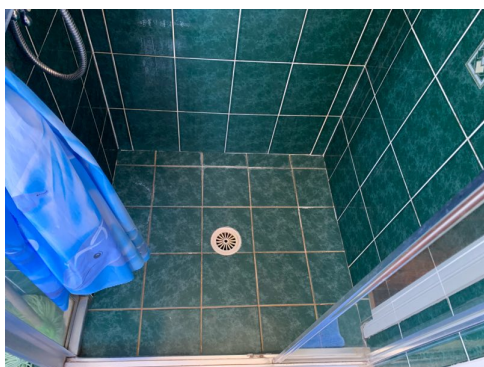
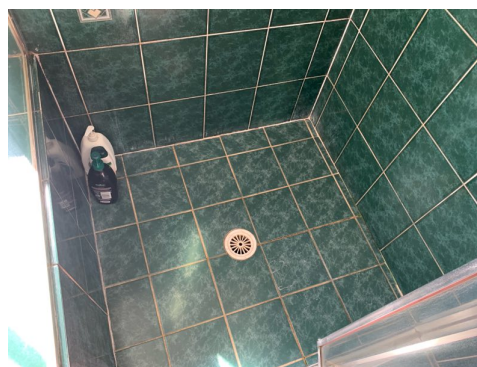
### Finding 3.07

Finding: Sealant and grouting - Missing or damaged

Information: It was noted on inspection that sealant or grout is degraded to the tiled shower alcove and or other areas of the bathroom.

Different materials and floor areas move at different rates, generally causing cracking to grout or sealant at this point.

There appears to be excessive mould to the sealant and grout which will likely require scraping out and replacement.

Flexible and mould resistant materials should be applied to affected areas to prevent any subsequent water damage that is likely to occur. Regular maintenance and replacement of damage or missing or damaged sealant and grout is highly recommended to the wet areas, as this is a regular wear and tear defect. Sealant and grouting in areas that come into regular contact with water should be maintained for the long term care of your property.

A sealant specialist or tiling contractor should be appointed to complete these works as soon as possible.

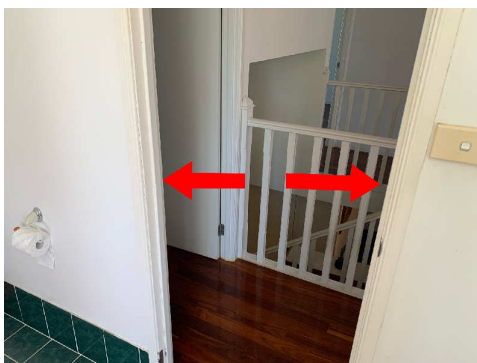
### Finding 3.08

Finding: Door - Missing

Replacement of any missing building element should be conducted as soon as possible to ensure that no damage or functional issues occur to associated building materials.

The appropriate tradesperson should be appointed as soon as possible to replace the missing building element.

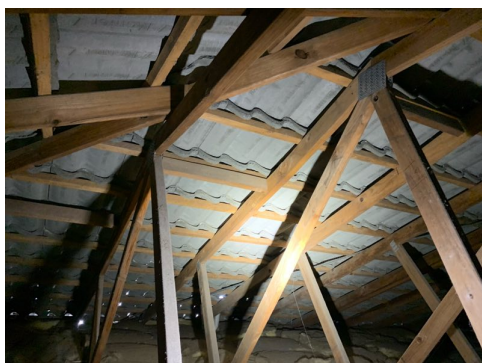
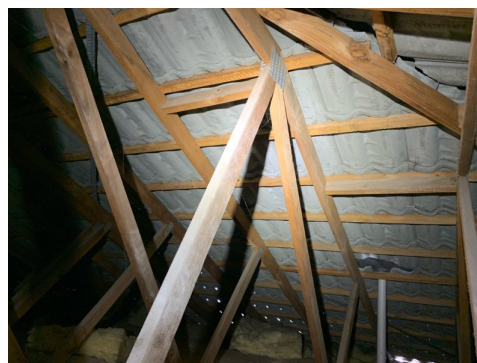
### Finding 3.09

Finding: Sarking - Missing

Information: Sarking is missing under the roof sheeting. Sarking acts as an insulator that helps with noise reduction and protects against water penetration. Sarking plays a key role in the operation and function of the overall roofing structure and its performance.

Although not a requirement at the time of construction, replacement of any missing building element is advisable (although this can be quite expensive to do after the time of construction).

Where sarking is missing, regular inspections of the roof tiles for cracking and potential moisture penetration is required.

Sarking may be retrospectively fitted by a registered builder at the discretion of the client.

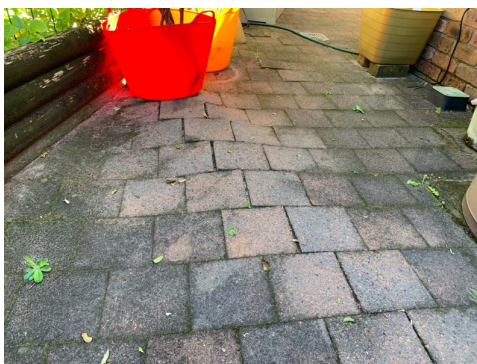
### Finding 3.10

Information: Sections of the external paved area are uneven, creating a potential trip hazard. It appears as though the area has been subject to rough installation, or that paving sections have lifted due to movements in the foundation of the property.

Where paving creates a trip hazard, personal injury may ensue if due caution is not taken by all persons within this area.

Re-paving of the area is required as soon as possible to remedy this situation. Further consultation with a specialist concreter is advised.

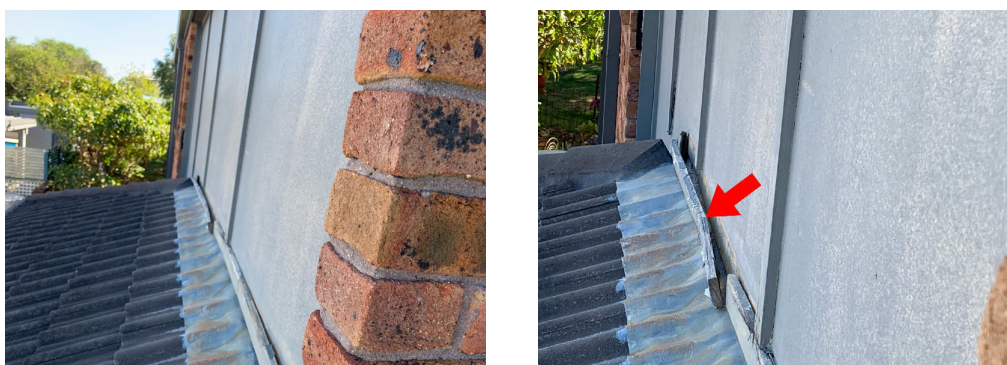
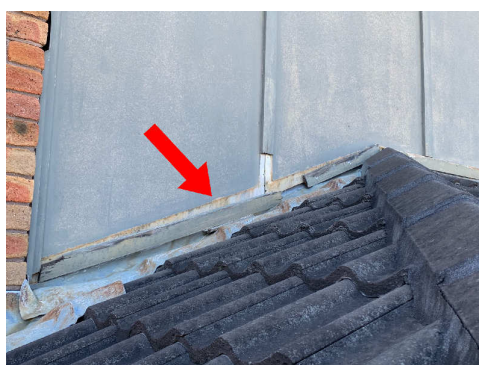
### Finding 3.11

Finding: Wall cladding trims - Loose

Information: Upon inspection of the exterior wall covering, it was noted that some wall trims have become loose from their original fixings. It is suspected that this defect has developed as a result of a lack of adequate maintenance, but may also have been caused by inappropriate fixings being used in the construction process.

Loose wall trims detracts from the weather tightness of the wall covering, making the wall lining susceptible to water penetration and subsequent damage.

If left unaddressed, it is likely that secondary damage to associated building elements will develop, potentially necessitating remedial works to these structures.

A building contractor should be appointed to advise on rectification options and on the cost of repair. It is advised that remedial works be performed as soon as possible to prevent any further damage.

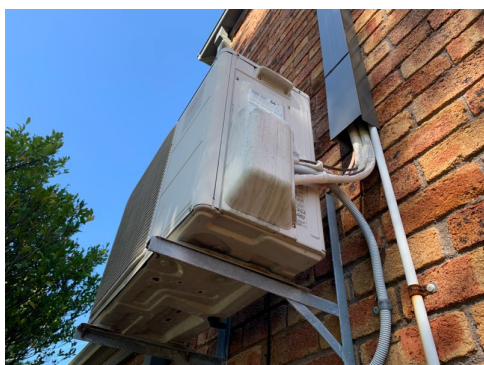
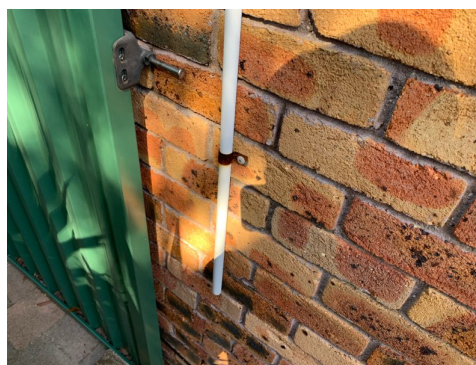
Such leaking creates an environment which is conducive to an array of defects, including water damage to associated building elements and the attraction of termite or timber pest infestation.

It is highly recommended that a licensed plumber be appointed to connect the A/C overflow in order to prevent such an environment from being created. These minor works should be carried out as soon as possible.

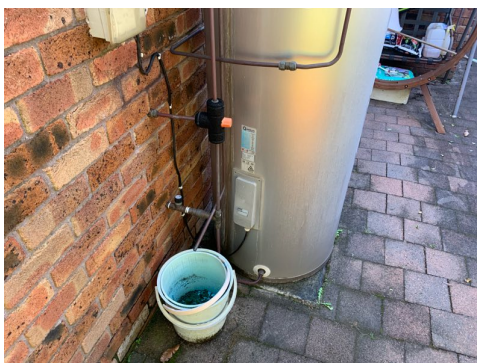
### Finding 6.02

Building:	Main Building
Location:	Exterior walls - left side
Finding:	HWS Overflow - Not Connected
Information:	The Hot Water System (HWS) overflow was found to be disconnected from storm water drainage and is creating excessive moisture in the surrounding area.

These damp conditions can lead to secondary defects such as rot, rust or corrosion of associated building elements, the formation of fungal decay, or even the creation of potential slip hazards. When coupled with poor site drainage, pooling of water may also attract termite activity to this area.

It is highly recommended that a licensed plumber be appointed to connect the HWS overflow in order to prevent such an environment from being created. These minor works should be carried out as soon as possible.

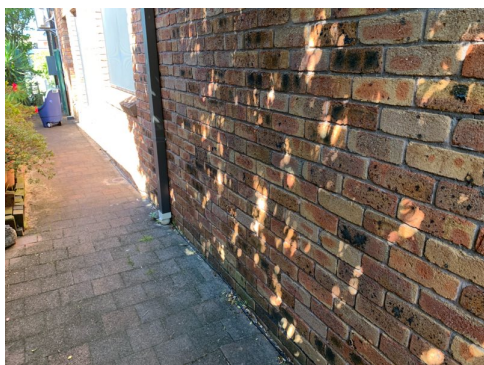
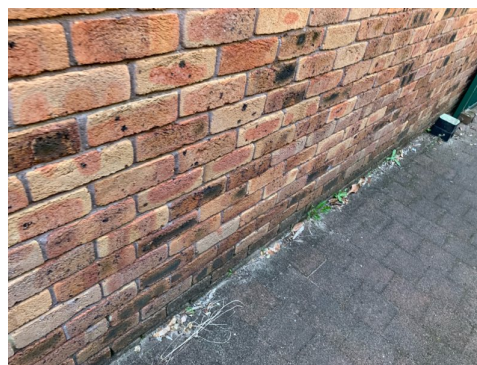
### Finding 6.03

If the slab edge is not properly exposed there is a high risk of termite attack. Sometimes, in order to determine the type of slab, a suitably qualified person such as an architect or builder may be required to consult the construction plans.

Where the slab edge cannot be properly inspected, it is highly recommended that termite or timber pest inspections be carried out every 6-12 months to aid protection of the property against infestation.

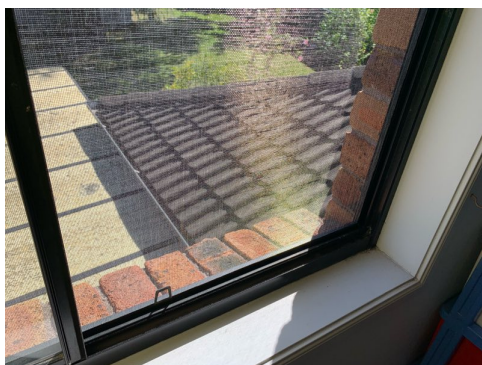
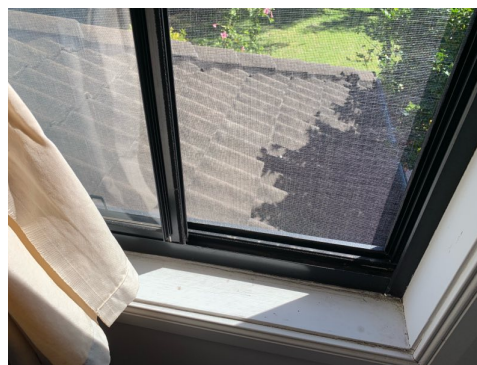
### Noted Item

Building:	Main Building
Location:	Bedrooms
Finding:	Window Child Safety Restraints missing
Information:	Although not the standard at the time of construction, the current National Construction Code (NCC) states that windows are required to have restraints as per the below:

A window contractor or general handyman engaged by strata experienced in the fitting of these restraints could be engaged to carry out and complete these works.
