Building and Timber Pest Inspection Report

Inspection Date: Wed, 7 Jan 2026

Property Address: 91A Prince Edward Ave, Culburra Beach
NSW 2540, Australia

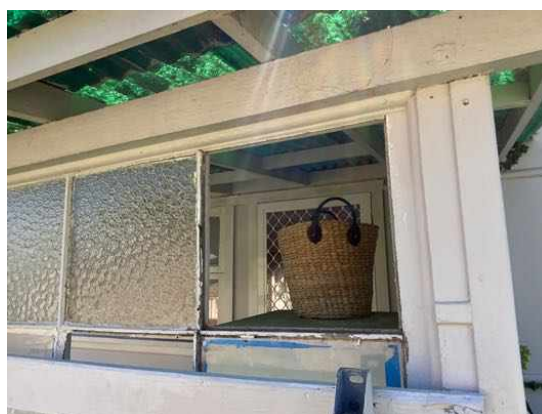
Building:	Main Building
Location:	Exterior walls - rear
Finding:	Building element - Damaged and missing (glass panes)
Information:	Breakage occurs generally when the building materials have either aged and decayed, or as a result of damage (accidental or deliberate).

Repair and/or replacement of broken elements is advised to ensure that additional secondary defects do not arise as a consequence. Such works are necessary, as all building elements play a key role in the operation and function of the overall structure and its performance.

A relevant tradesperson should be appointed to repair or replace the affected building element prior to any subsequent damage being caused.

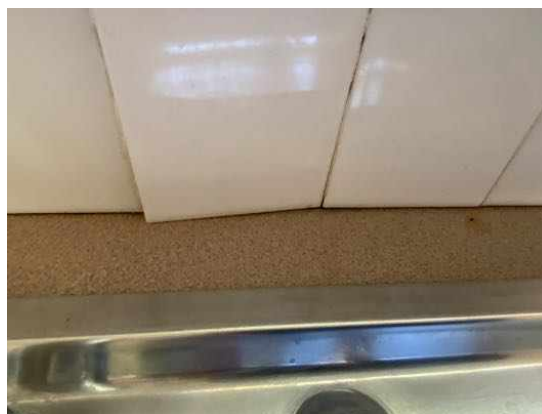
Building: Main Building
 Location: All Wet Areas
 Finding: Sealant or Grout - Deteriorated, Missing or substandard installation
 Information: Sealant appears to be inadequate to these tiled areas. The different materials and floor areas move at different rates therefore cracking the grout at this point. A flexible sealant is required to allow for this expansion & contraction while keeping the joint water tight and without holes for long term care of all building materials.

Apply a flexible sealant to match the grout that is best suited to the purpose as per product specifications. Regular maintenance &/or replacement of damage or missing sealant is highly recommended to the kitchen benches/splashbacks, vanity top to wall/splashback, laundry tub edge/splashback, wet areas floor edges and the shower floor & wall corners for the long term care of your property.

As a main priority remove damaged grout where applicable and thoroughly clean the area from old sealant, grout and soap scum. (Mouldy sealant is usually caused by dirt

Regular maintenance &/or replacement of damage or missing sealant is highly recommended for the long term care of your property.

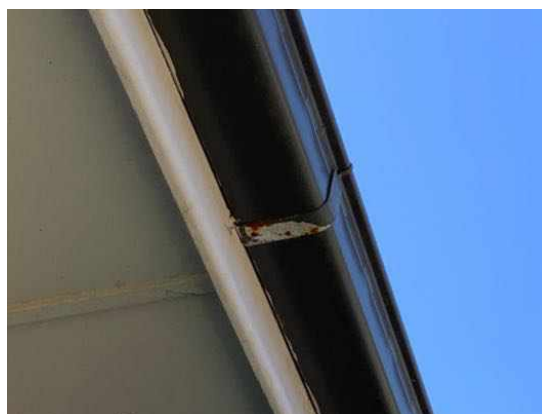
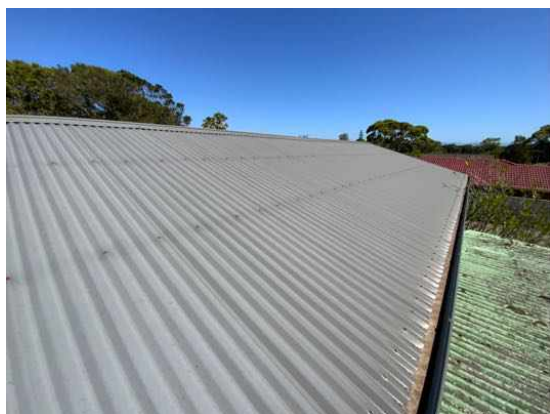
Building:	Main Building
Location:	Roof Exterior
Finding:	Building element - Rusted or corroded (gutter brackets and roofing screws to some areas)
Information:	This building element shows evidence of rusting and corrosion, which is likely to have developed as a result of excessive exposure to moisture and or inadequate coatings.

As surface rust provides no protection to the underlying iron, the deteriorating condition is likely to worsen if not addressed in the short-term future.

Where possible, the use of galvanized (treated) metals or aluminium coated metals aid in rust prevention, as does regular general maintenance. Rust formation can be controlled with coatings, such as paint, that isolate the iron from the environment.

Rusting and corrosion should be managed by ideally removing or limiting the affected surface from exposure to moisture. A registered builder may be appointed to replace any building elements that have been severely affected by rust or water damage.

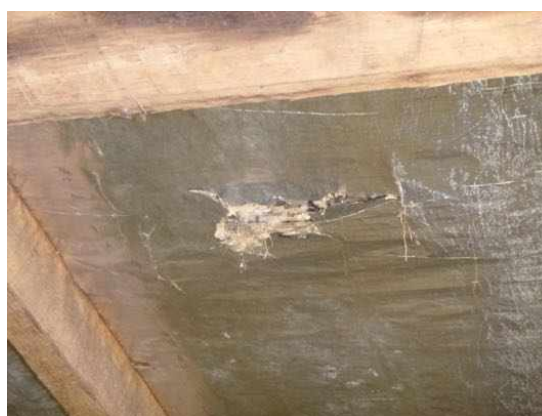
Finding 3.04

Building:	Main Building
Location:	Roof Void
Finding:	Sarking - Damaged
Information:	Sarking, a laminated aluminium foil applied to the interior of the roof covering, assists in insulating the property and acting as a vapour-barrier to the roof void and, subsequently, to the household.

Where sarking is damaged, both insulation and moisture protection of the property are inhibited. This creates a loss of energy and thus negatively impacts the energy efficiency of the property, allowing potential for moisture ingress from condensation or leaking roof tiles.

It is important to repair any holes or damaged sections of sarking to ensure that the building material is fully functional. A registered builder or qualified carpenter should be consulted to provide further advice on this defect and to perform rectification works at client discretion.

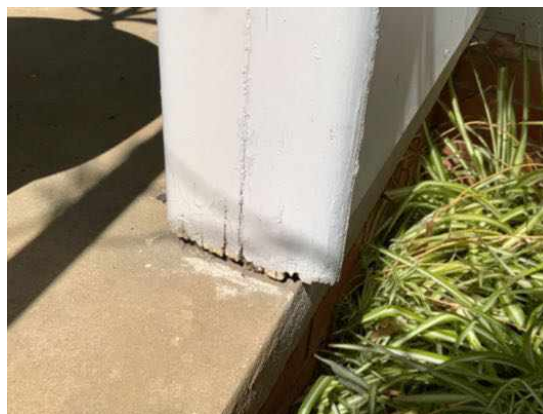
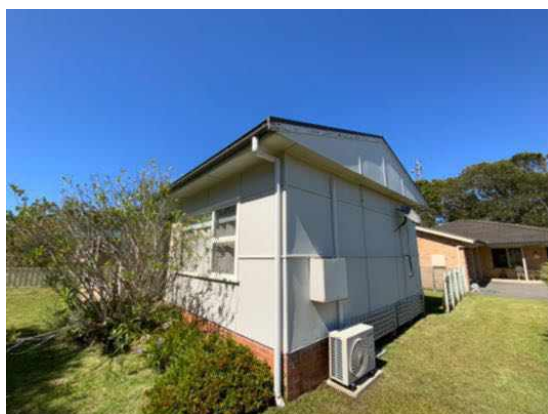
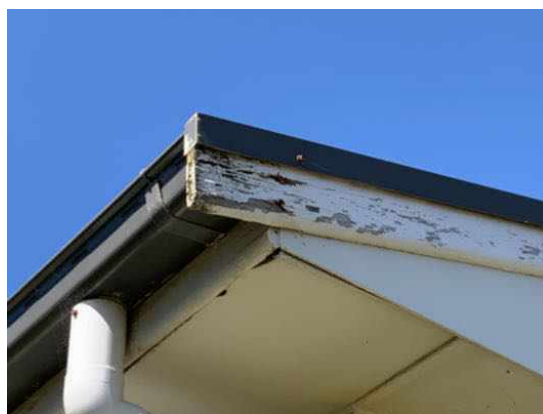
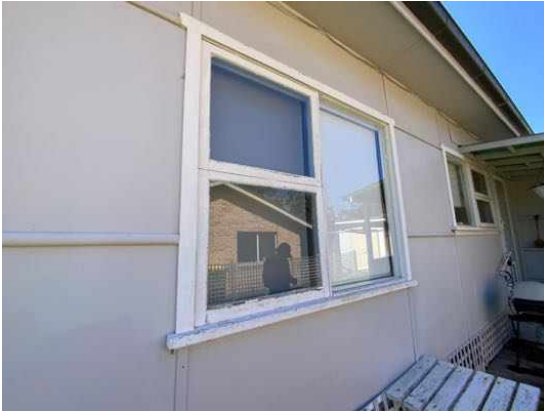
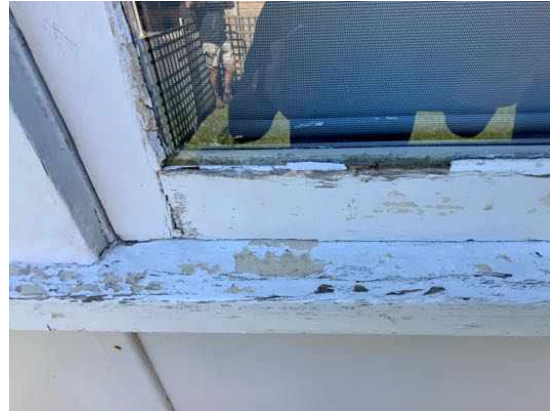
Finding 3.05

Building:	Main Building
Location:	All Areas

Finding: External paint to timbers - deteriorated
Information: Much of the external paintwork including but not limited to external timbers and trims have been neglected and require attention to prepare and re-paint.

Whilst incomplete or missing paint finish is generally an appearance defect, it can also lead to the development of secondary building defects over time. Incomplete areas of paint finish expose the area to moisture, potentially accelerating the deterioration of underlying building materials.

Degraded paint finishes should be sanded back, filled, leveled and painted, as applicable. Where inadequate or missing paint protection has led to the deterioration of the associated building element, repair and/or replacement of this building element may be required.

A painting contractor should be appointed as soon as possible to perform necessary works to aid the appearance of the affected area and to ensure the area is protected against further deterioration. Alternatively, the homeowner following manufacturer instructions may perform these works.

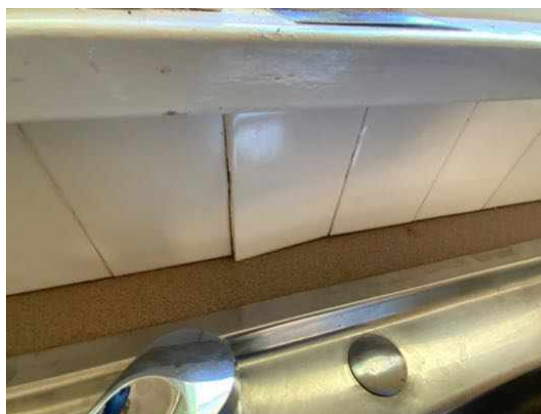
Building: Main Building
 Location: Kitchen
 Finding: Exhaust fan or Rangehood - Missing (above stove) - window & door may not always be opened while cooking
 Information: An exhaust fan or rangehood has not been installed in this area. Missing exhaust fans may lead to the development of more significant defects such as moisture damage to surrounding building materials from inadequate ventilation.

Where water penetration has led to water damage, appointment of a relevant tradesperson may be required to repair damaged building elements.

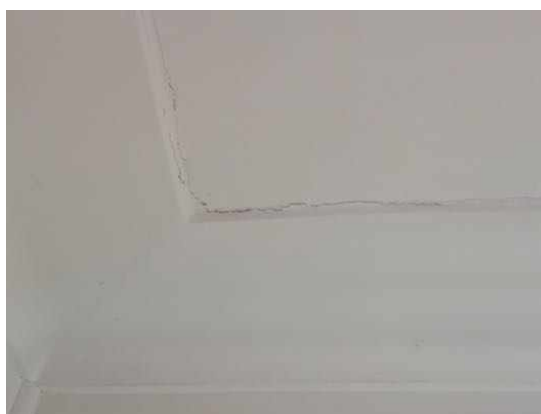
Finding 3.17

Building:	Main Building
Location:	All Areas
Finding:	Cracking - Damage Category 1 - Fine (up to 1mm)
Information:	Although fine cracks are quite noticeable, they are often only considered to be an appearance defect, and usually do not indicate any structural damage. Generally, the cause of a fine crack is indicative of a separation between building materials and finishes (e.g. paint, plaster, etc.) along joints.

Cracking of this nature can generally be repaired with minor sanding, filling and/or repainting. Such works should be performed by a qualified painter or a general handyman.

Monitoring of all cracking should be conducted frequently. Always contact a building inspector should cracks widen, lengthen, or become more numerous.

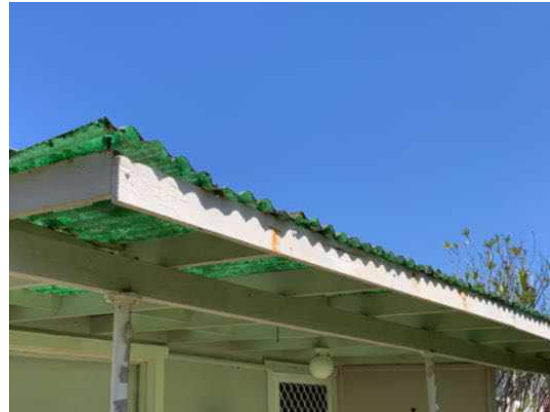
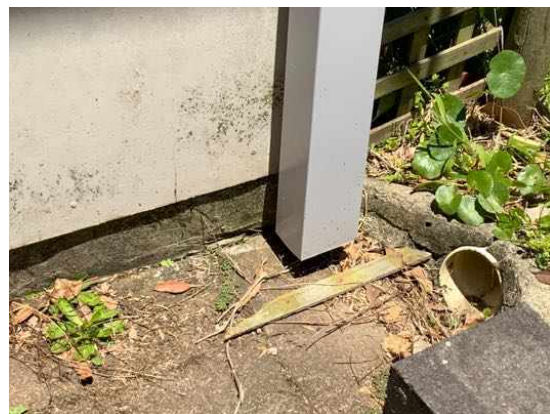
Finding 6.05

Building:	Main Building
Location:	All Areas
Finding:	Evidence of excessive moisture was present at the time of inspection (Guttering missing & Holes in down pipe)

It is highly recommended that all plumbing and drainage fixtures and fittings be maintained regularly in order to prevent excessive moisture being present in the external / internal property.

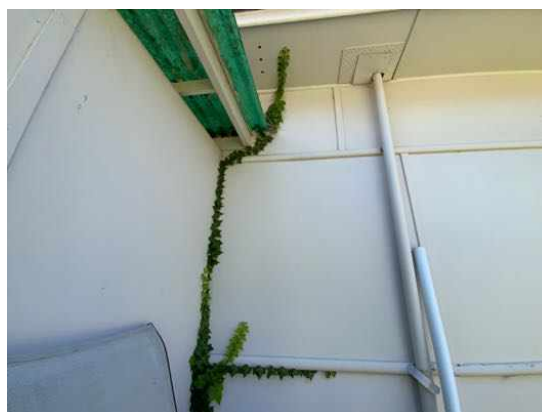
Finding 6.06

Building: Main Building
 Location: Exterior walls
 Finding: Bridging - Vegetation
 Information: Where vegetation obstructs inspection of building elements, also known as bridging as it provides a bridging point for the access of termites, full inspection can not be achieved. Consequently moisture or dampness may be present and the areas becomes conducive to termite activity. Plants against or very close to buildings provide cover, shade and can provide an environment that is attractive to termite infestation.

The removal of any such materials that may be conducive to termite activity should be carried out as soon as possible and arrange re inspection to minimize the risk of termite attack.

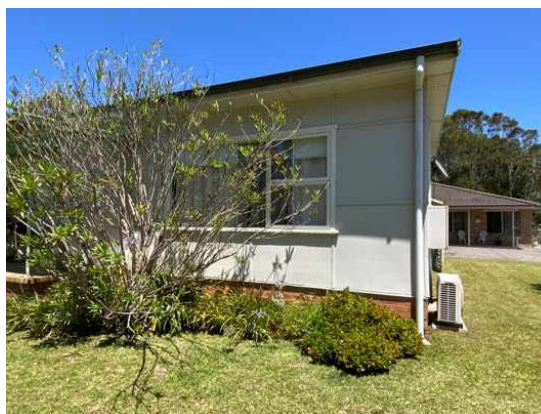
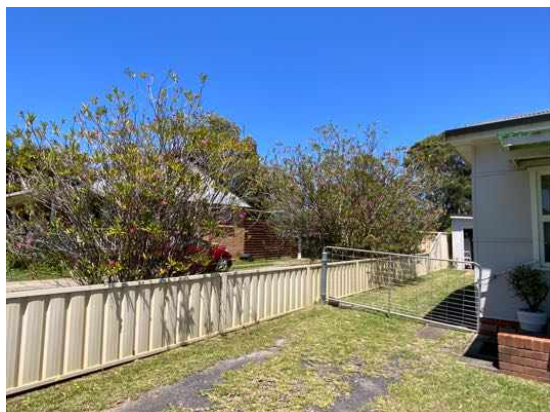
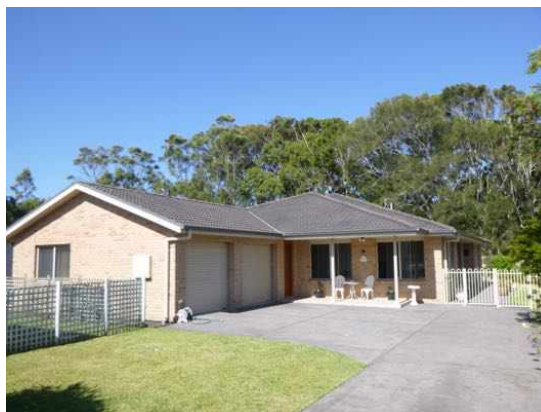
Finding 6.07

Building: Main Building
 Location: All Areas
 Finding: Trees within 50m of the property
 Information: Trees within 50m of the property can be conducive to termite activity. It is recommended an invasive inspection of all trees with 50m to the property be carried out by a qualified pest control expert.

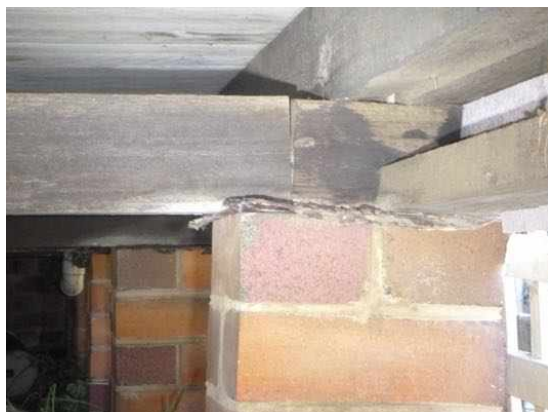
Finding 6.08

Building:	Main Building
Location:	Subfloor
Finding:	Ant capping - Missing or damaged (Rusted)
Information:	Ant capping appears to be damaged to several areas of the subfloor structure at the time of inspection. Generally, ant caps are installed to the intersection between the top of the stumps (or piers) and the subfloor structures (timbers). Installed during the construction process, ant caps are designed to easily identify termite or pest ingress from piers to the adjoining flooring timbers.

A termite management system is still highly recommended to be installed as well as ant capping. Consult a suitably qualified termite expert and pest controller for further advice and information.

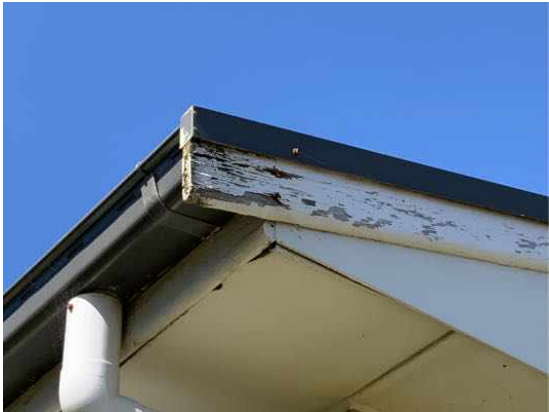
Finding 7.01

In this case although the affected timber element is in a decaying state the extent of any visible damage appears to be localised to a specific area and is yet to spread to other parts of the building element or affect adjoining structures. The fungal decay is therefore likely to be of a relatively superficial nature with minimal impact on the structural integrity or tensile strength of the timber element.

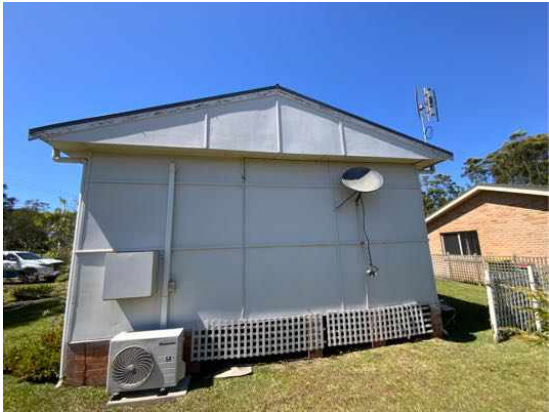
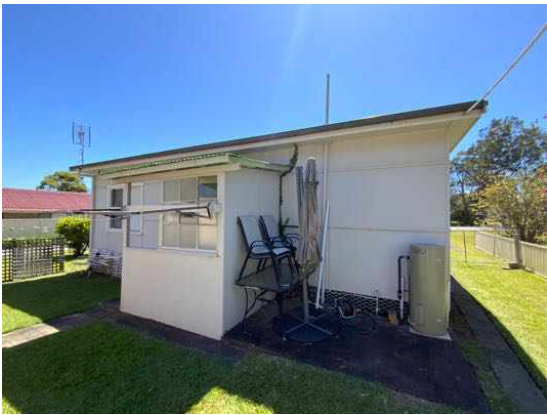
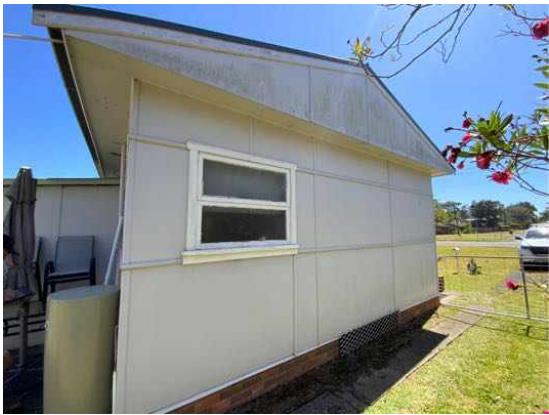
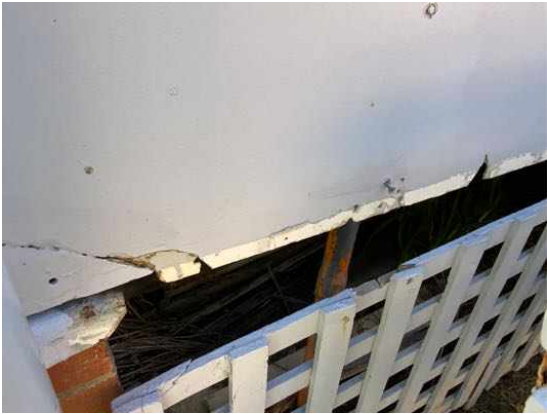
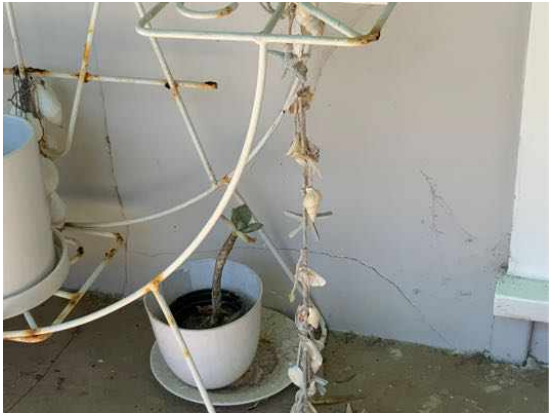
Building: Main Building
 Location: All Areas
 Finding: Asbestos - Suspected ACM Identified on Site
 Information: Reporting on Asbestos is outside the Scope of this Report. This suspected defect is highlighted as a caution only. We suspect, based on our experience in the building industry, that there is a higher risk of the identified building element containing asbestos.

In the interim, the client is advised to act with caution, especially when considering any damage to building materials general wear and tear renovations extensions demolition and general maintenance activities due to the suspected presence of Asbestos.
