# Building and Timber Pest Inspection Report

Inspection Date: Wed, 25 Feb 2026

Property Address: 21 Fallows Way, Cherrybrook NSW 2126,  
Australia

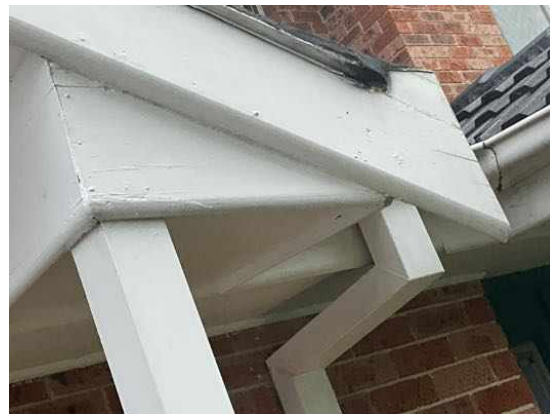
Information: External timbers that are frequently exposed to harsh weather conditions require adequate protection in order to maintain their condition. Where timbers have not been painted or treated adequately, general deterioration is likely to occur at an accelerated rate.

If left unattended, replacement of these timbers is likely to be necessary in the short-term future. Adequate treatment of these timbers is required as soon as possible by a painting contractor or general handyman.

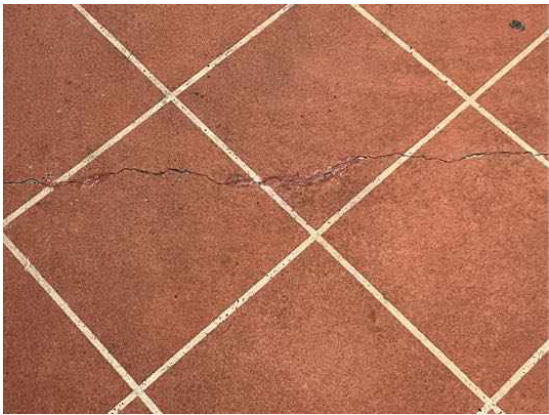
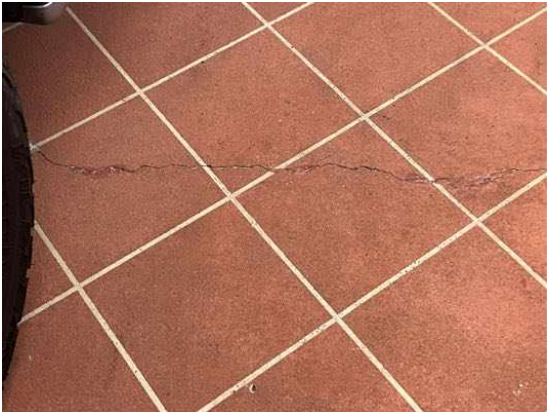
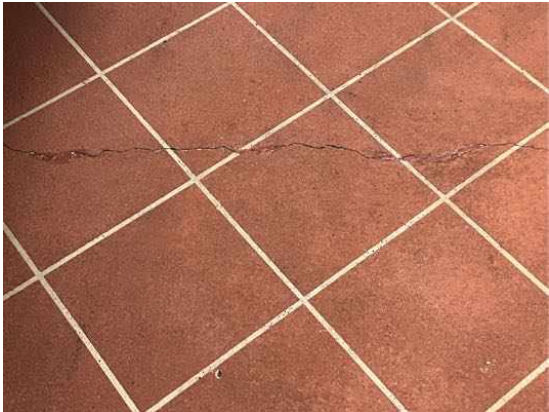
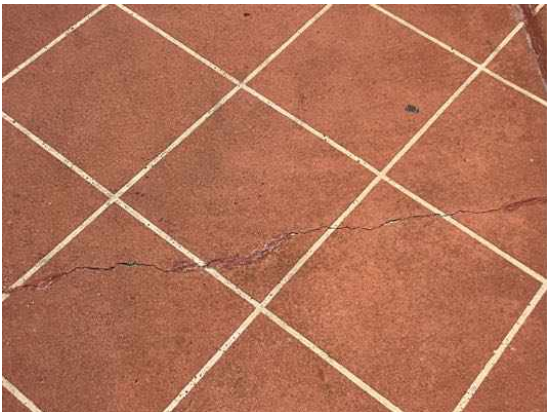
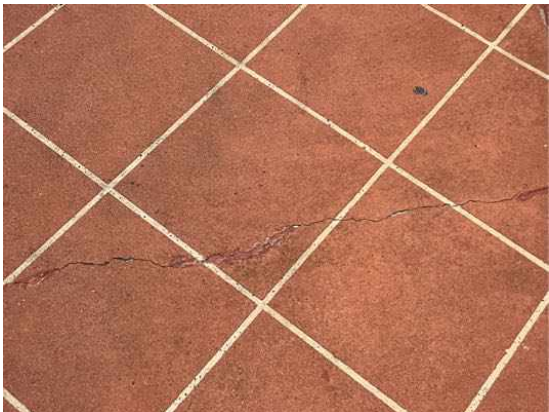
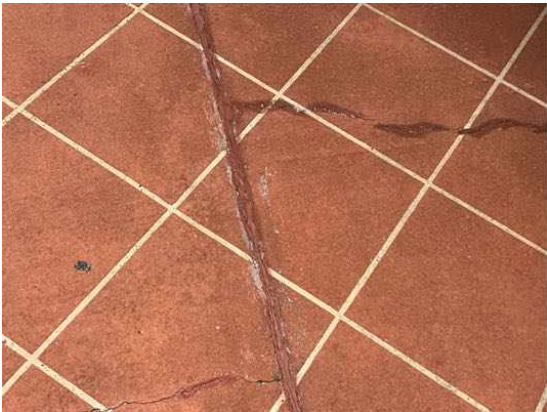
### Finding 3.03

Finding: Crack in concrete slab - Category 0

Information: A crack coded as Category 0 was identified in the slab. A Category 0 crack is described as a hairline crack, representing insignificant movement of slab from level.

The approximate width of the crack to be considered Category 0 is 0.3mm, or change in offset of less than 8mm when a 3m straight edge is placed over the defect.

No rectification is required at this time. However, all cracking should be monitored over a 12 month period to identify any further damage in the area.

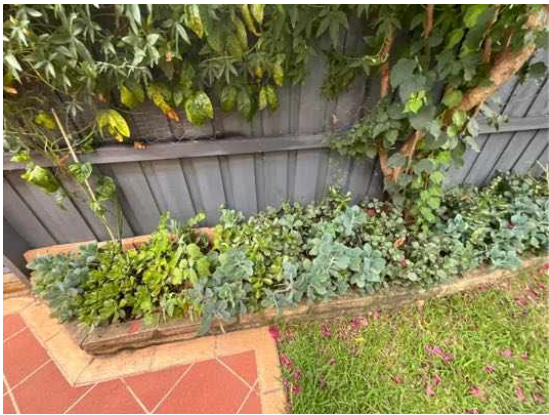
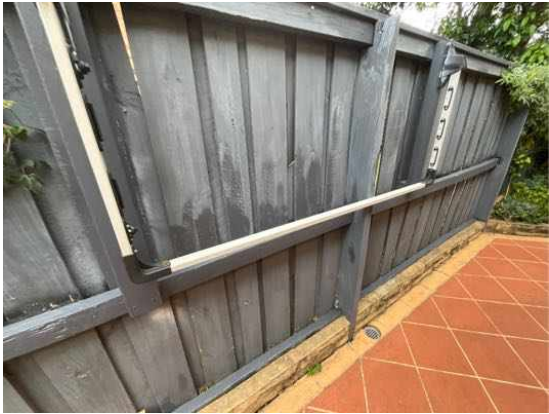
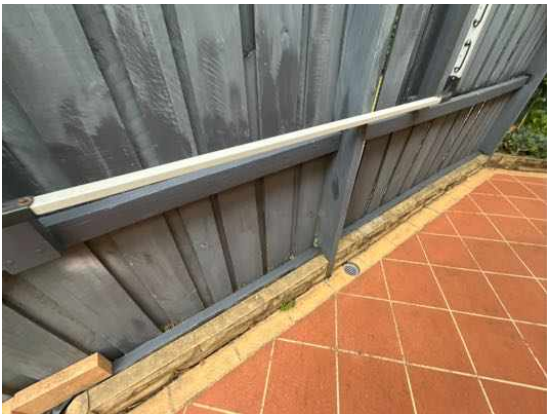
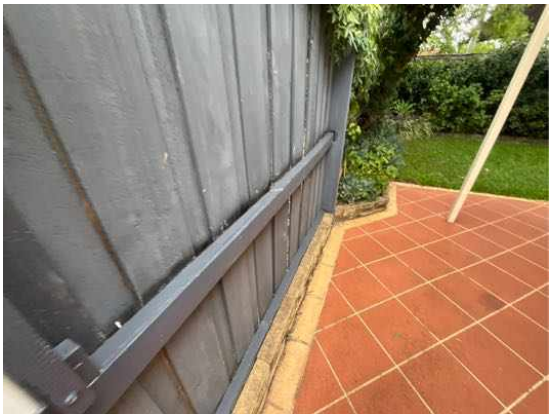
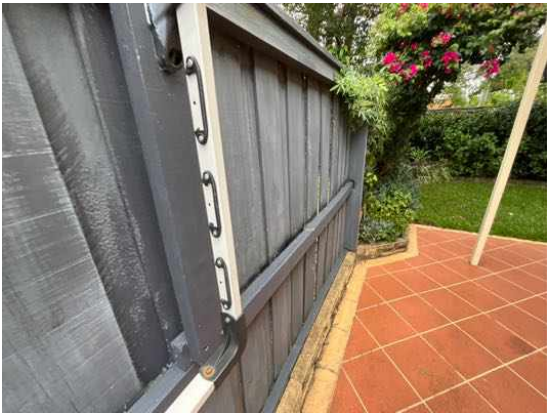
Finding 3.04

Building:	Main Building
Location:	All Areas
Finding:	Deteriorated fence
Information:	The fence along the property boundary has deteriorated significantly, showing signs of rot, rust, and structural weakness. Several sections are leaning or have become detached, compromising the integrity of the fence and its ability to perform its intended function.

The deteriorated fence poses multiple risks:

1. **Safety Hazard:** The unstable fence may collapse, posing a risk of injury to residents, visitors, and passersby.
2. **Security Concern:** The compromised fence may allow unauthorized access to the property, increasing the risk of theft, vandalism, or trespassing.
3. **Property Damage:** Falling sections of the fence could damage nearby structures, plants, or other property features.

- **Licensed Fencing Contractor:** A professional fencing contractor should be hired to assess the extent of the damage and either repair or replace the deteriorated sections.
- **Handyman Services:** For minor repairs, a qualified handyman could be engaged to reinforce or repair specific sections of the fence.
- **Landscaper (if the fence is part of a larger garden feature):** If the fence is integrated into the landscape design, a landscaper with experience in fencing could be involved in the repair or replacement process.

It's important to ensure that whoever is hired is experienced and qualified to ensure the fence is restored to a safe and functional condition, compliant with local regulations.

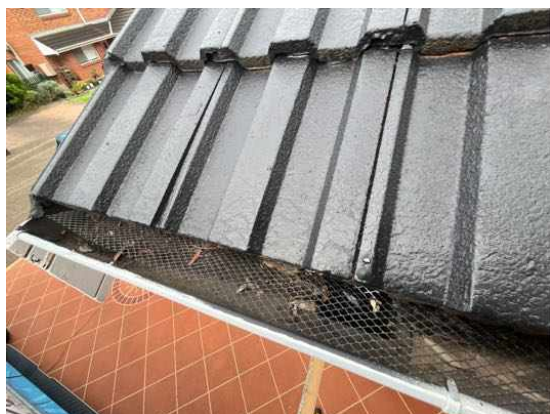
Building: Main Building  
 Location: All Areas  
 Finding: Blocked gutters - organic debris  
 Information: The roof gutter system was observed to be blocked with organic debris and moss growth, as evident in the provided images.

- Water ingress into the eaves or walls,
- Timber rot or deterioration of fascia and soffits,
- Accelerated moss and algae growth, promoting further blockages,
- Potential foundation issues if water pools near the base of the structure.

A licensed roofing contractor or qualified gutter cleaning service should be engaged to remove the debris and inspect the system for any further issues.

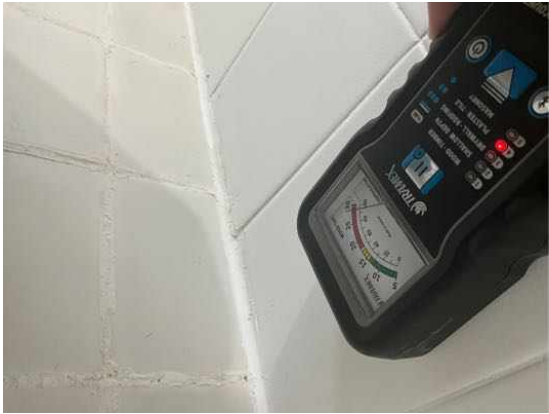
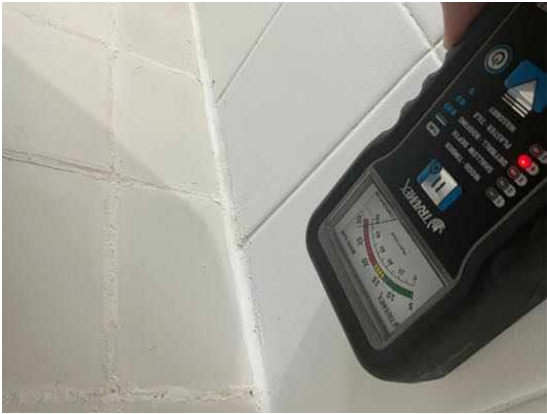
### Finding 3.07

Building:	Main Building
Location:	Bathroom
Finding:	Shower - Damp
Information:	Damp is evident to the lower 300mm of wall to the shower alcove. This defect is quite common, and is suspected to have been caused by moisture permeating through the grouting in this area, which shows evidence of deterioration. Leaking pipes within the adjoining wall is also a possible cause.

Damp (or structural damp) refers to the presence of unwanted moisture in the structure of a building, either as the result of intrusion from outside, or condensation from within the structure. In the shower area, internal water leaks or other sources of excessive moisture are generally the cause of damp.

Unmanaged damp in the shower recess is likely to facilitate the formation and development of mould and fungi growth, decaying associated building materials and compromising their structural integrity. It is important to address damp conditions, as the World Health Organisation notes that excess moisture leads - on almost all indoor materials - to growth of microbes such as moulds, fungi and bacteria, which subsequently emit spores and other matter into the indoor air. Exposure to these contaminants is associated with a wide range of respiratory and other health-related problems.

Consultation with a qualified plumber or bathroom specialist is advised immediately to identify the cause of damp and to perform remedial works as required. Where excessive mould growth is present, further inspection by a specialist environmental health inspector should also be considered.

Always ensure that sealant and grout is in good condition to prevent any moisture issues occurring in the future.

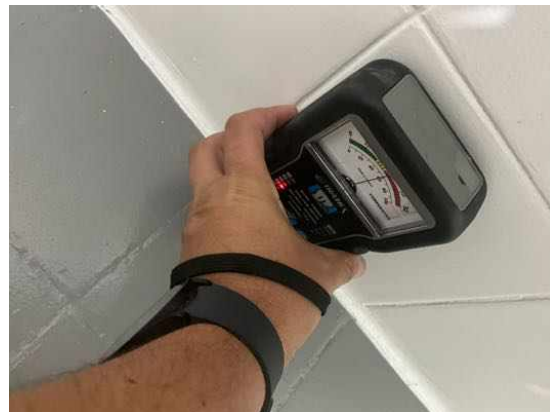
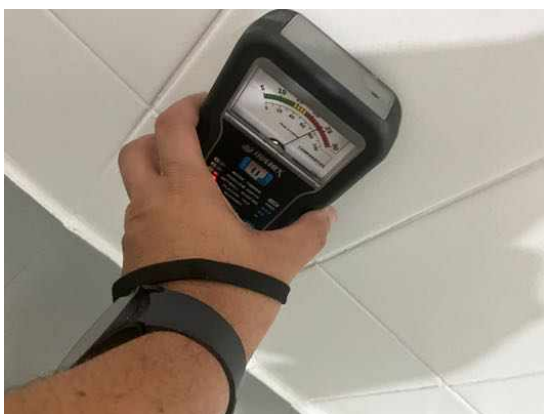
**Finding 3.08**

Building: Main Building  
Location: Ensuite  
Finding: Shower - Damp

Information: Damp is evident to the lower 300mm of wall to the shower alcove. This defect is quite common, and is suspected to have been caused by moisture permeating through the grouting in this area, which shows evidence of deterioration. Leaking pipes within the adjoining wall is also a possible cause.

Unmanaged damp in the shower recess is likely to facilitate the formation and development of mould and fungi growth, decaying associated building materials and compromising their structural integrity. It is important to address damp conditions, as the World Health Organisation notes that excess moisture leads - on almost all indoor materials - to growth of microbes such as moulds, fungi and bacteria, which subsequently emit spores and other matter into the indoor air. Exposure to these contaminants is associated with a wide range of respiratory and other health-related problems.

Consultation with a qualified plumber or bathroom specialist is advised immediately to identify the cause of damp and to perform remedial works as required. Where excessive mould growth is present, further inspection by a specialist environmental health inspector should also be considered.

Always ensure that sealant and grout is in good condition to prevent any moisture issues occurring in the future.

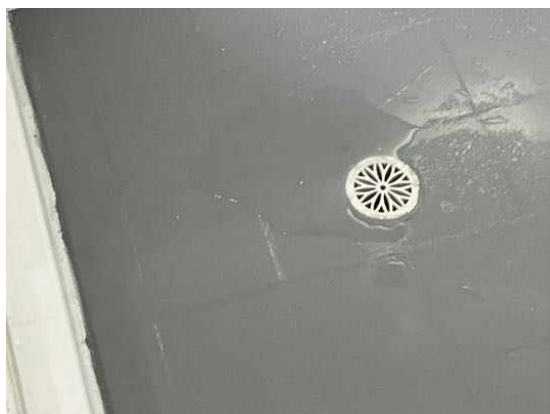
### Finding 3.09

Building:	Main Building
Location:	Ensuite
Finding:	Shower base - Water pooling
Information:	Evidence of water pooling around the floor waste in the shower recess was noticed at the time of inspection. It is suspected that this excessive moisture is attributed to insufficient fall in the shower floor tiles.

This pooling is minor overall but is still considered unsatisfactory, as standard tiling practices would not permit this situation to occur. Pooling water around floor wastes can create a slip hazard in extreme cases and create conditions that are conducive to mould growth over time. Where left unmanaged, the degradation of sealant and grouting is also likely to occur, possibly necessitating further repair works.

Remedial works may involve some sections of tiling and flooring repair and replacement. A tiling contractor or bathroom specialist should be appointed to provide further advice on reparation options and to perform works as necessary.

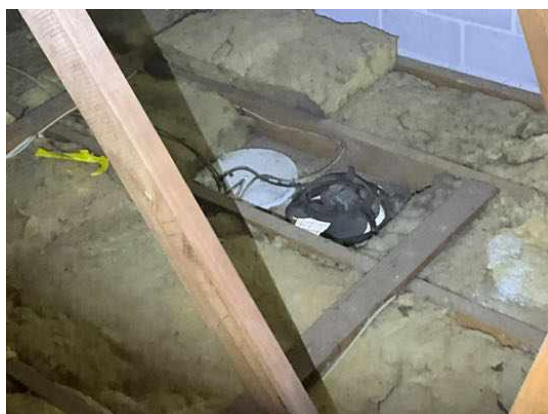
### Finding 3.10

Building:	Main Building
Location:	Roof Void
Finding:	Exhaust fan not vented out
Information:	The exhaust fan located within the roof void is not appropriately ducted to the external atmosphere and is currently discharging moist air directly into the roof space. This is considered a defect under AS 4349.1, as it does not meet the minimum standard of residential building performance expected under normal residential building practices.

This condition may lead to excessive condensation within the roof void, increasing the risk of mould growth, deterioration of insulation, timber decay, and overall reduced durability of building elements. It may also result in poor indoor air quality, potentially affecting occupant health.

It is recommended that the exhaust fan be modified by a licensed HVAC contractor or qualified builder, ensuring it is properly ducted to discharge externally in accordance with manufacturer specifications, the National Construction Code (NCC), and applicable Australian Standards.

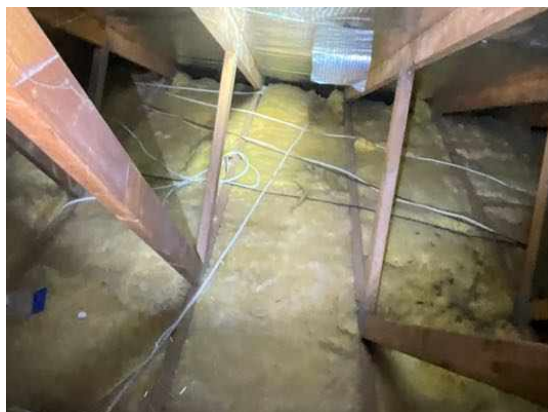
### Finding 3.11

Building:	Main Building
Location:	Roof Void
Finding:	Sarking - Damaged
Information:	Sarking, a laminated aluminium foil applied to the interior of the roof covering, assists in insulating the property and acting as a vapour-barrier to the roof void and, subsequently, to the household.

Where sarking is damaged, both insulation and moisture protection of the property are inhibited. This creates a loss of energy and thus negatively impacts the energy efficiency of the property, allowing potential for moisture ingress from condensation or leaking roof tiles.

It is important to repair any holes or damaged sections of sarking to ensure that the building material is fully functional. A registered builder or qualified carpenter should be consulted to provide further advice on this defect and to perform rectification works at client discretion.

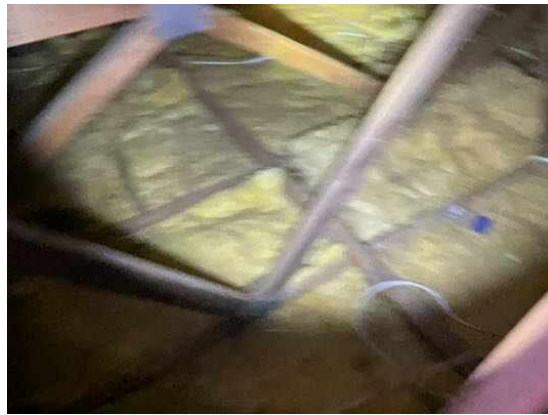
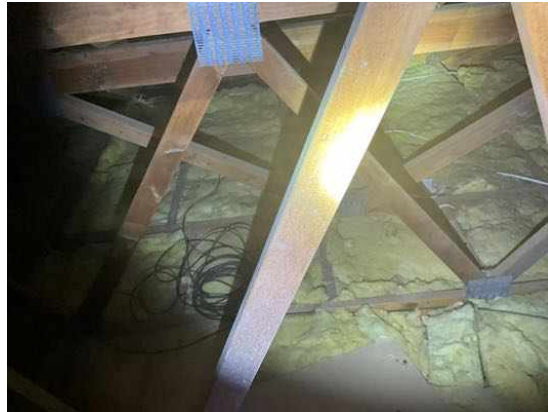
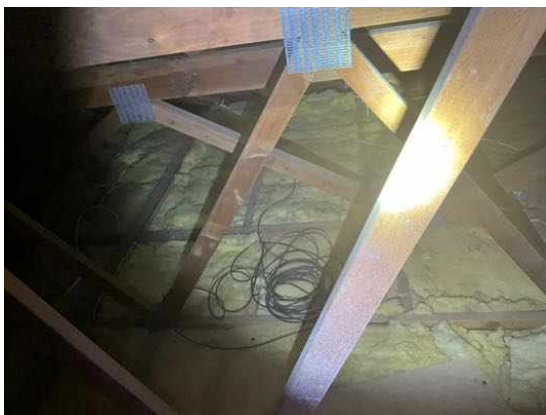
### Finding 3.12

Building:	Main Building
Location:	Roof Void
Finding:	Insulation - Covering downlights
Information:	Sections of insulation in the roof void have been poorly installed or moved from their original position and are covering down light fittings. While the down lights have been fitted with appropriate protective covers, the presence of this insulation creates a potential fire hazard.

Any insulation within the vicinity of down light fixtures should be moved and re-applied to more appropriate sections of the roof void, thus ensuring the area is fire-safe. An insulation contractor should be appointed as soon as possible to perform any necessary works as required.

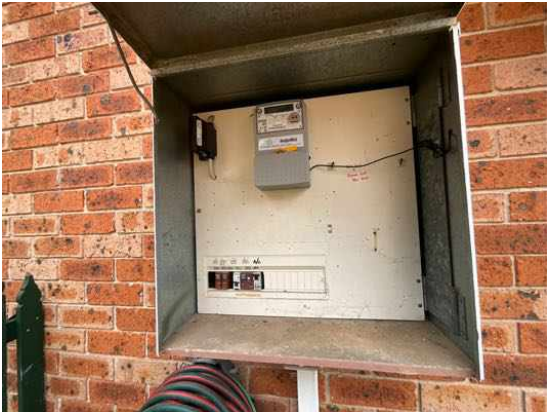
Building: Main Building  
Location: Exterior walls - left side  
Finding: No Evidence of Termite Management System - Durable notice / Legible Sticker  
Information: The application of a pre & post-construction chemical termite barrier is highly recommended for all properties. Such barriers are highly effective in preventing termite attack on any timber building elements throughout the property.

A durable notice was not placed in the switchboard unit to indicate current termite barriers is legible at the time of inspection.

Client must seek further information from the vendor or real estate agent if the conditions of termite management systems were maintained.

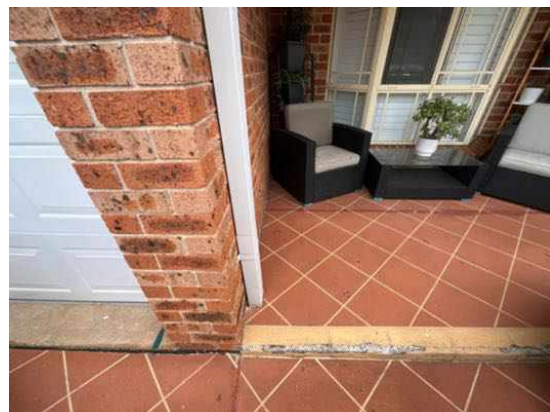
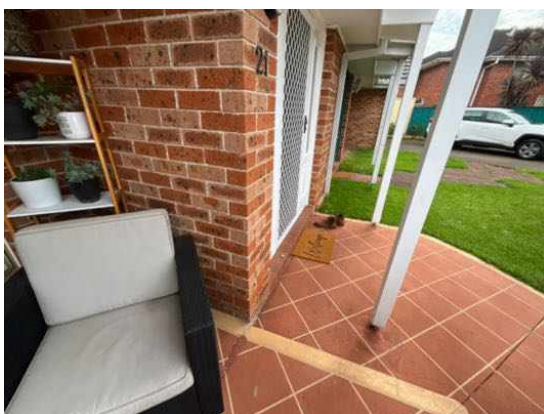
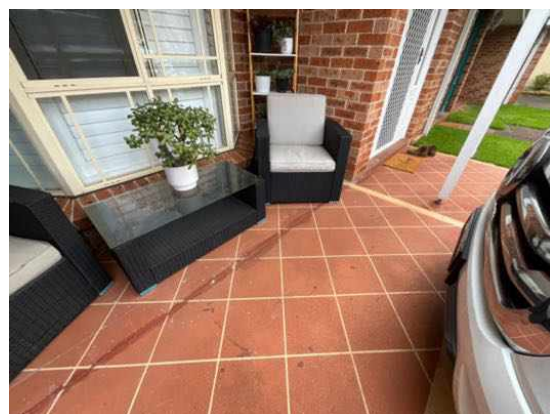
## Finding 6.02

If the slab edge is not properly exposed there is a high risk of termite attack. Sometimes, in order to determine the type of slab, a suitably qualified person such as an architect or builder may be required to consult the construction plans.

Where the slab edge cannot be properly inspected, it is highly recommended that termite or timber pest inspections be carried out every 6-12 months to aid protection of the property against infestation.

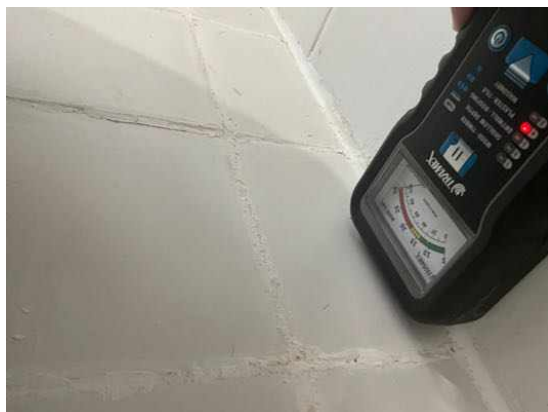
### Finding 6.07

Building:	Main Building
Location:	Bathroom
Finding:	Excessive moisture - Conducive to Timber pest
Information:	Excessive moisture can attract termites and produce conditions that promote fungal growth and wood decay.

Excessive moisture is generally caused by deteriorated inadequate or missing roof drainage leaking plumbing pipes or fixtures poorly plumbed HWS overflows or condenser units and poor site drainage.

Prior to any remedial works being performed a qualified plumber should be appointed to further inspect the property and to identify the cause of the excessive moisture. Works to remove affected building elements may then be necessary and should be performed by an appropriate tradesperson.

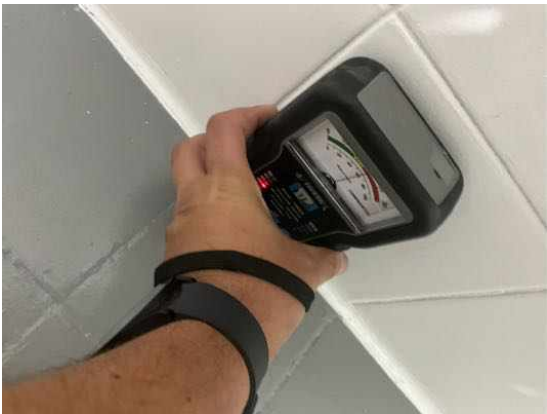
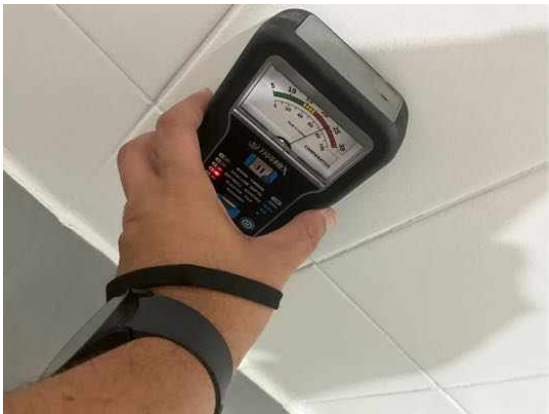
### Finding 6.08

Building:	Main Building
Location:	Ensuite
Finding:	Excessive moisture - Conducive to Timber pest
Information:	Excessive moisture can attract termites and produce conditions that promote fungal growth and wood decay.

Excessive moisture is generally caused by deteriorated inadequate or missing roof drainage leaking plumbing pipes or fixtures poorly plumbed HWS overflows or condenser units and poor site drainage.

Prior to any remedial works being performed a qualified plumber should be appointed to further inspect the property and to identify the cause of the excessive moisture. Works to remove affected building elements may then be necessary and should be performed by an appropriate tradesperson.

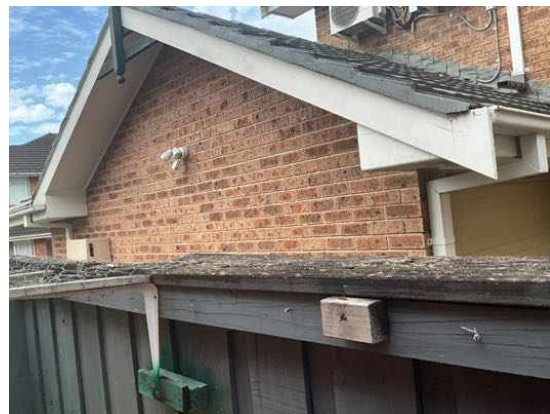
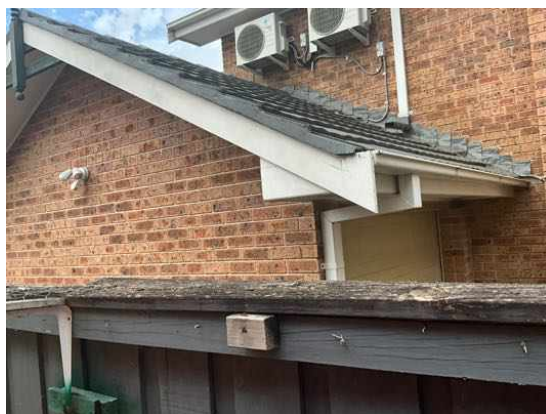
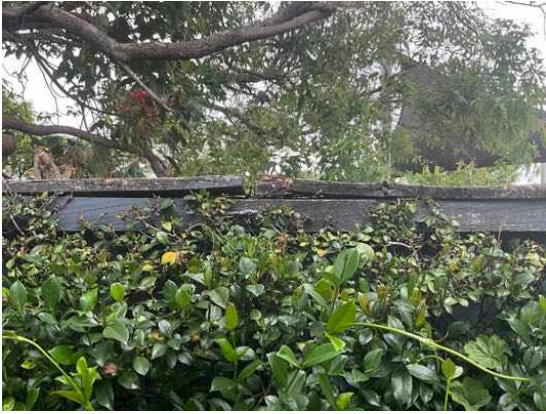
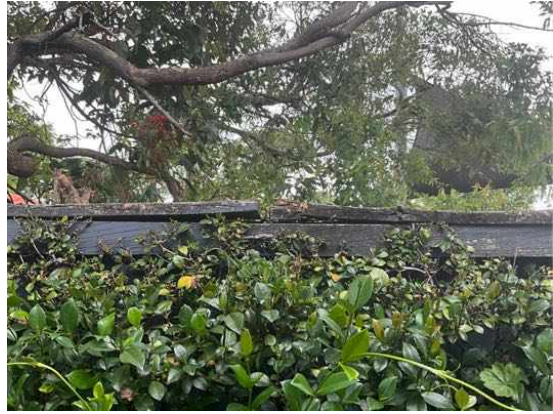
**Finding 7.01**

Building: Main Building  
Location: All Areas  
Finding: Wood rot  
Information: This building element shows evidence of wood rot. Wood rot, also known as Fungal Decay, occurs when timbers and other cellulose building materials are exposed to damp conditions on an ongoing basis. This could be the result of exposure to weathering over a prolonged period of time, or the attraction of excessive moisture

Wood rot is often associated with general damp problems and is evidenced by a 'musty' smell or mould and mildew occurring on surfaces. If left unmanaged, damp conditions can lead to further health problems and the decay of timbers will continue.

Early intervention and regular maintenance, particularly of exterior timbers, will prolong the useful life of these building elements. Prior to any works being performed, the cause of the moisture that has created the visible wood rot should be identified and addressed in a suitable manner. Replacement of affected timbers may then be a necessary step in protecting surrounding building elements from such deterioration.

A qualified plumber may be appointed to assess the cause of excessive moisture and to provide advice on any remedial works as required. A qualified carpenter or registered builder may also be required to replace affected building materials.
