Building and Timber Pest Inspection Report

Inspection Date: Wed, 8 Apr 2026

Property Address: 75 Boronia Dr, Voyager Point NSW 2172,
Australia

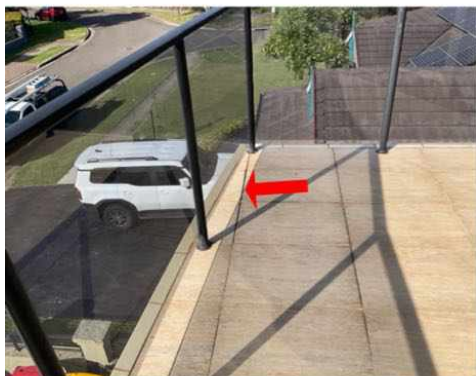
Building:	Building 1
Location:	Exterior walls & balconies
Finding:	Cracks in mortar beds and tile movement
Information:	Cracks and tile movement were identified in the upper verandah north east corner and other verandah areas.

All top floor damaged tile areas require rectification (tile removal, sealing and relaying) to stop moisture ingress causing tiles to dislodge and possible injury and potential concrete cancer to the verandah slabs.

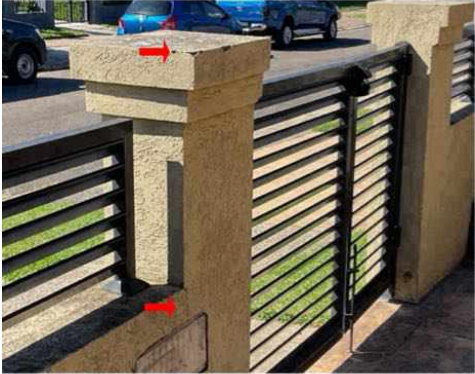
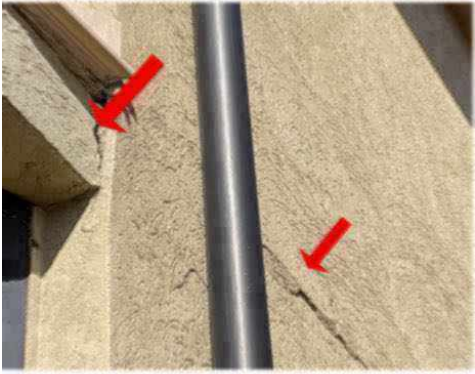
Finding 3.02

Building:	Building 1
Location:	Pictured front areas
Finding:	Render (external) cracking.
Information:	Cracking was observed to the external rendered wall finishes on the front right and three areas of the left elevations of the dwelling and other small areas. The cracks appear to be approximately up to 10 mm in width in places. Some of this render will fall off the walls in the near future. These cracked areas were inaccessible by ladder to measure. Based on visual inspection, the cracking appears consistent with movement and/or inadequate control joints within the render system. Cracks of this size may allow moisture ingress, potentially leading to deterioration of the render, loss of adhesion, and possible damage to the underlying substrate if left unrectified.

□ Further assessment by a qualified builder or renderer is recommended to determine the cause of movement and to carry out appropriate repairs. Repairs may include crack rectification, reinstatement of control joints where required, and re-rendering and repainting to restore weatherproofing and appearance.

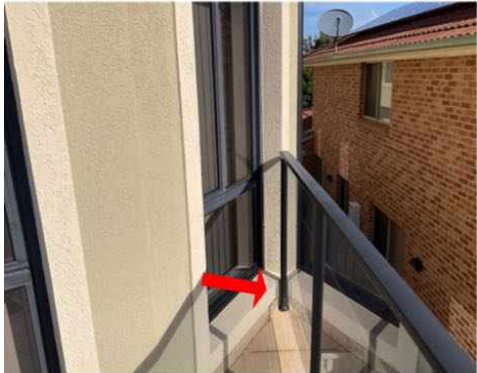
Finding 3.03

Building: Building 1
Location: Pictured areas
Finding: Render (external) cracking (continued)
Information:

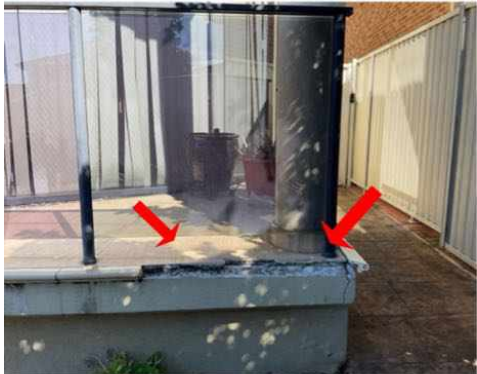
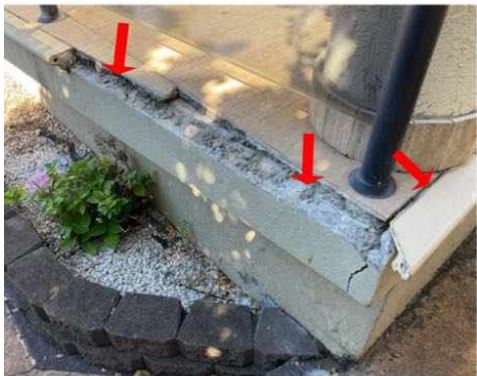
Finding 3.04

Building: Building 1
Location: Pictured front areas
Finding: Concrete spalling
Information: These right side verandahs has suffered Concrete Spalling. This is the breakdown of concrete via natural weathering and/or chemical reaction that results in sections of concrete chipping off the main body – often resulting in fractured, compromised concrete. Spalling looks like pitted acne scarring and breaks off in flecks which can expose rebar. It appears rainwater is getting into the areas of the missing and damaged grout on the verandahs.

A concreting contractor can provide advice on repairs of this damaged concrete when convenient.

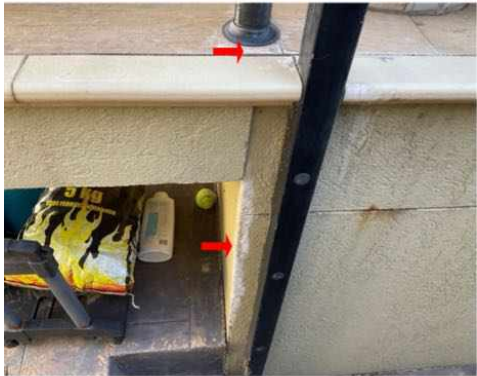
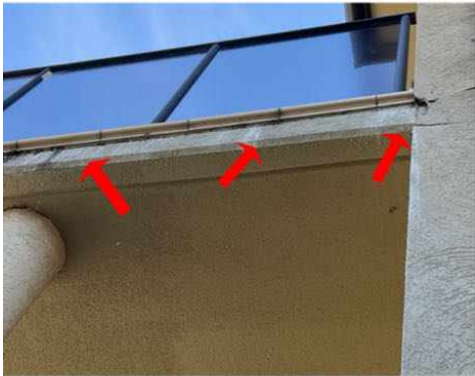
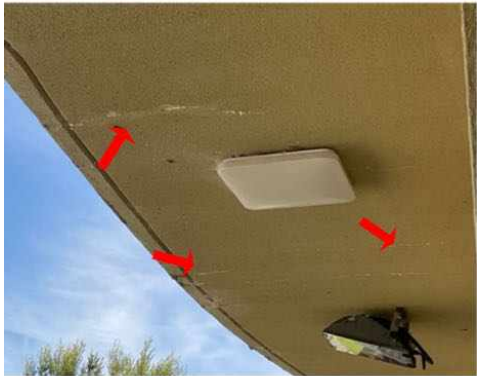
Finding 3.05

Building: Building 1
Location: External rear wall areas
Finding: Decks and balconies - Calcification or efflorescence
Information: Calcification or efflorescence caused by water coming from a deck or balcony that occurs on walls below or beside the deck or balcony, or that appears in the mortar joints of the deck or balcony tiling, may be considered a defect if it is due to defective or missing flashings, membrane, a damp proof course DPC or faulty design and needs to be investigated to identify the cause. A waterproofing expert is required for further investigation or a tiling contractor to repair all damaged areas.

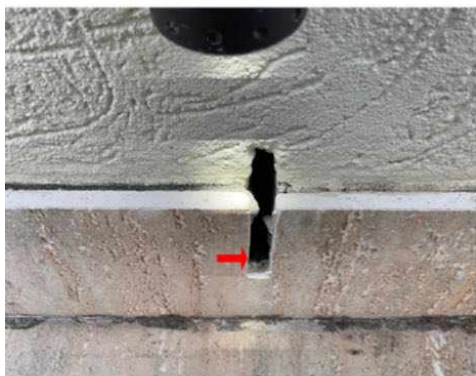
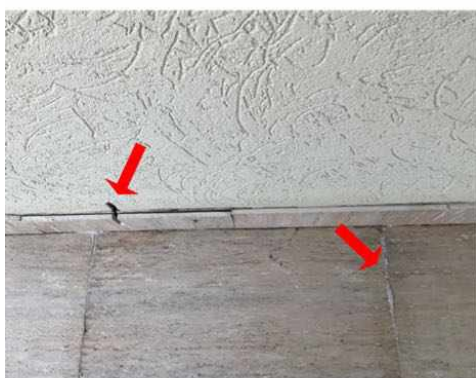
Finding 3.06

Building:	Building 1
Location:	Rear balcony
Finding:	Waterproofing of balconies
Information:	On inspection of the front and rear balconies, it is suspected no waterproofing membrane has been installed. There is a high risk of concrete cancer developing where the metal reinforcing in the concrete starts to rust, then expand and break apart the concrete. This is listed as a minor defect in this report as it is highly likely that it will lead to further damage over time if not repaired. If an invasive inspection by removing tiles shows concrete cancer, this defect may be upgraded to a major defect in this report.

Due to the amount of damaged sealant and grout, there are many areas rainwater can ingress the tiled surfaces and potentially damage the verandah slabs.

All elevated balconies, stairs and landings need urgent attention to stop further damage and very costly concrete and other repair work.

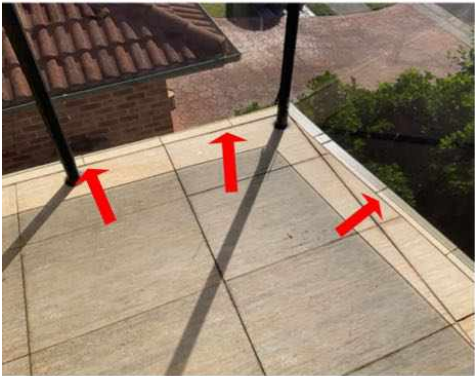
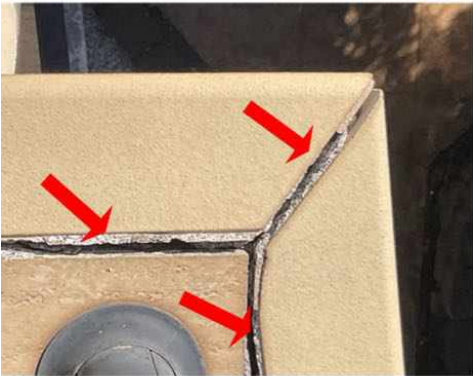
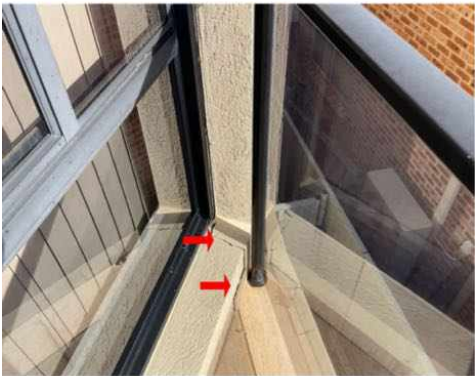
Building: Building 1
Location: Exterior walls & balconies
Finding: Sealant (external) - missing
Information: It was noted on inspection that numerous areas of external sealant was missing to many wall and balcony areas.

Flexible sealants should be applied to these affected areas to prevent any subsequent water damage that is occurring.

A sealant specialist or tiling contractor should be appointed to complete these works as soon as possible. Note - every area of render and concrete cracking is allowing rainwater ingress to damage these areas and all require sealing.

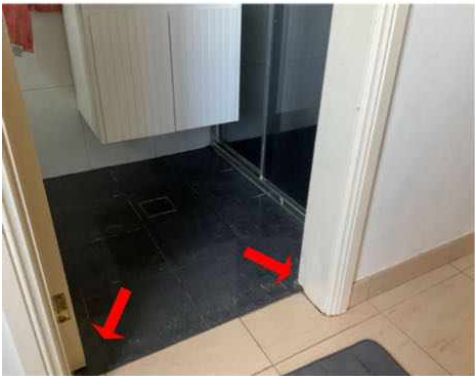
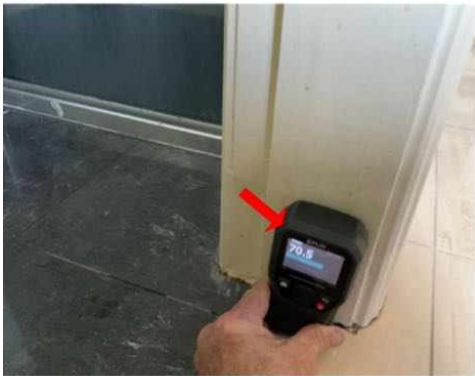
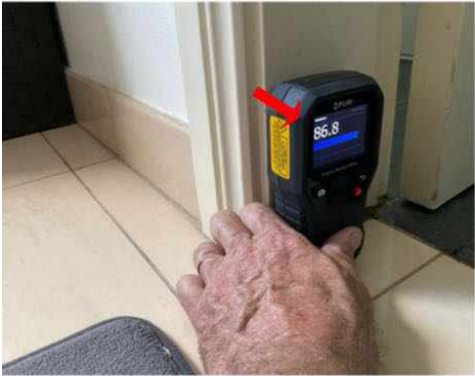
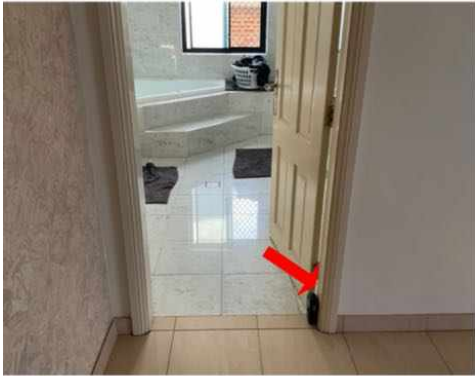
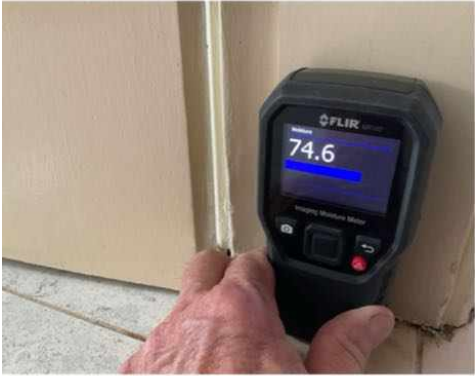
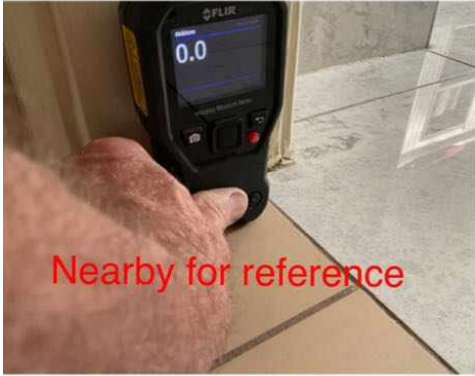
Finding 3.09

Building: Building 1
Location: Two bathrooms and rear left room
Finding: Excessive moisture and damaged wall elements
Information: Two bathroom door frames shows signs of excessive moisture and the main bathroom frame has progressed to wood rot. The rear left room also shows moisture evident.

Excessive moisture can damage walls as well as lead to the formation of mould and wood rot (see next defect).

Works to reseal or waterproofing the bathrooms may be required. A waterproofing expert should be consulted prior to purchase.

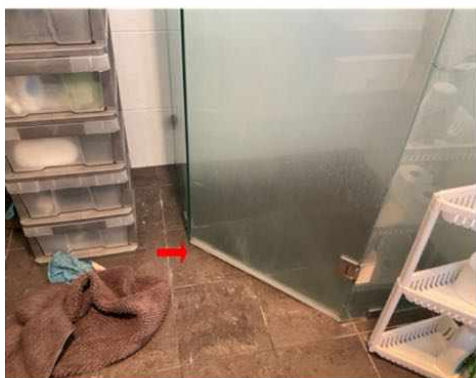
Finding 3.10

Building:	Building 1
Location:	Bathrooms
Finding:	Shower screens - Leaking
Information:	<p>Leaking was evident to two shower screens (one up and one downstairs) at the time of inspection. It is suspected that the leaking has occurred as a result missing sealant. Leaking from the showers , where left unattended, is likely to lead to water damage to adjoining flooring and walls. Such damage can lead to water damage and necessitate extensive remedial works being required. Active water leaks may also create an environment that is susceptible to the formation and development of mould.</p> <p>Appointment of a sealant expert is required to repair or replace this missing sealant. Such works should be performed as soon as possible to ensure that no further damage occurs. (see also areas of wood rot)</p>

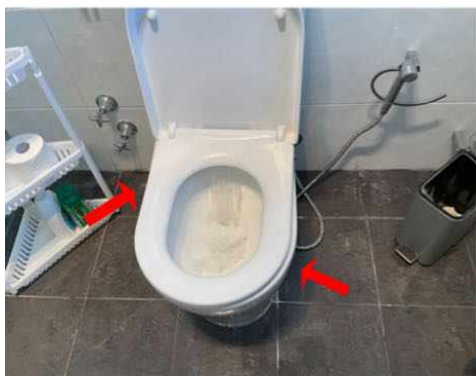
Finding 3.11

Building:	Building 1
Location:	Bathroom
Finding:	Efflorescence or calcification - Bathroom tiling
Information:	Efflorescence, characterised by white salt deposits visible at grout joints and tile surfaces, has been observed emerging from this bathroom tile bed. This condition typically indicates moisture migration through the tile system, drawing mineral salts from the underlying screed or adhesive bed to the surface.

The presence of efflorescence suggests the presence of excessive moisture beneath the tiles, potentially caused by:

A breach or failure of the waterproofing membrane,

Inadequate drainage to floor waste, resulting in water pooling.

Ongoing moisture below the tile bed can lead to the deterioration of adhesive bonds, tile debonding, and secondary water damage to the substrate or adjoining building elements.

Constant cleaning of the efflorescence will be required, if after a considerable amount of time and several cleaning attempts the efflorescence keeps returning a more intrusive inspection by a remedial builder is recommended.

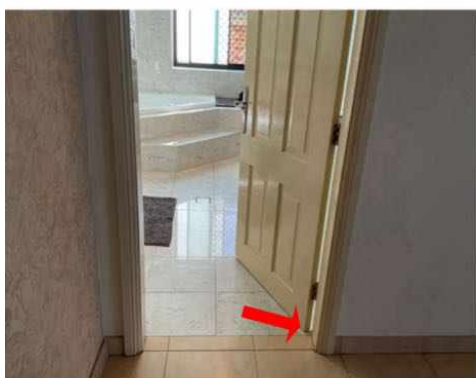
Finding 3.12

Building:	Building 1
Location:	Main bathroom door frame
Finding:	Wood rot
Information:	This area show evidence of wood rot to the frame. Wood rot, also known as Fungal Decay, occurs when timbers and other cellulose building materials are exposed to damp conditions on an ongoing basis. This is likely from a shower leak.

Prior to any works being performed, the cause of the moisture that has created the visible wood rot should be identified and addressed by a waterproofing expert.

Replacement of affected door timbers is a necessary step in protecting surrounding building elements from such deterioration.

A qualified carpenter or registered builder may also be required to replace affected building materials.

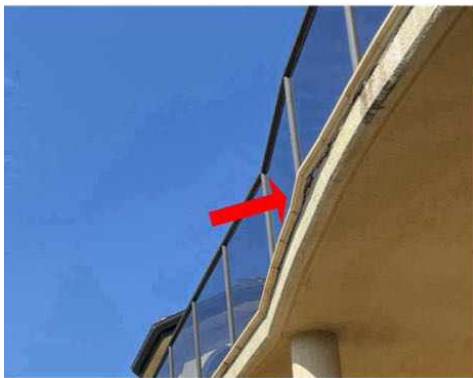
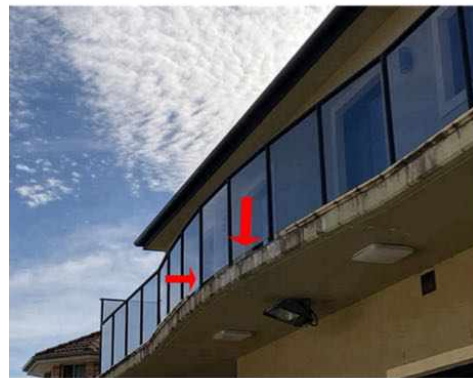
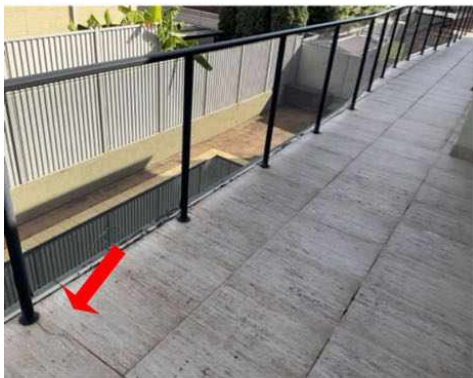
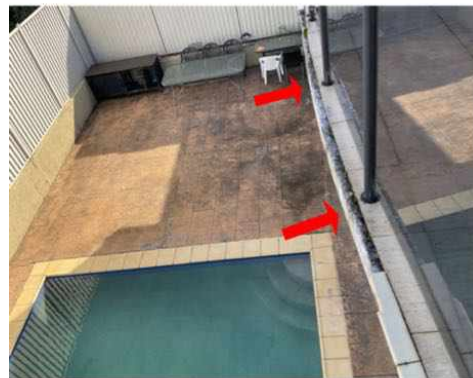
Finding 3.13

Building: Building 1
 Location: Balconies
 Finding: Tiles cracked or loose
 Information: Cracked, loose and missing tiles were evident in these pictured areas at the time of inspection. It is suspected that this cracking has occurred as a result of water ingress.

Cracked tiles throughout the household detract from the overall appearance of the affected areas. In wet areas of balconies it can lead to water damage of concrete slabs.

Replacement of cracked tiles is recommended as soon as possible. A tiling contractor may be appointed to perform these works.

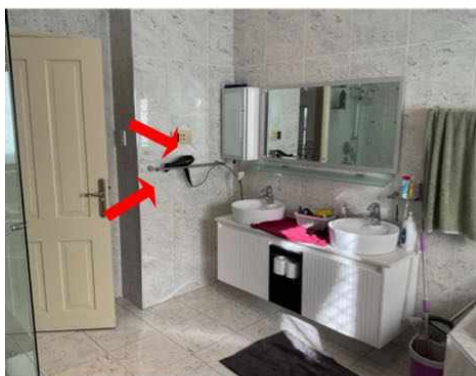
Finding 3.14

Building: Building 1
 Location: Bathrooms
 Finding: Tiles - Cracked or damaged
 Information: Cracking was evident to dozens of tiles in the wet areas at the time of inspection. These areas are frequently exposed to water, allowing potential for water penetration into adjoining sections of walls or flooring.

damage, which is likely necessitate repair work to affected building elements.

A tiling contractor should be appointed to ensure that no further water damage occurs. The re-application of silicone and grouting throughout remaining tile work is also advised, to further protect the area against water penetration.

Where water penetration has led to water damage, appointment of a relevant tradesperson may be required to repair damaged building elements.

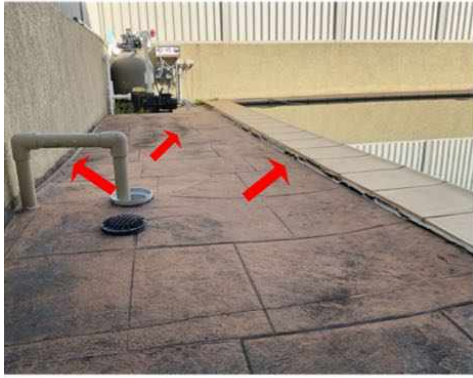
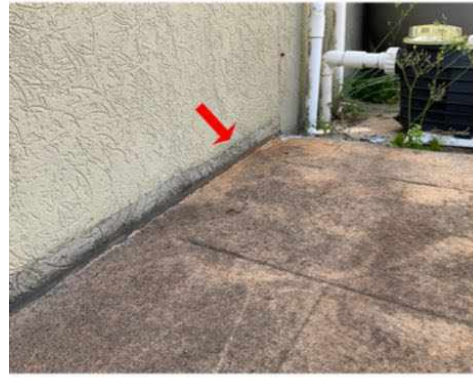
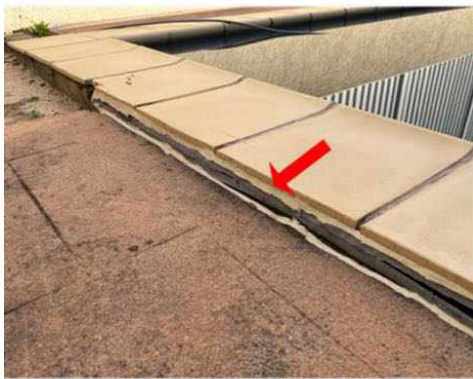
Building:	Building 1
Location:	Pool area
Finding:	Subsidence (external) Monitor
Information:	It appears that the left side pool paved area appears to have been affected by movement of the foundations, often referred to as sinking or subsidence. General subsidence is usually initiated by changes in soil moisture content. The most critical factor is identifying the specific causes, and identifying if this is a recurring or ongoing problem, or one that has been resolved by previous works in the past.

At this point it is recommended to contain storm water flows, ensure pavements flow away from buildings to lessen any excessive wetting and drying effects.

A concreting contractor can repair this area when convenient.

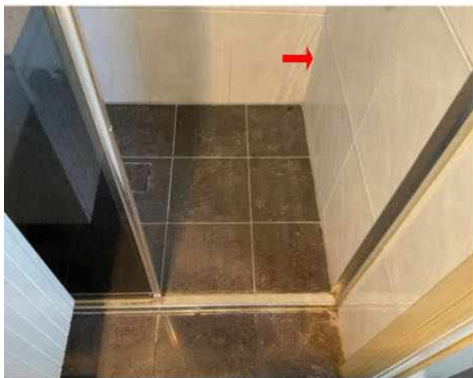
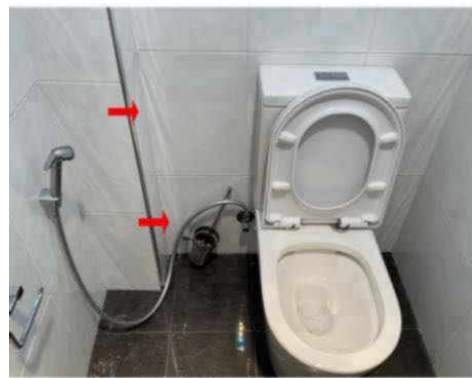
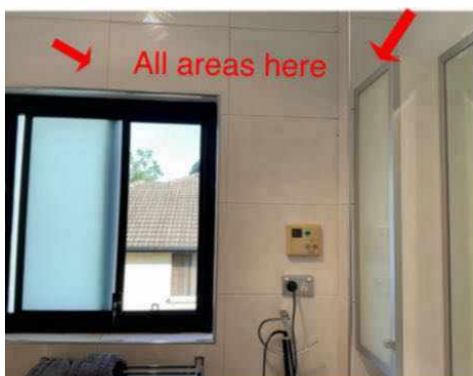
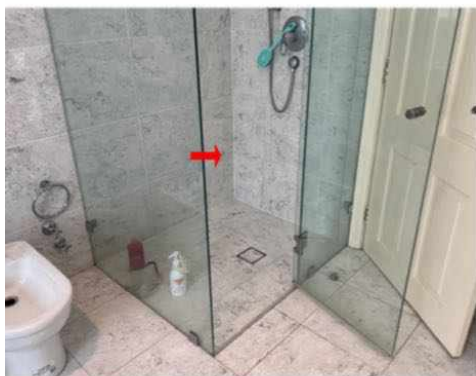
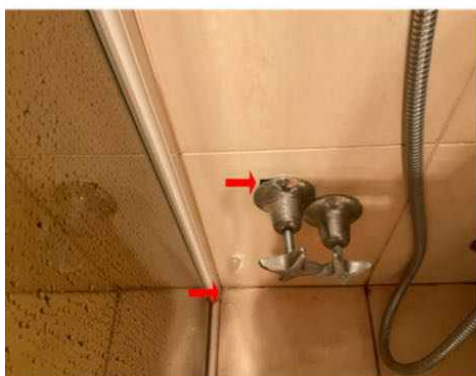
Building: Building 1
 Location: Bathrooms
 Finding: Sealant and grouting - Missing or damaged
 Information: It was noted on inspection that sealant or grout is degraded to numerous areas. The main ensuite has damaged sealant in every wall (see also cracked tiles defect).

The minor settlement since construction has meant dozens of wet areas have cracks inbetween tiles.

Different materials and floor areas move at different rates, generally causing cracking to grout or sealant at this point. A flexible sealant is required to allow for expected expansion and contraction, while keeping the joint water tight and protective of all associated building materials.

Flexible and mould resistant materials should be applied to affected areas to prevent any subsequent water damage that is likely to occur. Regular maintenance and replacement of damage or missing or damaged sealant and grout is highly recommended to the wet areas, as this is a regular wear and tear defect. Sealant and grouting in areas that come into regular contact with water should be maintained for the long term care of your property.

A sealant specialist or tiling contractor should be appointed to complete these works as soon as possible.

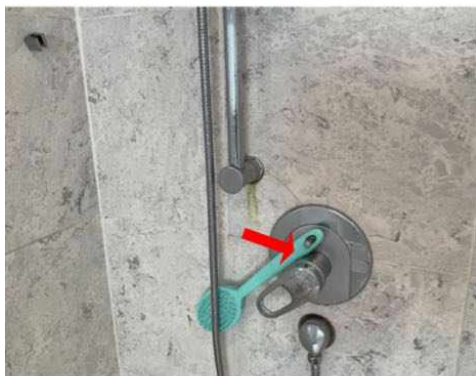
Finding 3.19

Building:	Building 1
Location:	Pictured areas
Finding:	Building elements - Damaged
Information:	Evidence of minor missing or damaged areas was identified at the time of the inspection. These include -

1. The main bathroom shower diverter does not work.
2. Many bathroom towel rails and shelves are loose or missing.
3. The front left bedroom shows a moisture damaged internal lower wall but no excessive moisture at the time of the inspection.

This is likely caused by the external damaged render.

A plumber and renderer would be the trades responsible for rectification of these areas when convenient.

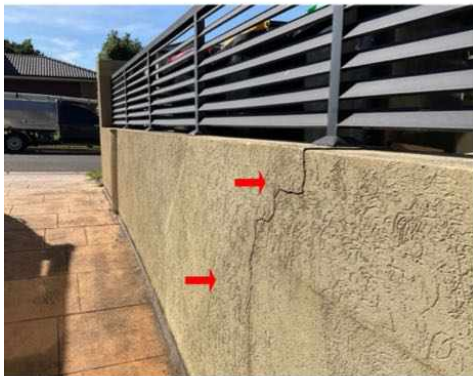
Building: Building 1
Location: Exterior driveway walls
Finding: Step cracking to brickwork (minor)
Information: Step cracking was identified to the brickwork in this area at the time of inspection. Step cracking, which is similar to other forms of cracking, has a variety of possible causes. However, the most common is the subsidence of adjacent footings.

Step cracking is a relatively common defect, and is most likely to occur adjacent to windows, doors and other openings. Mortar failure in the gaps between affected bricks indicates the stresses and tensions affecting the wall.

Where step cracking is extensive or severe, the client is advised to consult a structural engineer. This minor step cracking can be used as a warning sign to address factors causing stress to the wall, which can include the effect of surrounding trees, water leaks, soil erosion, or even the presence of reactive soils in the surrounding area.

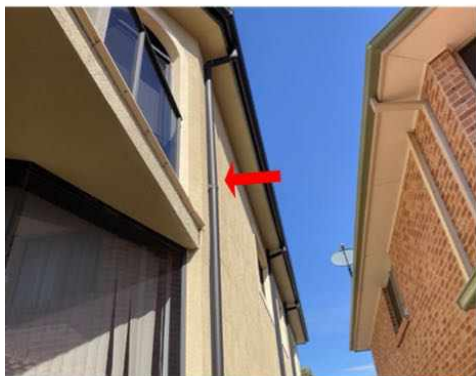
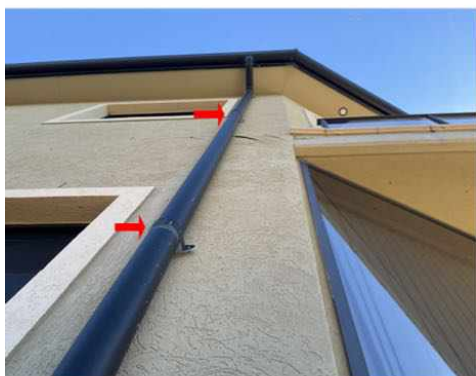
Finding 3.22

Building:	Building 1
Location:	Exterior walls - both sides
Finding:	Additional fixings to downpipe
Information:	Evidence of insufficient fixings were evident to most down pipe. This downpipes need additional fixings to affix to the adjoining wall ensure its longevity.

A carpenter, plumber or handy person should add additional fixings to this area as soon as possible to limit potential damage.

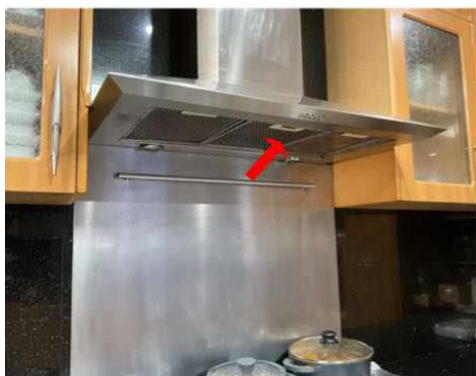
Finding 3.23

Building: Building 1
Location: Front & Rear decks, stairs and railings
Finding: Rangehood - Light not working
Information: While the range hood appears to be working at a satisfactory level, the light to the appliance was not working at the time of inspection.

A licensed electrician should be appointed to replace the light on the range hood to restore it to a fully operational state.

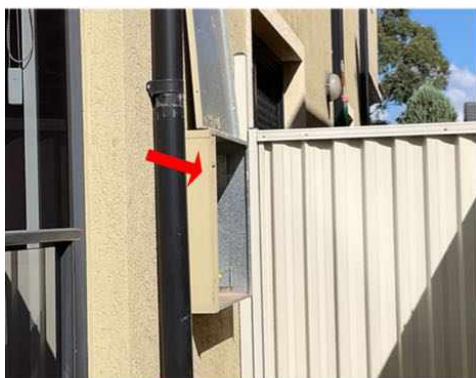
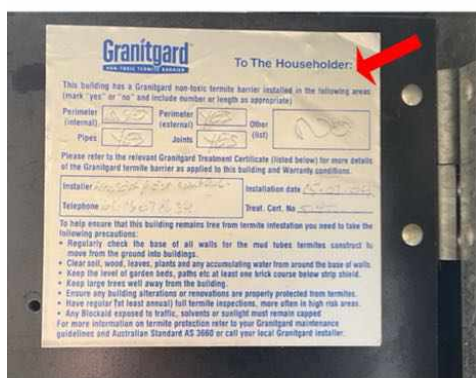
A durable notice should be placed in the switchboard unit to indicate current termite barriers. At the time of inspection, the durable notice was evident and it appeared as though a physical but no chemical termite management system has been installed, with no evidence to suggest preventative works taking place since the property was built.

The client may consider gaining further advice from a pest controller as to the costs and procedures involved with a 'chemical' application. It is recommended that obtaining such advice be a short-term priority.

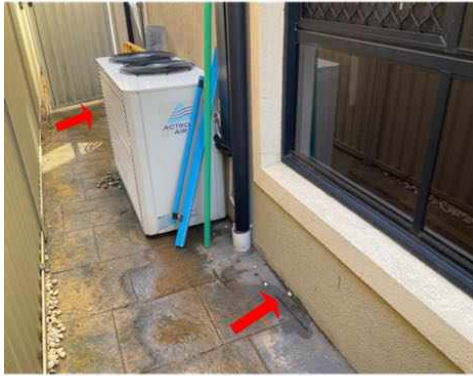
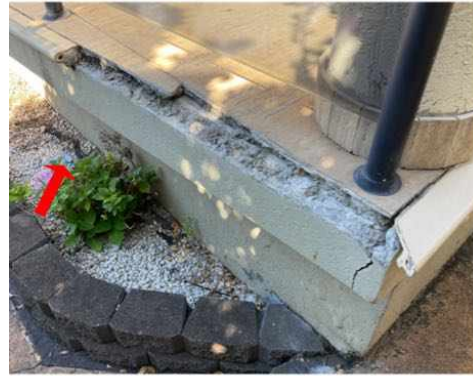
Finding 6.02

Building:	Building 1
Location:	Exterior walls - right side
Finding:	Bridging or breaching of termite barrier
Information:	The concrete around the property appears to bridge the termite barrier. The AC units also block inspection of the barrier.

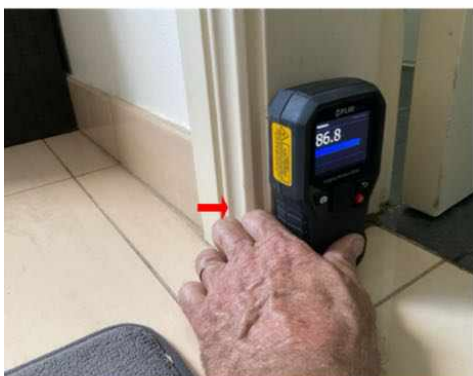
Finding 7.01

Note - See ALL wood rot photos in building defects above, all these show fungal decay.

In this case, the affected timber element is in a decaying state and will need replacement by a carpenter or licensed builder.
