Building Inspection Report

Inspection Date: Mon, 16 Mar 2026

Property Address: Unit 60, 151-153 Mudjimba Beach Rd,
Mudjimba QLD 4564, Australia

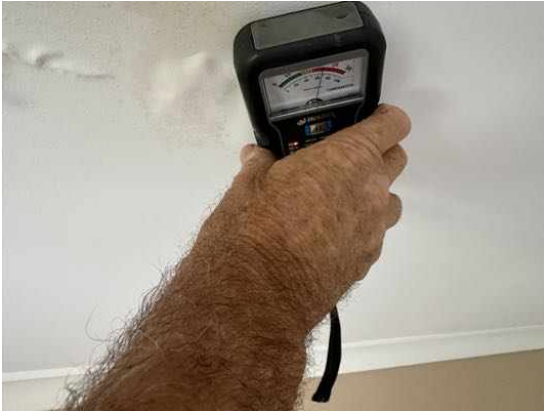
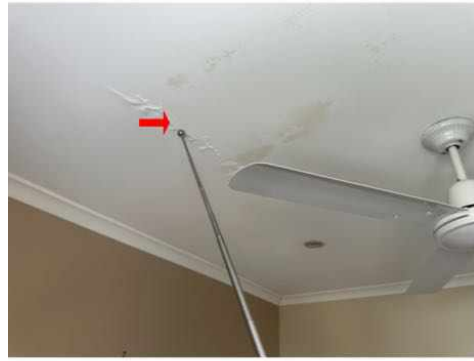
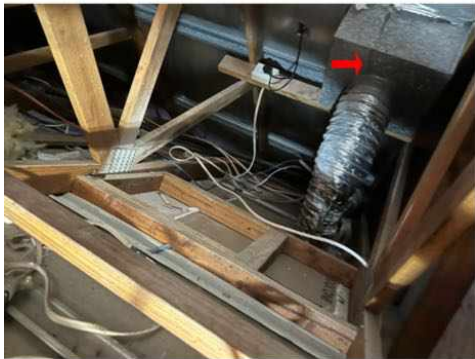
Defects 2.01

Building: Main Building
Location: Upstairs Bedroom
Finding: Ceiling - Water damaged
Information: Water damage to the ceiling lining is generally an indication of excessive moisture being present in the roof void, usually via a leak to the roof covering.

Where water damage is evident to the ceiling, the primary requirement is to identify and rectify the source of the leak. A roofing contractor should be appointed as soon as possible to identify the leak and perform rectification works as necessary, ensuring the water damage is restricted.

Once the leak is repaired, consultation with relevant tradespeople, including plasterers and painters, is advised. Rectification works may include replacement of ceiling lining or minor repainting, depending on the extent of the damage.

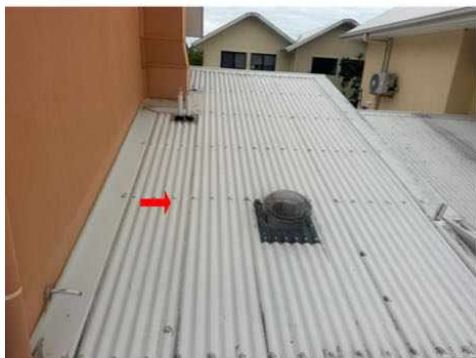
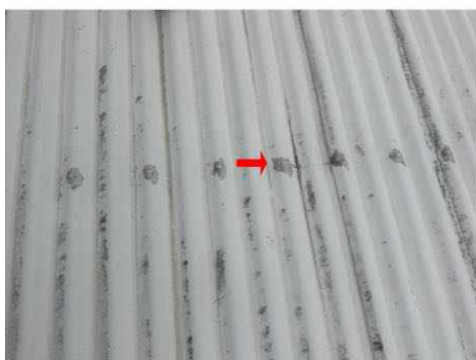
Defects 2.03

Building: Main Building
Location: Roof Exterior
Finding: Roof screws - Excessive silicone work
Information: The silicone repair work performed to the roofing screws is excessive and should not be necessary if the roof screws were correctly installed.

Recommend a roofing contractor be engaged to further investigate .

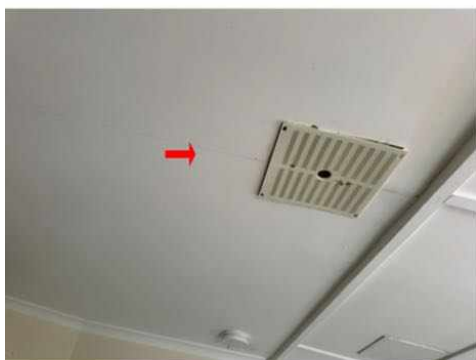
Defects 3.01

Building:	Main Building
Location:	Downstairs Living Room
Finding:	Cracking - Damage Category 1 - Fine (up to 1mm)
Information:	Although fine cracks are quite noticeable, they are often only considered to be an appearance defect, and usually do not indicate any structural damage. Generally, the cause of a fine crack is indicative of a separation between building materials and finishes (e.g. paint, plaster, etc.) along joints.

Cracking of this nature can generally be repaired with minor sanding, filling and/or repainting. Such works should be performed by a qualified painter or a general handyman.

Monitoring of all cracking should be conducted frequently. Always contact a building inspector should cracks widen, lengthen, or become more numerous.

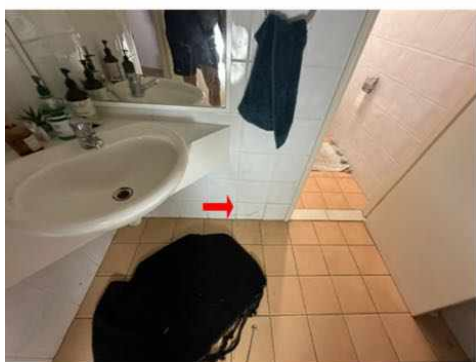
Defects 3.02

Building:	Main Building
Location:	Downstairs Bathroom
Finding:	Tiles - Cracked
Information:	Cracking was evident to the tiling in this bathroom at the time of inspection. While the cracking appears to be minor, this area is frequently exposed to water, allowing potential for water penetration into adjoining sections of walls or flooring.

If left unmanaged, water penetration to these areas may lead to subsequent water damage, which is likely necessitate repair work to affected building elements.

A tiling contractor should be appointed to ensure that no further water damage occurs. The re-application of silicone and grouting throughout remaining tile work is also advised, to further protect the area against water penetration.

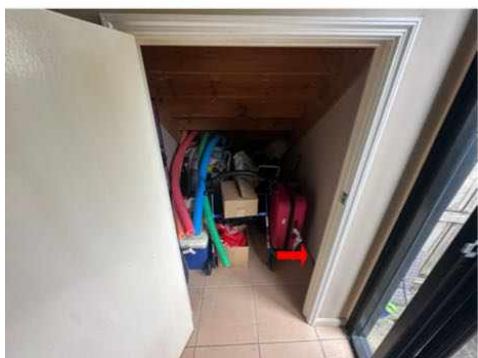
Defects 3.03

Building:	Main Building
Location:	Storage area wall under Stairs
Finding:	Evidence of excessive moisture and mould was present at the time of inspection
Information:	There was excessive moisture and mould to the external wall under the stair landing cupboard, there is also evidence of cracking between the block work and render in

this area to the external wall.

Recommend a carpenter or experienced handyman be engaged to reseal this joint between the external render and block work to this wall.

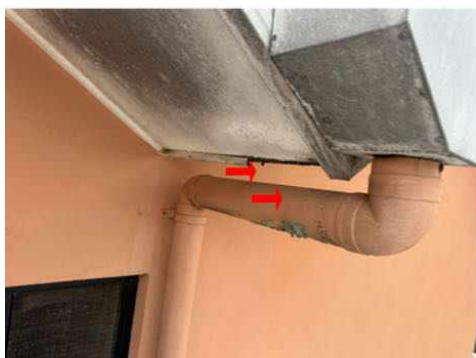
Defects 3.04

Location: Eaves

Finding: Wood Rot

Information: These timber eaves mouldings shows evidence of wood rot. Wood rot, also known as Fungal Decay, occurs when timbers and other cellulose building materials are exposed to damp conditions on an ongoing basis. This will be the result of exposure to weathering over a prolonged period of time. Early intervention and regular maintenance, particularly of exterior timbers, will prolong the useful life of these mouldings . A qualified carpenter or handyman may also be required to replace affected eave mouldings at owners discretion

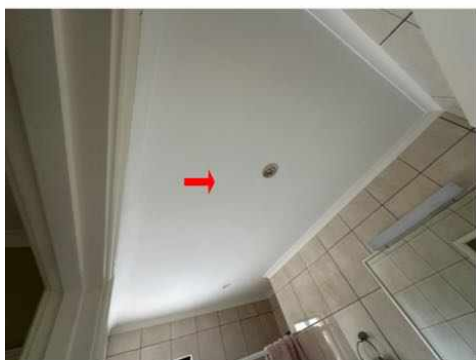
Defects 3.05

Building:	Main Building
Location:	Upstairs Bathroom
Finding:	Exhaust fan - Missing
Information:	An exhaust fan has not been installed in this bathroom . Missing exhaust fans may lead to the development of more significant defects such as moisture damage to surrounding ceilings and walls from inadequate ventilation. Inadequate ventilation in internal areas creates an environment that is conducive to the formation and development of mould and other respiratory hazards. It is highly advised that a licensed electrician be appointed to retrospectively install an exhaust fan. Failure to perform works to aid the ventilation of the area may lead to the development of these secondary defects.

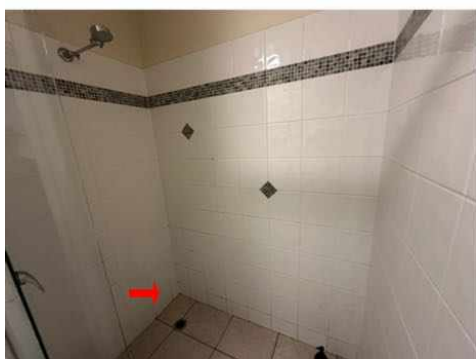
Defects 3.06

Building:	Main Building
Location:	Downstairs Bathroom
Finding:	Silicone and grout - mouldy
Information:	Silicone and grout is mouldy in this shower recess . Silicone and grout is used to protect gaps and crevices in building materials to ensure that they are water-tight and prevent water penetration to the associated structures.

Where silicone and grout is mouldy , a tiling contractor should be appointed immediately to re-apply any silicone and grout where necessary. Failure to do so is likely to lead to water damage to the surrounding area.

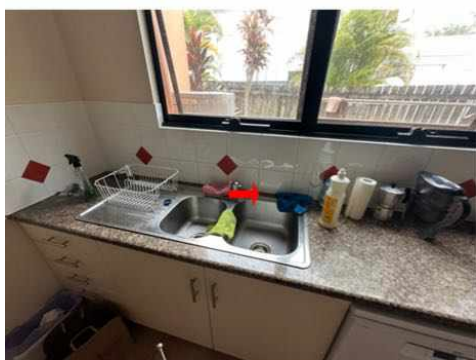
Defects 3.07

Building: Main Building
 Location: Downstairs Kitchen
 Finding: Silicone - missing
 Information: Silicone is missing in this kitchen splash back . Silicone is used to protect gaps and crevices in building materials to ensure that they are water-tight and prevent water penetration to the associated walls.

Where silicone is missing , a tiling contractor should be appointed immediately to re-apply any silicone where necessary. Failure to do so is likely to lead to water damage to the surrounding area.

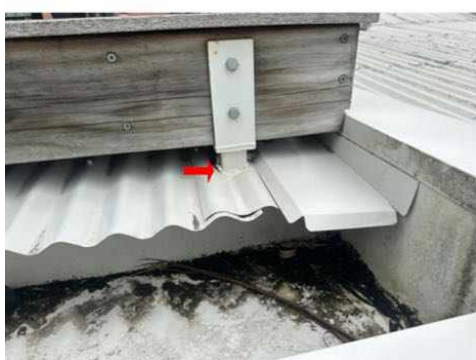
Defects 3.09

Building:	Main Building
Location:	Roof Exterior
Finding:	Deck tites missing
Information:	There were no deck tites on the steel posts holding up the deck above the lower downstairs roof, these posts were relying on silicon to seal between the post and the roof sheets, there is evidence of deterioration and cracking of the silicon which can allow water to enter the lower roof void, recommend a roofing contractor being engaged to fit deck tites around these steel posts.

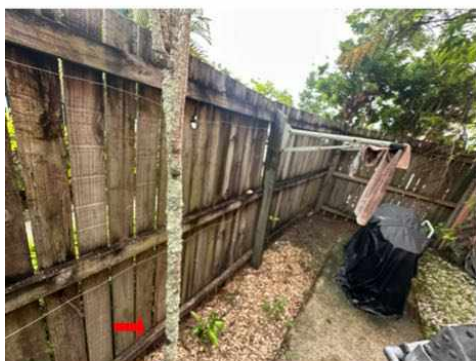
Defects 3.10

Building:	Yard
Location:	Yard - Side
Finding:	Fencing - Deteriorated

Information: It was noted at the time of inspection that sections of the fencing throughout the property have deteriorated. Typically fencing deteriorates due to age and rot which is generally expected for a structure of this age, due to prolonged exposure to weather conditions. Sometimes inadequate installation or maintenance can be to blame.

If left unattended, it is likely that further damage will occur. It is suspected that repair of several elements of the fencing may be required however replacement may be a consideration of the client also.

A licensed fencing contractor should be appointed to provide further advice and perform rectification works as necessary.

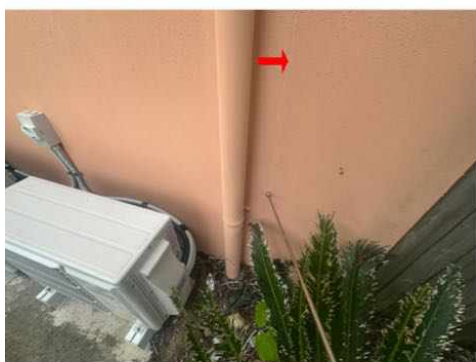
Defects 3.12

Building:	Main Building
Location:	Exterior walls - front and back
Finding:	Cracks to external render
Information:	It has been observed that cracking to internal rendered surfaces has occurred. The degree of damage falls within Category 2, described as noticeable cracks which are easily filled. Cracking of this size are generally less than 5mm in width.

Category 2 damage is required to be monitored for a period of 12 months. After the monitoring period, a crack rated at Category 2 or above is considered a defect requiring rectification.

Always contact your building inspector should cracks widen, lengthen, or become more numerous.

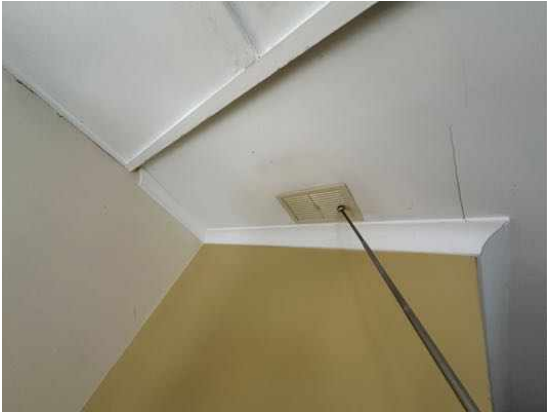
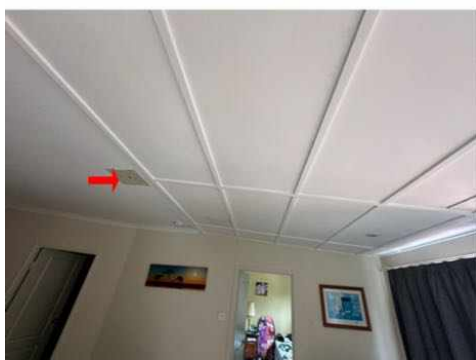
Building: Main Building
Location: Downstairs Living Room
Finding: Ceilings - inspection holes and vents
Information: There were evidence of several areas in the downstairs ceiling living area where they have been inspection outlets cut in the ceilings , this would indicate that there have been leaks in this ceiling in the past.

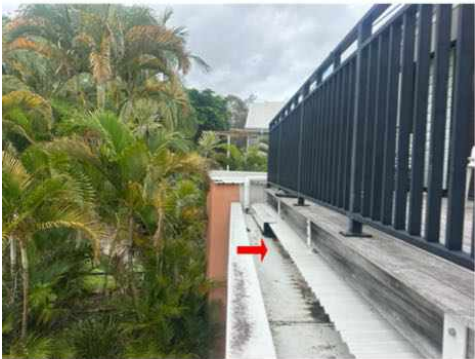
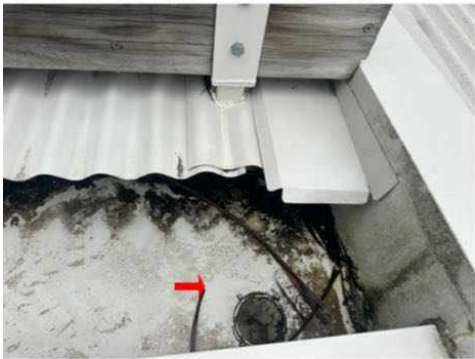
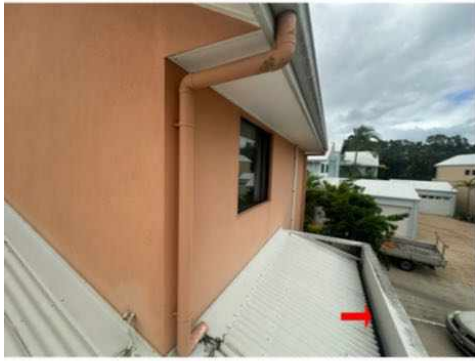
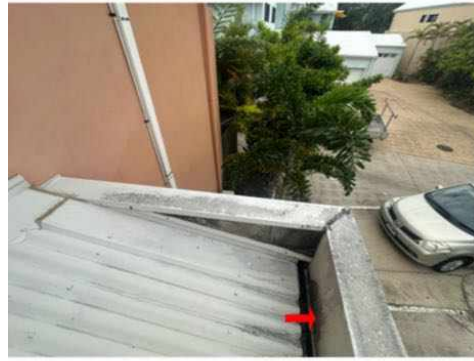
Building: Main Building
Location: Roof Exterior
Finding: Box gutters
Information: Roof plumbing structures, such as box gutters , should be free of all debris to prevent blockages. Blockages of the guttering and downpipes will lead to pooling and accumulated water overflows, which is likely to subsequently flood eaves and interior walls.

Regular maintenance checks by a licensed roof plumber is recommended for any properties with box gutters to maintain silicones and help eliminate the risk of roof leaks as box gutters are frequently the cause of water damage.

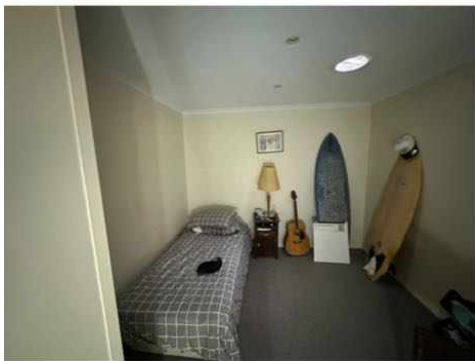
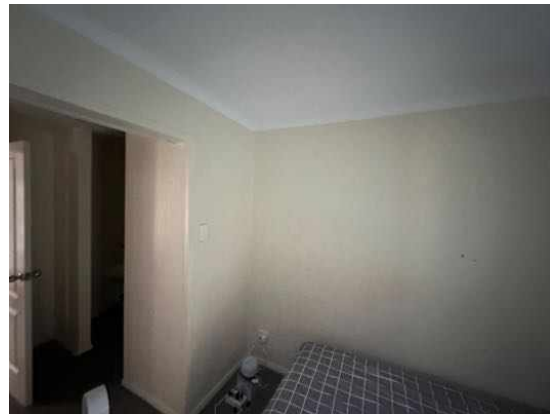
Building: Main Building
Location: Downstairs Bedroom
Finding: Window - Missing
Information: There is no window or ventilation in this room that is being used as a bedroom.

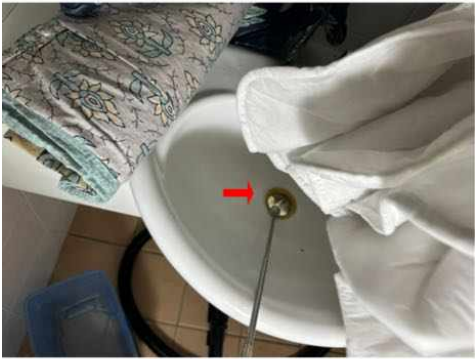
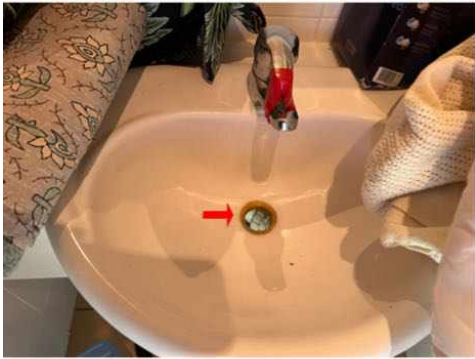
Building: Main Building
Location: Downstairs Powder Room
Finding: Sink disconnected
Information: There was no plumbing connections to this sink on the day of inspection.
