Building and Timber Pest Inspection Report

Inspection Date: Wed, 4 Mar 2026

Property Address: 45 Mahoney Dr, Campbelltown NSW 2560,
Australia

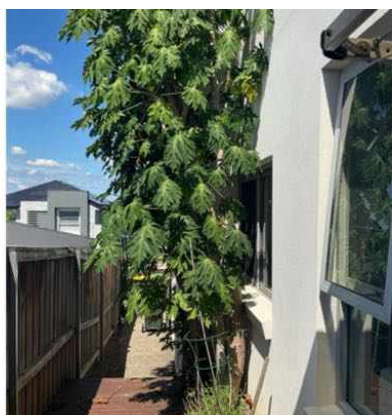
Finding 1.01

Building:	Main Building
Location:	All External Areas - Right
Finding:	Observation – Vegetation/Tree Proximity to Dwelling
Information:	A large tree is located immediately adjacent to the dwelling wall, with the trunk leaning toward the structure; this proximity poses risks including potential damage to footings and underground services from root activity, increased moisture retention conducive to timber pest activity, and ongoing maintenance issues from falling fronds and debris. While the lean of the tree may also present a future safety risk if it becomes unstable, and further assessment by an arborist is recommended to determine stability and potential impacts, with consideration for trimming, monitoring, or removal if necessary.

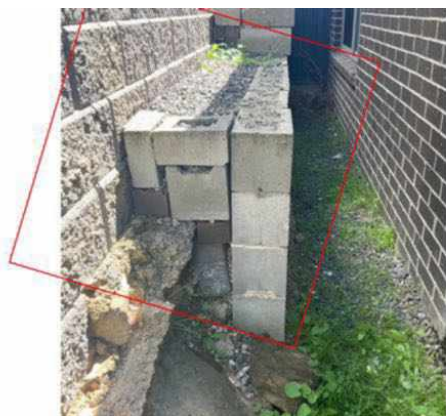
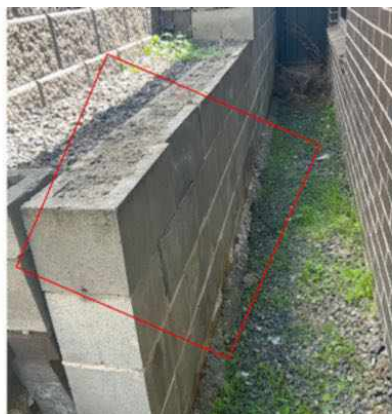
Finding 2.01

Building:	Main Building
Location:	All External Areas - Front , Right , Rear , Left
Finding:	Retaining walls - Defective (cracking , misaligned , efflorescence, brick displacement , drainage provisions can't be confirmed)
Information:	The retaining wall in this area was found to be defective at the time of inspection. Generally, defective retaining walls are caused by poor original design or material use. However, deteriorated retaining walls may also be a result of substandard construction, poor site drainage or unmanaged stormwater flows.

If left unmanaged, the retaining wall may become a safety hazard if it continues to destabilise. Where retaining walls further rot and decay, an environment is created that is conducive to termite and pest infestation.

Significant repair and replacement should be expected. Where retaining walls are considered structural walls, a structural engineer / surveyor should be consulted regarding required remedial works. Otherwise, a landscaper or retaining wall installer may be appointed to repair or replace the wall, at the discretion of the client.

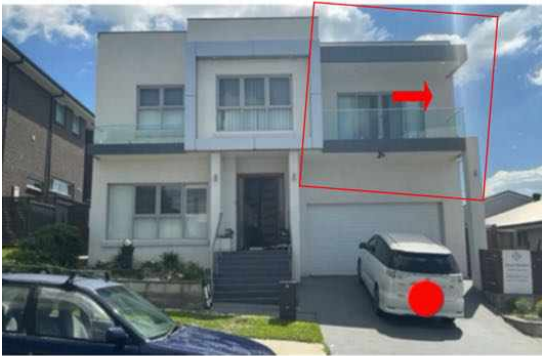
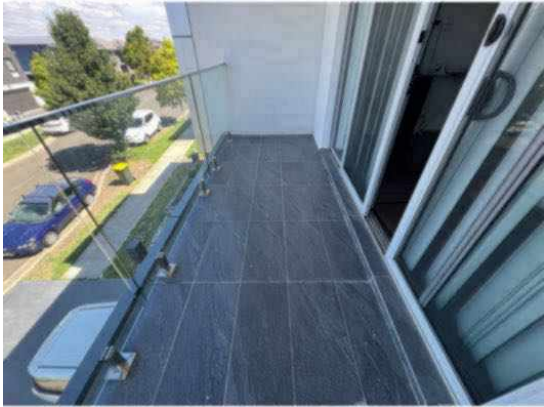
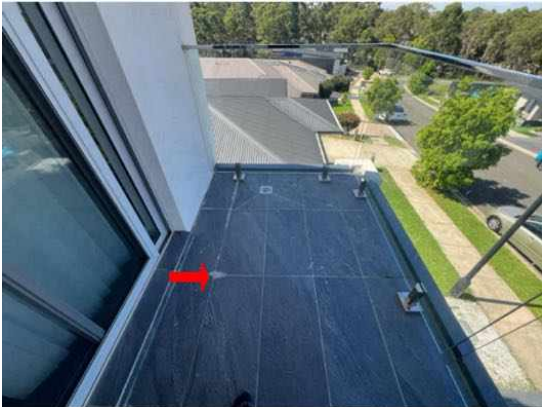
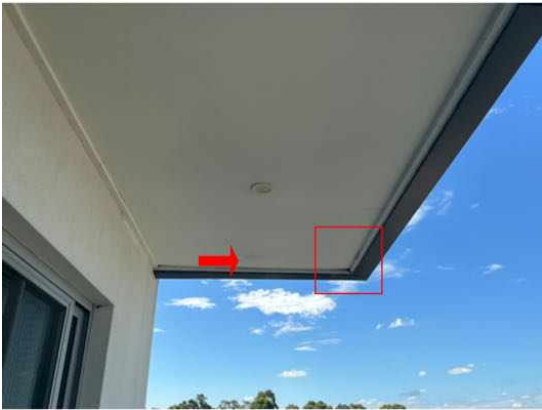
Finding 2.02

Building:	Main Building
Location:	All Internal Areas - Front balcony soffit and above balcony and garage
Finding:	Water staining/Paint bubbling - Further investigation required (Also refer to defect 3.1)
Information:	Water staining was evident in this area at the time of inspection. Water staining indicates that surfaces have been exposed to excessive moisture over time. The minerals and other elements in the water lead to staining, which may graduate to corrosion and deterioration if left unmanaged.

These conditions are consistent with moisture ingress from above, potentially associated with balcony waterproofing, roof drainage or flashing defects.

The exact source of water ingress could not be confirmed at the time of inspection.

Further investigation by a licensed plumber and/or licensed roofing/waterproofing contractor is recommended to determine the cause. Failure to rectify could result in significant works in the future.

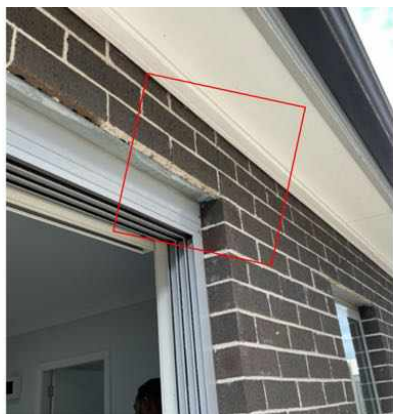
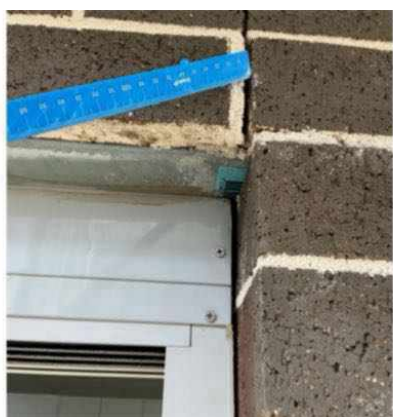
Finding 2.03

Building:	Granny-Flat
Location:	All Internal Areas - Granny
Finding:	Brickwork - Cracking [Repair required]
Information:	Significant vertical cracking approximately 10 mm wide was observed in the brickwork above the sliding door opening. Cracking of this magnitude in this location may indicate movement or distress associated with the supporting lintel or load transfer above the opening, rather than normal shrinkage cracking. Open cracks of this size can permit moisture ingress and ongoing deterioration of masonry and supporting elements if not addressed. It is recommended that the condition be assessed by a suitably qualified structural engineer to determine the cause and recommend

appropriate rectification to prevent further movement or damage.

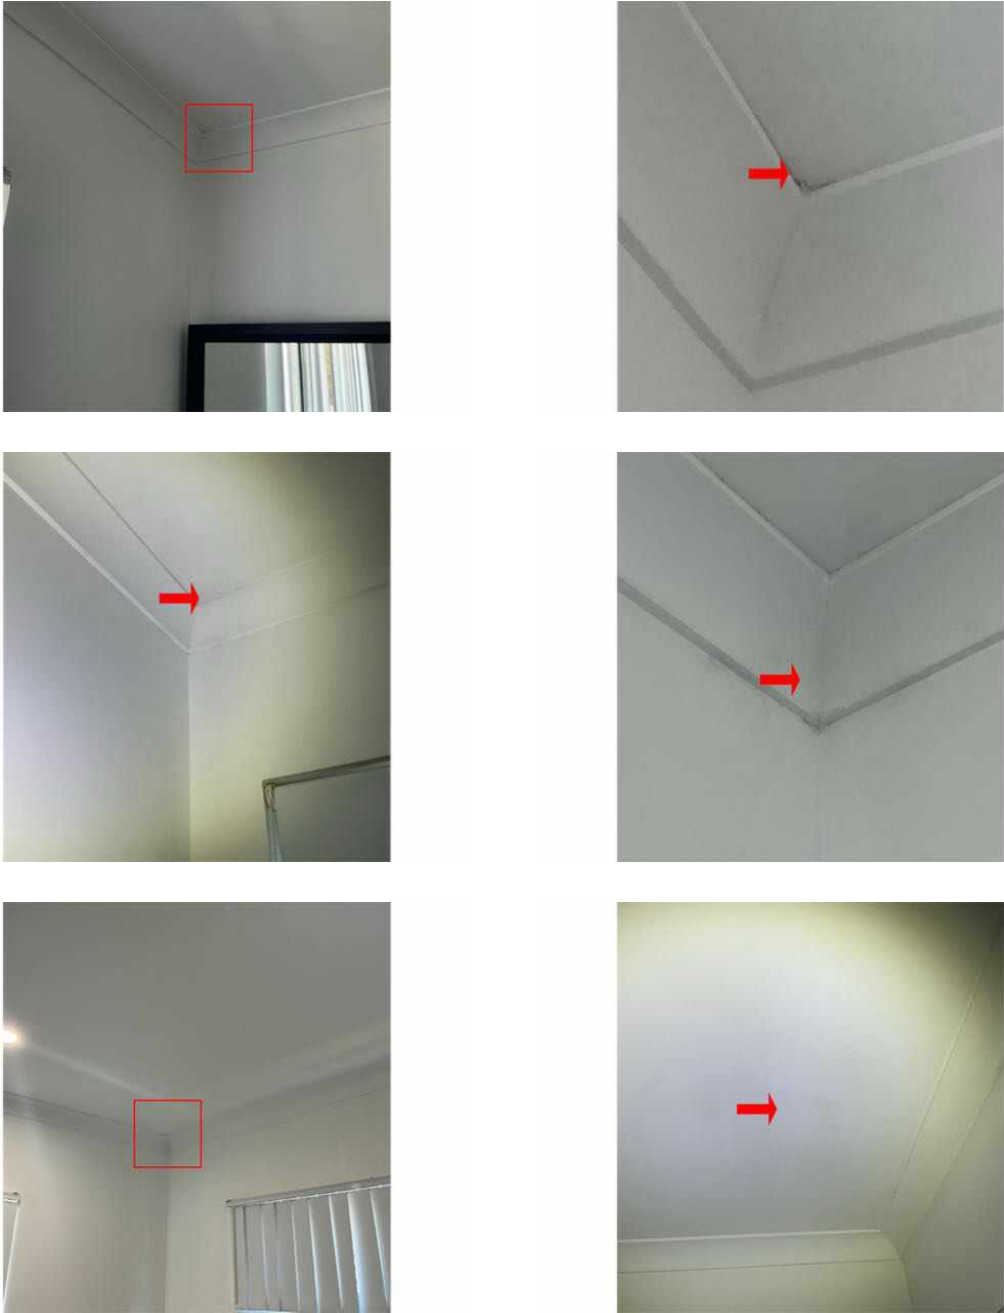
Finding 3.01

Building:	Main Building
Location:	Bedroom - Master, bedroom front
Finding:	Water staining to some areas
Information:	Water staining was evident in this area at the time of inspection. Water staining indicates that surfaces have been exposed to excessive moisture over time. The minerals and other elements in the water lead to staining, which may graduate to corrosion and deterioration if left unmanaged.

While mostly an appearance defect, water staining can be indicative of more serious defects, which may be currently concealed by other building elements.

Where water staining is active, a licensed plumber must be consulted to identify the cause of the staining and to provide advice on any reparation works that may be required. Replacement of any broken or damaged structures is advised.

Conversely, where water staining is old and inactive, affected building materials may

be repaired or replaced at client discretion. A qualified carpenter or registered builder may be appointed to perform these works.

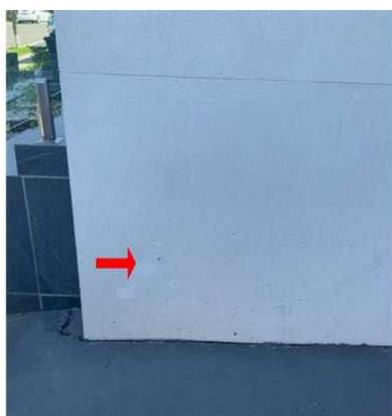
Finding 3.02

Building: Main Building
Location: All External Areas
Finding: Damp
Information: Damp (or structural damp) refers to the presence of unwanted moisture in the structure of a building, either as the result of intrusion from outside, or condensation from within the structure. Generally, structural damp is caused by rain penetration, rising damp, and leaks from plumbing pipes.

Unmanaged damp facilitates the formation and development of mould, fungi growth and wood rot, decaying associated building materials and compromising their structural integrity. Damage to finishes is also likely to occur, including lifting, bubbling, peeling and staining of paint, plaster and wallpaper.

The first step in addressing damp is to diagnose the cause. The identified cause should be addressed first prior to repairing the appearance and other defects which have resulted from the rising damp. If the original cause is not resolved, further cases of damp are likely to ensue, resulting in secondary defects.

Consultation with a qualified plumber is advised immediately to identify the cause of damp and perform remedial works as required. Where excessive mould growth is present, further inspection by a specialist environmental health inspector should also be considered.

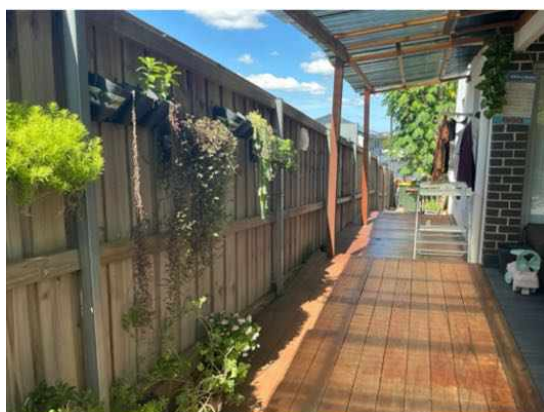
Finding 3.06

Building:	Main Building
Location:	All External Areas
Finding:	Site drainage
Information:	Drainage under the deck cannot be verified in a visual inspection, recommend a licensed plumber to check for falls away from the slab and building as a good building practice

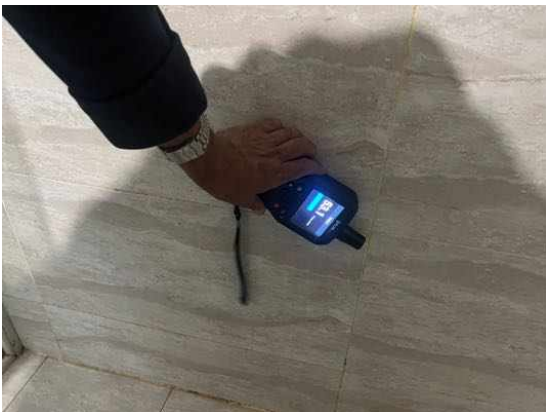
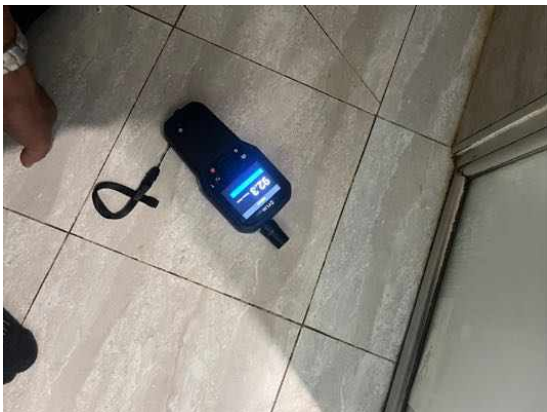
Finding 3.07

Building:	Main Building
Location:	Bathrooms, laundry
Finding:	Elevated Moisture Bathroom (No visible deterioration noted)
Information:	<p>Elevated moisture levels were detected to tiled surfaces in bathroom/shower areas. Persistent moisture ingress can lead to concealed damage, including timber rot and mould growth.</p> <p>Elevated moisture readings in tiled wet areas can occur from normal shower use, age/deterioration of waterproofing membranes, plumbing leaks or moisture absorption through grout lines. While no damage was visible, elevated readings may indicate moisture retention behind tiles, which can be a conducive condition for future</p>

deterioration if not monitored.

No immediate action required. Monitor the area over time for signs of drumming, efflorescence, tile movement, or grout deterioration. If concerns arise, a licensed waterproofing specialist can perform further investigation (e.g., pressure testing, membrane assessment).

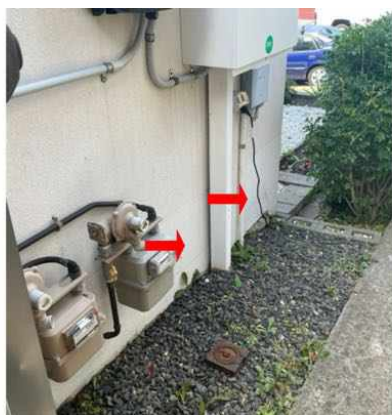
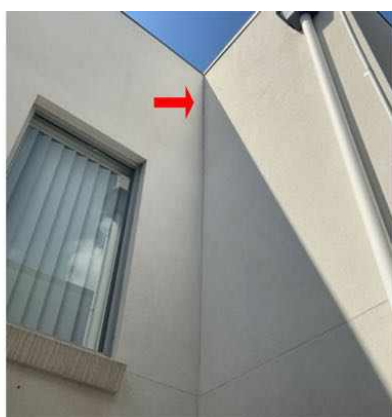
which are less than 1.0mm in width limit.

Damage of this category is not considered a defect for rectification. Always contact your building inspector should cracks widen, lengthen, or become more numerous.

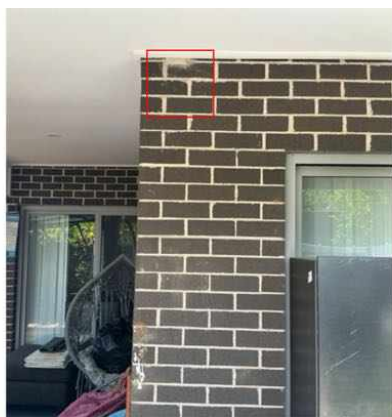
Finding 3.14

Building:	Main Building
Location:	All External Areas
Finding:	Brickwork - Deteriorated mortar to some areas
Information:	Mortar, or 'bedding', is the material which fills joins and intersections between bricks in masonry walls and structures. Sections of mortar in this brickwork were identified as having deteriorated, which is generally expected for a property of this age and condition.

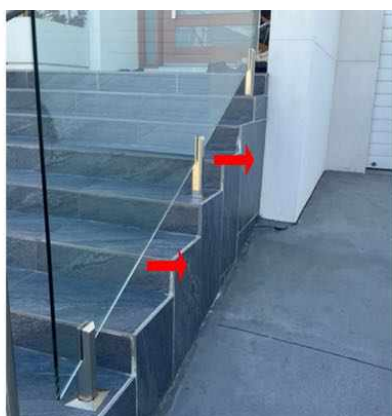
Finding 3.15

Building:	Main Building
Location:	All External Areas
Finding:	Building element - Damaged - timber damaged , weathered and some areas showing early signs of decay
Information:	Breakage occurs generally when the building materials have either aged and decayed, or as a result of damage (accidental or deliberate).

Specialist trades are available for these types of services. A registered builder may be required to undertake works if damage is extensive or if secondary building defects have resulted. Otherwise, it is advised that a tiling contractor be appointed to perform works as necessary. Immediate action is recommended to ensure that no further damage is sustained in the affected area.

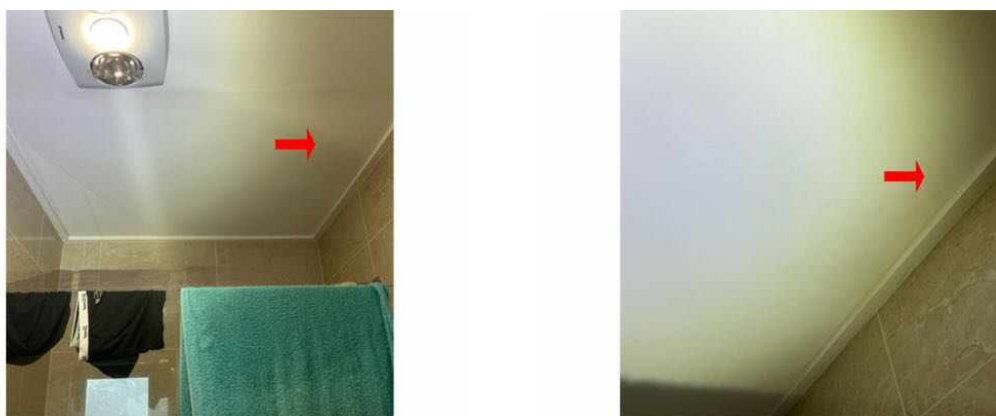
Finding 3.21

Building:	Main Building
Location:	Ensuite
Finding:	Water Staining - Humidity or Ventilation
Information:	The ceiling surface shows faint darkened spotting or shadowing, commonly consistent with surface mould or humidity-related staining, often found in bathroom or wet area ceilings with insufficient ventilation. While there is no visible sagging or major water damage, the pattern suggests prolonged moisture exposure, possibly due to steam accumulation or minor condensation issues. According to AS 4349.1–2007 (Appendix C), this would be classified as a minor defect unless further deterioration or active leaks are found. Recommend improving mechanical or natural ventilation, cleaning the surface with mould treatment, and monitoring for recurrence.

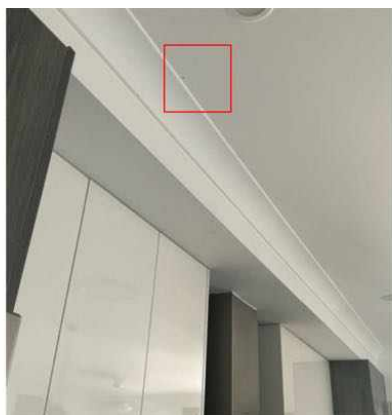
Finding 3.22

Building:	Main Building
Location:	All Internal Areas
Finding:	Building element - Damaged , external kitchen cabinets moisture damage
Information:	Breakage occurs generally when the building materials have either aged and decayed, or as a result of damage (accidental or deliberate).

Re-fastening of popped nails will help to maintain the stability of the internal ceiling and associated building elements. Such minor works will also help to improve the appearance of the affected area and secure the ceiling sheets, so as to prevent the onset of ceiling sagging. These works should be performed by a qualified carpenter or plasterer at client discretion.

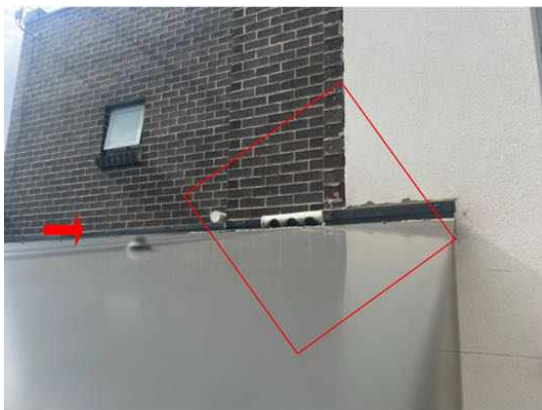
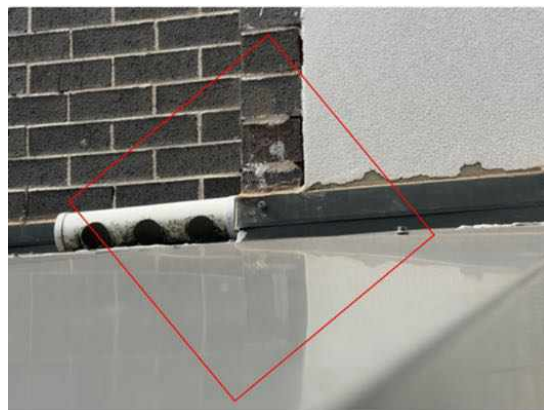
Finding 3.27

Building:	Granny-Flat
Location:	All Internal Areas - Granny
Finding:	Flashing defective -poor installation
Information:	The metal flashing at the wall junction appears inadequately installed, with visible gaps and lifting and reliance on surface sealant rather than a properly chased and continuous detail. The junction does not appear fully weather-tight, increasing the risk of moisture ingress into the wall cavity or roof structure over time. Defective flashing installation can lead to concealed deterioration if not addressed. Recommend assessment and rectification by a qualified roofing contractor to ensure compliant and effective weatherproofing.

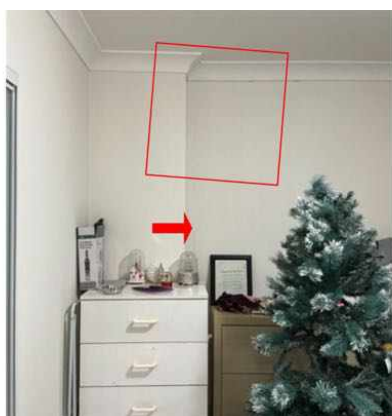
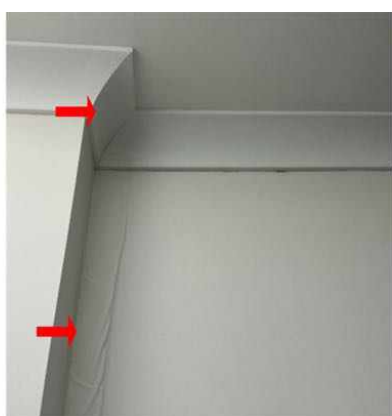
Finding 3.28

Building: Granny-Flat
 Location: All Internal Areas - Granny
 Finding: Painted surface - Bubbling
 Information: Sections of paint in this area was found to have bubbled and deteriorated. Paint bubbling is generally an indication of excessive moisture in the area, that is currently hidden by the painted surface.

It is highly advised that the affected paint be cleaned to allow a further, more invasive inspection by a licensed plumber. Failure to act on this defect may necessitate major works in the future.

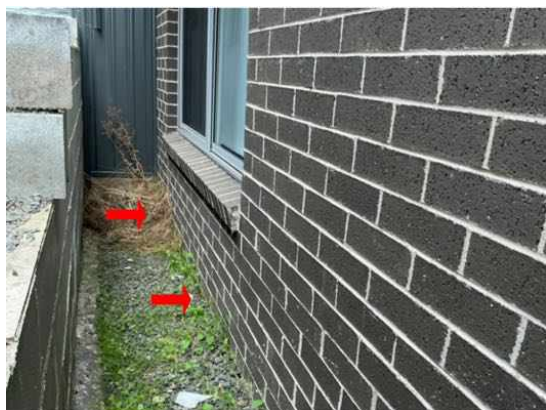
Finding 3.35

Building:	Granny-Flat
Location:	All Internal Areas - Granny
Finding:	DPC & Weep Holes
Information:	The ground level is nearly flushed or level with no visible step-down or separation from the weep holes or the damp-proof course (DPC). This presents a moisture risk, as AS 2870 and NCC Volume 2 Part 3.1.2 require ground levels or hard surfaces to be at least 75 mm below the DPC or the lowest course of brickwork with weep holes to prevent rising damp or lateral moisture ingress. Monitoring is recommended along with creating a 75 mm clearance or isolation gap along the wall line as required by NCC Vol 2 Part 3.1.2.3 and AS 2870 Clause 5.3.3. Monitor for any signs of rising damp or efflorescence.

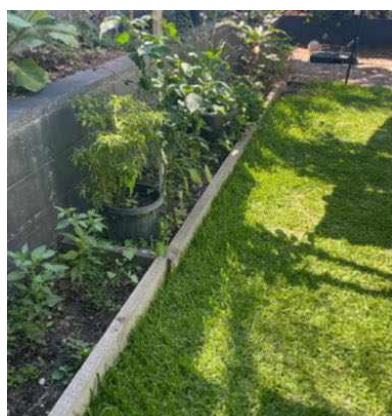
Finding 6.04

Building: Main Building
 Location: All External Areas
 Finding: In ground contact - Timber
 Information: Any timbers in direct ground contact provide opportunity for concealed termite entry

Remove untreated timber that is in direct contact with external grounds. Consider replacement with more durable materials i.e. treated timber or non timber elements. Frequent pest inspections are advised to readily identify any termite activity in these areas.

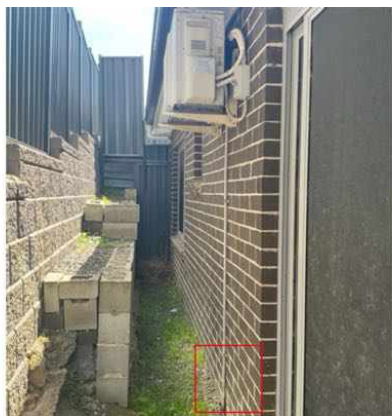
Finding 6.05

Building:	Main Building
Location:	All External Areas - Granny
Finding:	Air conditioner - Disconnected overflow
Information:	The Air Conditioner (A/C) overflow was found to be disconnected from storm water drainage and is creating excessive moisture in the surrounding area.

It is highly recommended that a licensed plumber be appointed to connect the A/C overflow in order to prevent such an environment from being created. These minor works should be carried out as soon as possible.

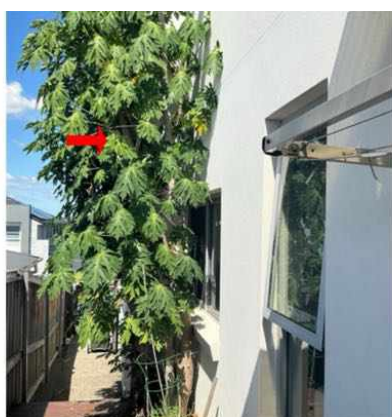
Finding 6.06

Building:	Main Building
Location:	All External Areas
Finding:	Bridging - Vegetation
Information:	Where vegetation obstructs inspection of building elements, also known as bridging as it provides a bridging point for the access of termites, full inspection can not be achieved. Consequently moisture or dampness may be present and the areas becomes conducive to termite activity. Plants against or very close to buildings provide cover, shade and can provide an environment that is attractive to termite infestation.

The removal of any such materials that may be conducive to termite activity should be carried out as soon as possible and arrange re inspection to minimize the risk of termite attack.
