# Building and Timber Pest Inspection Report

Inspection Date: Mon, 30 Mar 2026

Property Address: 26 Sydney Ave, Callala Bay NSW 2540,  
Australia

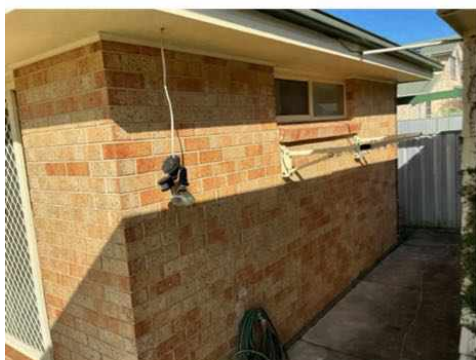
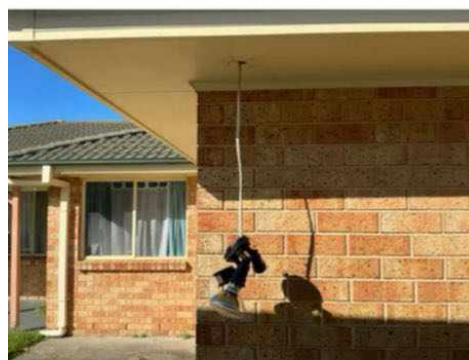
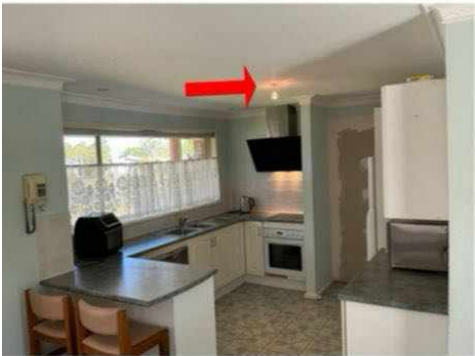
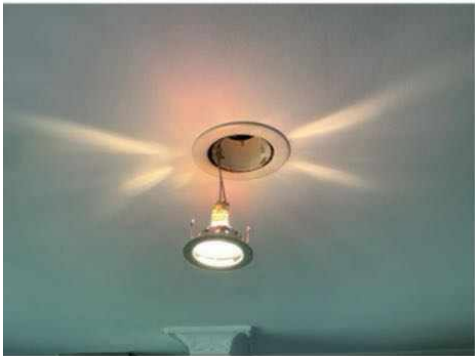
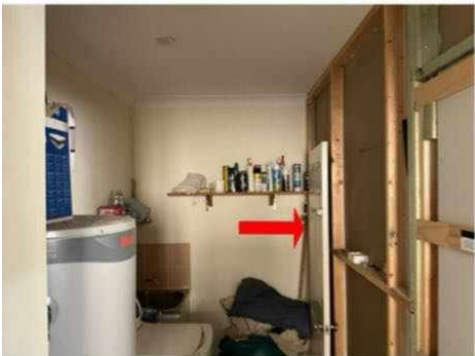
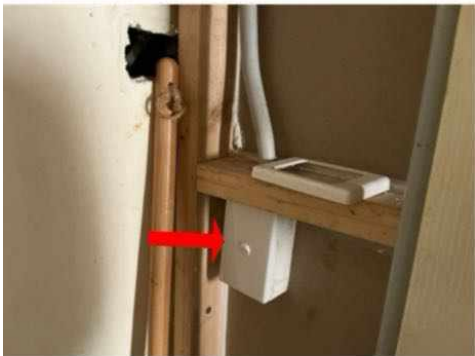
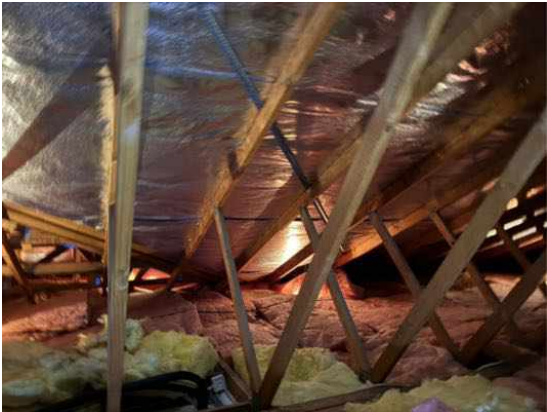
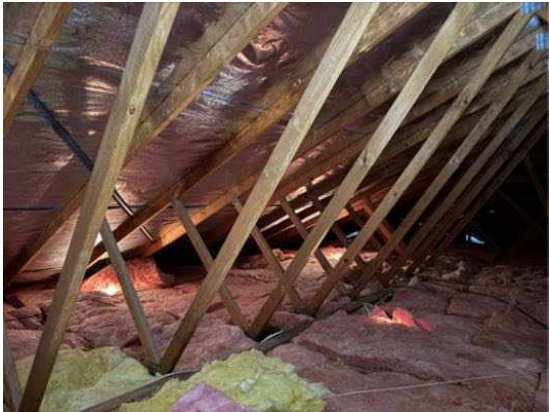
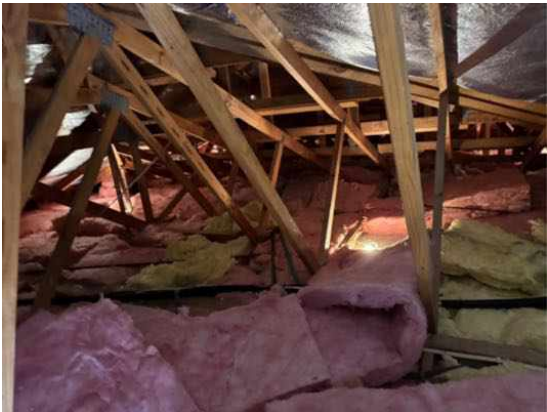
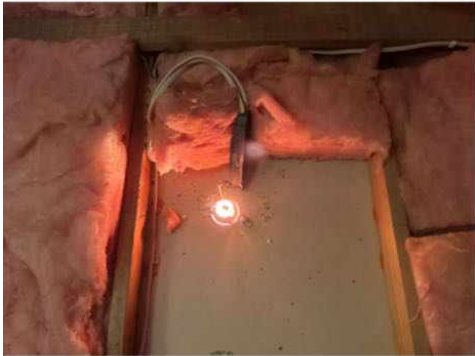
#### Finding 1.01

Building: Main Building  
Location: All Areas  
Finding: Electrical Defect Suspected  
Information: At the time of inspection it appeared that there were suspected defects with the electricals. This includes;

- rear spot light electrical not connected.
- loose lighting in the kitchen requires repairs.
- Laundry light switch not operational.
- halogen downlights require protective cans over them in the roof space to prevent roof space fires from the heat they generate.

Faulty wiring, switches and damaged outlets can cause shorting out of areas of the house, damage appliances and possibly cause electrocution or fires. It is advised all suspect issues be inspected by a licensed electrician before use.

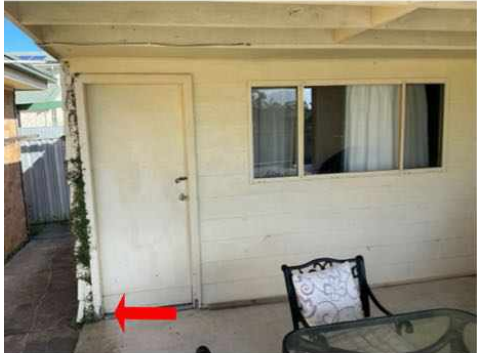
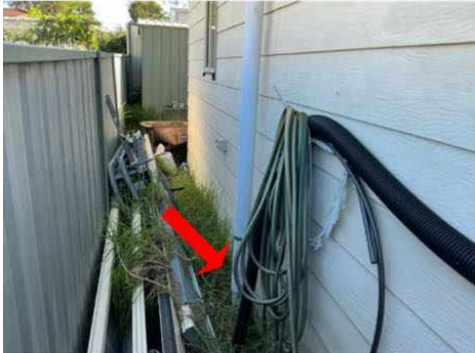
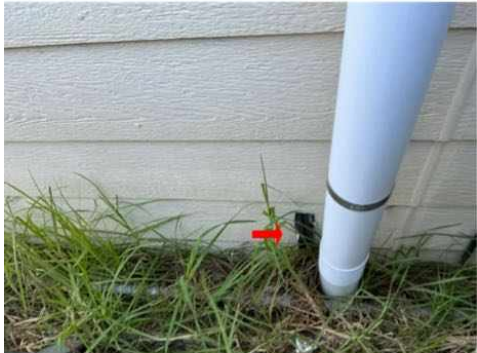
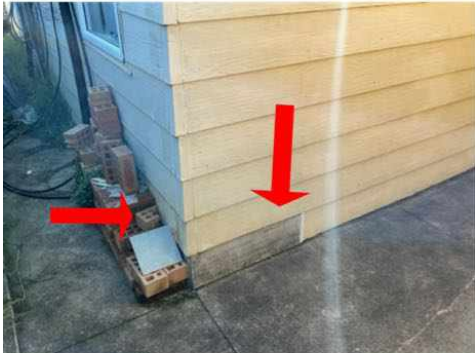
## Finding 2.01

Building: Main Building  
Location: Garage  
Finding: Cladding Damaged  
Information: At the time of inspection the cladding in this area appears to be damaged.

The cladding is the main barrier protecting the structural components and interior building elements against the weather. If the cladding is compromised this can trigger costly, secondary defects including wood rot, pest and mould ingress, electrical issues and damaged interior items. Any damaged cladding should be repaired as soon as possible to prolong the life of the internal building components.

A relevant, experienced tradesman should be contacted to complete the required works.

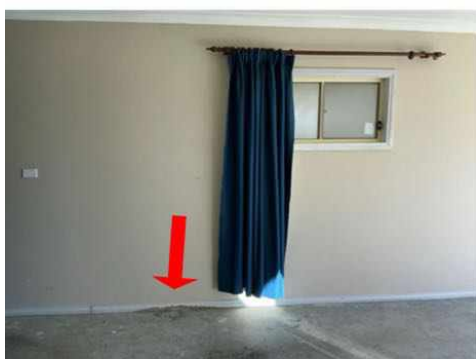
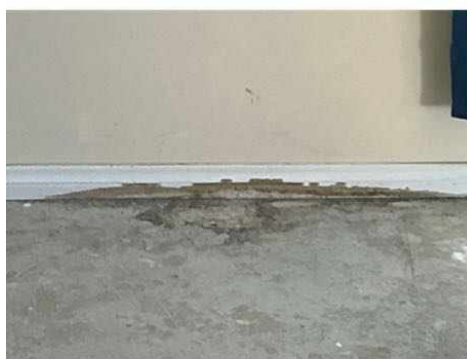
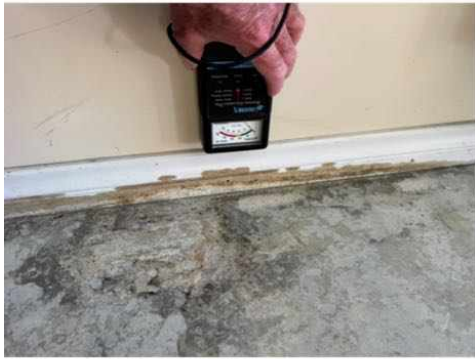
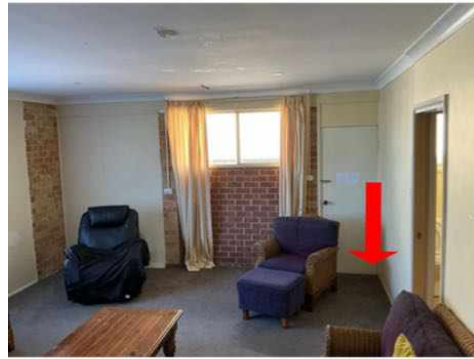
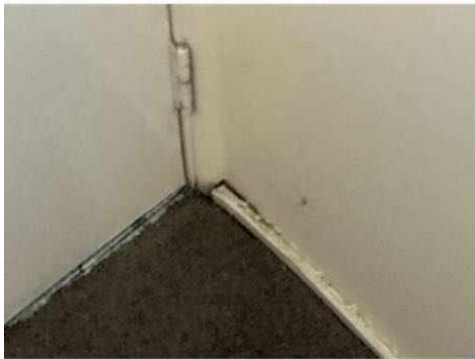
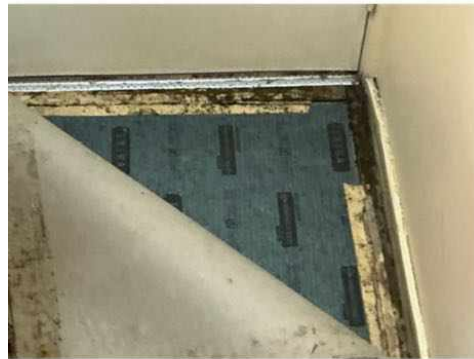
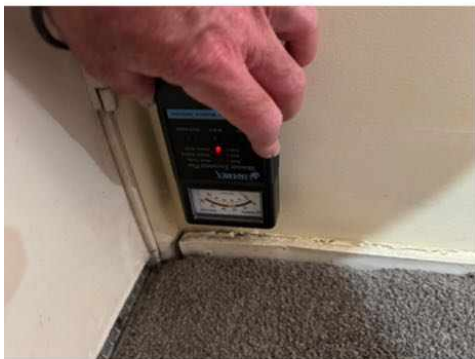
## Finding 2.02

Finding: Water Damage.

Information: At the time of inspection apparent water damage was evident in this area;

- water staining in the rear garage looks like a spill rather than an ongoing concern.

- Water staining was identified in the renovated front garage room.

The moisture meter readings around these areas were normal.

Water damage can be in many forms from staining, peeling paint and mould to swollen materials, decay and structural damage. These kinds of defects can be the result of water penetration, either externally or internally. It is advised the cause of the water ingress be identified as soon as possible to prevent any further deterioration. A more invasive inspection may have to be conducted to determine the extent of the damage. Replacement of materials is likely.

A licensed Builder should be consulted for rectification works.

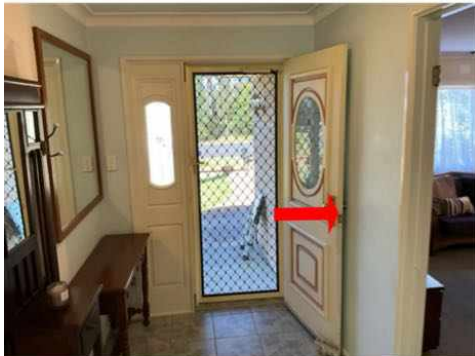
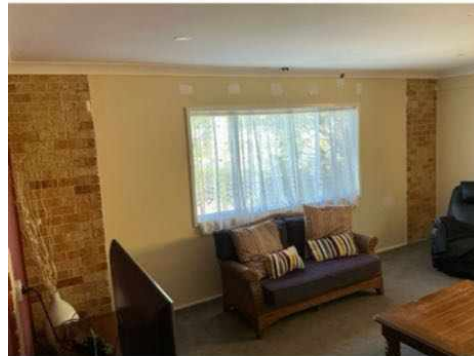
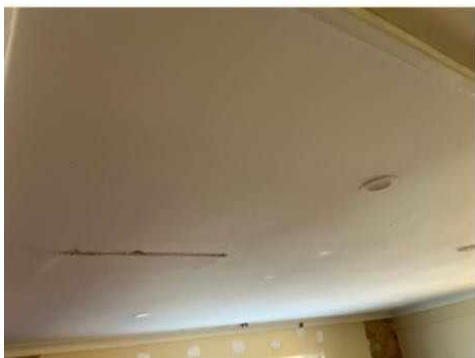
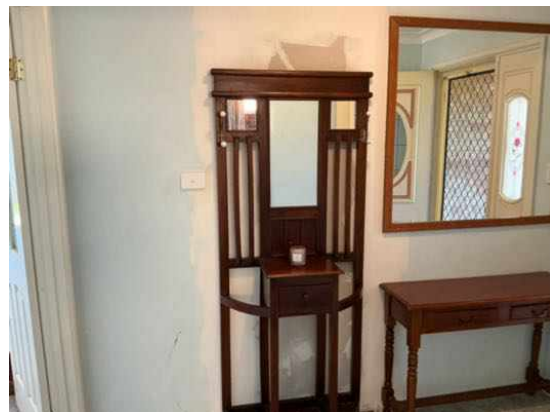
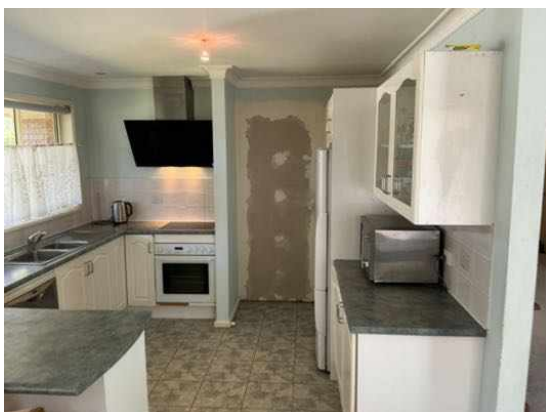
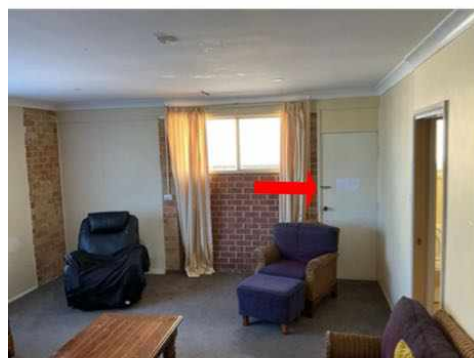
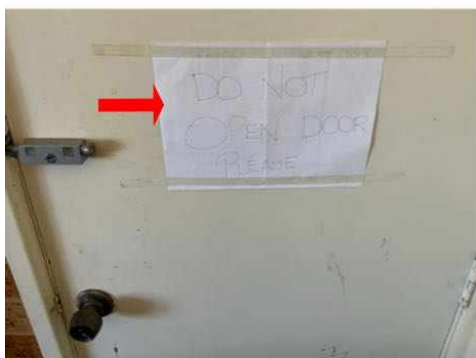
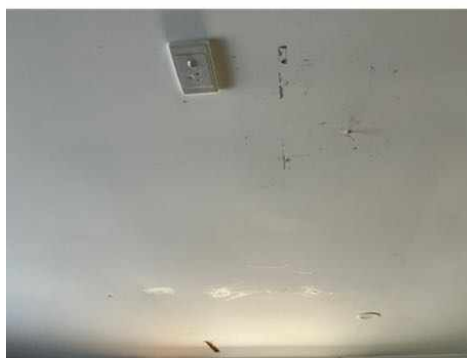
### Finding 3.01

Building:	Main Building
Location:	All Areas
Finding:	Building element - Damaged
Information:	Breakage occurs generally when the building materials have either aged and decayed, or as a result of damage (accidental or deliberate). This includes; <ul style="list-style-type: none"> <li>- sections of wall are scuffed requiring repairs.</li> </ul>

Repair and/or replacement of broken elements is advised to ensure that additional secondary defects do not arise as a consequence. Such works are necessary, as all building elements play a key role in the operation and function of the overall structure and its performance.

A relevant tradesperson should be appointed to provide a quote to repair or replace the affected building element prior to purchase.

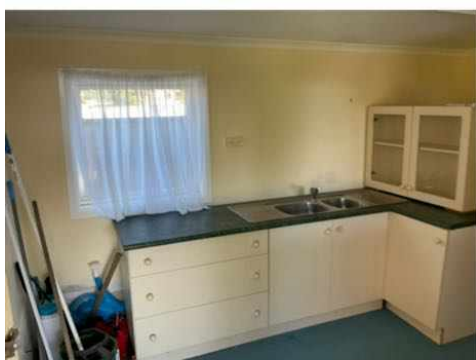
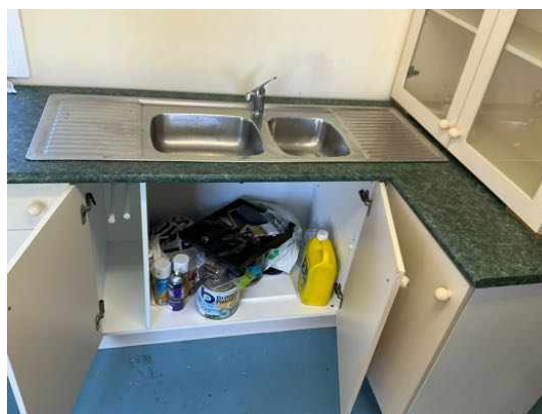
### Finding 3.02

Building: Main Building  
 Location: Garage  
 Finding: Building element - Not operating  
 Information: Non-operational items should be addressed to ensure that the full function of the building structure is available. Where some building elements are not operating as intended, it is possible that secondary building defects could arise due to their non-operation. This includes;

- storeroom sink plumbing not connected

Repair and/or replacement of the faulty building element is recommended. It is highly recommended that the relevant tradesperson be engaged to perform any necessary works.

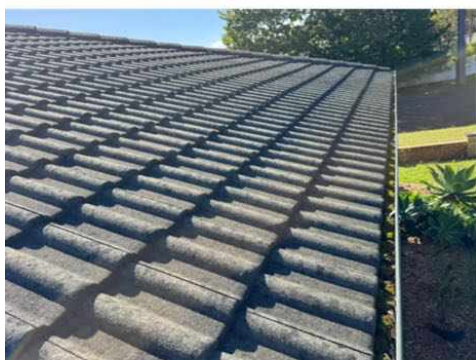
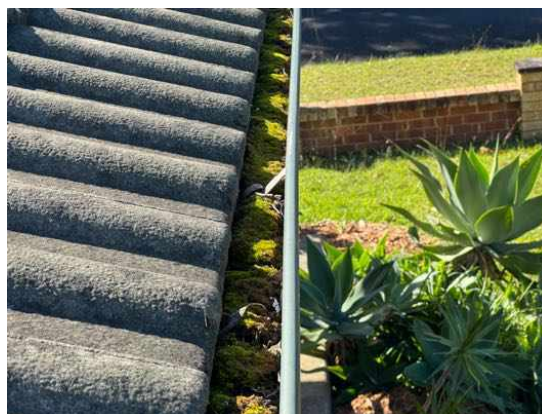
### Finding 3.03

Building: Main Building  
 Location: Roof Exterior  
 Finding: Gutters - Blocked  
 Information: Roof plumbing structures, such as guttering and downpipes, should be free of all debris to prevent blockages. Blockages of the guttering and downpipes will lead to

Blocked gutters are likely to lead to high levels of moisture in the affected areas. Such moisture will not only cause rust and decay of the associated building materials, but can also provide conditions that are conducive to termite and timber pest activity. Blockages in gutters should therefore be removed immediately to ensure dry conditions are maintained.

Consult a Licensed Plumber for further specific advice on remedial works that may be required. In the interim, it is highly advised that blocked gutters be removed by the homeowner or a general handyperson as a matter of urgency.

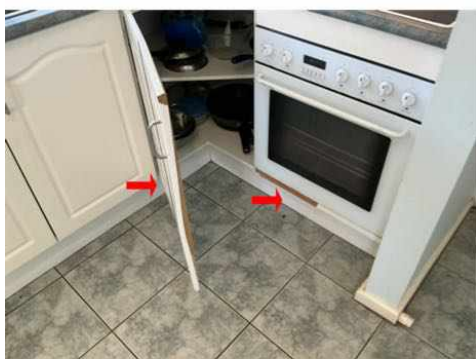
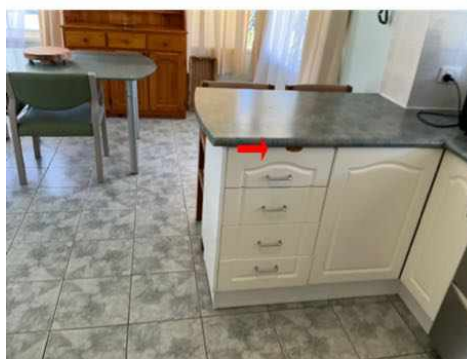
### Finding 3.04

Building:	Main Building
Location:	All Areas
Finding:	Delamination of timbers
Information:	Delamination is one means by which composite materials (e.g. layered timber composites) may fail over time. In laminated materials, repeated cyclic stresses may lead to the formation of mini-structures of separate layers, with significant loss of mechanical toughness. Water penetration or the presence of excessive moisture also generally contributes to delamination.

Where building materials have become delaminated, they lose their structural strength, and are likely to have a variety of appearance and serviceability defects as a result.

Delamination of timbers may be repaired where the area affected is minor and/or easily accessible, by gluing and screwing layers back together. However, this is an interim repair, and where delamination has occurred, the client should plan for the replacement of affected timbers sooner than would otherwise be expected.

All timber structures affected by delamination should be replaced as soon as possible to avoid any further damage. Repair and replacement estimates should be sought from a registered builder or qualified carpenter.

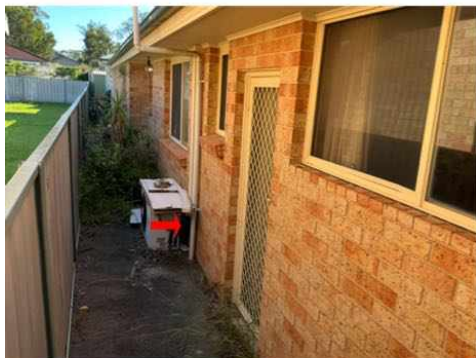
Finding: Air-conditioning unit - Condensation Pipe Leak

Information: Leaking from an external air-conditioning unit condensation pipe is a normal function of the unit, however this should be plumbed into the house drainage or directed away from the house structure.

Heavy leaking from the air-conditioning unit is likely to produce damp conditions in the surrounding area conditions which are conducive to termite attack. If left unattended, such leaking can develop into water pooling below the unit, creating potential for subsequent water damage to associated building elements.

A refrigeration mechanic or licensed plumber should be appointed to assess the condition of the unit and to perform any remedial works as necessary. While discharge from an air-conditioning unit can generally be managed through basic plumbing work, such appointments are deemed necessary to identify any major issues.

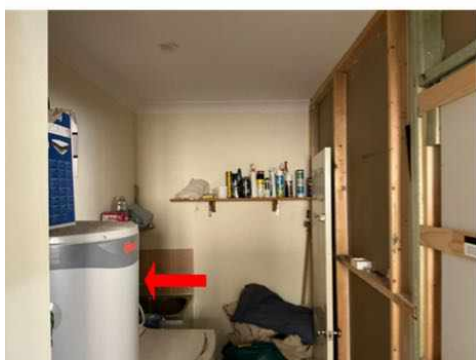
### Finding 6.03

Building:	Main Building
Location:	Exterior walls
Finding:	HWS Overflow - Not Connected
Information:	The Hot Water System (HWS) overflow was found to be disconnected from storm water drainage and is creating excessive moisture in the surrounding area.

These damp conditions can lead to secondary defects such as rot, rust or corrosion of associated building elements, the formation of fungal decay, or even the creation of potential slip hazards. When coupled with poor site drainage, pooling of water may also attract termite activity to this area.

It is highly recommended that a licensed plumber be appointed to connect the HWS overflow in order to prevent such an environment from being created. These minor works should be carried out as soon as possible.

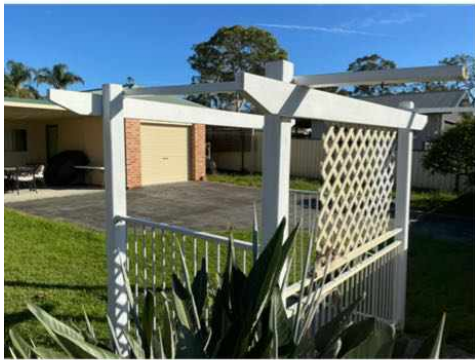
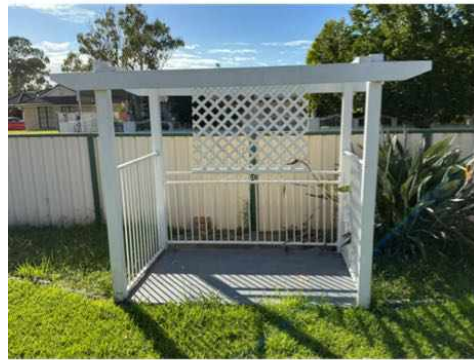
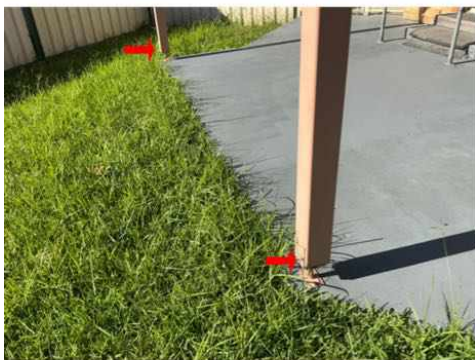
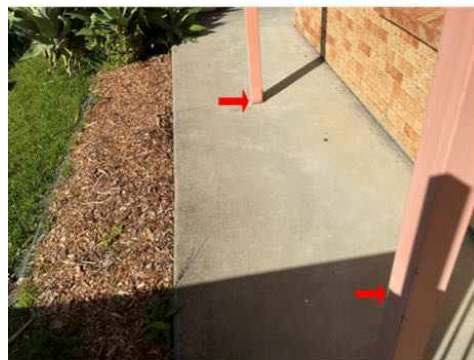
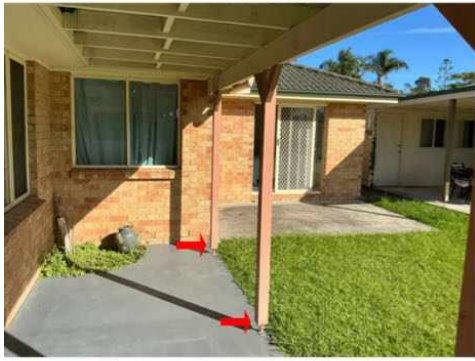
### Finding 7.01

Building:	Main Building
Location:	All Areas
Finding:	Fungal decay - present (localised)
Information:	Fungal decay also known as wood decay generally refers to the deterioration of timber elements when in contact with excessive levels of moisture for a prolonged period of time. Generally fungal decay develops on timber elements that are in use in an external environment which are exposed to rain penetration.

In this case although the affected timber element is in a decaying state the extent of any visible damage appears to be localised to a specific area. The fungal decay is therefore likely to be of a relatively superficial nature with minimal impact on the structural integrity or tensile strength of the timber element.

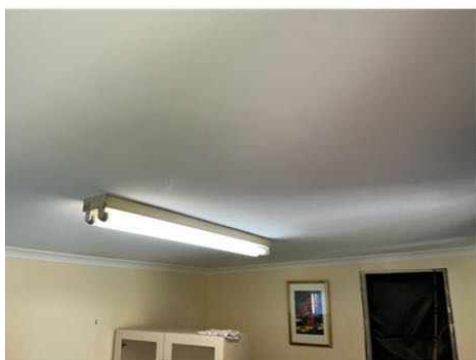
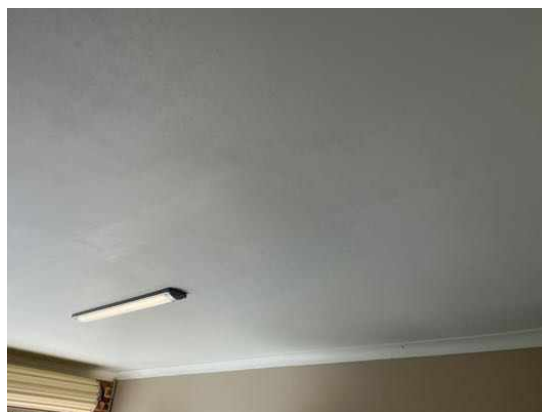
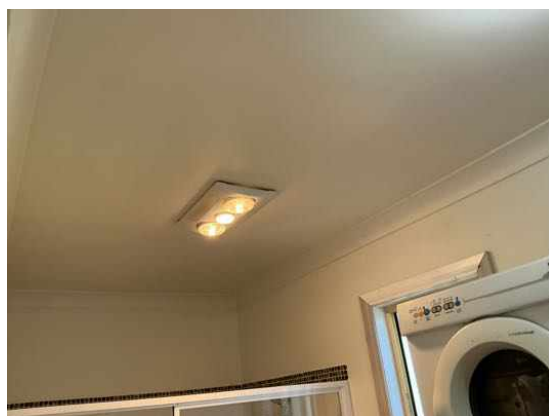
- no access to the garage roof space.

The condition of this area is unknown. Alternatively access to this area is highly recommended for a more comprehensive inspection of the building.

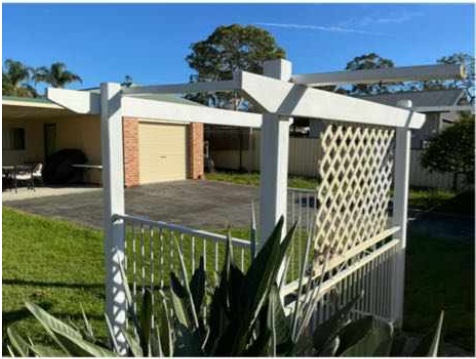
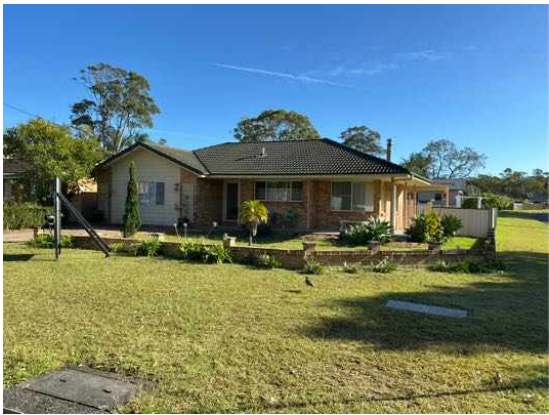
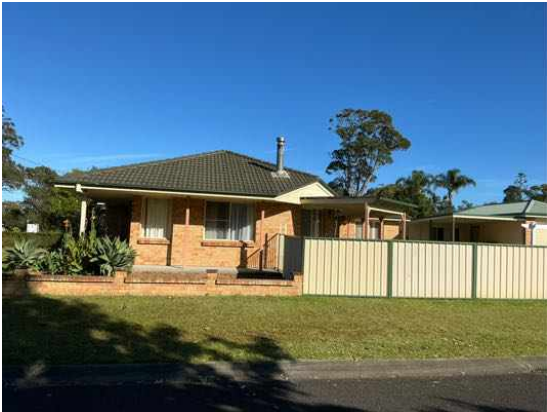
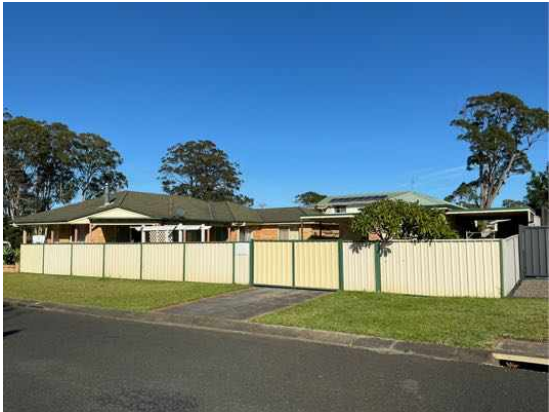
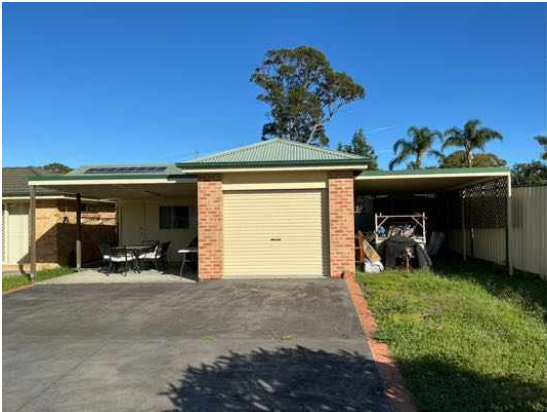
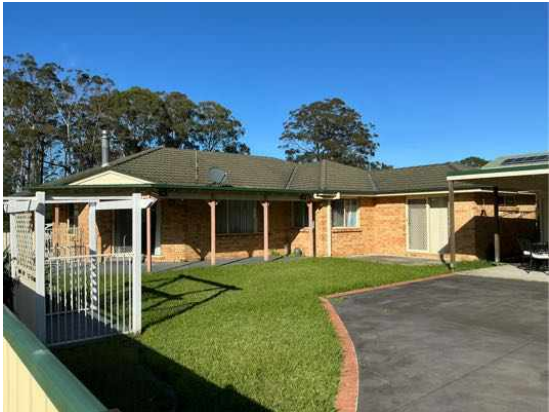
Building: Main Building  
 Location: All Areas  
 Finding: Additional Photos - Obstructions and Limitations  
 Information: These photographs are an indication of the obstructions and limitations which

impeded full inspection of the property at the time of inspection. These obstructions can hide an array of defects and should be removed to allow full inspection to be carried out. A re-inspection is recommended once the areas are made accessible.

- areas bridging termite management systems.
- areas too small to enter in the roof space and walls.
- skillion roofing has no access to the roof void.
- no access to the garage roof space.
- no access through wall, floor, ceiling and roof linings.
- patios.
- stored items.
- furniture.
- insulation & sarking.
- rubbish and debris.
- obstructions from other building materials.
- finished concrete and paving levels.
- finished ground levels.
- vegetation.

A further invasive inspection is recommended to these areas immediately.

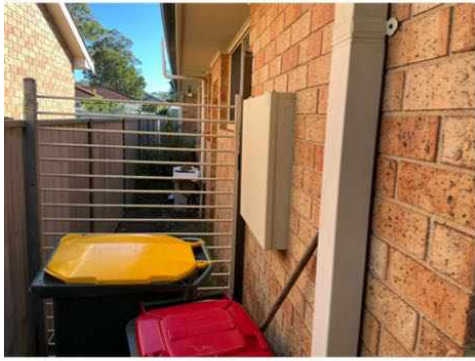
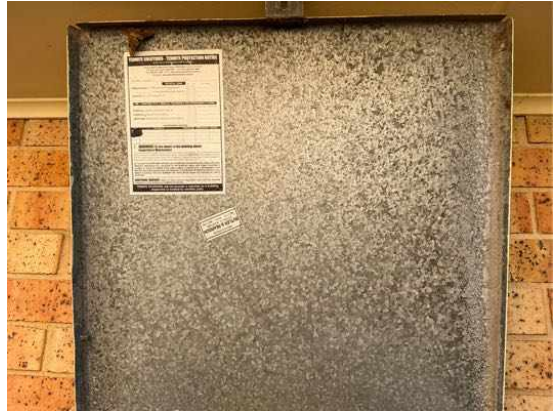
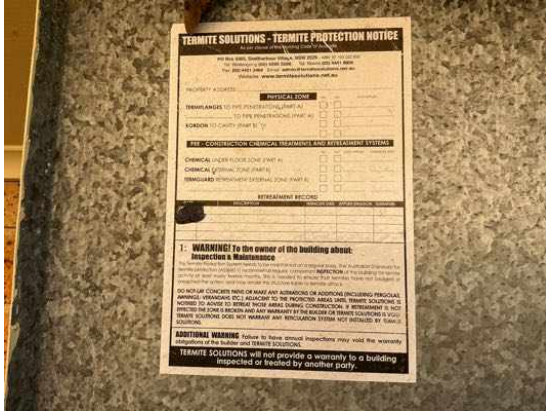
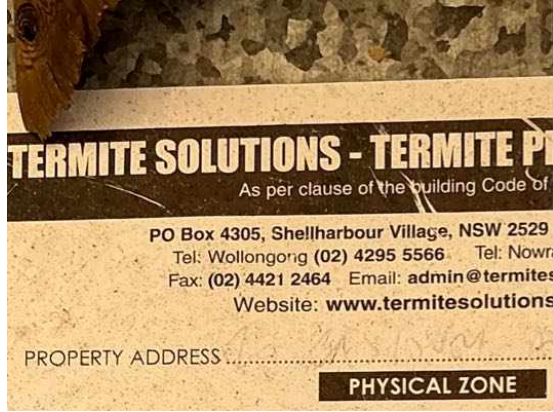
Where a Termite Management System has been identified you should refer to the type of barrier date of installation warranty conditions and any documentation provided by a builder or past owner. Consult the company who installed the barrier to confirm whether the system is still under warranty.

Most chemical termite management systems expire and require replenishment and all physical systems are primarily designed to prevent concealed entry.
