Building and Timber Pest Inspection Report

Inspection Date: Fri, 13 Mar 2026

Property Address: 92A Sixth Ave, Altona North VIC 3025,
Australia

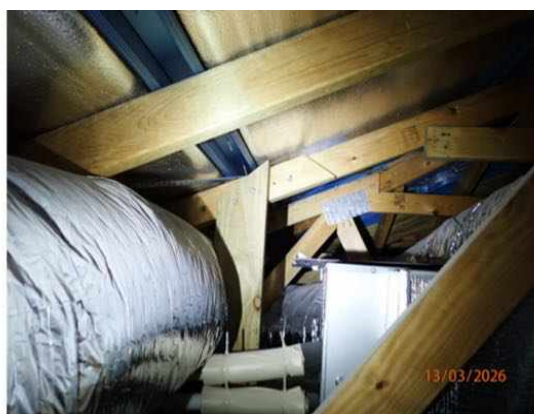
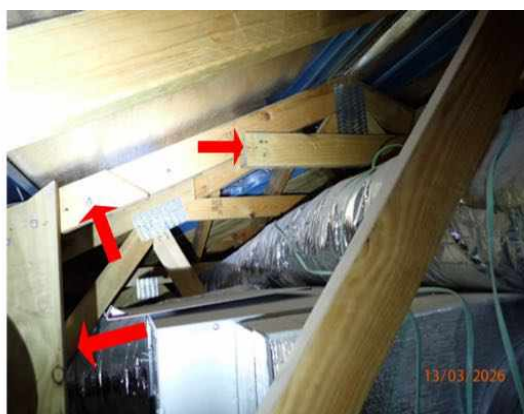
Finding 2.01

Building:	Main Building
Location:	Roof Void
Finding:	Roof truss modified/cut for air-conditioning unit:
Information:	During the inspection, a roof truss was noted cut/modified to allow installation of the air-conditioning unit. Temporary additional timber members were also noted screwed and nailed to the truss as an apparent make-shift support. Unauthorised modification of roof trusses is considered a major defect, as it may affect the structural performance of the roof frame. It is highly recommended that this be brought to the attention of your builder and that the truss manufacturer and/or a structural engineer be engaged to verify whether the modification has been carried out in accordance with the manufacturer's requirements and to specify any necessary rectification.

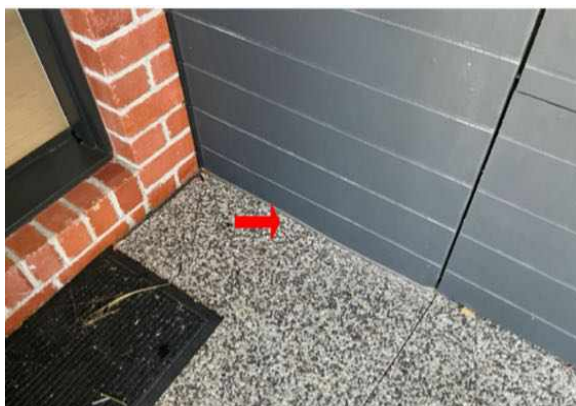
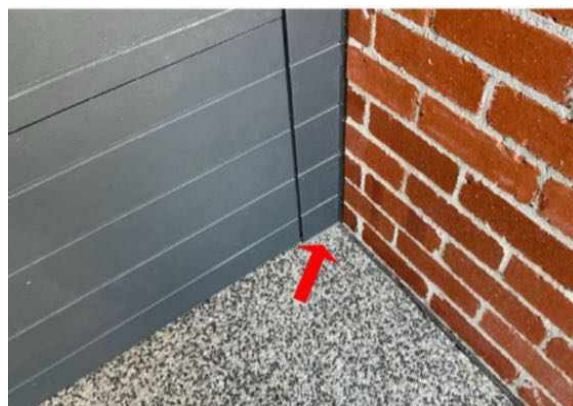
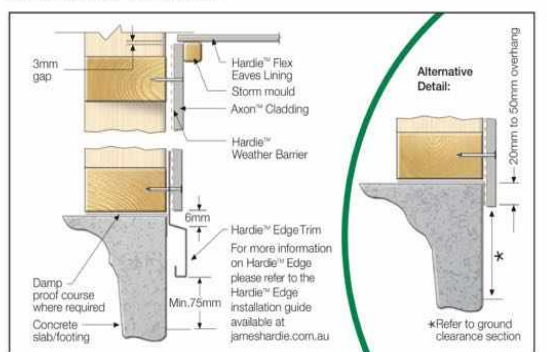
Finding 3.01

Building:	Main Building
Location:	Exterior walls - front
Finding:	External cement sheet cladding installed too into paving:
Information:	In this section of the house, the external cement sheet cladding was noted embedded into to the external concrete , and this installation does not follow normal manufacturer installation practice, which generally requires clearance between the bottom of the

cladding and finished ground surface. If left as is, this may allow moisture uptake, premature deterioration, and damage to the lower walling materials—engage a registered builder and qualified carpenter to assess the cladding installation and carry out rectification to provide appropriate clearance and weather protection urgently.

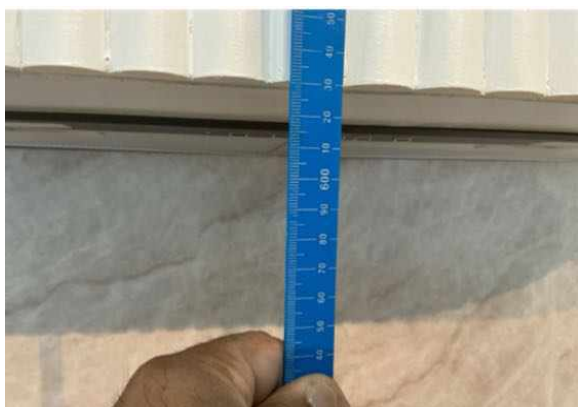
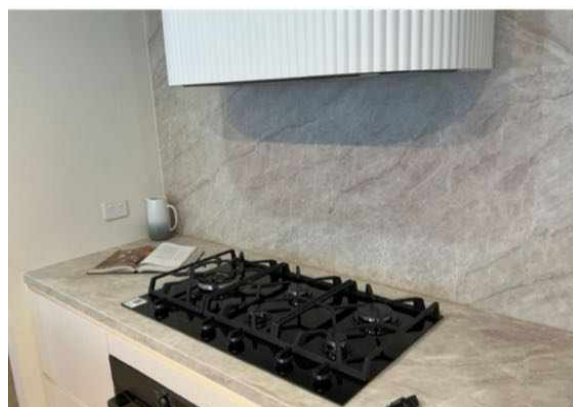
Finding 3.02

The distance between the cooktop and the range hood was noted to be 630mm

When installing a domestic gas cooking appliance, AS/NZS 5601.1: 2013 Gas installations : General installations explains that the required clearance distance between a gas cooking appliance and a range hood or exhaust fan must be in accordance with the manufacturer's relevant instructions or 650mm

This defect creates a potential safety hazard and should be rectified as soon as possible to ensure the safety of the occupants and to meet present building standards and regulations.

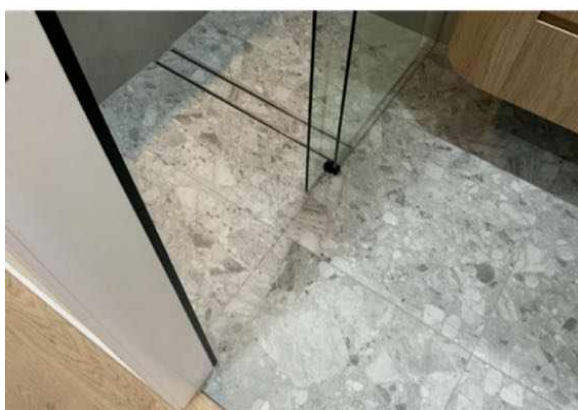
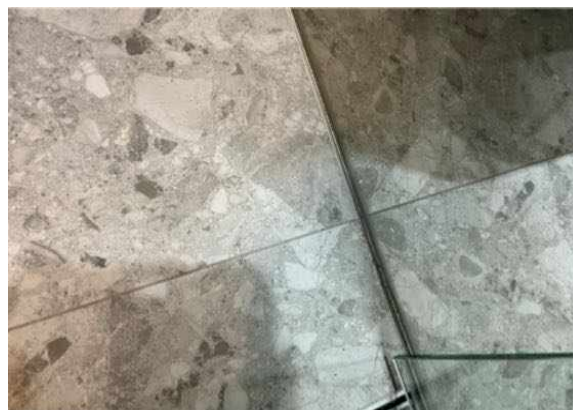
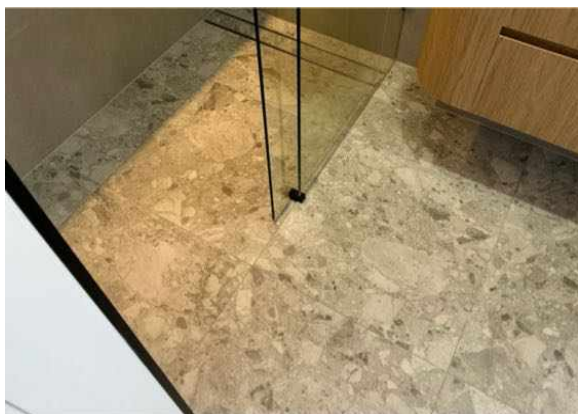
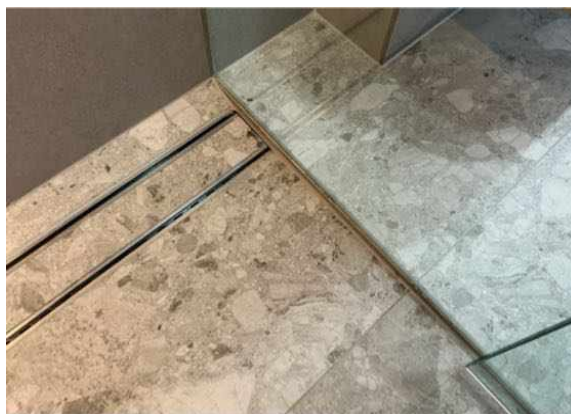
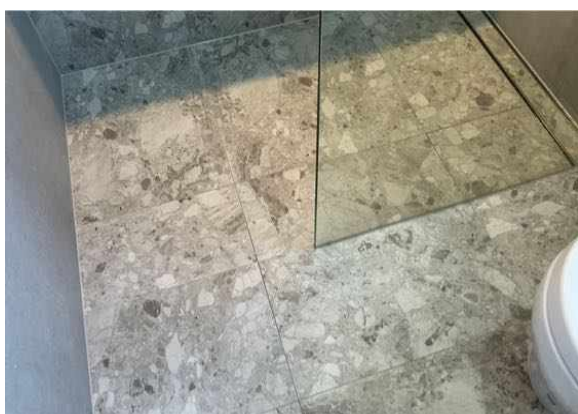
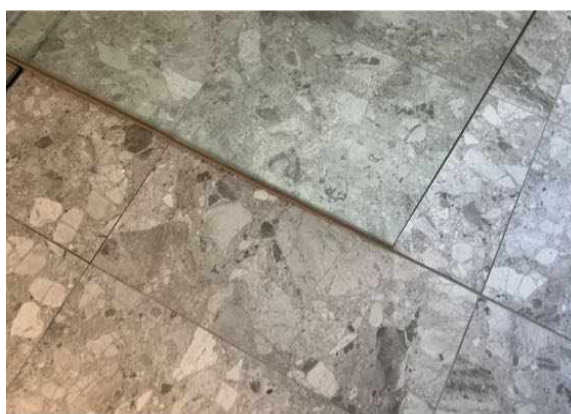
Finding 3.03

Building:	Main Building
Location:	Bathroom 1, 2 and 3
Finding:	Water stop not visible in shower
Information:	During the inspection in the bathrooms, the water stop to the shower area was not visible. Water stops are essential components of waterproofing systems designed to prevent water or moisture from escaping the wet area and causing damage to other materials and structural building elements.

The absence of visible water stops suggests potential issues with the waterproofing of the shower areas. Without proper waterproofing, water leakage can occur, leading to damage to surrounding materials and compromising the structural integrity of the building.

It is recommended to further investigate the waterproofing system of the shower areas to ensure they meet appropriate standards and to address any deficiencies promptly to prevent water damage issues in the future. If necessary, consulting a qualified waterproofing specialist for an assessment and potential remediation is advised.

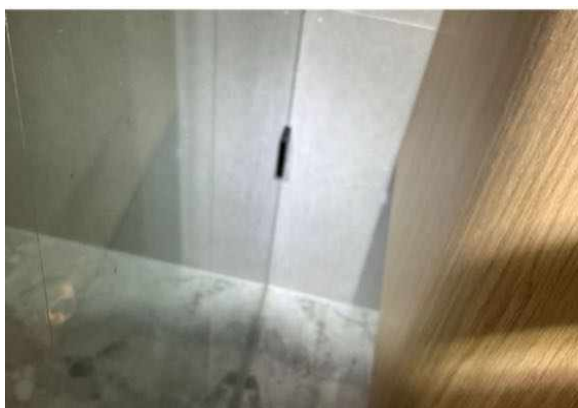
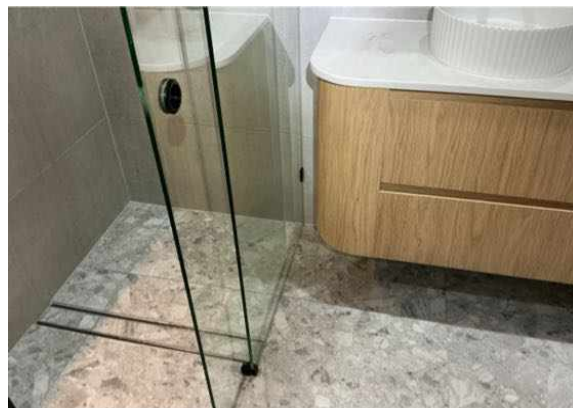
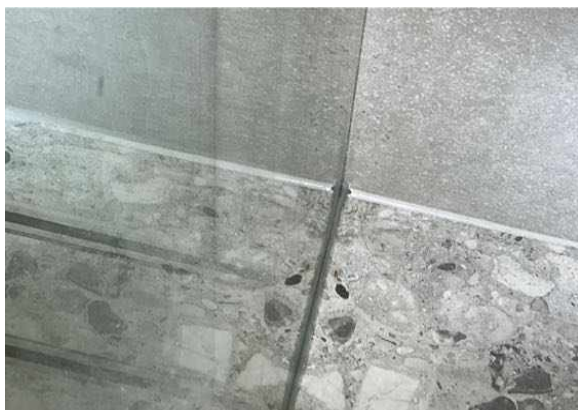
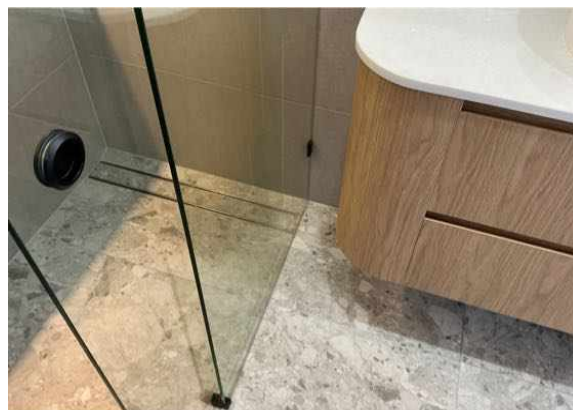
Finding 3.04

Building:	Main Building
Location:	Bathroom 1&2
Finding:	Shower - Leaking
Information:	Leaking was evident to the shower at the time of inspection. It is suspected that the leaking is occurring due to damaged or missing sealant.

Leaking from the shower, where left unattended, is likely to lead to water damage to adjoining flooring and walls. Such damage can lead to water damage and necessitate extensive remedial works being required. Active water leaks may also create an environment that is susceptible to the formation and development of mould and conducive to termites

Appointment of a tiling contractor is required to repair or seal the shower. Such works should be performed as soon as possible to ensure that no further damage occurs.

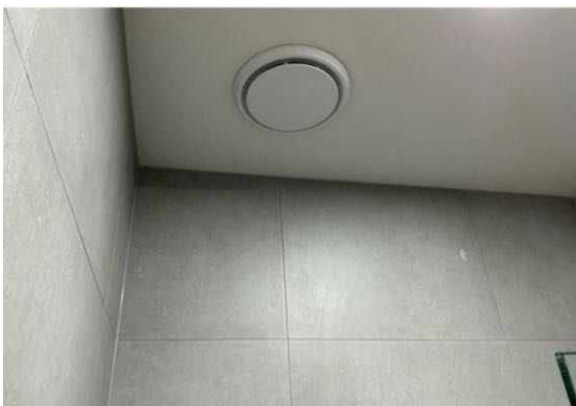
Finding 3.05

Building:	Main Building
Location:	Bathroom 1
Finding:	Exhaust fan timer not provided
Information:	During the inspection, the exhaust fan to the bathroom was noted not provided with a 10-minute run-on timer. Under NCC 2022 Volume Two H4D9, condensation management is satisfied by compliance with Part 10.8 of the ABCB Housing Provisions, and Clause 10.8.2(4) requires that an exhaust system serving a bathroom or sanitary compartment that is not ventilated in accordance with 10.6.2(a) be interlocked with the light switch and include a run-on timer for 10 minutes after the light is turned off. It is recommended that you discuss this with your builder and arrange rectification by a licensed electrician to confirm the exhaust fan complies with the NCC requirements.

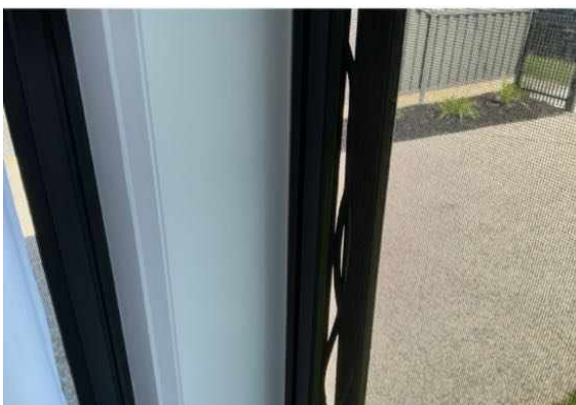
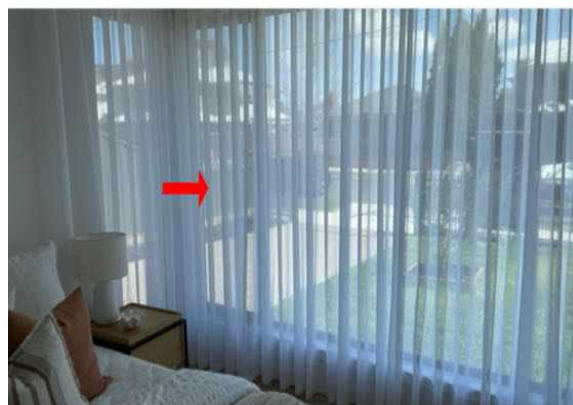
Finding 3.06

Building:	Main Building
Location:	Bedroom
Finding:	Damaged window rubber seal:
Information:	During the inspection, the rubber seal to the window was noted damaged or not properly attached. As per the Guide to Standards and Tolerances 2015 – Clause 8.02 (Weather-tightness of windows and doors), windows are defective if they are not sealed properly and may allow water entry. It is recommended to discuss this with your builder and arrange rectification by a registered builder or suitable tradesperson.

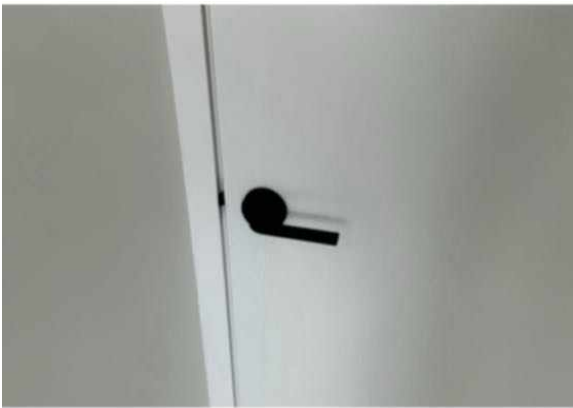
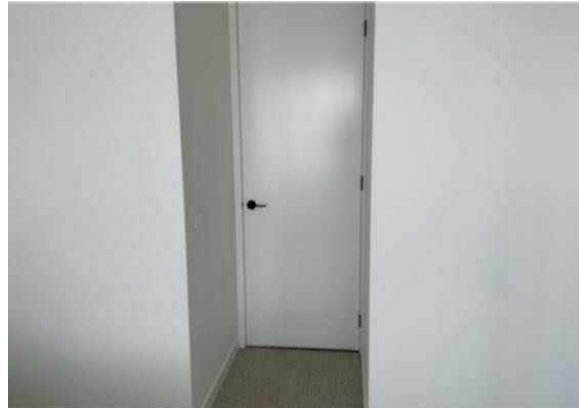
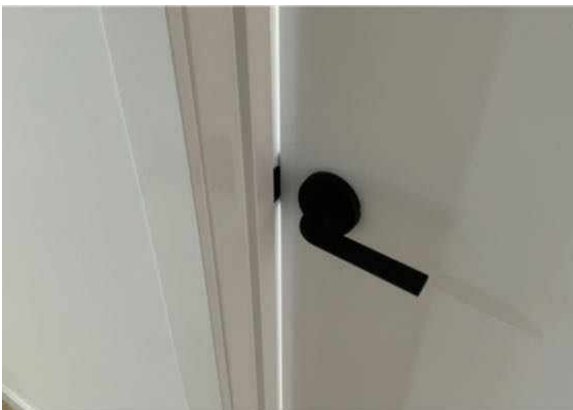
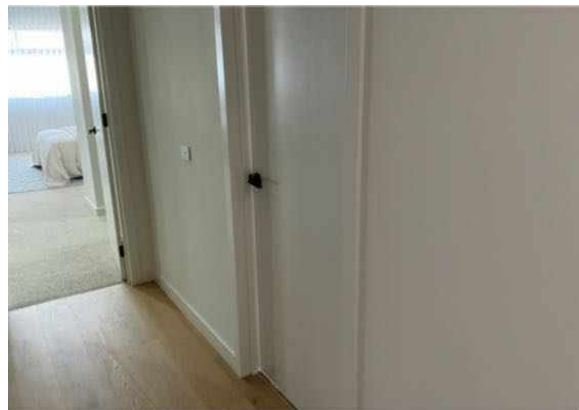
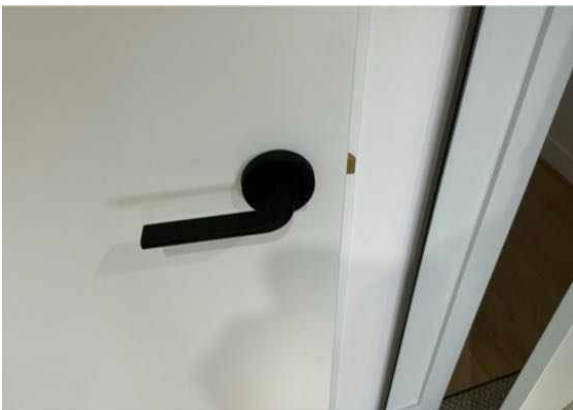
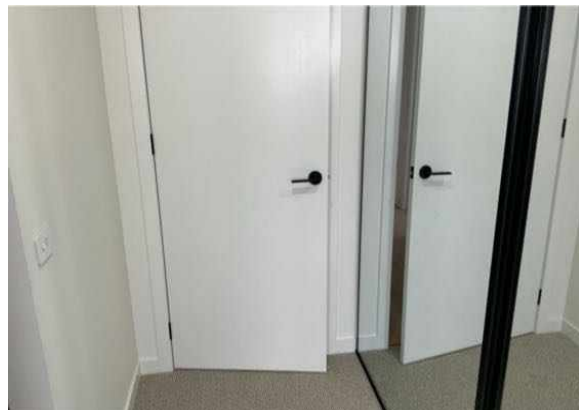
Finding 3.07

Building:	Main Building
Location:	Bedroom 2&3 and 4
Finding:	Door - Striker plate misaligned
Information:	The striker plate on this door was noted misaligned during inspection, affecting the door's operation.

Misalignment can result from general wear and tear or substandard installation, making it difficult to open or close the door.

It is recommended to engage a qualified carpenter or general handyman to realign the

striker plate and restore the door's proper functionality.

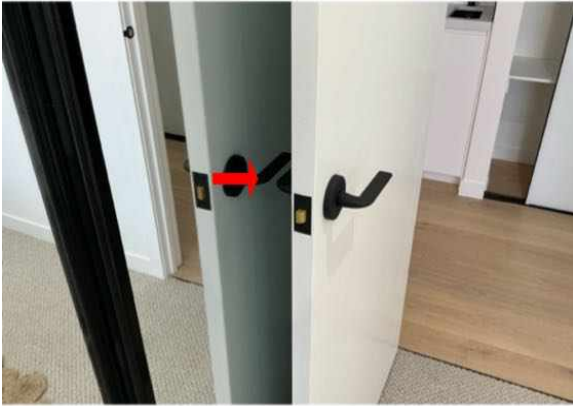
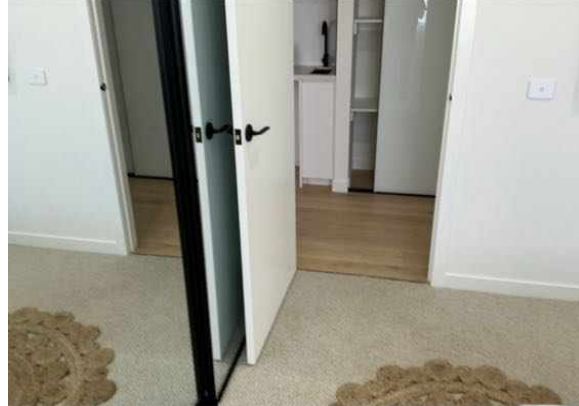
Finding 3.08

Finding: Door stop incorrectly positioned:

Information: During the inspection, the door stop for this door was noted improperly positioned, resulting in the door handle contacting the glass wardrobe door when opened. This condition may lead to damage to the glass if left unresolved. It is recommended to discuss this with your builder and have a registered builder or suitable tradesperson adjust or reposition the door stop to prevent contact.

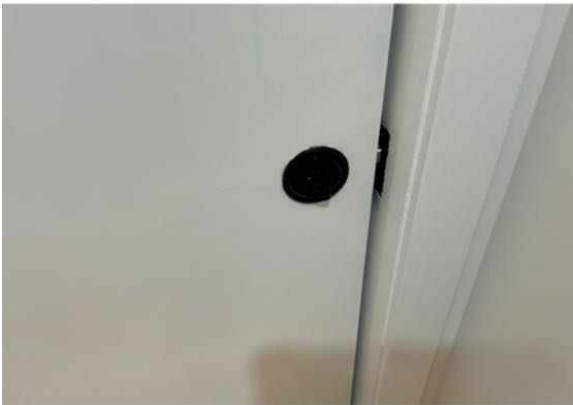
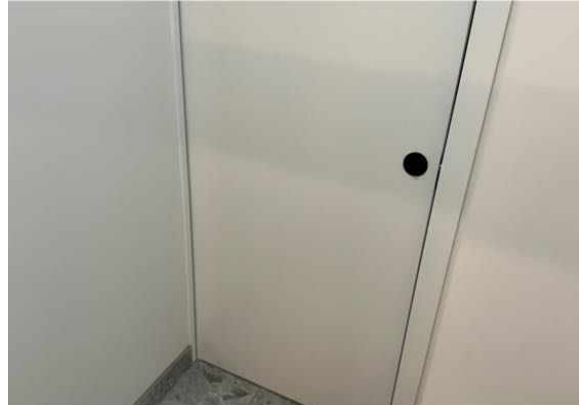
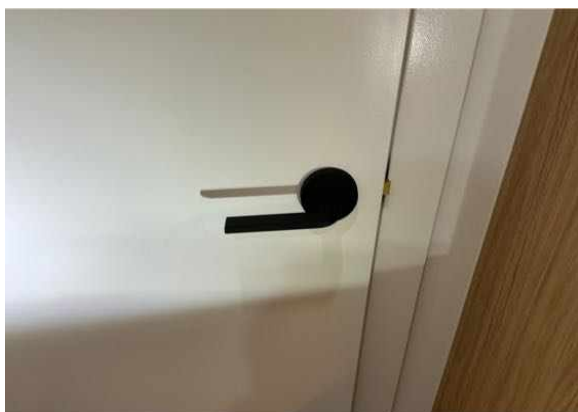
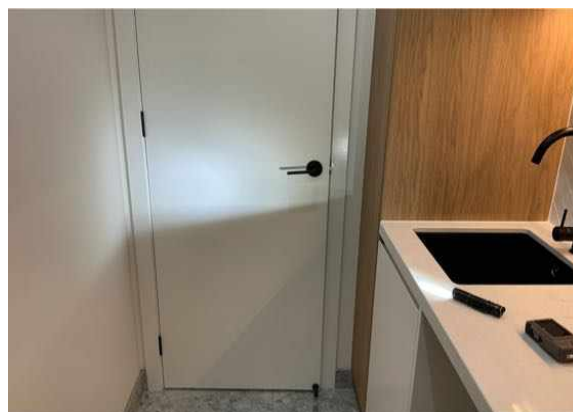
Finding 3.09

Information: The striker plate on this door was noted misaligned during inspection, affecting the door's operation.

Misalignment can result from general wear and tear or substandard installation, making it difficult to open or close the door.

It is recommended to engage a qualified carpenter or general handyman to realign the striker plate and restore the door's proper functionality.

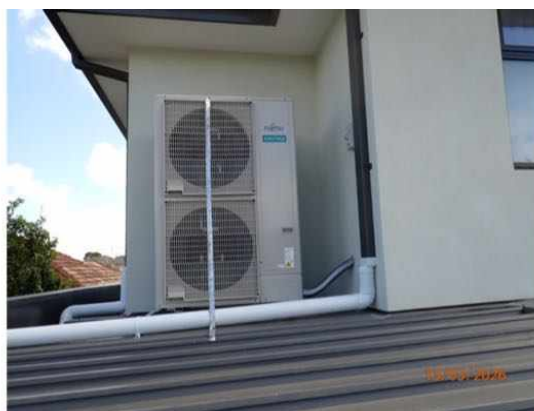
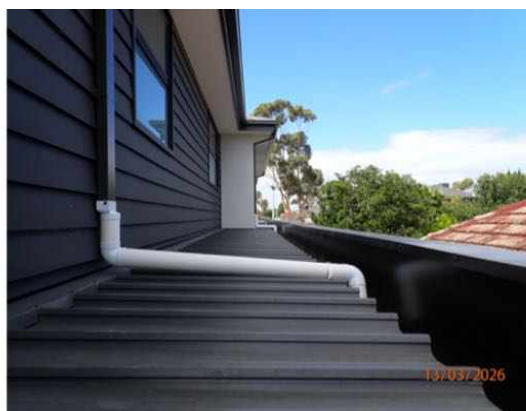
Finding 3.10

Building:	Main Building
Location:	Roof Exterior
Finding:	Exposed PVC pipe not protected from UV:
Information:	During the inspection, exposed PVC pipe connected to the gutter/downpipe system was noted unpainted. AS/NZS 3500.1 Clause 2.4.3 requires plastic pipes and fittings to be protected from direct sunlight. It is recommended that this be discussed with your builder and the exposed PVC pipe be painted or otherwise protected to prevent long-term UV deterioration.

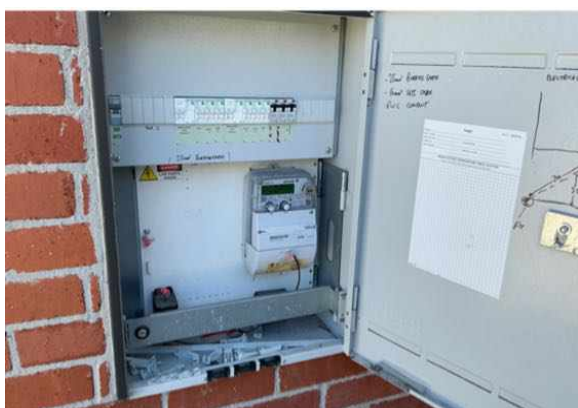
Building:	Main Building
Location:	Meter Box
Finding:	Termite Management System - no evidence of a chemical installation
Information:	The application of a post-construction chemical termite barrier is highly recommended for all properties, particularly if live termite activity has been found on the site previously. Such barriers are highly effective in preventing termite attack on any timber building elements throughout the property.

A durable notice should be placed in the switchboard unit to indicate current termite barriers. At the time of inspection, it appeared as though no termite management system has been installed, with no evidence to suggest preventative works taking place.

The client may consider gaining further advice from a pest controller as to the costs and procedures involved with this application. It is recommended that obtaining such advice be a short-term priority.

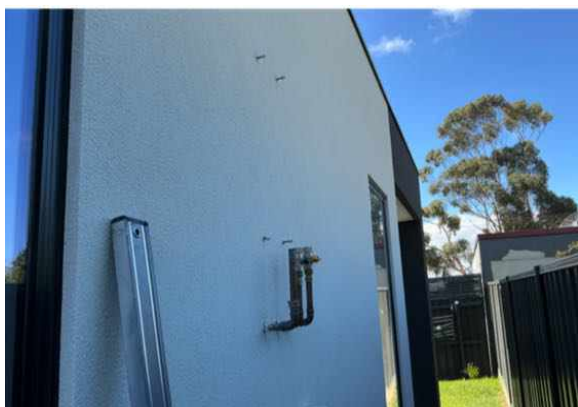
Building:	Main Building
Location:	Exterior walls - right side
Finding:	Hot water unit not installed:
Information:	During the inspection, the hot water unit was noted not installed. This is not uncommon in new construction, as external appliances are sometimes installed shortly before handover. The client should ensure the unit is installed prior to handover by a licensed plumber and confirm it is operating properly, complete, and commissioned as intended.

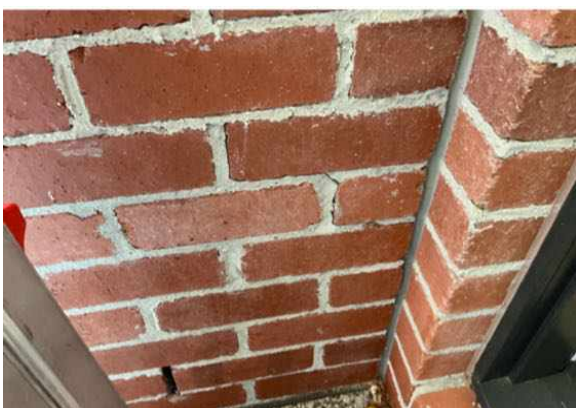
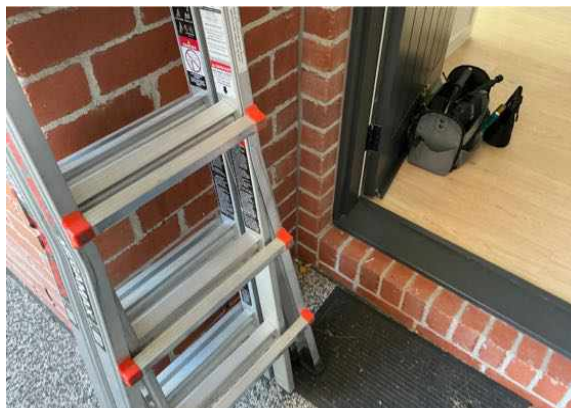
Building:	Main Building
Location:	Exterior walls - front
Finding:	Brickwork - cracking hairline
Information:	Minor cracking was observed on the brickwork during the inspection. This is consistent with the age of the house and expected foundation movements over the years.

While the cracks are not currently a structural concern, it is recommended to monitor them for any changes, such as widening or lengthening. If significant changes are noted, it may be necessary to engage a structural engineer to assess and recommend appropriate remedial actions.

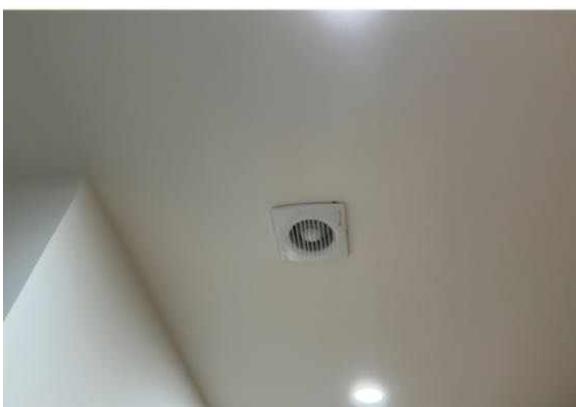
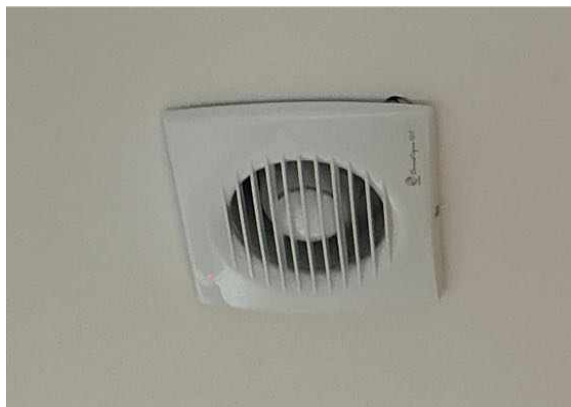
Finding: Plaster - Blemishes

Information: During the inspection, plaster blemishes were noted. According to the Guide to Standards and Tolerances 2015, Clause 9.14, plaster is considered defective if it has visible blemishes, such as surface imperfections, cracks, or unevenness, that affect its appearance when viewed from a normal viewing position. Blemishes in plaster can detract from the overall finish of the wall. It is recommended that this issue be discussed with the builder to ensure the plaster is repaired or refinished in accordance with the standards outlined in Clause 9.14 of the Guide to Standards and Tolerances 2015.

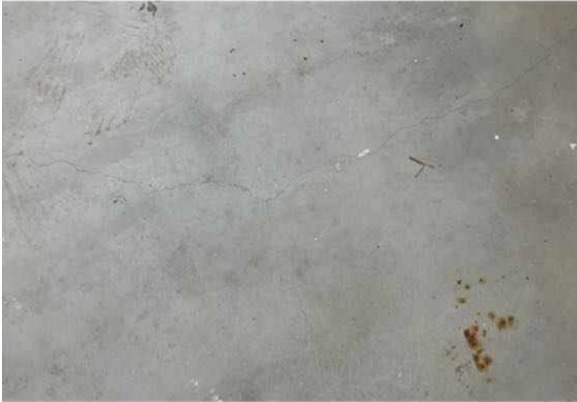
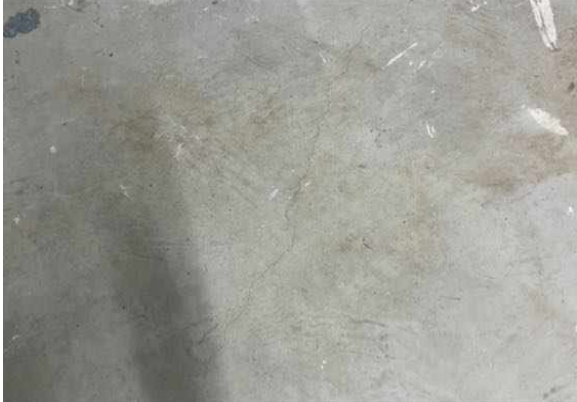
Finding: Cracking Concrete - Fine

Information: Fine cracks were identified in the concrete ceiling during inspection.

While these are typically considered appearance defects and do not usually indicate structural damage, they may worsen over time if left unmanaged. Regular monitoring

is advised to assess any changes in the width, length, or number of cracks.

If the cracks expand or further deterioration is observed, it is recommended to engage a structural engineer to assess the condition and provide guidance. Early intervention can help maintain the structural integrity of the concrete and prevent potential future issues.
