Building Inspection Report

Inspection Date: Mon, 16 Mar 2026

Property Address: 26 Pyingerra Cres, Cheltenham VIC 3192,
Australia

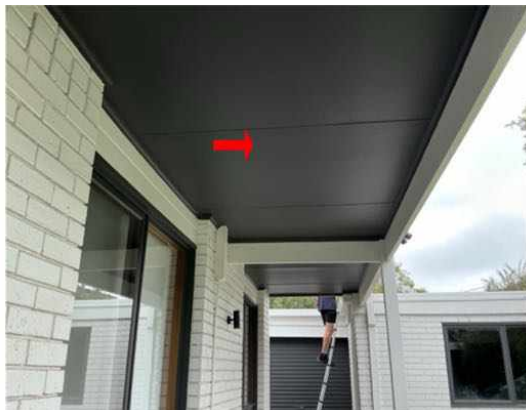
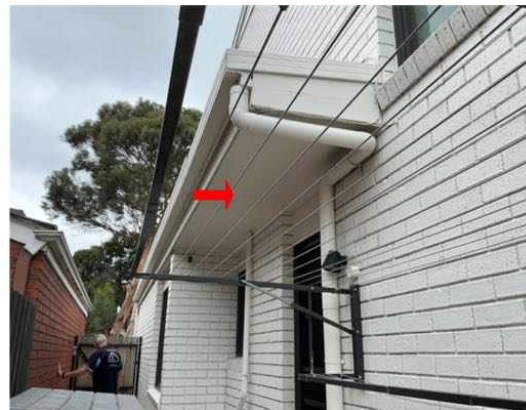
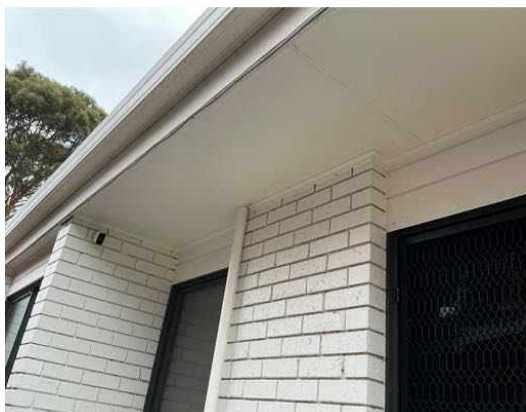
Defects 1.01

Building:	Main Building
Location:	Eaves
Finding:	Asbestos - Suspected ACM Identified on Site
Information:	Reporting on Asbestos is outside the Scope of this Report. This suspected defect is highlighted as a caution only. We suspect, based on our experience in the building industry, that there is a higher risk of the identified building element containing asbestos.

As Asbestos Reporting is outside the scope of this report, we advise that you consider a separate Asbestos Inspection and Condition Audit, which can include the taking of samples for definitive confirmation of the presence of Asbestos.

In the interim, the client is advised to act with caution, especially when considering any damage to building materials general wear and tear renovations extensions demolition and general maintenance activities due to the suspected presence of Asbestos.

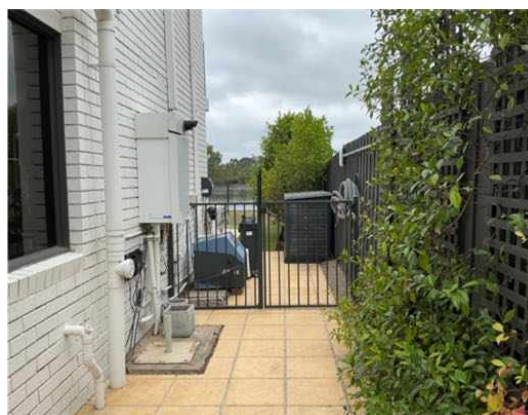
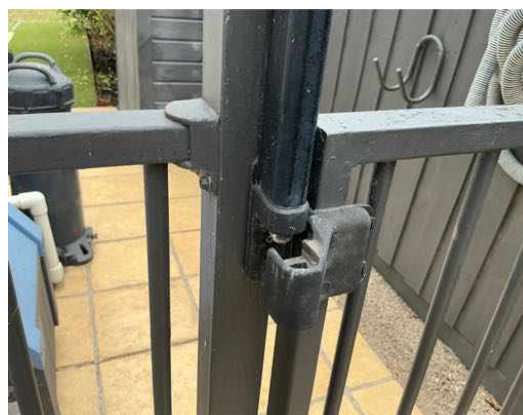
Defects 1.02

Building: Main Building
 Location: Pool Area
 Finding: Pool fencing - Inspection required
 Information: It is suspected that areas of the pool fencing do not to comply with Australian Standards and do not appear to be safe. Assessment of the pool area is required.

Please note that this inspection does not cover pool fencing and other pool fittings and fixtures. It is highly advised that a specialist be appointed to inspect the pool and surrounding area and provide advice on rectification works that may be required.

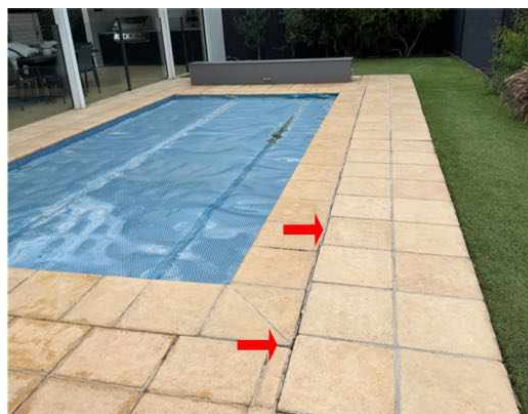
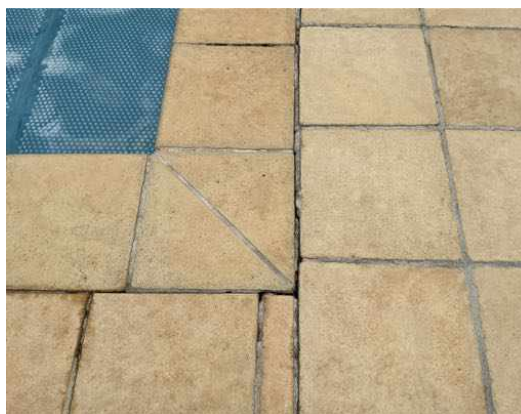
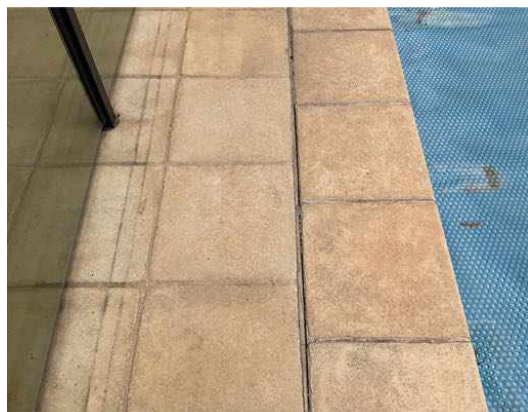
Defects 3.01

Building: Main Building
 Location: Pool Area
 Finding: Grout - Missing
 Information: Grout is missing in this area. Grout is used to protect gaps and crevices in building materials to ensure that they are water-tight and prevent water penetration to the associated structures.

Where grout is missing, a tiling contractor should be appointed immediately to apply grout and re-apply any silicone where necessary. Failure to do so is likely to lead to water damage to the surrounding area.

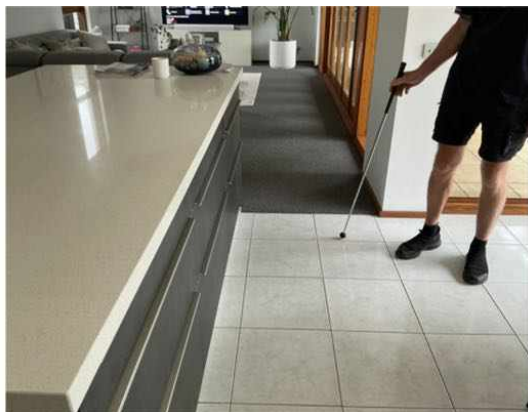
Defects 3.02

Building:	Main Building
Location:	Kitchen
Finding:	Tiles - Drummy
Information:	Drummy tiled areas were identified at the time of inspection. The term 'drummy' refers to tiles that have become detached from their fixing, despite otherwise being in relatively good condition. Such defects are generally caused by physical or moisture damage to the area. Drummy tiled areas may also be a direct result of poor workmanship during the construction process.

Tiled areas may swell and shrink with changes in air humidity if the area has sustained moisture damage. Any exposure to moisture is capable of causing tiled areas to become drummy and/or cracked over a prolonged period of time. Drummy tiled areas generally require removal and replacement of affected tiles, with adequate sealant and grouting.

Specialist trades are available for these types of services. A registered builder may be required to undertake works if damage is extensive or if secondary building defects have resulted. Otherwise, it is advised that a tiling contractor be appointed to perform works as necessary. Immediate action is recommended to ensure that no further damage is sustained in the affected area.

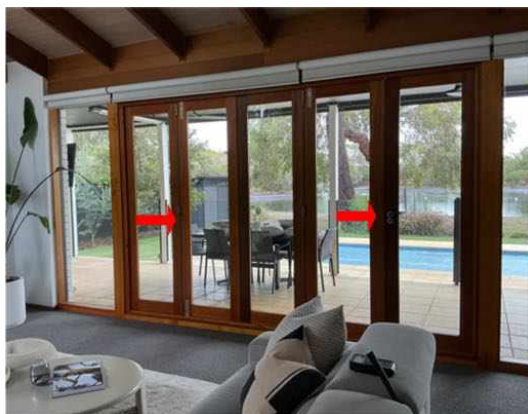
Defects 3.03

Building: Main Building
 Location: Lounge Room
 Finding: Door - stiff to slide
 Information: The door to this area was difficult to operate at the time of inspection. This is likely due to damaged wheels which help the door to operate in a smooth fashion.

Doors provide ventilation and exits to the adjoining area and should be at a fully operational level to ensure user comfort and safety. Restricted function of the door may also pose as a potential safety hazard if required for emergency egress from the building.

Generally, factors such as general age of the building element and a lack of maintenance are the usual causes for this type of defect.

Replacement of door running hardware may be required, as well as minor repairs and cleaning. A registered builder or general handy person will be required to repair the sliding door.

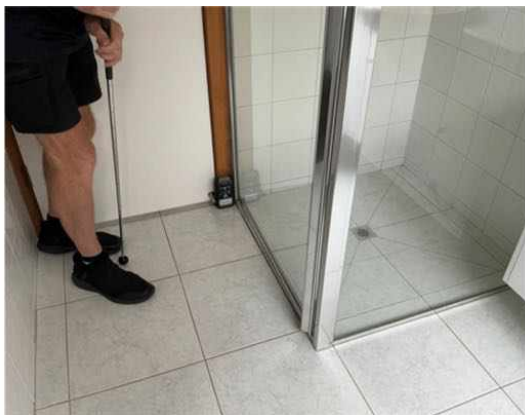
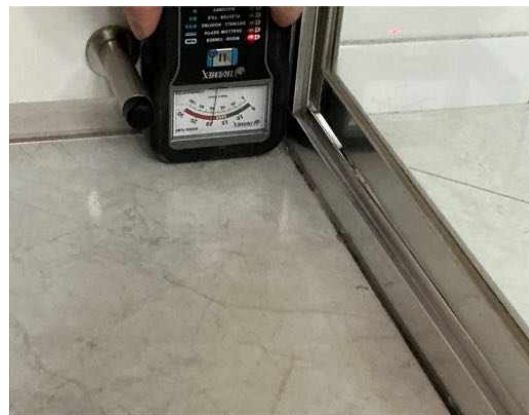
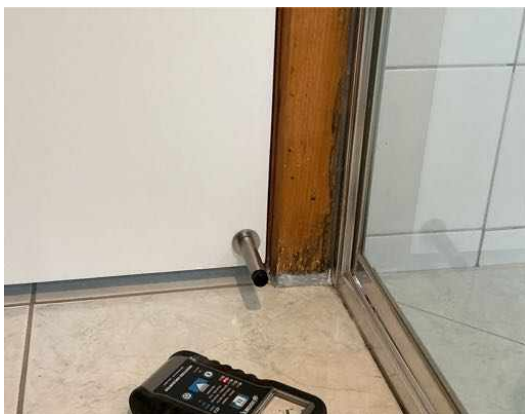
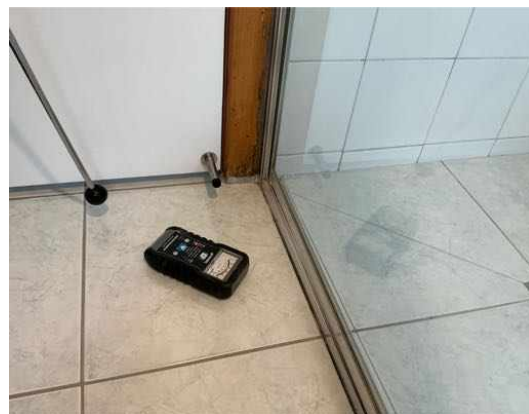
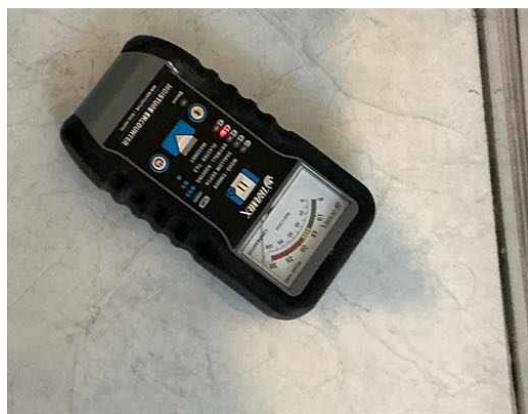
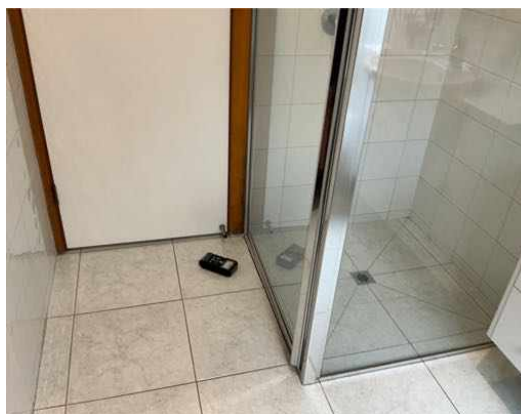
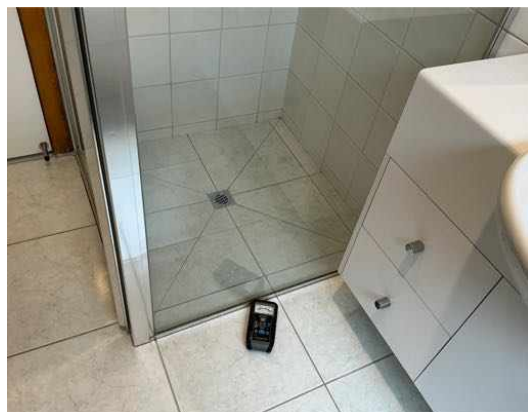
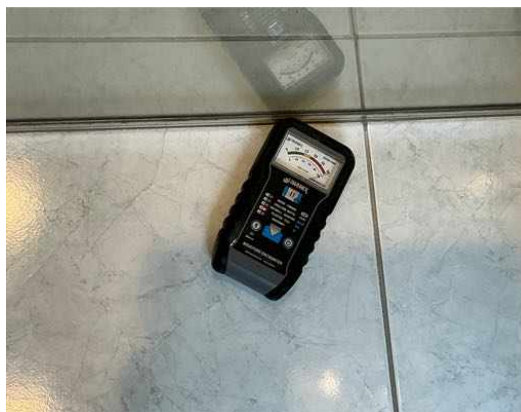
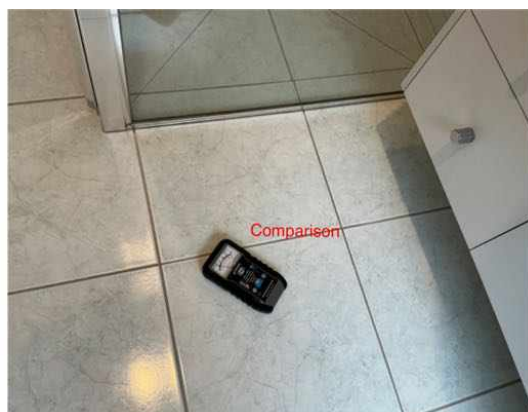
Defects 3.04

Building: Main Building
 Location: Ensuite - Master

Finding: Shower - Leaking

Information: Leaking was evident to the shower area at the time of inspection as shown in photos with the moisture meter. It is suspected that the leaking has occurred as a result of general ageing of the building elements.

Leaking from the shower base, where left unattended, is likely to lead to water damage to adjoining flooring and walls. Leaking can lead to water damage and necessitate extensive remedial works being required. Active water leaks may also create an environment that is susceptible to the formation and development of mould.

The downstairs shower was found to be leaking. Appointment of a tiling contractor is required to replace the shower the bathroom waterproofing and tiling. Such works should be performed as soon as possible to ensure that no further damage occurs.

Appointment of a tiling contractor is required to replace the shower the bathroom waterproofing and tiling. Such works should be performed as soon as possible to ensure that no further damage occurs.

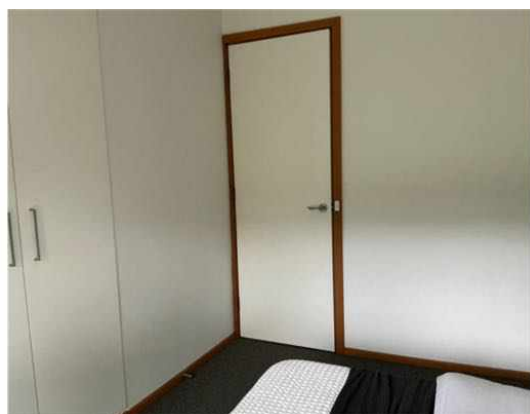
Defects 3.06

Building:	Main Building
Location:	Downstairs Bedroom
Finding:	Door handle - Not latching
Information:	It was noted that the door in this area was not latching during operation at the time of inspection. Whilst detracting from the functionality of this building element, this minor defect may also be a security risk, and may therefore have serious implications if left unattended.

It is suspected that this defect has occurred due to minor issues with the associated hinges. Such damage is identified as general wear and tear, which is expected for building elements of this age.

A qualified carpenter or general handyperson may be appointed to perform rectification works as necessary, at client discretion. If left unattended, further functional impairment is likely to occur.

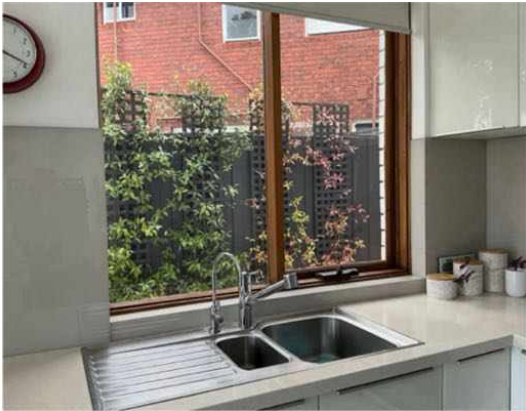
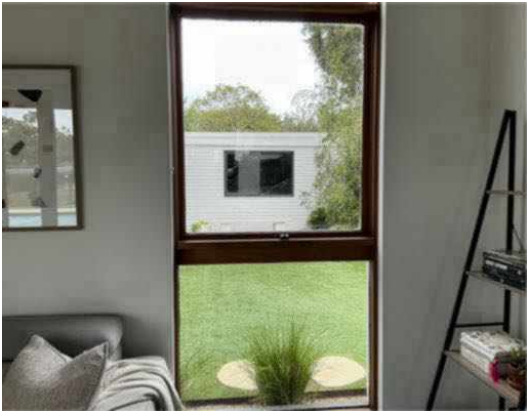
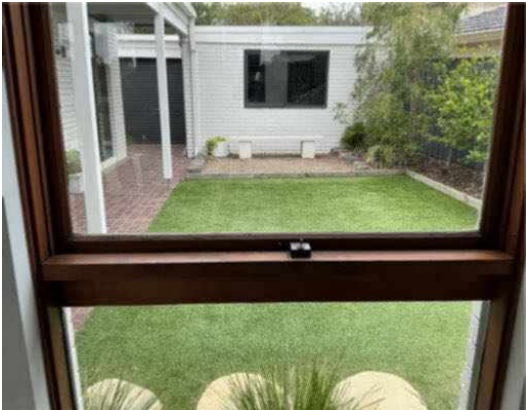
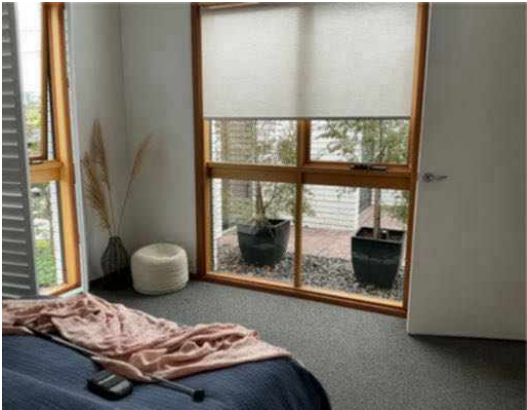
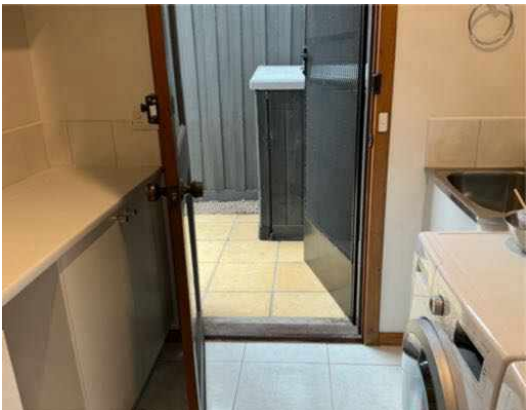
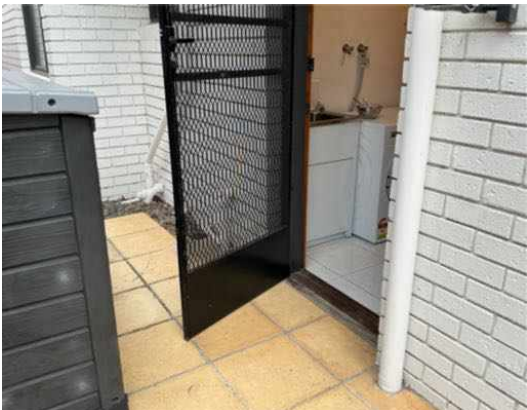
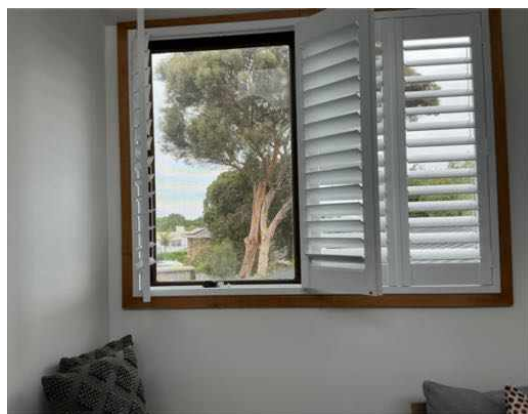
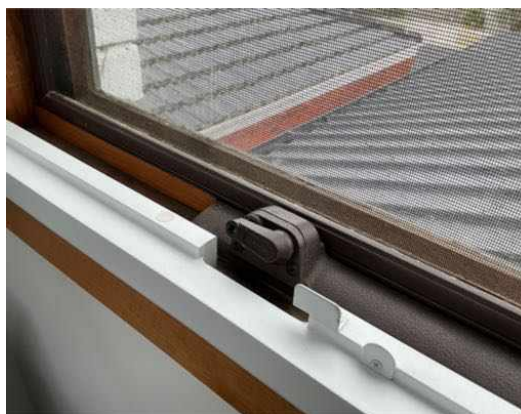
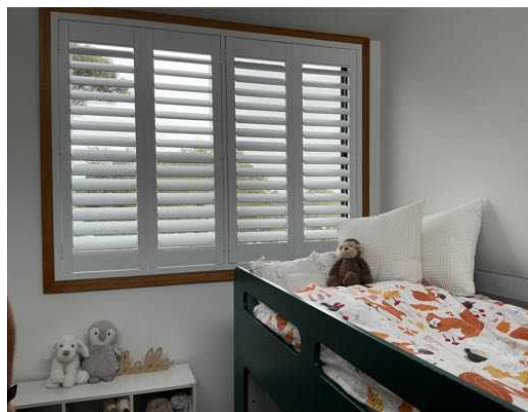
Defects 3.07

Building:	Main Building
Location:	All Areas
Finding:	Window- Broken handle and sticking and jamming
Information:	Several window handles throughout were found to be broken at the time of inspection. Breakage occurs generally when the building materials have aged and decayed, but may be indicative of impact damage (accidental or deliberate).

Many windows were also found to be sticking and jamming at the time of inspection

Repair and/or replacement of the broken handle is advised to improve the operational

state of the associated window

A qualified carpenter or general handyman should be appointed to repair/replace the handles and work on any sticking windows at the client's discretion.

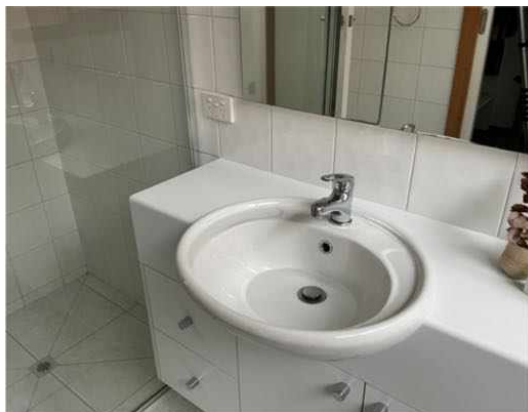
Defects 3.08

Building:	Main Building
Location:	Ensuite - Master
Finding:	Basin - Blocked
Information:	The basin drain appeared to be blocked at the time of inspection. Blockages prevent building elements from operating as intended. If left unmanaged, a lack of general maintenance may lead to the development of more significant defects, such as water damage to surrounding building materials.

It is advised that the blockage be removed prior to any further inspection or remedial works. Additionally, check for any secondary or concealed damage and then attempt to address the cause of the blockage to prevent any water damage to associated structures.

A licensed plumber should be appointed as soon as possible to perform any remedial works where required. Please be advised that a cabinet maker or qualified carpenter may be required if water damage is evident.

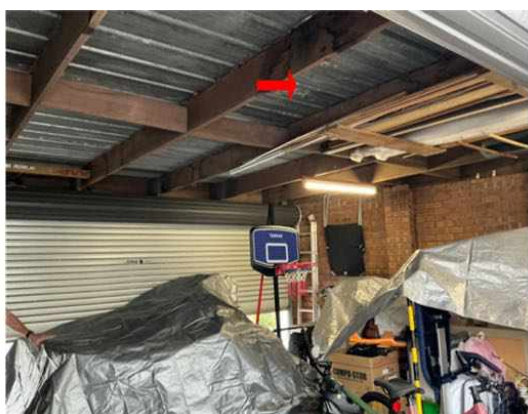
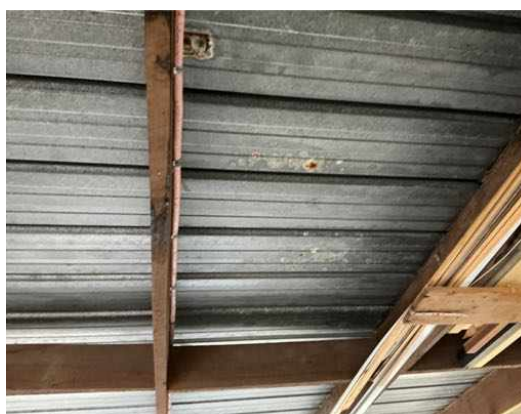
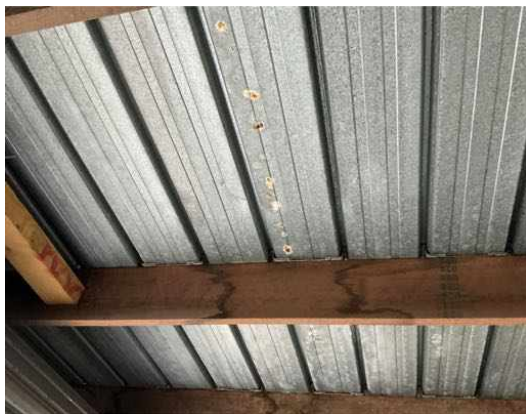
Defects 3.09

Building:	Main Building
Location:	Garage
Finding:	Roof sheets - Rusted
Information:	Metal roofs generally comprise numerous individual sheets, which join and overlap. These intersections are particularly prone to lift at the edge and consequently rust at these points.

Upon inspection of the exterior roofing structure, evidence of rust to these sections was identified. If left unmanaged, these degrading joints can allow water ingress to the internal roofing structures, potentially leading to secondary damage of building elements. Accelerated deterioration of the roofing sheets and any associated building elements is also likely to occur.

A roofing contractor should be appointed immediately to assess the damage to the roofing sheets and to perform remedial works as necessary. Works may include replacement of severely affected roofing sheets or minor works such as the application of rust-retardant surface protectors.

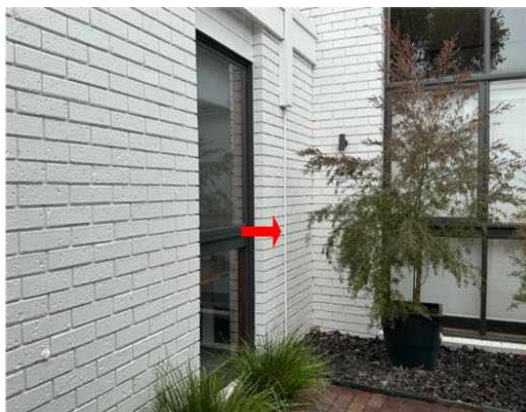
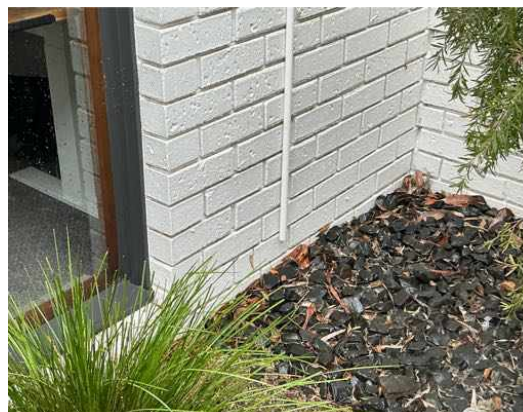
Defects 3.10

Building:	Main Building
Location:	Airconditioning
Finding:	Air conditioner - Disconnected overflow
Information:	The Air Conditioner (A/C) overflow was found to be disconnected from storm water drainage and is creating excessive moisture in the surrounding area.

Such leaking creates an environment which is conducive to an array of defects, including water damage to associated building elements and the attraction of termite or timber pest infestation.

It is highly recommended that a licensed plumber be appointed to connect the A/C overflow in order to prevent such an environment from being created. These minor works should be carried out as soon as possible.

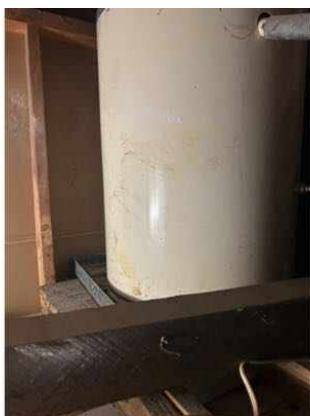
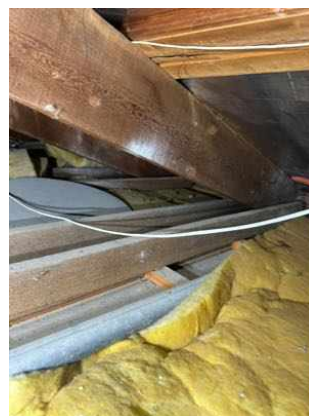
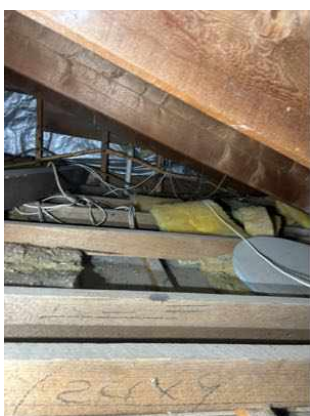
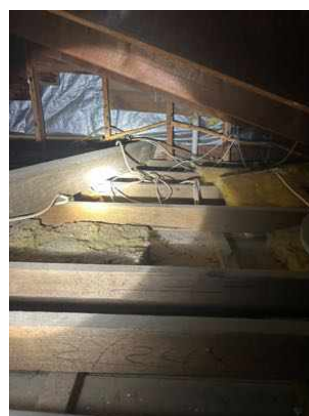
Defects 3.11

Building:	Main Building
Location:	All Areas
Finding:	Insulation - Inadequate
Information:	Upon inspection of the roof void it was noted that there is a lack of adequate insulation.

Insufficient insulation will result in a comparatively higher cost to heat and cool a property as there is a lack of Insulation (or uneven coverage of insulation) which works as a barrier to heat transfer. This helps to keep out unwanted heat in summer and preserves warmth inside your home in winter. It can also help soundproof your home from unwanted airborne noise transfer.

Example - Where there is a gap in coverage totaling 5% there is a potential for up to 50% of the energy efficiency to escape.

The level of insulation in the property does not meet current Australian Standards. Installation of adequate insulation is required and should be conducted as soon as possible.

Caution should be exercised when accessing the roof void. Do not attempt to stand on the framework to the underside of the trusses and be aware there is a potential for electric shock if contact is made with exposed or faulty electrical wiring.

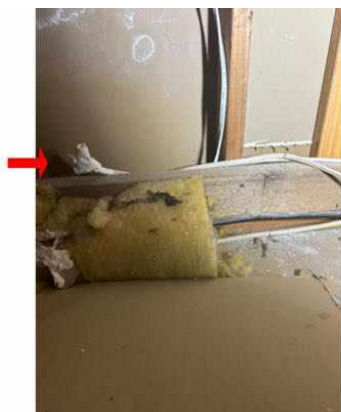
Defects 3.12

Building:	Main Building
Location:	All Areas
Finding:	Unconventional handyman work
Information:	This handyman work appears to have been completed to a substandard level and does not comply with regular building practices. Where handyman work is not completed satisfactorily, accelerated deterioration of the associated building elements is likely to occur and secondary defects to surrounding structures may develop.

It is highly recommended that the substandard work be rectified by professional services. Works to improve this area are likely to increase the safety and the operation of the associated building elements.

The client should exercise care when coming into the immediate vicinity of the substandard works. Rectification works are advised as soon as possible by the appropriate trades.

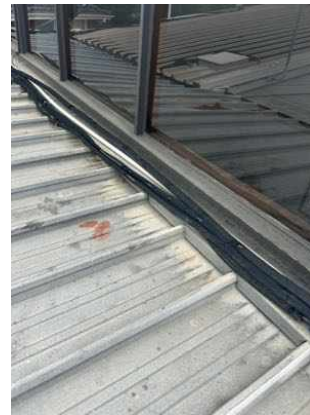
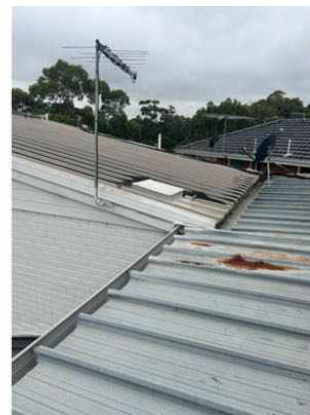
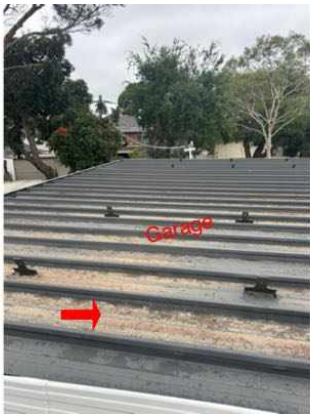
Defects 3.13

Building:	Main Building
Location:	All Areas
Finding:	Roof sheets - Rusted

Information: Metal roofs generally comprise numerous individual sheets, which join and overlap. These intersections are particularly prone to lift at the edge and consequently rust at these points.

Upon inspection of the exterior roofing structure, evidence of rust to these sections was identified. If left unmanaged, these degrading joints can allow water ingress to the internal roofing structures, potentially leading to secondary damage of building elements. Accelerated deterioration of the roofing sheets and any associated building elements is also likely to occur.

Some evidence of rust was found on the roof sheets. However the roof has mainly been painted and this may be hiding other areas of Rusting.

A roofing contractor should be appointed immediately to assess the damage to the roofing sheets and to perform remedial works as necessary. Works may include replacement of severely affected roofing sheets or minor works such as the application of rust-retardant surface protectors.

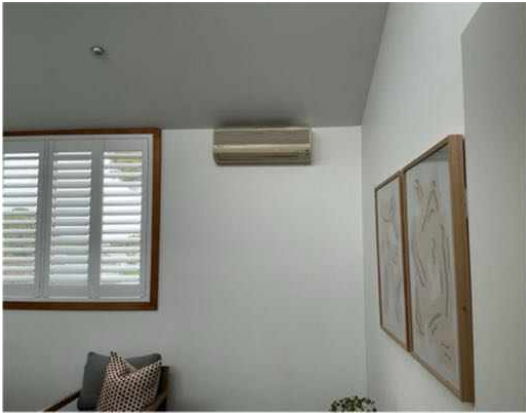
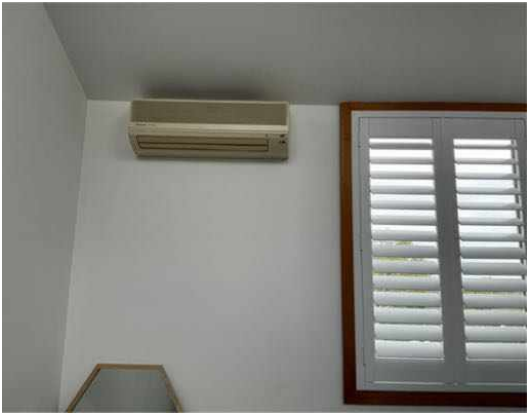
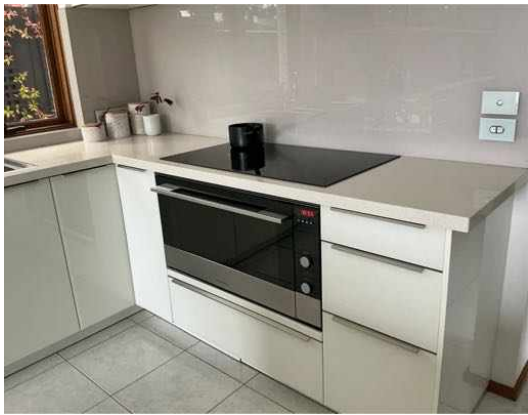
Noted Item

Building: Main Building
Location: Appliances
Finding: Warranty - Expired
Information: Where appliances are beyond their warranty period, the owner should be prepared to meet the cost of replacement or repair of the item at any time. The operation of the appliance can not be guaranteed and further inspection by an appropriately qualified tradesperson may be required.
