# Building and Timber Pest Inspection Report

Inspection Date: Thu, 26 Mar 2026

Property Address: 805 Merrylands Rd, GREYSTANES, NSW,  
2145, Australia

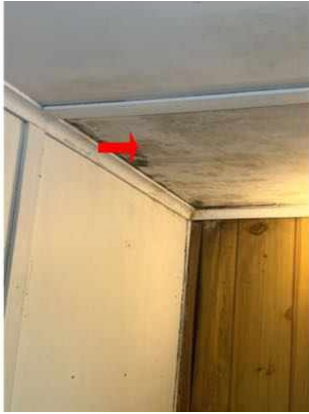
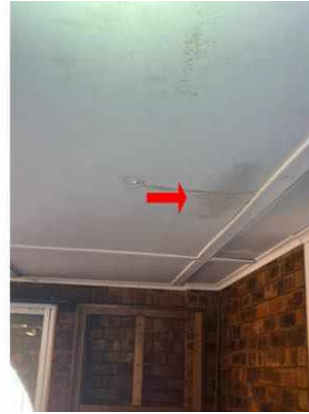
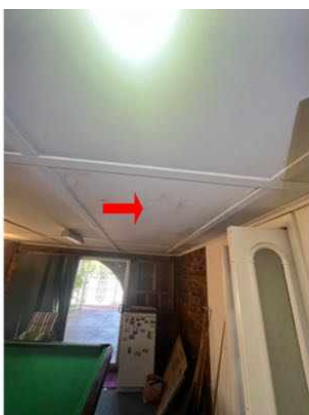
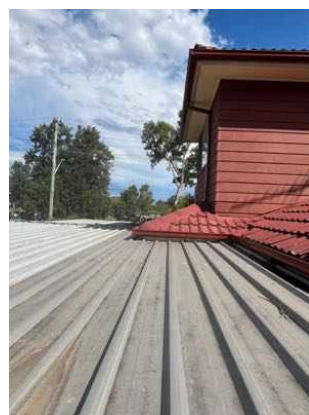
Building:	Main Building
Location:	Garage Converted to a Entertainment Area
Finding:	Mould - Present
Information:	Mould growth is evident to the ceiling linings and wall junctions within the converted garage/entertainment area. The affected areas display widespread discolouration, dark spotting, and patchy staining, particularly concentrated along ceiling corners and perimeter junctions. Localised areas also show heavier fungal growth consistent with prolonged damp conditions. The ceiling lining panels exhibit visible moisture staining, and the adjoining wall linings—particularly the timber panelling—show signs of moisture absorption and surface deterioration.

The pattern and extent of mould growth indicate that this is not a superficial or isolated issue, but rather the result of ongoing elevated moisture levels within the space. Contributing factors are likely to include a combination of roof leakage (as supported by visible ceiling staining), inadequate insulation, and poor ventilation—conditions commonly associated with garage-to-living-area conversions that may not meet current building or moisture control standards.

The presence of mould in this location raises potential environmental and health concerns, particularly where spores may become airborne in an enclosed area used for occupancy. In addition, prolonged moisture exposure may result in concealed deterioration to structural timbers and lining materials.

Overall, the condition is considered significant, with clear evidence of prolonged moisture ingress and inadequate environmental control within the converted garage space. Prompt remediation is required to address both the cause and the resulting damage.

A specialist inspection by a suitably qualified environmental health or mould remediation professional is recommended where the extent of growth is significant or where indoor air quality concerns exist. Immediate action should be taken to address the underlying moisture source—this includes engaging a licensed roofing plumber to investigate and rectify any roof leaks or defective flashings contributing to water ingress.

Following rectification of the moisture source, all affected surfaces should be cleaned and treated using appropriate mould remediation methods by a qualified contractor or competent person. Severely affected materials, including ceiling linings and possibly sections of wall lining, may require removal and replacement by a licensed builder or qualified carpenter.

It is also recommended that the space be improved in terms of ventilation and moisture control. This may include the installation of adequate ventilation openings or mechanical ventilation, ensuring proper insulation is in place, and maintaining the area in a dry condition to prevent recurrence.

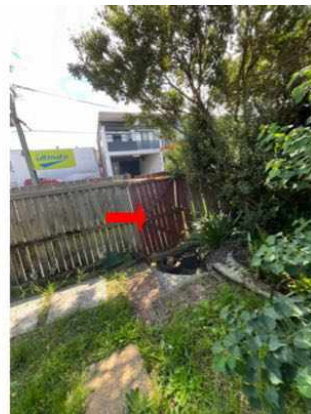
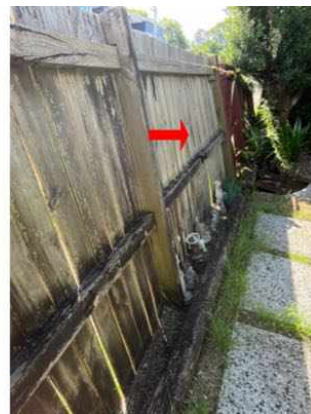
Finding: Fencing - Noticeably Deteriorated

Information: It was noted at the time of inspection that sections of the fencing throughout the property have noticeably deteriorated. Typically fencing deteriorates due to age and or wear, rot and or rust which is generally expected for a structure of this age, due to prolonged exposure to weather conditions. Sometimes inadequate installation or maintenance can be to blame.

If left unattended, it is likely that further damage will occur. It is suspected that repair of several elements of the fencing may be required however replacement may be a consideration of the client also.

A licensed fencing contractor should be appointed to provide further advice and perform rectification works as necessary.

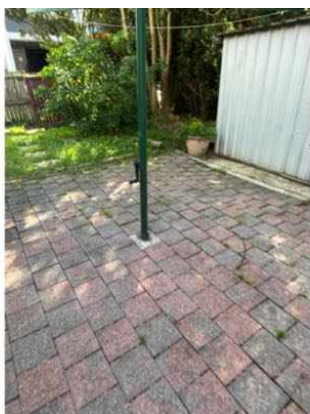
Building:	Main Building
Location:	All Areas
Finding:	Pavements - Uneven
Information:	<p>Inspection of the side pathway and adjoining areas revealed sections of brick paving that are uneven, with notable height variations and displacement of individual pavers. In some locations, the brick surface has lifted or subsided, which may present a potential trip hazard. Additionally, sections of the adjoining retaining brickwork display vertical cracking, which appears consistent with minor movement of the structure over time.</p>

If left unattended, further movement could increase the extent of the defect and potentially compromise the safe use of the area.

While the movement appears localised, it is recommended that these areas be monitored for any progression. Rectification may involve re-levelling the pavers and addressing any underlying soil movement or drainage issues contributing to the unevenness. The cracks in the retaining wall should be repointed or repaired to prevent further deterioration and maintain structural integrity.

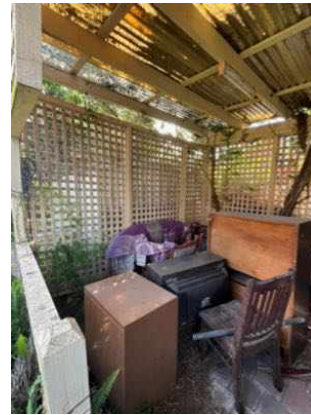
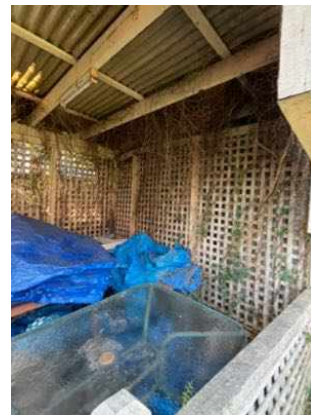
### Finding 3.05

Building:	Main Building
Location:	Yard - Back
Finding:	Deteriorated Entertaining Area
Information:	The detached rear entertaining structure was found to be in a significantly deteriorated condition at the time of inspection, with multiple elements exhibiting advanced weathering, structural fatigue, and lack of ongoing maintenance. The structure appears to be of lightweight timber construction with lattice screening and a corrugated roof covering, and overall it has reached the latter stage of its serviceable life.

The roof sheeting shows visible ageing and corrosion, with sections allowing light penetration, indicating deterioration and potential water ingress during rainfall events. Supporting timber members, including beams and rafters, exhibit surface weathering, discolouration, and early signs of decay consistent with prolonged exposure to moisture and inadequate protective coatings. The presence of vegetation growth and vine intrusion through the structure further contributes to moisture retention and accelerates timber deterioration.

The lattice wall panels and perimeter balustrade are notably degraded, with warping, splitting, and loosening of fixings observed. Sections of the framing appear misaligned, and the overall rigidity of the structure is reduced. The front railing and posts show signs of movement and are no longer providing adequate lateral support. The paved

Internally, the structure is cluttered, which limited full inspection of all surfaces; however, visible areas indicate poor ventilation, organic debris accumulation, and conditions conducive to timber decay and potential pest activity. The combination of moisture exposure, vegetation encroachment, and ageing materials suggests that concealed structural elements may be further compromised.

In its current condition, the structure is considered to be beyond economical repair for long-term use. While minor patch repairs may provide short-term usability, the extent of deterioration indicates that substantial rectification or complete replacement would be the more appropriate course of action. Immediate attention is recommended if the structure is to remain in use, particularly to address potential safety concerns associated with weakened structural components.

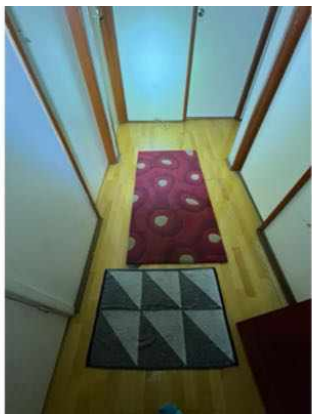
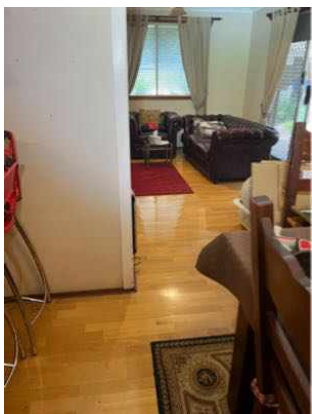
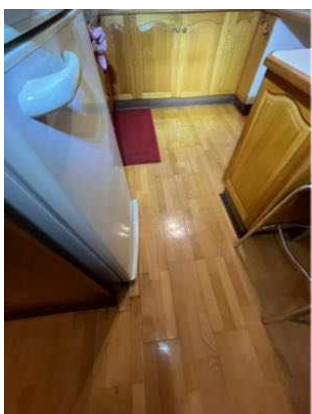
### Finding 3.06

Building:	Main Building
Location:	All Areas
Finding:	Floorboards - Noticeably Uneven
Information:	The internal flooring in this area was observed to be uneven and produced squeaking under foot traffic. Uneven flooring and floor squeaking may indicate minor defects such as normal foundation movement, slight movement of floor framing members, or potential subsidence or settlement of the subfloor stumps. Such conditions are relatively common in homes constructed on pier and stump foundations, where timber floor structures can move slightly over time due to changes in moisture levels, natural settlement, or wear of fixings.

It is recommended that the flooring condition be monitored over time to identify whether further movement or deterioration occurs. If the floor level and squeaking remain relatively stable over the coming months, the condition is likely associated with typical settlement and aging of the structure.

However, if the unevenness or squeaking becomes more pronounced, a more detailed inspection of the subfloor structure, including stumps, bearers, joists and associated fixings, will be required to determine whether structural movement or deterioration is present. Should this occur, rectification works such as re-leveling or re-stumping may be required, and such works should be undertaken by a registered builder experienced in subfloor structural repairs.

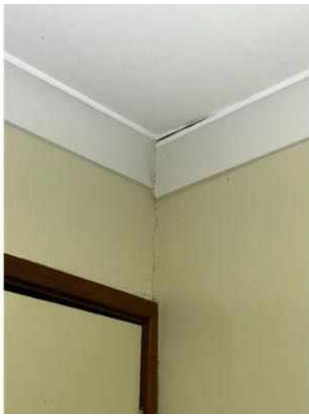
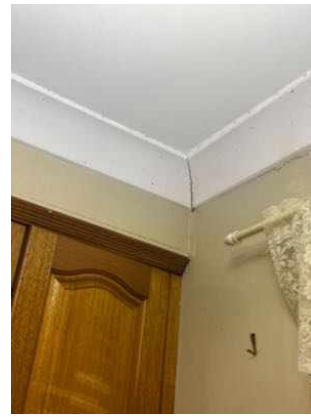
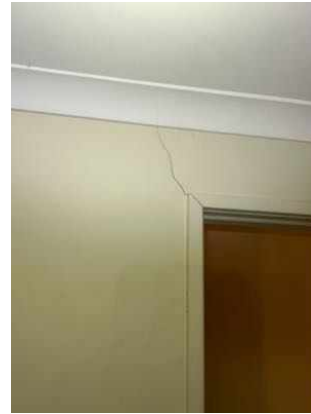
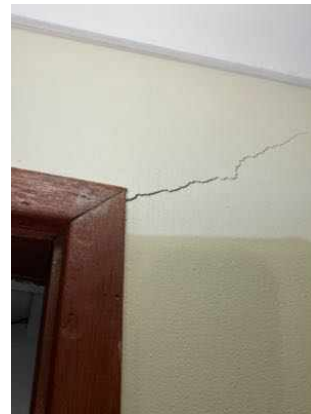
Finding: Minor Cracks

Information: The interior cracks at wall corners or wall junctures with ceilings may have developed due to the separation of building materials caused by differential moisture levels or wood shrinkage during the framing drying process. Additionally, the cracks around openings, doors, and windows appear to be the result of inadequate installation of timber studs during the construction stage.

While these cracks may be noticeable, they are typically considered to be cosmetic issues and do not usually indicate any structural damage. Repairing such cracks can generally be done through minor sanding, filling, and repainting. It is important to have these repair works carried out by a qualified painter or a licensed handyman.

Regular monitoring of all cracks is recommended. If cracks widen, lengthen, or increase in number, it is advisable to contact a building inspector for further assessment.

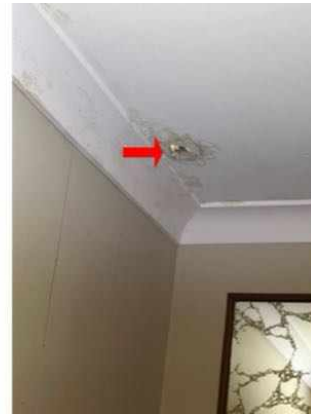
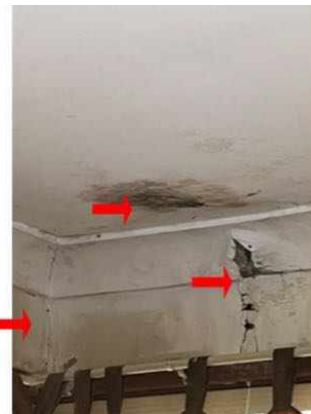
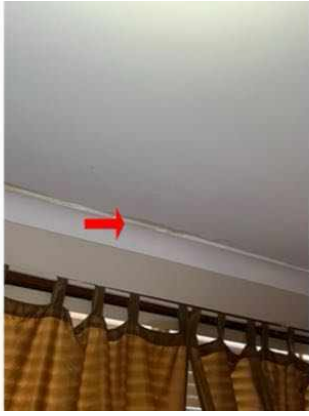
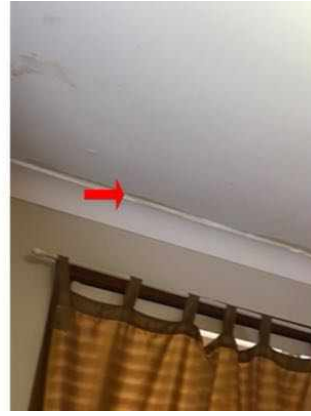
Building:	Main Building
Location:	Lounge Room
Finding:	Ceiling - Water damaged
Information:	Water damage is evident to the ceiling linings in multiple locations within the dwelling, particularly adjacent to external wall junctions and window areas. The damage is characterised by widespread staining, discolouration, bubbling and deterioration of paint finishes, as well as localised cracking and delamination of the plasterboard. In more advanced areas, the ceiling lining shows signs of softening and breakdown, with visible deformation and splitting to the cornice and adjoining surfaces.

The pattern and concentration of staining—particularly at ceiling corners and along the wall/ceiling junction—are consistent with moisture ingress originating from above, most likely associated with defects to the roof covering, flashings, or roof plumbing components. The extent of staining and material deterioration indicates that this is not a recent or isolated event, but rather a prolonged or recurring moisture issue. In some sections, the level of damage suggests that water has penetrated beyond the surface finish and may have affected the underlying ceiling substrate and potentially adjacent framing.

There is also evidence of patch repairs and repainting in some areas, indicating previous attempts to address the symptoms without fully resolving the underlying cause. The presence of darkened staining and possible organic growth further suggests that the affected areas have remained damp for extended periods, creating conditions conducive to mould development and material degradation.

Overall, the condition is considered to be moderate to severe, with a high likelihood of ongoing moisture ingress if not addressed promptly. Immediate action is recommended to prevent further deterioration and potential concealed damage within the roof structure.

The primary requirement is to identify and rectify the source of moisture ingress. A licensed roofing plumber should be engaged as a matter of priority to carry out a thorough inspection of the roof covering, flashings, valleys, penetrations, and associated drainage systems, and to undertake all necessary repairs to eliminate water entry.

Following confirmation that the leak has been effectively rectified, internal remediation works should be undertaken. This may include removal and replacement of damaged ceiling linings where deterioration is advanced, treatment of any affected framing if required, and reinstatement of finishes by a qualified plasterer and painter. Any mould-affected materials should be appropriately treated or replaced in accordance with health and safety guidelines.

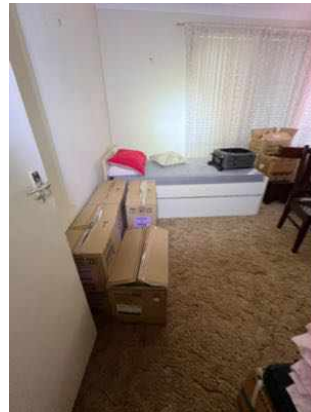
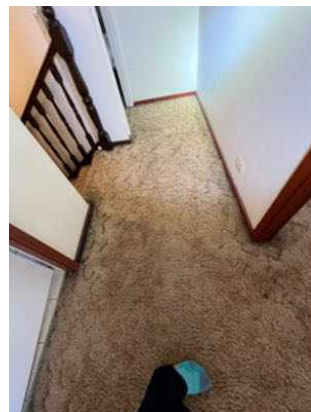
### Finding 3.11

Building:	Main Building
Location:	All Areas > Upstairs
Finding:	Squeaking Floor
Information:	During the inspection, creaking floors were noted in this area. This often occurs when the timbers are loose, causing friction between the edges of the boards when walked upon. It is recommended that the client consult a handyman or Registered Builder if the creaking intensifies or if the floor becomes excessively bouncy for further assessment and necessary action.

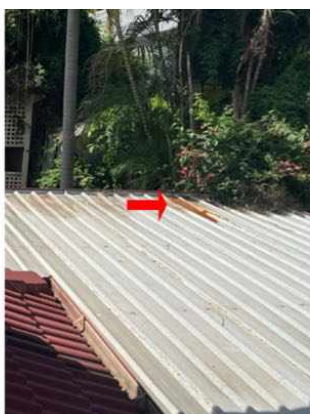
### Finding 3.12

Building:	Main Building
Location:	Roof Exterior
Finding:	Roof sheets - Rusted
Information:	Metal roofs generally comprise numerous individual sheets, which join and overlap. These intersections are particularly prone to lift at the edge and consequently rust at these points.

Upon inspection of the exterior roofing structure, evidence of rust to these sections was identified. If left unmanaged, these degrading joins can allow water ingress to the internal roofing structures, potentially leading to secondary damage of building elements. Accelerated deterioration of the roofing sheets and any associated building elements is also likely to occur.

A roofing contractor should be appointed immediately to assess the damage to the roofing sheets and to perform remedial works as necessary. Works may include replacement of severely affected roofing sheets or minor works such as the application of rust-retardant surface protectors.

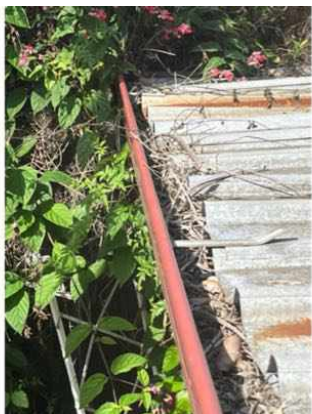
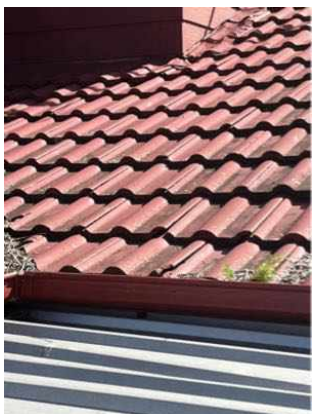
### Finding 3.13

Building:	Main Building
Location:	Roof Exterior
Finding:	Gutters - Blocked
Information:	Roof plumbing structures, such as guttering and downpipes, should be free of all debris to prevent blockages. Blockages of the guttering and downpipes will lead to pooling and accumulated water overflows, which is likely to subsequently flood eaves and exterior walls.

Blocked gutters are likely to lead to high levels of moisture in the affected areas. Such moisture will not only cause rust and decay of the associated building materials, but can also provide conditions that are conducive to termite and timber pest activity.

Blockages in gutters should therefore be removed immediately to ensure dry conditions are maintained.

Consult a Licensed Plumber for further specific advice on remedial works that may be required. In the interim, it is highly advised that blocked gutters be removed by the homeowner or a general handyperson as a matter of urgency.

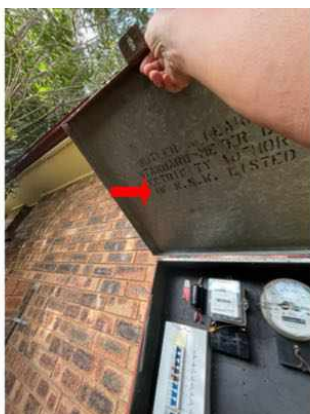
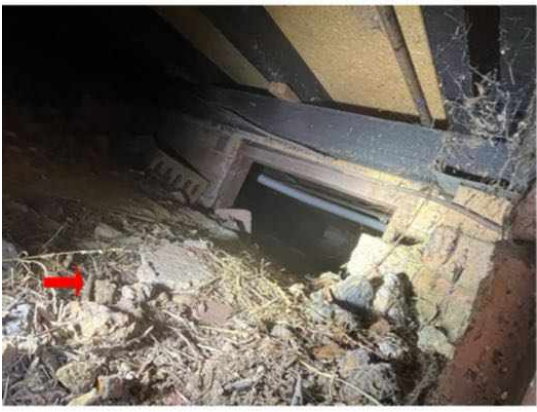
Finding: Conditions Conducive to Termite Activity

Information: The following areas and environmental conditions were identified as conducive to termite activity. These conditions increase the risk of concealed termite entry and should be addressed through appropriate maintenance, repairs, improved drainage, additional monitoring, or the installation of a compliant termite management system.

The HWS overflow discharges directly to ground, resulting in constant moisture at the building perimeter. Excess moisture provides conditions favourable to termite activity.

Air conditioner condensation lines discharging near walls can cause damp soil conditions, attracting termites.

Recommendation: Where no system exists, install a compliant termite management system and retain all documentation for future reference.

Recommendation: Connect the overflow to suitable stormwater drainage to divert water away from all structural elements.

Recommendation: Ensure AC overflow pipes are connected to appropriate stormwater drainage.

Recommendation: Confirm all drains are correctly connected to the stormwater system.

- Rectify all identified conducive conditions through appropriate maintenance and repair.
- Implement routine moisture monitoring and schedule regular timber pest inspections.
- Install or upgrade a termite management system for long-term protection.
- Where mature trees are present, test-drill trees over 100 mm in diameter to assess potential termite activity.
- Where high-risk conditions or concealed areas exist, consider invasive inspection prior to purchase or during further investigation.

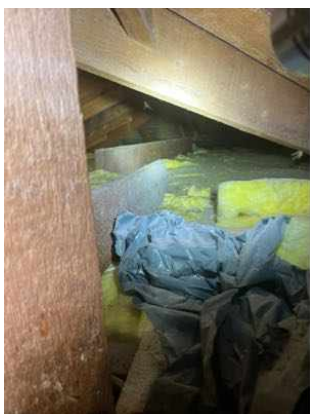
### Noted Item

Building: Main Building  
 Location: Roof Void  
 Finding: Condition of Building Elements in the Roof Void  
 Information: The accessible roof void was inspected and found to be in a generally serviceable but poorly maintained condition, with several defects and risk factors noted. The timber

Storage of miscellaneous materials, including loose boards and plastic sheeting, has been noted within the roof void. This not only restricts access for inspection and maintenance but may also contribute to uneven loading on ceiling linings and create additional fire load. Walk boards are present but are inconsistently laid and not securely fixed in all areas, posing a potential safety risk during access.

Overall, the roof void condition is considered fair to poor, with evidence of moisture ingress, insulation disturbance, and pest activity. It is recommended that a licensed roofing contractor investigate and rectify any sources of water ingress, including roof coverings, flashings, and penetrations. Damaged sarking should be repaired or replaced where accessible. Insulation should be reinstalled or replaced to achieve adequate and consistent coverage, and contaminated materials should be removed. Pest control measures are also recommended to prevent further infestation. Regular maintenance and improved housekeeping within the roof space will assist in preserving the condition of the building elements.
