Building and Timber Pest Inspection Report

Inspection Date: Mon, 2 Feb 2026

Property Address: 14 Darri Dr, Springdale Heights NSW 2641,
Australia

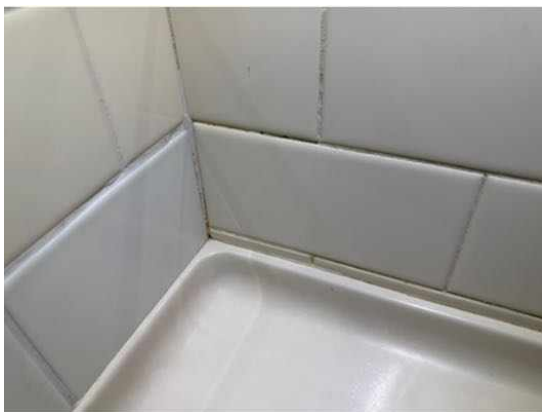
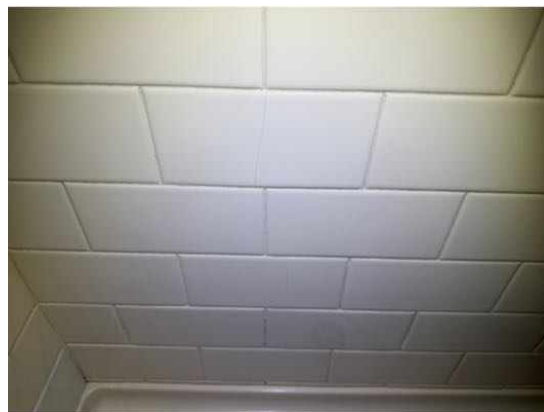
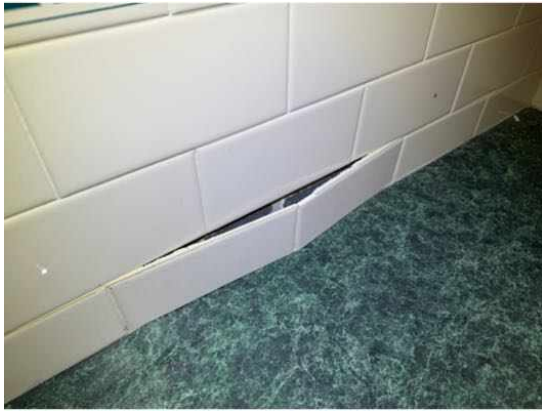
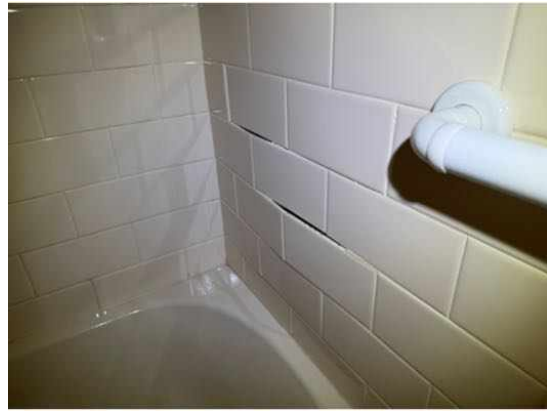
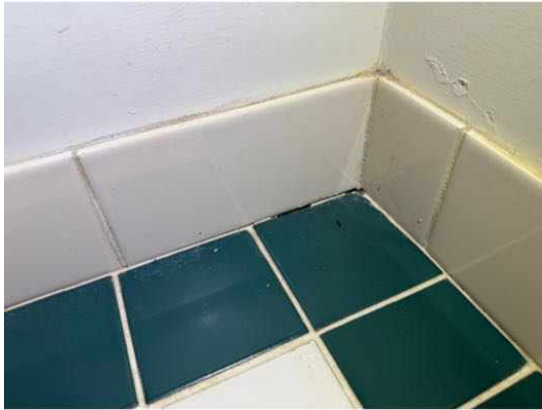
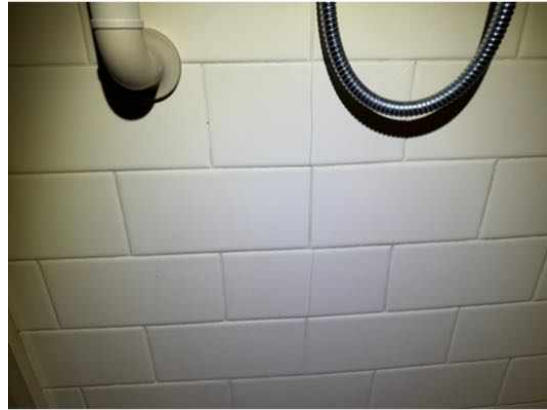
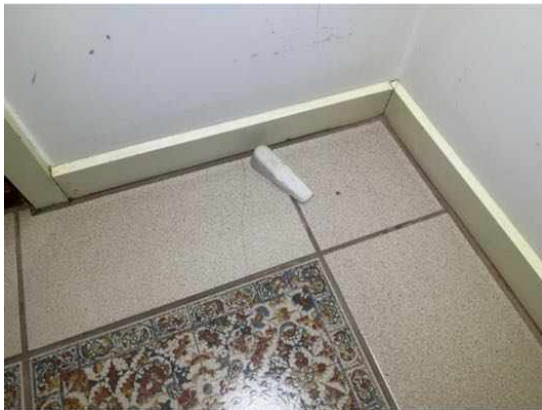
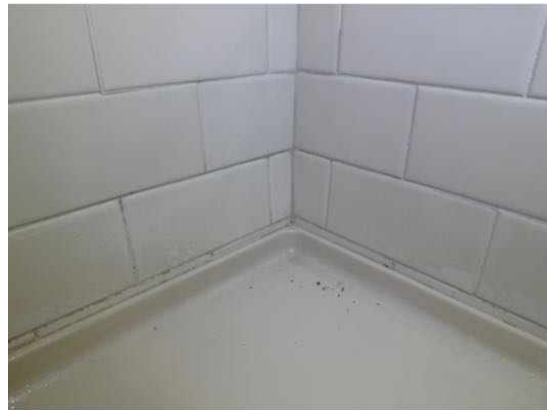
Finding 3.01

Building: Main Building
Location: Tiled Areas, Bathroom
Finding: Sealant / grouting - deteriorated or missing & Cracked/Loose Tiles
Information: It appears that the sealant and grout has deteriorated in some tiled areas, a common defect in buildings of a similar age. Areas of cracked and loose tiles were also noted in the bathrooms, which can allow for moisture ingress behind the tiles, if neglected.

Areas of the tiling in the wet areas were found to be cracked and loose. The sealant & grout was also found to be deteriorated, a common defect in buildings of a similar age. Recommend consulting with a licensed tiling contractor in the short term, to provide remedial works where necessary to ensure all tiled areas are sufficiently grouted, sealed & waterproofed.

Sealant and grouting in areas that come into regular contact with water should be maintained for the long term care of your property.

Recommend engaging a licensed tiling contractor in the short term, to provide remedial works to ensure all tiled areas are sufficiently grouted, sealed and waterproofed.

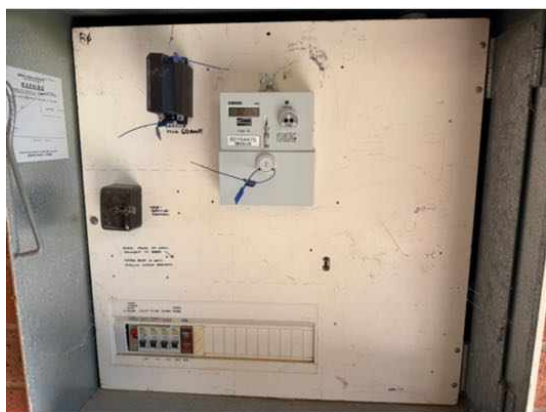
Finding 6.01

Building:	Main Building
Location:	Switchboard
Finding:	Termite Management System - no evidence of a chemical installation
Information:	The application of a termite barrier is highly recommended, as it appears no termite management system has been installed, with no evidence or durable notice to suggest works taking place. Generally, a durable notice is placed in the meter box to indicate current termite barriers.

Such barriers are highly effective in preventing termite attack on the building and therefore should be installed.

Recommend seeking further advice from a licensed pest controller.

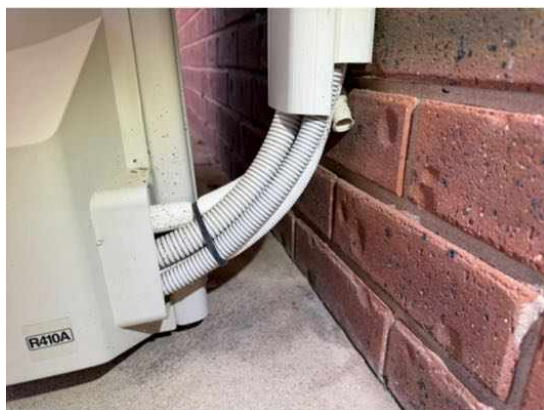
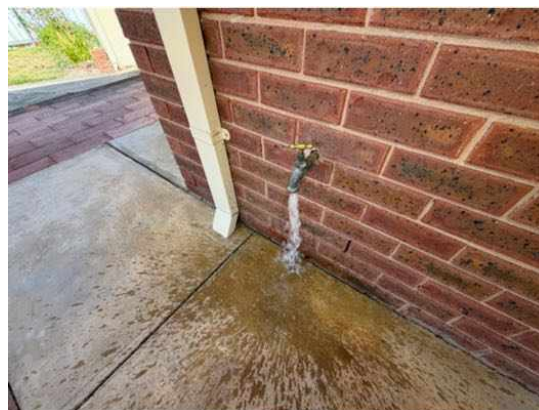
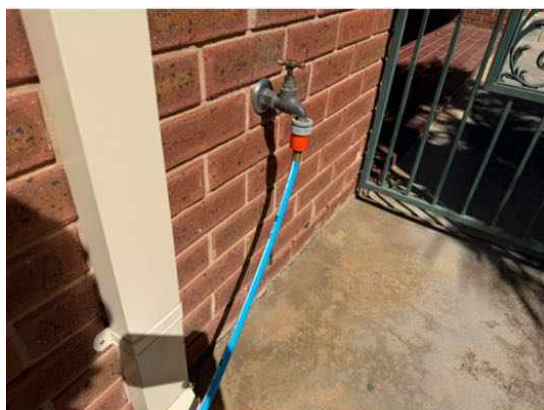
Finding 6.02

Building:	Main Building
Location:	All external areas
Finding:	Potential Water pooling - against property
Information:	Potential areas of water pooling around the perimeter of the property were identified. Where insufficient drainage of taps, & & aircon overflows, are present, water pooling is likely to occur, and can create areas conducive to timber pests.

Recommend consulting with a licensed plumber and/or landscaping contractor to provide further advice.

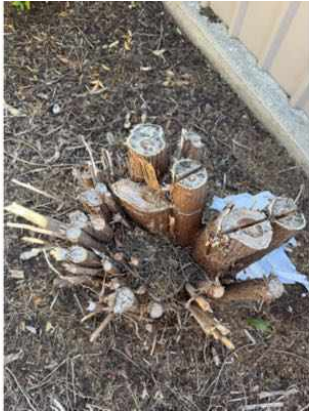
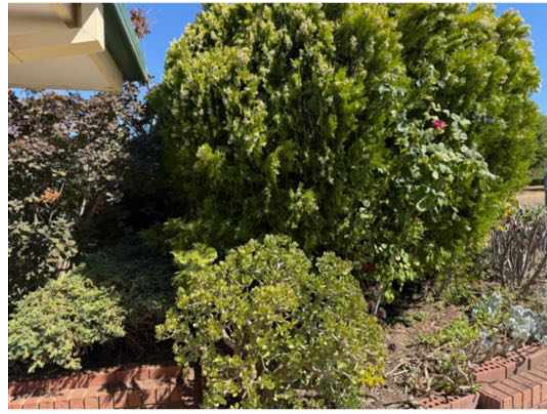
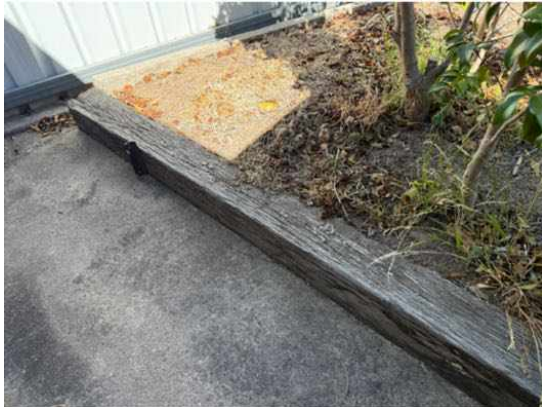
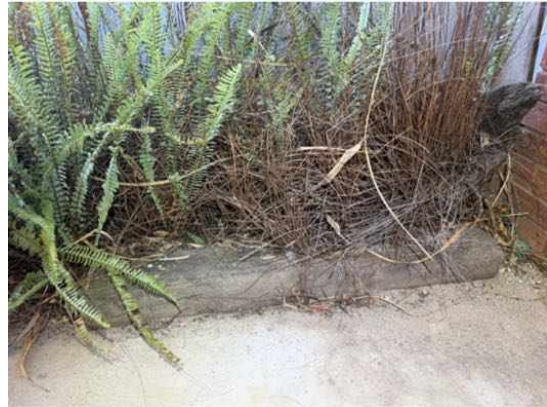
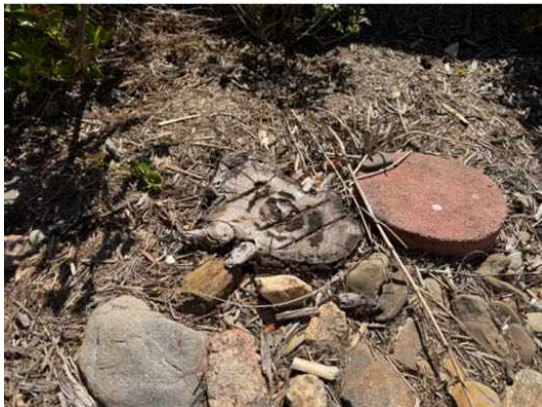
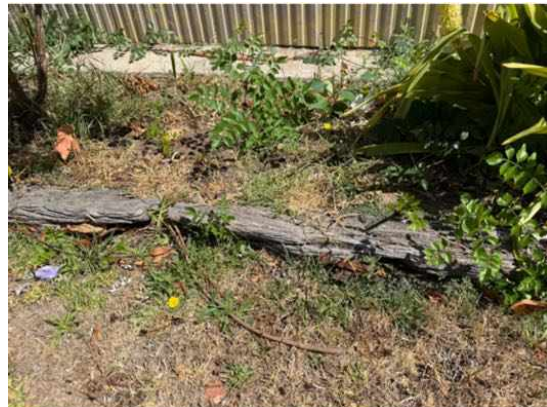
Finding 6.03

Building:	Main Building
Location:	All External Areas
Finding:	Timber in direct ground contact & trees - conducive to termites
Information:	Where timber materials are in direct contact with the ground and consequently moisture, they become conducive to termite activity. The tree stumps, landscaping timbers, and trees surrounding the building create an environment conducive to termite infestation.

Where feasible, any timbers in direct contact with the ground should be removed and any trees in close proximity to the building should be removed or test drilled (inspected) at least annually to reduce the risk of termite infestation & detect any early signs of termite activity.

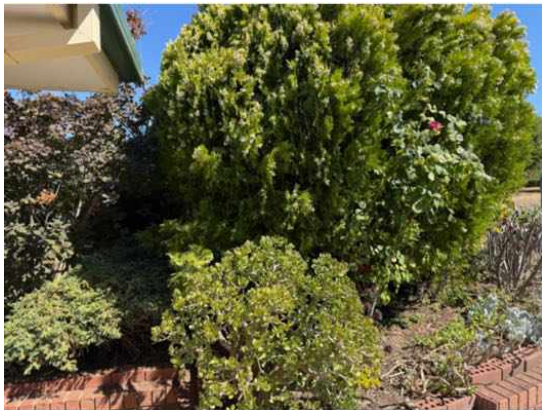
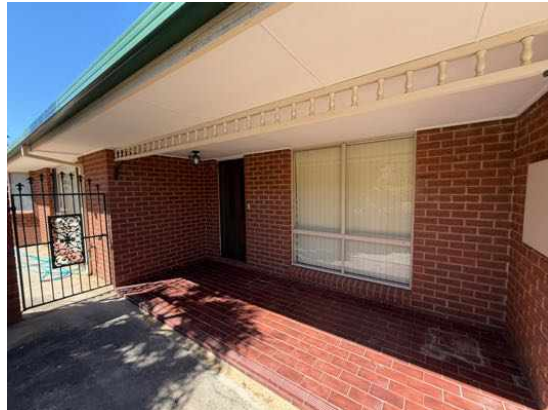
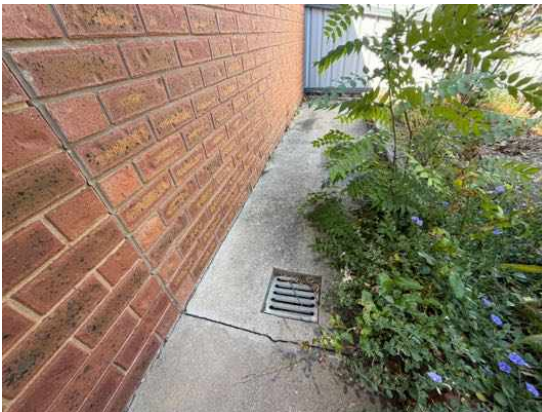
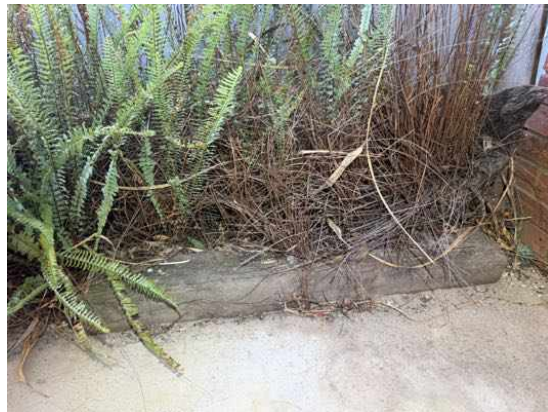
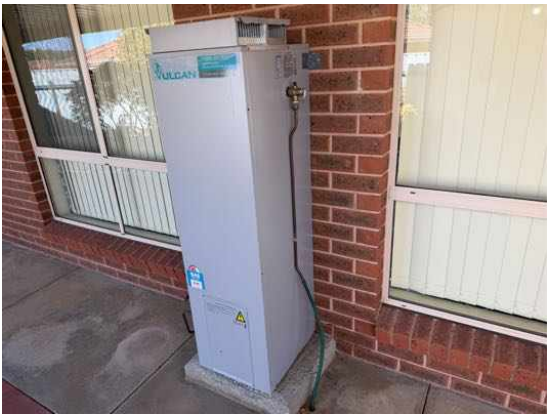
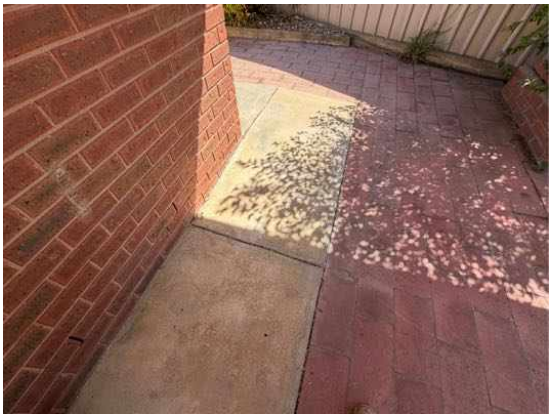
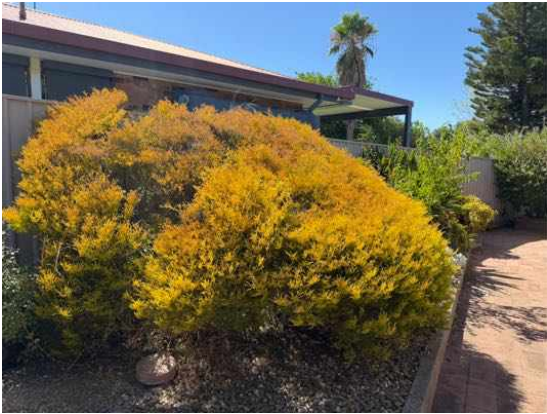
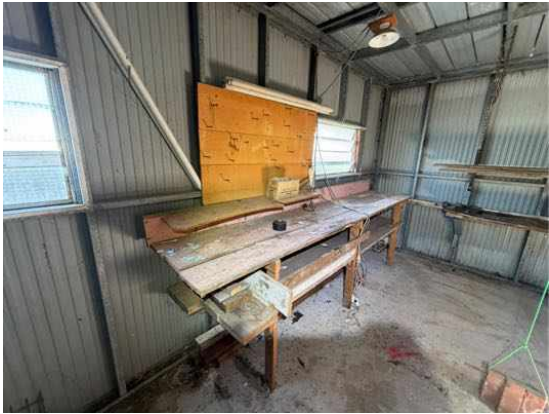
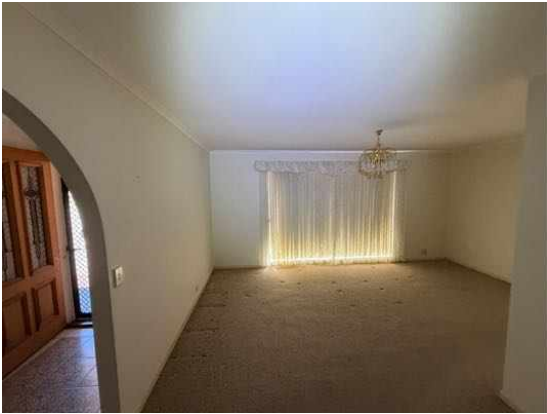
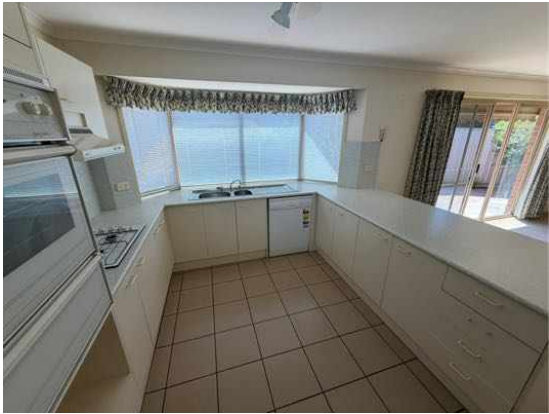
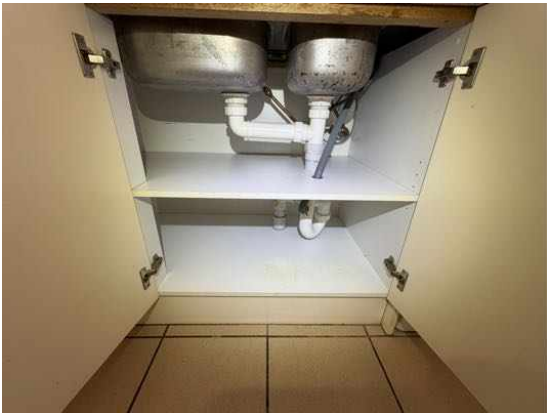
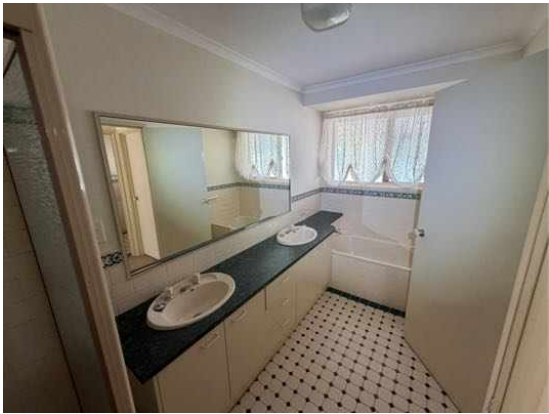
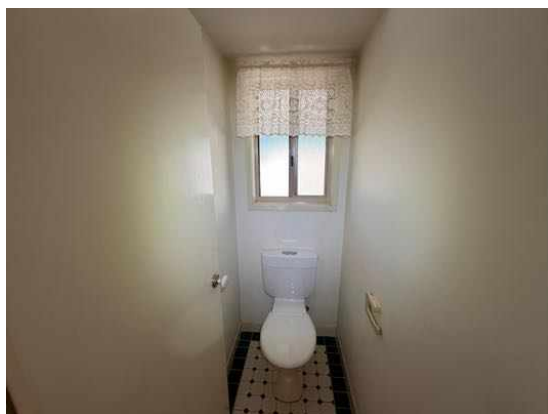
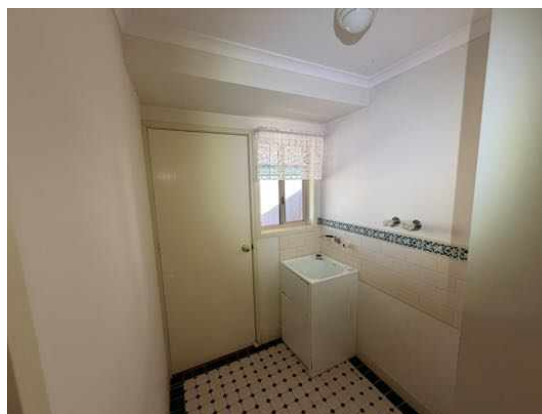
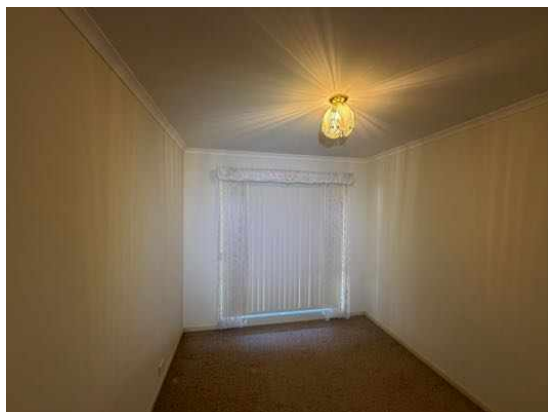
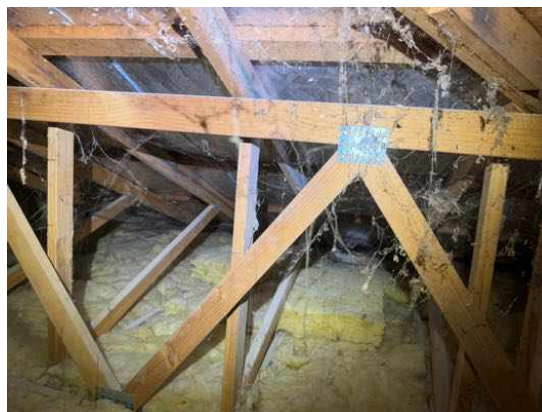
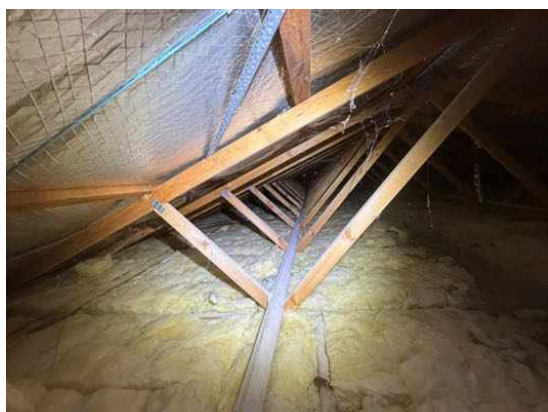
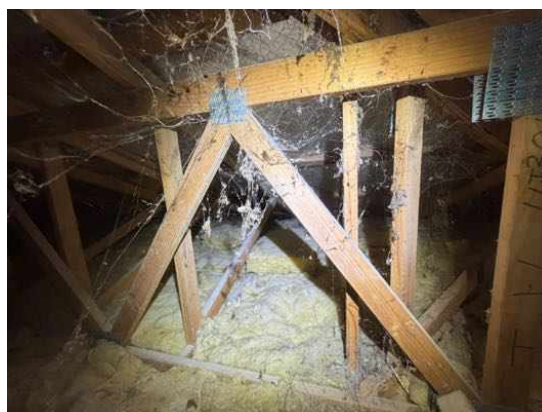
Building: Main Building
Location: All Areas
Finding: Additional Photos - Obstructions and Limitations
Information: These photographs are an indication of the obstructions and limitations which impeded full inspection of the property at the time of inspection. These obstructions can hide an array of defects and should be removed to allow full inspection to be carried out. A re-inspection is recommended once the areas are made accessible.

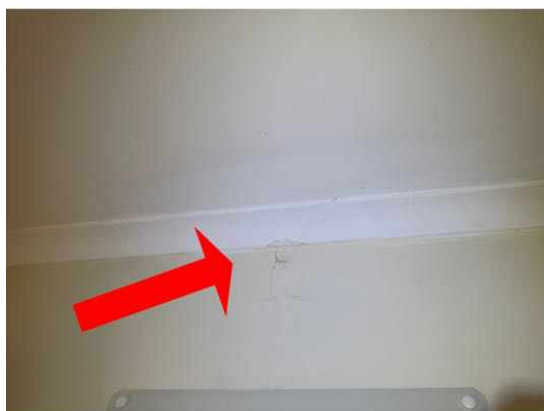
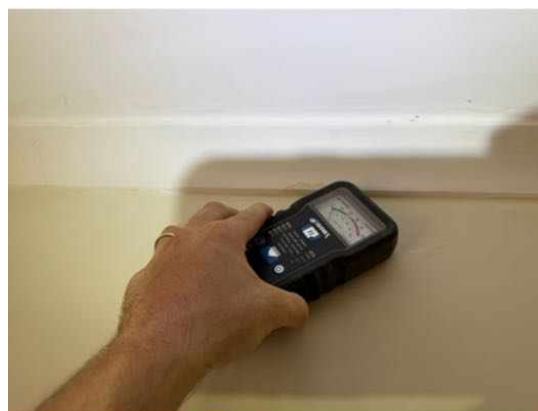
Building: Main Building
 Location: Lounge room
 Finding: Water Staining Present
 Information: It appears that water staining was present at, but not limited to, the wall of the lounge room, above the heater. Potential causes of leaking include deteriorated roof cladding or damaged plumbing fittings and fixtures. No high moisture was evident in the area at the time of inspection.

Recommend that the client monitor the area and engage a licensed plumber promptly, should the leak persist or return.

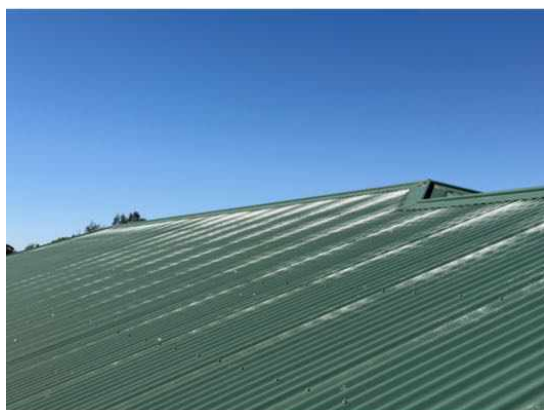
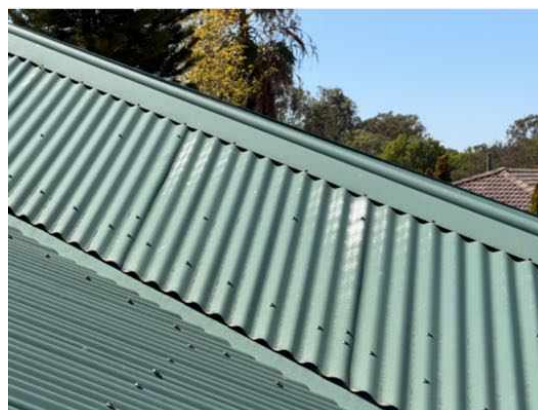
Building:	Main Building
Location:	Roof Exterior
Finding:	Roof Exterior - General Fading
Information:	Areas of general fading were identified to the roof exterior. While weathering of the roof exterior is consistent with the age of the property, the client can engage a licensed roofing contractor at their discretion, to provide further advice regarding future maintenance works needed.

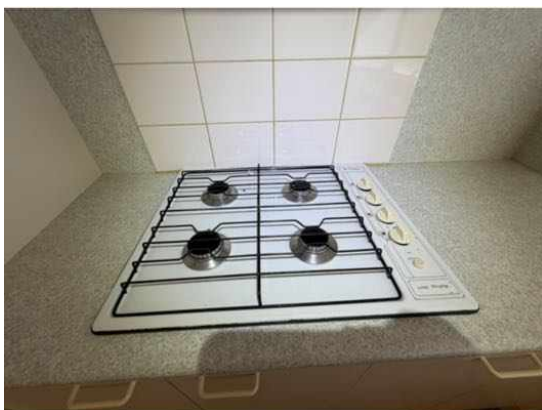
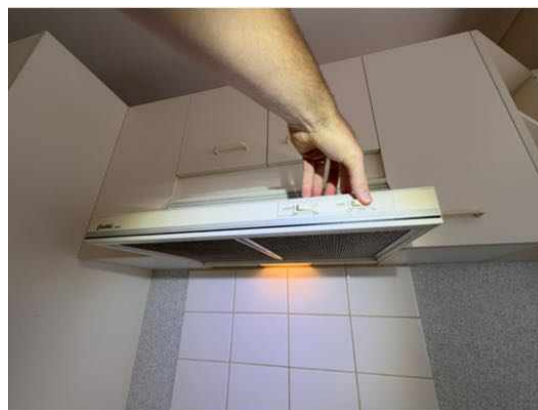
Building:	Main Building
Location:	Kitchen
Finding:	Rangehood & Stove - Not Operating
Information:	It appears that the range hood fan and stove was not operating/igniting at the time of inspection. Recommend engaging a licensed electrician and/or gas plumber at clients discretion, to provide further advice and maintenance works where necessary.

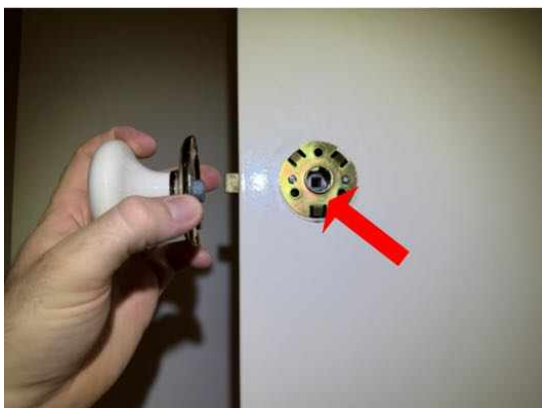
Building: Main Building
 Location: Bedroom
 Finding: Door Handles - Missing Part
 Information: It appears that the bedroom door handle was missing a part, inhibiting the normal function of the door handle. A general handyman may be appointed to perform minor maintenance works at clients discretion.

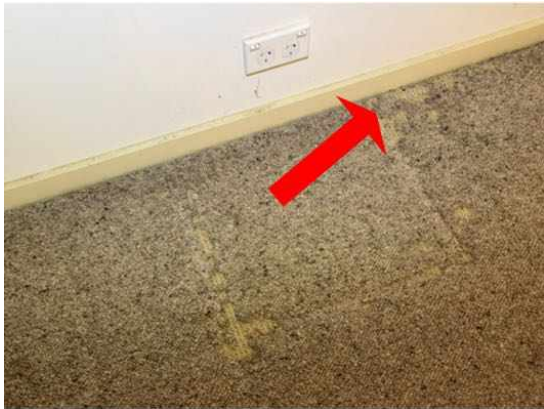
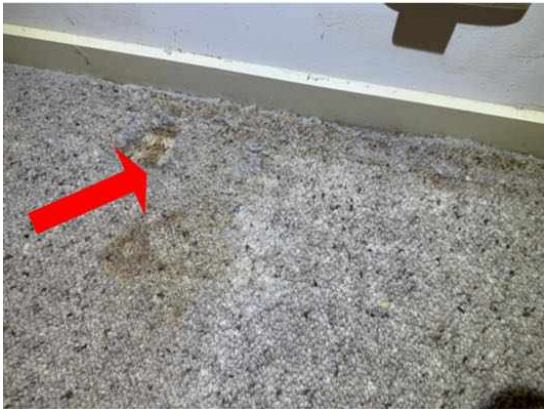
Building: Main Building
 Location: Carpeted Areas
 Finding: Carpet - Deteriorated / Weathered
 Information: It is noted for the clients information that the carpet throughout the building was found to be in a weathered / deteriorated state, which is consistent with the age of the building. Although this is mostly visual defect, the client can engage a flooring contractor at their discretion, to provide remedial works where necessary.
