Building Inspection Report

Inspection Date: Mon, 16 Mar 2026

Property Address: 3A Thomson St, Sunshine VIC 3020,
Australia

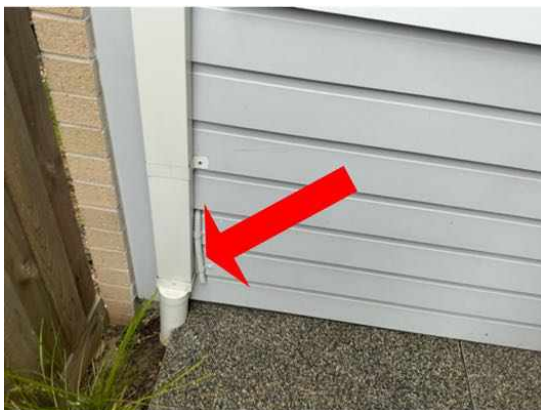
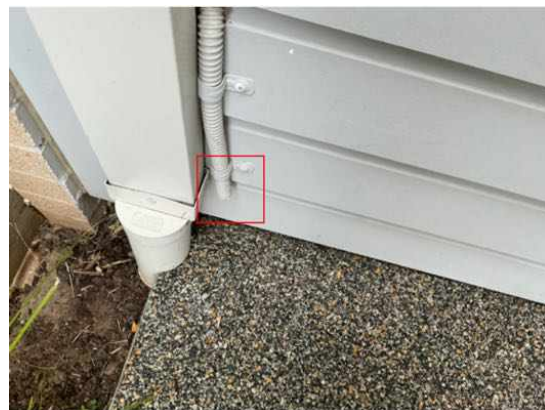
Defects 3.01

Building: Main Building
 Location: All External Areas
 Finding: AC Overflows - Not plumbed to suitable drainage
 Information: Upon inspection, it was found that the AC overflow is not plumbed or connected to suitable drainage. This could lead to the surrounding area becoming excessively damp, which in turn may cause secondary defects such as rot, rust, corrosion of associated building elements, and the formation of fungal decay. In addition, prolonged damp conditions could create potential slip hazards. Poor site drainage may exacerbate the issue, potentially attracting termite activity to the area.

We recommend that a licensed plumber be appointed to properly plumb the AC overflow and connect it to suitable drainage. This will help ensure that the area remains dry and free from secondary defects.

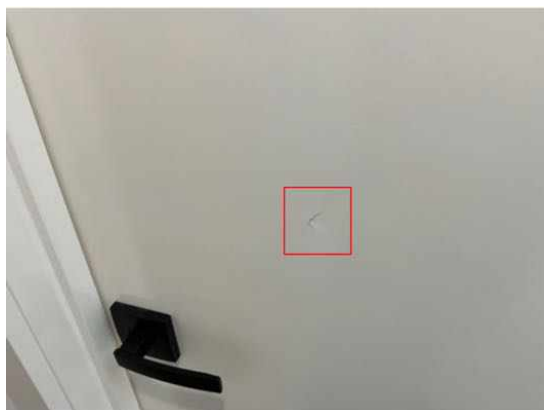
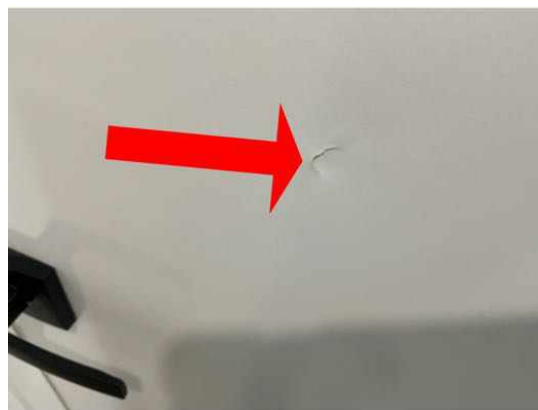
Defects 3.02

Building: Main Building
 Location: Bedroom 2
 Finding: Minor Crack to Bedroom 2 Door (Cosmetic Defect)
 Information: A minor crack was observed to the surface of the door leaf in Bedroom 2 at the time

of inspection. The defect appears superficial in nature and is considered cosmetic, with no immediate impact on the structural integrity or functionality of the door.

If left unaddressed, the crack may become more noticeable over time and could affect the visual finish of the door, particularly if the surrounding paint or coating begins to deteriorate.

It is recommended that the client engage a qualified painter or carpenter to fill, sand, and repaint the affected area as required to restore the finish. Rectification can be carried out at the client's discretion.

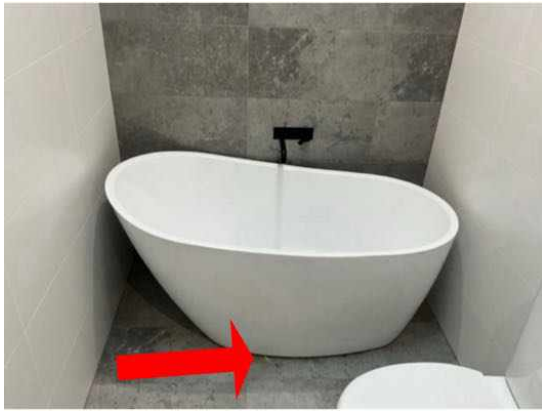
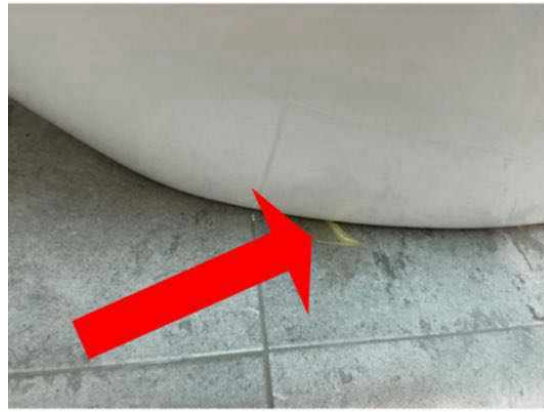
Defects 3.03

Building:	Main Building
Location:	Bathroom
Finding:	Unsecured and Movable Bathtub Installation
Information:	The bathtub in the bathroom was found to be unsecured at the time of inspection, with noticeable lateral movement when manually tested. It appears that the bathtub was originally fixed in place using a silicone application; however, this has failed, resulting in the bathtub becoming loose and no longer properly anchored to the floor or surrounding structure.

It is recommended that the client engage a qualified bathroom specialist or licensed plumber to properly secure and stabilise the bathtub in accordance with acceptable installation practices. The bathtub should be adequately fixed and resealed to prevent movement and ensure a watertight installation.

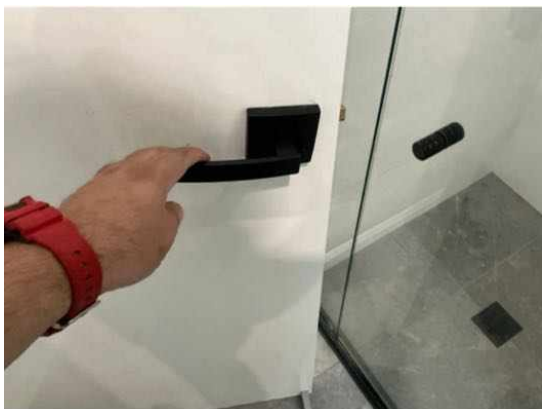
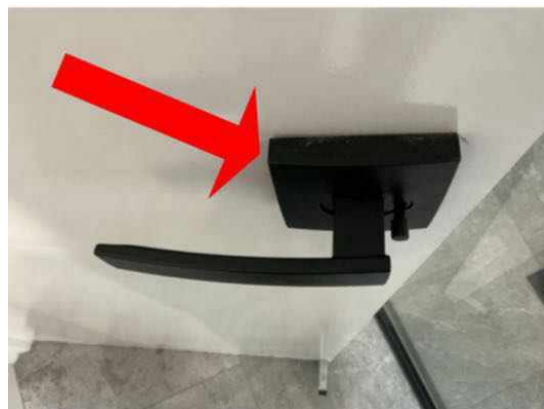
Defects 3.04

Building: Main Building
 Location: Bathroom
 Finding: Loose Bathroom Door Handle and Faulty Latch Mechanism
 Information:

The bathroom door handle was found to be loose at the time of inspection, with the lock latch mechanism not engaging or securing the door properly. The defect indicates improper fixing and/or misalignment of the latch and strike plate components.

If left unrectified, the door may fail to close and lock as intended, affecting privacy and functionality. Continued use in this condition may also lead to further loosening of hardware and potential damage to the door or frame.

It is recommended that the client engage a qualified carpenter or locksmith to tighten, realign, and adjust the door handle and latch mechanism. Any defective components should be replaced as necessary to ensure the door operates smoothly and can be securely latched and locked.

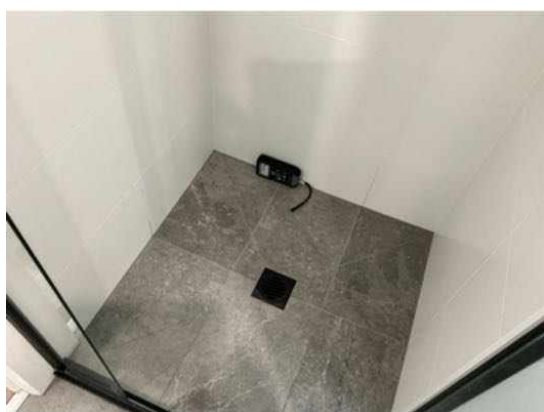
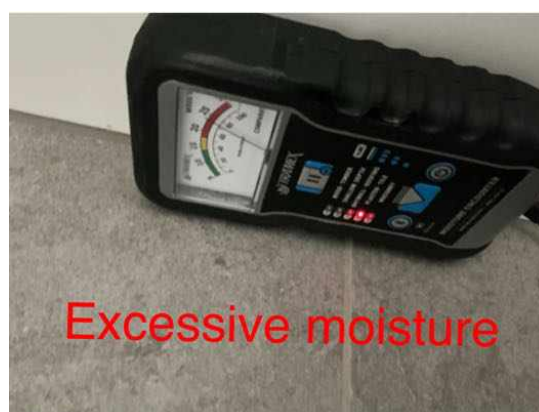
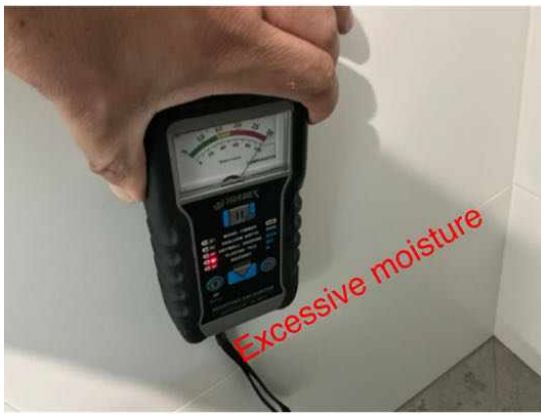
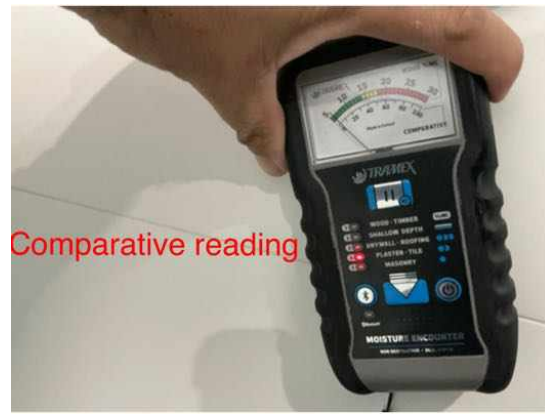
Defects 3.05

Building: Main Building
 Location: Bathroom

Finding: Shower - Damp

Information: Damp is evident to the lower 300mm of wall to the shower alcove. This defect is quite common, and is suspected to have been caused by moisture permeating through the grouting in this area, which shows evidence of deterioration. Leaking pipes within the adjoining wall is also a possible cause.

Unmanaged damp in the shower recess is likely to facilitate the formation and development of mould and fungi growth, decaying associated building materials and compromising their structural integrity. It is important to address damp conditions, as the World Health Organisation notes that excess moisture leads - on almost all indoor materials - to growth of microbes such as moulds, fungi and bacteria, which subsequently emit spores and other matter into the indoor air. Exposure to these contaminants is associated with a wide range of respiratory and other health-related problems.

Consultation with a qualified plumber or bathroom specialist is advised immediately to identify the cause of damp and to perform remedial works as required. Where excessive mould growth is present, further inspection by a specialist environmental health inspector should also be considered.

Always ensure that sealant and grout is in good condition to prevent any moisture issues occurring in the future.

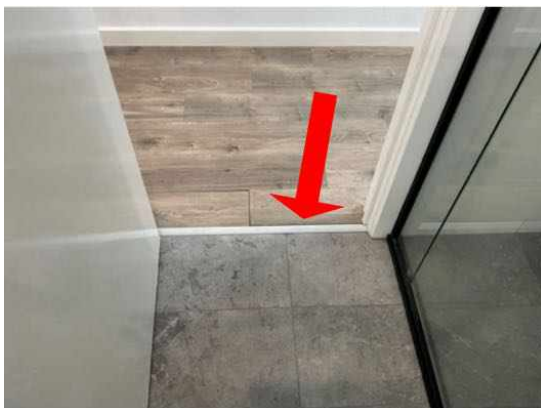
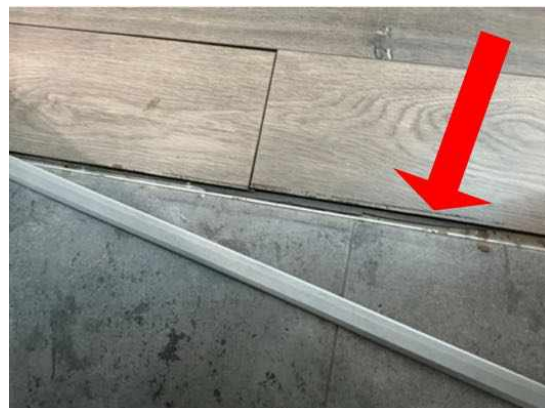
Defects 3.06

Building: Main Building
 Location: Bathroom
 Finding: Loose and Detached Bathroom Divider Trim at Entrance
 Information:

The trim to the bathroom divider at the entrance was found to be loose and partially detached at the time of inspection. The fixing appears inadequate, resulting in the trim not being securely held in place.

If left unrectified, the trim may fully detach, posing a minor safety risk and leading to further deterioration of the surrounding finishes. It may also impact the overall quality of workmanship and presentation of the area.

It is recommended that the client engage a qualified carpenter or handyman to properly refix and secure the trim using appropriate fixings and installation methods to ensure it remains firmly in place.

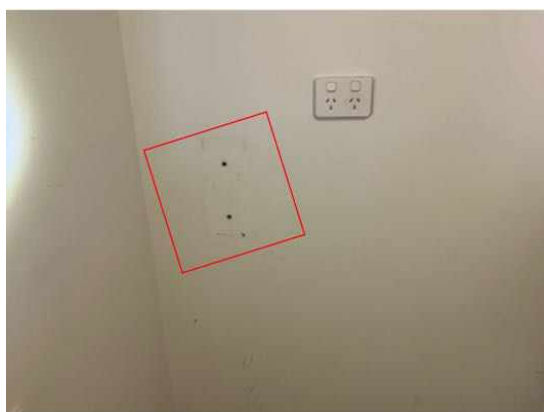
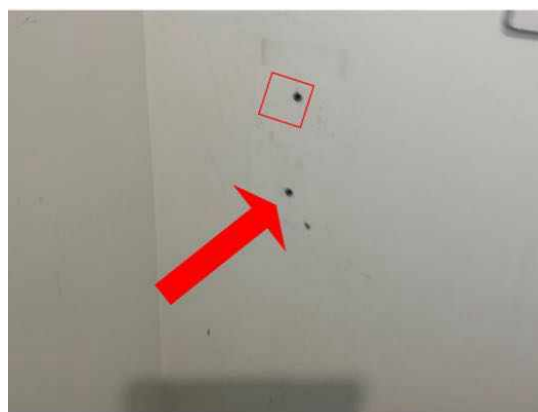
Defects 3.07

Building: Main Building
 Location: Laundry
 Finding: Nail Holes to Laundry Cupboard (Cosmetic Defect)
 Information:

Multiple nail holes were observed to the internal surfaces of the laundry cupboard at the time of inspection. These appear to have resulted from previous fixings or items being mounted within the cupboard and are considered cosmetic in nature.

If left unrectified, the holes may affect the visual presentation of the cupboard surfaces but will not impact functionality.

It is recommended that the client engage a qualified painter or handyman to fill, sand, and repaint the affected areas as required. Rectification can be carried out at the client's discretion.

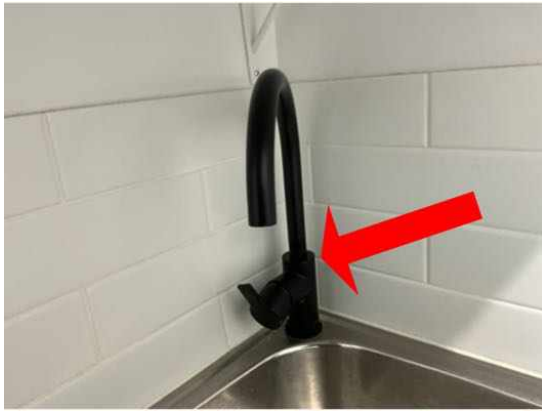
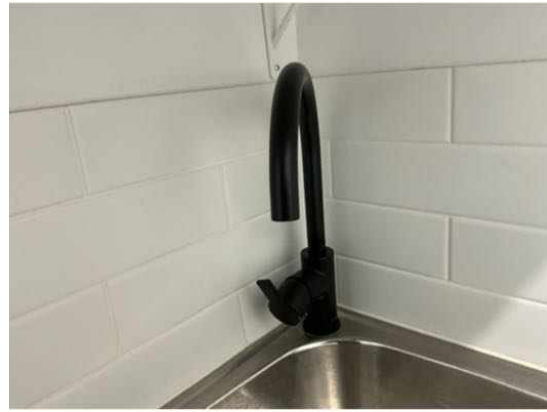
Defects 3.08

Building: Main Building
Location: Laundry
Finding: Laundry Tap Not Operational
Information:

The laundry tap was found to be non-operational at the time of inspection, with no water discharge observed when tested. This indicates a potential issue with the tap fixture, valve, or associated plumbing supply.

If left unrectified, the laundry facility will remain unusable, and the underlying issue may indicate a broader plumbing concern that could worsen over time.

It is recommended that the client engage a licensed plumber to inspect, diagnose, and rectify the issue. Any defective components should be repaired or replaced as necessary to restore proper operation.

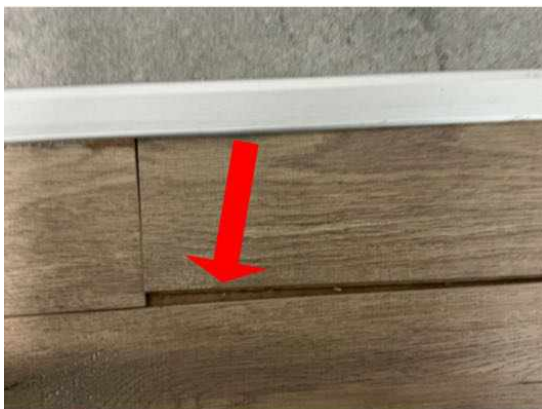
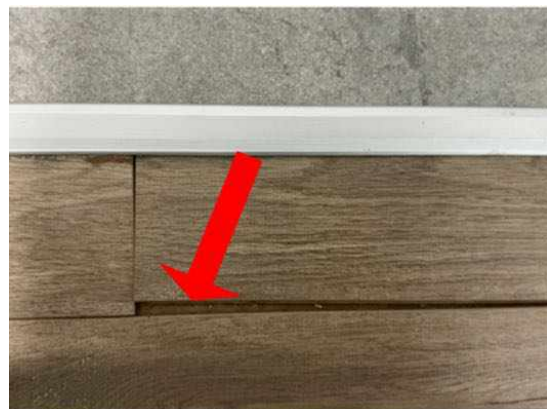
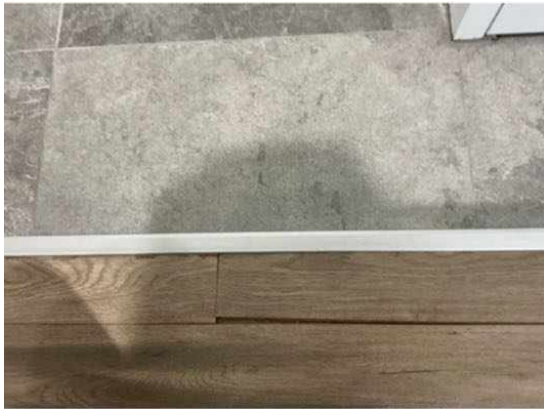
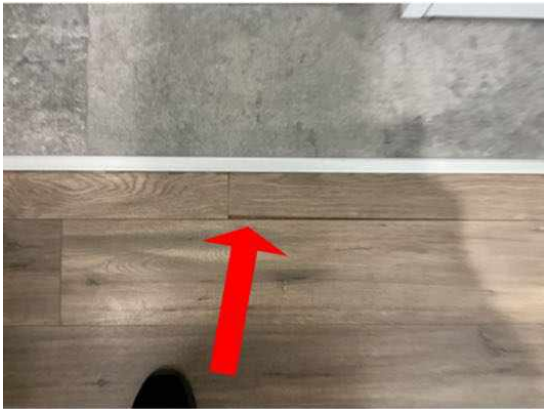
Defects 3.09

Building: Main Building
 Location: All Internal Areas
 Finding: Gaps and Glue Residue to Vinyl Flooring Installation
 Information:

Sections of the vinyl plank flooring were found to have visible gaps between adjoining planks at the time of inspection, indicating inconsistent or inadequate installation. In addition, areas of residual adhesive were observed on the surface of the flooring, suggesting poor workmanship during installation.

If left unrectified, the gaps may accumulate dirt and debris and may worsen over time with movement, potentially affecting the overall appearance and finish of the flooring. The presence of glue residue may also detract from the visual quality of the surface.

It is recommended that the client engage a qualified flooring specialist to inspect the affected areas and carry out localised rectification works as required. This may include realignment or replacement of planks and removal of adhesive residue to achieve an acceptable finish. Rectification can be undertaken at the client's discretion.

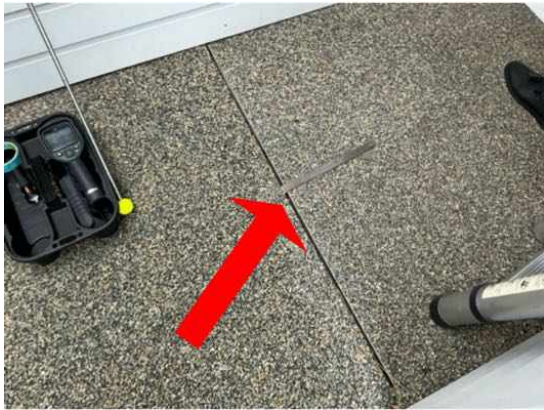
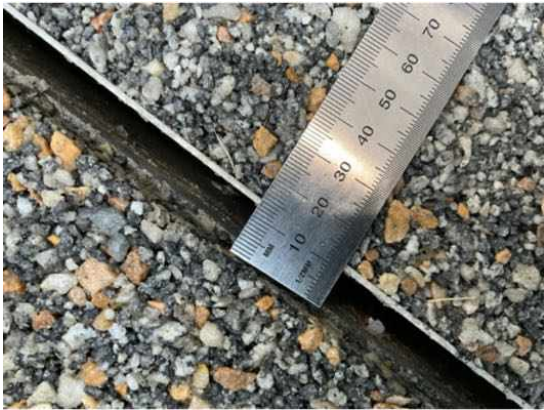
Defects 3.10

Building: Main Building
Location: Covered Porch
Finding: Gap to Concrete Flooring at Covered Porch
Information:

A significant gap was observed within the concrete flooring at the covered porch area at the time of inspection. The defect is likely associated with ground movement and/or settlement affecting the concrete paving.

If left unrectified, the gap may widen over time, allowing water ingress and potential further movement of the slab. This may lead to additional cracking, trip hazards, and deterioration of the concrete surface.

It is recommended that the client engage a qualified concreter to assess the extent of movement and provide appropriate rectification measures. This may include sealing, filling, or undertaking remedial works as required to stabilise and protect the affected area.

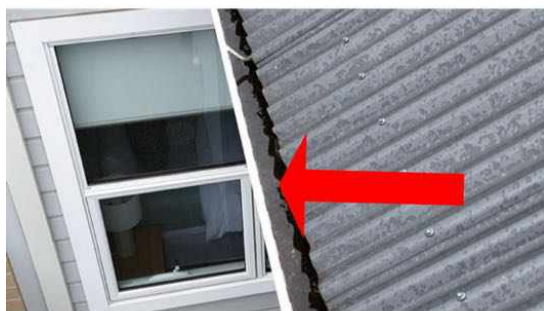
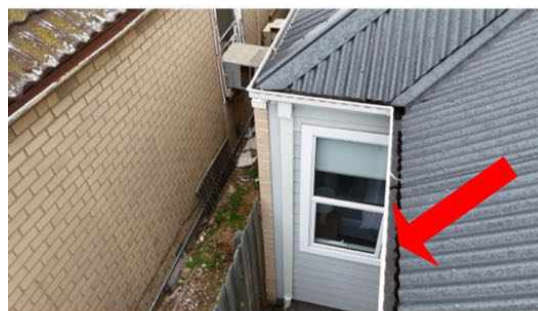
Defects 3.11

Building: Main Building
Location: Gutters
Finding: Gutters - Water pooling

Information: Water was found to be pooling in sections of the roof guttering. This is generally a secondary defect caused by blocked or partially blocked gutters. Such blockages and subsequent water pooling are likely to lead to rust and water damage to associated structures if left unattended.

Any areas of guttering that shows evidence of water pooling should be checked for partial or full blockages and any secondary damage that may have occurred as a result. Depending on the extent of the damage, building elements may require repair and/or replacement to ensure adequate roof drainage and function of exterior plumbing system.

A roofing plumber should be appointed as soon as possible to rectify this issue. It is highly advised that all gutters be maintained on a frequent basis to ensure the condition of roof plumbing.

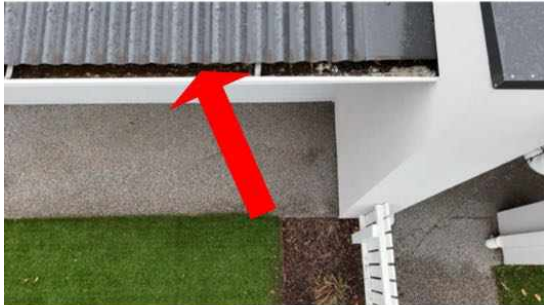
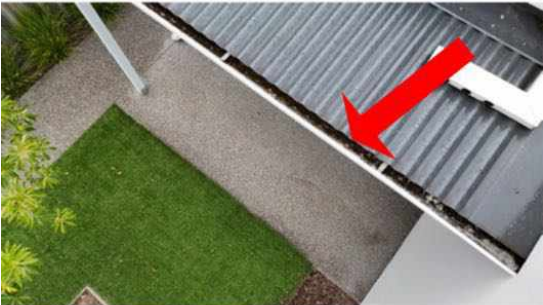
Defects 3.12

Building: Main Building
Location: Gutters
Finding: Gutters - Partially Blocked
Information: Sections of the external gutters were partially blocked with debris, soil and leaves. Roof plumbing structures, such as guttering and downpipes, should be free of all debris to prevent blockages. Blockages of the guttering and downpipes will lead to pooling and accumulated water overflows, which is likely to subsequently flood eaves and exterior walls.

Blocked gutters are likely to lead to high levels of moisture in the affected areas. Such moisture will not only cause rust and decay of the associated building materials, but can also provide conditions that are conducive to termite and timber pest activity. Blockages in gutters should therefore be removed immediately to ensure dry conditions are maintained.

Where gutter guard is installed regular maintenance should include cleaning out any debris which may rest on top of or filter through the gutter guard.

Consult a Licensed Plumber for further specific advice on remedial works that may be required. In the interim, it is highly advised that blocked gutters be removed by the homeowner or a general handyperson as a matter of urgency.

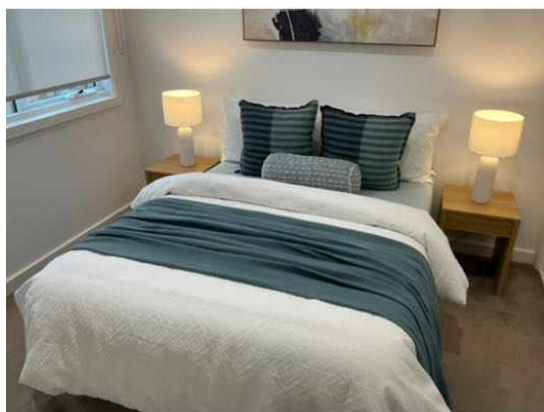
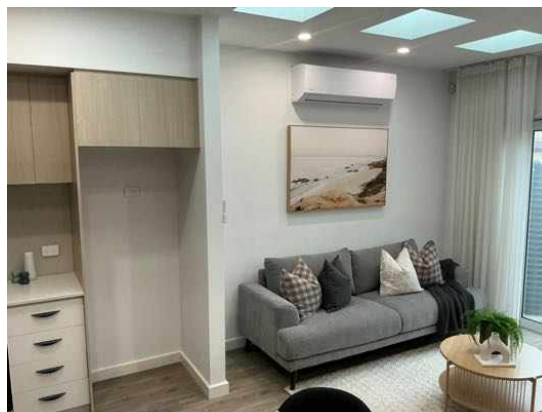
Building: Main Building
Location: All Internal Areas
Finding: Obstructions and Limitations - Interior
Information: These photographs are an indication of the obstructions and limitations which impeded the inspection of the internal areas of the property at the time of inspection. These obstructions can hide an array of defects and should be removed to allow full inspection to be carried out. A re-inspection is recommended once the areas are made accessible.

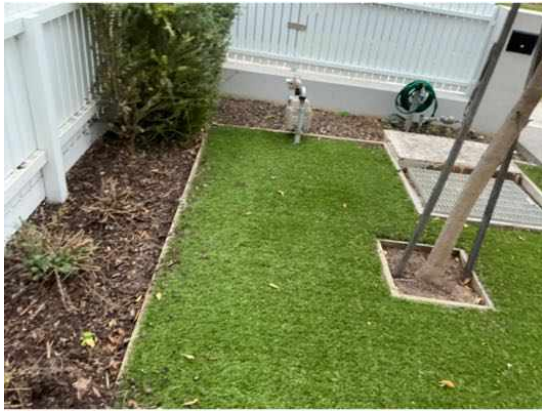
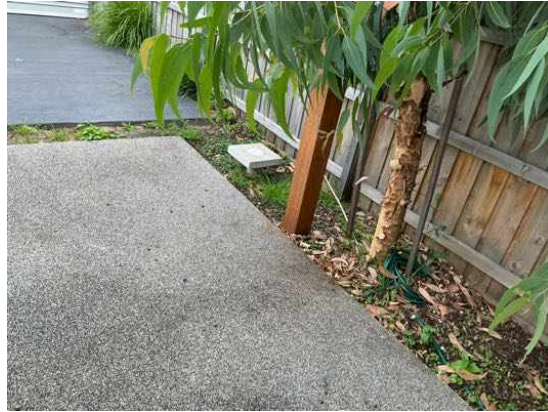
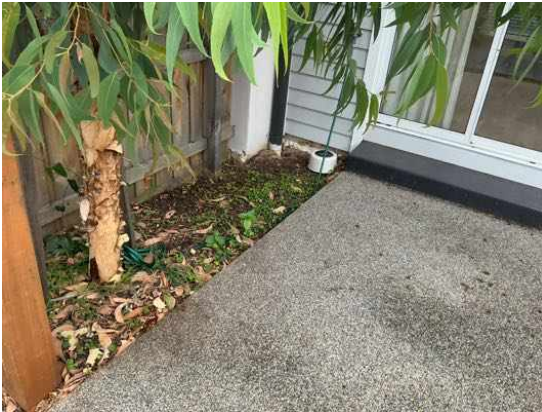
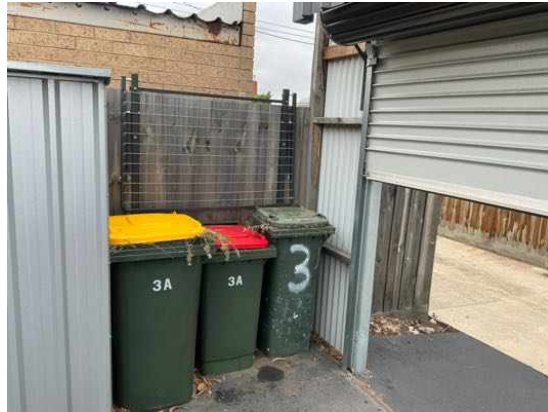
Building: Main Building
Location: All External Areas
Finding: Obstructions and Limitations - Exterior
Information: These photographs are an indication of the obstructions and limitations which impeded the inspection of the external areas of the property at the time of inspection. These obstructions can hide an array of defects and should be removed to allow full inspection to be carried out. A re-inspection is recommended once the areas are made accessible.

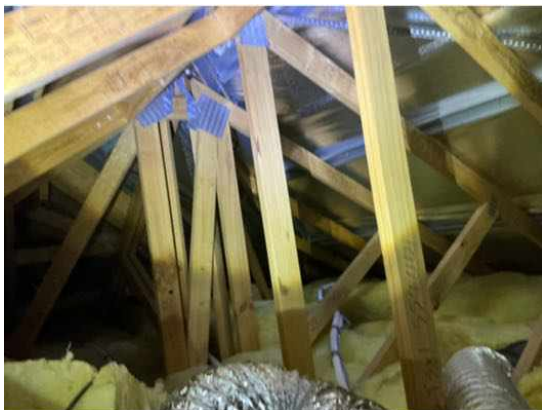
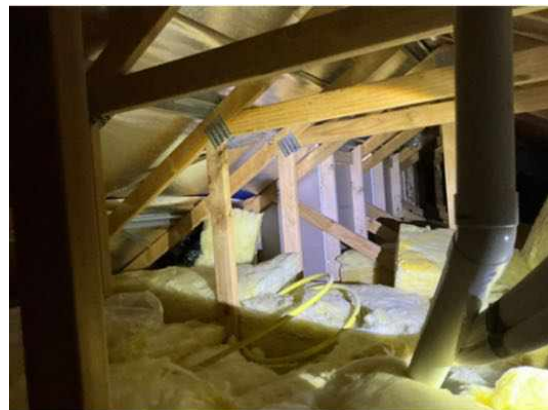
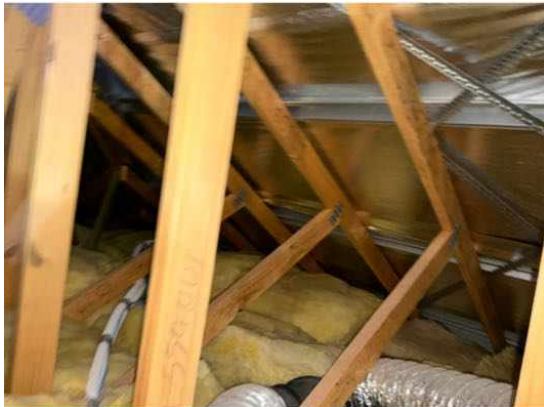
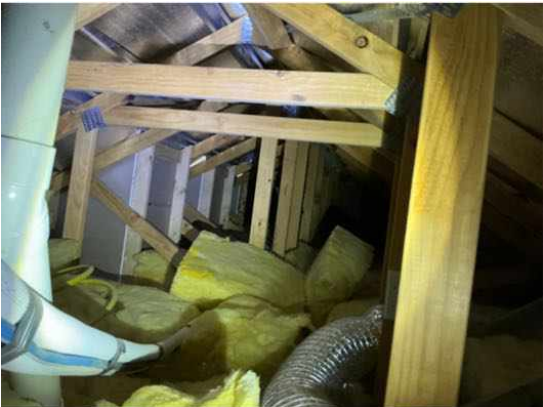
Building: Main Building

Location: Roof Void

Finding: Obstructions and Limitations - roof cavity

Information: These photographs are an indication of the obstructions and limitations which impeded the inspection of the roof cavity area of the property at the time of inspection. These obstructions can hide an array of defects and should be removed to allow full inspection to be carried out. A re-inspection is recommended once the areas are made accessible.
