Building Inspection Report

Inspection Date: Wed, 4 Mar 2026

Property Address: 12 Grand Rd, Munno Para SA 5115,
Australia

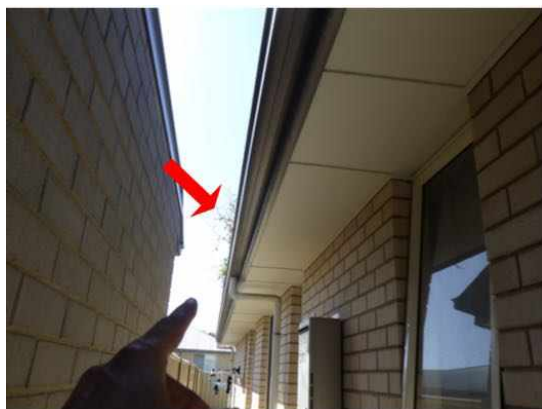
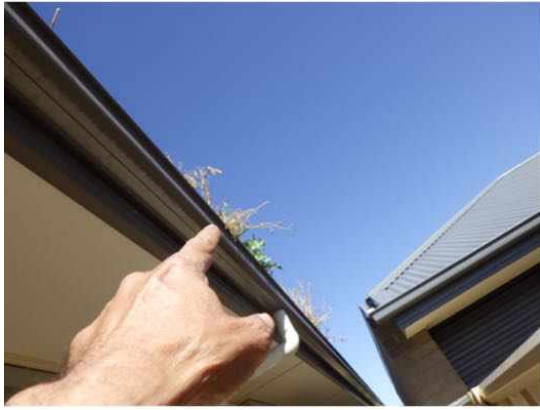
Defects 2.01

Building: Building 1
Location: All External Areas
Finding: Gutters - Blocked
Information: At the time of inspection it was noticed that gutters were blocked in few sections around the property. Gutters have to be cleaned in regular intervals.

Roof plumbing structures, such as guttering and downpipes, should be free of all debris to prevent blockages. Blockages of the guttering and downpipes will lead to pooling and accumulated water overflows, which is likely to subsequently flood eaves and exterior walls.

Blocked gutters are likely to lead to high levels of moisture in the affected areas. Such moisture will not only cause rust and decay of the associated building materials, but can also provide conditions that are conducive to termite and timber pest activity. Blockages in gutters should therefore be removed immediately to ensure dry conditions are maintained.

Consult a Licensed Plumber for further specific advice on remedial works that may be required. In the interim, it is highly advised that blocked gutters be removed by the homeowner or a general handyperson as a matter of urgency.

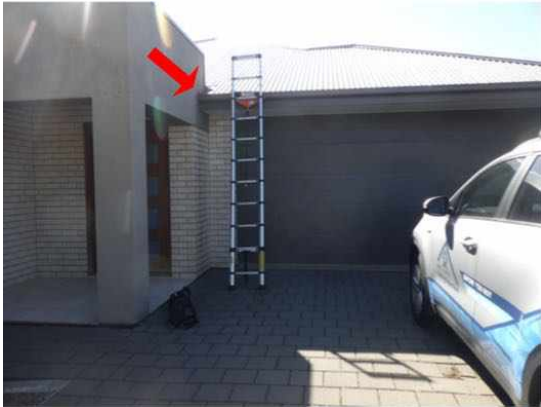
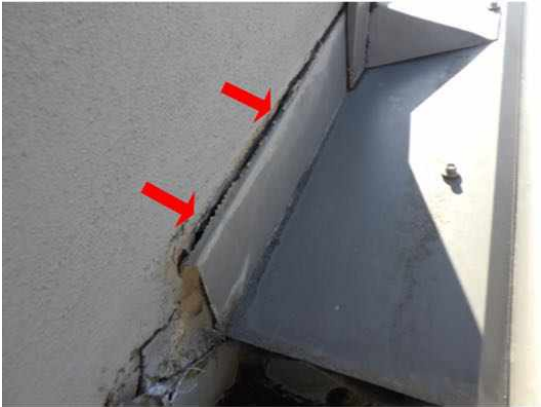
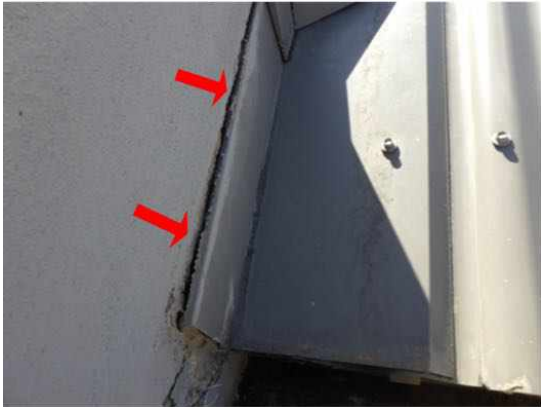
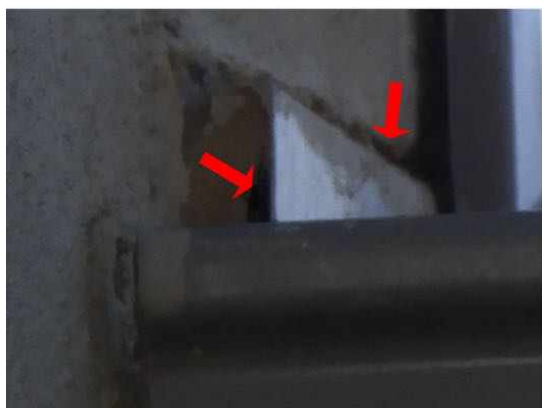
Defects 2.02

Building:	Building 1
Location:	All External Areas
Finding:	Roof plumbing - Flashing inadequate
Information:	At the time of inspection it was noticed that some sections of the roof flashing are inadequate / loose from its original fixing in this entry area.

Flashings that are not installed adequately or are missing are likely to result in water

penetration to the interior of the property, as well as creating excessively damp conditions against the exterior surfaces and around the base perimeter of the building.

Premature ageing and secondary building defects are imminent where roof plumbing is missing or inadequately installed. Additionally, water pooling also creates an environment that is susceptible to termite and pest infestation.

A roofing plumber should be appointed as soon as possible to install relevant roof plumbing materials, ensuring that no further damage is sustained.

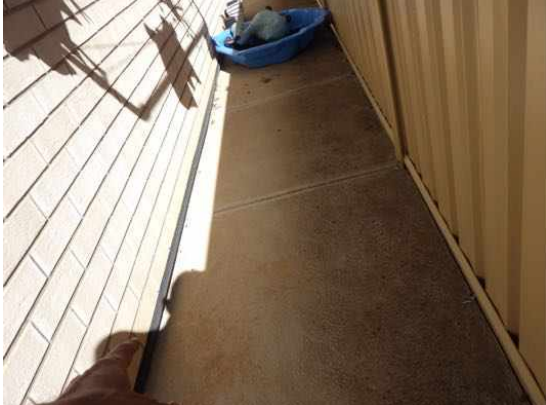
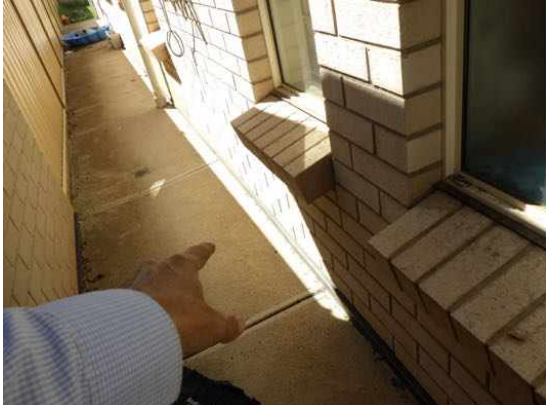
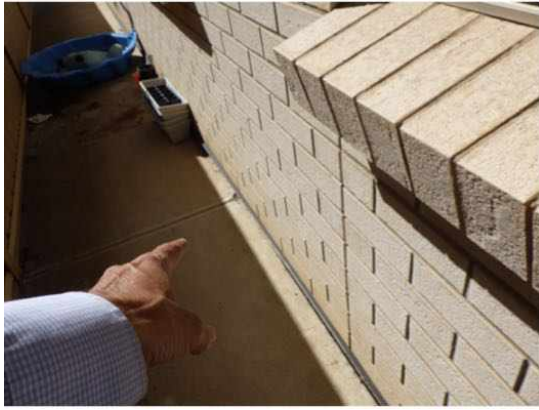
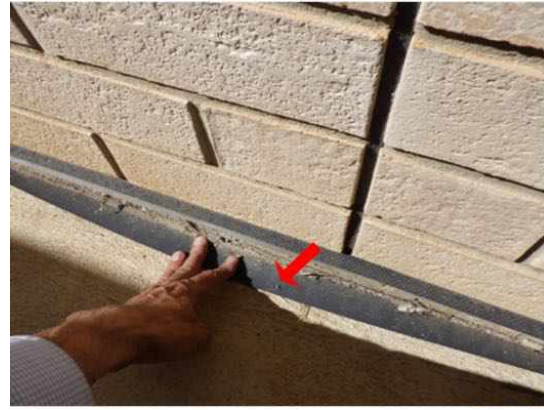
Defects 3.01

If the slab edge is not properly exposed there is a high risk of termite attack. Sometimes, in order to determine the type of slab, a suitably qualified person such as an architect or builder may be required to consult the construction plans.

Where the slab edge cannot be properly inspected, it is highly recommended that termite or timber pest inspections be carried out every 6-12 months to aid protection of the property against infestation.

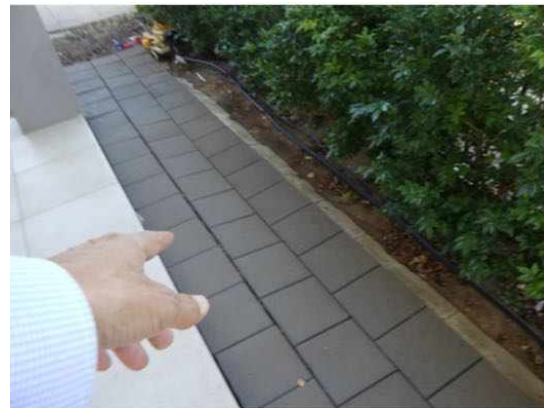
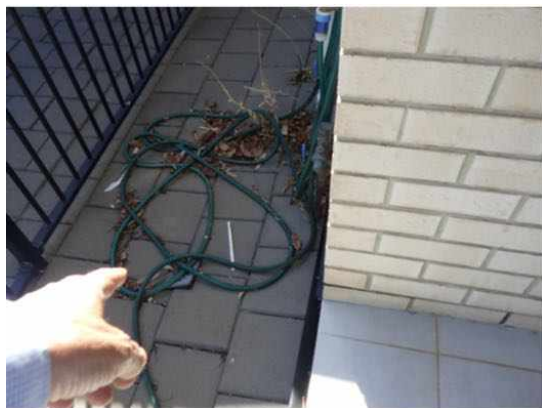
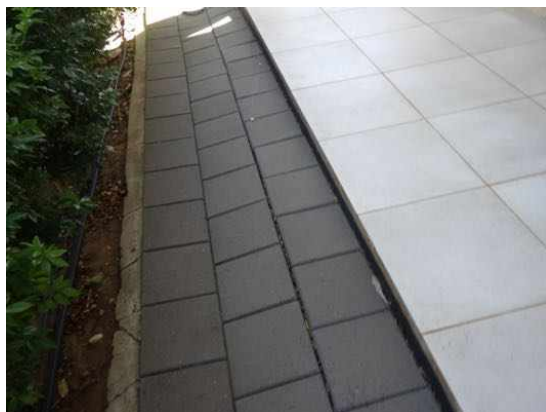
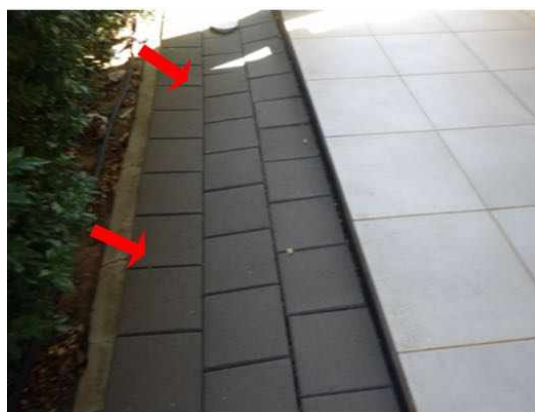
Defects 3.02

Finding: Paving - Uneven

Information: Sections of the external paved area are uneven, creating a potential trip hazard. It appears as though the area has been subject to rough installation, or that paving sections have lifted due to movements in the foundation of the property.

Where paving creates a trip hazard, personal injury may ensue if due caution is not taken by all persons within this area.

Re-paving of the area is required as soon as possible to remedy this situation. Further consultation with a specialist concreter is advised.

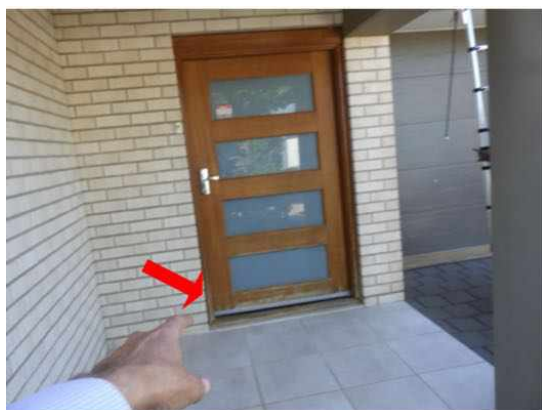
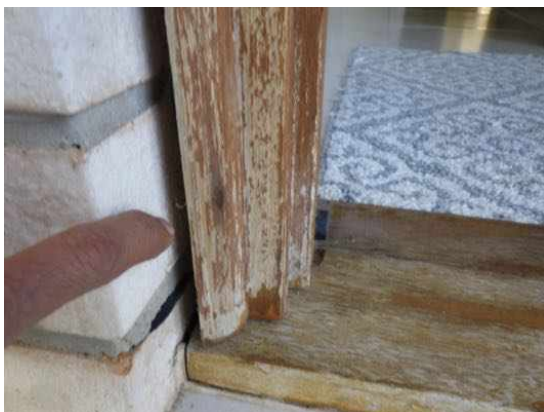
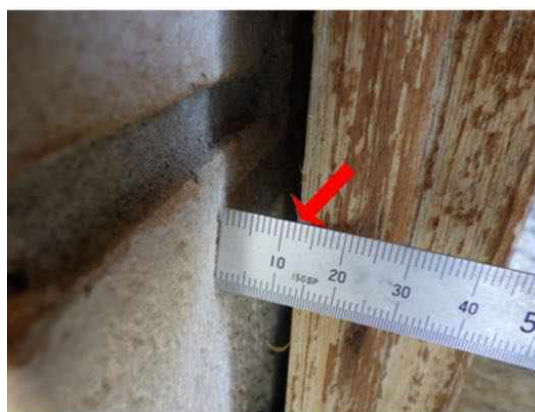
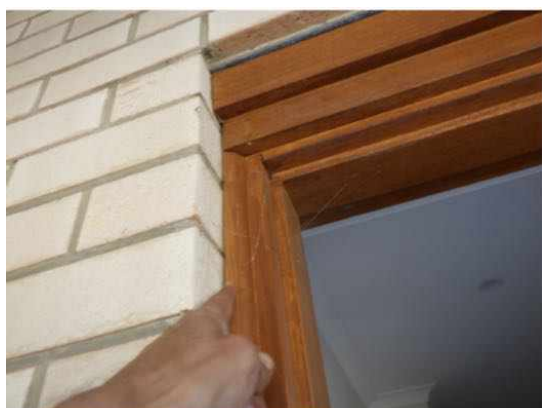
Defects 3.03

Building:	Building 1
Location:	All External Areas
Finding:	External Walls & Entry Door Frame Assembly - Significant Gaps Observed
Information:	At the time of inspection, it was noted that significant gaps are present between the external walls and entry door frame assembly. These gaps indicate poor detailing, movement, deterioration of materials, or inadequate installation and sealing.

Such conditions may arise due to age-related degradation, environmental exposure, or physical damage. If left unrectified, these gaps may allow water and air ingress, potentially leading to secondary defects, including moisture damage, deterioration of adjacent building elements, and reduced thermal and weatherproof performance.

Repair and/or replacement of the affected components is recommended to reinstate the integrity and performance of the building envelope. All building elements play an essential role in the operation and overall performance of the structure, and defects of this nature may adversely impact durability and habitability.

It is advised that a suitably qualified and licensed tradesperson be engaged to assess and rectify the affected areas to prevent further deterioration or consequential damage.

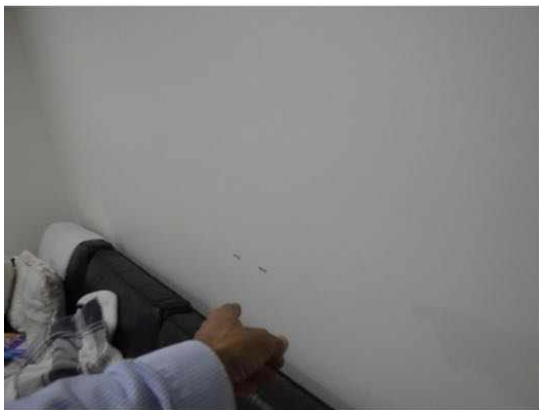
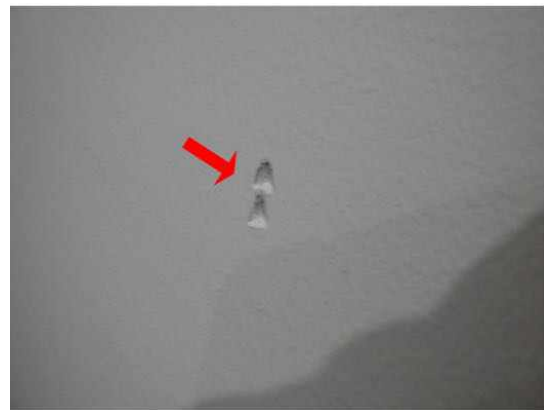
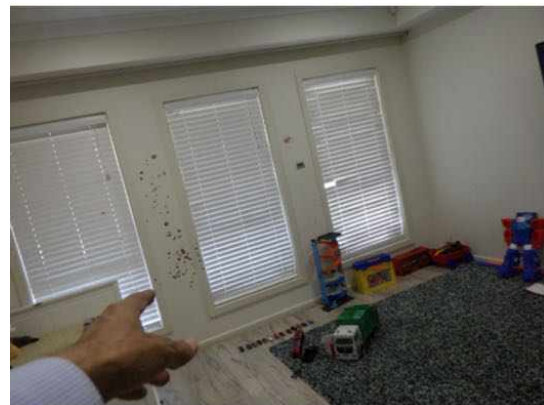
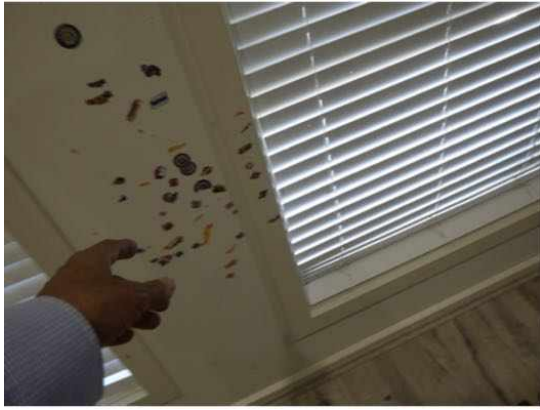
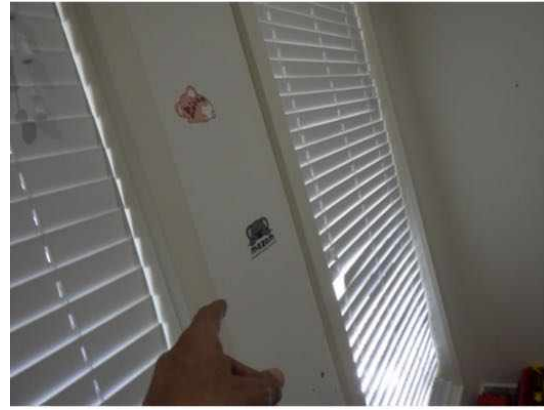
Defects 3.05

Scuffed surfaces, while detracting from the overall appearance of the affected building element, do not indicate any operational or structural damage. This degree of surface damage is consistent with general wear and tear and minor impact damage, normally accumulated over a number of years.

Marked surfaces may be left as is at the discretion of the client; no repairs or replacement are necessarily required, as this is an appearance defect. However, the client may wish to seek quotations for the cost to refurbish or replace the identified building element.

A general handyman or plasterer may be appointed to rectify marked surfaces if considered necessary by the client.

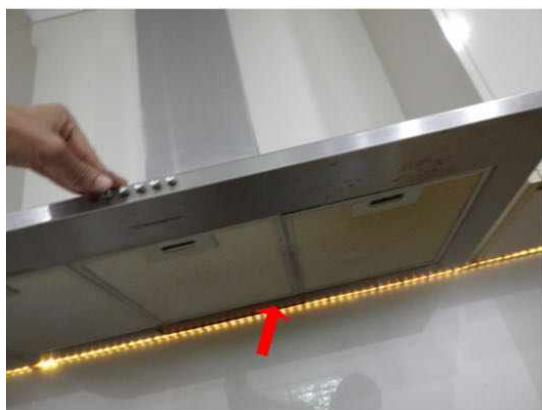
Defects 3.06

Building: Building 1
Location: Kitchen
Finding: Rangehood - Light not working
Information: While the range hood appears to be working at a satisfactory level, the light to the appliance was not working at the time of inspection.

A licensed electrician should be appointed to replace the light on the range hood to restore it to a fully operational state.

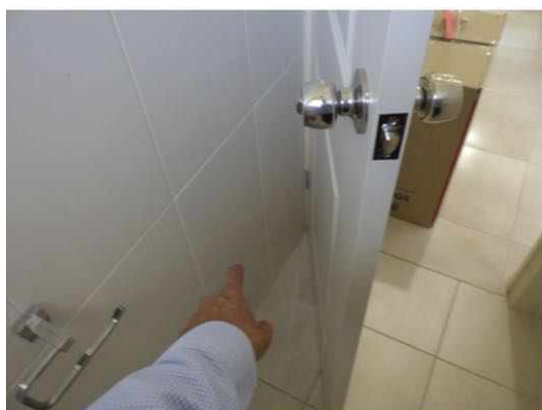
Defects 3.07

Building:	Building 1
Location:	All Internal Areas
Finding:	Door stop - Missing
Information:	At the time of inspection it was noticed that the toilet door stop is missing or is inadequate to stop the door handle from damaging the wall. Although some building elements may seem irrelevant or unnecessary, all building elements play a key role in the operation and function of the overall structure and its performance.

Re-installation or replacement of the door stop is advised as soon as possible to prevent any subsequent damage to the door or associated structures. A general handyman may be appointed to perform these works at client discretion.

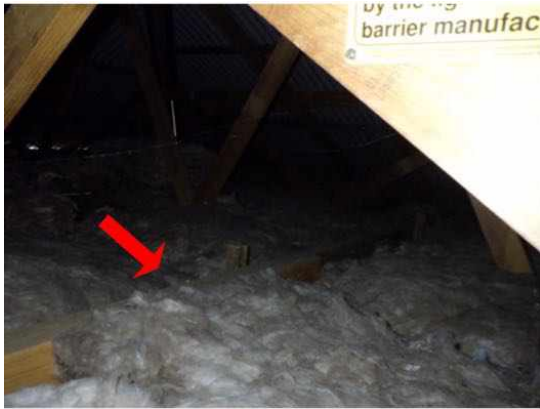
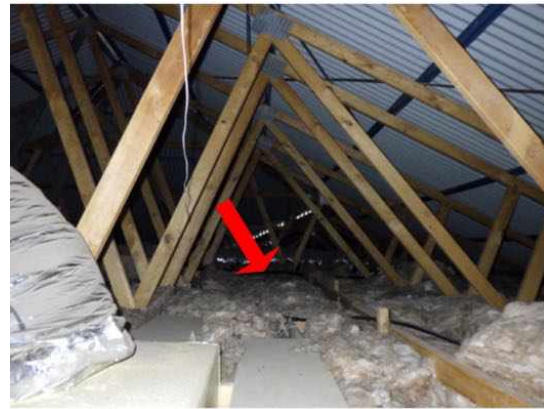
Defects 3.08

Building:	Building 1
Location:	All Internal Areas
Finding:	Insulation - Missing
Information:	Upon inspection of the roof void it was noted that insulation is not present in few sections in this roof space area. Apart from that at the time of inspection it was also noticed that insulation was present in most sections in this roof space area.

Where insulation is absent, the area does not meet current Australian Standards. Installation of adequate insulation is required and should be conducted as soon as possible.

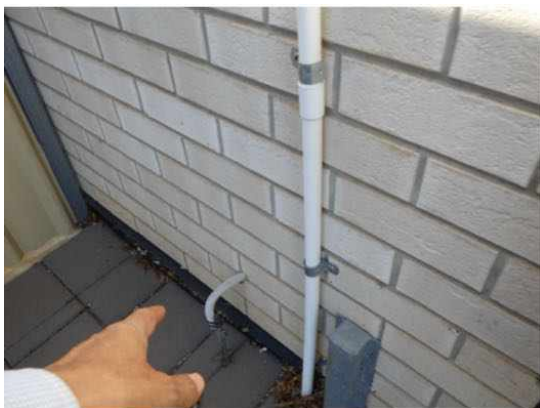
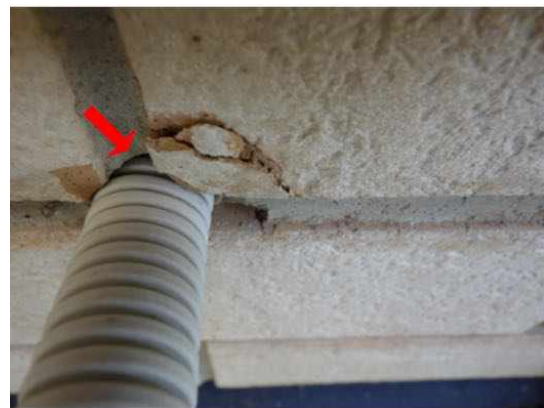
Defects 3.09

Building:	Building 1
Location:	All External Areas
Finding:	External walls - Holes
Information:	Significant holes were identified around pipe penetrations in this wall section. It is suspected that the installation of this pipework was completed to a substandard level of workmanship or is incomplete.

Gaps and holes around pipework makes the area susceptible to insect and vermin ingress, as well as allowing water penetration to the cavity wall. As such, associated building elements are likely to deteriorate at an accelerated rate, and major implications are expected if holes around the pipework are left unmanaged.

All excessive holes, gaps or cracks should be adequately filled by a suitable sealant or trimmings as soon as possible to prevent any further damage. Such works may be conducted by a general handyperson or licensed plumber.

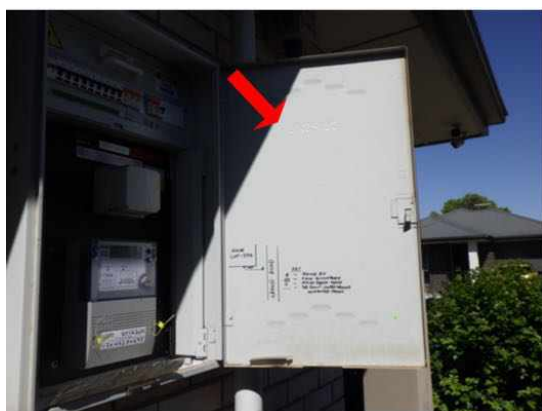
Building: Building 1
 Location: All External Areas >
 Finding: Termite Management System - No evidence of a chemical installation
 Information: The application of a post-construction chemical termite barrier is highly recommended for all properties, particularly if live termite activity has been found on the site previously. Such barriers are highly effective in preventing termite attack on any timber building elements throughout the property.

A durable notice should be placed in the switchboard unit to indicate current termite barriers. At the time of inspection, it appeared as though no termite management system has been installed, with no evidence to suggest preventative works taking place.

The client may consider gaining further advice from a pest controller as to the costs and procedures involved with this application. It is recommended that obtaining such advice be a short-term priority.

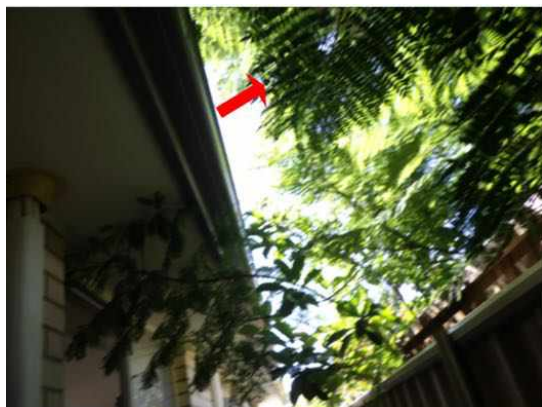
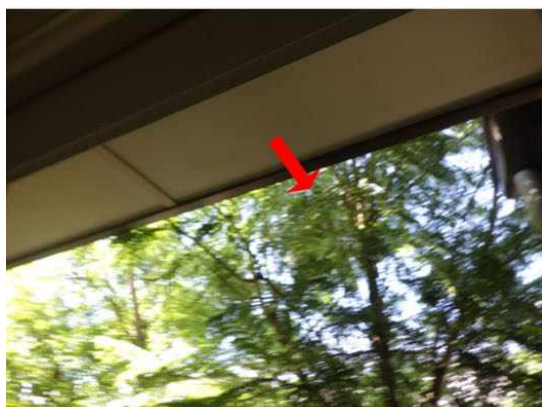
Building: Building 1
 Location: All External Areas
 Finding: Trees - Overhanging and filling gutters
 Information: Overhanging trees often result in excessive amounts of leaf debris accumulating in gutters.

Gutters are a critical part of the building's management of storm water and rain. It is therefore important that they be kept clear to prevent secondary damage to associated building elements, including exterior and interior walls, ceiling linings and

any adjoining building elements. Where gutters are blocked, pooling of rainwater is likely to occur, fast-tracking rust and corrosion of the roof plumbing elements.

It is highly advised that all overhanging tree branches be removed as soon as possible to prevent any further damage. Repair and/or replacement of sections of damaged guttering may also be required where the extent of the damage necessitates.

Such works should be performed by the homeowner; however, appointment of a landscape contractor or an arborist may be required. Consultation with a licensed roof plumber is required where guttering has been damaged.

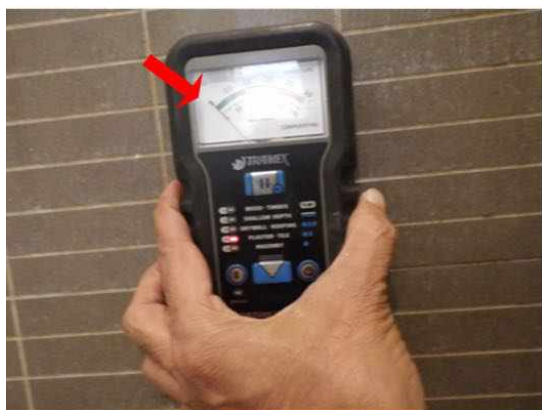
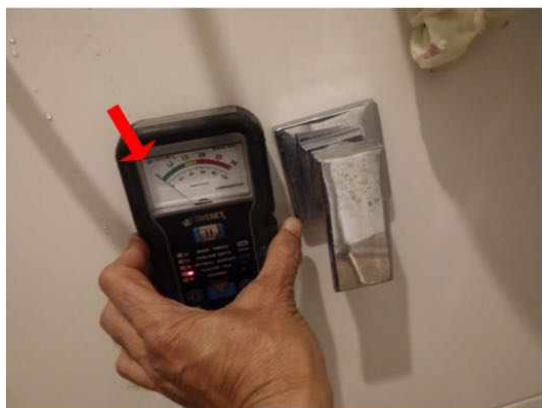
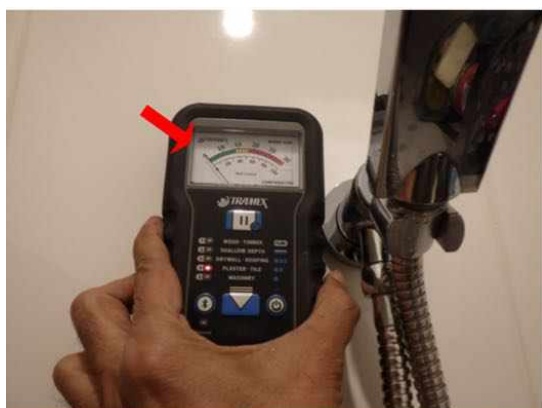
Building: Building 1
 Location: Bathroom-Ensuite
 Finding: Shower Alcove - No Damp
 Information: At the time of inspection it was noticed that damp is not evident to the shower alcove.
