Building and Timber Pest Inspection Report

Inspection Date: Wed, 14 Jan 2026

Property Address: 17 Loch Avenue, Glenmore Park NSW
2745

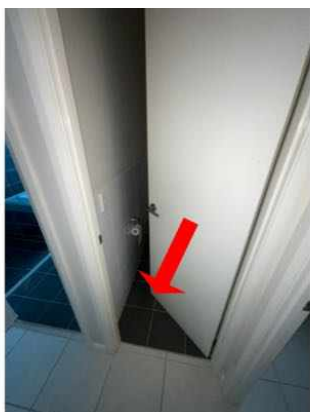
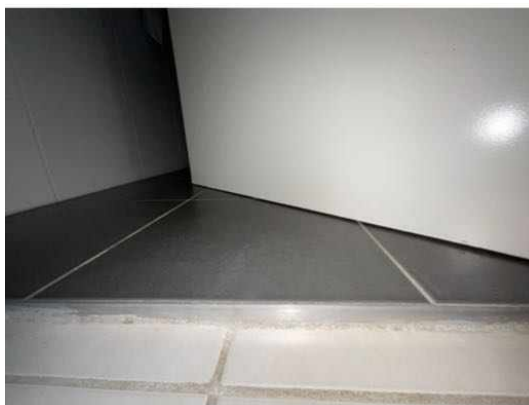
Binding or rubbing was observed between the bottom edge of the door and the floor covering during normal operation. The door does not open or close freely due to insufficient clearance.

The bottom edge of the door should be trimmed or planed to provide adequate clearance, and the edge sealed appropriately after adjustment.

Rectification can be carried out by a qualified carpenter or general handyperson, depending on the extent of adjustment required and at the client's discretion.

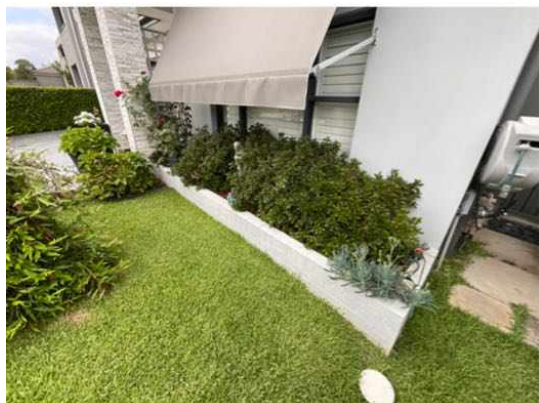
Garden beds were observed directly against the perimeter of the building. This condition can result in water pooling or retention during rainfall or from regular watering/hosing, which may lead to moisture ingress beneath the structure.

- Persistent moisture buildup around the base of the building creates an environment that is conducive to termite activity and timber decay.
- Plants and vegetation close to or in contact with external walls can provide shade and cover, further increasing the likelihood of termite infestation.
- Garden beds may also conceal weep holes, slab edges, or termite barriers, reducing visibility during inspections and allowing for undetected termite entry.

It is strongly recommended that garden beds be removed or relocated away from the building perimeter. Maintaining a clear inspection zone around the structure helps reduce moisture retention and improves visibility during regular pest inspections. This preventative measure significantly lowers the risk of termite ingress and related structural damage.

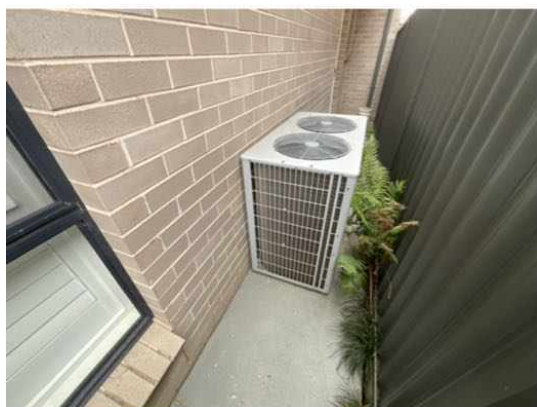
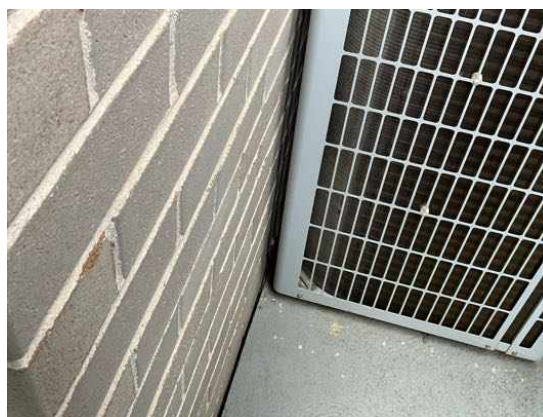
Finding 6.02

Building: Main Building
 Location: All External Areas
 Finding: Bridging or Obstruction - A/C Unit..
 Information: Obstruction to Inspection – External Wall Area

An air conditioning unit is positioned in close proximity to the external wall, obstructing visual access to the wall surface and/or weep holes in this location.

- Obstructions such as this limit the ability to detect evidence of termite activity or conditions conducive to infestation.
- Termites may enter a structure in a concealed or undetectable manner, particularly where weep holes are blocked or not visible, allowing them to bridge physical barriers unnoticed.

- It is recommended that the A/C unit or associated obstruction be moved to allow a clear inspection of the wall and weep holes.
- A re-inspection should be carried out once access is available.
- It is also recommended that external walls remain clear of obstructions for ongoing periodical termite inspections, in accordance with best practice.

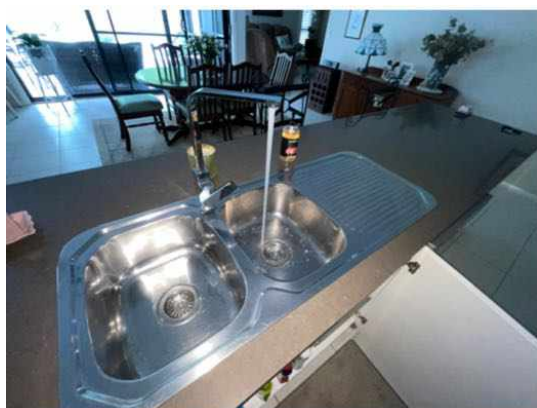
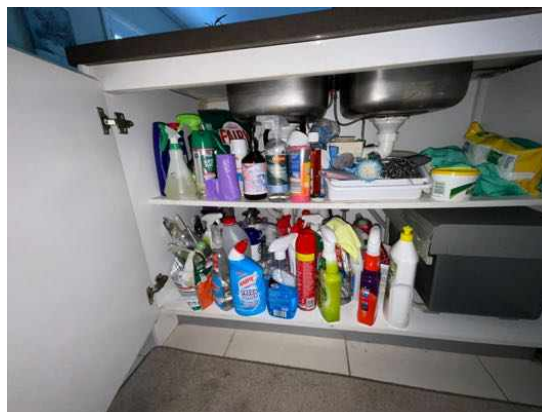
Building:	Main Building
Location:	Kitchen
Finding:	Kitchen Sink – Overall Condition & Recommendations.

- The kitchen sink tap(s) were water tested at the time of inspection, with no evidence of leaks or blockages observed in the visible plumbing or drainage.
- No significant water damage was observed to the cabinetry/unit.
- Stored items under the sink obstructed access, limiting a full inspection of the plumbing and internal cabinetry.

- Further monitoring and testing are recommended once the tap(s) are in constant use, to identify any drainage issues or signs of slow leaks not evident during the limited inspection.
- It is recommended that the stored items beneath the sink be removed to allow for a full re-inspection of the plumbing and cabinetry, ensuring no concealed defects are present.

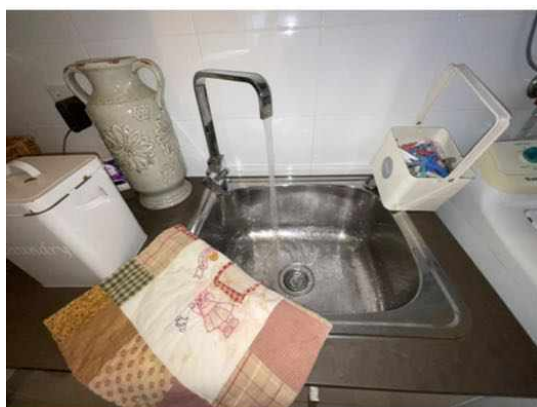
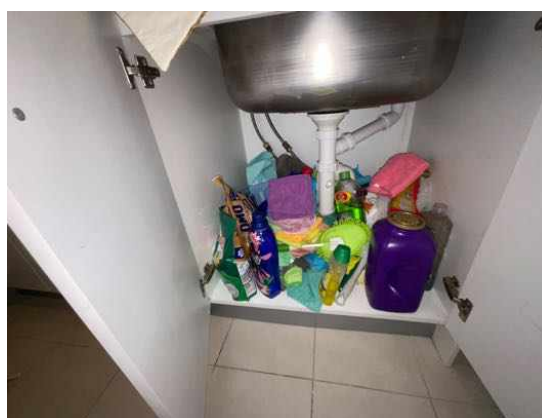
- The taps to the laundry tub were water tested and inspected, with no evidence of plumbing or drainage leaks observed at the time of inspection.
- No visible signs of water damage, rust, or corrosion were noted to the cabinetry or surrounding unit during the inspection.

- Further monitoring or testing is recommended once the taps are placed into regular use, to ensure no leaks develop over time and that the drainage system continues to perform adequately.
- Flexible and mould-resistant sealant should be applied to junctions between the basin and the wall to prevent water ingress that may lead to damage.
- Regular maintenance and prompt replacement of missing or deteriorated sealant is highly recommended, as this is a common wear-and-tear issue.
- Sealant and grouting in wet areas should be maintained as part of the long-term care and upkeep of the property.

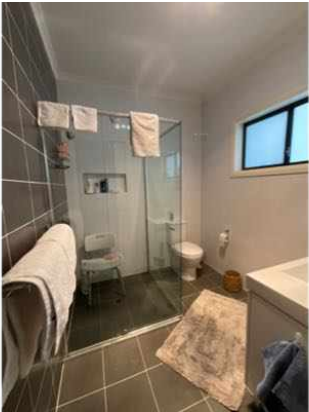
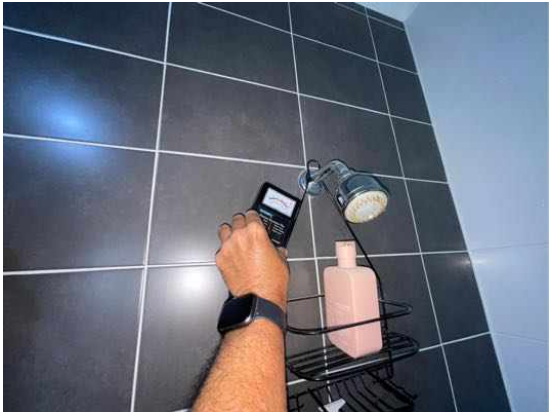
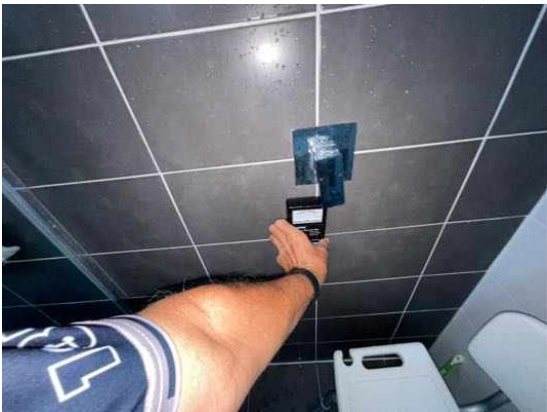
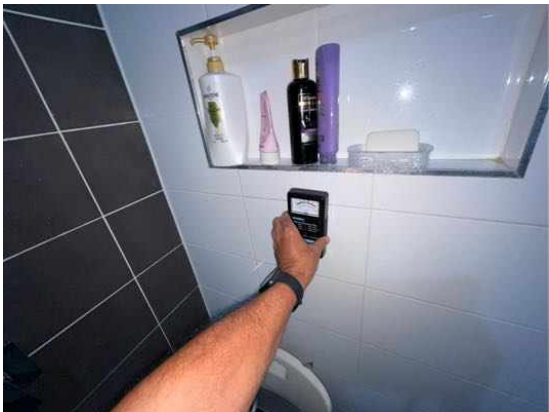
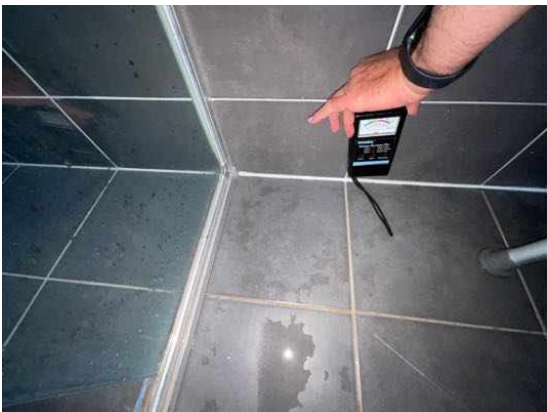
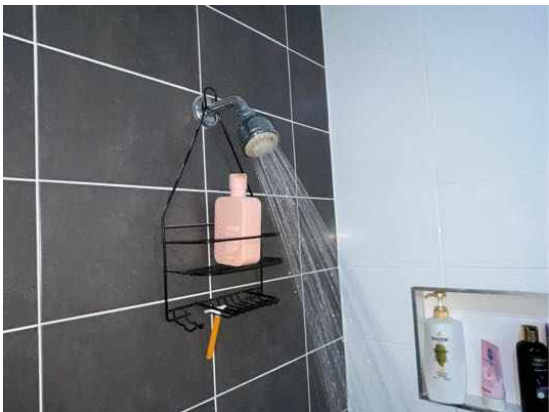
Building:	Main Building
Location:	Ensuite
Finding:	Wet Areas - Bathroom(s) - Overall Condition & Recommendations.
Information:	Overall Condition & Recommendations

- Water appeared to flow freely towards the floor waste during testing of the shower taps. However, further monitoring is required after regular use to determine whether water pooling or retention occurs.
- Flood testing of the shower recess is recommended. This may reveal inadequacies in the waterproofing or shower screens, which could lead to water damage in surrounding areas.
- Floor waste was found to be clear and free of blockages at the time of inspection. Further monitoring is advised after consistent use to identify any drainage issues or

- No elevated moisture readings were detected around the tap fittings or behind the shower walls (as viewed from adjacent rooms), suggesting no active plumbing leaks at the time of inspection.
- Sealing of grout and tiles is recommended to prevent moisture buildup and mould growth in damp areas such as showers.
- The condition of grout and sealant appeared to be good.
- The exhaust fan appeared to be operational, which supports moisture control in the bathroom.

- No leaks were observed during flushing. The toilet operated normally, and the toilet pan appeared to be securely fixed to the floor.

- Basin(s) were water tested and inspected, with no leaks or blockages identified in the plumbing or drainage system at the time of inspection.
- Further monitoring is recommended after the basin(s) are placed under regular use to confirm ongoing performance and cleanliness.
- No visible water damage was observed to the vanity cabinetry at the time of inspection.
- Stored items inside the vanity obstructed full visibility during the inspection. It is advised that the area be re-inspected once all obstructions are removed.

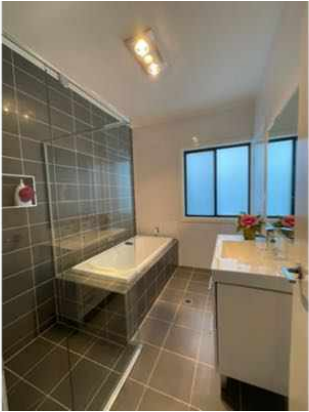
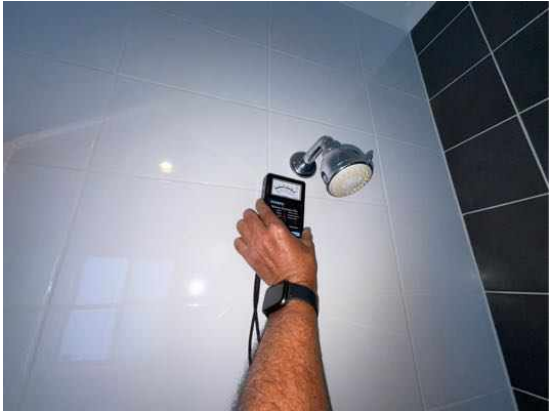
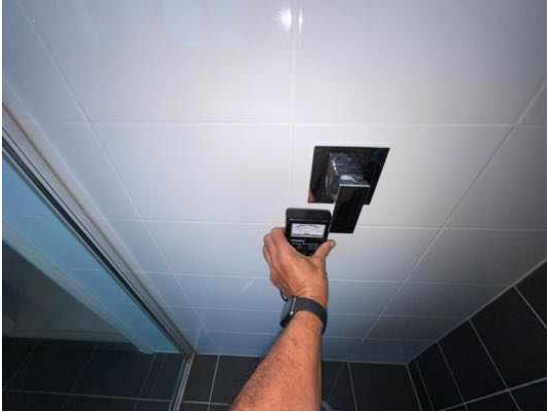
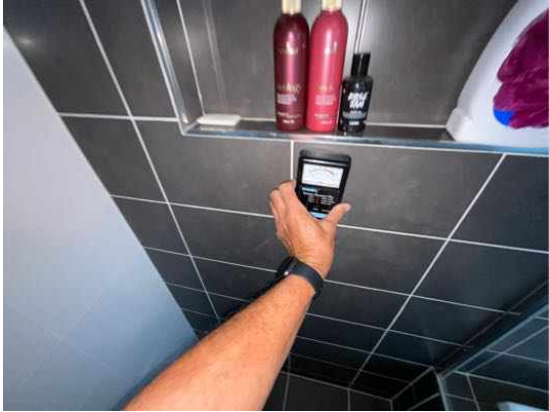
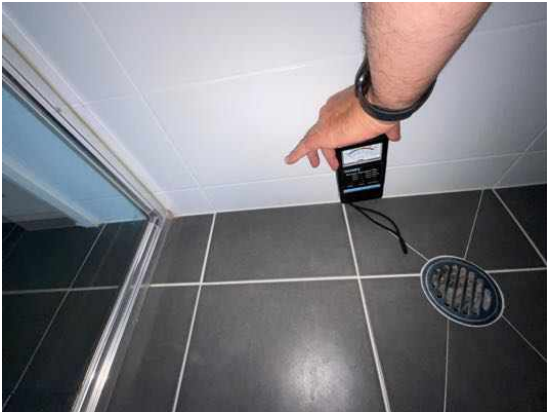
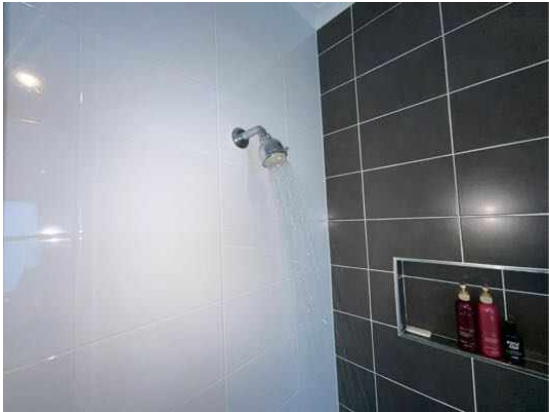
Building: Main Building
 Location: Bathroom
 Finding: Wet Areas - Bathroom(s) - Overall Condition & Recommendations.
 Information: Overall Condition & Recommendations

- Sealing of grout and tiles is recommended to prevent moisture buildup and mould growth in damp areas such as showers.
- The condition of grout and sealant appeared to be good.
- The exhaust fan appeared to be operational, which supports moisture control in the bathroom.

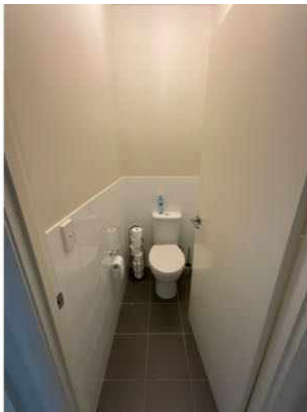
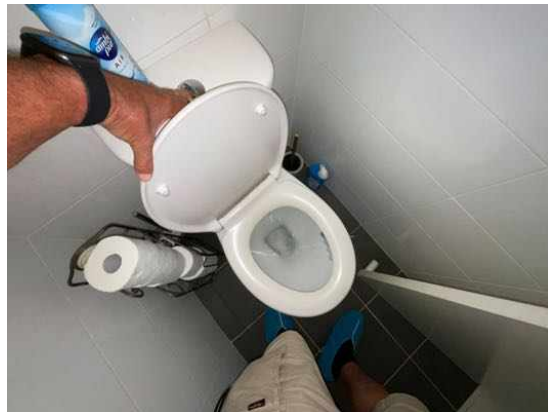
Building: Main Building
Location: Toilet (WC)
Finding: Overall Condition: Toilet.
Information: TOILET ASSESSMENT

- No leaks were observed during the flushing process.
- The toilet operated normally with no signs of malfunction or abnormal water flow.
- The toilet pan was securely fixed to the floor at the time of inspection.
- The exhaust fan appeared to be operational, which is a requirement for a toilet with no windows.
