Building and Timber Pest Inspection Report

Inspection Date: Mon, 2 Feb 2026

Property Address: 157 Riverview Rd, Earlwood NSW 2206,
Australia

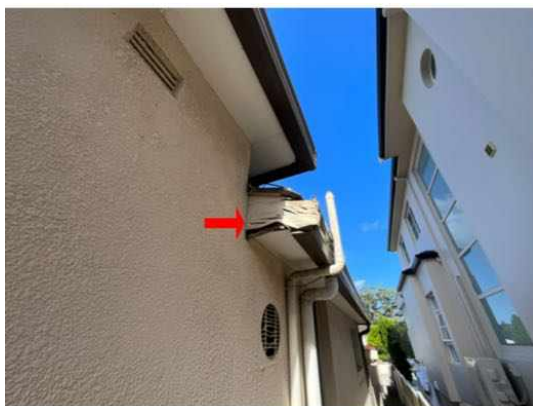
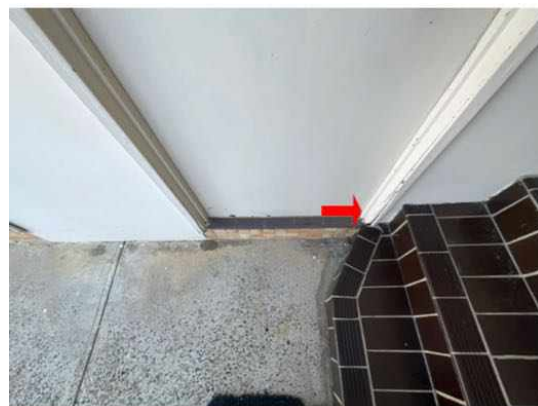
Building:	Main Building
Location:	External Areas
Finding:	Wood rot
Information:	This building element shows evidence of wood rot. Wood rot, also known as Fungal Decay, occurs when timbers and other cellulose building materials are exposed to damp conditions on an ongoing basis. This could be the result of exposure to weathering over a prolonged period of time, or the attraction of excessive moisture from other abutting building materials.

Early intervention and regular maintenance, particularly of exterior timbers, will prolong the useful life of these building elements. Prior to any works being performed, the cause of the moisture that has created the visible wood rot should be identified and addressed in a suitable manner. Replacement of affected timbers may then be a necessary step in protecting surrounding building elements from such deterioration.

A qualified carpenter or registered builder may also be required to replace affected building materials.

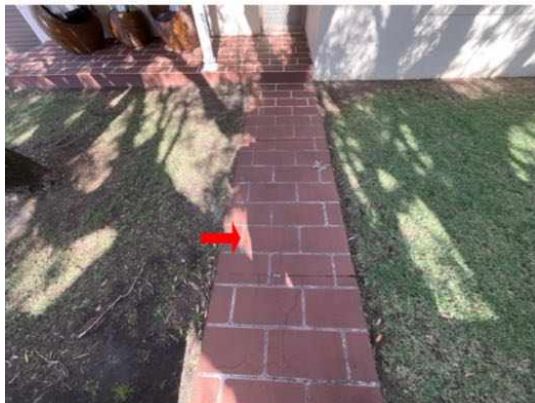
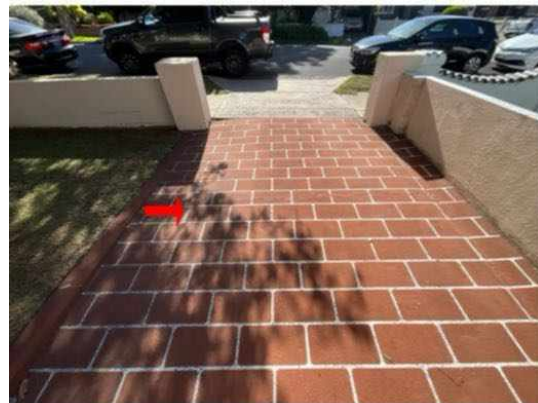
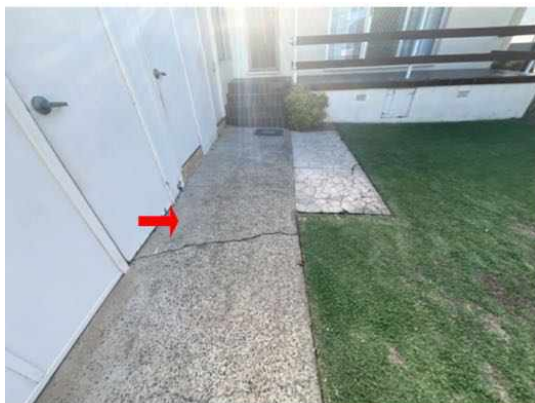
Finding 3.02

Building:	Yard
Location:	Pathway
Finding:	Cracking - External Concrete Paving Damage Category 1 - Fine (less than 2mm)
Information:	Fine cracks were identified in external concrete paving. Although fine cracks are quite noticeable, they are often only considered to be an appearance defect, and usually do not indicate any structural damage. To be considered a Category 1 or fine crack, the crack is found to be less than 2mm in width.

Generally the cause of a hairline crack in existing concrete paving such as driveways and pathways is indicative of the expansion and contraction of the concrete. Such causes are generally due to environmental factors, such as moisture levels, weather conditions, root systems of nearby trees or the soil types on which they are laid.

Fine cracks may also be due to poor original installation of the concrete. Factors such as poor compaction of the sub surface and/or inadequate reinforcing of the slab may create cracking and other secondary defects.

Monitoring of all cracking should be conducted frequently. Always contact a building inspector should cracks widen, lengthen, or become more numerous.

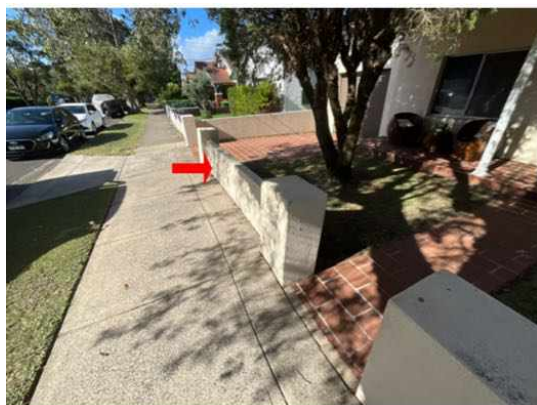
Finding 3.03

Building:	Yard
-----------	------

Although the wall does appear be stable works will need to be done to the brickwork in the area.

I recommend appointing a bricklayer to see what necessary works are required.

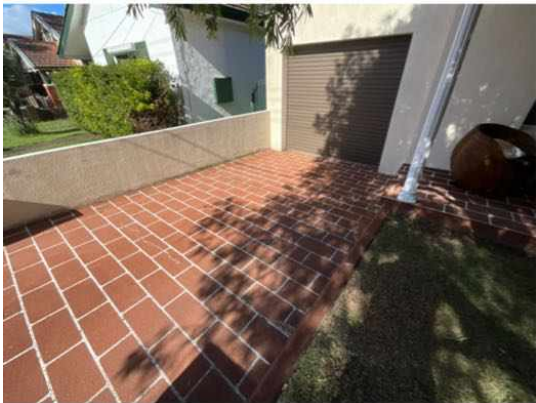
Finding 3.04

Building: Yard
Location: The Site
Finding: Site drainage - Inadequate
Information: The site drainage in this area was found to be inadequate at the time of inspection, creating potential for subsequent water damage to associated building elements.

It is important that water does not lie against the base of walls; surrounding paths and ground levels should be sloped to drain water away from walls.

Where site drainage is inadequate, installation of drains may be required. A qualified plumber should be appointed to further inspect the property and perform any remedial works as necessary. Water damage and secondary defects are likely to occur if left unmanaged.

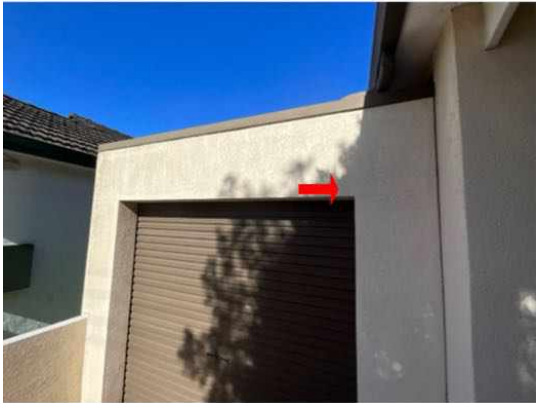
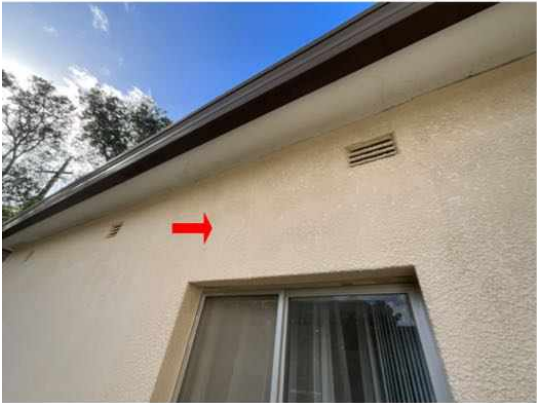
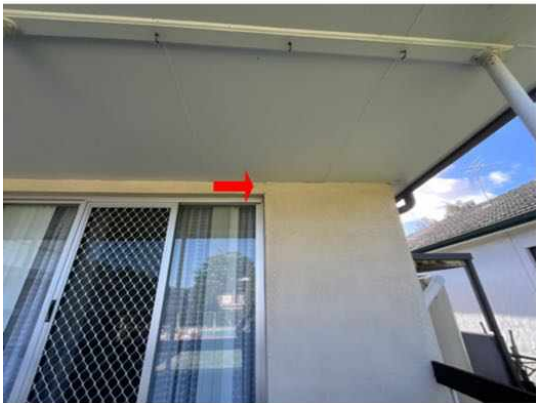
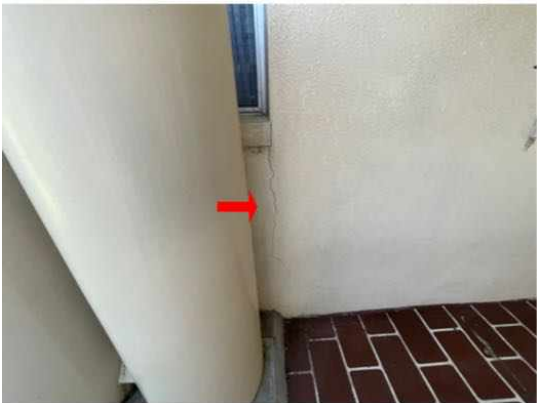
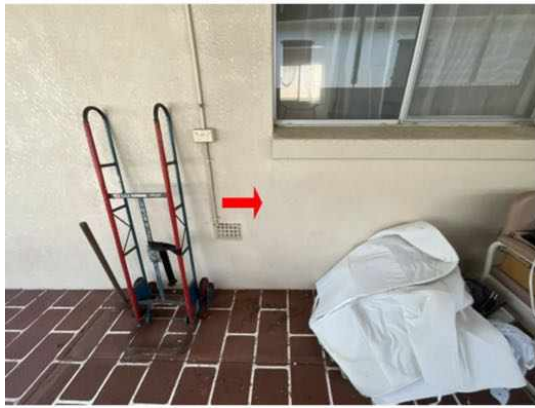
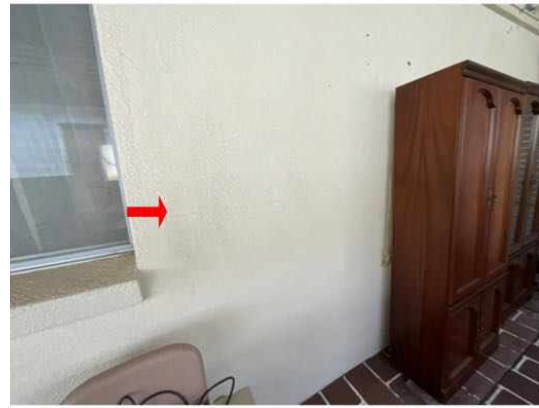
Finding 3.05

Building: Main Building
Location: Exterior walls
Finding: Cracking - Damage Category 2 - Noticeable (up to 5mm)
Information: Noticeable cracks are a common occurrence as a result of many primary defects. Such causes may include age, general wear and tear, expected building movement, general expansion/contraction of building materials in different weather conditions, and/or minor failings in the installation or application of building materials.

I recommend monitoring and if further cracking is evident appoint a bricklayer to see what works are required.

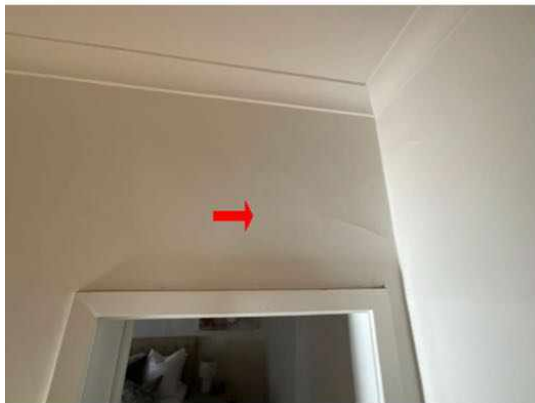
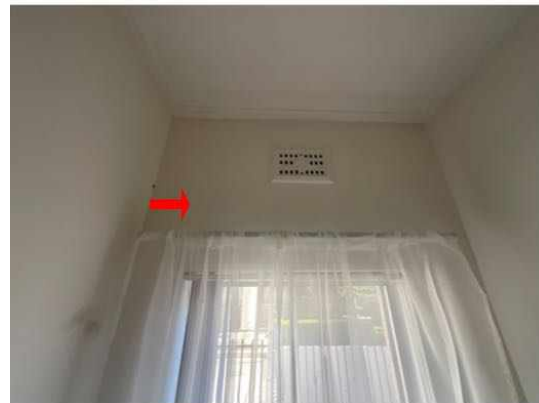
Finding 3.06

Building:	Main Building
Location:	Internal Areas
Finding:	Cracking - Damage Category 2 - Noticeable (up to 5mm)
Information:	Noticeable cracks are a common occurrence as a result of many primary defects. Such causes may include age, general wear and tear, expected building movement, general expansion/contraction of building materials in different weather conditions, and/or minor failings in the installation or application of building materials.

I recommend monitoring and if further cracking is evident appoint a bricklayer to see what works are required.

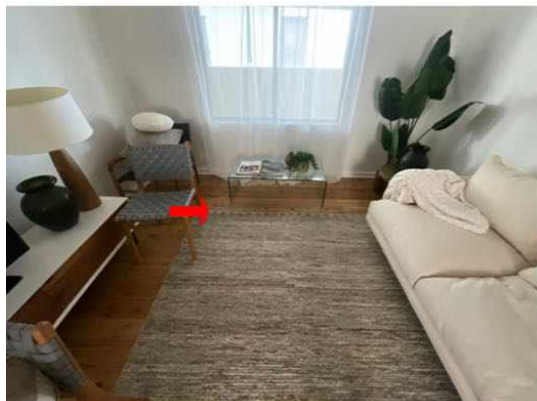
Finding 3.07

Building:	Main Building
Location:	Lounge Room
Finding:	Floors - bouncy
Information:	The internal flooring in this area was identified as being bouncy at the time of inspection. A bouncy floor surface generally presents as a discernible change in level as they are walked across, in noisy or creaking flooring, or in consequent movement of surrounding furniture and fixtures.

Bouncy floors generally indicate that the floorboards or the subfloor structures are coming loose from the joists that they are installed on. Bouncy flooring may also be the result of gaps between flooring and joist structures, which require packing.

The client is advised to seek quotations for required repairs from a Registered Builder.

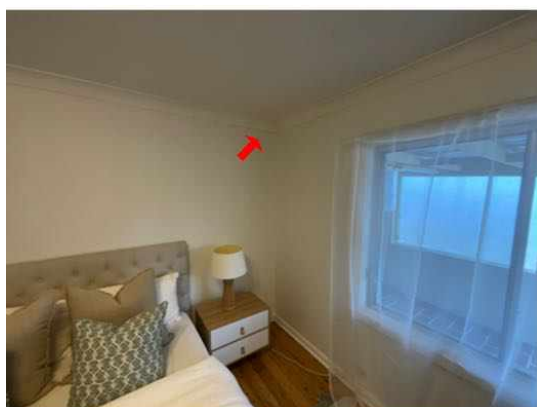
Finding 3.08

Building: Main Building
 Location: Lounge Room
 Finding: Painted surface - Bubbling
 Information: Sections of paint in this area was found to have bubbled and deteriorated. Paint bubbling is generally an indication of excessive moisture in the area past or present.

Although there was no moisture detected in the wall I would recommend monitoring this area.

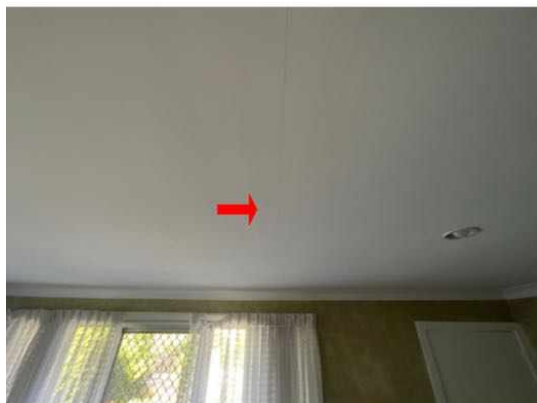
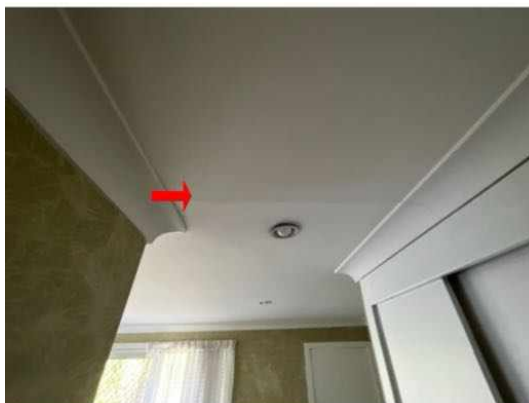
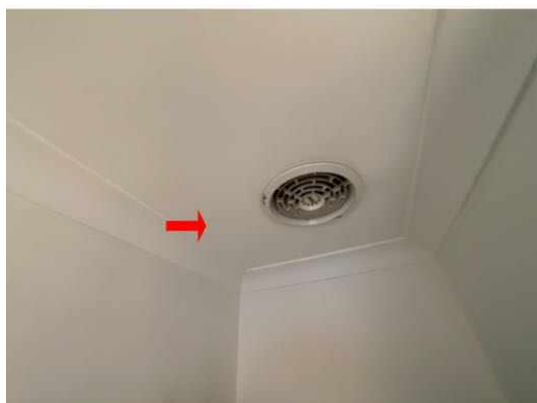
Finding 3.09

Building: Main Building
 Location: Internal Areas
 Finding: Cracking - Damage Category 1 - Fine (up to 1mm)
 Information: Although fine cracks are quite noticeable, they are often only considered to be an

appearance defect, and usually do not indicate any structural damage. Generally, the cause of a fine crack is indicative of a separation between building materials and finishes (e.g. paint, plaster, etc.) along joins.

Cracking of this nature can generally be repaired with minor sanding, filling and/or repainting. Such works should be performed by a qualified painter or a general handyman.

Monitoring of all cracking should be conducted frequently. Always contact a building inspector should cracks widen, lengthen, or become more numerous.

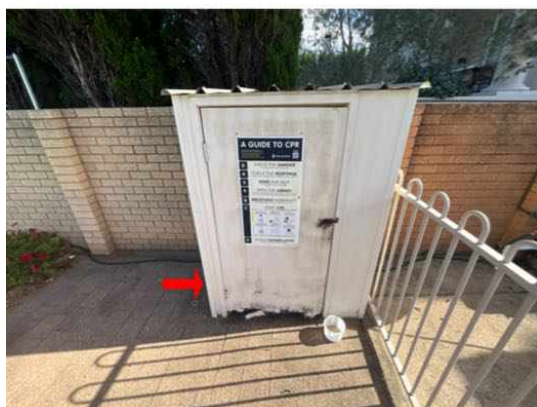
Finding 3.10

Building:	Yard
Location:	Yard - Back
Finding:	Delamination of timbers
Information:	Delamination is one means by which composite materials (e.g. layered timber composites) may fail over time. In laminated materials, repeated cyclic stresses may lead to the formation of mini-structures of separate layers, with significant loss of mechanical toughness.

Delamination of timbers may be repaired where the area affected is minor and/or easily accessible, by gluing and screwing layers back together. However, this is an interim repair, and where delamination has occurred, the client should plan for the

replacement of affected timbers sooner than would otherwise be expected.

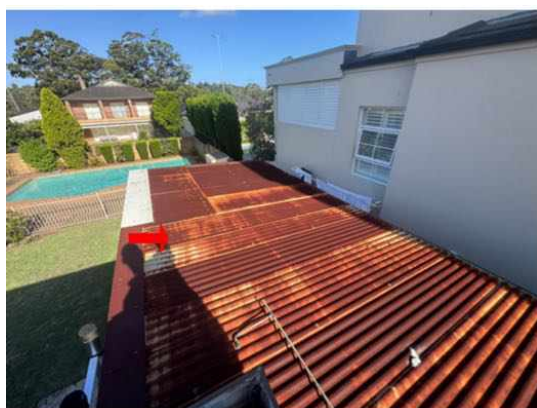
Finding 3.11

Building:	Building 2
Location:	Roof Exterior
Finding:	Roof sheets - Rusted
Information:	Metal roofs generally comprise numerous individual sheets, which join and overlap. These intersections are particularly prone to lift at the edge and consequently rust at these points.

Upon inspection of the exterior roofing structure, evidence of rust to these sections was identified.

A roofing contractor should be appointed to assess the damage to the roofing sheets and to perform remedial works as necessary.

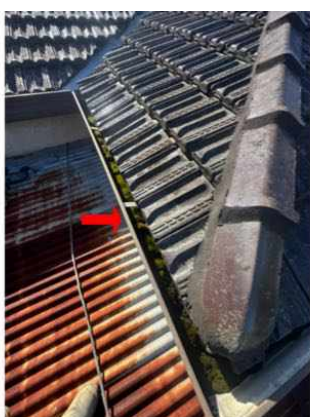
Finding 3.12

Building:	Main Building
Location:	Roof Exterior
Finding:	Gutters - Blocked
Information:	Roof plumbing structures, such as guttering and downpipes, should be free of all

Blocked gutters are likely to lead to high levels of moisture in the affected areas. Such moisture will not only cause rust and decay of the associated building materials, but can also provide conditions that are conducive to termite and timber pest activity. Blockages in gutters should therefore be removed to ensure dry conditions are maintained.

Consult a Licensed Plumber for further specific advice on remedial works that may be required. In the interim, it is highly advised that blocked gutters be removed by the homeowner or a general handyperson as a matter of urgency.

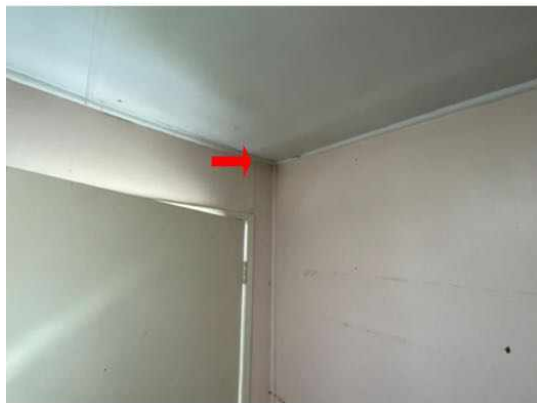
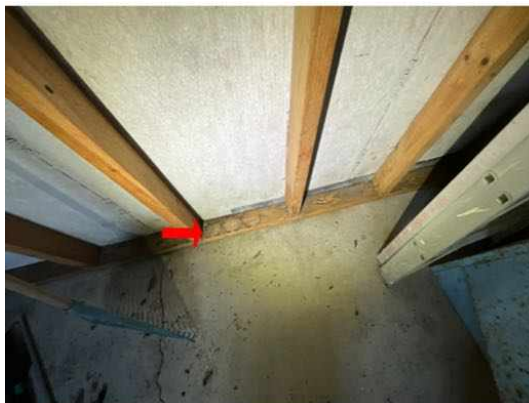
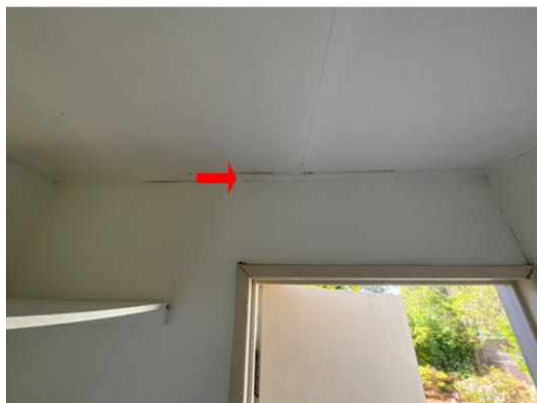
Building:	Building 2
Location:	Laundry, WC & Shed
Finding:	Termite - damage identified
Information:	Despite no live termite or timbered pest activity being indicated, termite damage was found to have affected this area.

A building contractor should be appointed to provide a further invasive inspection and to see what necessary works are required.

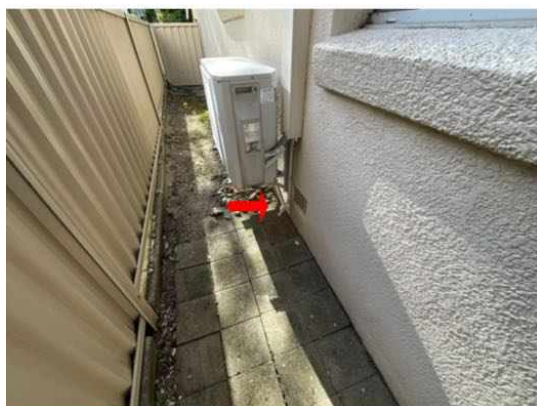
Finding 6.01

Building:	Main Building
Location:	Exterior walls
Finding:	Air conditioner - Disconnected overflow
Information:	The Air Conditioner (A/C) overflow was found to be disconnected from storm water drainage and is creating excessive moisture in the surrounding area.

Such leaking creates an environment which is conducive to an array of defects, including water damage to associated building elements and the attraction of termite or timber pest infestation.

It is highly recommended that a licensed plumber be appointed to connect the A/C overflow in order to prevent such an environment from being created. These minor works should be carried out as soon as possible.

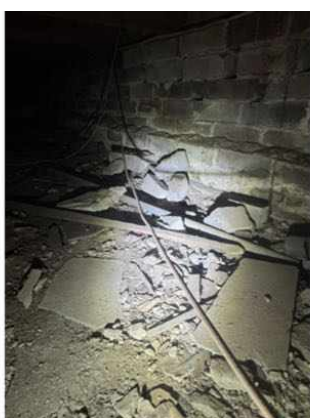
Finding 6.02

Information: An array of debris was found in the subfloor area at the time of inspection. Debris in this area restricts subfloor ventilation and creates potential for concealed pest entry. Stored timbers and other materials may also make the area susceptible to termite activity and wood rot.

A clear and empty subfloor will be better ventilated and easier to maintain in a dry condition. The removal of any timber debris is vital in minimising the risk of termite or wood borer activity.

Debris in the subfloor should be removed as soon as possible. Depending on the location and amount of debris and stored items, the homeowner may elect to undertake this task. Alternatively there are a large number of rubbish removal subcontractors that could undertake these works.

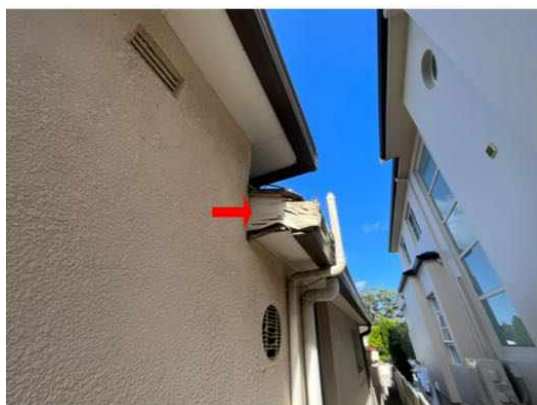
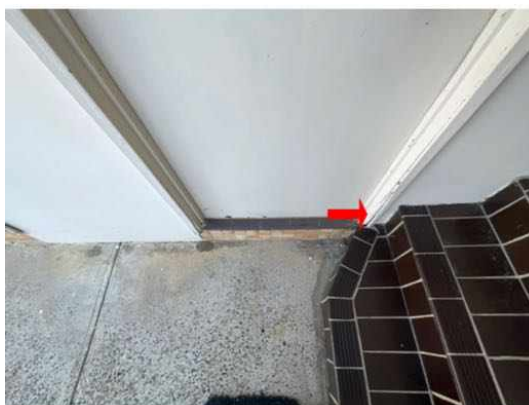
Finding 7.01

Building:	Main Building
Location:	External Areas
Finding:	Fungal decay - present (localised)
Information:	Fungal decay also known as wood decay or wood rot generally refers to the deterioration of timber elements when in contact with excessive levels of moisture for a prolonged period of time.

The development of fungal decay is accelerated by temperatures in the range of 5degreeC to 40degreeC as well as the presence of oxygen. Generally fungal decay develops on timber elements that are in use in an external environment which are exposed to rain penetration.

In this case although the affected timber element is in a decaying state the extent of any visible damage appears to be localised to a specific area and is yet to spread to other parts of the building element or affect adjoining structures. The fungal decay is therefore likely to be of a relatively superficial nature with minimal impact on the structural integrity or tensile strength of the timber element.

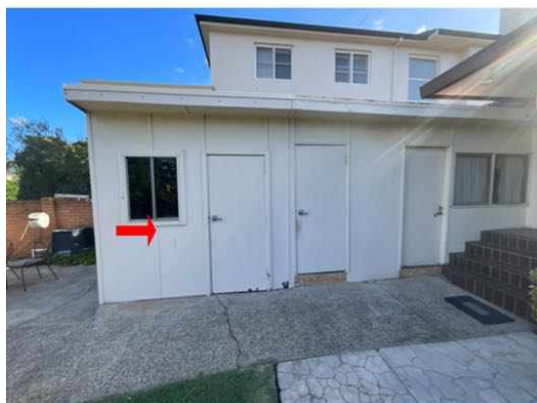
Building:	Building 2
Location:	Exterior walls
Finding:	Asbestos - Suspected ACM Identified on Site
Information:	Reporting on Asbestos is outside the Scope of this Report. This suspected defect is highlighted as a caution only. We suspect, based on our experience in the building industry, that there is a higher risk of the identified building element containing asbestos.

As Asbestos Reporting is outside the scope of this report, we advise that you consider a separate Asbestos Inspection and Condition Audit, which can include the taking of samples for definitive confirmation of the presence of Asbestos.

In the interim, the client is advised to act with caution, especially when considering any damage to building materials general wear and tear renovations extensions demolition and general maintenance activities due to the suspected presence of Asbestos.
