Building and Timber Pest Inspection Report

Inspection Date: Wed, 11 Feb 2026

Property Address: 36/31-35 chamberlain street Campbelltown

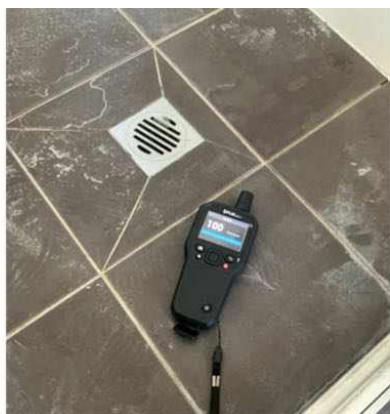
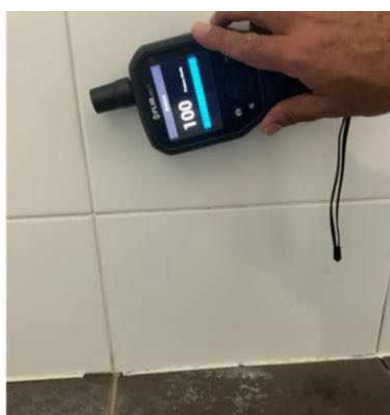
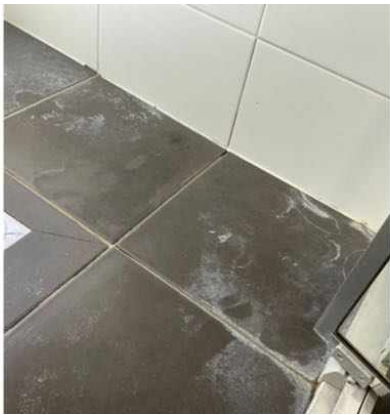
Finding: Elevated Moisture Bathroom and efflorescence

Information: Elevated moisture levels were detected to tiled surfaces in bathroom/shower areas. This may be due to porous or missing grout, cracked tiles or recent use, however the possibility of waterproofing membrane failure or plumbing leaks cannot be excluded.

Persistent moisture ingress can lead to concealed damage, including timber rot and mould growth. Further investigation by a licensed plumber and/or waterproofing contractor is recommended as soon as possible.

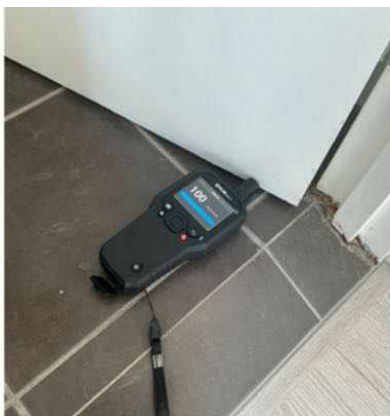
Finding 2.02

Building: Main Building
Location: Bathroom
Finding: Wet-Area Door Jambs – Moisture Staining / Decay
Information: moisture staining and deterioration were observed at the base of the wet-area door jamb and architraves. This is commonly due to water splashing or moisture tracking from the bathroom floor into adjacent joinery or inadequate waterproof transition at the bathroom threshold.

Further inspection by a licensed waterproofing contractor is recommended to verify exact cause and remedial measures

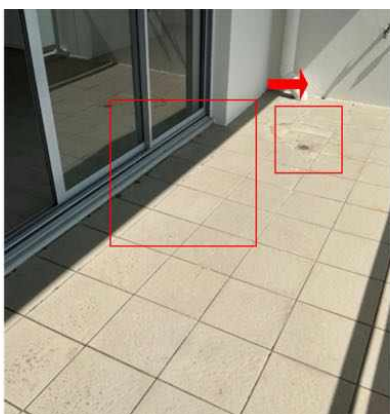
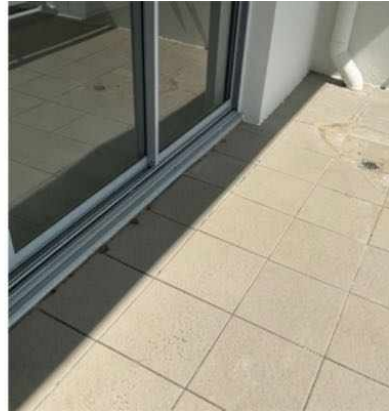
Finding 2.03

Building:	Main Building
Location:	Balcony - Lounge
Finding:	Balcony – Elevated Moisture , Efflorescence, Tiles lifting
Information:	Elevated moisture readings were detected to the tiled balcony floor with lifting tiles , visible efflorescence and discolouration to grout lines indicating prolonged or recurring moisture presence beneath the tile finish. This condition is commonly associated with failed grout or sealant joints, insufficient surface drainage and/or inadequate waterproofing allowing moisture to become trapped within the balcony substrate.

While no internal water ingress was evident at the time of inspection .It has potential to escalate if moisture migration continues, and assessment by a suitably qualified strata appointed waterproofing specialist is recommended.

Depending on the strata plan, this area may form part of the common property, in which case remedial responsibility may rest with the owners corporation (strata). Purchasers should seek clarification from the strata manager and legal adviser prior to purchase.

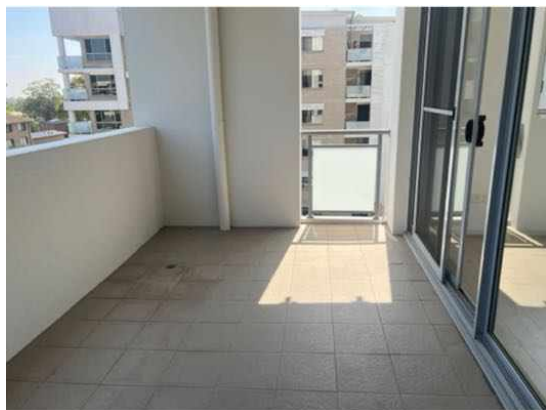
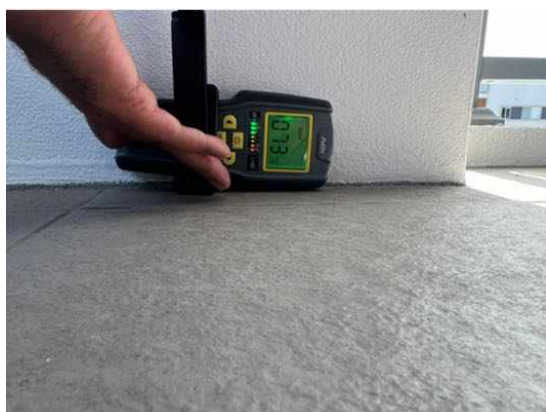
Finding 3.01

Building:	Main Building
Location:	Balcony 2
Finding:	Balcony Elevated Moisture - Strata
Information:	Elevated moisture was recorded at the base of the balcony wall and tiles, with associated staining consistent with water exposure. While no internal damage was visible at the time of inspection, balconies in multi-unit dwellings are high-risk areas for waterproofing failure, which can lead to leaks into adjoining units and significant

rectification costs. Further investigation by a licensed waterproofing contractor is strongly recommended.

Depending on the strata plan, this area may form part of the common property, in which case remedial responsibility may rest with the owners corporation (strata). Purchasers should seek clarification from the strata manager and legal adviser prior to purchase.

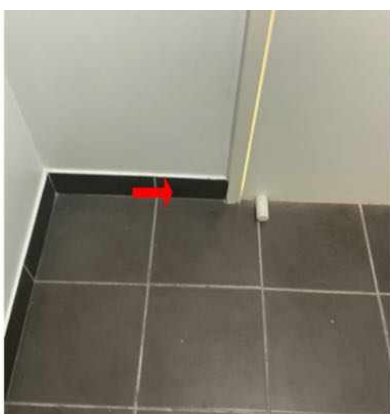
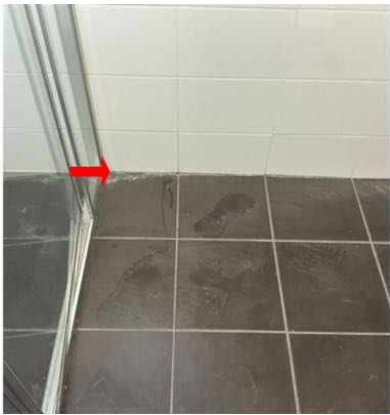
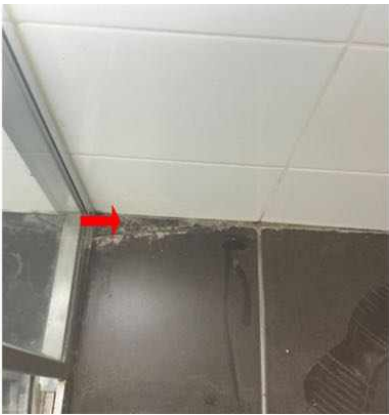
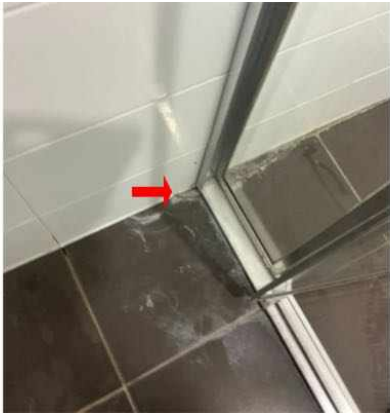
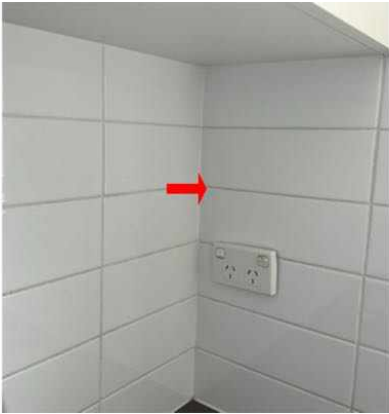
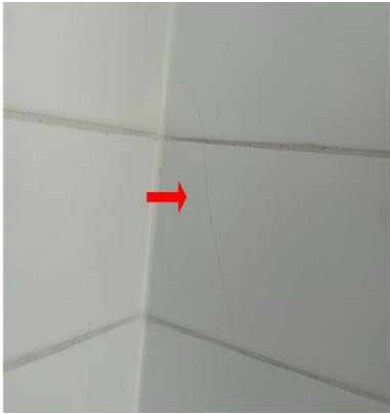
Building:	Main Building
Location:	All Internal Areas - Laundry, bathroom, kitchen
Finding:	Tiles - Cracked or damaged to some areas
Information:	Cracking was evident to the tiling in this area at the time of inspection. While the cracking appears to be minor, this area is frequently exposed to water, allowing potential for water penetration into adjoining sections of walls or flooring.

If left unmanaged, water penetration to these areas may lead to subsequent water damage, which is likely necessitate repair work to affected building elements.

A tiling contractor should be appointed to ensure that no further water damage occurs. The re-application of silicone and grouting throughout remaining tile work is also advised, to further protect the area against water penetration.

Where water penetration has led to water damage, appointment of a relevant tradesperson may be required to repair damaged building elements.

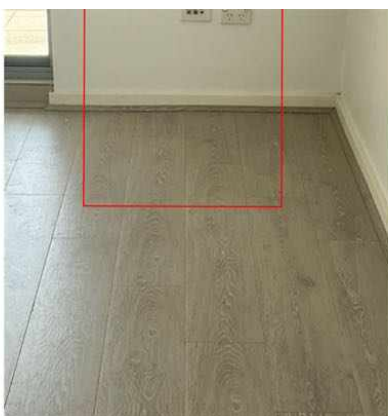
Finding 3.04

Building: Main Building
Location: All Internal Areas
Finding: Uneven Laminate Floor
Information: unevenness was observed to sections of the laminate flooring. This condition is typically associated with installation tolerances, minor subfloor irregularities, or natural movement of a floating floor system. While not considered a major defect, the unevenness may present a minor trip hazard and lead to accelerated wear of the flooring if left unrectified. Monitoring and, if required, localised rectification by a flooring contractor is recommended.

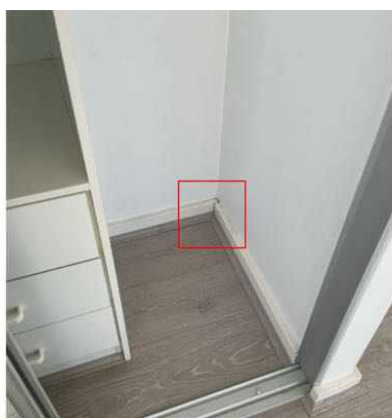
Finding 3.05

Building:	Main Building
Location:	Bedroom 2
Finding:	Building element - Damaged - Skirting possible moisture damage
Information:	Breakage occurs generally when the building materials have either aged and decayed, or as a result of damage (accidental or deliberate).

Repair and/or replacement of broken elements is advised to ensure that additional secondary defects do not arise as a consequence. Such works are necessary, as all building elements play a key role in the operation and function of the overall structure and its performance.

A relevant tradesperson should be appointed to further investigate ,repair or replace the affected building element prior to any subsequent damage being caused.

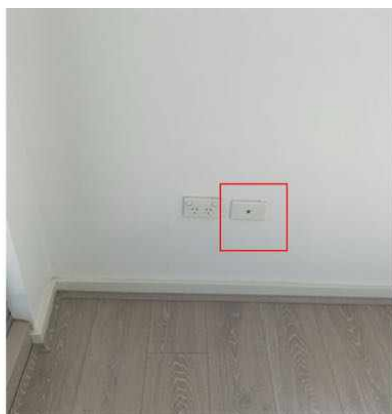
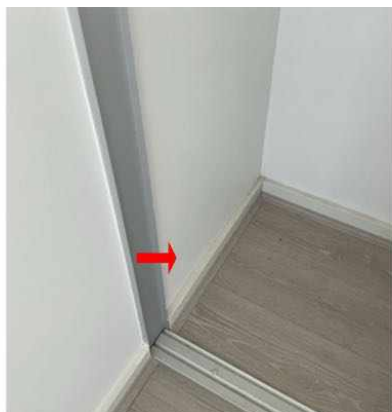
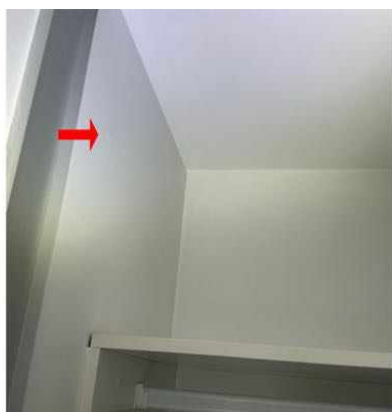
Finding 3.06

Building:	Main Building
Location:	All Internal Areas
Finding:	Paint finish and hairline cracking to some areas
Information:	The paint finish in this area was identified as being incomplete at the time of inspection including some hairline minor cracking.

Whilst incomplete or missing paint finish is generally an appearance defect, it can also lead to the development of secondary building defects over time. Incomplete areas of paint finish expose the area to moisture, potentially accelerating the deterioration of underlying building materials.

Incomplete paint finishes should be sanded back, filled, leveled and painted, as applicable. Where inadequate or missing paint protection has led to the deterioration of the associated building element, repair and/or replacement of this building element may be required.

A painting contractor should be appointed as soon as possible to perform necessary works to aid the appearance of the affected area and to ensure the area is protected against further deterioration. Alternatively, the homeowner following manufacturer

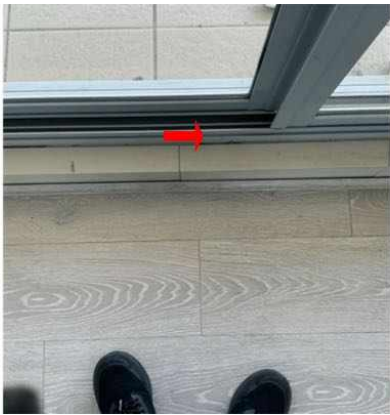
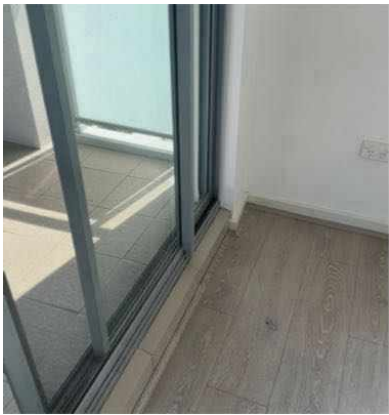
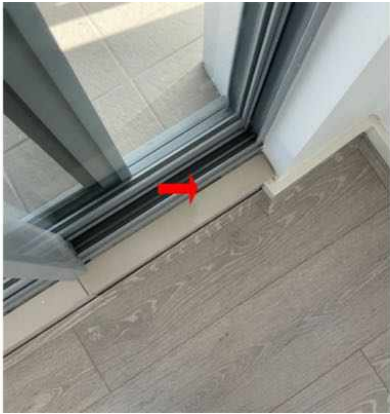
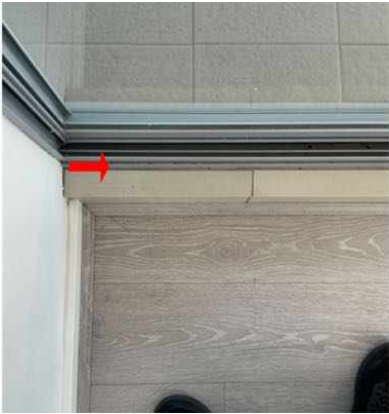
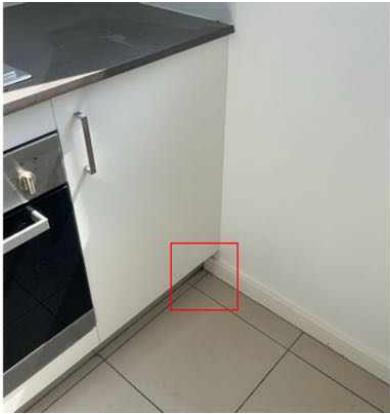
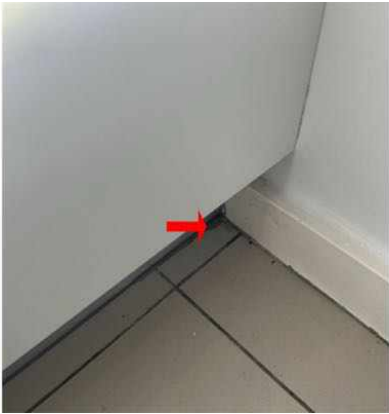
Finding 3.07

Building:	Main Building
Location:	All Internal Areas
Finding:	Sealant and grouting - Missing or degraded to some areas
Information:	It was noted on inspection that sealant or grout is degraded. There is also evidence of poor workmanship and excessive use of sealant. Silicone should never be used as a first line of defence against waterproofing. Further inspection by a licensed waterproofing contractor is highly recommend

Different materials and floor areas move at different rates, generally causing cracking to grout or sealant at this point. A flexible sealant is required to allow for expected expansion and contraction, while keeping the joint water tight and protective of all

There appears to be excessive mould to the sealant and grout which will likely require scraping out and replacement.

Flexible and mould resistant materials should be applied to affected areas to prevent any subsequent water damage that is likely to occur. Regular maintenance and replacement of damage or missing or damaged sealant and grout is highly recommended to the wet areas, as this is a regular wear and tear defect. Sealant and grouting in areas that come into regular contact with water should be maintained for the long term care of your property.

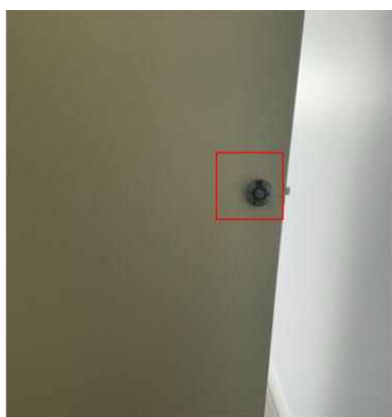
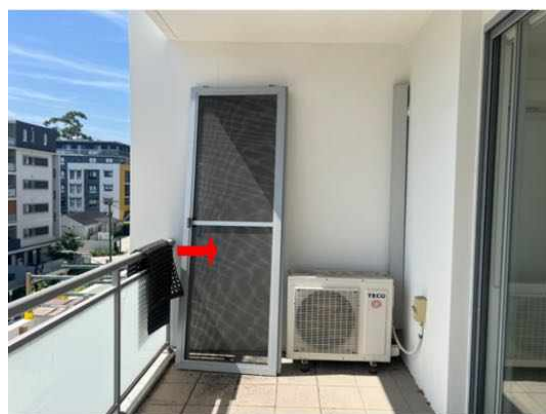
Finding 3.08

Building:	Main Building
Location:	All Internal Areas
Finding:	Building element - Damaged - Door handle broken hallway , Flyscreens not installed
Information:	Breakage occurs generally when the building materials have either aged and decayed, or as a result of damage (accidental or deliberate).

Repair and/or replacement of broken elements is advised to ensure that additional secondary defects do not arise as a consequence. Such works are necessary, as all building elements play a key role in the operation and function of the overall structure and its performance.

A relevant tradesperson should be appointed to repair or replace the affected building element prior to any subsequent damage being caused.

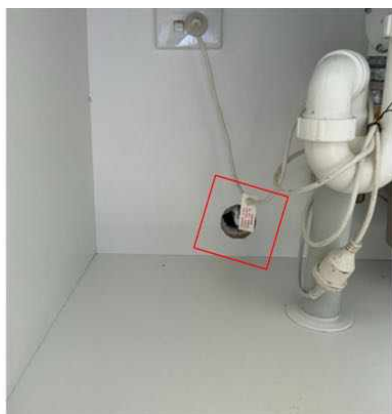
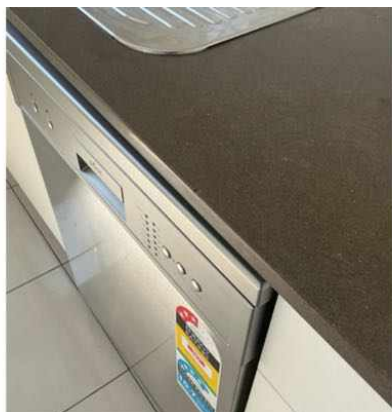
Finding 3.09

Building:	Main Building
Location:	Bathroom , kitchen
Finding:	Building element - Damaged - vanity moisture damaged , basin tap handle loose , light cover missing bathroom , kitchen holes not sealed , benchtop chipped
Information:	Breakage occurs generally when the building materials have either aged and decayed, or as a result of damage (accidental or deliberate).

Repair and/or replacement of broken elements is advised to ensure that additional secondary defects do not arise as a consequence. Such works are necessary, as all building elements play a key role in the operation and function of the overall structure and its performance.

A relevant tradesperson should be appointed to repair or replace the affected building element prior to any subsequent damage being caused.

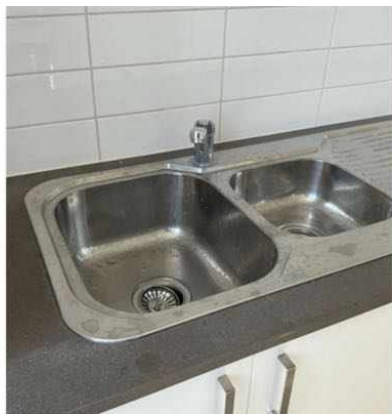
Finding 3.10

Building:	Main Building
Location:	All Internal Areas
Finding:	Tap - Water hammer
Information:	This tap shows evidence of slight water hammer being present. Water hammer, a pressure surge resulting when a fluid is forced to suddenly change direction, is a common defect in plumbing fittings, particularly those that are aged and not frequently maintained. Water hammer is generally caused by factors that create high water pressure in the affected plumbing fixture, usually evidenced by a faint banging noise during operation of the affected tap.

Although water hammer is generally considered to be a minor defect, subsequent damage such as erosion of tap hardware and/or water damage to associated building elements is likely to occur if left unmanaged.

A licensed plumber should be appointed as soon as possible to replace any affected tap hardware and perform any remedial works as necessary. Please be advised that the appointment of a cabinet maker or qualified carpenter may be necessary if water damage to associated building elements has occurred.

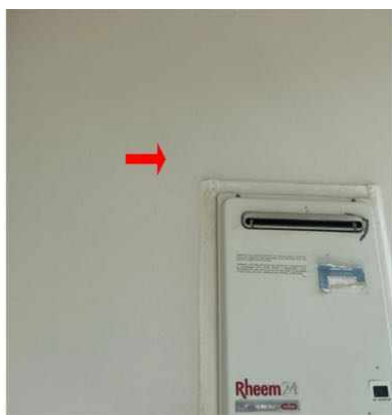
Finding 3.11

Building:	Main Building
Location:	Balcony - Lounge
Finding:	Cracks to render - Category 1 to some areas
Information:	It has been observed that cracking to rendered surfaces has occurred. The degree of damage falls within Category 1, described as fine cracks that do not need repair and which are less than 1.0mm in width limit.

Damage of this category is not considered a defect for rectification. Always contact your building inspector should cracks widen, lengthen, or become more numerous.

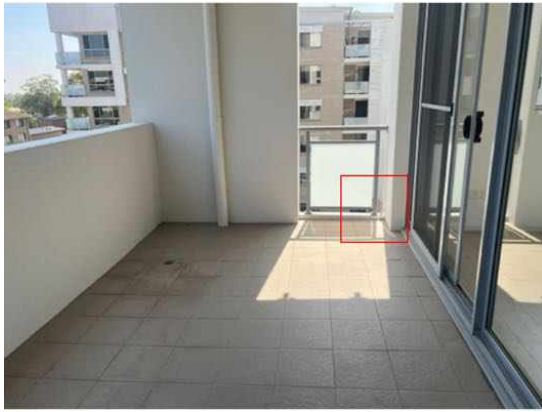
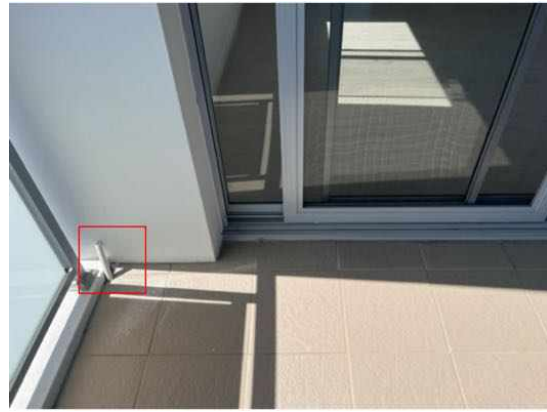
Finding 3.12

Building:	Main Building
Location:	Balcony 2
Finding:	Service Conduit
Information:	A service conduit penetration was observed at the balcony slab/wall junction. Service penetrations in external wet areas are vulnerable points for water ingress if not adequately sealed. Recommend confirmation of compliant waterproof detailing and purpose.

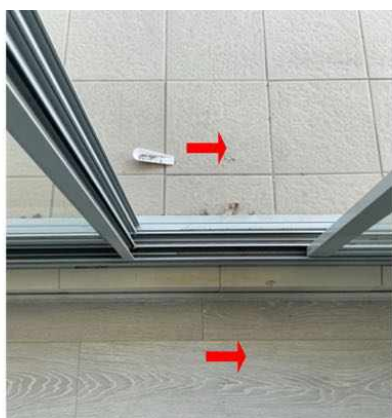
Building:	Main Building
Location:	Balcony
Finding:	Balcony Floor Level Differential
Information:	The balcony finished surface appears to be close to, higher or at the same level as, the internal floor. Standard construction practice requires a step-down of approximately 50 mm unless a fully engineered threshold drainage system is provided. No such drainage features were visible during inspection. This configuration increases the risk of water ingress, and confirmation of the balcony waterproofing detail through strata/building management is recommended.
