Building and Timber Pest Inspection Report

Inspection Date: Wed, 18 Mar 2026

Property Address: 15 Ballybunnion Terrace, Glenmore Park
NSW 2745

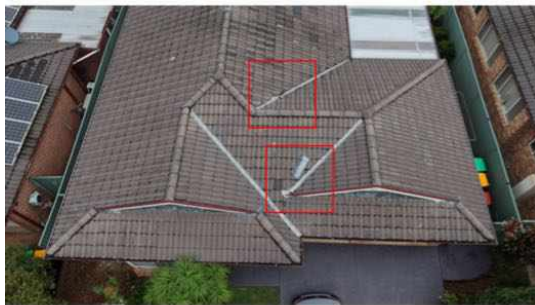
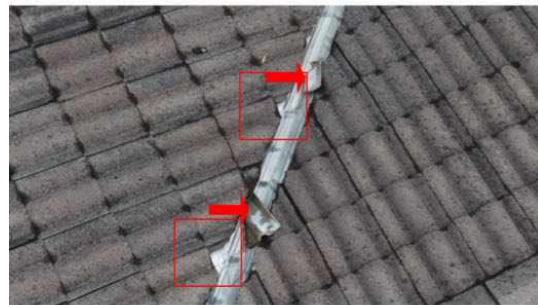
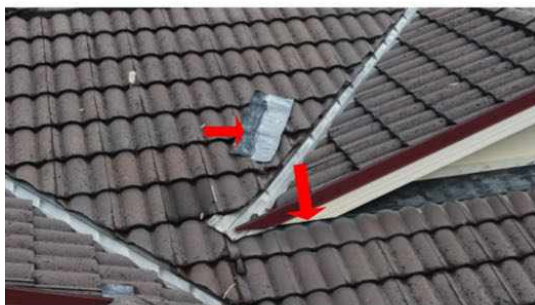
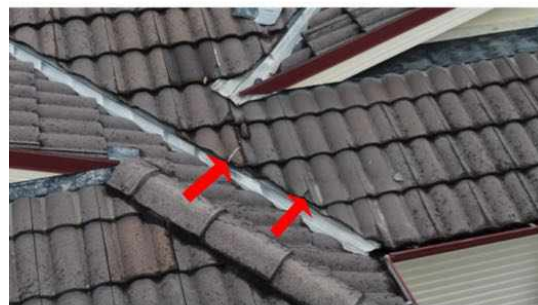
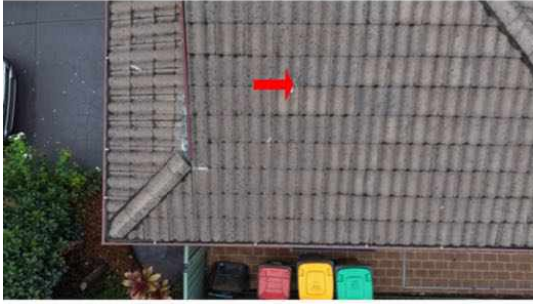
Tile alignment appeared generally uniform across the roof surface. Some loose and displaced tiles were noted, particularly within valley sections. Isolated chipped tiles were also observed.

Loose flashing was identified to the Dutch gable, requiring reinstatement. Flashings to other visible penetrations appeared serviceable, with no evidence of active water ingress noted at the time of inspection.

The tiled roof covering was observed to be in generally sound and serviceable condition at the time of inspection, with no evidence of active leakage. Notwithstanding, localised maintenance issues were identified, including loose tiles within valley areas and loose flashing to the Dutch gable.

These defects are considered typical of a roof of this type and age; however, if left unaddressed, they may contribute to water ingress and progressive deterioration.

It is recommended that a licensed roofing contractor undertake the necessary repairs and carry out a more detailed assessment if required. Ongoing maintenance, including periodic inspection, cleaning of gutters and valleys, and repointing of ridge cappings, will assist in maintaining the roof's weatherproofing and extending its serviceable life.

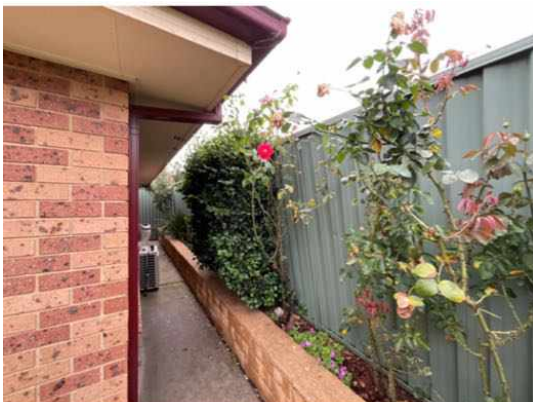
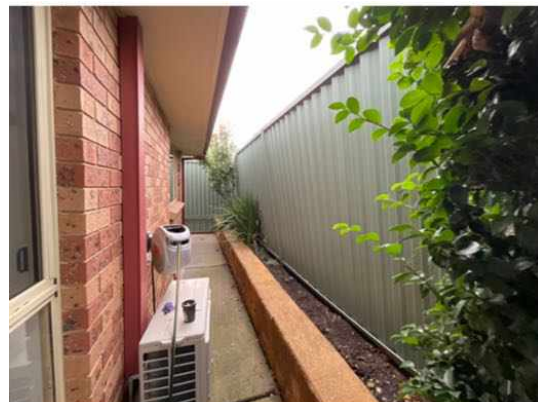
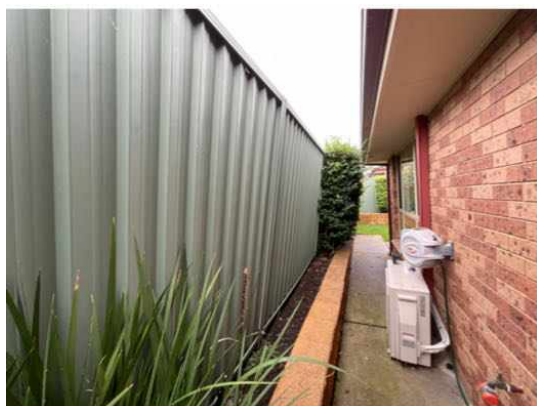
Finding 3.02

Building: Yard
 Location: Fencing
 Finding: Leaning Boundary Fence.
 Information: Observation:

At the time of inspection, sections of the boundary fencing were observed to be leaning. This condition is typically caused by natural deterioration due to age, prolonged exposure to weather, or potentially inadequate original installation or maintenance.

While currently considered a minor defect, continued movement or further degradation may result in instability, reduced privacy, or boundary disputes.

Rectification is at the discretion of the client. A licensed fencing contractor or qualified handyman should be engaged to assess the extent of deterioration and carry out repairs or replacement as required.

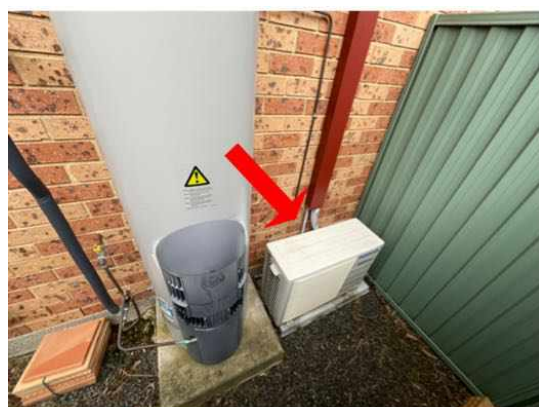
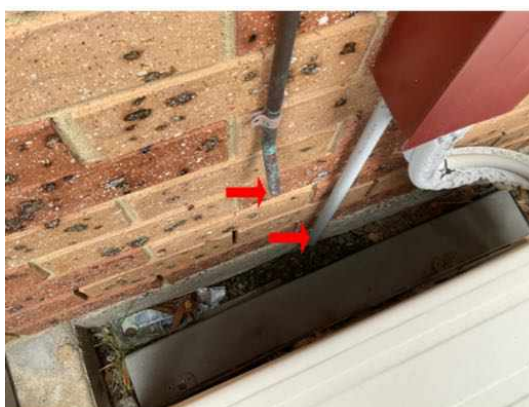
Building:	Main Building
Location:	All External Areas
Finding:	Overflow Management – Risk of Termite Activity..
Information:	Observation: Water Pooling from HWS and Air Conditioning Overflows

Water discharge from the Hot Water System (HWS) pressure relief valve and air conditioning unit overflows was observed discharging close to the base of the structure, contributing to water pooling around the building perimeter.

Persistent moisture near the foundation or subfloor area significantly increases the likelihood of termite activity. Termites are highly attracted to damp environments, and stagnant water near structural elements provides ideal conditions for foraging and infestation.

It is highly recommended that all overflows from the HWS and air conditioning units be redirected away from the building, preferably via fixed drainage or extension piping, to prevent water accumulation near the structure.

These minor corrective works should be undertaken promptly to minimise the risk of both termite ingress and potential structural damage due to ongoing moisture exposure.

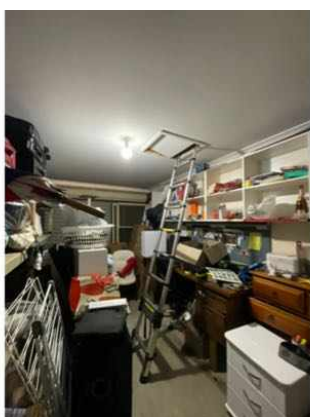
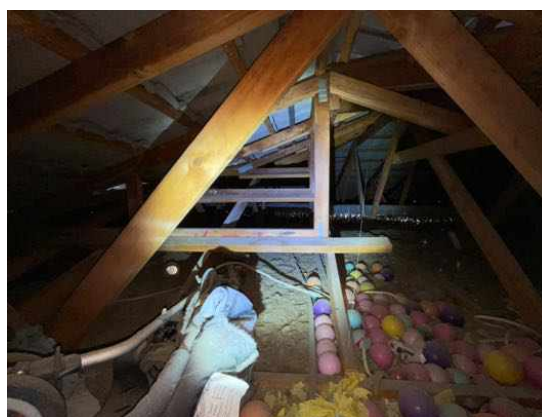
Noted Item

Building:	Main Building
Location:	Roof Void
Finding:	Roof Void – Limited Accessibility..

Installation of an additional manhole is recommended to facilitate a re-inspection and enable a more thorough assessment of the roof void in the future. This will help ensure that all structural elements and concealed areas are properly evaluated.

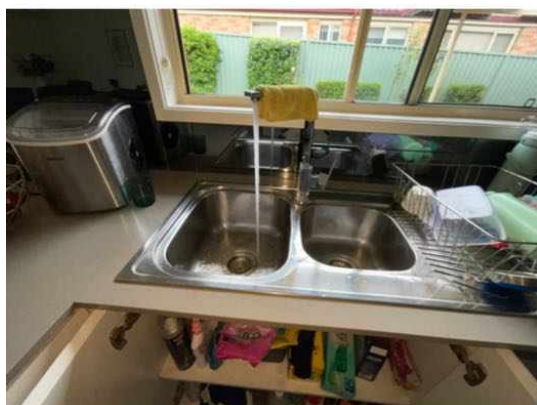
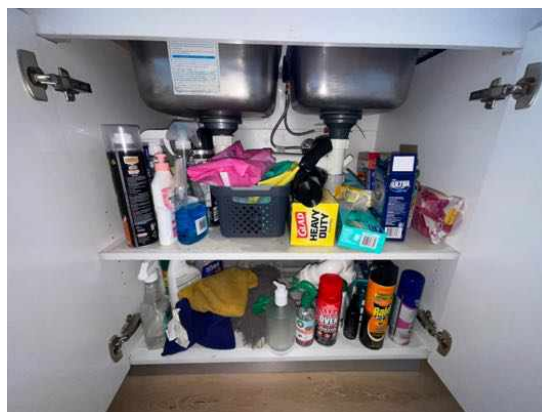
Noted Item

Building: Main Building
 Location: Kitchen
 Finding: Kitchen Sink – Overall Condition & Recommendations.
 Information: Observations:

- Further monitoring and testing are recommended once the tap(s) are in constant use, to identify any drainage issues or signs of slow leaks not evident during the limited inspection.
- For long-term property care, it is advised that sealant and grouting in water-exposed areas be regularly inspected and maintained.
- It is recommended that the stored items beneath the sink be removed to allow for a full re-inspection of the plumbing and cabinetry, ensuring no concealed defects are present.

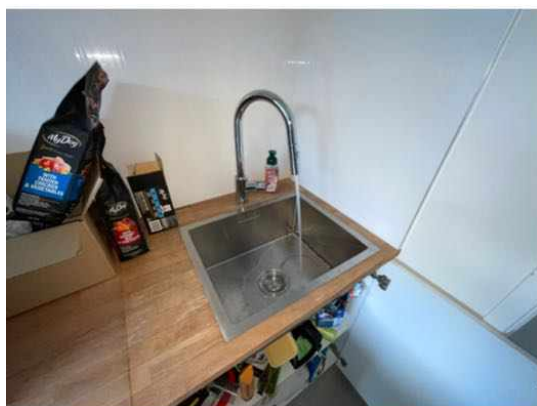
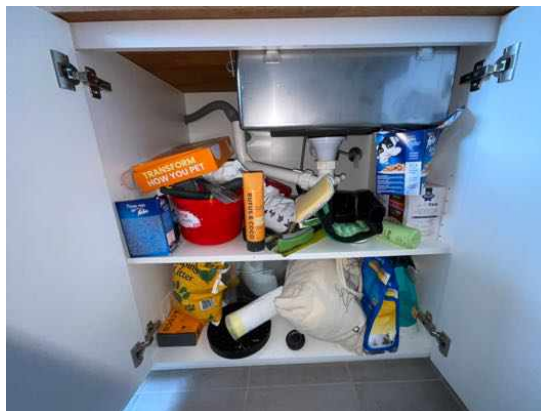
Noted Item

Building: Main Building
 Location: Laundry
 Finding: Laundry - Taps/Plumbing/Drainage.
 Information: Observation: Laundry Tub – Taps, Plumbing, and Cabinetry

- Sealant and grouting in wet areas should be maintained as part of the long-term care and upkeep of the property.

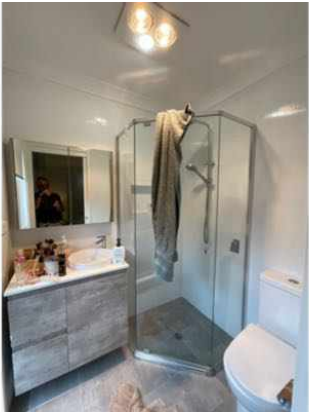
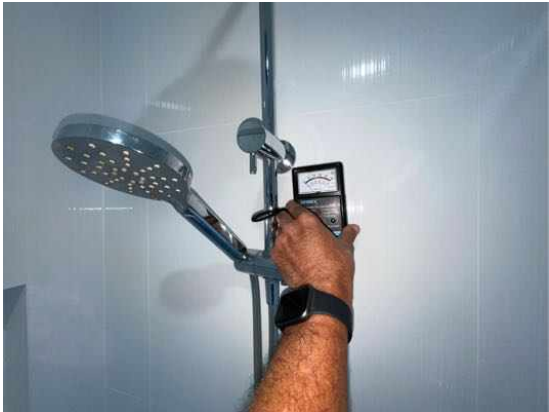
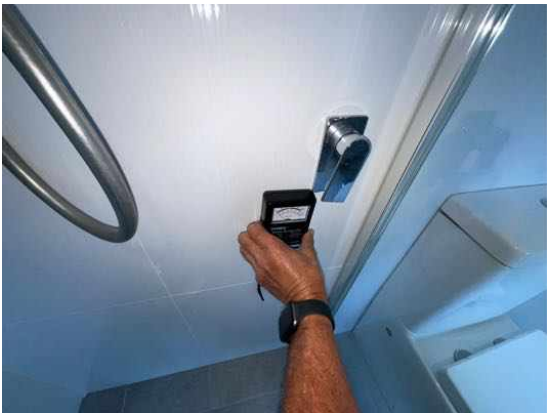
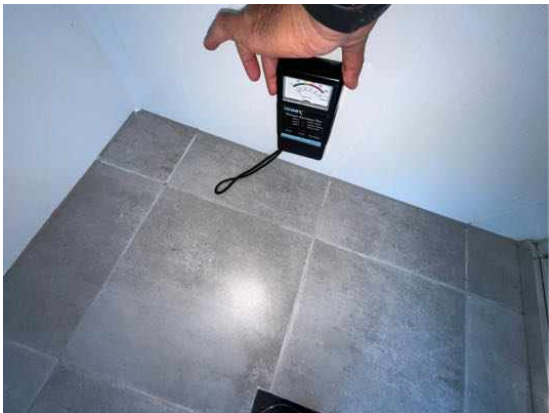
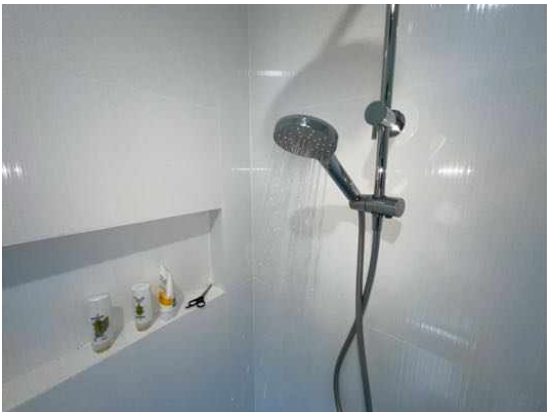
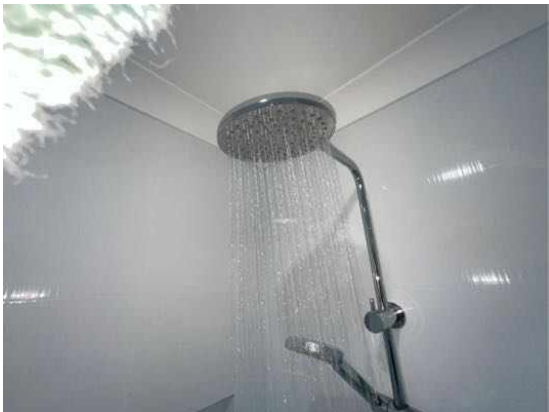
Noted Item

Building: Main Building
 Location: Ensuite
 Finding: Wet Areas - Bathroom(s) - Overall Condition & Recommendations.
 Information: Overall Condition & Recommendations

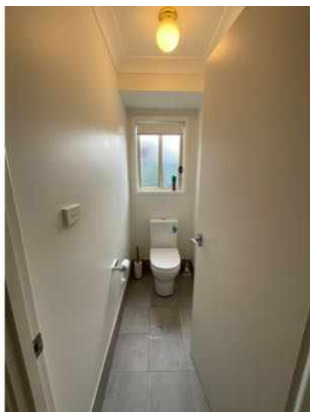
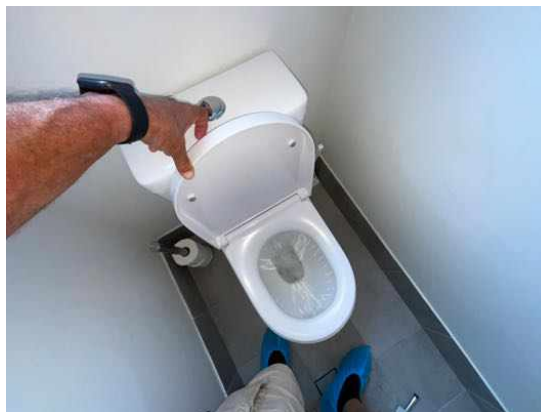
Noted Item

Building: Main Building
Location: Toilet (WC)
Finding: Overall Condition: Toilet.
Information: TOILET ASSESSMENT

- No leaks were observed during the flushing process.
- The toilet operated normally with no signs of malfunction or abnormal water flow.
- The toilet pan was securely fixed to the floor at the time of inspection.

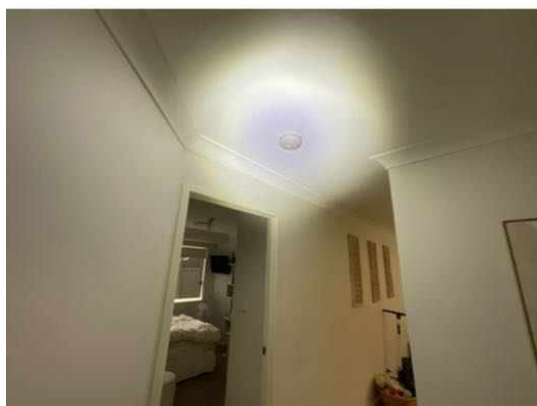
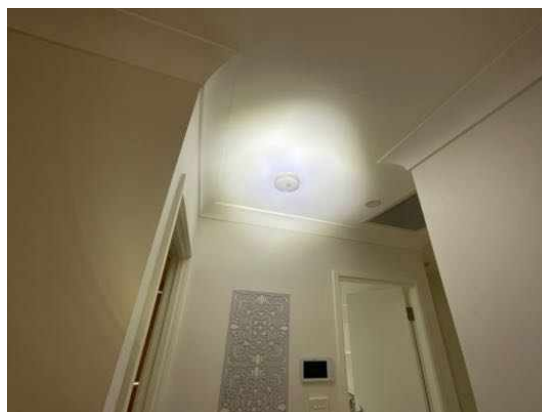
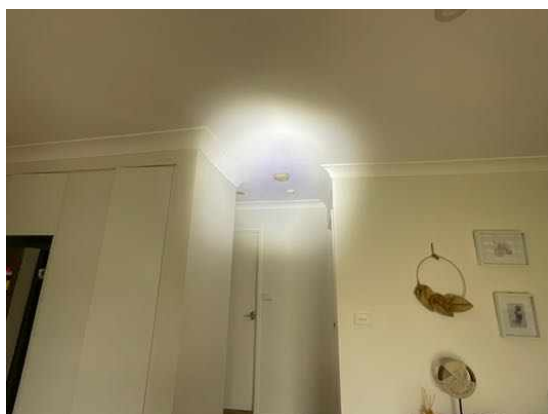
Noted Item

Building:	Main Building
Location:	All Areas
Finding:	Smoke Detectors / Alarms.
Information:	Reporting on the presence, type, location, or compliance of smoke detectors or alarms, including hard-wired smoke detection systems and their legislative requirements, is outside the scope of this inspection report.

- All smoke detectors be tested monthly by the homeowner.
- All systems comply with the requirements of AS 3786 and any applicable state-based legislation.
