Building and Timber Pest Inspection Report VR

Inspection Date: Fri, 9 Jan 2026

Property Address: 20 Glen Frew St, Kenmore QLD 4069,
Australia

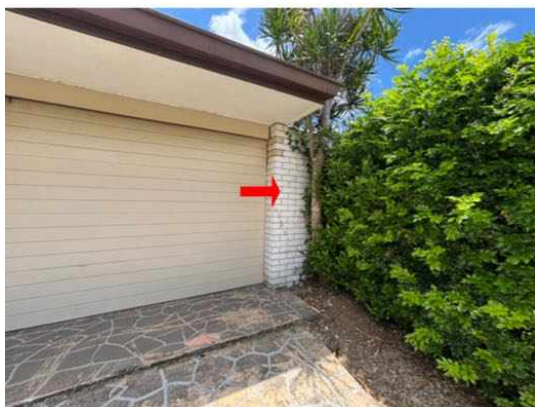
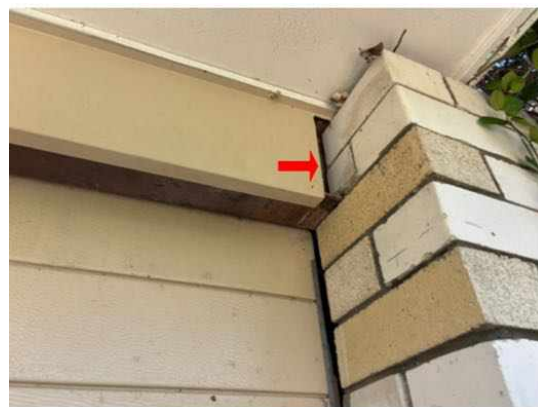
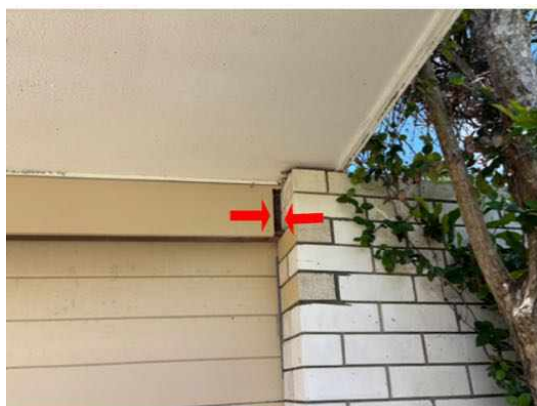
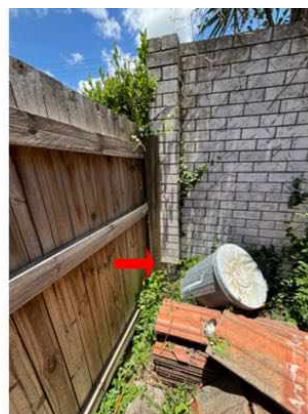
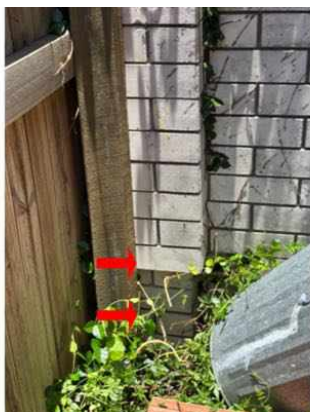
Information: At the time of the inspection, it was noted that there has been movement to the brickwork on the right hand side of the carport. This brickwork supports the metal beam that spans the carport door. The timber retaining wall on the boundary next to the brickwork appears to have moved which may have affected the foundations of the brickwork. The brickwork has shifted to the right and as seen on the engaged pier, it has also shifted backwards. There is movement to the brickwork when pressure is applied to it.

If left unaddressed, this brickwork may fail causing the steel beam to fall. This would be a major defect.

A structural engineer should be engaged to assess this brickwork and provide a solution for this issue, while at the same time, the noted cracks could be assessed. A licensed bricklayer would be required if this section of brickwork needs to be rebuilt. This should be done as a matter of urgency.

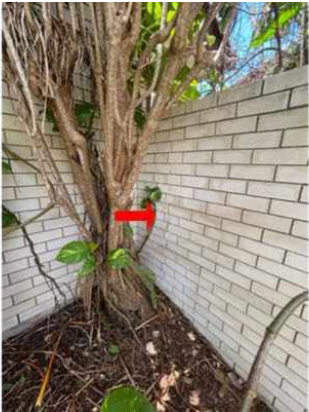
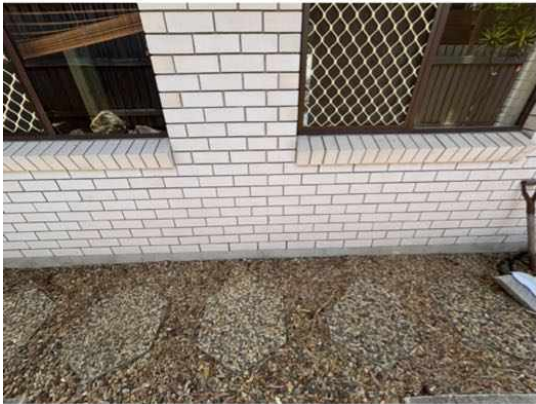
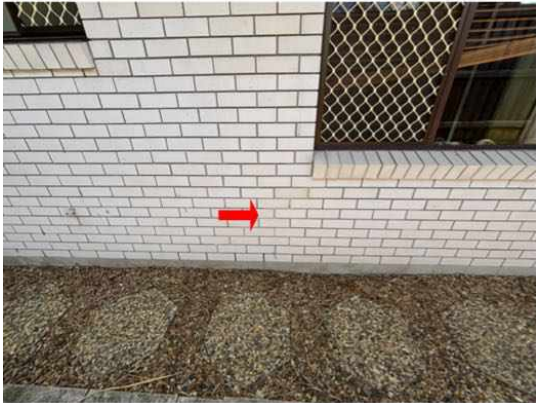
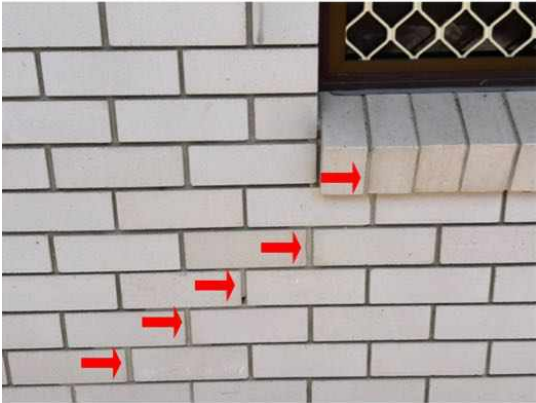
Finding 3.01

Building:	Main Building
Location:	All External Areas
Finding:	Brickwork - Step cracking
Information:	At the time of the inspection, it was noted that there was step cracking to the brickwork on the left hand side of the carport area and on in sections of the brickwork on the left hand side of the dwelling. The client should monitor this area for any change to the step cracking.

Step cracking, which is similar to other forms of cracking, has a variety of possible causes. However, the most common is the subsidence of adjacent footings.

Step cracking is a relatively common defect, and is most likely to occur adjacent to windows, doors and other openings. Mortar failure in the gaps between affected bricks indicates the stresses and tensions affecting the wall.

Where step cracking is extensive or severe, the client is advised to consult a structural engineer. Minor step cracking can be used as a warning sign to address factors causing stress to the wall, which can include the effect of surrounding trees, water leaks, soil erosion, or even the presence of reactive soils in the surrounding area.

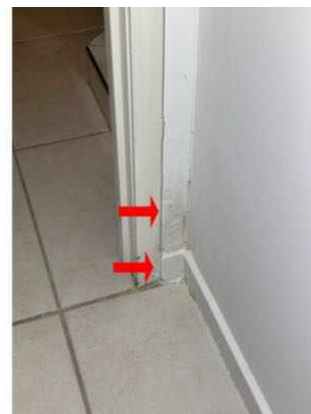
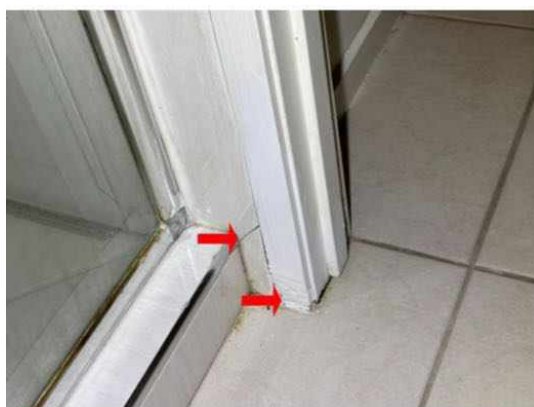
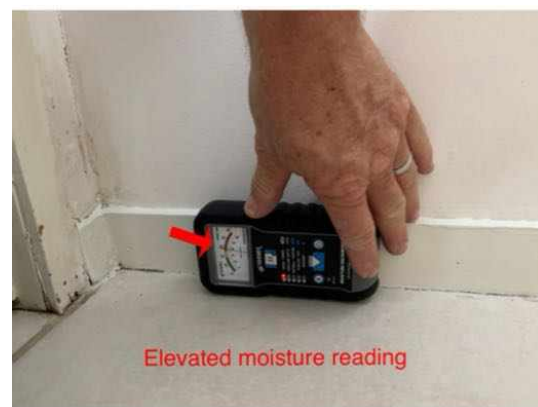
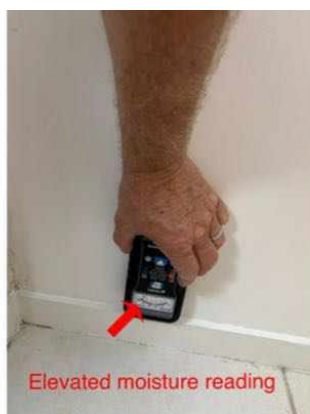
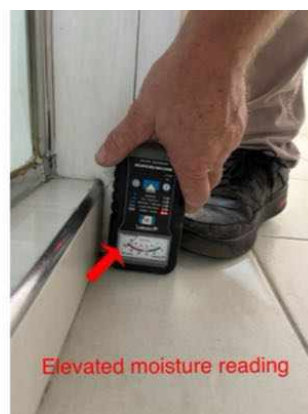
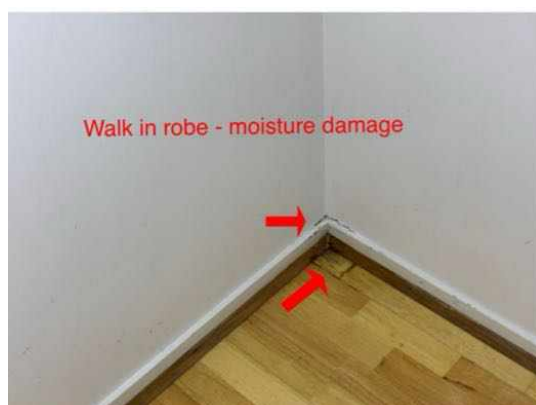
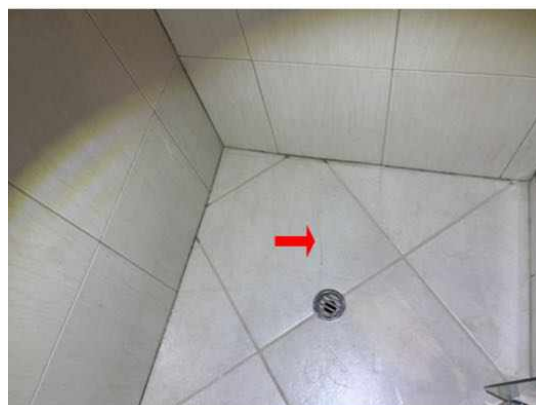
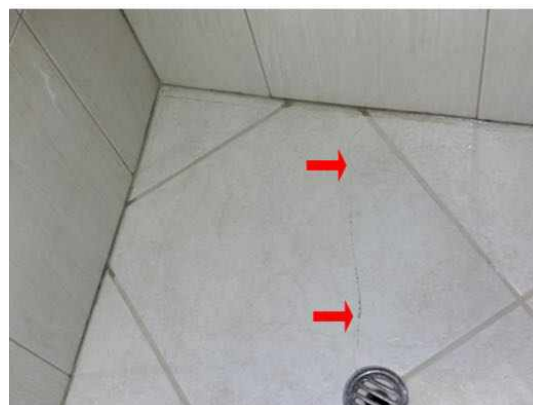
Finding 3.02

Information: At the time of the inspection, it was noted that there was evidence of moisture damage to doorway of the family bathroom and on the other side of the wall in the walk in robe. This moisture damage may be caused by a leaking shower screen or failed waterproofing in the family bathroom shower. An invasive inspection may be necessary to determine the source of the moisture. A cracked tile was found on the shower cubicle floor.

If left unaddressed, this will become a major defect.

Moisture in wall cavities creates a conducive environment for termite activity and can cause undetected damage to the associated building materials.

A bathroom specialist, such as The Grout Guys, should be engaged to assess the family bathroom shower and provide a solution to rectify this issue. This should be done as a matter of urgency.

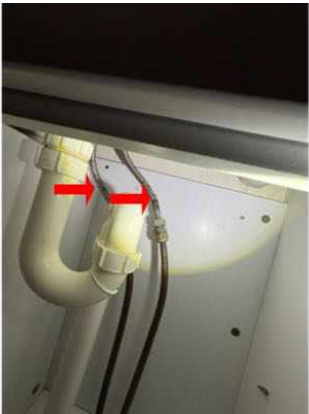
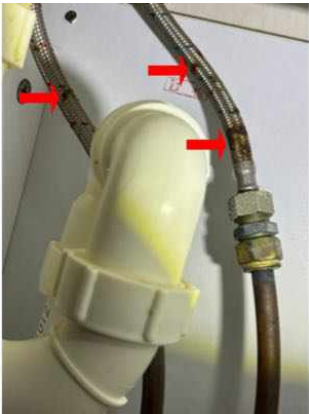
Finding 3.04

Building:	Main Building
Location:	Family bathroom
Finding:	Family bathroom - flexible hoses have signs of rusting
Information:	At the time of the inspection, it was noted that a flexible hoses to the family bathroom vanity mixer had signs of rusting. This may be due to the age of the hose. Flexible hoses typically have a 5 - 10 year lifespan. It is recommended that they be changed if they have signs of bulging, fraying, kinking or rust.

A licensed plumber should be engaged to replace both the flexible hoses to the family bathroom vanity mixer. This should be done as a matter of urgency.

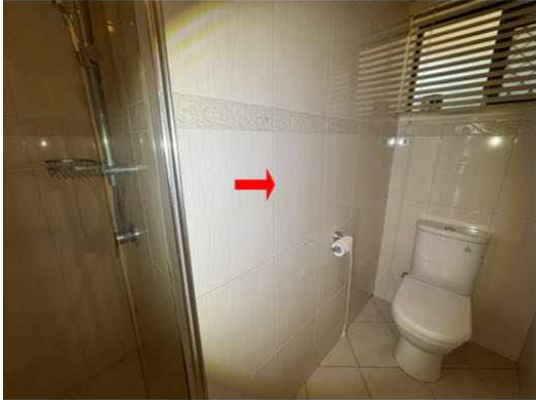
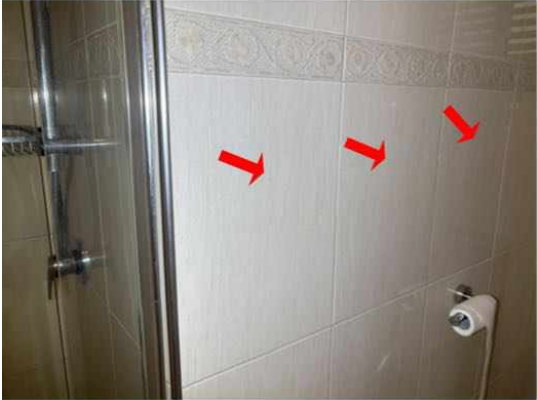
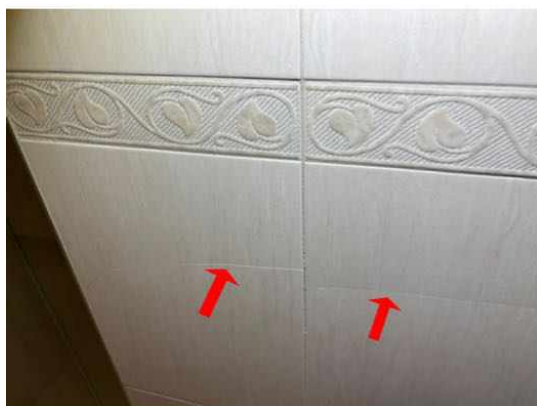
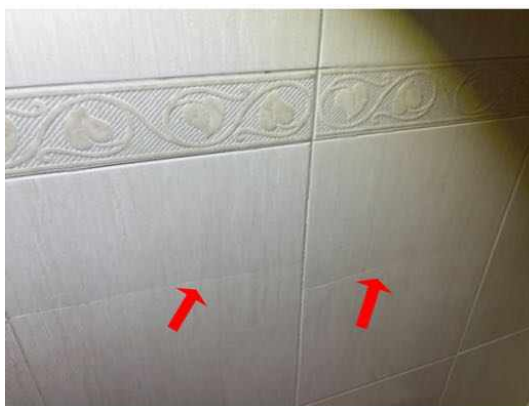
Finding 3.05

Finding: Ensuite - cracked wall tiles

Information: At the time of the inspection it was noted that several wall tiles were cracked in the ensuite. This appears to be purely an aesthetic issues and could be attended to at the clients discretion. The client should monitor the cracked tiles for any change in appearance.

A tiler or building maintenance professional would be able to carry out the necessary repair works.

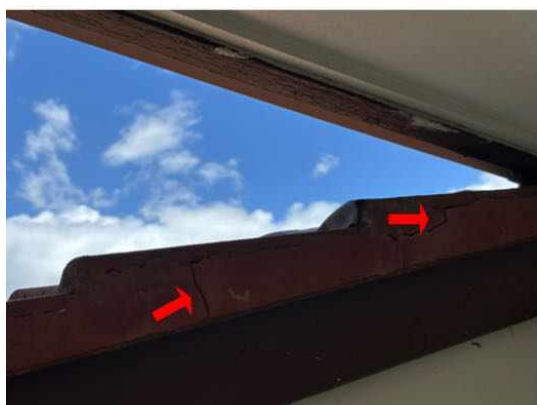
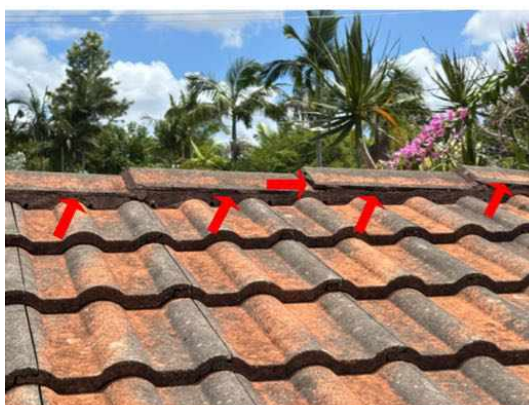
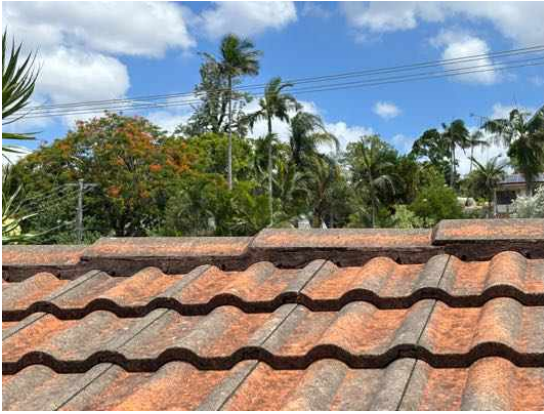
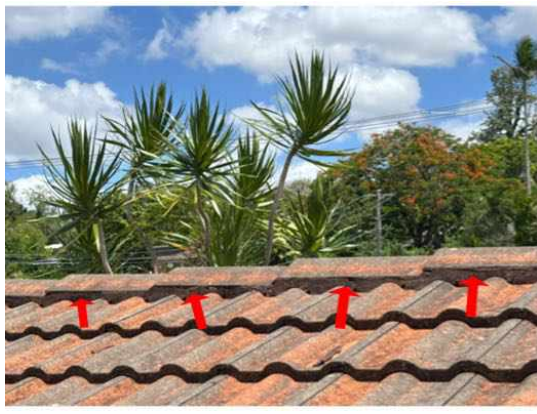
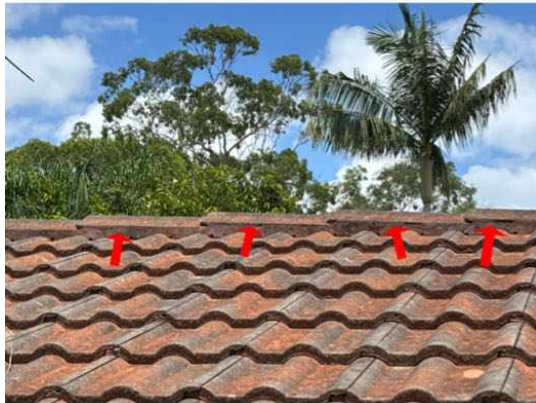
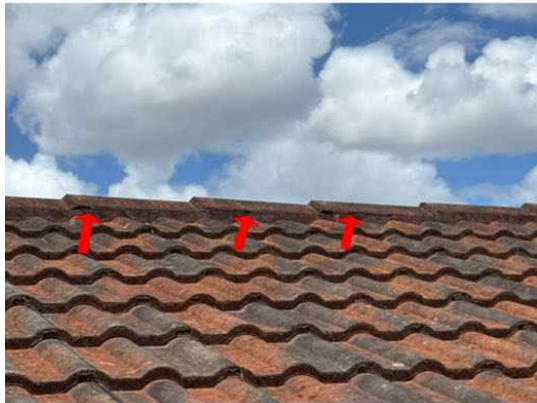
Finding 3.06

Building:	Main Building
Location:	Roof Exterior
Finding:	Roof tiles - Weathered and mortar cracking
Information:	Upon inspection of the exterior roofing, the majority of roof tiles were considered to be in a fair condition. While weathering of the tiles is consistent with the age of the property, maintenance works are required.

The mortar to all ridge capping on the tiled roof is showing evidence of cracking. This is a possible ingress point for moisture into the roof space.

Where left unmanaged, deteriorating roof tiles are likely to lead to a number of secondary defects, including minor water leaks and weather exposure to internal roofing structures.

Consultation with a roofing contractor is highly advised to gain advice on cost of remedial works that may be required in the short to medium term. Remedial works are likely to increase the longevity of the exterior roofing structure.

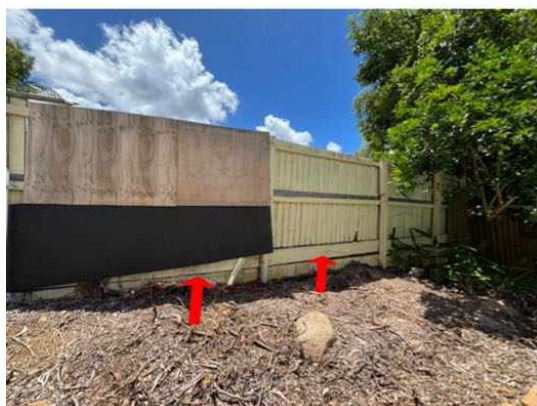
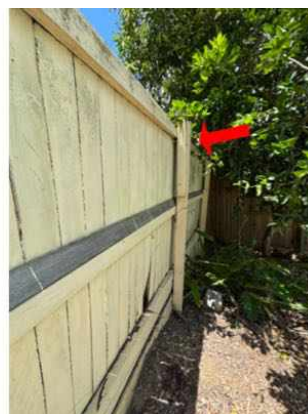
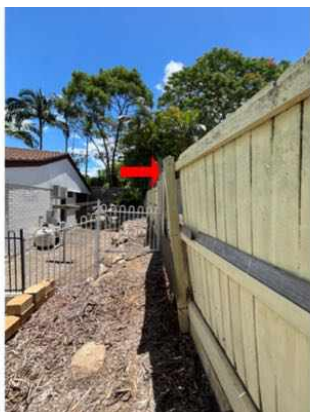
Finding 3.07

Building:	Main Building
Location:	Rear boundary
Finding:	Rear boundary - deterioration of retaining wall
Information:	At the time of the inspection, it was noted that the timber retaining wall in the pool area is deteriorating. As a result the timber retaining wall is leaning into the yard. The timber fence on top of the retaining wall is leaning over as a result of the retaining wall deterioration.

A building maintenance professional or retaining wall specialist could be engaged to replace the affected sections of the timber retaining wall and fence. This can be done at the clients discretion.

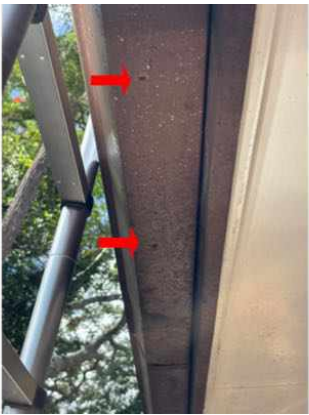
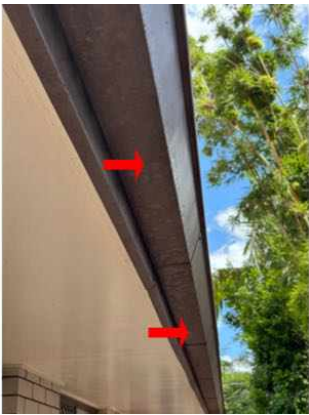
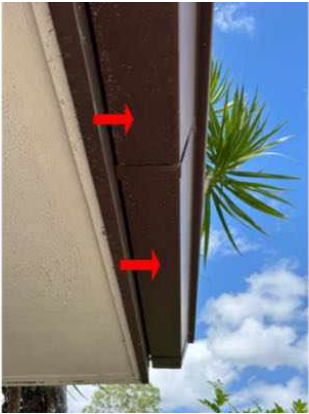
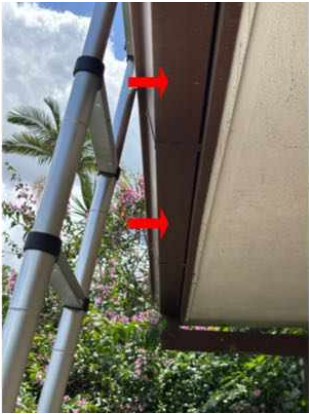
Finding 3.08

Finding: Gutters - rusting

Information: At the time of the inspection, it was noted that sections of the gutters were rusting. The gutter on the left hand side of the dwelling and at the front of the carport are affected. Gutters need to be in good working order to drain the roof properly.

If gutters are leaking , moisture may get to areas of the building that are meant to be keep dry. Damage to building elements may result of moisture ingress.

A licensed roof plumber should be appointed to inspect the gutters and advise on necessary rectification works. This should be done as a matter of urgency.

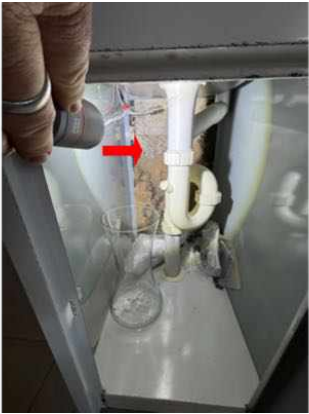
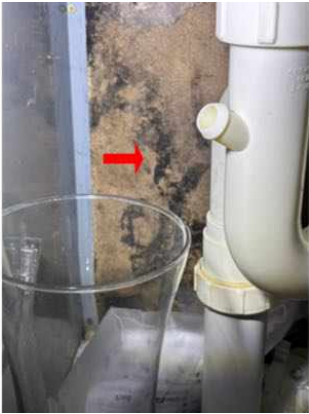
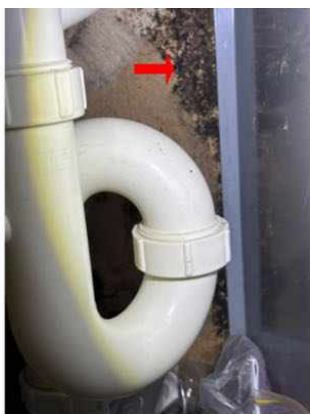
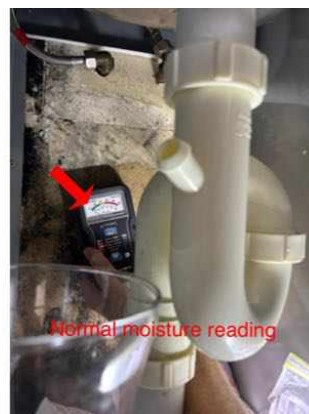
Building: Main Building
Location: Laundry
Finding: Laundry - mould
Information: At the time of the inspection, it was noted that there was mould under the laundry tub. Normal moisture levels were recorded in this area.

A mould remediation specialist should be engaged to clean up the affected area. This should be done as a matter of urgency.

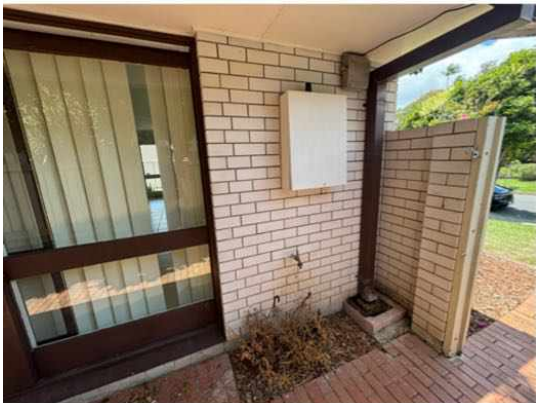
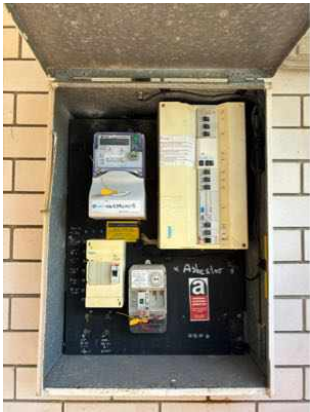
Finding 6.02

Building:	Main Building
Location:	All External Areas
Finding:	Termite Management System - no evidence of a chemical installation
Information:	At the time of the inspection, no evidence of a chemical termite management system was found. There is no durable notice in the meter box. No record of annual termite inspections was found on site.

The application of a post-construction chemical termite barrier is highly recommended for all properties, particularly if live termite activity has been found on the site previously. Such barriers are highly effective in preventing termite attack on any timber building elements throughout the property.

The client may consider gaining further advice from a pest controller as to the costs and procedures involved with this application. It is recommended that obtaining such advice be a short-term priority.

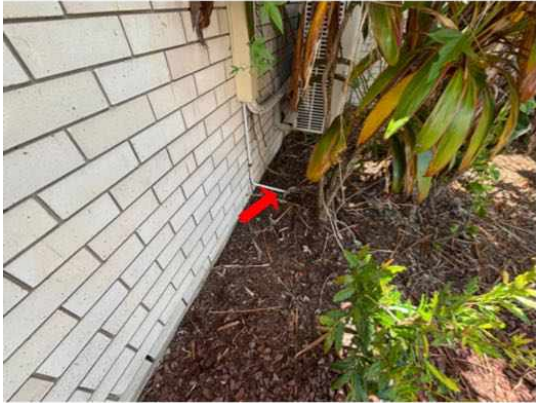
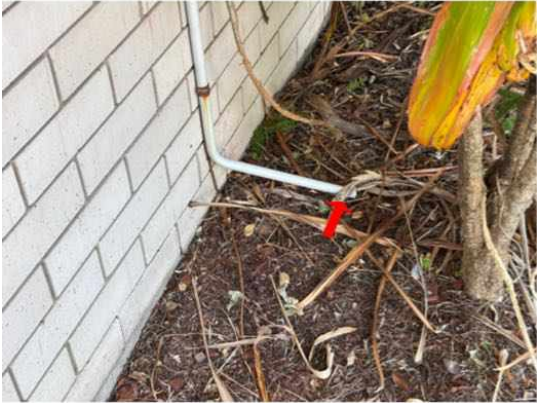
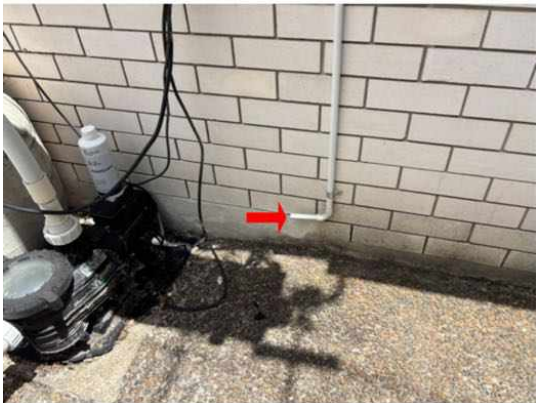
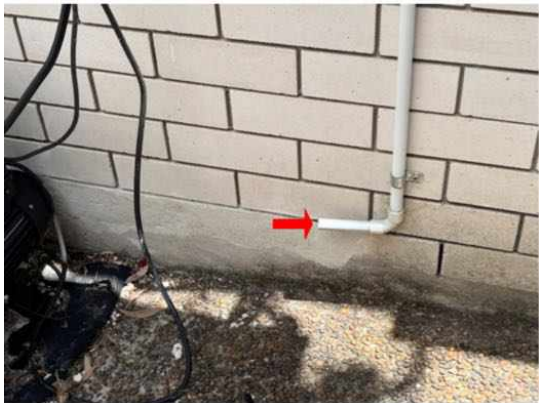
Finding 6.03

Building: Main Building
Location: All External Areas
Finding: Air conditioner - Disconnected overflows
Information: At the time of the inspection, it was noted that the air conditioner drain overflows to all the units were not connected to the storm water drainage and as a result are draining next to the foundations of the dwelling.

Air conditioning overflows that are not connected to the storm water drainage and are draining near the foundation can create excessive moisture in the surrounding area.

Such leaking creates an environment which is conducive to an array of defects, including water damage to associated building elements and the attraction of termite or timber pest infestation.

It is highly recommended that a licensed plumber be appointed to connect the A/C overflow in order to prevent such an environment from being created. These minor works should be carried out as soon as possible.

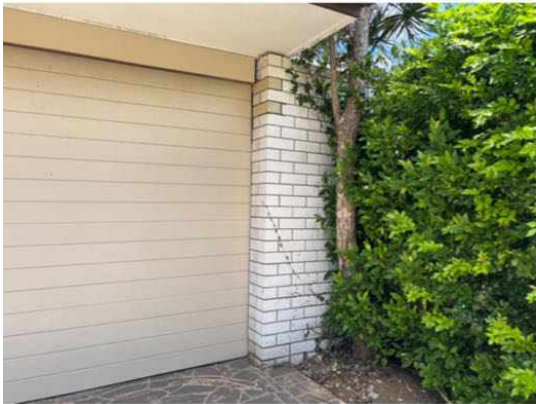
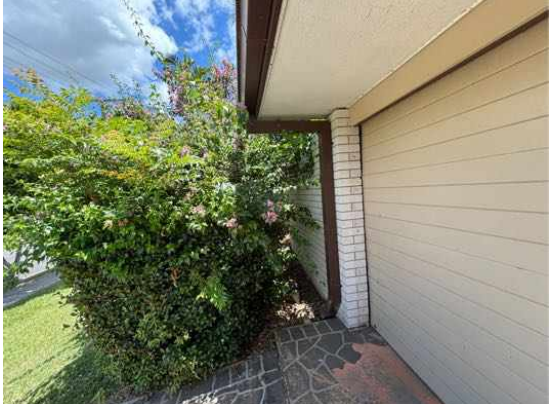
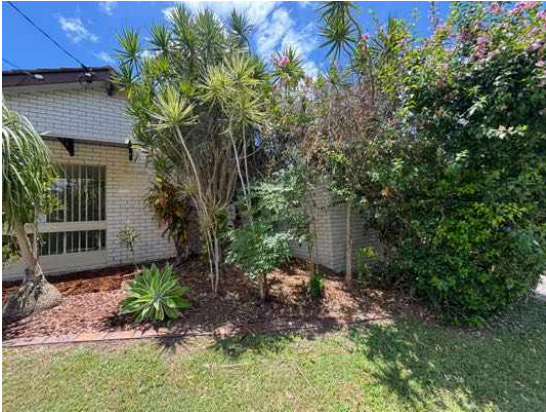
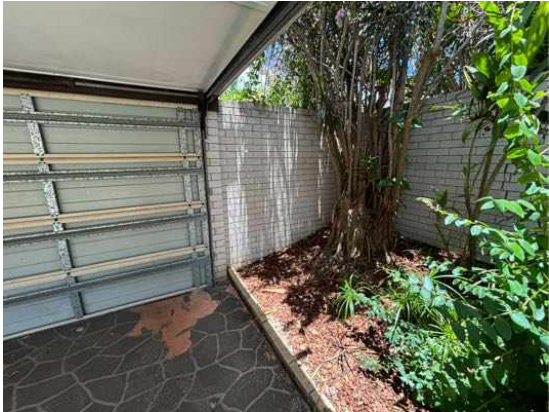
Building: Main Building
 Location: Front elevation
 Finding: Vegetation touching the building
 Information: At the time of the inspection, it was noted that there was vegetation touching the building in several locations. This creates a potential access point for termites to enter the building undetected. This is a conducive condition for termite activity.

The client is to ensure that the vegetation is trimmed back to prevent undetected termite entry to the building. This should be done as a matter of urgency.

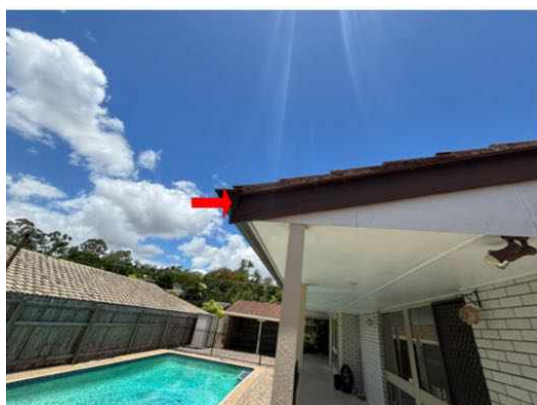
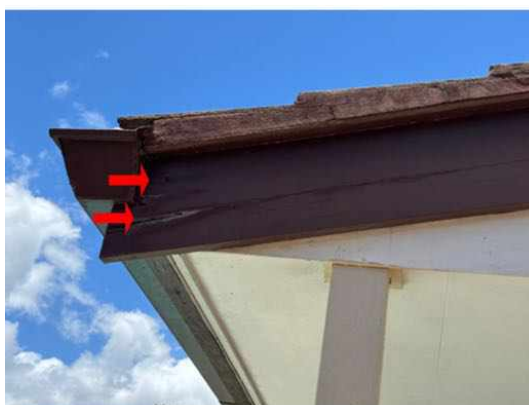
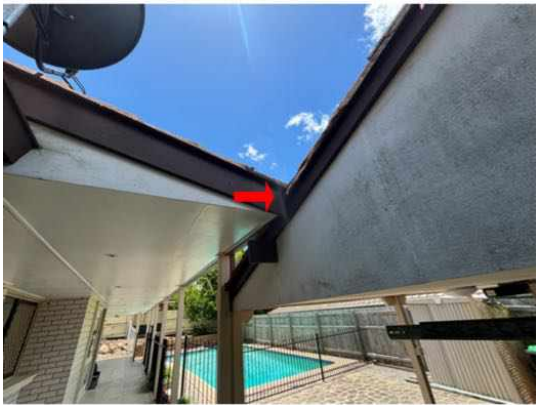
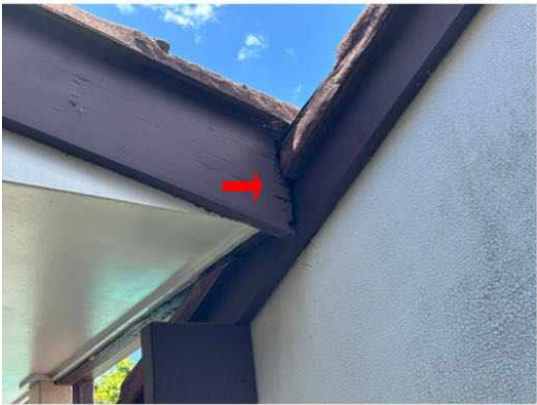
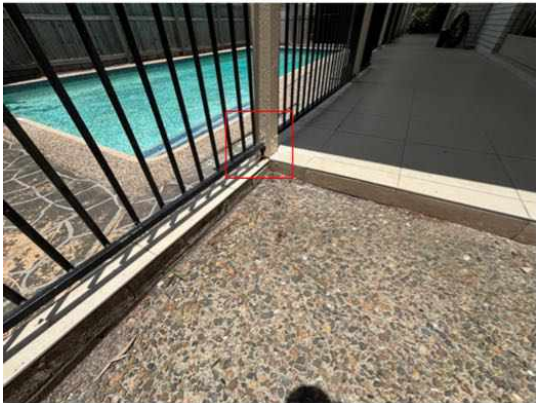
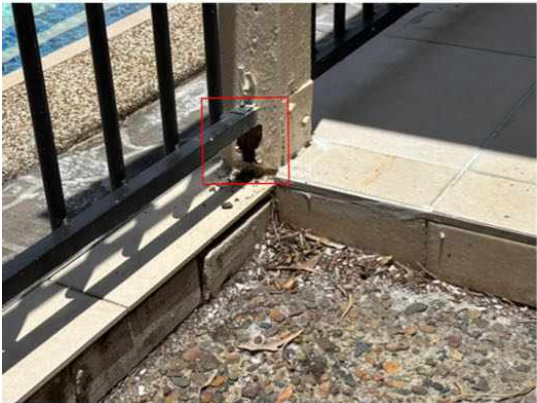
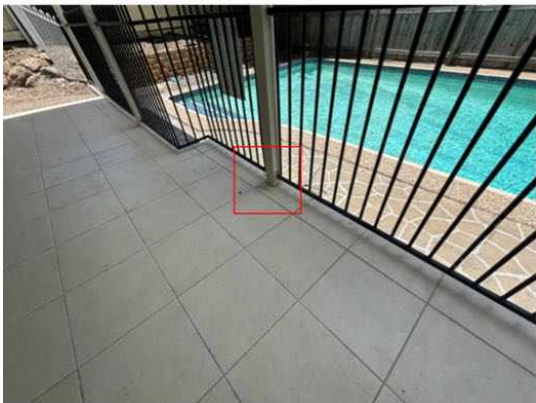
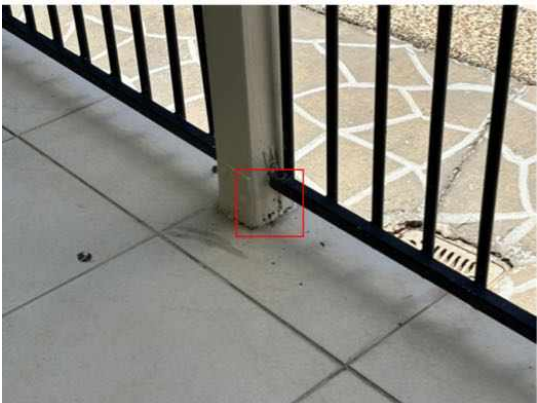
Finding 7.01

Building:	Main Building
Location:	All External Areas
Finding:	Wood rot
Information:	At the time of the inspection, it was noted that there were examples of wood rot to sections of the timber fascia and to two timber posts near the pool. This may be due to the age of the timber building elements and general weathering.

This building element shows evidence of wood rot. Wood rot, also known as Fungal Decay, occurs when timbers and other cellulose building materials are exposed to damp conditions on an ongoing basis.

Wood rot is often associated with general damp problems and is evidenced by a 'musty' smell or mould and mildew occurring on surfaces. If left unmanaged, damp conditions can lead to further health problems and the decay of timbers will continue.

Early intervention and regular maintenance, particularly of exterior timbers, will prolong the useful life of these building elements. Prior to any works being performed, the cause of the moisture that has created the visible wood rot should be identified and addressed in a suitable manner. Replacement of affected timbers may then be a necessary step in protecting surrounding building elements from such deterioration.

A qualified carpenter or registered builder may also be required to replace affected building materials.

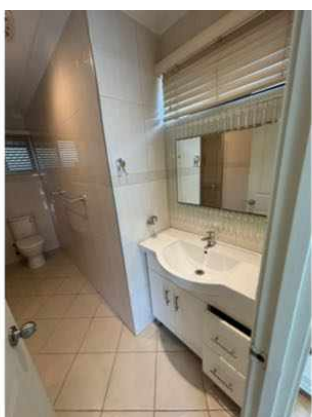
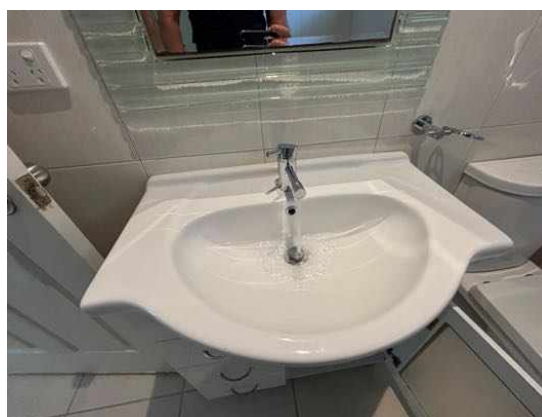
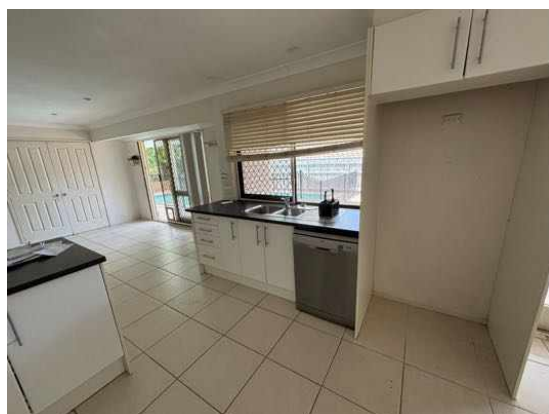
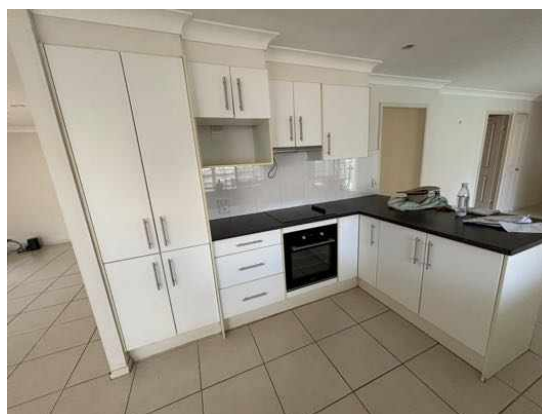
Building: Main Building
 Location: All Internal Areas
 Finding: Obstructions and Limitations - Internal areas
 Information: These photographs are an indication of the obstructions and limitations which impeded full inspection of the property of the internal areas at the time of inspection. These obstructions can hide an array of defects and should be removed to allow full inspection to be carried out. A re-inspection is recommended once the areas are made accessible.

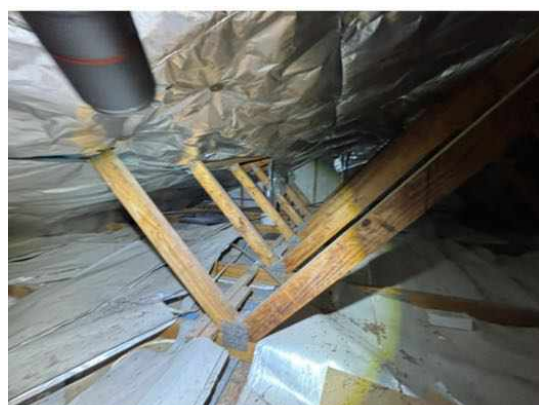
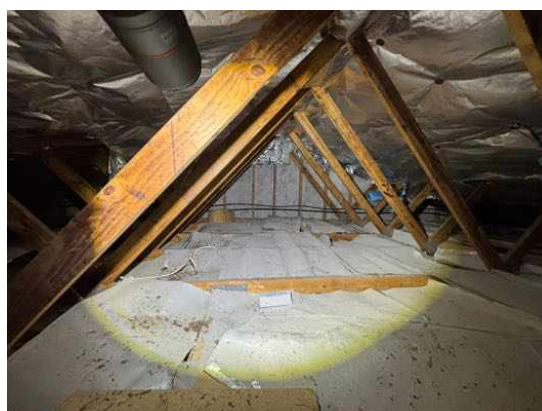
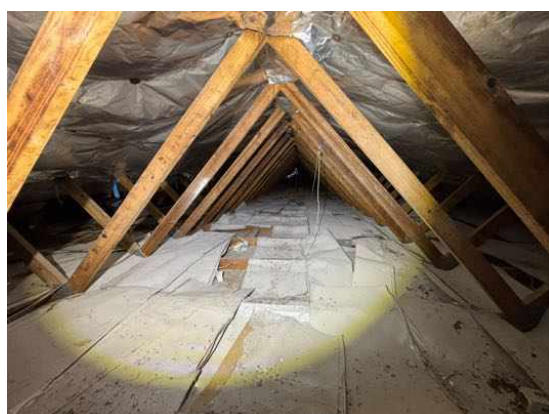
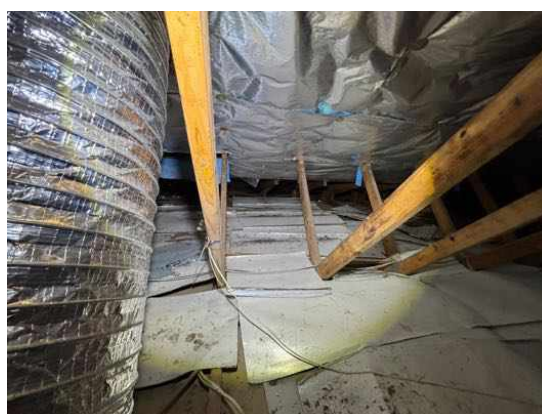
Building: Main Building
 Location: Roof Void
 Finding: Obstructions and Limitations - Roof cavity
 Information: These photographs are an indication of the obstructions and limitations which impeded full inspection of the property of the roof cavity

at the time of inspection. These obstructions can hide an array of defects and should be removed to allow full inspection to be carried out. A re-inspection is recommended once the areas are made accessible.

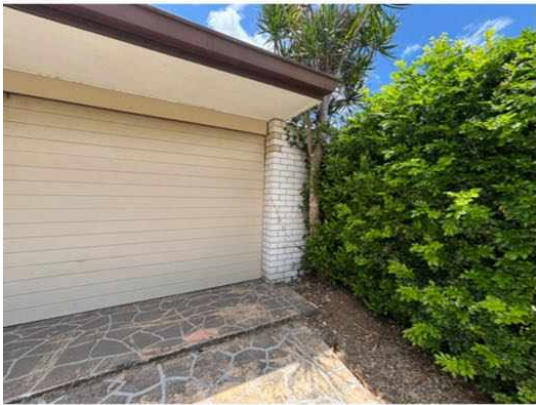
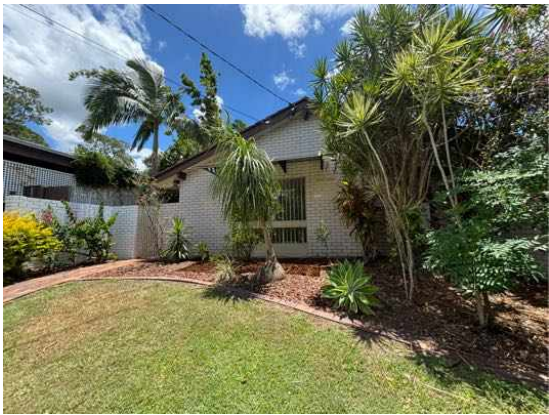
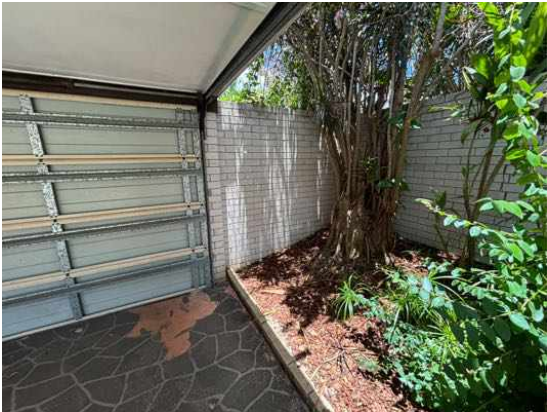
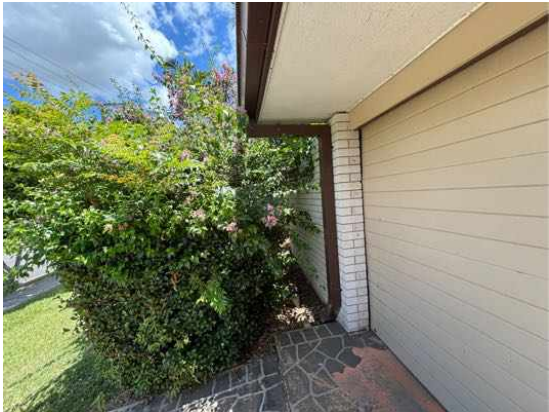
Building:	Main Building
Location:	Front elevation
Finding:	Obstructions and Limitations - External areas
Information:	These photographs are an indication of the obstructions and limitations which impeded full inspection of the property of the external areas at the time of inspection. These obstructions can hide an array of defects and should be removed to allow full inspection to be carried out. A re-inspection is recommended once the areas are made accessible.
