## Building and Timber Pest Inspection Report VR

Inspection Date: Wed, 21 Jan 2026

Property Address: 7 Evadne St, Graceville QLD 4075, Australia

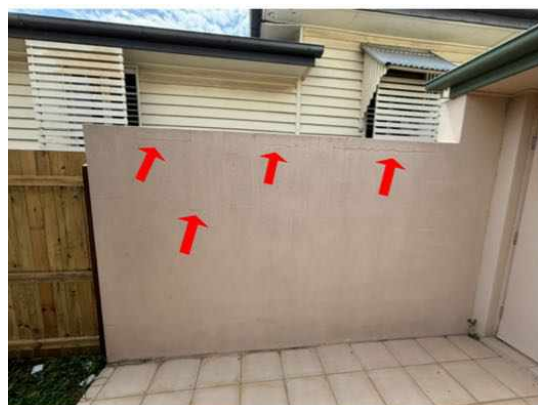
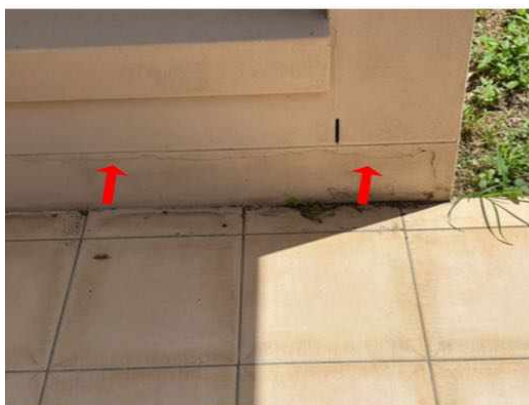
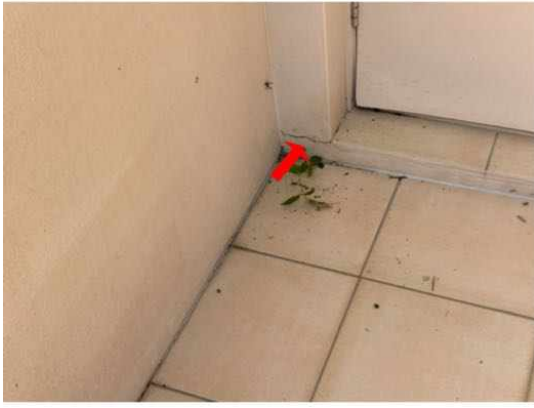
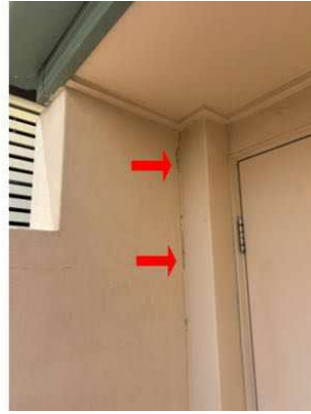
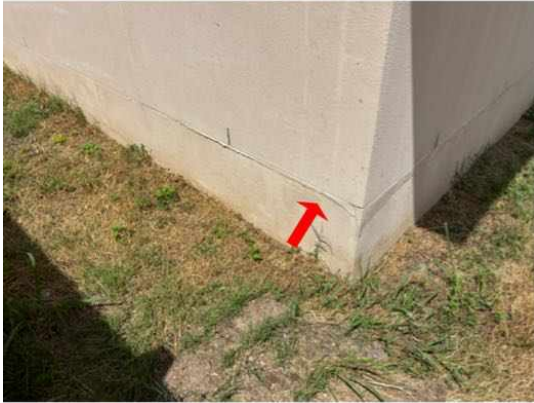
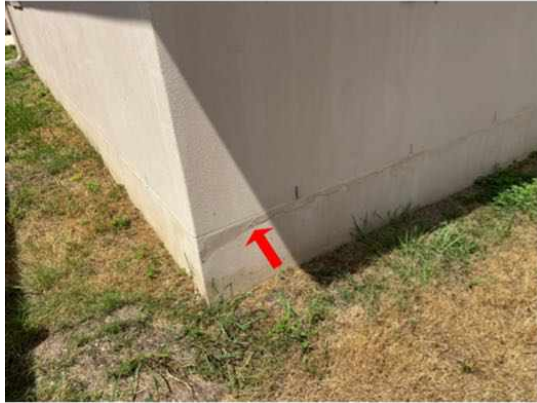
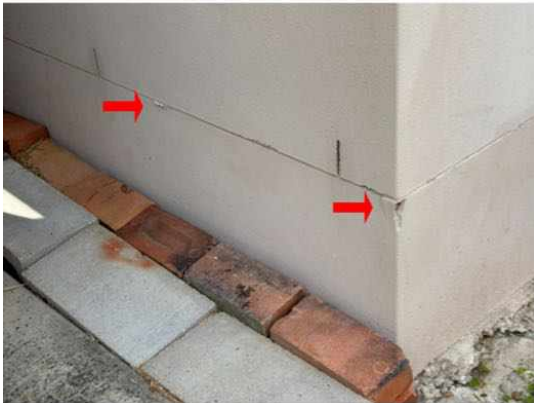
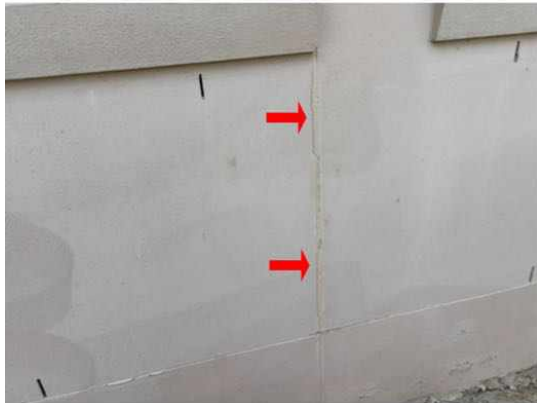
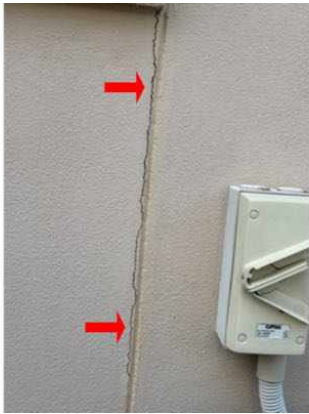
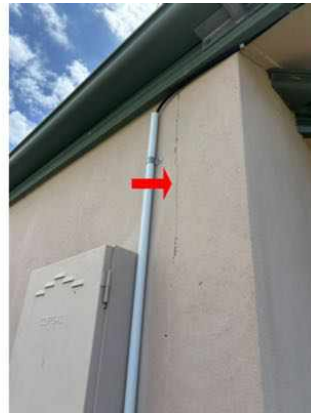
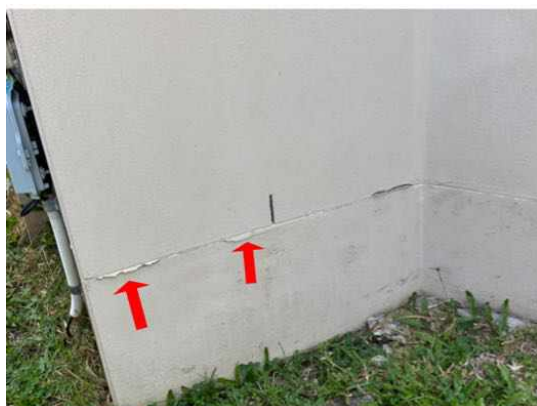
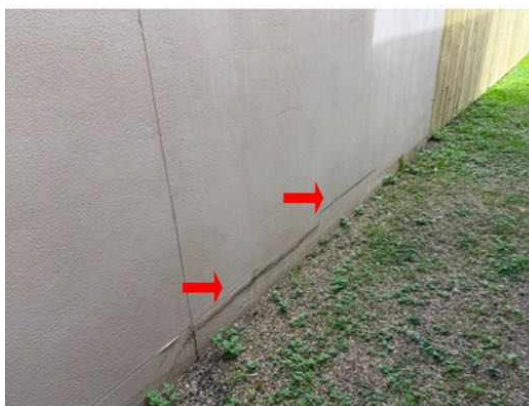
#### Finding 3.01

Finding: Render - cracking

Information: At the time of the inspection, it was noted that there was cracking to several areas of the render coat around the dwelling. This may be due to general wear and tear and the age of the materials.

A solid plasterer or painting contractor could be engaged to carry out these repairs. This can be done at the clients discretion.

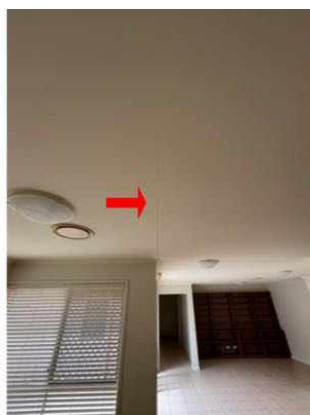
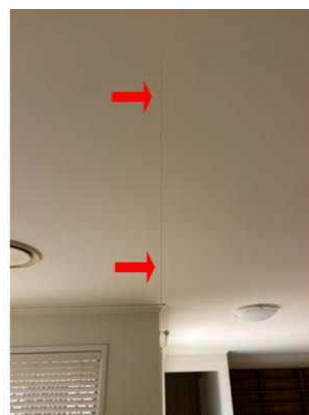
### Finding 3.02

Building:	Main Building
Location:	Dining room
Finding:	Ceiling lining - cracking
Information:	At the time of the inspection, it was noted that there was a crack to the ceiling lining in the dining area. This appears to be general wear and tear and normal movement of the associated building materials.

The functionality of the ceiling lining is not affected at present. A plasterer could be engaged to repair the crack to the dining room ceiling. This can be done at the clients discretion.

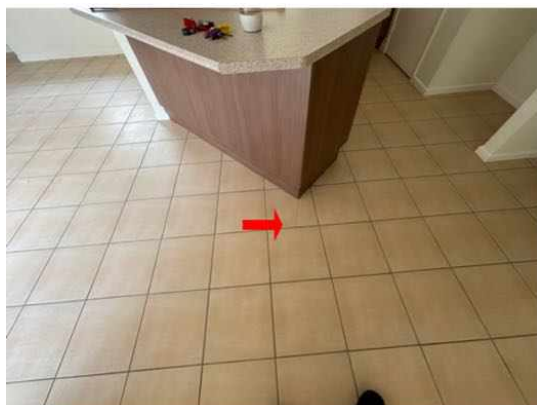
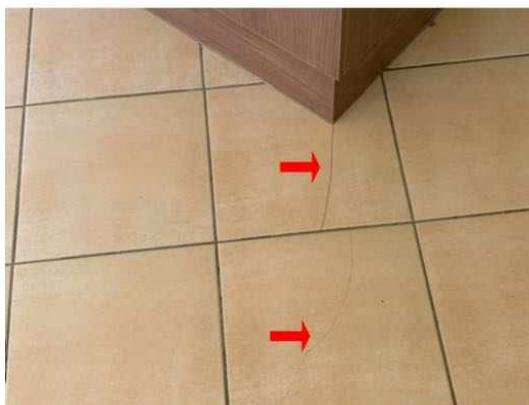
### Finding 3.03

Building:	Main Building
Location:	Kitchen
Finding:	Kitchen - cracked tiles
Information:	At the time of the inspection it was noted that several tiles were cracked on the floor next to the kitchen. This appears to be purely an aesthetic issues and could be attended to at the clients discretion. The tiles may have cracked because they are drummy and something has been dropped on them.

A tiler or building maintenance professional would be able to carry out the necessary works.

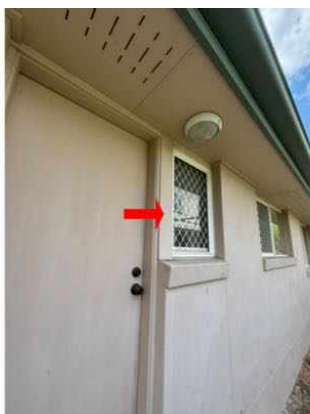
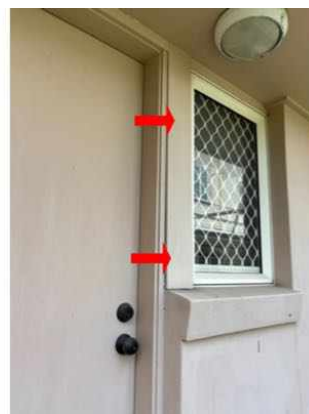
### Finding 3.04

Building:	Main Building
Location:	Laundry area
Finding:	Exterior - timber moulding loose
Information:	At the time of the inspection, it was noted that the timber moulding next to the laundry door was loose. This may be due to the fasteners failing.

A building maintenance professional could be engaged to re-secure the timber moulding. This can be done at the clients discretion.

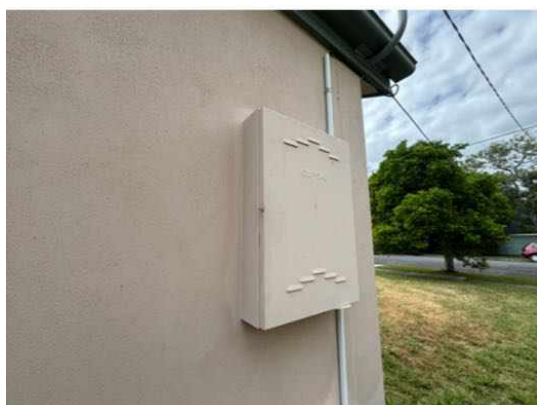
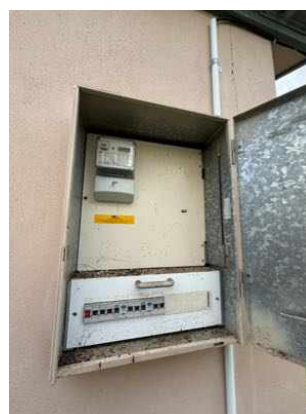
### Finding 6.01

Building:	Main Building
Location:	All External Areas
Finding:	Termite Management System - no evidence of a chemical or physical termite management system
Information:	At the time of the inspection, no evidence of a chemical or physical termite management system was found. There is no durable notice in the meter box or in the kitchen sink cabinet.

A durable notice should be placed in the switchboard unit to indicate current termite barriers. At the time of inspection, it appeared as though no termite management system has been installed, with no evidence to suggest preventative works taking place.

The application of a post-construction chemical termite barrier is highly recommended for all properties, particularly if live termite activity has been found on the site previously. Such barriers are highly effective in preventing termite attack on any timber building elements throughout the property.

The client may consider gaining further advice from a pest controller as to the costs and procedures involved with this application. It is recommended that obtaining such advice be a short-term priority.

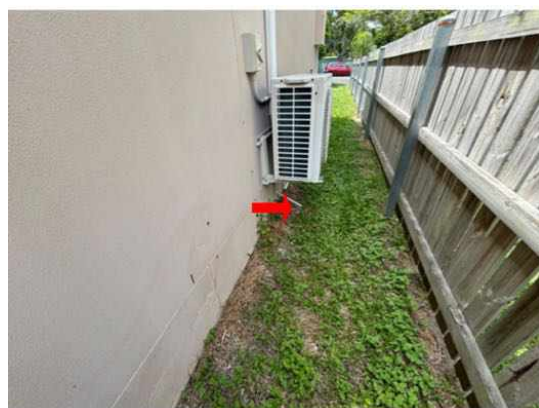
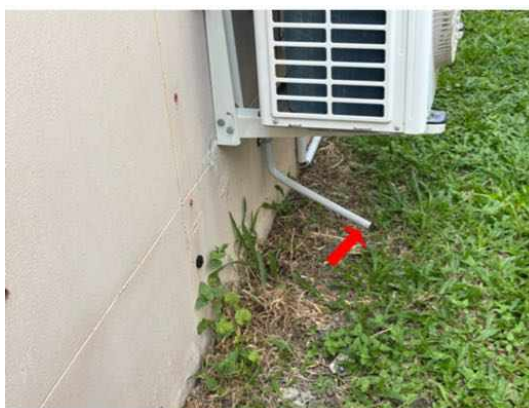
### Finding 6.02

Building:	Main Building
Location:	Side yard
Finding:	Air conditioner - Disconnected overflows

Information: At the time of the inspection, it was noted that the air conditioner drain overflow to all the unit on the side of the dwelling was not connected to the storm water drainage and as a result are draining next to the foundations of the dwelling.

Air conditioning overflows that are not connected to the storm water drainage and are draining near the foundation can create excessive moisture in the surrounding area.

Such leaking creates an environment which is conducive to an array of defects, including water damage to associated building elements and the attraction of termite or timber pest infestation.

It is highly recommended that a licensed plumber be appointed to connect the A/C overflow in order to prevent such an environment from being created. These minor works should be carried out as soon as possible.

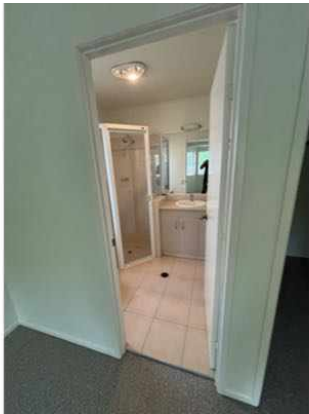
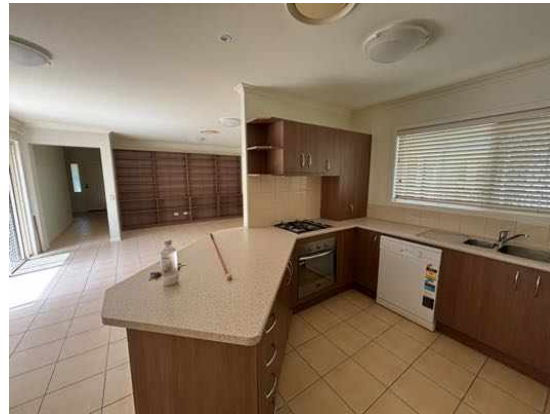
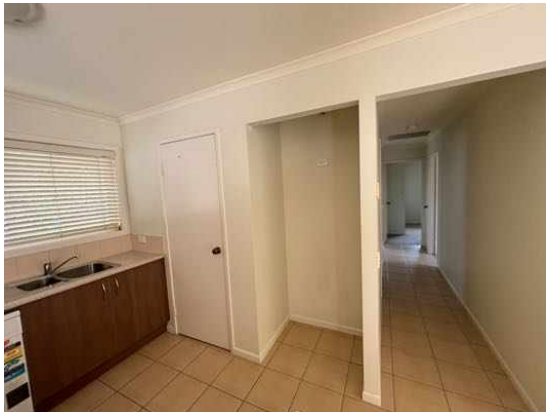
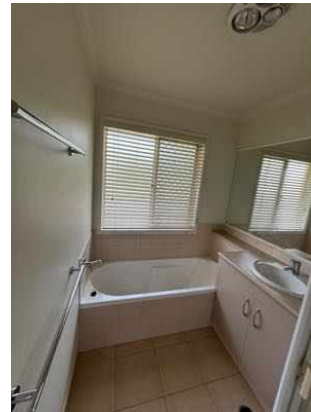
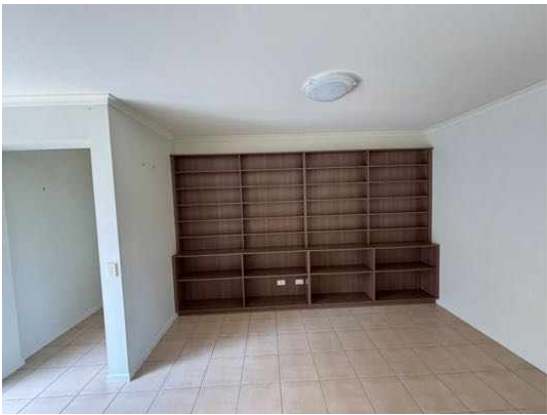
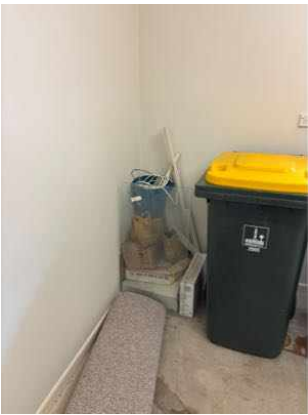
Building: Main Building  
Location: All Internal Areas  
Finding: Obstructions and Limitations - Internal areas  
Information: These photographs are an indication of the obstructions and limitations which impeded full inspection of the property of the internal areas at the time of inspection. These obstructions can hide an array of defects and should be removed to allow full inspection to be carried out. A re-inspection is recommended once the areas are made accessible.

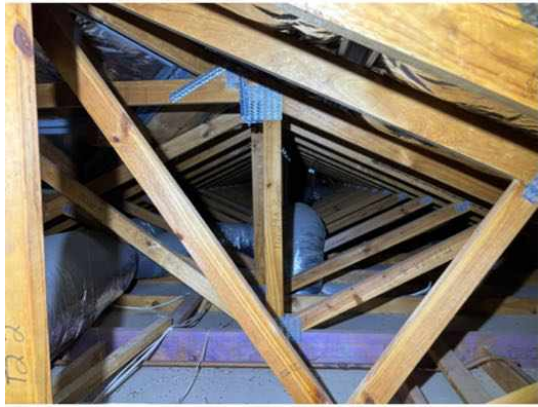
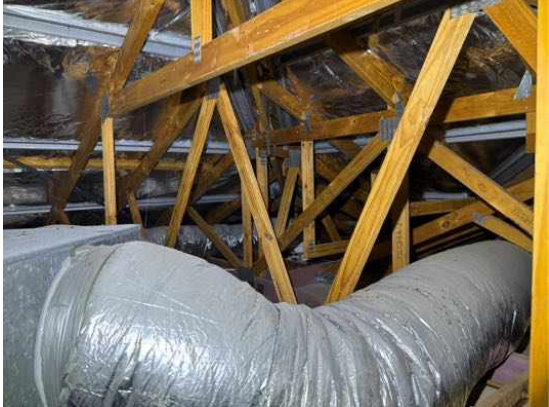
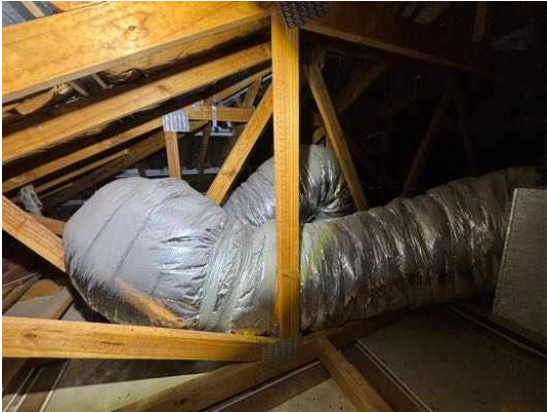
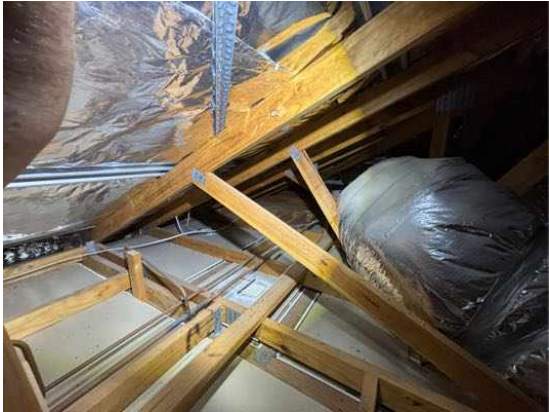
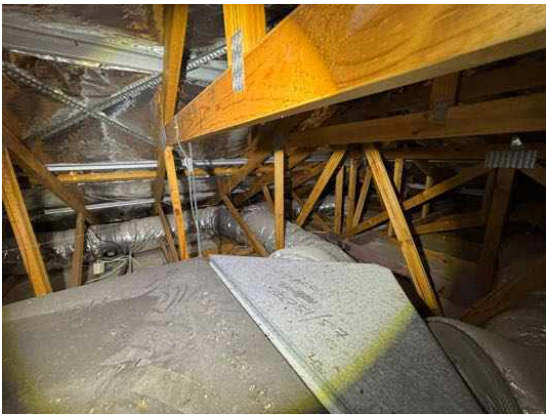
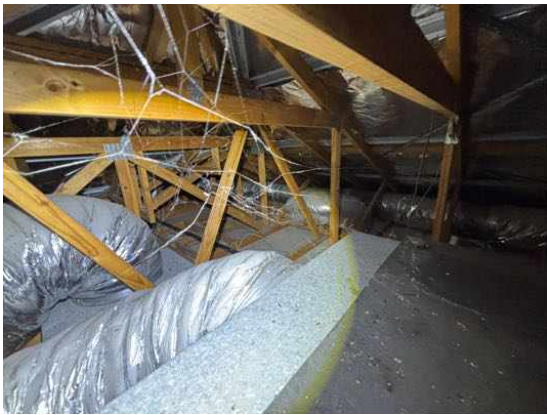
Building: Main Building  
Location: Roof Void  
Finding: Obstructions and Limitations - Roof cavity  
Information: These photographs are an indication of the obstructions and limitations which impeded full inspection of the property of the roof cavity

at the time of inspection. These obstructions can hide an array of defects and should be removed to allow full inspection to be carried out. A re-inspection is recommended once the areas are made accessible.
