Building and Timber Pest Inspection Report

Inspection Date: Tue, 17 Feb 2026

Property Address: 147 The Trongate, GRANVILLE, NSW, 2142, Australia

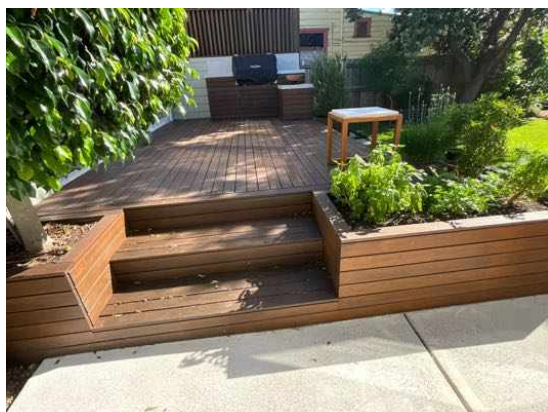
External timber structures are also constantly exposed to weather deteriorates in an exhilarate manner, ongoing assessments are required.

It is highly recommended that a structural engineer further, assess the external timber balcony or a deck to inform the client of its load capacity.

Regular maintenance inspections by competent practitioners is needed.

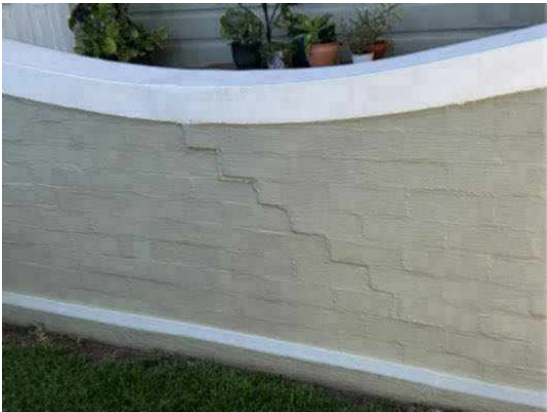
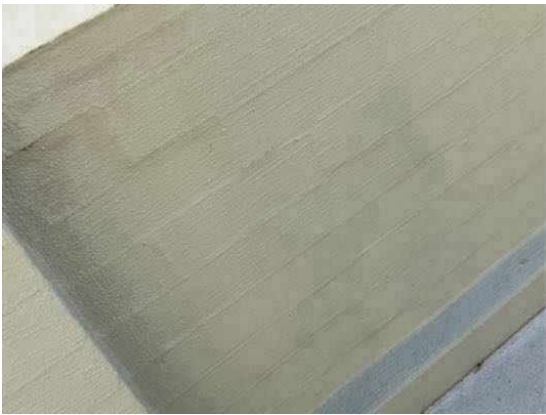
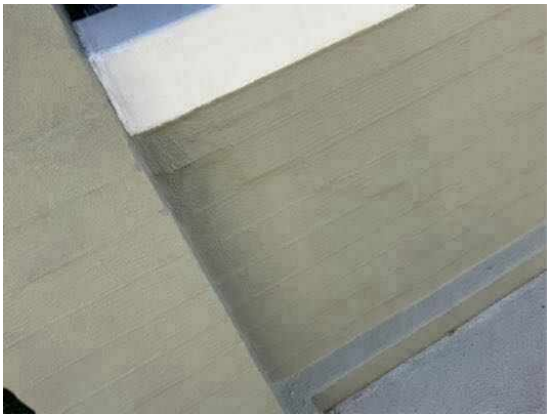
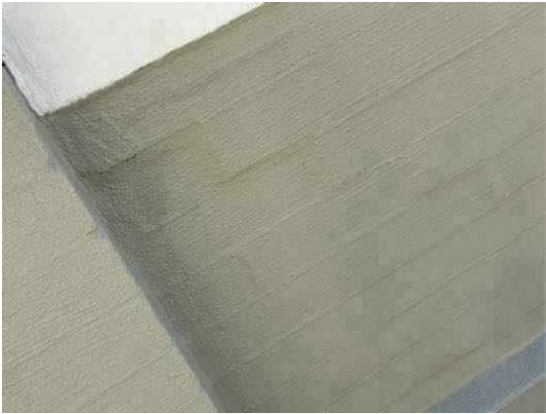
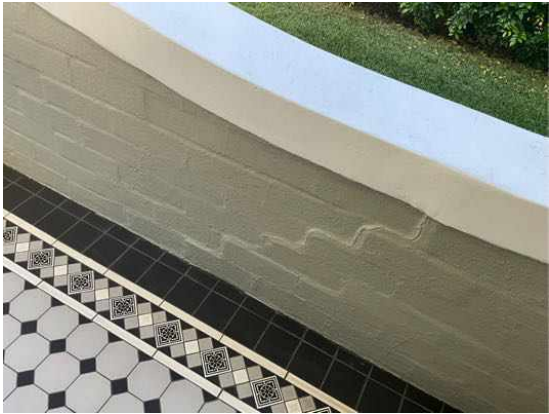
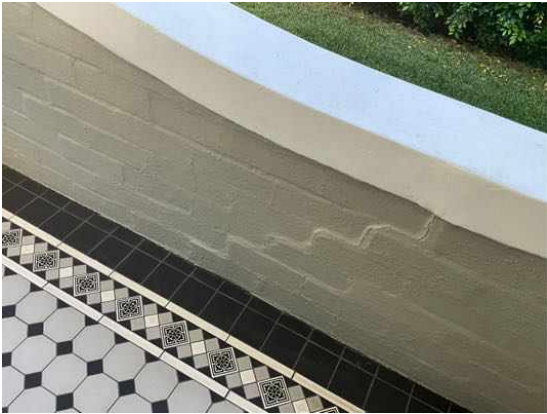
Finding 2.01

Building: Main Building
Location: All Areas
Finding: Brickwork - Cracking [Repair required]
Information: Major cracking was identified to the brickwork in this area. Cracks of this type are likely to have been caused by movement of building elements, but may also have a structural cause that is more significant. A crack of this size may be repaired by extensive filling.

A qualified bricklayer should be contacted immediately to estimate and perform repair and restoration works. Consultation with a structural engineer may be required where structural instability is found to be the underlying cause of the cracking.

Always contact a building inspector should cracks widen, lengthen, or become more numerous.

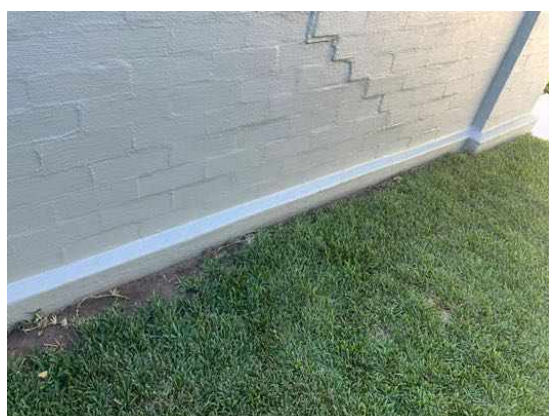
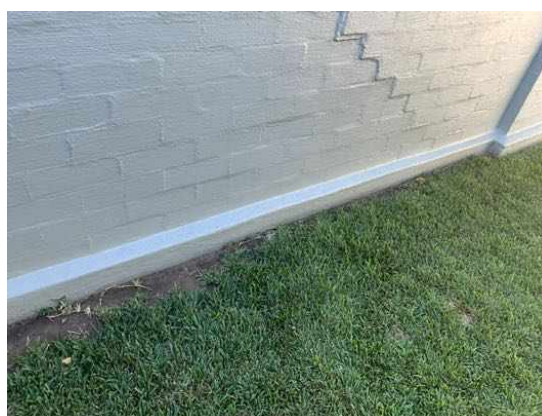
Finding 3.01

Building: Main Building
 Location: All Areas
 Finding: Perimeter - Insufficient Fall
 Information: The perimeter ground levels were found to have an inadequate slope away from the adjoining building structure, creating potential for water pooling in this area.

Perimeter is required to fall from the building by a minimum of 25mm in the first metre and bare ground should fall away from the house by 50mm in the first meter. This standard ensures that excessive moisture does not pool around the base of building structures, which creates potential for water and structural damage, as well as making the area susceptible to termite and timber pest activity.

Where ground levels do not have adequate fall, a licensed paving contractor should be appointed to install or remove and re-level pavement.

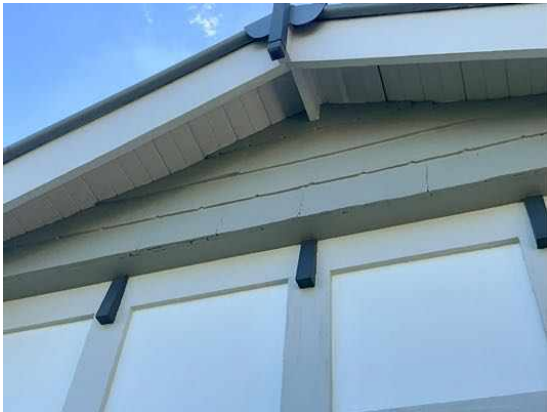
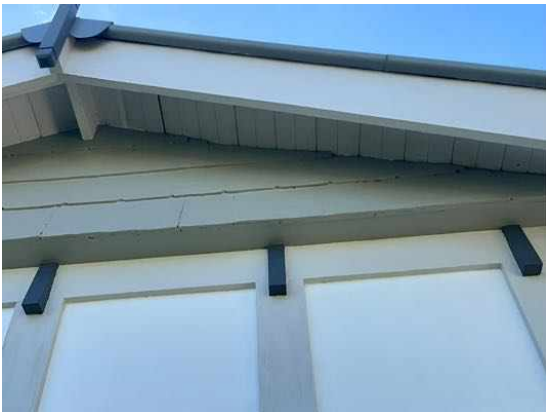
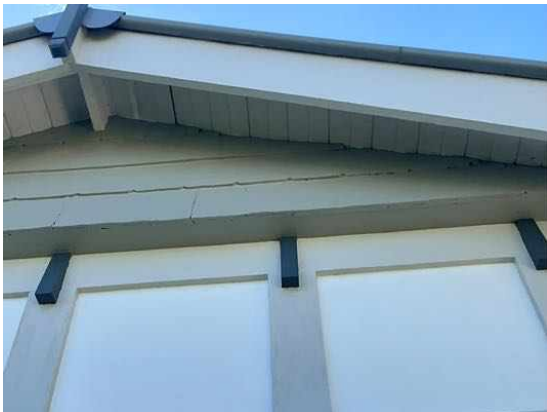
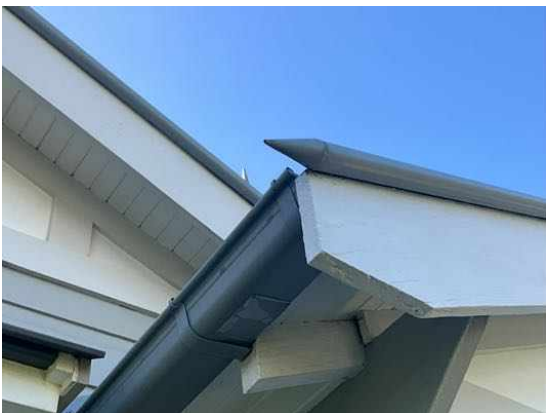
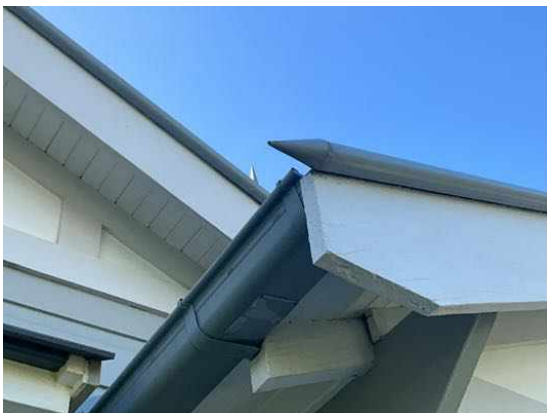
Finding 3.02

Finding: Timber - exposed to weather
Information: External timbers that are frequently exposed to harsh weather conditions require adequate protection in order to maintain their condition. Where timbers have not been painted or treated adequately, general deterioration is likely to occur at an accelerated rate.

If left unattended, replacement of these timbers is likely to be necessary in the short-term future. Adequate treatment of these timbers is required as soon as possible by a painting contractor or general handyman.

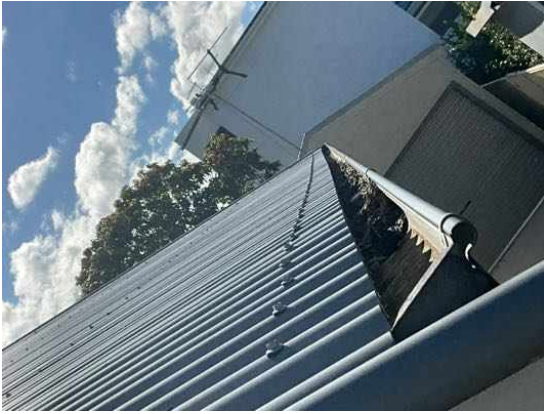
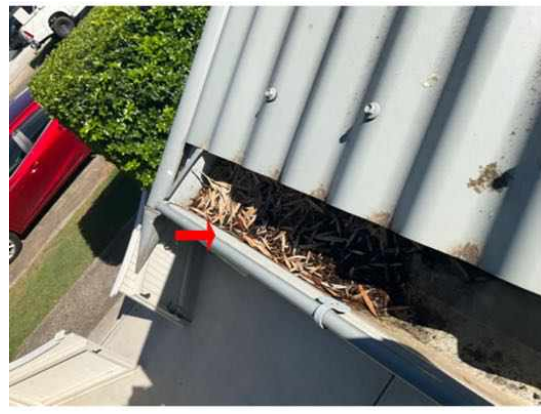
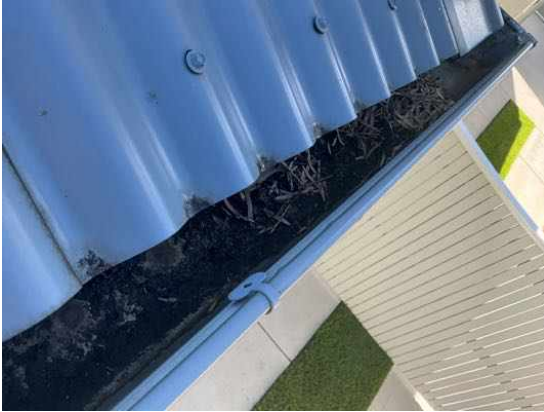
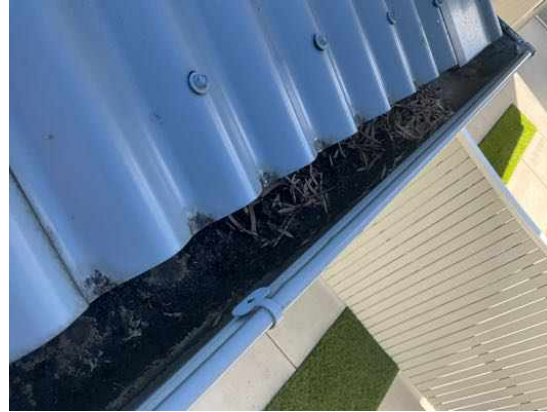
Finding 3.03

Information: The roof gutter system was observed to be blocked with organic debris and moss growth, as evident in the provided images.

- Water ingress into the eaves or walls,
- Timber rot or deterioration of fascia and soffits,
- Accelerated moss and algae growth, promoting further blockages,
- Potential foundation issues if water pools near the base of the structure.

A licensed roofing contractor or qualified gutter cleaning service should be engaged to remove the debris and inspect the system for any further issues.

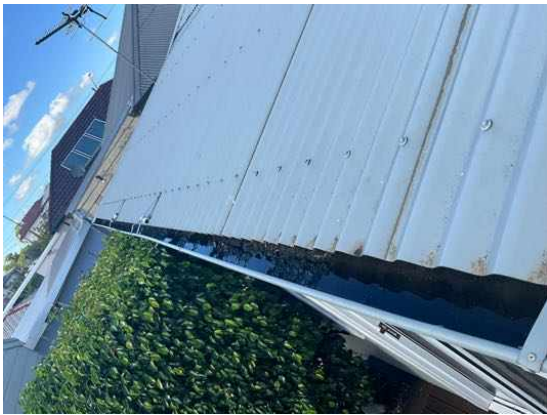
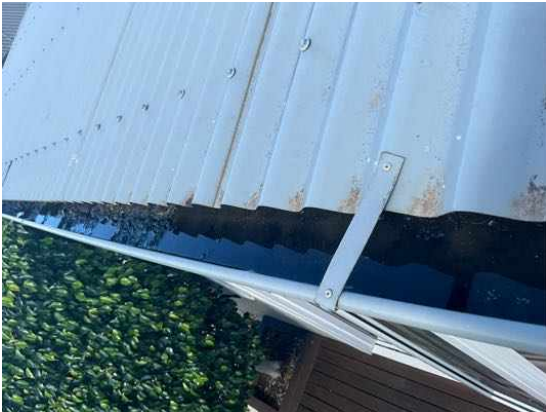
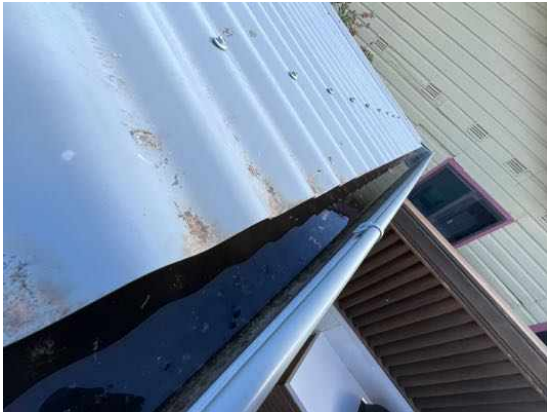
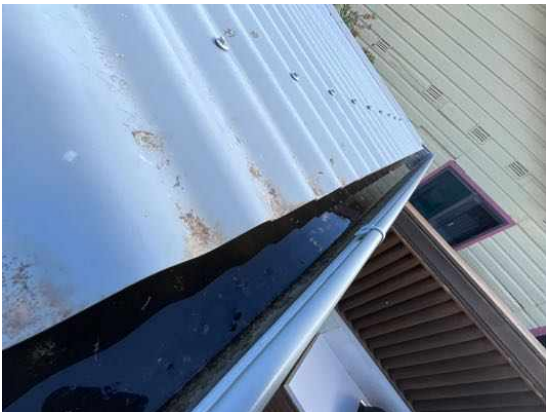
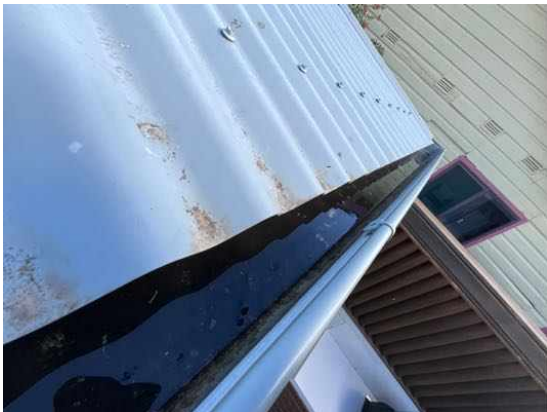
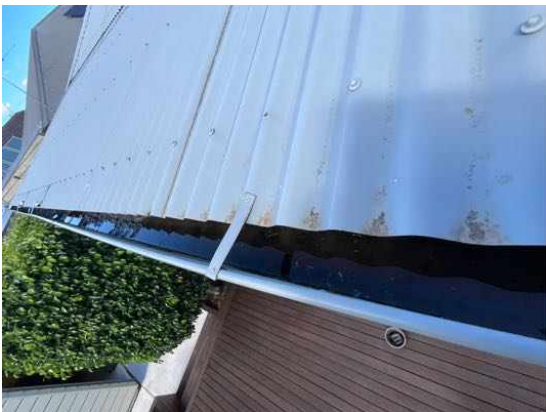
Finding 3.04

Building:	Main Building
Location:	All Areas
Finding:	Gutters - Water pooling
Information:	Water was found to be pooling in sections of the roof guttering. This is generally a secondary defect caused by blocked or partially blocked gutters. Such blockages and subsequent water pooling are likely to lead to rust and water damage to associated structures if left unattended.

Any areas of guttering that shows evidence of water pooling should be checked for partial or full blockages and any secondary damage that may have occurred as a result. Depending on the extent of the damage, building elements may require repair and/or replacement to ensure adequate roof drainage and function of exterior plumbing system.

A roofing plumber should be appointed as soon as possible to rectify this issue. It is highly advised that all gutters be maintained on a frequent basis to ensure the condition of roof plumbing.

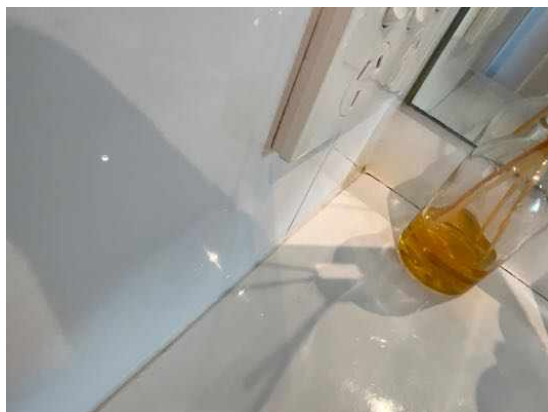
Information: The silicone seal around the basin has deteriorated, with visible gaps and discolouration noted along the edges.

Water penetration through the deteriorated seal may cause damage to surrounding surfaces, promote mould growth, and lead to deterioration of adjacent materials.

A licensed plumber or qualified handyman should remove the old sealant and reapply a sanitary-grade silicone to ensure watertight protection.

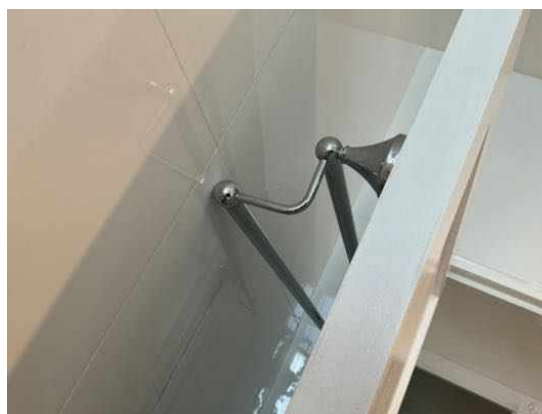
Finding 3.07

Building:	Main Building
Location:	All Areas
Finding:	Missing Door Stopper
Information:	The door lacks a stopper, which is essential to prevent the door from swinging too far and potentially damaging the wall or the door handle. The absence of a door stopper increases the likelihood of impact damage to both the door and surrounding surfaces over time.

- **Damage Risk:** Moderate risk of damage to the door handle, wall, or door itself from repeated impacts when the door is opened forcefully or by a gust of wind.
- **Wear and Tear Risk:** Increased wear on door hardware and hinges due to the potential for abrupt stops without a dedicated stopper.

This issue is a minor defect but should be addressed to prevent potential damage and

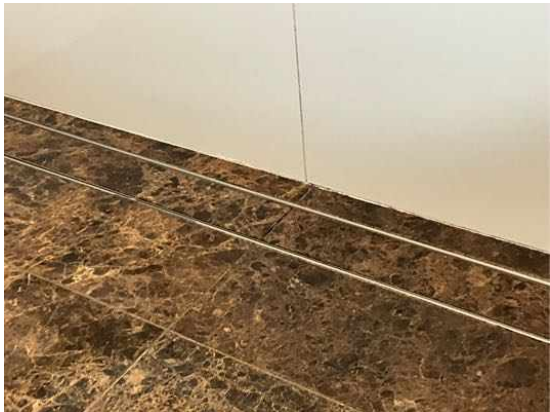
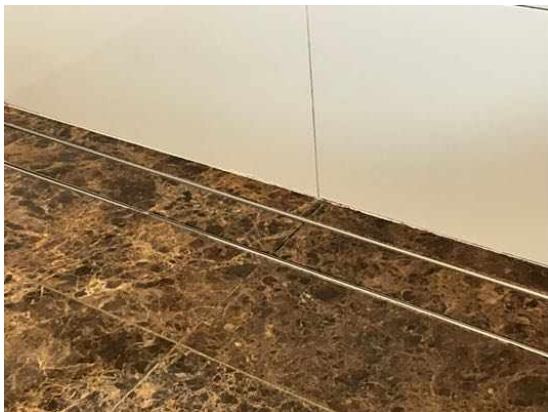
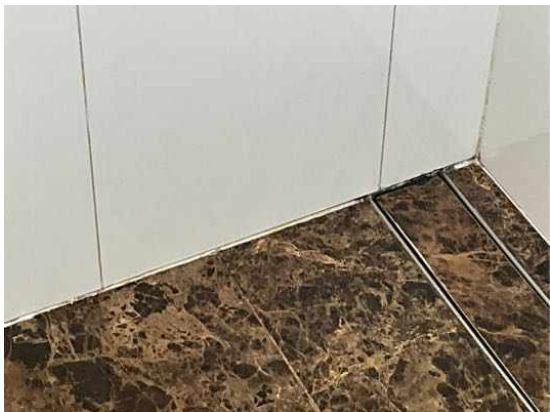
Building: Main Building
Location: Bathroom
Finding: Sealant and grouting - Missing or damaged
Information: It was noted on inspection that sealant or grout is degraded to the tiled shower alcove and or other areas of the bathroom.

Different materials and floor areas move at different rates, generally causing cracking to grout or sealant at this point. A flexible sealant is required to allow for expected expansion and contraction, while keeping the joint water tight and protective of all associated building materials.

There appears to be excessive mould to the sealant and grout which will likely require scraping out and replacement.

Flexible and mould resistant materials should be applied to affected areas to prevent any subsequent water damage that is likely to occur. Regular maintenance and replacement of damage or missing or damaged sealant and grout is highly recommended to the wet areas, as this is a regular wear and tear defect. Sealant and grouting in areas that come into regular contact with water should be maintained for the long term care of your property.

A sealant specialist or tiling contractor should be appointed to complete these works as soon as possible

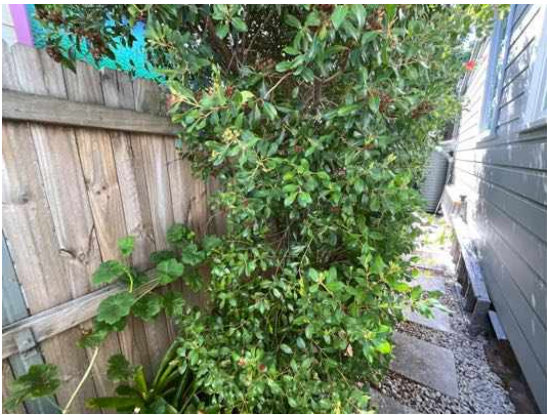
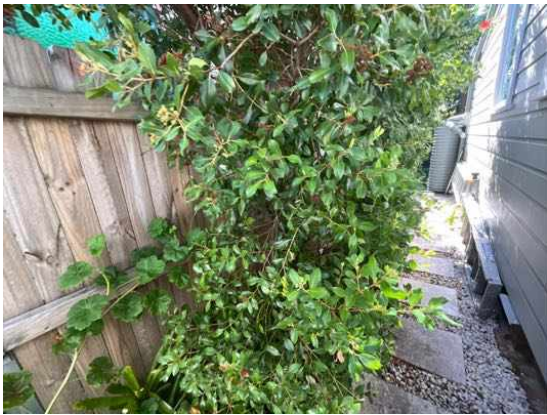
Building: Main Building
Location: Exterior walls - left side
Finding: No Evidence of Termite Management System - Durable notice / Legible Sticker
Information: The application of a pre & post-construction chemical termite barrier is highly recommended for all properties. Such barriers are highly effective in preventing termite attack on any timber building elements throughout the property.

Client must seek further information from the vendor or real estate agent if the conditions of termite management systems were maintained.

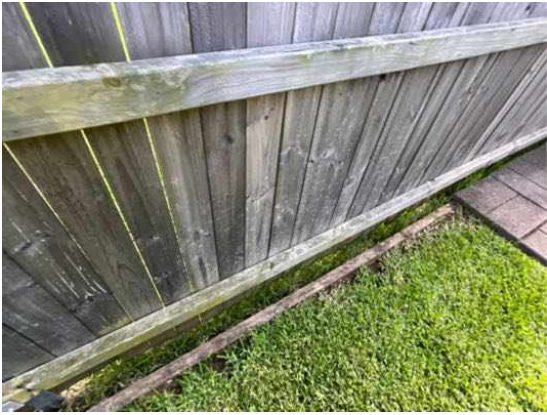
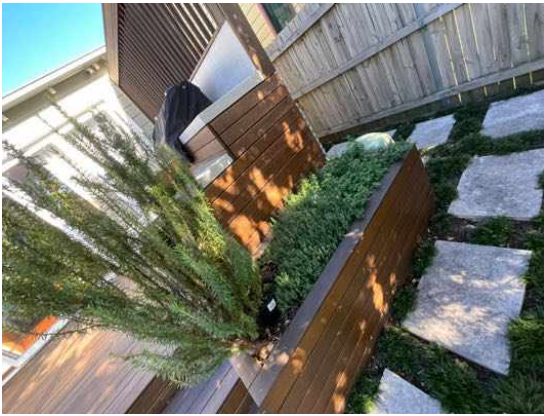
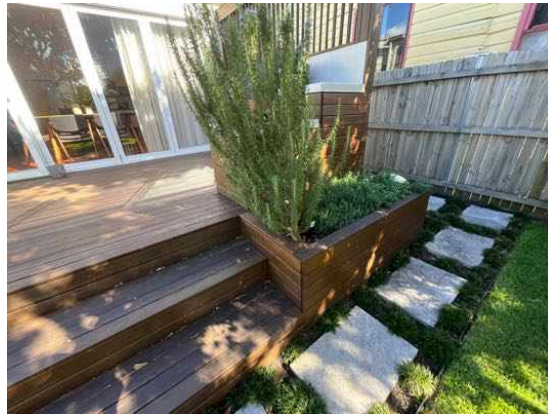
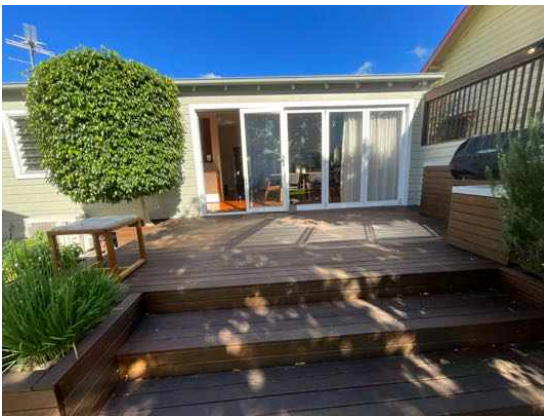
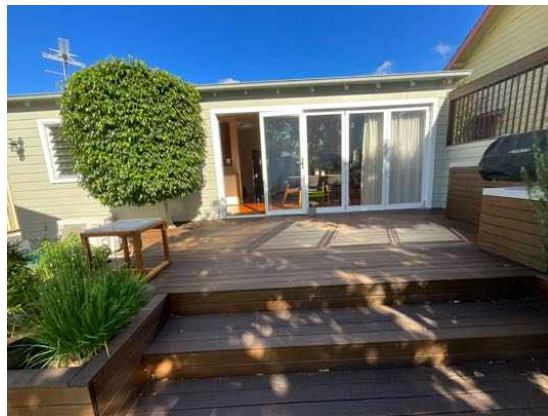
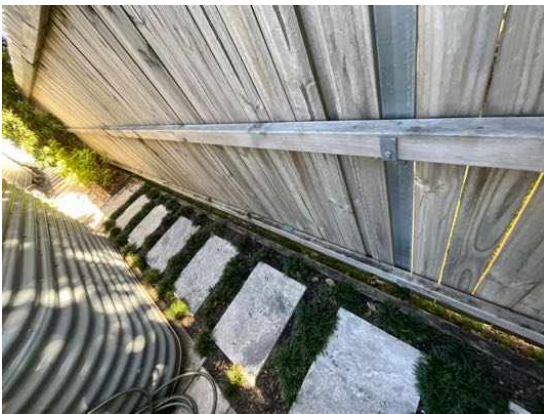
Finding 6.03

Building: Main Building
 Location: All Areas
 Finding: Timber on ground / conducive conditions to termite damage
 Information: Timber on the ground is indeed conducive to termite damage. Termites are known to thrive in moist environments, and wood in contact with soil or moisture is more susceptible to infestation.

To prevent this, it's important to keep timber elevated and away from direct ground contact. Regular inspections and proper termite control measures are also essential to protect your wooden structures from termite damage.

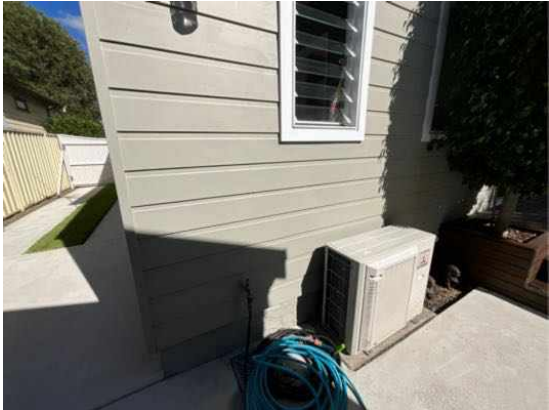
Finding 6.04

Building:	Main Building
Location:	All Areas
Finding:	Bridging or Obstruction Conducive environment for Termites
Information:	Bridging of termite barriers occurs when termites bridge (usually by building a mud tunnel) a termite barrier or inspection inspection zone or where termites have a passage, allowing them to bridge the barrier.

Where bridging has occurred full inspection is prevented and termites may enter a property in a concealed or undetected manner.

Recommended moving obstructions away from the external walls for further and future inspections.
