Building and Timber Pest Inspection Report

Inspection Date: Wed, 25 Feb 2026

Property Address: 2/2 Geraldton Dr, Varsity Lakes QLD 4227,
Australia

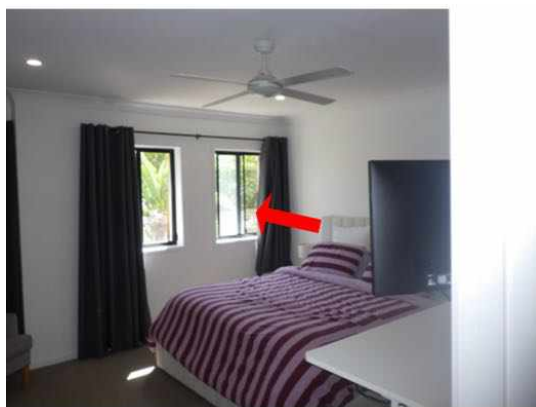
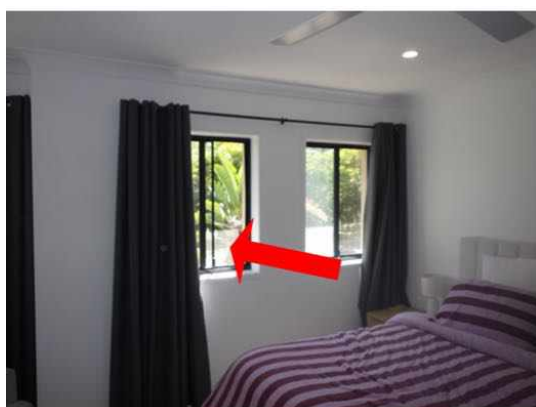
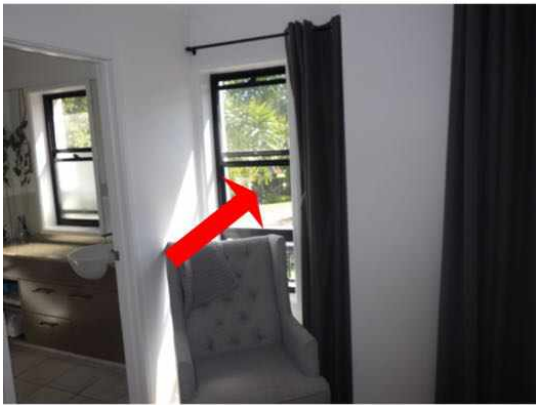
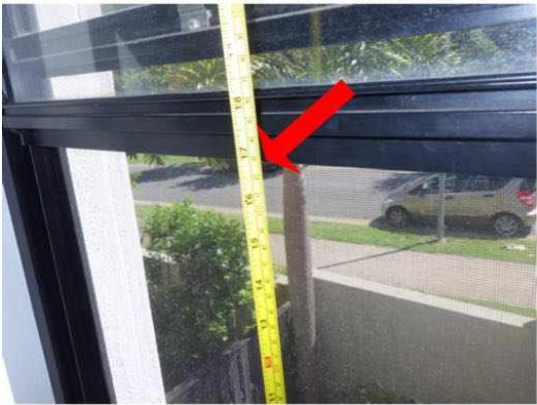
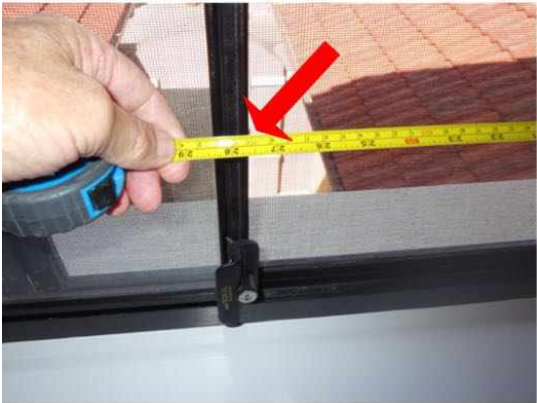
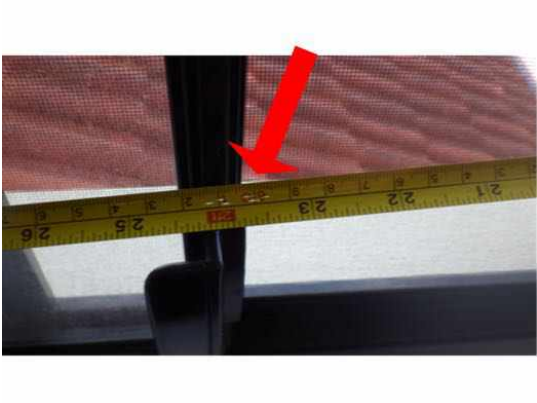
Building: Main Building
Location: Bedrooms > Existing
Finding: Window safety
Information: It was noted that the windows of the upper level bedrooms are less than 1.7m from the floor and have a fall greater than 2m on the exterior from the sill and as such are required to only open upto 125mm or have security grills fitted.

This is noted as a safety concern and this regulation may not have been in place at the time of construction.

Windows are defective if they do not comply with provision 3.9.2.5 of Volume 2 of the BCA that requires that a window opening must have protection if the floor below the window in a bedroom is 2 m or more above the ground surface beneath.

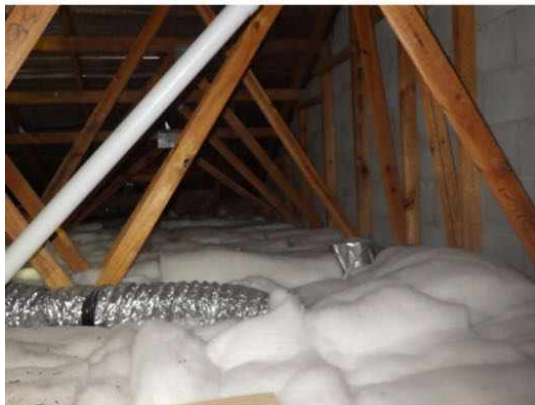
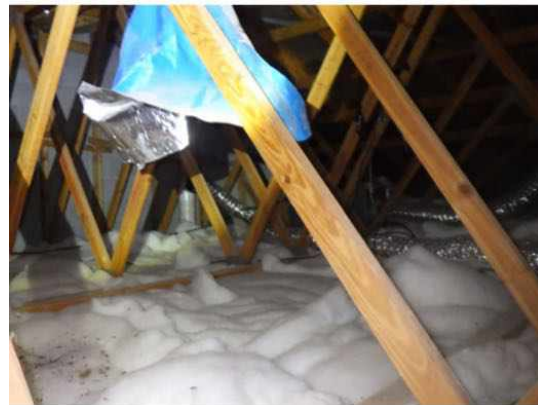
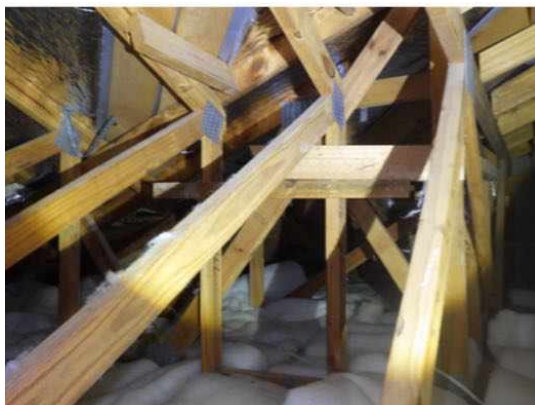
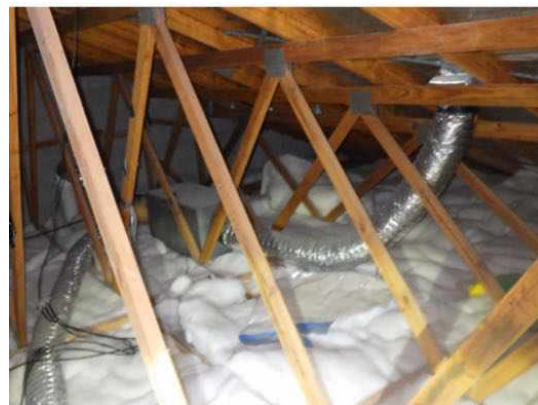
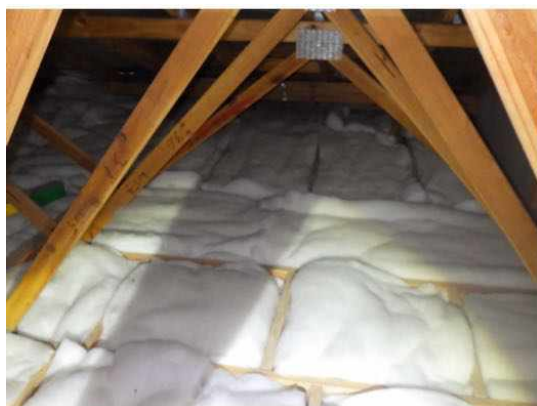
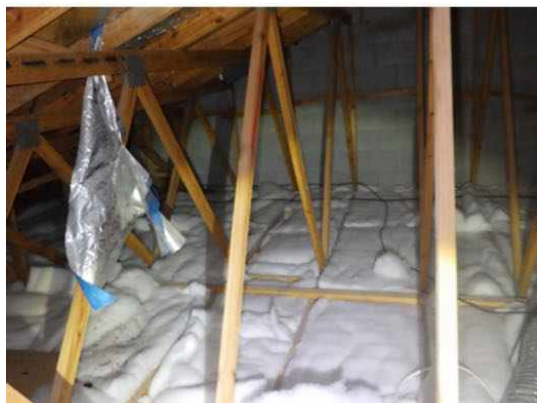
Building: Main Building
Location: Attic > Existing
Finding: Insulation - Covering downlights
Information: At the time of inspection it was suspected sections of insulation in the roof void may be covering down light fittings. While the down lights appear to be sealed LED style lights the presence of this insulation can create a potential fire hazard.

Downlights with clear markings and supporting documentation showing the appropriate IC-F or IC ratings may be covered with insulation, but is still not recommended by the manufacturers.

The client is advised to engage a licensed electrician to confirm the IC-F or IC rating of the properties installed down lights.

Alternatively a general handyman could be engaged to provide a clear space of 50 - 100mm minimum around the installed downlight fittings.

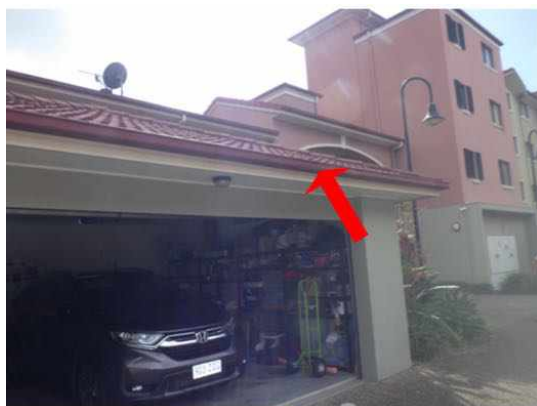
Building: Main Building
 Location: Roof Exterior > Front
 Finding: Gutters - damaged
 Information: At the time of inspection there was dent type damage to a section of the roof guttering to the front of the garage area. The dent or damage to the roof guttering appears to be the result of impact.

A roofing plumber or general handyman could be appointed to rectify this issue. It is highly advised that all gutters be maintained on a frequent basis to ensure the condition of roof plumbing.

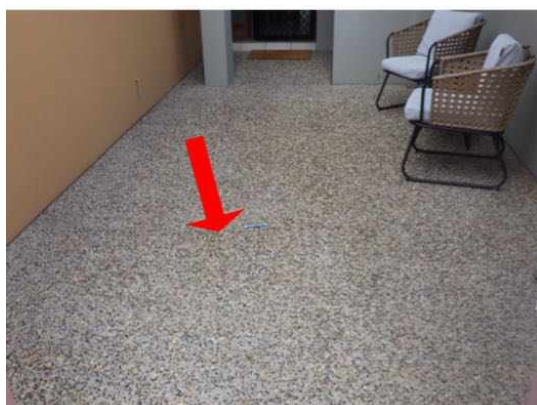
Finding 3.02

Building:	Main Building
Location:	Court Yard > Ground Level
Finding:	Cracking in concrete slab - Category 1
Information:	Cracking coded as Category 1 was identified in the footpaths concrete slab. A Category 1 crack is described as a fine but noticeable crack, with the slab at an otherwise reasonable level.

To be considered Category 1, the approximate width of the crack is less than 1.0mm, or a less than 10mm change in offset when a 3m straight edge is placed over the defect.

Category 1 cracks should be monitored for a period of 12 months. At the end of the monitoring period, identified cracks that are rated greater than Category 2 are considered defects, and require rectification.

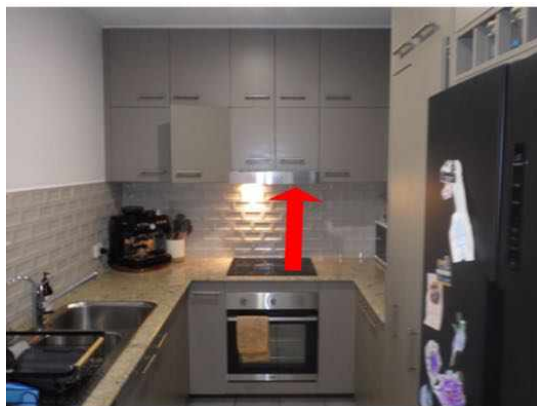
Building: Main Building
Location: Kitchen > Rear
Finding: Rangehood - Light
Information: The right side range hood light was not working at the time of inspection. It is advised

to replace the bulb first - if still not functioning, a licensed electrician could be appointed to repair or replace the range hood to restore it to a fully operational state.

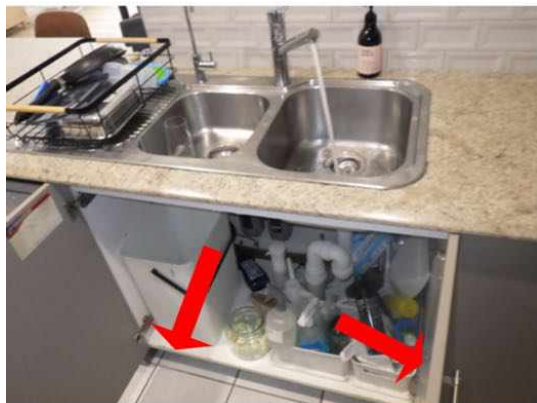
Finding 3.05

Building: Main Building
 Location: Kitchen > Centre Left
 Finding: Cabinetry - Deterioration
 Information: At the time of inspection the kitchen cabinetry showed signs of minor deterioration. The level of damage appears consistent with exposure to moisture or general wear and tear.

A qualified cabinet maker or general handyman could be engaged to undertake repair works at the clients discretion.

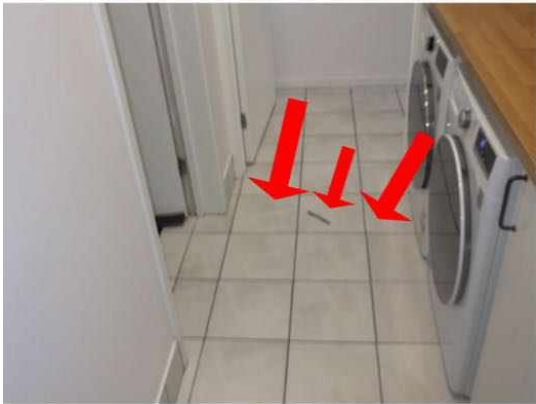
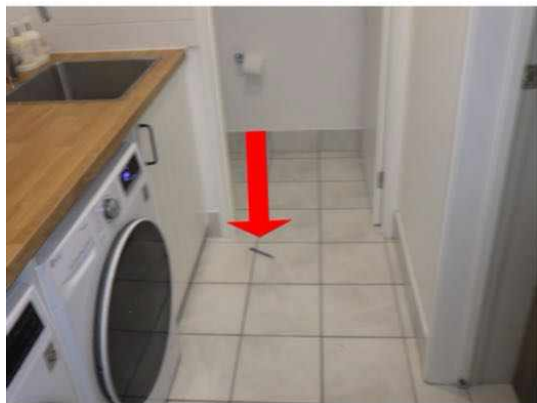
Finding 3.06

Building: Main Building
Location: Laundry > Existing
Finding: Tiles - Cracked
Information: Cracked tiles to the laundry floor area were identified at the time of inspection 9as per example photos). Such defects are generally caused by impact. Cracked or broken tiled areas may also be a direct result of poor workmanship during the construction process.

A tiling contractor could be appointed to perform repair works at the clients discretion.

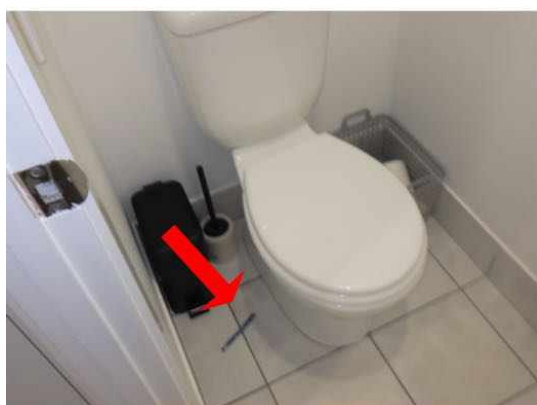
Finding 3.07

Building:	Main Building
Location:	Toilet (WC) > Front Left
Finding:	Tile - Cracked
Information:	Cracked tiles to the WC floor area were identified at the time of inspection. Such defects are generally caused by impact. Cracked or broken tiled areas may also be a direct result of poor workmanship during the construction process.

A tiling contractor could be appointed to perform repair works at the clients discretion.

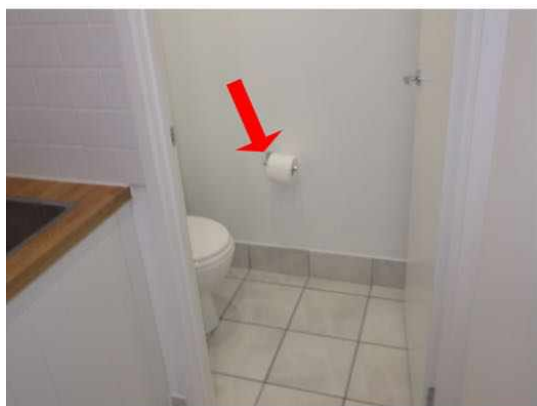
Finding 3.08

Building:	Main Building
Location:	Toilet (WC) > Centre
Finding:	Toilet roll holder - Loose
Information:	The toilet roll holder was found to be loose at the time of inspection. While not a major operational defect, function can deteriorate if the problem is left unmanaged.

It is advised that the homeowner performs remedial works to re-tighten the toilet roll holder to its original fixing. A general handyperson may be required to perform these works.

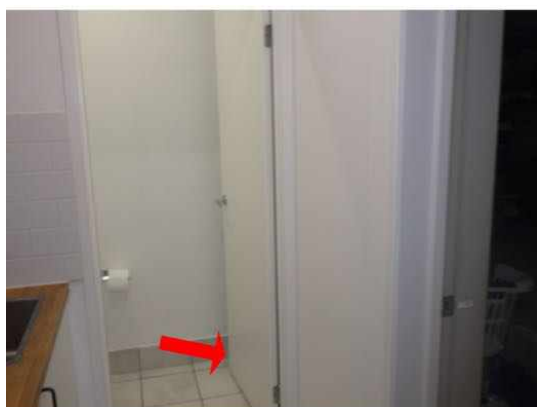
Finding 3.09

Building:	Main Building
Location:	Toilet (WC) > Front Right
Finding:	Door stop - Missing
Information:	The WC door stop is missing or is inadequate to stop the door handle from impacting the wall.

Re-installation or replacement of the door stop is advised to prevent any subsequent damage to the wall linings or associated structures.

A general handyman may be appointed to perform these works at client discretion.

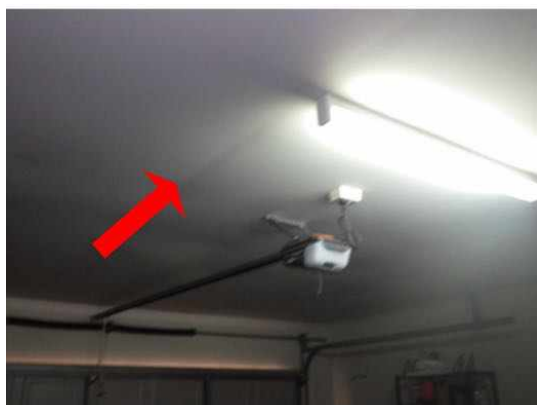
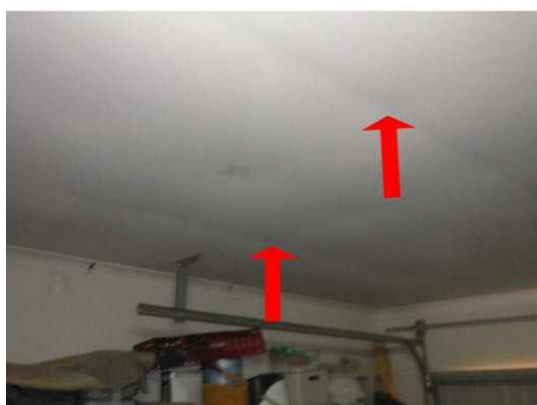
Sagging to the fixed ceiling structure generally indicates that the building materials have swollen, due to exposure to moisture, or that fixings (e.g. nails or glue) have become loose and require reattachment.

Where minor sagging is evident, comparatively minor works, such as re-gluing and re-screwing of ceiling sheets, may be required.

Such works may be performed by relevant tradespeople, such as plasterers and painters.

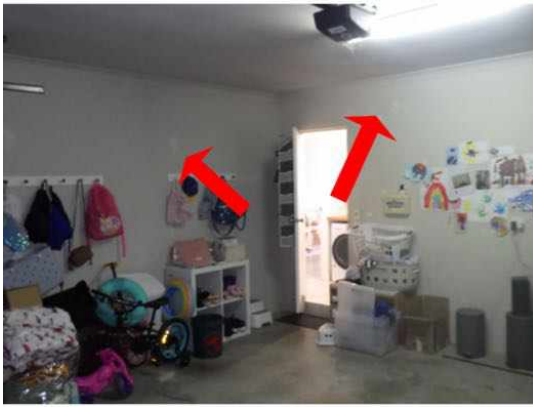
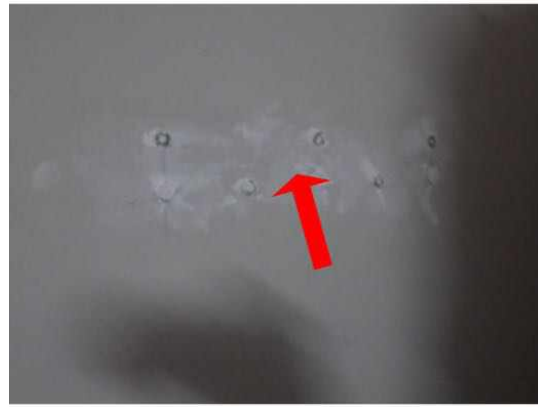
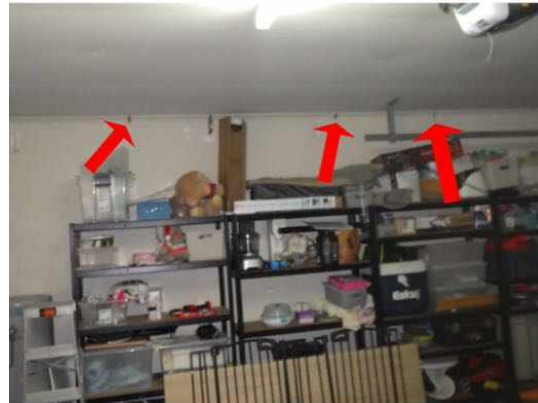
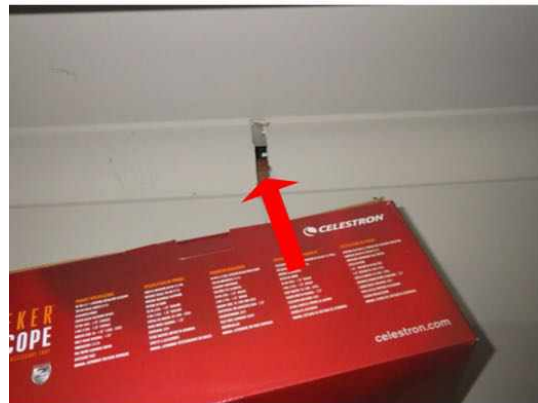
Finding 3.12

Building:	Main Building
Location:	Garage > Existing
Finding:	Internal Wall - Holes
Information:	Holes and previous repair works were identified to the garage wall linings and ceiling cornices (as per example photos). It is suspected that the holes are from a previously removed fixtures or fittings.

All excessive holes, gaps or cracks should be adequately filled by a suitable sealant or filler to prevent any possible pest or vermin activity or nesting. Such works may be conducted by a general handyperson or licensed painter.

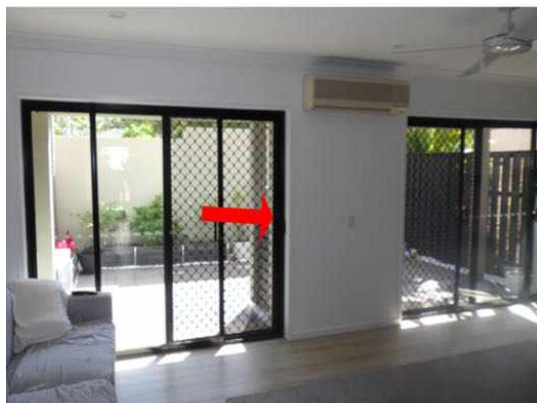
Finding 3.13

Building: Main Building
 Location: Living Room > Rear Left
 Finding: Security screen
 Information: The living room area left side security screen door latch was found to be sticking or not latching properly at the time of inspection.

Where not replaced or repaired, damaged security screens and/or latches are a potential security risk.

A security screen service agent or general handyman may be appointed to repair or adjust the security screen latch at the discretion of the client.

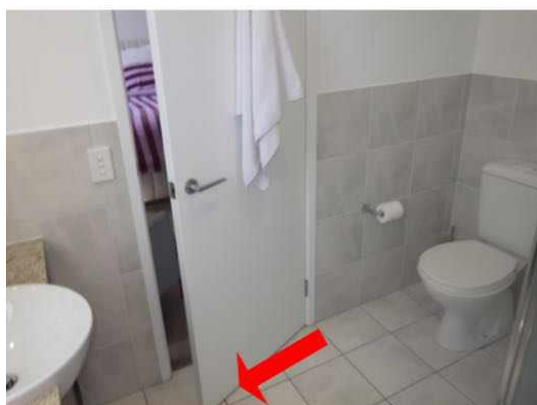
Finding 3.14

Building:	Main Building
Location:	Ensuite > Front
Finding:	Damaged Door
Information:	The door leading into the ensuite has suffered minor damage to the bottom edge.

Damage occurs generally when the building materials have aged and decayed, but in this instance the damage appears to be the result of exposure to moisture, possibly from the bottom and/or top edges of the door not being sealed with a suitable paint or sealant at the time of construction.

A qualified carpenter or general handyman could be appointed to repair/replace the door at the clients discretion.

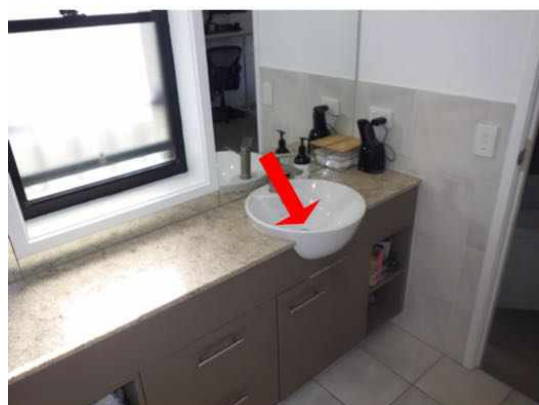
Finding 3.15

Building:	Main Building
Location:	Ensuite > Centre Right
Finding:	Basin - Pop up waste stiff.
Information:	The ensuite basin pop up waste was stiff to operate at the time of inspection. It is advised that maintenance is carried out on the waste so as it functions as intended.

A handyman could be appointed to perform any remedial works where required.

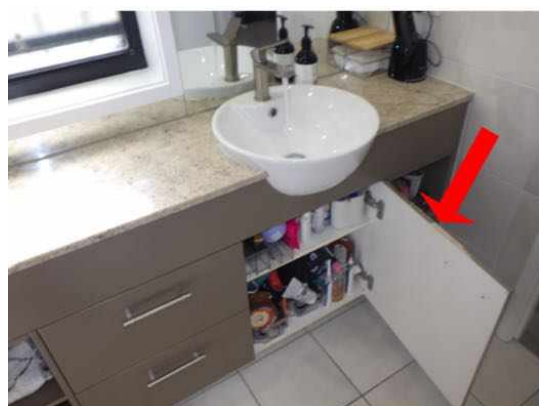
Finding 3.16

Building: Main Building
 Location: Ensuite > Centre Right
 Finding: Cabinetry - Deterioration
 Information: At the time of inspection the ensuite cabinetry showed signs of minor deterioration. The level of damage appears consistent with exposure to moisture or general wear and tear.

A qualified cabinet maker or general handyman could be engaged to undertake repair works at the clients discretion.

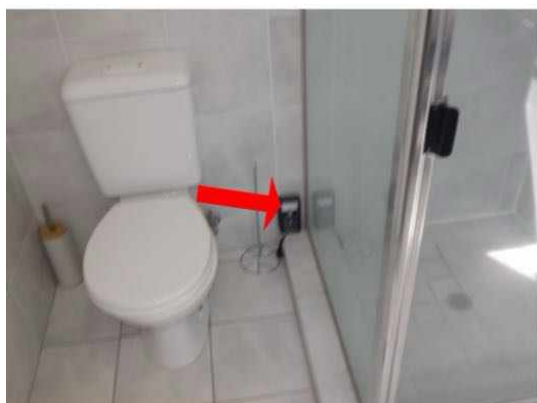
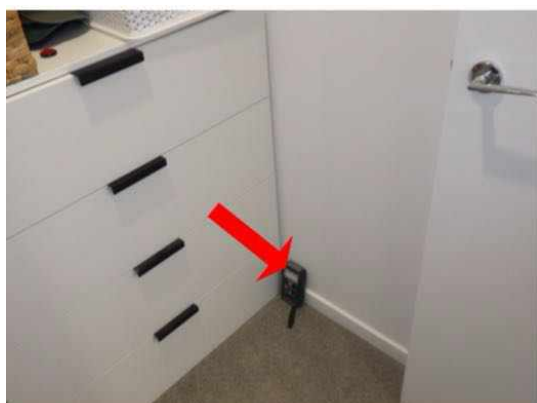
Finding 3.17

Building: Main Building
 Location: Ensuite > Rear Left
 Finding: Tiles - Sealant & Grout
 Information: Areas of missing grout and/or deteriorated sealant were evident to the floor and wall tiling in the ensuite shower cubicle at the time of inspection. As this area is frequently exposed to water, the missing grout and/or deteriorated sealant creates potential for possible water penetration into adjoining sections of walls or flooring.

If left unmanaged, any potential water penetration to these areas may lead to subsequent water damage, which is likely necessitate repair work to affected building elements. At the time of inspection elevated moisture level readings were observed to the lower area of the left side shower cubicle wall, but the elevated readings didn't transfer outside the shower cubicle or to the opposite sides of the wall in areas where moisture level readings could be obtained.

As noted in the report there is deteriorated sealant and grout to the ensuite area shower cubicle floor and wall tiles. It is highly recommended a licensed tiler or shower area specialist is engaged to further investigate and/or undertake repairs as required.

A tiling contractor or shower sealant specialist should be appointed to undertake repair work to ensure that no further water damage occurs. The re-application of silicone and grouting throughout remaining tile work is also advised, to further protect the area against water penetration.

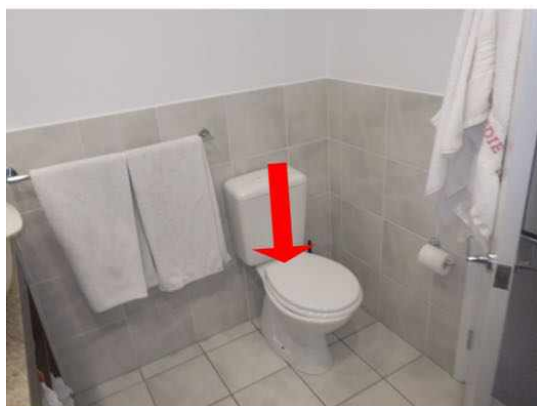
Finding 3.18

Building: Main Building
 Location: Bathroom > Front Right
 Finding: Toilet seat - Loose
 Information: The bathroom area toilet seat was found to be loose at the time of inspection. It is suspected that this defect has developed due to general wear and tear.

If left unmanaged, the toilet seat could deteriorate further, leading to destabilisation and the potential for water leaks to the toilet pan area.

It is recommended that the seat be repaired by a licensed plumbing or general handyman.

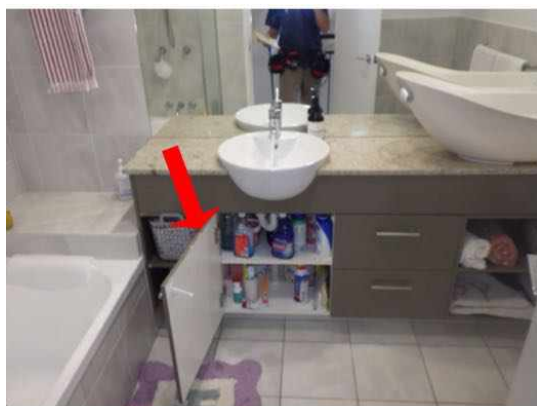
Finding 3.19

Building: Main Building
 Location: Bathroom > Centre
 Finding: Cabinetry - Deterioration
 Information: At the time of inspection the bathroom cabinetry showed signs of minor deterioration. The level of damage appears consistent with exposure to moisture or general wear and tear.

A qualified cabinet maker or general handyman could be engaged to undertake repair works at the clients discretion.

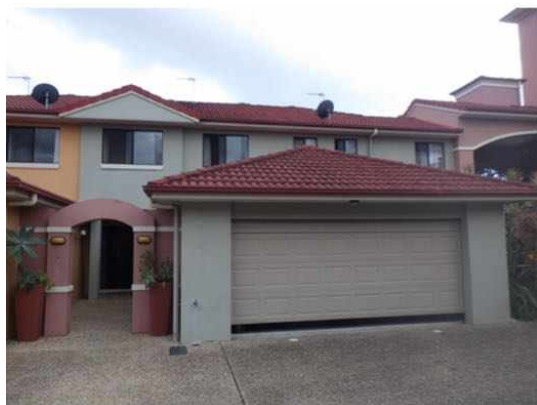
The application of a post-construction chemical termite barrier is highly recommended for all properties, particularly if live termite activity has been found on the site previously. Such barriers are highly effective in preventing termite attack on any timber building elements throughout the property.

The client should consider gaining further advice from a licensed timber termite pest technician as to the costs and procedures involved with this application. It is highly recommended that obtaining such advice be a short-term priority.

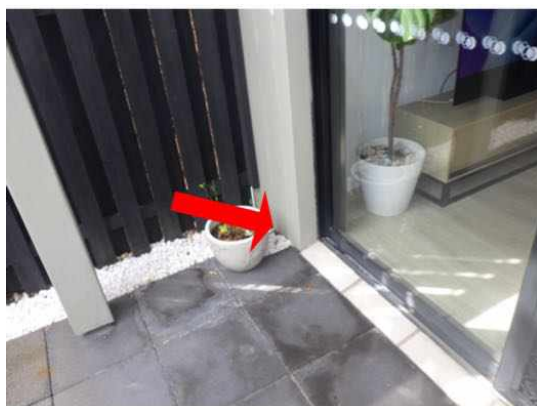
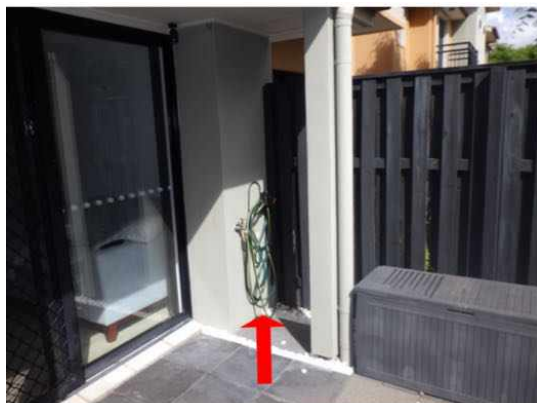
Finding 6.03

Building:	Main Building
Location:	Exterior walls - rear > Ground Level
Finding:	Weep holes exposure
Information:	It was noted at the time of inspection areas of the finished ground level at the rear of the property partly cover the brickwork weep holes.

It is highly advised the area be regularly monitored for timber termite pest activity.

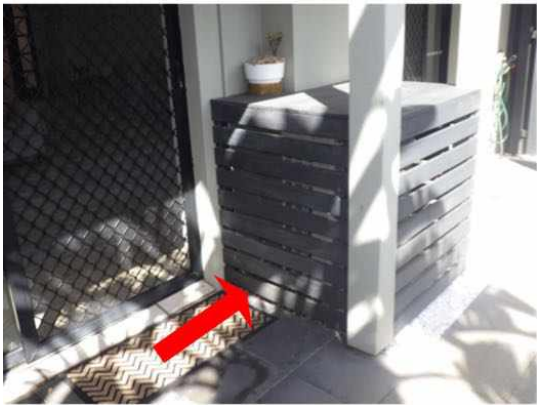
Finding 6.04

Building:	Main Building
Location:	Exterior walls - rear > Ground Level
Finding:	Overflow - Not plumbed for drainage
Information:	At the time of inspection it appeared the air conditioning unit overflow is not plumbed or connected to suitable drainage, which can result in the surrounding area becoming excessively damp. These damp conditions can lead to secondary defects such as rot, rust or corrosion of associated building elements, the formation of fungal decay, or even the creation of potential slip hazards. When coupled with poor site drainage, pooling of water may also attract termite activity to this area. It is highly recommended that a qualified plumber be appointed to install adequate drainage to the overflow. These works will ensure that the area remains dry and free of any secondary defects.

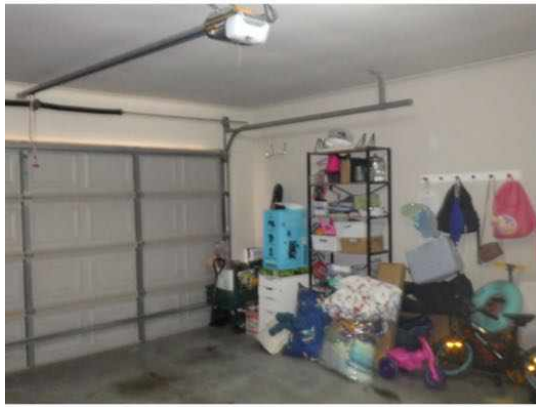
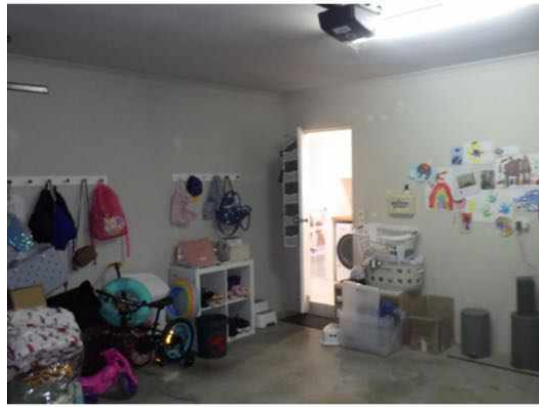
Finding 6.05

Building: Main Building
Location: Garage > Existing
Finding: Stored Items
Information: At the time of inspection there was furniture, personal and stored items against internal walls in areas of the garage area inspected.

It is highly recommended the items are removed to allow for complete inspection of the area.
