Building and Timber Pest Inspection Report

Inspection Date: Wed, 8 Apr 2026

Property Address: 10/10 Stanbury Pl, Quakers Hill NSW 2763,
Australia

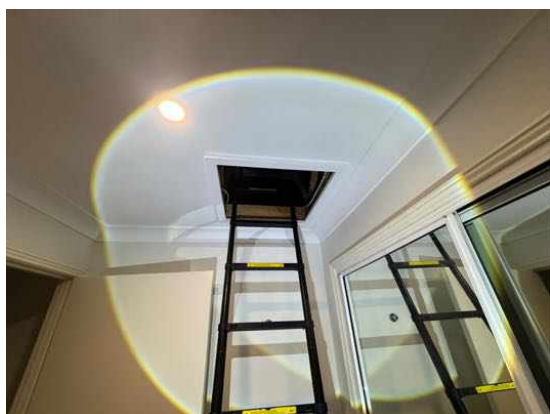
Building:	Main Building
Location:	Roof Void
Finding:	Sarking - Damaged
Information:	Sarking, a laminated aluminium foil applied to the interior of the roof covering, assists in insulating the property and acting as a vapour-barrier to the roof void and, subsequently, to the household.

Where sarking is damaged, both insulation and moisture protection of the property are inhibited. This creates a loss of energy and thus negatively impacts the energy efficiency of the property, allowing potential for moisture ingress from condensation or leaking roof tiles.

It is important to repair any holes or damaged sections of sarking to ensure that the building material is fully functional. A registered roofer should be consulted to provide further advice on this defect and to perform rectification works at client discretion.

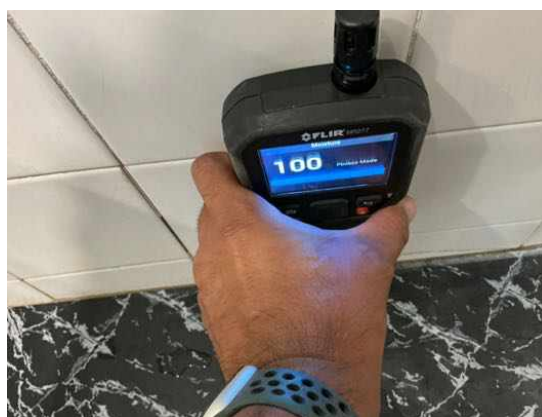
Building:	Main Building
Location:	Bathroom
Finding:	Shower Damp - Adjacent Bathroom (Monitoring)
Information:	At the time of inspection, elevated moisture levels were detected on the wall adjacent to the shower area. While no visible water damage or deterioration was noted, the presence of moisture suggests possible seepage or condensation associated with regular shower use.

At this stage, no immediate action is required. However, the area should be monitored over the next 12 months for any signs of deterioration such as staining, bubbling paint, or mould growth. It should be noted that moisture ingress of this nature does not generally resolve without intervention, and at some point remedial works are likely to be required. Should conditions worsen, the client is advised to engage services of a licensed plumber or waterproofing specialist to rectify the issue of moisture before this minor defect turns into major defect.

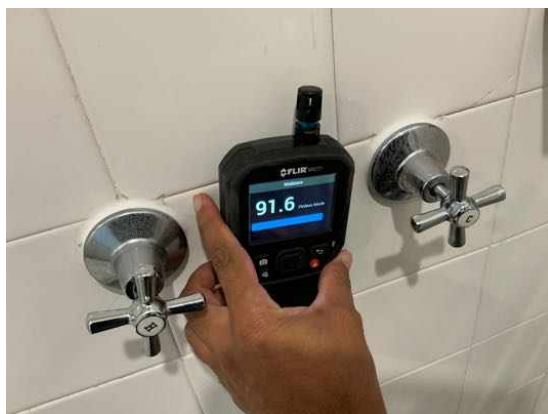
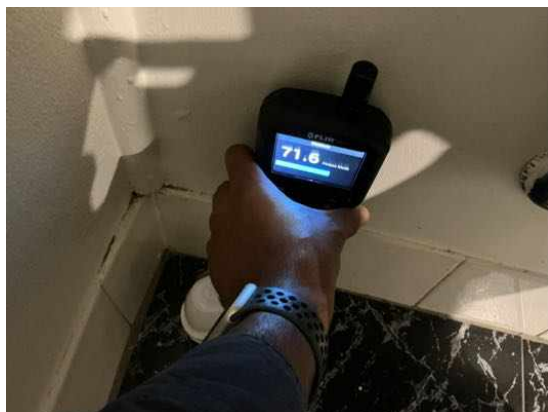
Finding 3.11

Building:	Main Building
Location:	Both Bathrooms
Finding:	Sealant/Grouting - Missing or Damaged
Information:	At the time of inspection, areas of missing and/or deteriorated sealant and grout were noted in this area. This condition can allow water to penetrate behind finishes, which may lead to moisture ingress, deterioration of waterproofing membranes, mould growth, and potential leaks into adjoining areas over time. If left unaddressed, this may result in costly repairs and hidden water damage.

It is recommended that a licensed plumber (or suitably qualified tradesperson experienced in wet area sealing) be engaged to assess the affected areas and

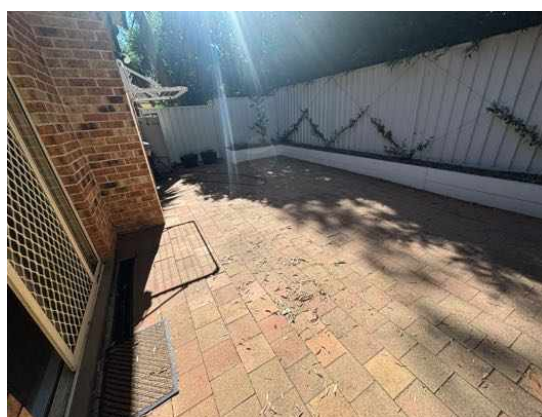
It is essential that these obstructions be cleared to allow for a comprehensive inspection of the external areas. Removing these barriers will enable a more accurate assessment of the property's condition and allow any hidden defects to be identified and addressed promptly. Failure to do so could result in undetected issues worsening over time, potentially leading to more costly repairs in the future.

Therefore, it is strongly recommended that the obstructions be removed and a re-inspection be scheduled once the affected areas are made fully accessible. This will ensure a complete evaluation of the property's exterior and provide the client with a clear understanding of any potential issues that may have been concealed during the initial inspection.

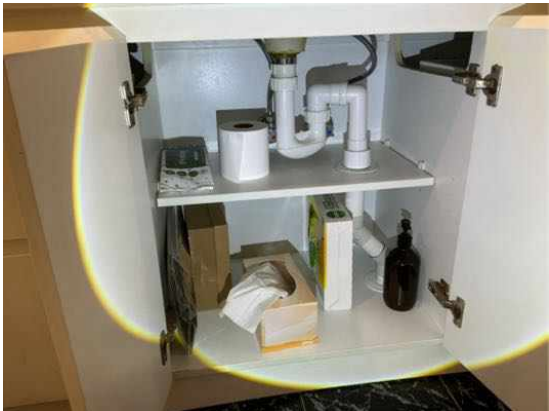
It is important to note that while a visual inspection of cupboards and cabinetry beneath sinks and vanities was undertaken, stored personal items and fixtures presented obstructions that limited full visibility of the internal areas. As per standard inspection practices, inspectors are not permitted to move or disturb personal belongings during the inspection process. Therefore, only visible and accessible sections were inspected, and concealed water damage or plumbing defects may not have been detected.

Given this, a re-inspection is recommended after all obstructions have been cleared to allow for a comprehensive assessment of these areas. Regular maintenance and monitoring of plumbing and drainage systems is also advised to ensure ongoing functionality and early detection of potential issues.
