# Building and Timber Pest Inspection Report

Inspection Date: Thu, 29 Jan 2026

Property Address: 85 Starkey St, Wellington Point QLD 4160,  
Australia

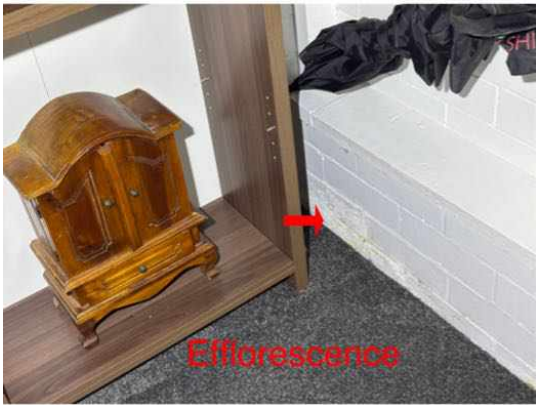
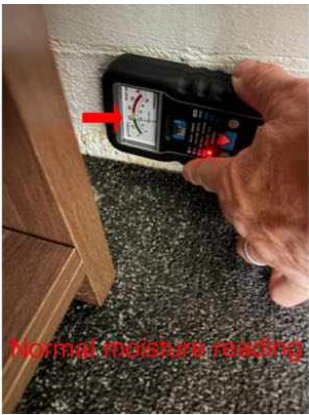
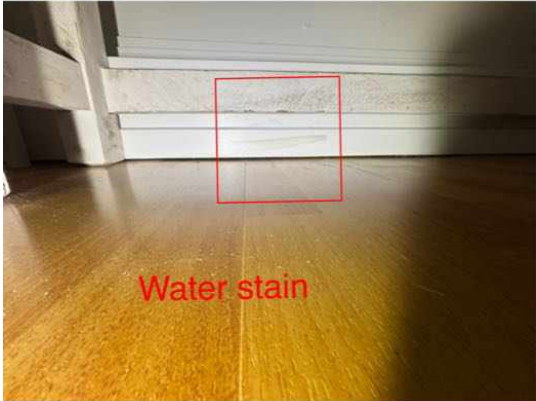
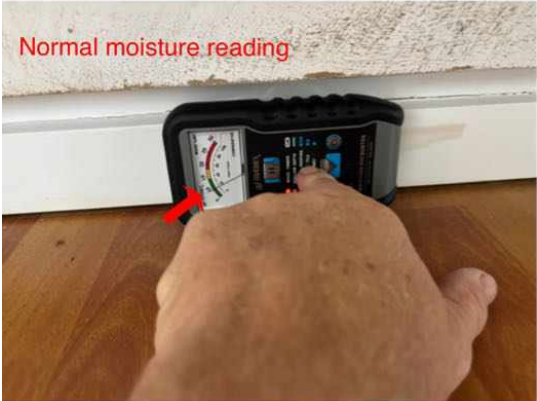
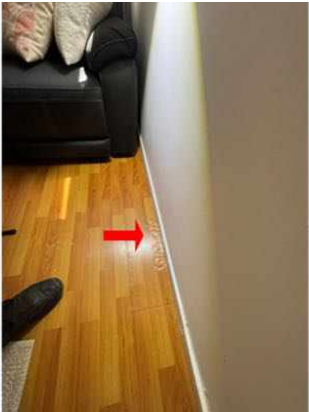
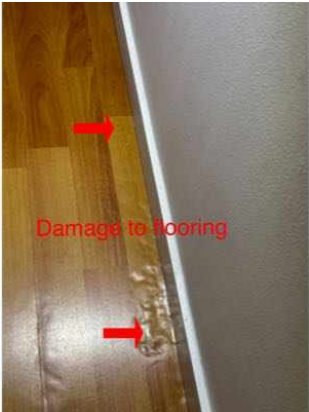
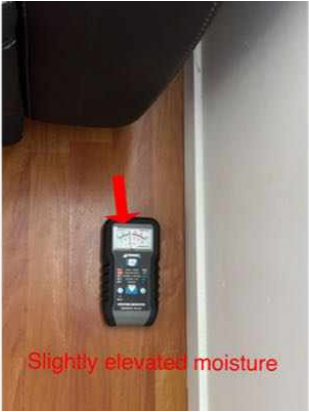
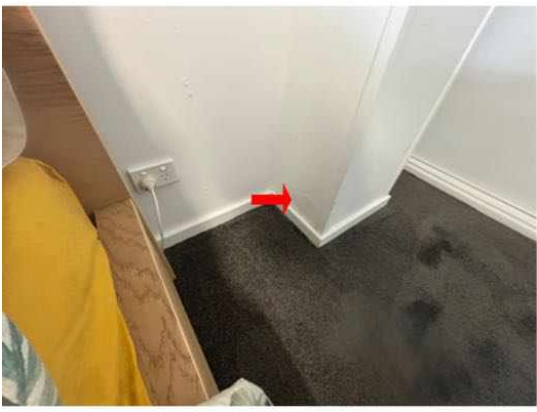
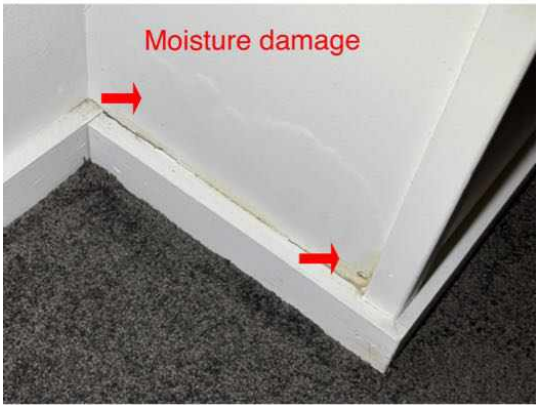
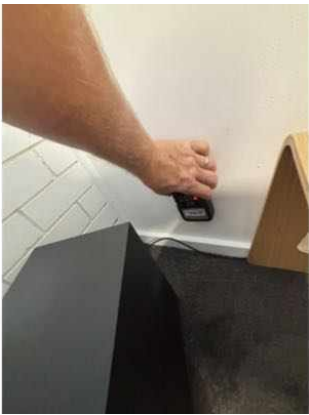
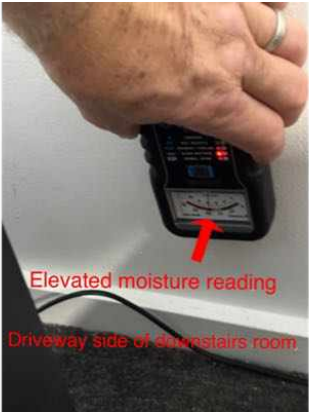
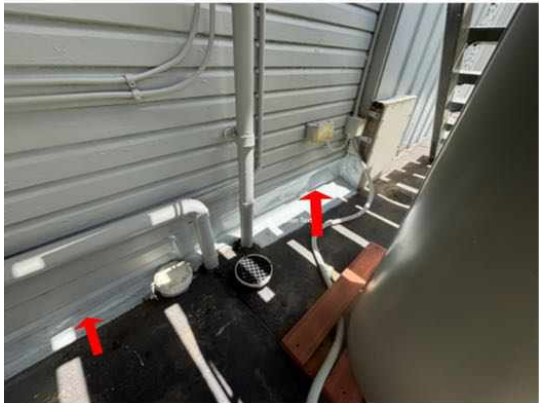
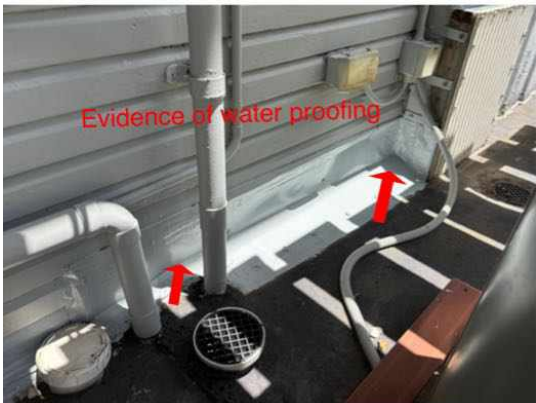
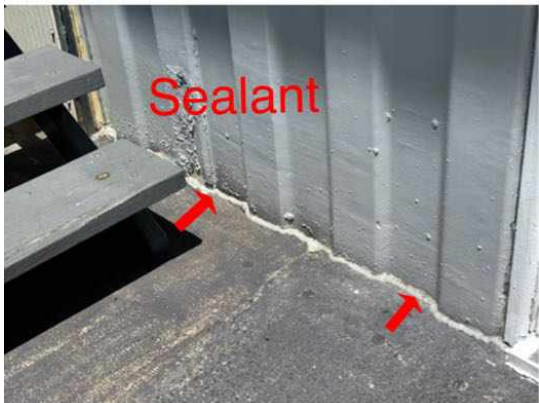
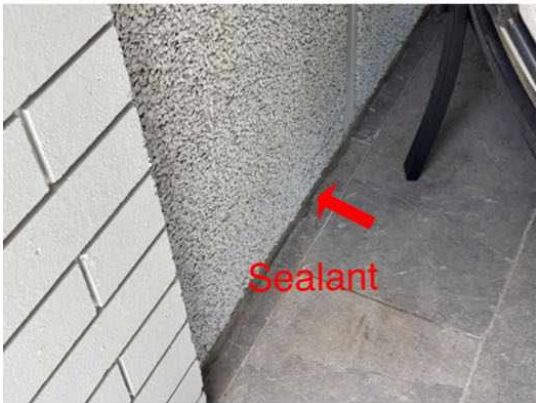
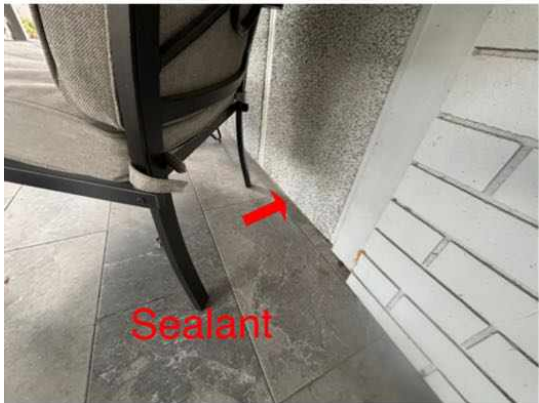
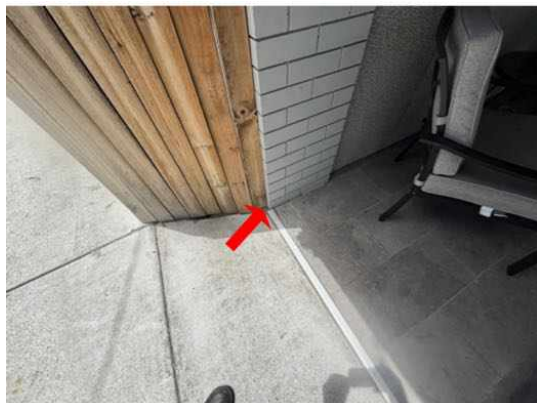
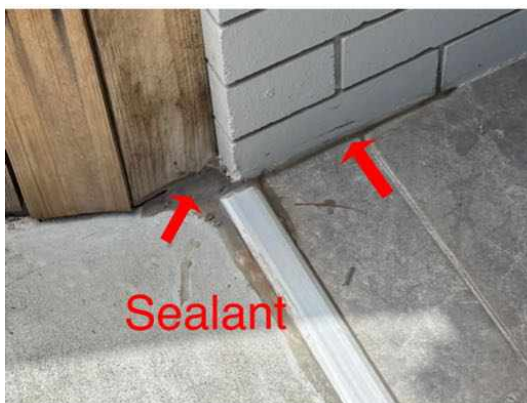
#### Finding 2.01

Building: Main Building  
Location: Lower level  
Finding: Lower level - evidence of moisture damage  
Information: At the time of the inspection, it was noted that there was evidence of moisture damage in the lower level of the dwelling. It was also noted that the internal concrete level appears to be below the exterior ground level.

Efflorescence was found on the block work in the study. Normal moisture readings were recorded in this area. Damage and staining was found to the wall lining in the room on the left hand side of the dwelling. Normal moisture readings were recorded in the area however elevated moisture levels were recorded in the front left hand corner of this room. Sealant was noted to the exterior wall near where the elevated moisture readings were recorded.

In the lounge, water staining was found to the skirting board on the right hand side of the dwelling. Normal moisture readings were recorded here. Damage can be seen to the flooring between the laundry and the kitchenette. Normal moisture readings were recorded on the damaged section of the flooring. The external wall in this area has had a large flashing applied in order to waterproof or stop moisture ingress into the building.

The vendor confirmed the application of sealant to parts of the perimeter of the dwelling to stop moisture entering the lower level. The client must monitor the lower level for any re-occurrence of moisture entering the dwelling.

Evidence of moisture damage and or ingress into the lower level was noted. Elevated moisture readings were recorded in the front left hand room. Sealant and flashings have been applied to areas of the perimeter in an attempt to stop moisture entering the lower level. Due to the internal concrete level being lower than the exterior ground level, moisture ingress into the lower level may be an ongoing issue. This has been marked as a major defect for this reason.

A licensed plumber could be engaged to install a channel drain around the perimeter of the dwelling in order to stop moisture from entering the dwelling. This should be done as a short term priority.

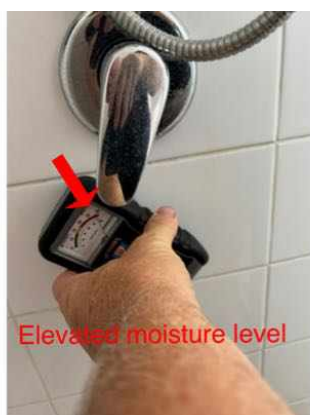
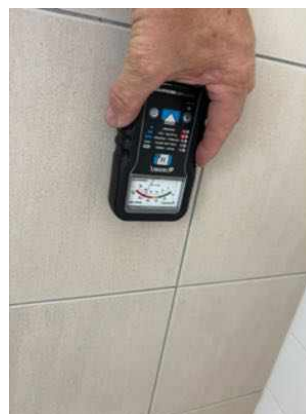
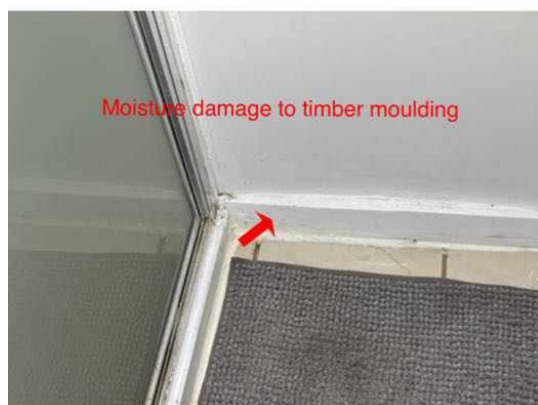
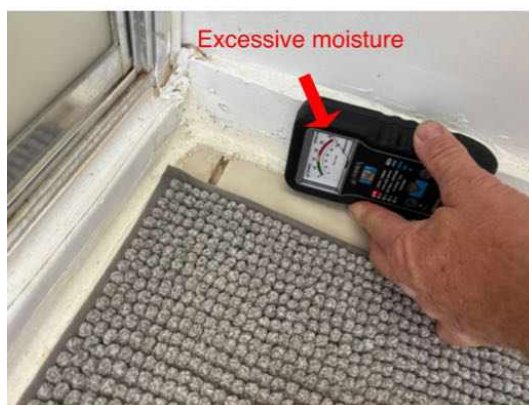
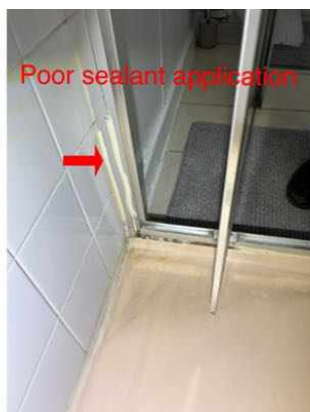
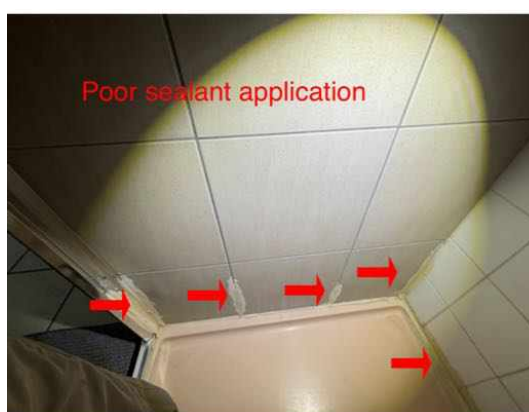
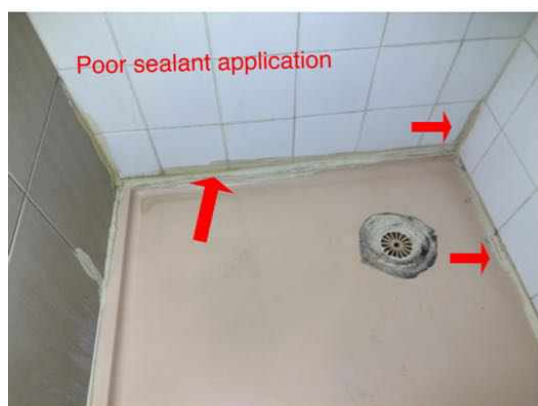
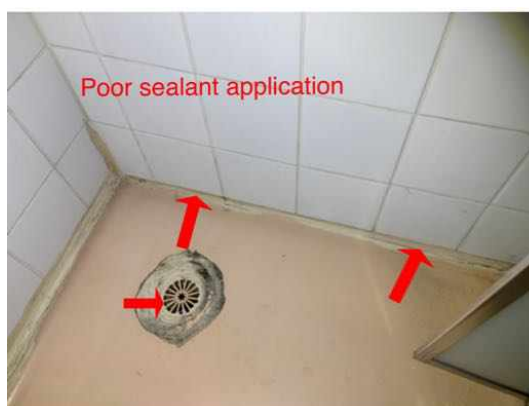
### Finding 3.01

Building:	Main Building
Location:	Lower level bathroom
Finding:	Lower level bathroom - moisture damage
Information:	At the time of the inspection, it was noted that there was elevated moisture readings recorded in the lower level bathroom shower cubicle. This may be due to the deterioration of the grout and the poorly applied sealant. The readings indicate that moisture has penetrated behind the tiles.

A timber moulding next to the shower has signs of moisture damage and excessive moisture readings were recorded on the timber moulding. It appears that the shower screen is leaking. The grout and sealant in the shower cubicle need to be replaced.

If left unaddressed, this will become a major defect.

A bathroom specialist should be engaged to assess the shower cubicle to ensure that the grout and sealant can be replaced to provide longevity to the bathroom. This should be done as a matter of urgency.

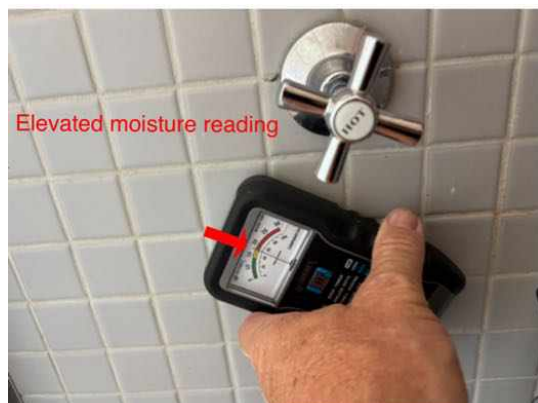
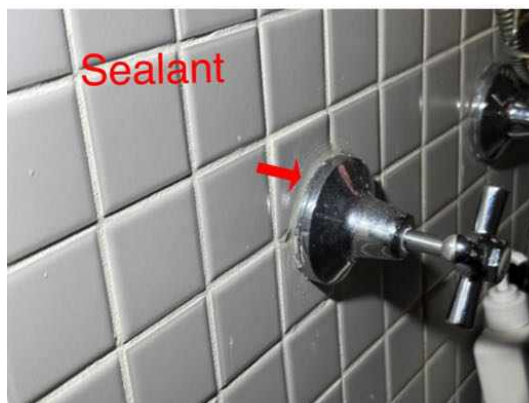
### Finding 3.02

Building:	Main Building
Location:	Upper level bathroom
Finding:	Upper level bathroom - elevated moisture readings recorded
Information:	At the time of the inspection, it was noted that there were elevated moisture readings recorded around the hot water tap in the shower. Sealant has been applied to the base cover of the hot tap and may be the cause of the elevated moisture readings. Normal moisture readings were recorded on the bath side of this wall.

A bathroom specialist should be engaged to assess the shower cubicle and provide a solution for the elevated moisture readings. This should be done as a short term priority.

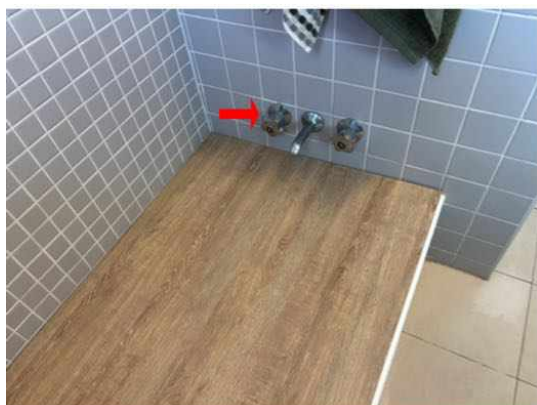
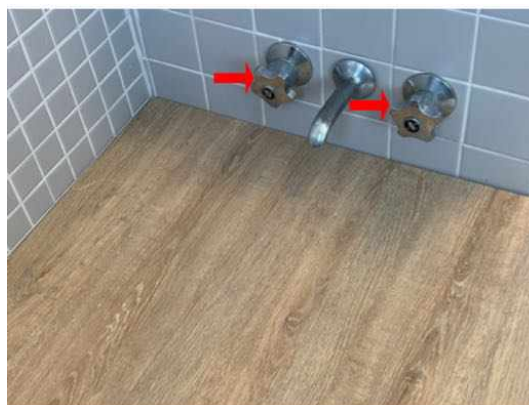
### Finding 3.03

Building:	Main Building
Location:	Upper level bathroom
Finding:	Upper level bathroom - bath taps leaking
Information:	At the time of the inspection, it was noted that the bath tub taps were leaking when turned off. The taps only stop leaking when excess pressure is used to turn them off. This may be due to the seals wearing.

A licensed plumber should be engaged to replace the seals in the taps. This should be done as a short term priority.

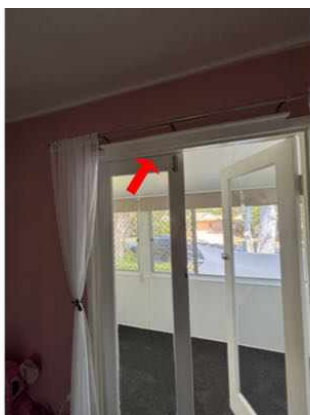
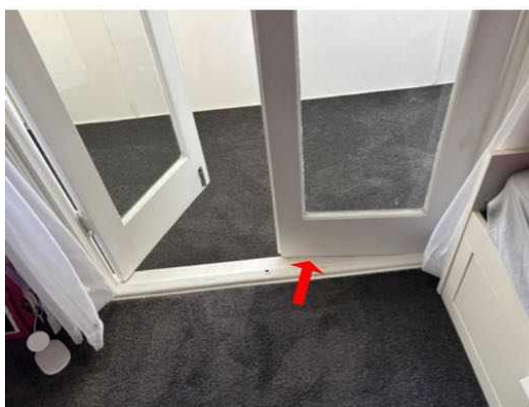
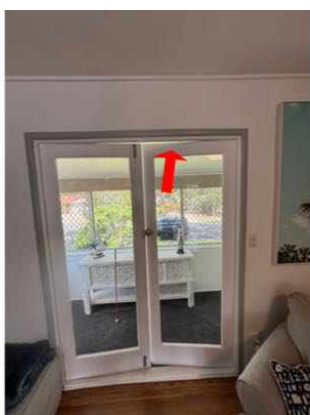
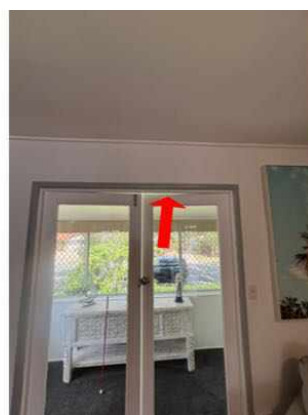
### Finding 3.04

Building:	Main Building
Location:	Upper level
Finding:	Upper level - French doors binding during normal operation
Information:	At the time of the inspection, it was noted that the French doors at the front of the dwelling were binding on the door frame during normal operation. This appears to be general wear and tear.

For minor causes, a qualified carpenter or building maintenance professional should

be appointed to perform minor rectification works at client discretion.

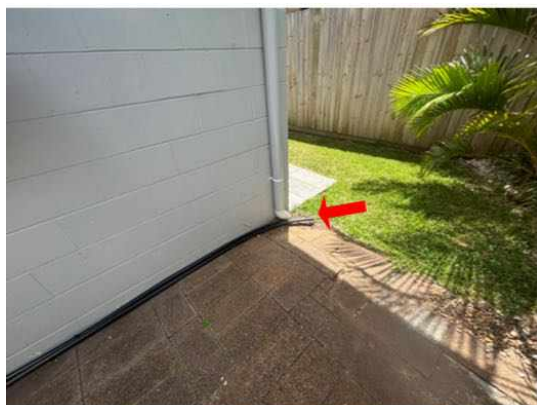
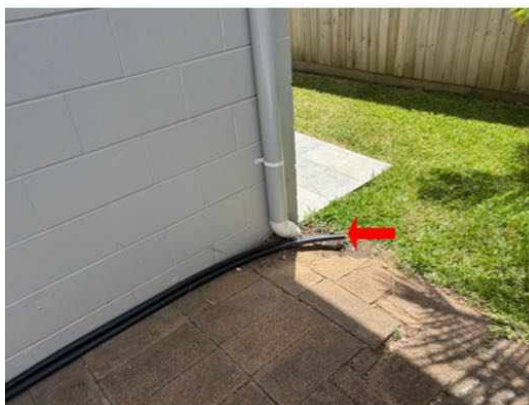
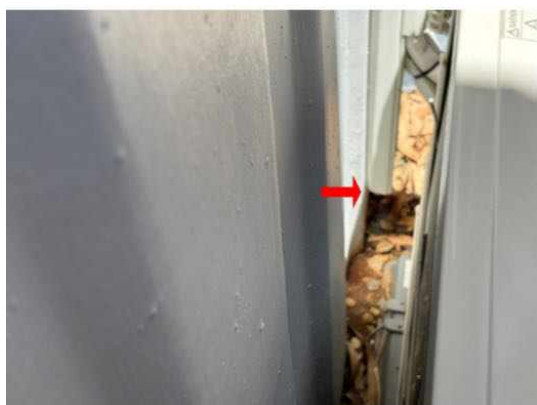
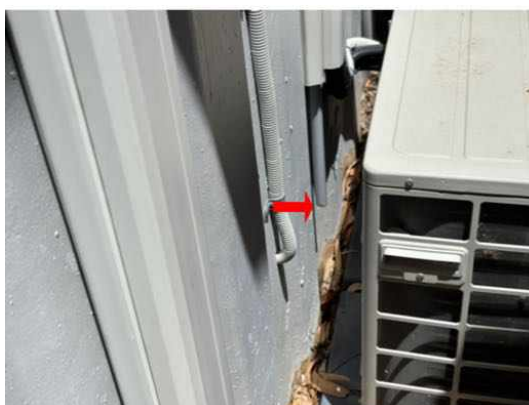
### Finding 6.01

Building:	Main Building
Location:	All External Areas
Finding:	Termite Management System - no evidence of a current chemical installation
Information:	At the time of the inspection, no evidence of a current chemical termite management system was found. There is a durable notice in the meter box showing a chemical treatment was carried out on the 30/07/2015 with an expected lifespan of 8 years. This treatment will no longer be effective.

Evidence of a past chemical termite treatment system was found during the inspection. A durable notice was found in the meter box. The durable notice is dated the 30/07/2015, this had an expected life span of 8 years. This treatment will no longer be effective.

works should be carried out as soon as possible.

A termite and timber pest technician should be engaged to provide a chemical termite treatment system to suit this style of building. This should be done as a matter of urgency.

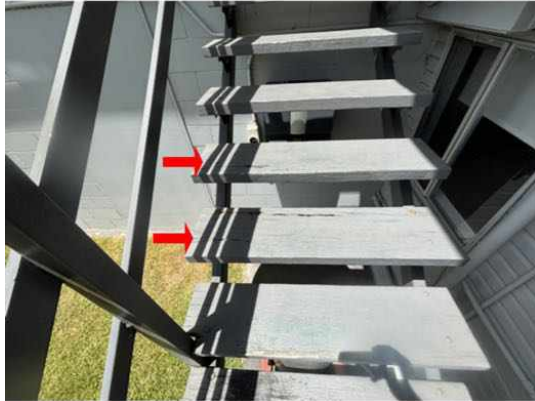
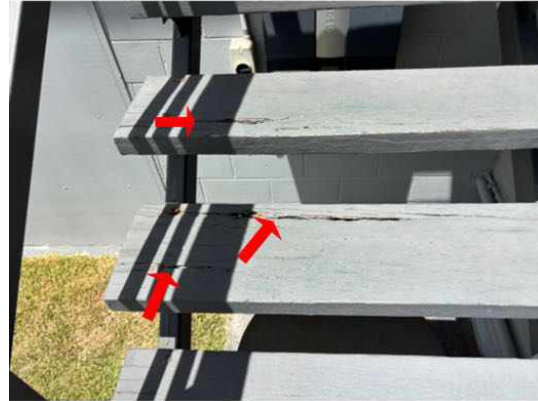
### Finding 7.01

Building: Main Building

Location: Rear elevation

Finding: Wood rot

Information: At the time of the inspection, it was noted that there was evidence of wood rot to two timber step treads on the rear stairs. This may be due to the age of the timber building elements and general weathering.

This building element shows evidence of wood rot. Wood rot, also known as Fungal Decay, occurs when timbers and other cellulose building materials are exposed to damp conditions on an ongoing basis.

the useful life of these building elements. Prior to any works being performed, the cause of the moisture that has created the visible wood rot should be identified and addressed in a suitable manner. Replacement of affected timbers may then be a necessary step in protecting surrounding building elements from such deterioration.

A qualified carpenter or registered builder may also be required to replace affected building materials.

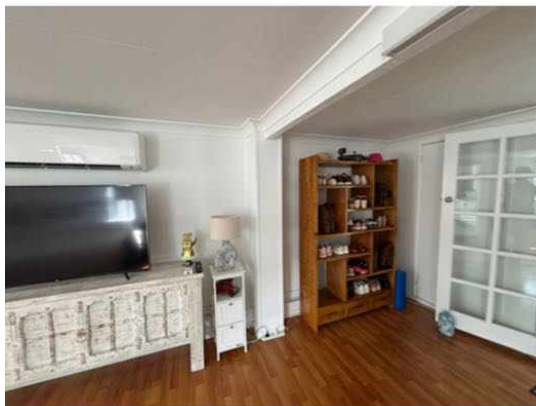
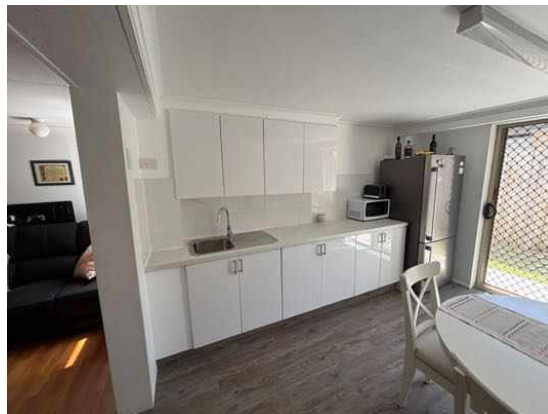
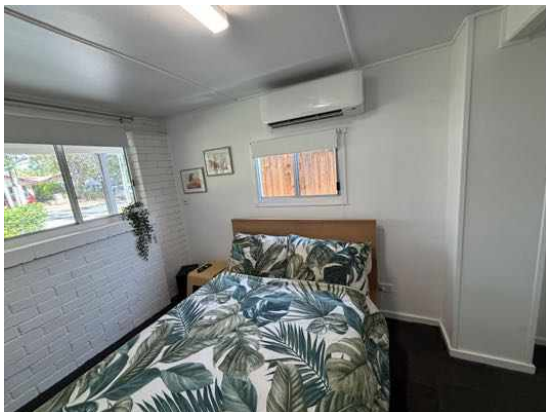
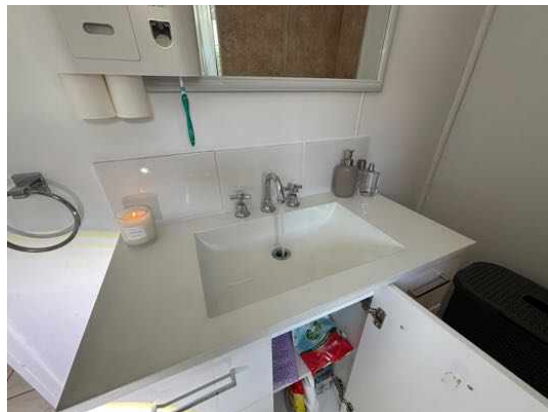
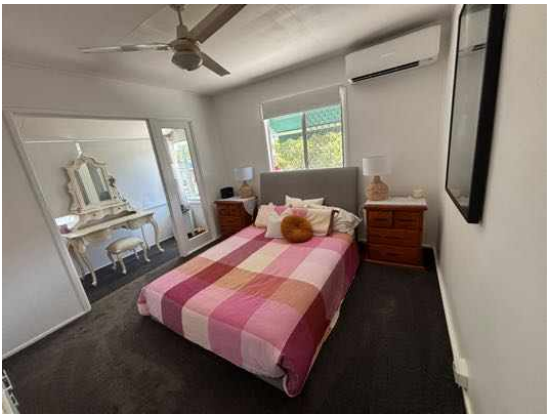
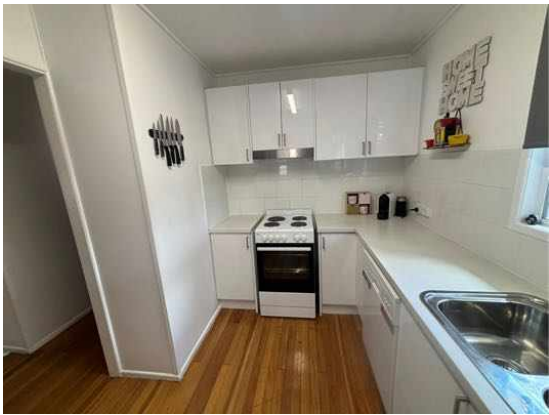
#### Noted Item

Building: Main Building  
Location: All Internal Areas  
Finding: Obstructions and Limitations - Internal areas  
Information: These photographs are an indication of the obstructions and limitations which impeded full inspection of the property of the internal areas at the time of inspection. These obstructions can hide an array of defects and should be removed to allow full inspection to be carried out. A re-inspection is recommended once the areas are made accessible.

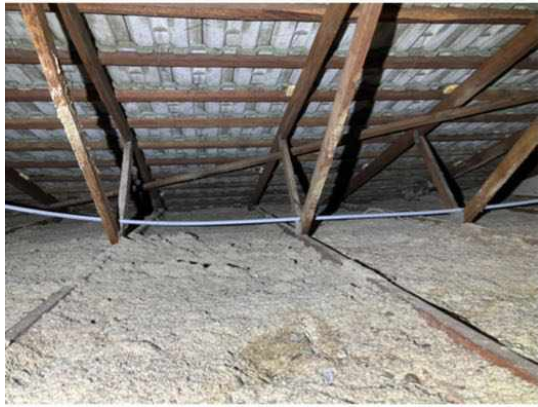
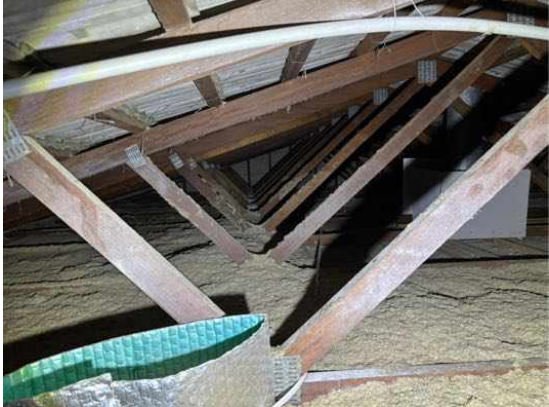
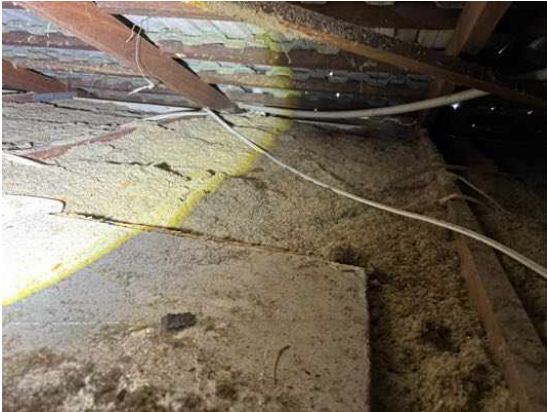
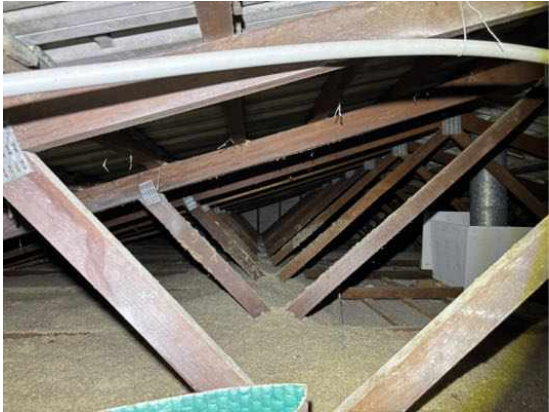
**Noted Item**

Building: Main Building  
Location: Roof Void  
Finding: Obstructions and Limitations - Roof cavity  
Information: These photographs are an indication of the obstructions and limitations which impeded full inspection of the property of the roof cavity

at the time of inspection. These obstructions can hide an array of defects and should be removed to allow full inspection to be carried out. A re-inspection is recommended once the areas are made accessible.

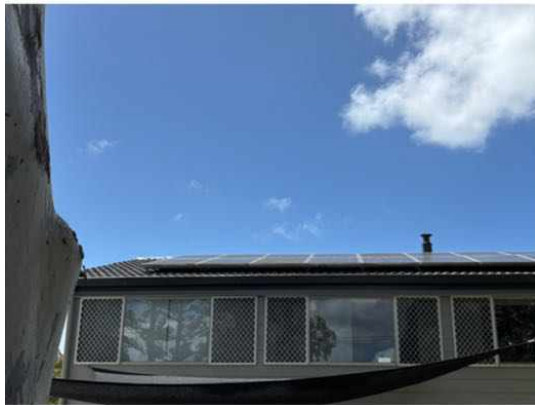
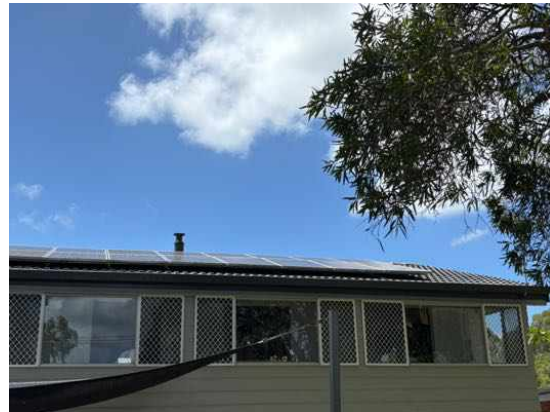
## Noted Item

Building: Main Building  
Location: Roof Exterior  
Finding: Obstructions and Limitations - Roof exterior  
Information: These photographs are an indication of the obstructions and limitations which impeded full inspection of the property of the roof exterior

at the time of inspection. These obstructions can hide an array of defects and should be removed to allow full inspection to be carried out. A re-inspection is recommended once the areas are made accessible.
