Building and Timber Pest Inspection Report

Inspection Date: Fri, 6 Feb 2026

Property Address: 43/10 Dural St, Hornsby NSW 2077,
Australia

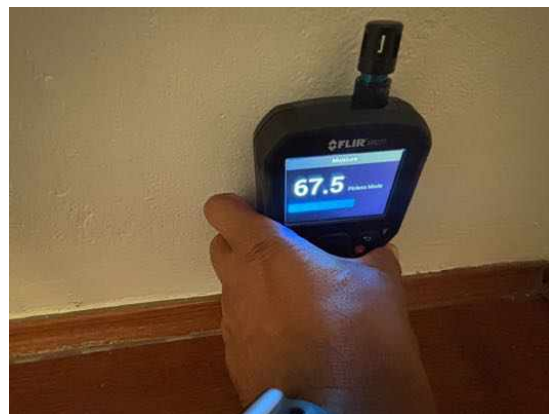
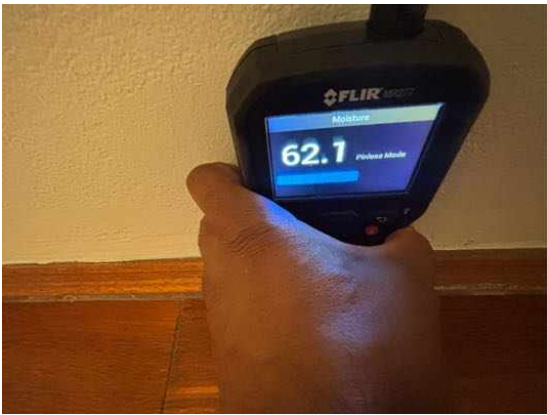
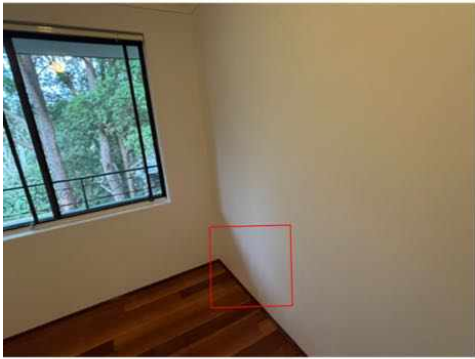
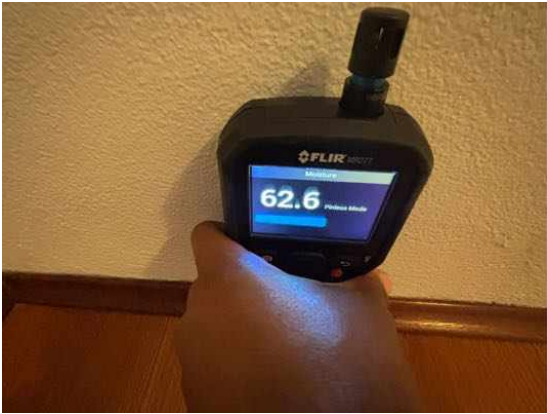
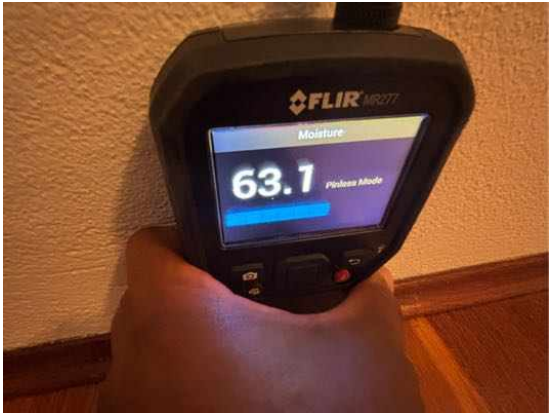
Building: Main Building
Location: Bedroom 1, Hallway
Finding: Shower Damp - Adjacent Bathroom (Monitoring)
Information: At the time of inspection, elevated moisture levels were detected on the wall adjacent to the shower area. While no visible water damage or deterioration was noted, the presence of moisture suggests possible seepage or condensation associated with regular shower use.

At this stage, no immediate action is required. However, the area should be monitored over the next 12 months for any signs of deterioration such as staining, bubbling paint, or mould growth. It should be noted that moisture ingress of this nature does not generally resolve without intervention, and at some point remedial works are likely to be required. Should conditions worsen, the client is advised to engage services of a licensed plumber or waterproofing specialist to rectify the issue of moisture before this minor defect turns into major defect.

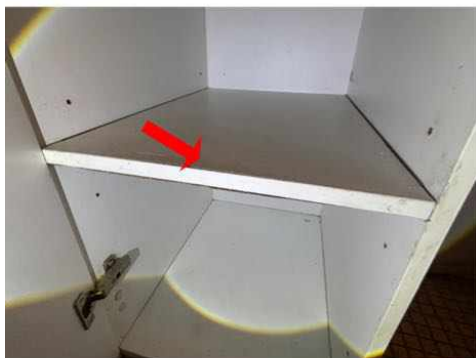
Finding 3.02

Building: Main Building
Location: Bathroom, Laundry
Finding: Cabinetry - Water Damage
Information: At the time of inspection, water-damaged cabinetry was observed, indicating previous or ongoing exposure to moisture. The affected sections show swelling, discolouration, and material deterioration, which may reduce the cabinetry’s structural integrity and appearance over time. It is recommended that the client engage a cabinet maker to repair or replace the damaged sections and inspect for any underlying leaks or moisture sources to prevent recurrence.

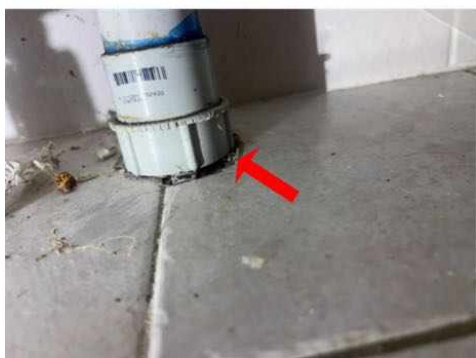
Finding 3.03

Finding: Sealant/Grouting - Missing or Damaged

Information: At the time of inspection, areas of missing and/or deteriorated sealant and grout were noted in this area. This condition can allow water to penetrate behind finishes, which may lead to moisture ingress, deterioration of waterproofing membranes, mould growth, and potential leaks into adjoining areas over time. If left unaddressed, this may result in costly repairs and hidden water damage.

It is recommended that a licensed plumber (or suitably qualified tradesperson experienced in wet area sealing) be engaged to assess the affected areas and reinstate compliant waterproof sealant and grout as required, ensuring all junctions are properly sealed to prevent further water ingress.

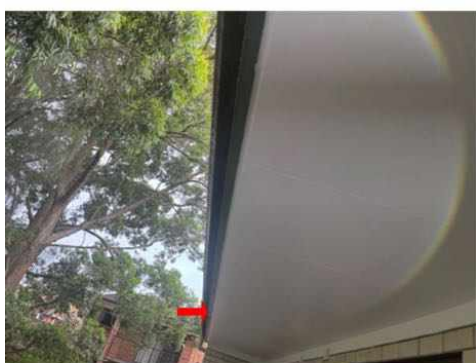
Building: Main Building
 Location: Balcony
 Finding: Downpipe(s)/Gutter(s) - Corroded/Rusted
 Information: At the time of inspection, sections of the gutters and downpipes were observed to be

rusted and showing signs of corrosion. This deterioration is likely the result of prolonged exposure to moisture, debris build-up, and standing water, which can prevent proper drainage and accelerate metal decay. Over time, corrosion can lead to leaks, restricted water flow, and eventual failure of the stormwater drainage system, potentially allowing water to overflow and impact the building structure.

As gutters and downpipes typically form part of the common property, it is recommended that the client consult with the strata manager or owners corporation to confirm responsibility and arrange for inspection, repair, or replacement of the affected sections by an appropriately licensed contractor. Ongoing maintenance, including regular cleaning and ensuring adequate fall, is also advised to reduce the risk of further corrosion.

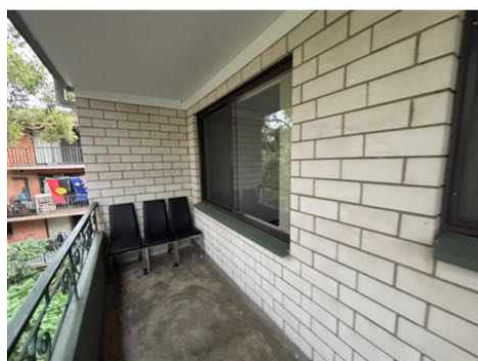
Building: Main Building
 Location: All External Areas
 Finding: Obstructions and Limitations - External Areas
 Information: The attached photographs provide a visual representation of the obstructions and limitations that impeded a full inspection of the external areas of the property at the time of assessment. These obstructions, which may include vegetation, stored items, debris, or other physical barriers, can obscure potential defects and prevent a thorough evaluation of the property's condition. Obstructions of this nature can conceal a wide range of issues, such as structural damage, water ingress, pest infestations, or deteriorating building materials, which may not be visible during the initial inspection.

It is essential that these obstructions be cleared to allow for a comprehensive inspection of the external areas. Removing these barriers will enable a more accurate assessment of the property's condition and allow any hidden defects to be identified and addressed promptly. Failure to do so could result in undetected issues worsening over time, potentially leading to more costly repairs in the future.

Therefore, it is strongly recommended that the obstructions be removed and a re-inspection be scheduled once the affected areas are made fully accessible. This will ensure a complete evaluation of the property's exterior and provide the client with a clear understanding of any potential issues that may have been concealed during the initial inspection.

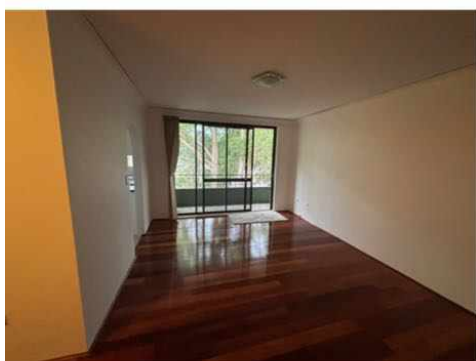
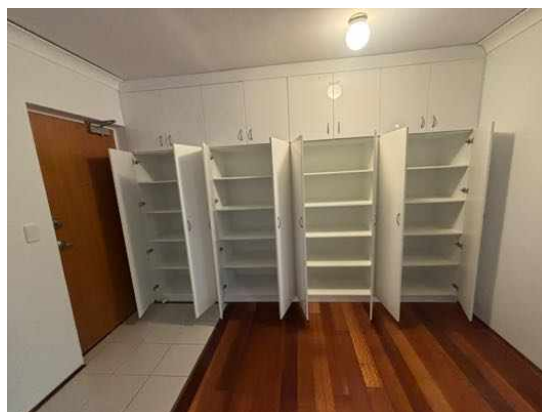
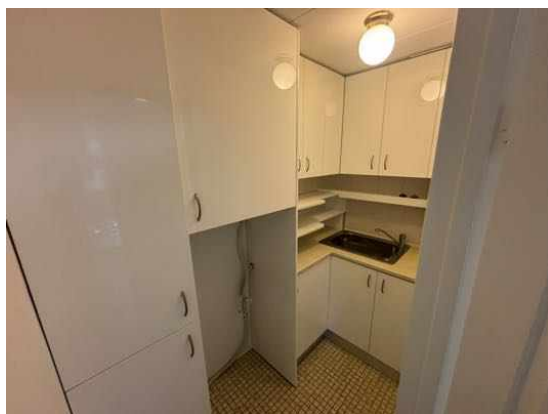
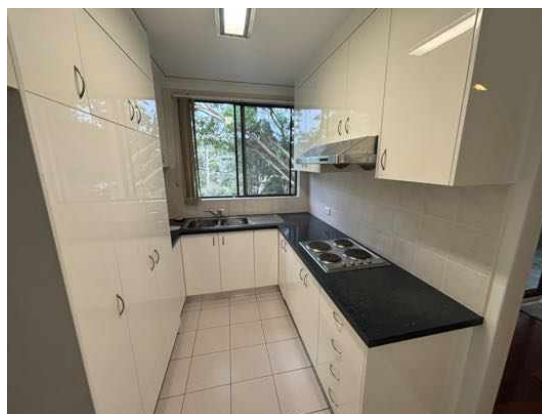
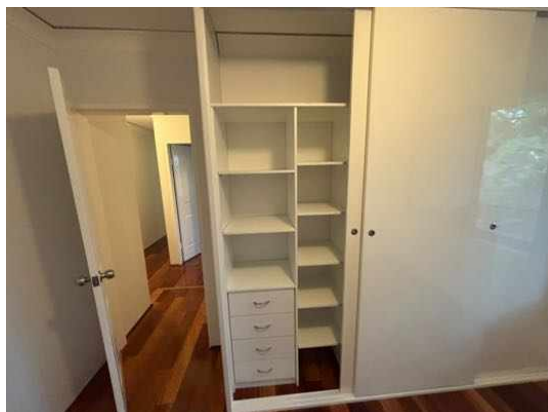
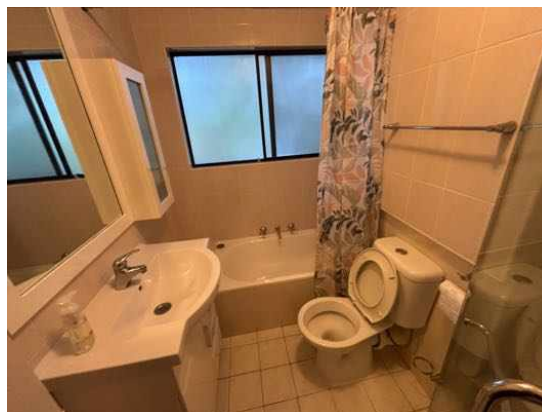
Information: The accompanying photographs provide clear evidence of the obstructions and limitations that restricted a comprehensive inspection of the internal areas of the property at the time of assessment. These obstructions, which may include furniture, personal belongings, stored items, or structural elements such as wall coverings and built-ins, significantly hindered the ability to thoroughly evaluate these areas. It is important to note that such obstructions can potentially conceal a wide array of defects, ranging from hidden structural damage, water leaks, pest infestations, or electrical issues, to deteriorating materials that may not be visible during the initial inspection.

The presence of these impediments means that critical areas of the property were not accessible, and therefore, any underlying defects that may affect the integrity and safety of the property could remain undetected. These hidden defects, if left unaddressed, could worsen over time and may result in costly repairs or pose potential safety hazards to the occupants.

It is highly recommended that all obstructions be cleared to facilitate a complete and thorough inspection of the internal areas. Once the obstructions have been removed and full access is available, a re-inspection should be carried out to ensure that any previously concealed issues can be properly identified and rectified. This follow-up inspection will provide a more accurate assessment of the property's internal condition and help the client make informed decisions about any necessary repairs or maintenance.

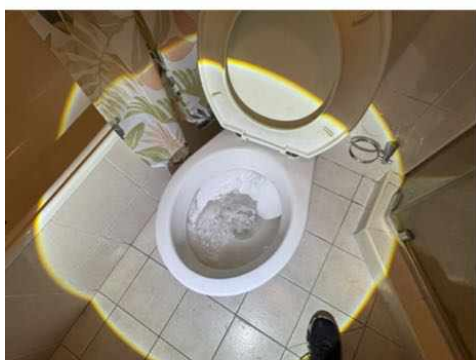
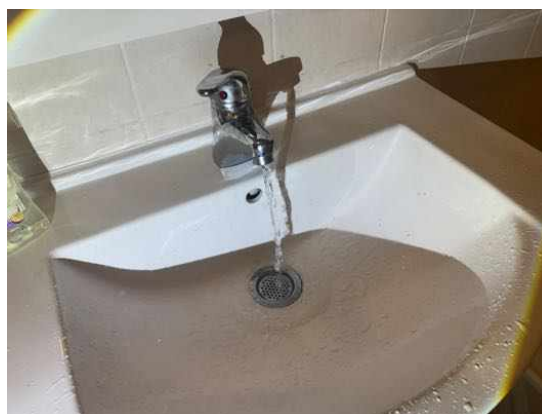
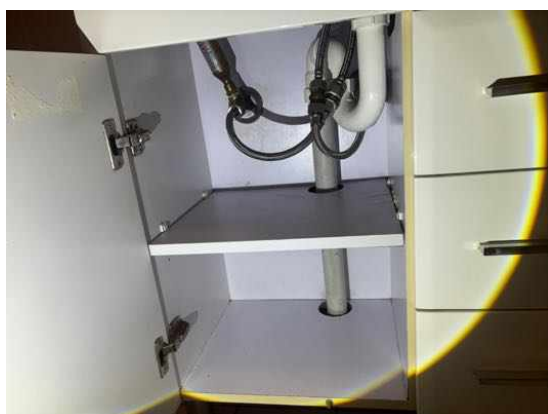
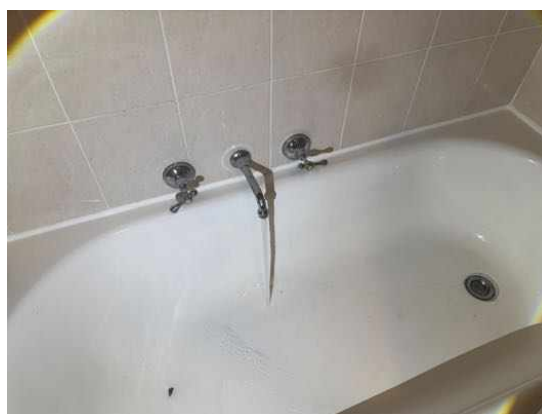
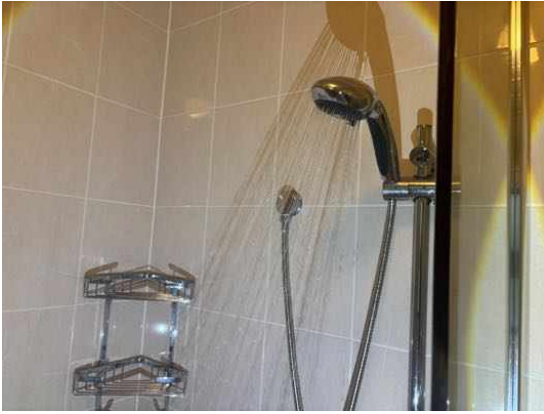
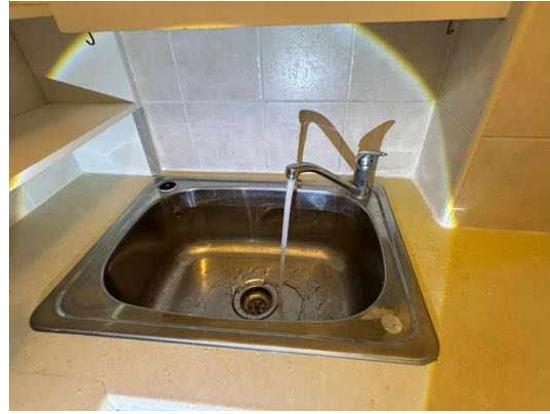
Building: Main Building
Location: All Areas
Finding: FYI - Taps, Drainage & Toilets Tested and Cabinetry Obstructions
Information: During the inspection, all accessible taps, drainage systems, and toilets were tested for water flow and drainage efficiency, and checked for any visible signs of leakage. At the time of the inspection, no issues were noted in these areas. Unless highlighted in a separate defect statement, no immediate remedial work appears necessary. Supporting images may be found in the additional photos section for reference.

It is important to note that while a visual inspection of cupboards and cabinetry beneath sinks and vanities was undertaken, stored personal items and fixtures presented obstructions that limited full visibility of the internal areas. As per standard inspection practices, inspectors are not permitted to move or disturb personal belongings during the inspection process. Therefore, only visible and accessible sections were inspected, and concealed water damage or plumbing defects may not have been detected.

Given this, a re-inspection is recommended after all obstructions have been cleared to allow for a comprehensive assessment of these areas. Regular maintenance and monitoring of plumbing and drainage systems is also advised to ensure ongoing functionality and early detection of potential issues.
