# Building and Timber Pest Inspection Report

Inspection Date: Fri, 27 Feb 2026

Property Address: 14 Harrington St, Altona VIC 3018, Australia

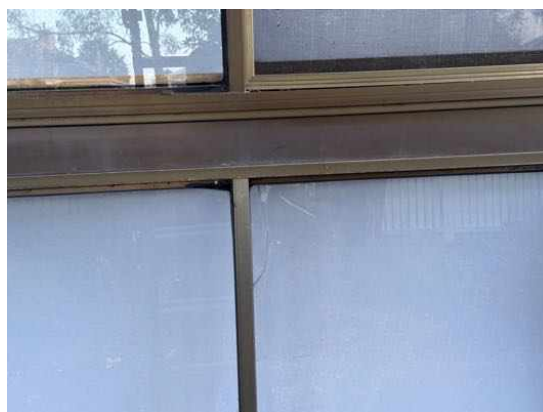
Building:	Main Building
Location:	Bedroom
Finding:	Minor Safety Hazard – Cracked Glass to External Bedroom Window
Information:	The external bedroom window glazing was observed to be cracked to one pane. Although the glass remains intact at the time of inspection, cracked glazing compromises the structural integrity of the pane and increases the risk of sudden failure, particularly under wind load, thermal expansion, or accidental impact. Broken glass may pose a minor injury risk to occupants and can also allow moisture ingress if the crack propagates.

It is recommended that the affected glass pane be replaced by a qualified glazier in the near term to restore safety, weather resistance, and overall serviceability of the window assembly.

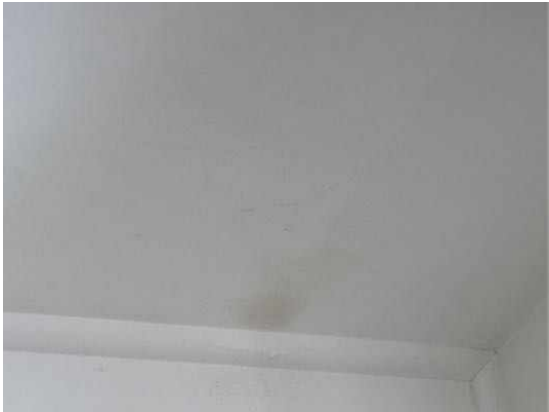
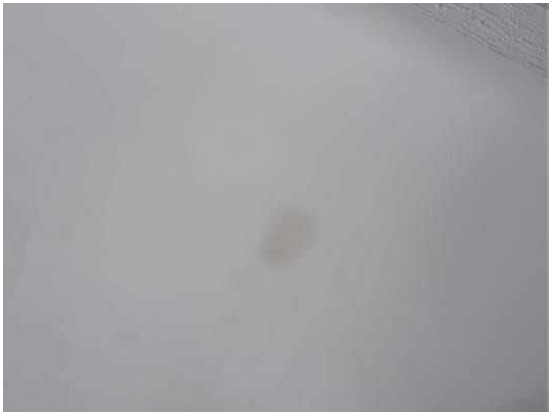
#### Finding 2.01

Building:	Main Building
Location:	Lounge Room
Finding:	Ceiling - Water stained
Information:	Water staining to ceiling linings in this area was evident at the time of inspection. At least 3-4 water stains were present in the lounge.

Water staining indicates that surfaces have been exposed to excessive moisture over time. The minerals and other elements in the water lead to staining, which may graduate to corrosion and deterioration if left unmanaged.

While mostly an appearance defect, water staining can be indicative of more serious defects, which may be currently concealed by interior ceilings. Externally the roof exterior has excessive vegetation/ debris covering the roof (cleanup is highly recommended)

Evidence of excessive moisture

Nearby low moisture comparison

Where water staining is active, a licensed roof plumber must be consulted to identify the cause of the staining and to provide advice on any reparation works that may be required. Replacement of any damaged structures is advised.

Conversely, where water staining is old and inactive, affected building materials may be repaired, repainted or replaced at client discretion.

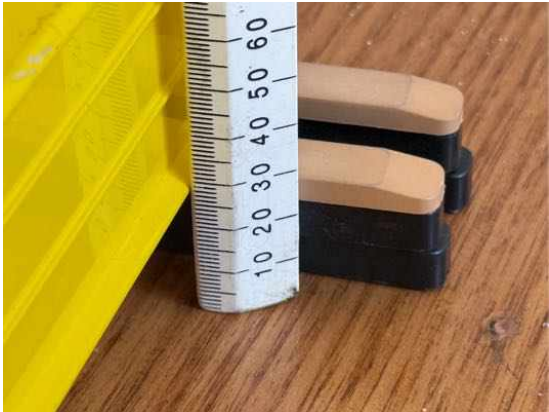
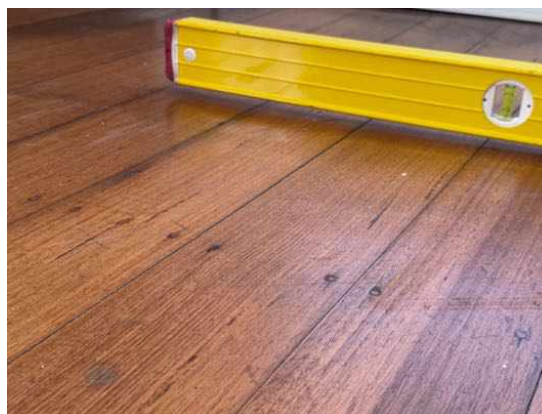
Building:	Main Building
Location:	Some Internal Areas
Finding:	Subsidence- moderately significant
Information:	It is suspected that the subfloor structure might have been affected by movement of the foundations, often referred to as sinking or subsidence.

General subsidence is usually initiated by changes in soil moisture content. The most critical factor is identifying the specific causes, and identifying if this is a recurring or ongoing problem, or one that has been resolved by previous works in the past.

Subsidence can have complex and varying causes, which will influence the required remedial works. If secondary defects like door binding, cracks around the cornices, or gaps between walls & flooring are evident (some are evident) . It will be advised to begin by consulting a structural engineer to determine the required scope of works. This generally includes some form of underpinning, as well as addressing the underlying cause.

A Registered Builder specialising in re-stumping would then generally carry out works as advised by an Engineer.

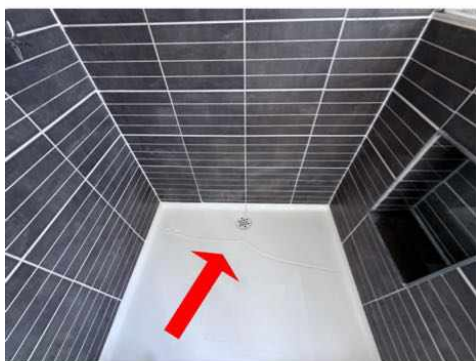
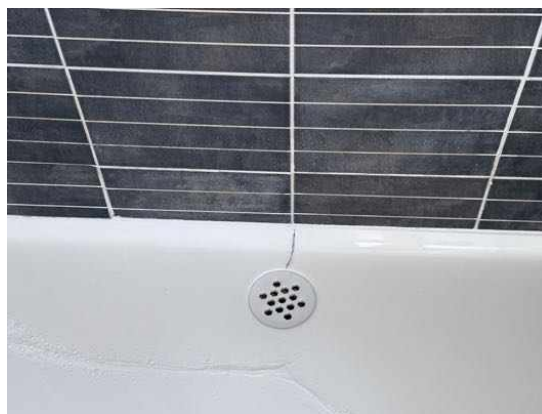
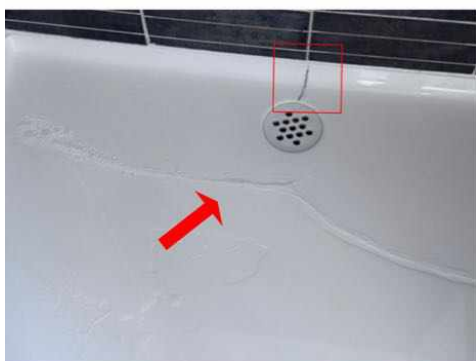
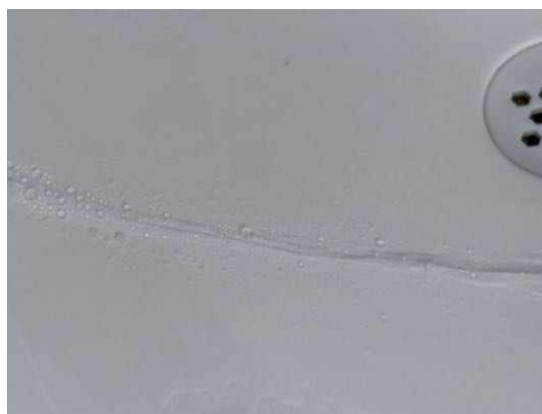
### Finding 3.02

Building:	Main Building
Location:	Bathroom
Finding:	Cracked & Previously Repaired Shower Base (Moderately Significant)
Information:	The shower base was observed to have a visible crack extending across the tray surface, which has been previously sealed/filled. While the repair appears to be holding at present, such patch repairs are generally considered temporary and may not provide a long-term watertight solution. Movement, thermal expansion, and regular use can cause the crack to reopen over time.

Failure of the repair may allow water to penetrate beneath the base, potentially resulting in concealed moisture accumulation, subfloor deterioration, mould growth, or

structural timber decay.

It is recommended that the condition be monitored closely. However, replacement of the shower base should be considered in the short to medium term to ensure long-term integrity. Note that replacement can involve removal of surrounding tiles/screens and associated plumbing works, which may result in relatively high labour costs.

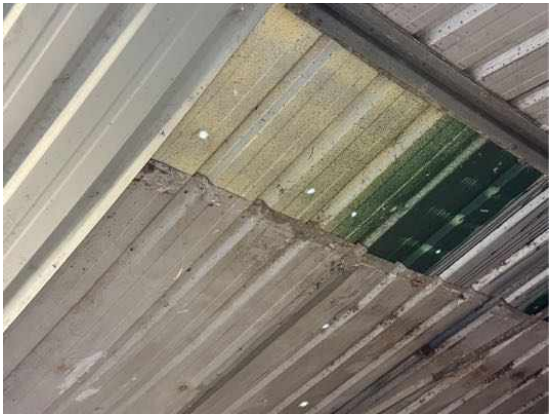
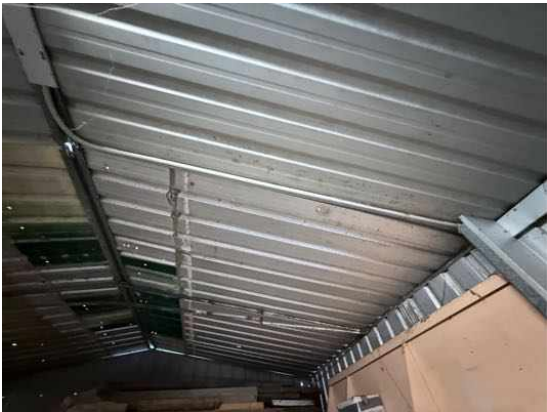
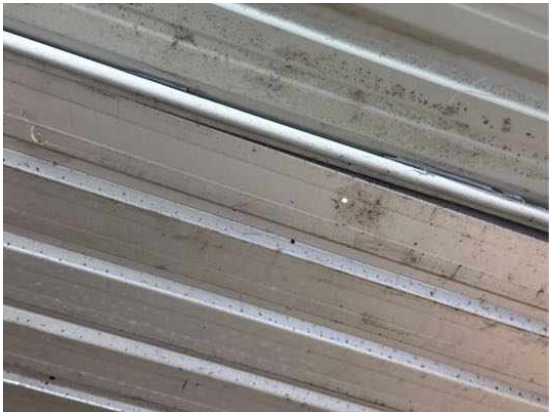
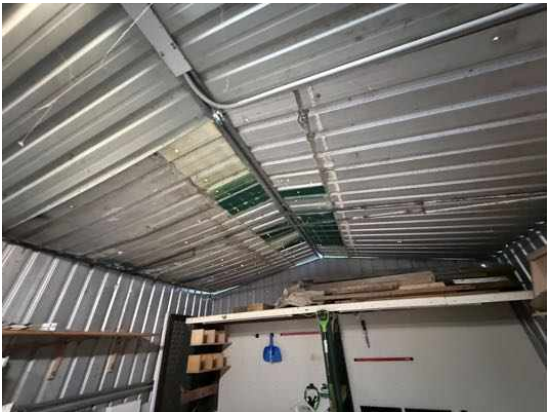
### Finding 3.03

Building:	Main Building
Location:	Yard - shed
Finding:	Shed Roof (small holes)
Information:	The metal roof sheeting to the shed is in fair to poor condition, with visible holes at a few locations. Evidence of basic sealant/caulking has been noted; however, such temporary sealing methods are prone to deterioration over time due to UV exposure and thermal movement. These gaps may allow moisture ingress during wind-driven rain events, and the current sealing cannot be relied upon as a long-term waterproofing solution.

While no active major leak was observed at the time of inspection, preventative maintenance is recommended. Consider proper mechanical rectification (e.g., refastening, replacement of damaged sheets, installation of appropriate flashing or closures) rather than relying solely on surface caulking to maintain weatherproofing

integrity.

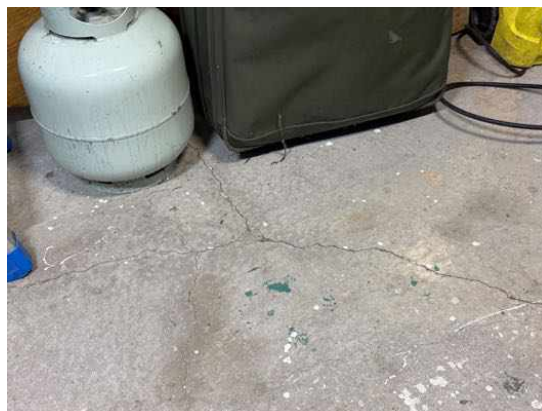
**Finding 3.04**

Building: Main Building  
Location: Yard - shed  
Finding: Crack in concrete slab - Category 2  
Information: A crack coded as Category 2 was identified in the slab. A Category 2 crack is described as a distinct crack, with the slab being noticeably curved or changed in level.

To be considered Category 2, the approximate width of the crack is less than 2.0mm,

or a change in offset of less than 15mm when a 3m straight edge is placed over the defect.

Category 2 cracks to slabs should be monitored for a period of 12 months. At the end of the monitoring period, cracks rated greater than Category 2 are considered defects that require rectification.

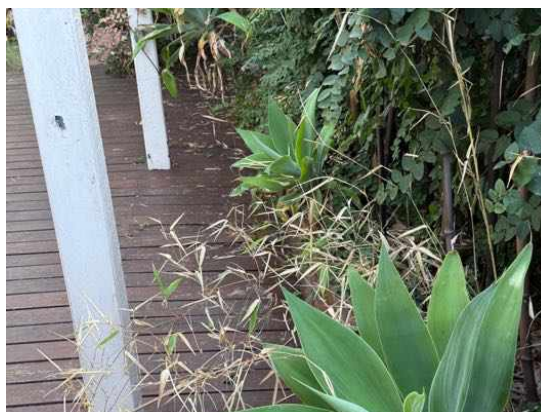
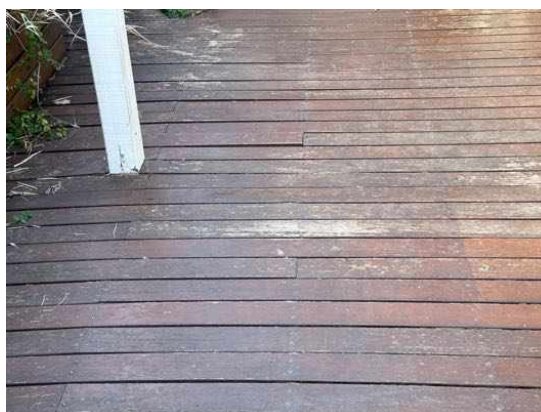
### Finding 3.05

Building:	Main Building
Location:	Yard - Side
Finding:	Localised Deck Subsidence Adjacent to Planter Box (moderately significant)
Information:	The timber decking adjacent to the raised planter box exhibits signs of localised deflection, with sections appearing to slope downward and sit lower than surrounding boards. Given the proximity to dense vegetation and soil-filled planter beds, prolonged moisture exposure is likely. This condition increases the risk of concealed timber decay to decking boards, joists, or bearers beneath the affected area.

While no immediate structural failure was observed at the time of inspection, continued moisture retention from irrigation, soil contact, and restricted ventilation may accelerate deterioration. If left unattended, this may lead to progressive rot and potential load-bearing reduction.

It is recommended that the planter interface be further investigated by lifting selected

boards to assess the condition of the substructure. Any decayed members should be replaced, and improvements to drainage, moisture separation (e.g., barrier or flashing), and ventilation should be implemented to prevent recurrence.

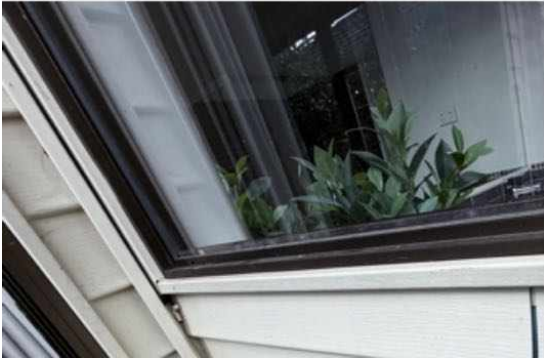
### Finding 3.06

Building:	Main Building
Location:	Exterior walls - right side
Finding:	Loose Lightweight Cladding Panel
Information:	A section of the lightweight external cladding beneath the window was found to be loose and not securely fixed to the substrate. The affected board demonstrates movement when lightly pressed, indicating inadequate fixing or possible fastener failure. While no immediate water ingress was observed at the time of inspection, loose cladding can allow moisture penetration, wind-driven rain entry, and potential pest access if left unaddressed.

It is recommended that the panel be refixed and securely fastened in accordance with manufacturer installation requirements to prevent future deterioration or damage.

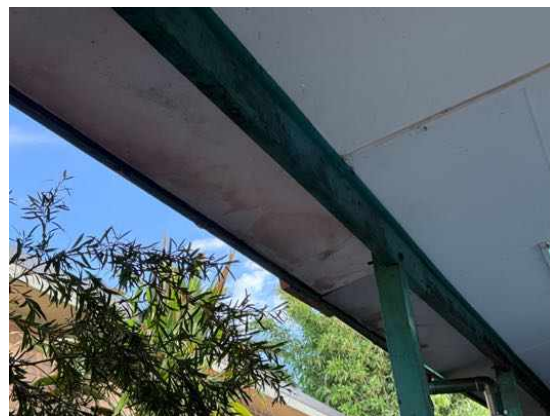
### Finding 3.07

Building:	Main Building
Location:	Carport
Finding:	Eaves- Water stained.
Information:	Water stain to eaves was evident at the time of inspection. This type of defect is generally consistent with older properties, where the eave sheeting has worn over time.

Eaves are important in preventing water ingress to associated walls by promoting adequate water run-off from roofing structures. Their secondary function is to prevent shelter to adjoining structures from excessive moisture and hence prevent water damage to these areas.

Eaves which are water stained might get damaged over time & hence will be susceptible to the attraction of excessive moisture, and are therefore will be considered non-functional. This defect also detracts from the overall appearance and condition of the roofing structure and any associated structures.

A roofing plumbing or a building maintenance provider is recommended to perform rectification works if eaves starts sagging.

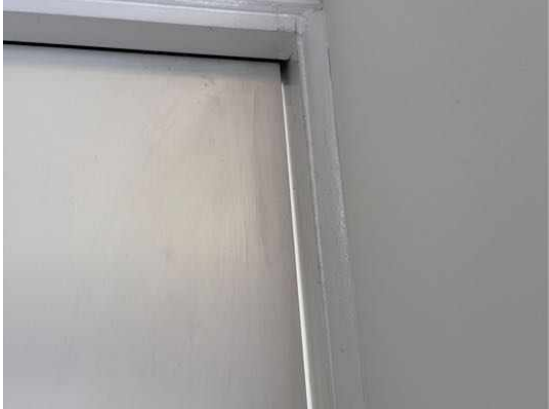
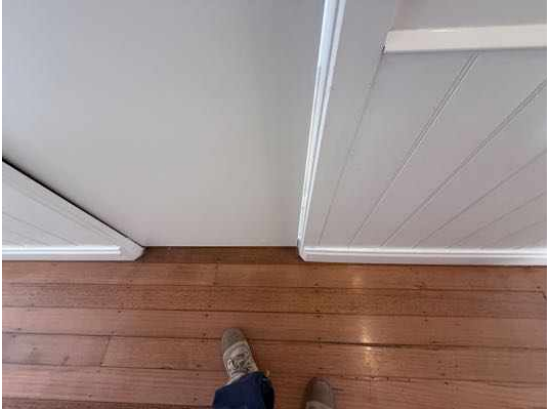
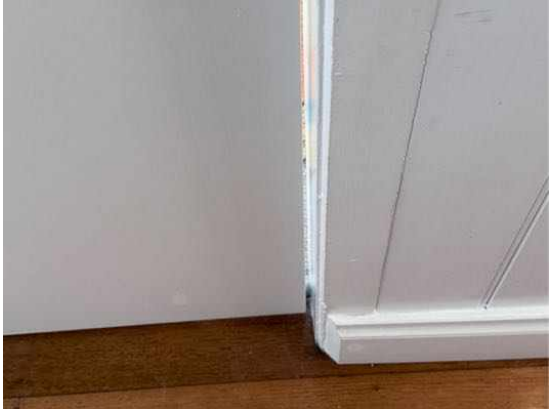
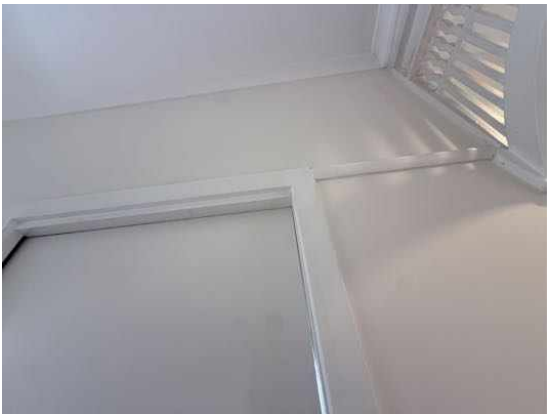
Building: Main Building  
 Location: All Internal Areas  
 Finding: Doors Misaligned on closing.  
 Information: It is observed that some of the Doors are not aligned and / or have inconsistent gaps between the doors. Its a result of substandard workmanship & sometimes ground movements.

A carpenter can be hired at clients discretion to rectify the issue.

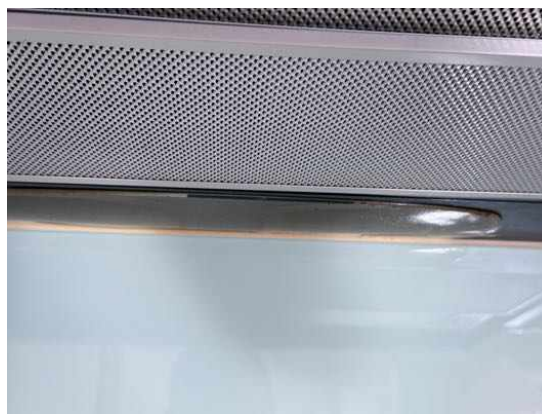
Building:	Main Building
Location:	Kitchen
Finding:	Rangehood - Light not working
Information:	While the range hood appears to be working at a satisfactory level, the light to the appliance was not working at the time of inspection.

A licensed electrician should be appointed to replace the light on the range hood to restore it to a fully operational state.

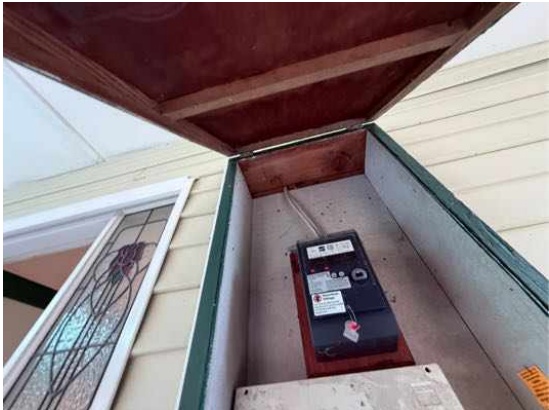
Building:	Main Building
Location:	Meter Box
Finding:	Termite Management System - no evidence of a chemical installation
Information:	The application of a post-construction chemical termite barrier is highly recommended for all properties, particularly if live termite activity has been found on the site previously. Such barriers are highly effective in preventing termite attack on any timber building elements throughout the property.

A durable notice should be placed in the switchboard unit to indicate current termite barriers. At the time of inspection, it appeared as though no termite management system has been installed, with no evidence to suggest preventative works taking place.

The client may consider gaining further advice from a pest controller as to the costs and procedures involved with this application. It is recommended that obtaining such advice be a short-term priority.

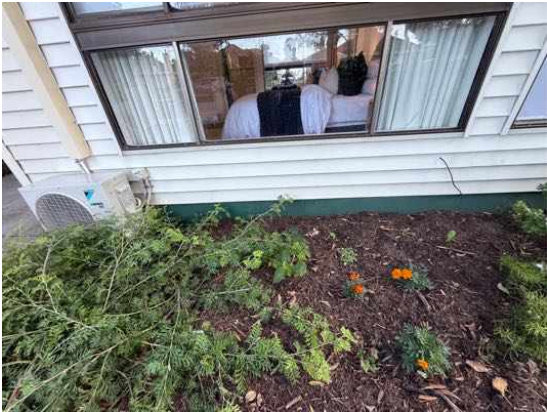
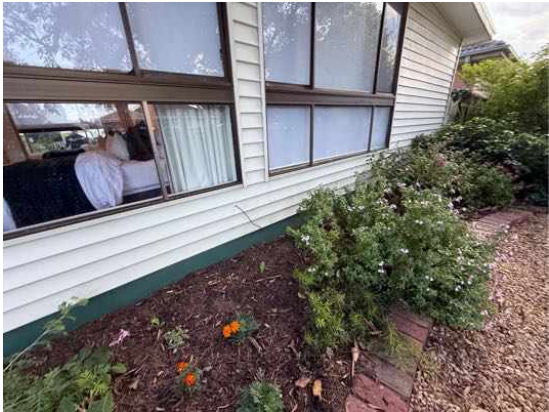
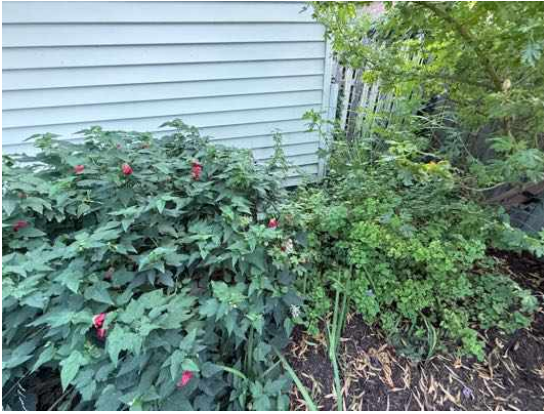
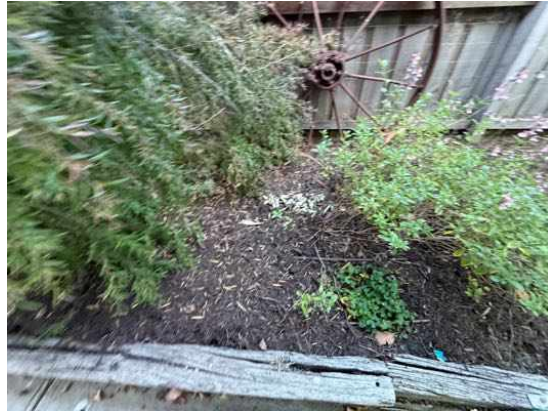
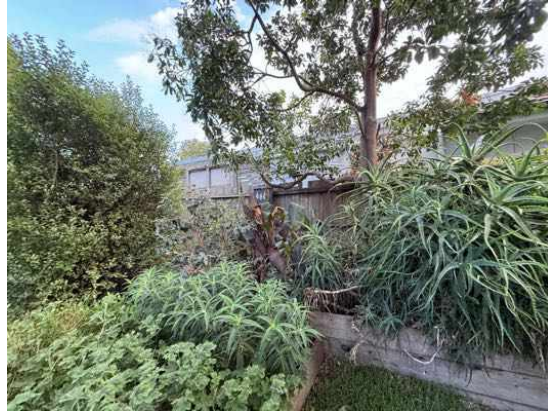
**Finding 6.02**

Building: Main Building  
Location: All External Areas  
Finding: Garden Bed/ Mulch - Conditions Conducive to Termites  
Information: Mulch were found around the property. These areas can include untreated timber, and with a combination of moisture from watering hosing can make conditions conducive to termite activity and termite ingress.

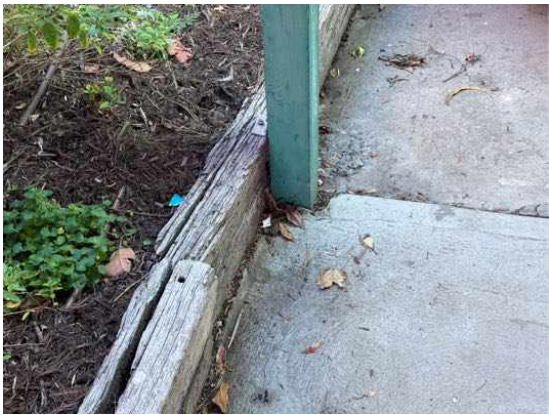
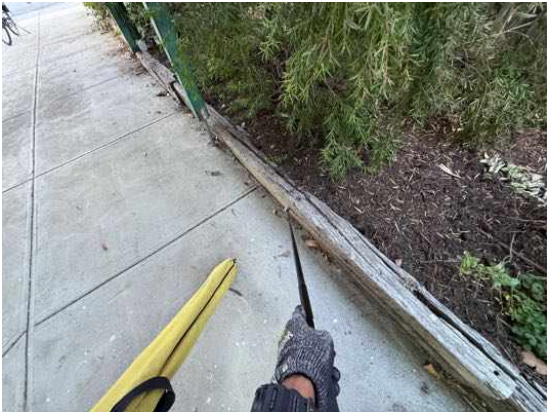
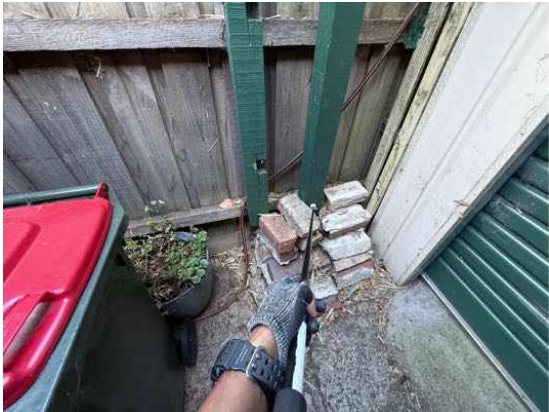
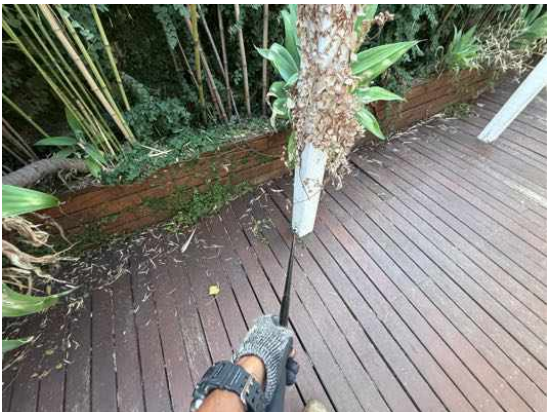
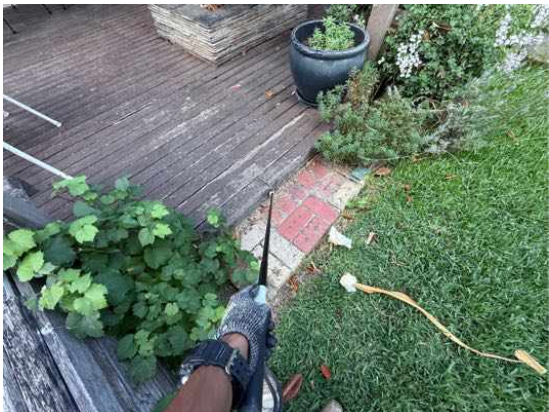
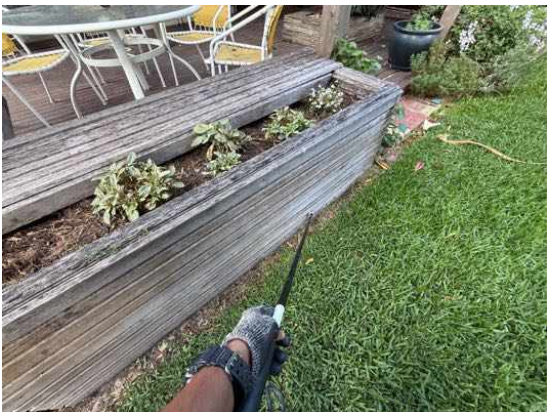
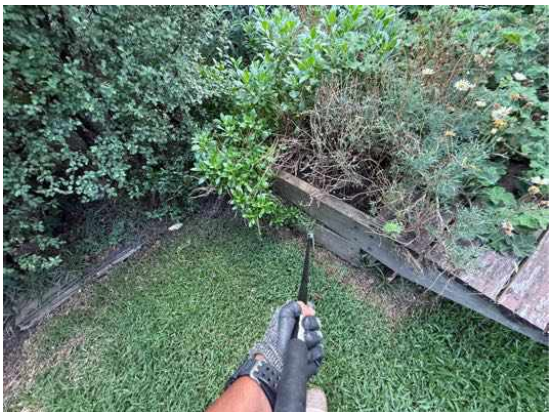
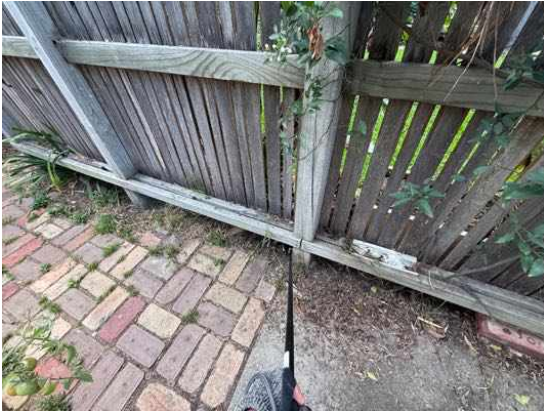
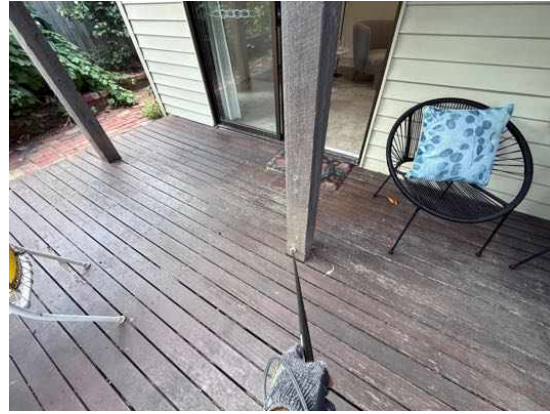
### Finding 6.03

Building:	Main Building
Location:	All External Areas
Finding:	In ground contact
Information:	Any timbers in direct ground contact provide opportunity for concealed termite entry and are likely to be subject to premature rot and decay as the soil retains moisture or damp conditions against the timbers.

Remove untreated timber that is in direct contact with external grounds. Consider replacement with more durable materials i.e. treated timber or non timber elements. Frequent pest inspections are advised to readily identify any termite activity in these areas.

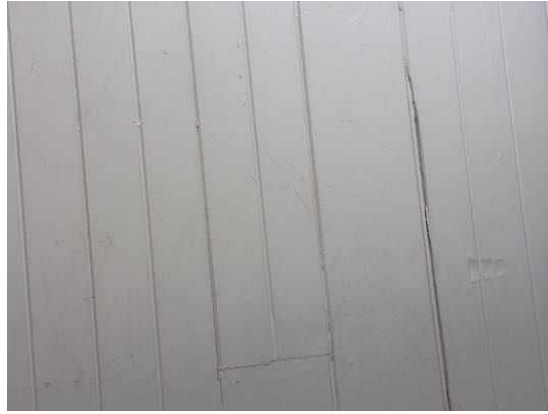
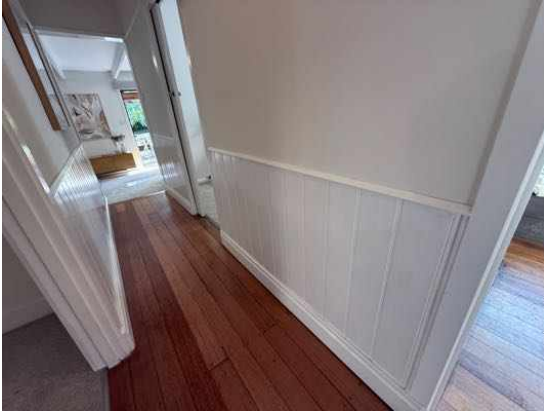
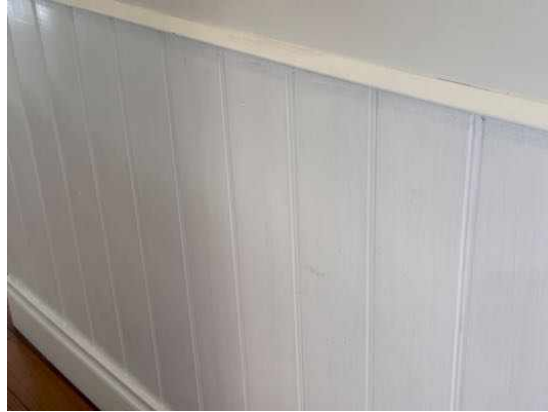
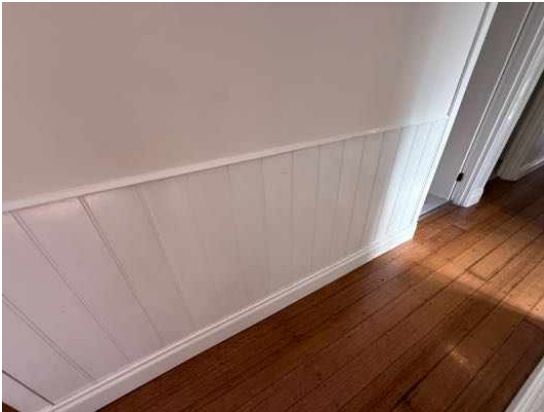
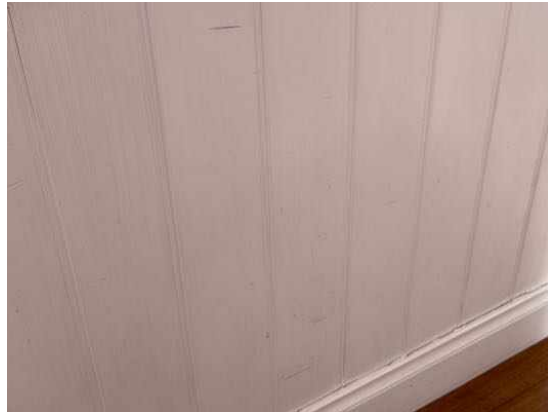
### Finding 6.06

Building: Main Building  
 Location: All Areas  
 Finding: Timber cladding- conducive condition  
 Information: Timber cladding can also be vulnerable to attack from termites, which can cause significant damage if not taken care of early on. Concealed entry is high possibility.

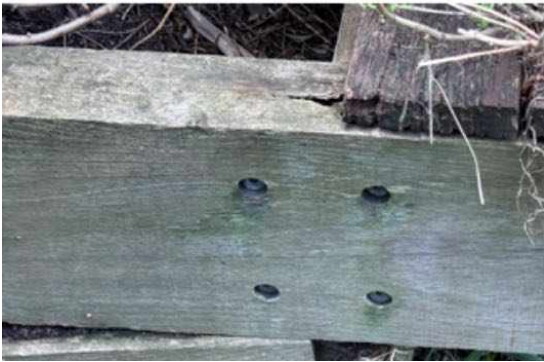
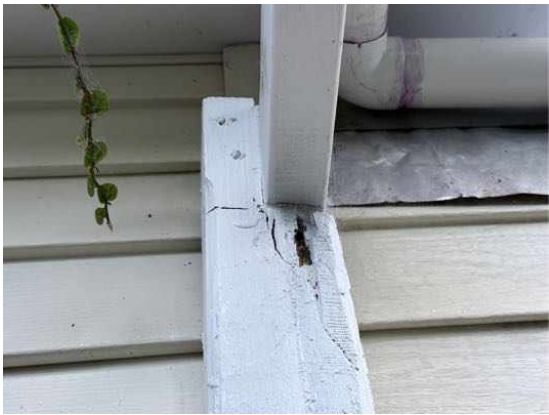
### Finding 7.01

Finding: Wood rot

Information: These building elements shows evidence of wood rot. Wood rot, also known as Fungal Decay, occurs when timbers and other cellulose building materials are exposed to damp conditions on an ongoing basis. This could be the result of exposure to weathering over a prolonged period of time, or the attraction of excessive moisture

Wood rot is often associated with general damp problems and is evidenced by a 'musty' smell or mould and mildew occurring on surfaces. If left unmanaged, damp conditions can lead to further health problems and the decay of timbers will continue.

Early intervention and regular maintenance, particularly of exterior timbers, will prolong the useful life of these building elements. Prior to any works being performed, the cause of the moisture that has created the visible wood rot should be identified and addressed in a suitable manner. Replacement of affected timbers may then be a necessary step in protecting surrounding building elements from such deterioration.

A qualified plumber may be appointed to assess the cause of excessive moisture and to provide advice on any remedial works as required. A qualified carpenter or registered builder may also be required to replace affected building materials.
