BEFORE YOU BUY
BEFORE YOU BUILD

Building Inspection Report

Inspection Date: Thu, 9 Apr 2026

Property Address: 5/20 Pennant Hills Rd, NORTH

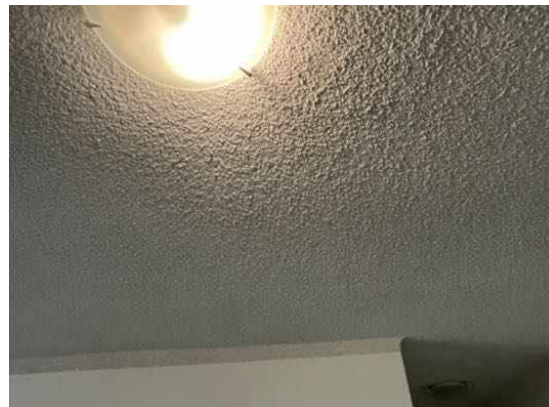
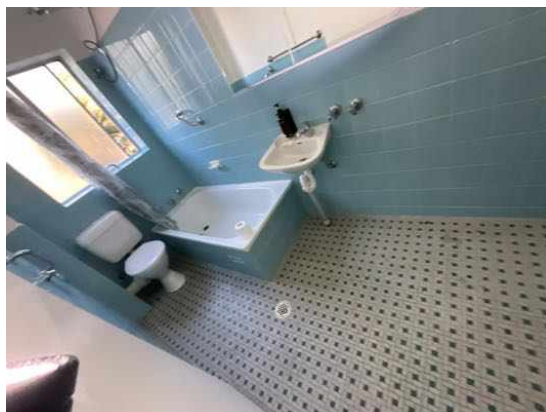
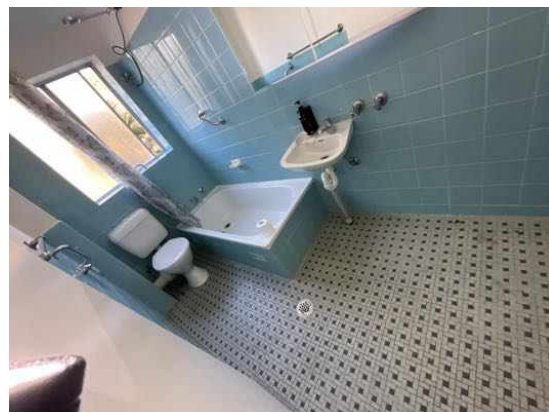
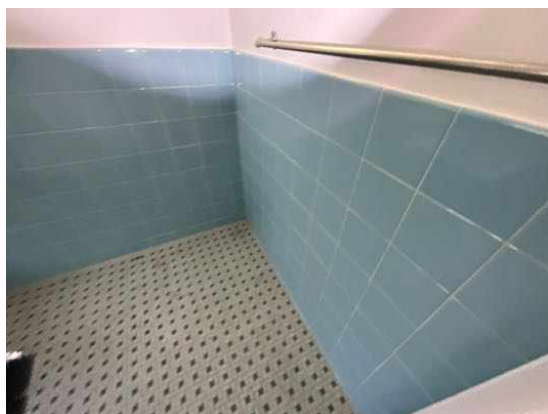
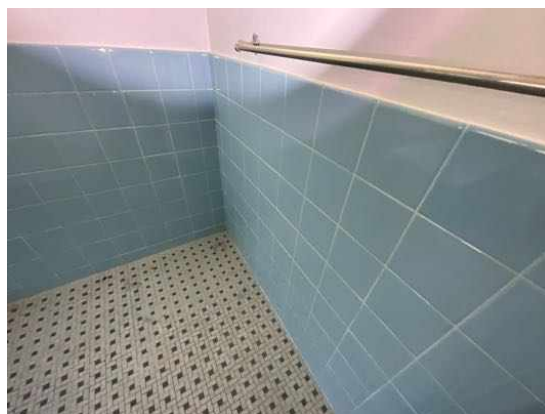
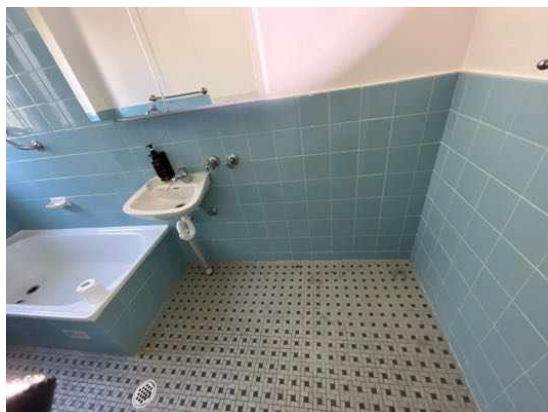
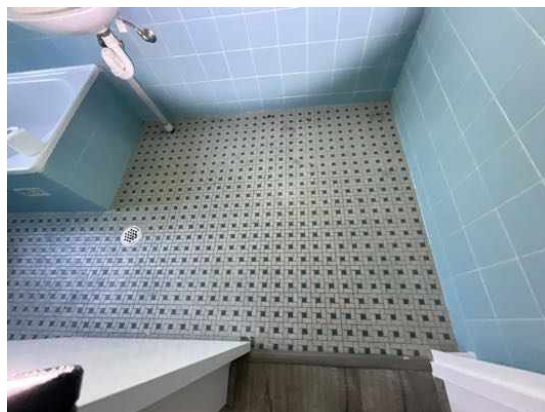
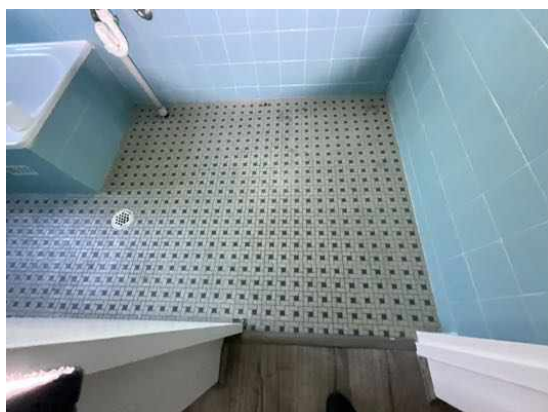
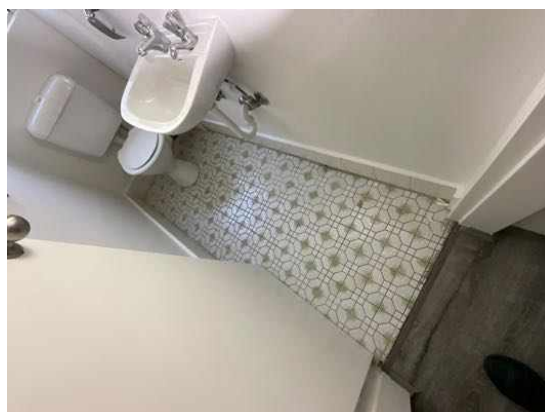
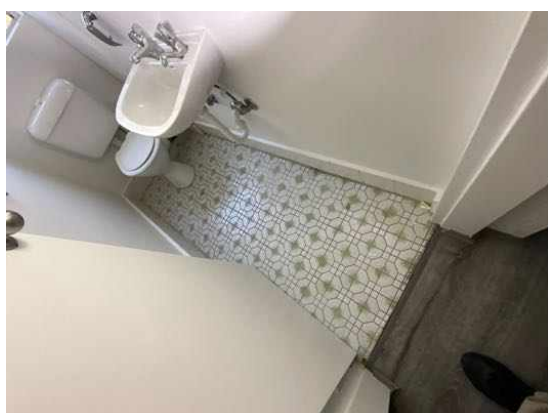
Defects 1.01

Building:	Main Building
Location:	All Areas
Finding:	Asbestos - Suspected ACM Identified on Site
Information:	Reporting on Asbestos is outside the Scope of this Report. This suspected defect is highlighted as a caution only. We suspect, based on our experience in the building industry, that there is a higher risk of the identified building element containing asbestos.

As Asbestos Reporting is outside the scope of this report, we advise that you consider a separate Asbestos Inspection and Condition Audit, which can include the taking of samples for definitive confirmation of the presence of Asbestos.

In the interim, the client is advised to act with caution, especially when considering any damage to building materials general wear and tear renovations extensions demolition and general maintenance activities due to the suspected presence of Asbestos.

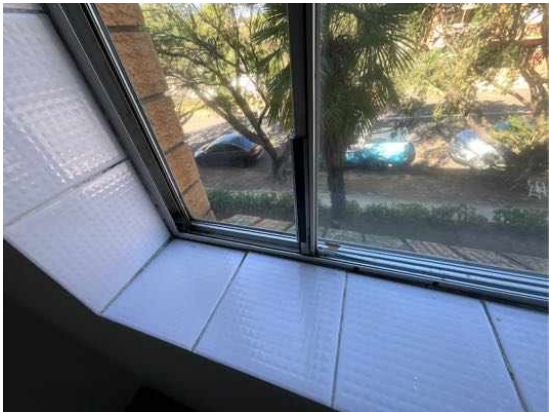
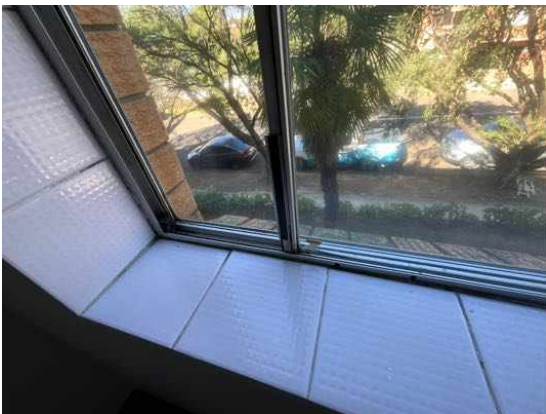
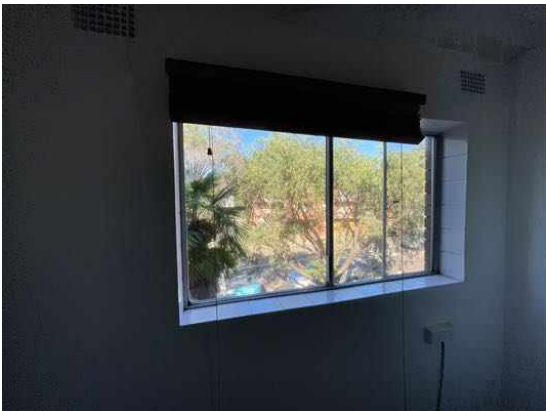
Defects 1.02

Building: Main Building
Location: All Areas
Finding: Window child lock missing
Information: The window in question lacks a child lock mechanism, which poses a potential safety risk to young occupants in the premises. As per Australian Standards windows accessible to children should be equipped with appropriate child safety locks to prevent accidental opening, reducing the risk of falls and ensuring compliance with safety regulations.

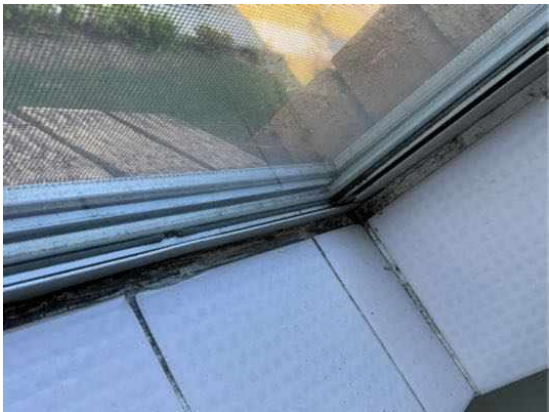
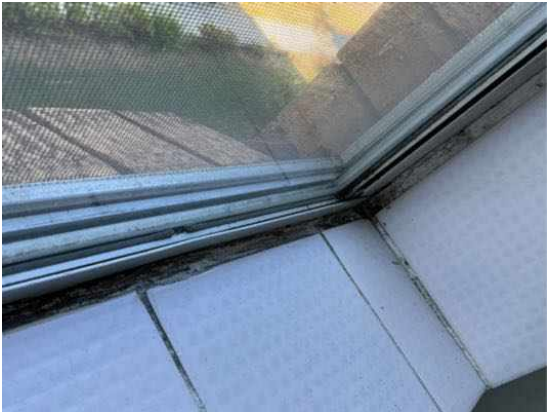
Defects 1.03

Building:	Main Building
Location:	Bedroom
Finding:	Mould - Present
Information:	Mold growth is present throughout the property, primarily due to inadequate ventilation. Poor airflow and moisture accumulation within the house have created ideal conditions for mold to thrive.

- ****Health Hazards****: Mold growth can pose serious health risks to occupants, particularly those with allergies, asthma, or other respiratory conditions. Prolonged exposure to mold spores can cause respiratory issues, skin irritation, and other allergic reactions.
- ****Structural Damage****: Mold can degrade building materials over time, leading to rot and weakening of the structural components such as timber, drywall, and insulation, which can result in costly repairs.
- ****Decreased Property Value****: The presence of mold can significantly reduce the value of the property, as it indicates underlying moisture and ventilation issues that need addressing.

A licensed mold remediation specialist should be engaged to remove the mold and treat affected areas. In addition, a ventilation expert or builder should assess and improve the house's ventilation system, possibly installing exhaust fans, vents, or mechanical ventilation systems to ensure adequate airflow and prevent future mold growth.

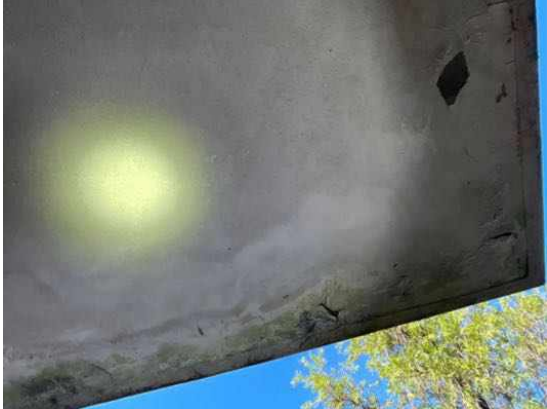
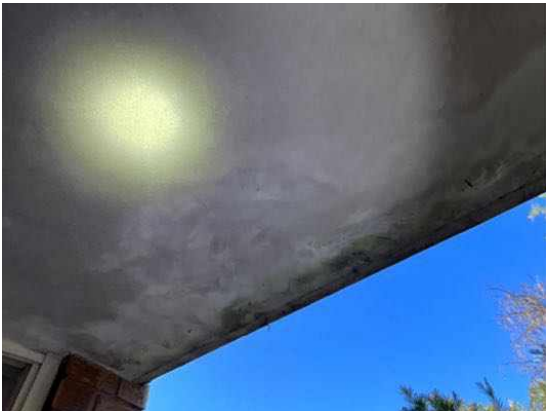
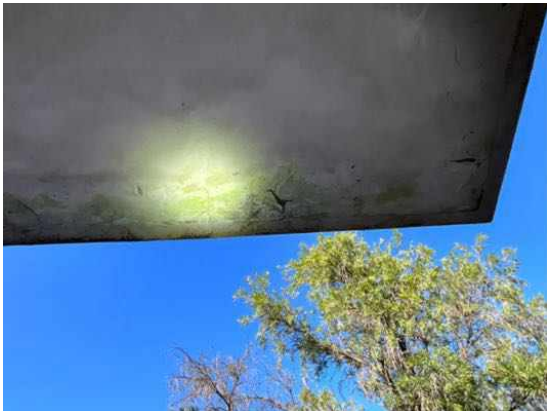
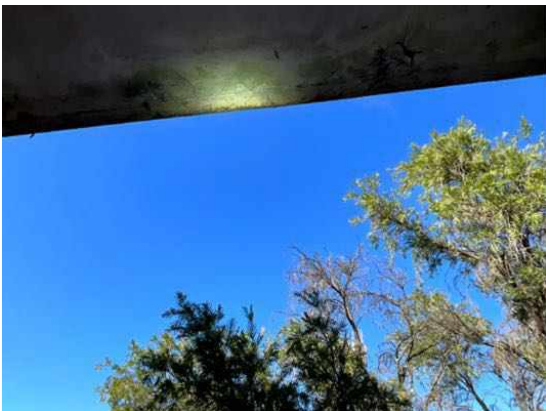
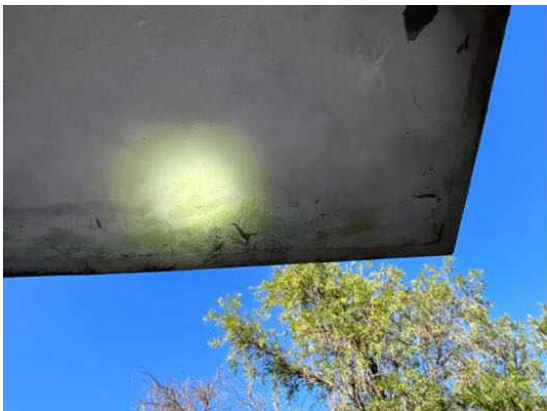
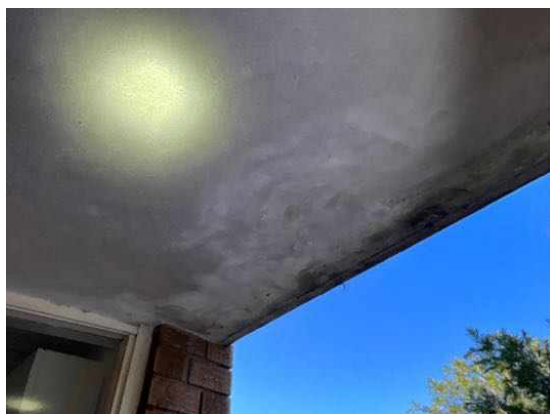
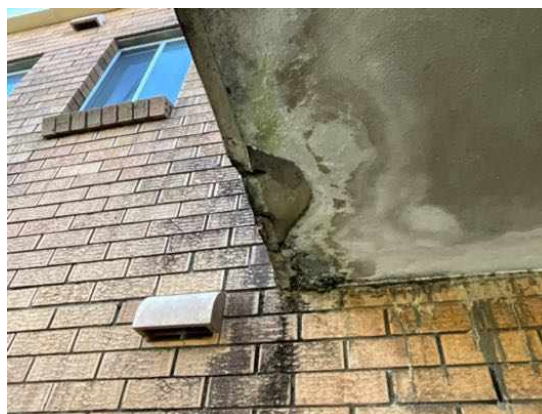
Defects 2.01

Building: Main Building
Location: Balcony
Finding: Water damage
Information: The area has sustained water damage resulting in potential structural issues. This damage compromises both the aesthetic and functional aspects.

1 **Plumber:** If the water damage is due to plumbing issues, a plumber can fix leaks and ensure there are no further water-related problems.

2 **General Contractor:** If the damage is extensive and affects the surrounding area, a general contractor can coordinate the repair work, including any related structural or cosmetic repairs.

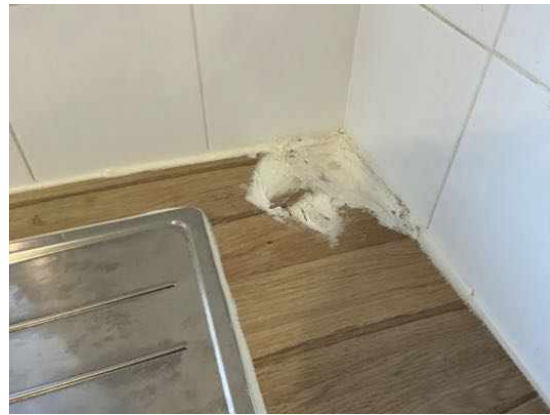
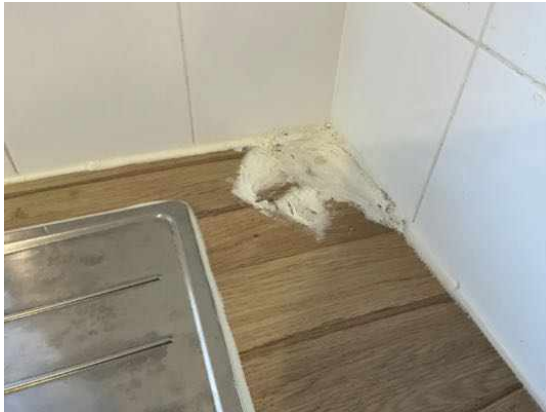
Defects 2.02

Building:	Main Building
Location:	Kitchen
Finding:	Water damage
Information:	The area has sustained water damage resulting in potential structural issues. This damage compromises both the aesthetic and functional aspects.

1 **Plumber:** If the water damage is due to plumbing issues, a plumber can fix leaks and ensure there are no further water-related problems.

2 **General Contractor:** If the damage is extensive and affects the surrounding area, a general contractor can coordinate the repair work, including any related structural or cosmetic repairs.

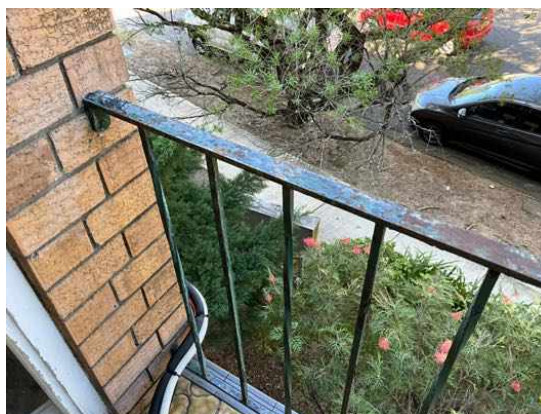
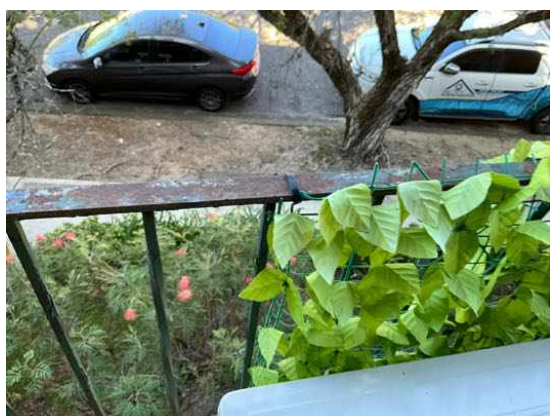
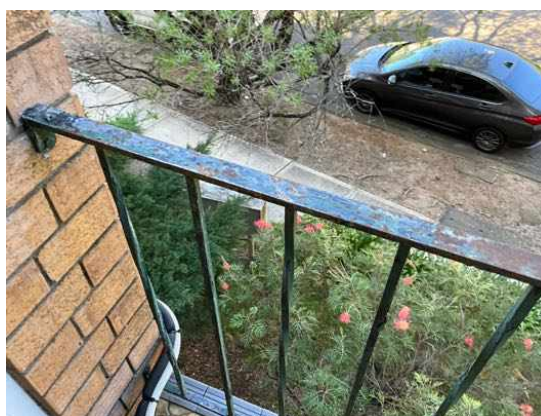
Defects 3.01

Building:	Main Building
Location:	Balcony
Finding:	Building element - Rusted or corroded
Information:	This building element shows evidence of rusting and corrosion, which is likely to have developed as a result of excessive exposure to moisture and or inadequate coatings.

As surface rust provides no protection to the underlying iron, the deteriorating

condition is likely to worsen if not addressed in the short-term future.

Where possible, the use of galvanized (treated) metals or aluminium coated metals aid in rust prevention, as does regular general maintenance. Rust formation can be controlled with coatings, such as paint, that isolate the iron from the environment.

Rusting and corrosion should be managed by ideally removing or limiting the affected surface from exposure to moisture. A registered builder may be appointed to replace any building elements that have been severely affected by rust or water damage.

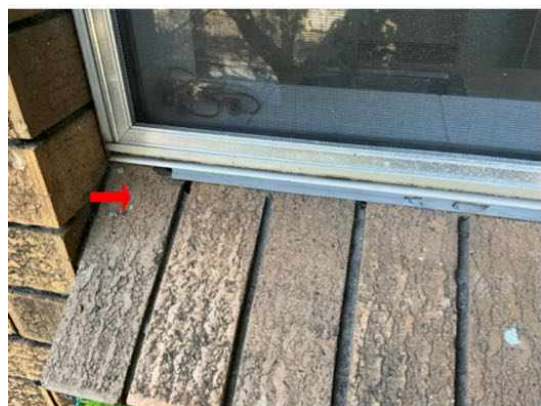
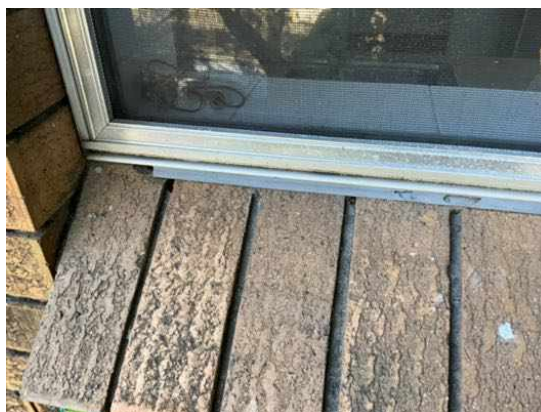
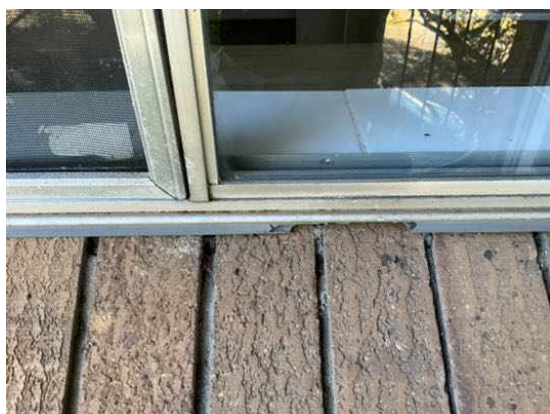
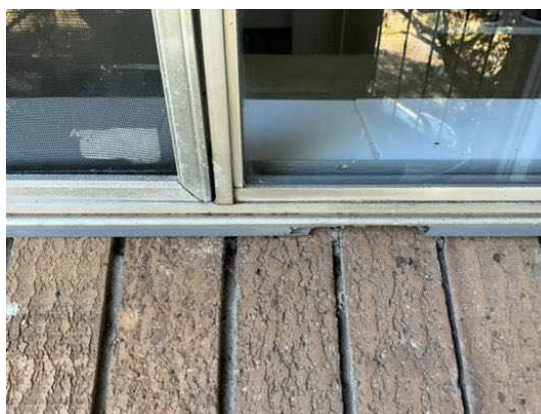
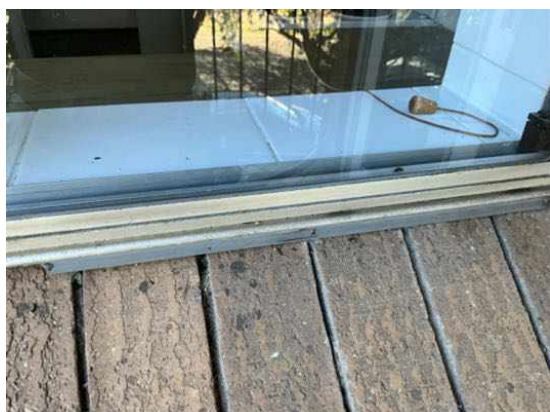
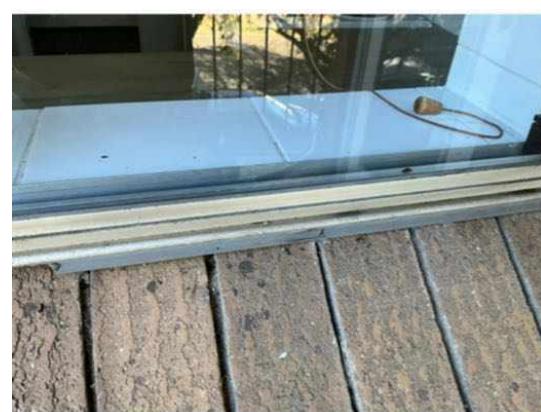
Defects 3.02

Building:	Main Building
Location:	Balcony
Finding:	Window Sill - Damaged or Poorly Installed Window Sill Flashing
Information:	The sill flashing below the aluminium window frame is damaged and not correctly sealed, allowing potential water ingress. This compromises the building's weatherproofing and may cause internal moisture damage.

Recommendation: Rectify by a licensed builder or window installer in accordance with relevant Australian Standards.

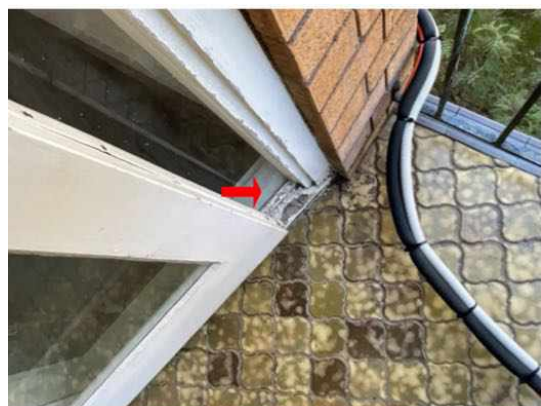
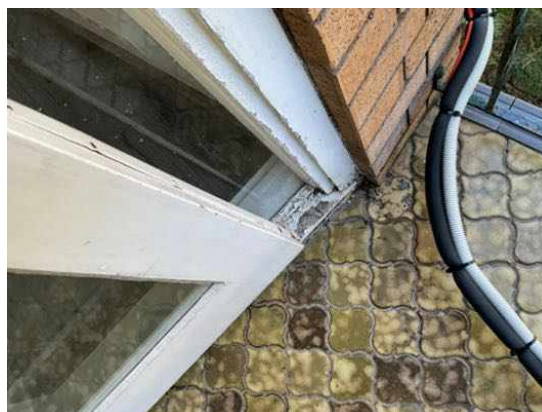
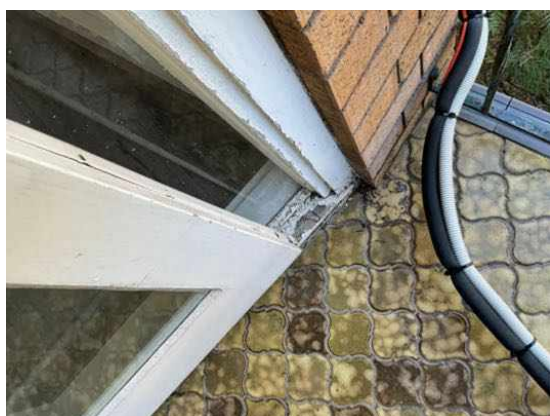
Defects 3.03

Information: External timbers that are frequently exposed to harsh weather conditions require adequate protection in order to maintain their condition. Where timbers have not been painted or treated adequately, general deterioration is likely to occur at an accelerated rate.

If left unattended, replacement of these timbers is likely to be necessary in the short-term future. Adequate treatment of these timbers is required as soon as possible by a painting contractor or general handyman.

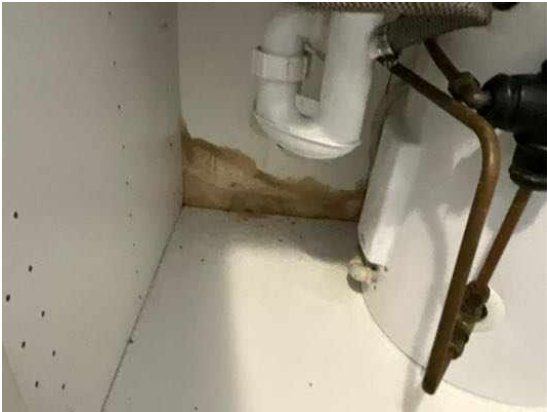
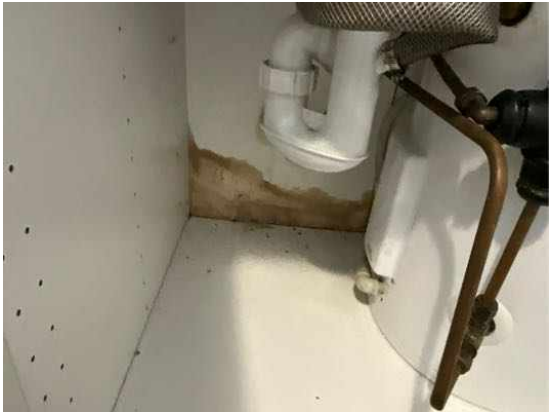
Defects 3.04

Building:	Main Building
Location:	Kitchen
Finding:	Water damage / Vanity
Information:	"The vanity in the shower area has sustained water damage, resulting in swelling and discoloration of the wood, as well as potential structural issues. This damage compromises both the aesthetic and functional aspects of the vanity."

1. **Carpenter or Woodworker:** They can assess and repair the damage to the vanity, potentially replacing any irreparable parts.
2. **Plumber:** If the water damage is due to plumbing issues, a plumber can fix leaks and ensure there are no further water-related problems.
3. **General Contractor:** If the damage is extensive and affects the surrounding area, a general contractor can coordinate the repair work, including both the vanity and any related structural or cosmetic repairs.

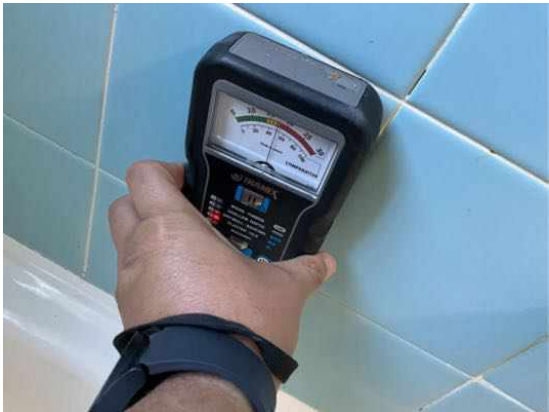
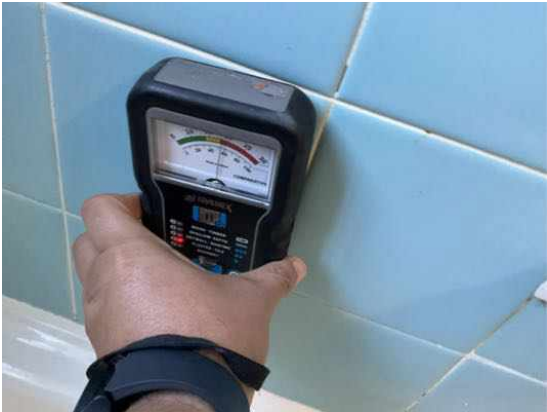
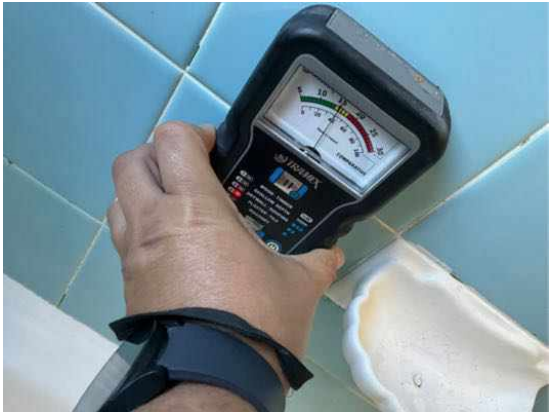
Defects 3.06

Finding: Evidence of excessive moisture was present at the time of inspection
Information: Excessive moisture is present behind the bathroom tiles, indicating a potential water leakage issue within the wall.

The prolonged presence of moisture can lead to mold growth, deteriorate the structure, and create an environment conducive to health hazards. Additionally, it may compromise the adhesive holding the tiles, leading to their detachment.

A licensed plumber or a qualified contractor specializing in water damage remediation should investigate the source of the moisture, fix any leaks, and address the damage. Additionally, replacing affected tiles and ensuring proper waterproofing are crucial to preventing future issues.

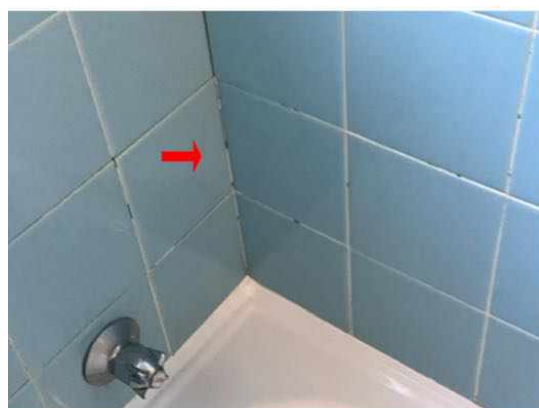
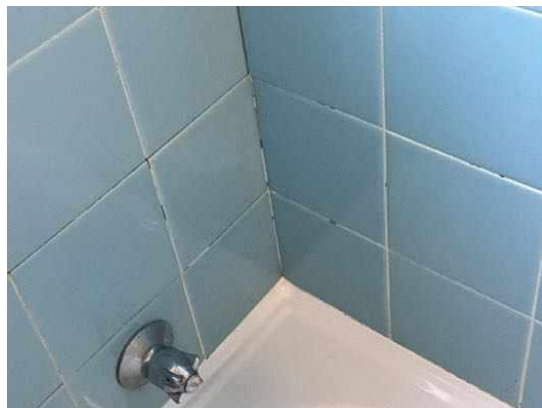
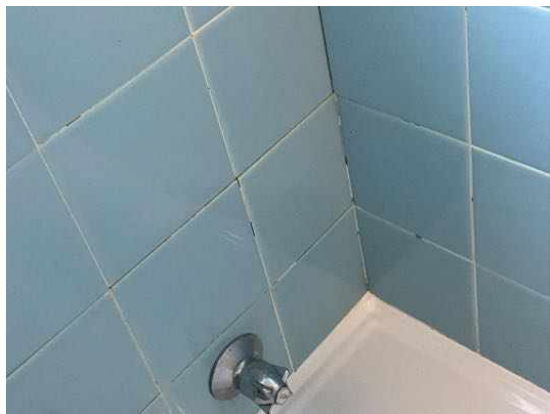
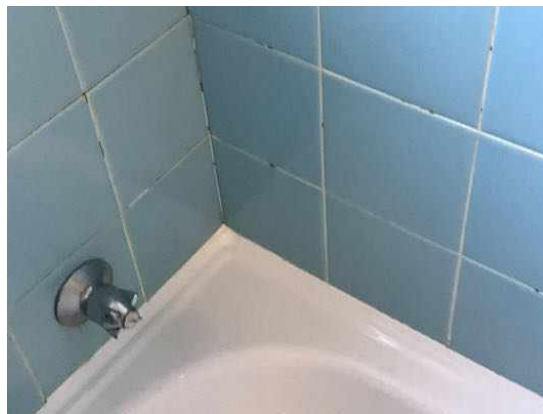
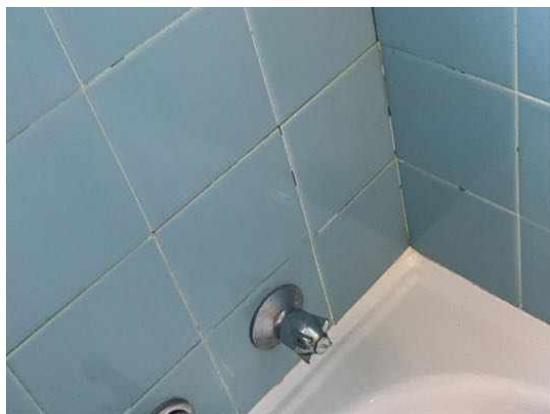
Defects 3.07

Building:	Main Building
Location:	Bathroom
Finding:	Sealant and grouting - Missing or damaged
Information:	It was noted on inspection that sealant or grout is degraded to the tiled shower alcove and or other areas of the bathroom.

Different materials and floor areas move at different rates, generally causing cracking to grout or sealant at this point. A flexible sealant is required to allow for expected expansion and contraction, while keeping the joint water tight and protective of all associated building materials.

There appears to be excessive mould to the sealant and grout which will likely require scraping out and replacement.

Flexible and mould resistant materials should be applied to affected areas to prevent any subsequent water damage that is likely to occur. Regular maintenance and replacement of damage or missing or damaged sealant and grout is highly recommended to the wet areas, as this is a regular wear and tear defect. Sealant and grouting in areas that come into regular contact with water should be maintained for the long term care of your property.

A sealant specialist or tiling contractor should be appointed to complete these works as soon as possible

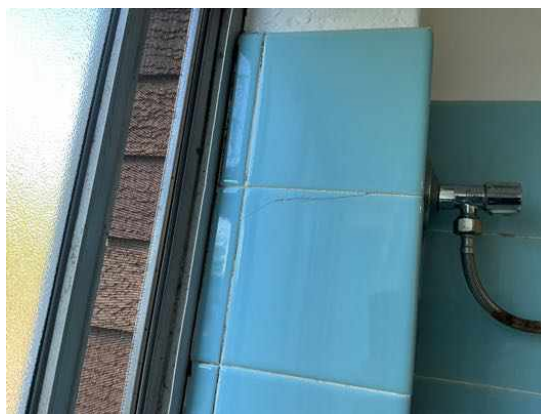
Defects 3.08

Building:	Main Building
Location:	Bathroom
Finding:	Tiles - Cracked or damaged
Information:	Cracking was evident to the tiling in this area at the time of inspection. While the cracking appears to be minor, this area is frequently exposed to water, allowing potential for water penetration into adjoining sections of walls or flooring.

If left unmanaged, water penetration to these areas may lead to subsequent water damage, which is likely necessitate repair work to affected building elements.

A tiling contractor should be appointed to ensure that no further water damage occurs. The re-application of silicone and grouting throughout remaining tile work is also advised, to further protect the area against water penetration.

Where water penetration has led to water damage, appointment of a relevant tradesperson may be required to repair damaged building elements.

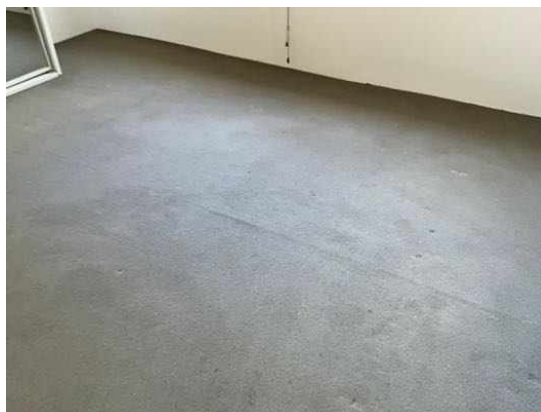
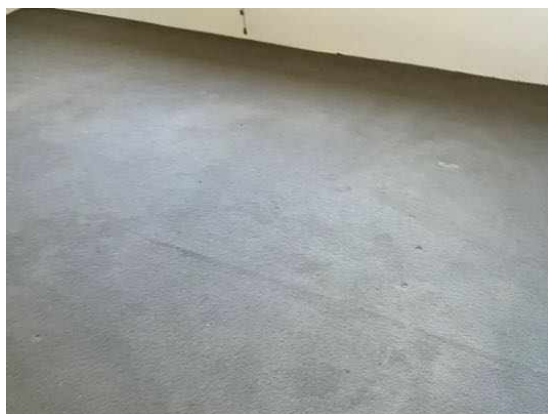
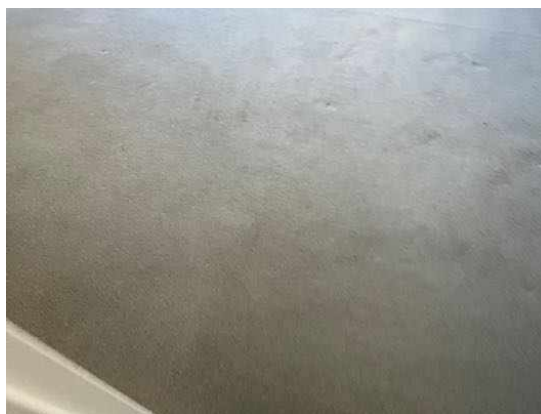
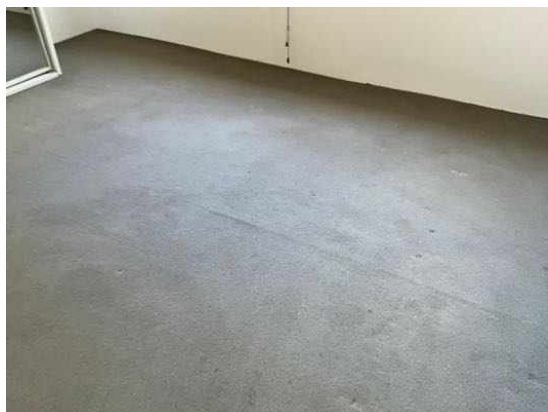
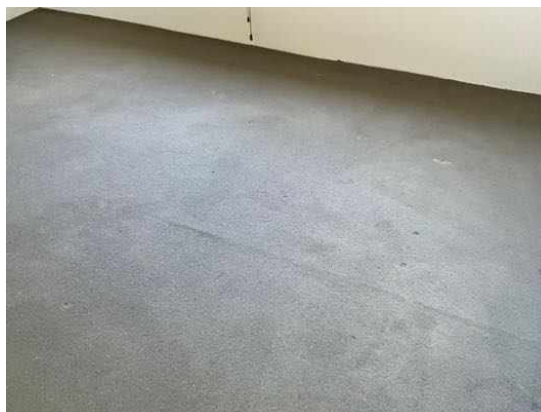
Defects 3.09

Building:	Main Building
Location:	All Areas
Finding:	carpet exhibits visible signs of aging
Information:	Carpets are exhibiting visible signs of aging, including fraying edges, faded colors, and flattened fibers, diminishing their aesthetic appeal and functional quality.

The risk associated with aging carpets includes diminished appearance, decreased comfort, potential tripping hazards due to frayed edges, and a negative impact on indoor air quality if fibers begin to degrade and release particles into the air.

Professional carpet cleaning and restoration services can address issues such as deep cleaning to rejuvenate colors, repairing frayed edges, and restoring fibers. Additionally, replacing the carpets entirely may be necessary in severe cases of aging or damage beyond repair.

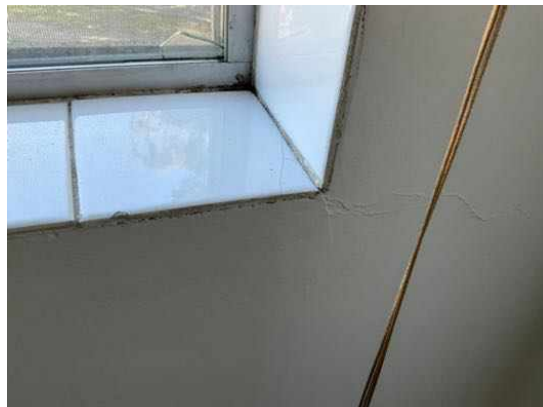
Defects 3.11

Building: Main Building
 Location: Bedroom 2
 Finding: Tile Damaged
 Information: A tile is visibly damaged, showing a chipped/broken section on the surface.

The damaged tile presents a trip hazard, may lead to cuts if stepped on barefoot, and can allow moisture ingress into the substrate, which may cause further deterioration or loosening of adjacent tiles. It also affects the overall appearance of the floor.

A licensed tiler should be engaged to remove the damaged tile and install a matching replacement. If spare tiles are unavailable, additional remedial work may be required to blend the repair with surrounding finishes.

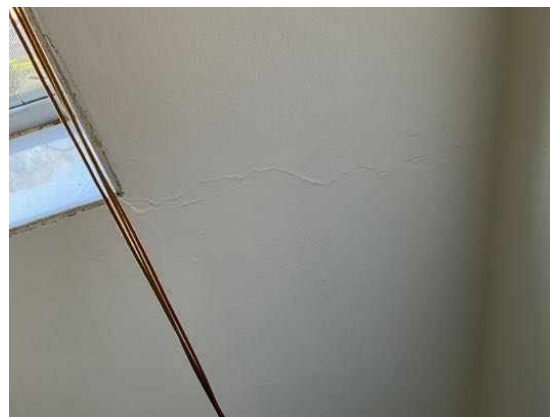
Defects 3.12

Finding: Brickwork - Cracking [Fine]

Information: Although fine cracks are quite noticeable, they are often only considered to be an appearance defect and usually do not indicate any structural damage. Generally, the cause of a fine crack is indicative of a separation between brickwork and mortar throughout the structure, but single bricks may also show cracks of this nature.

Cracking of this nature can generally be repaired with minor filling and should be conducted by a qualified bricklayer.
