Building Inspection Report

Inspection Date: Tue, 13 Jan 2026

Property Address: Unit 205, 24 Crimea St, St Kilda Vic 3182

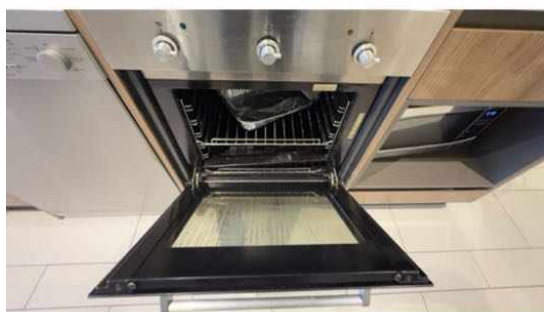
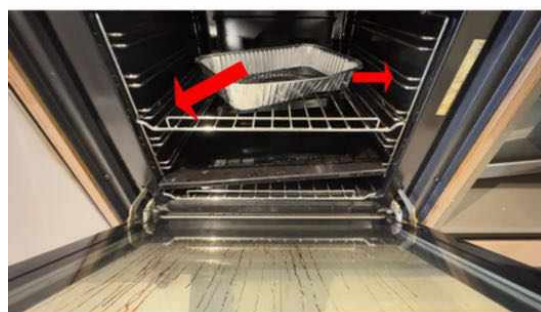
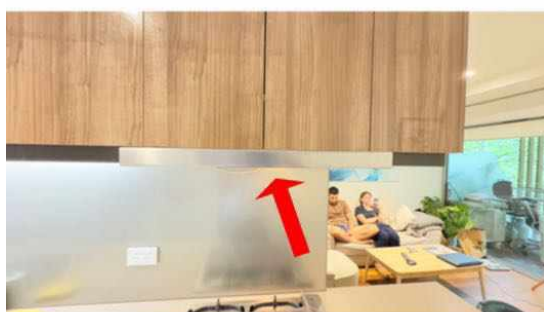
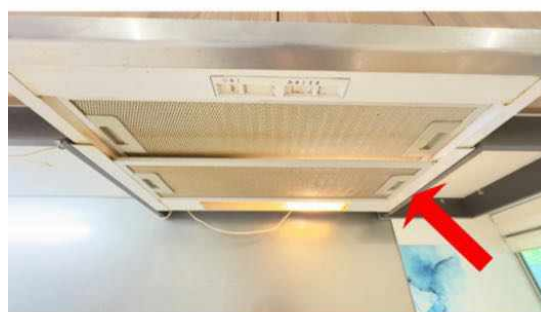
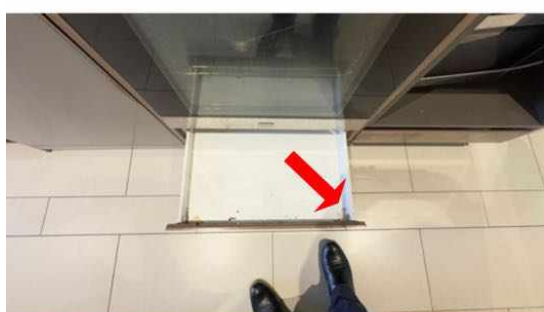
Defects 3.08

The kitchen, and associated appliances were visually inspected. Dirt accumulation, grease buildup, and lack of routine maintenance was observed. Untended appliances and surfaces can reduce functionality, accelerate wear, and create hygiene concerns.

Possible causes include grease, dust, and food debris from regular use, lack of routine cleaning, and age-related wear of components and fixtures.

When practical, a qualified appliance technician should be engaged to inspect and service all appliances. A professional clean of the kitchen, BBQ and appliances is also recommended to restore hygiene and operational efficiency. Ongoing routine maintenance will help prolong the life of all kitchen components.

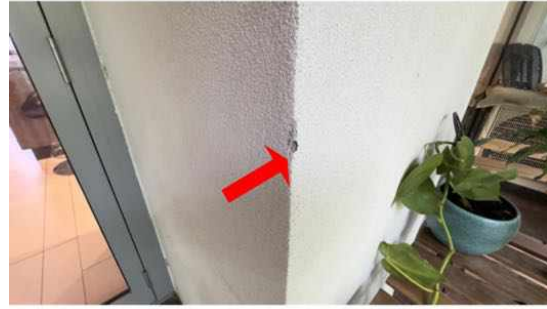
Defects 3.10

Building:	Main Building
Location:	Balcony
Finding:	Walls - Rendered Walls Damaged
Information:	Minor damage to wall surfaces was observed in this area, including small dents, chips, and surface imperfections. This type of damage is commonly associated with general wear and tear, minor impact, or movement over time.

While the damage is not considered structural in nature, it detracts from the overall presentation and finish of the property. Ongoing deterioration may occur if left unattended.

A suitably qualified renderer or competent handyman should be engaged, at the client's discretion, to carry out minor patching, sanding, and repainting as required to restore the affected areas to an acceptable standard.

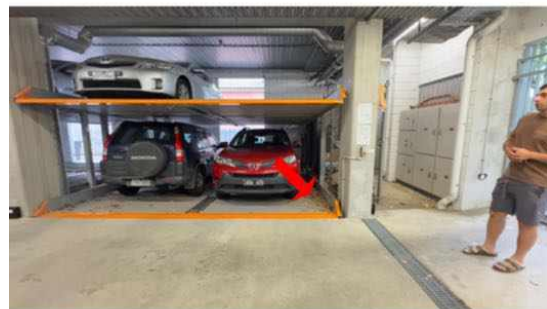
Defects 3.11

Building:	Main Building
Location:	Allocated Car Parking >
Finding:	Allocated Car Parking - Cleanliness & Hygiene
Information:	The allocated car parking space was inspected. At the time of inspection, the area was not in a clean or acceptable condition, likely due to a lack of routine cleaning or post-works housekeeping within the common property.

As this area forms part of the strata-managed common property, responsibility for cleaning and maintenance typically rests with the Owners Corporation, unless otherwise specified in the strata plan or by-laws.

It is recommended that the matter be raised with the strata manager for review and rectification in accordance with the strata maintenance obligations.

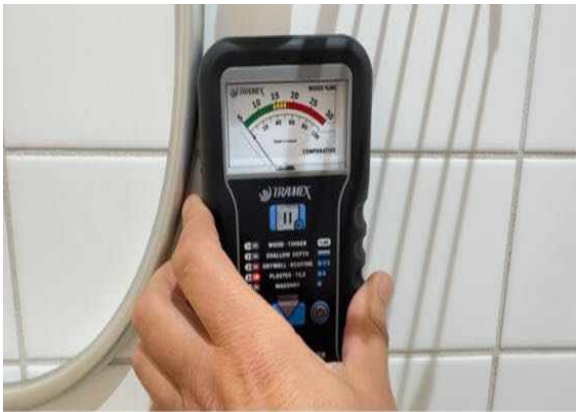
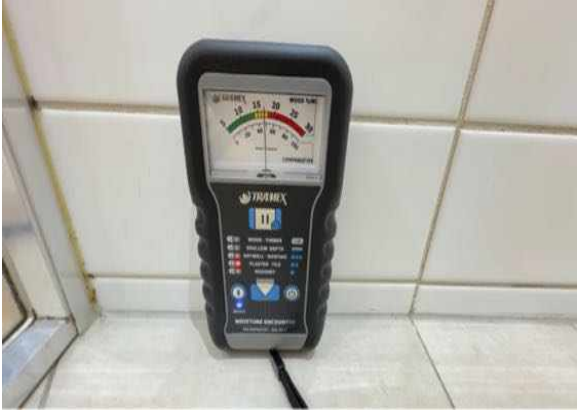
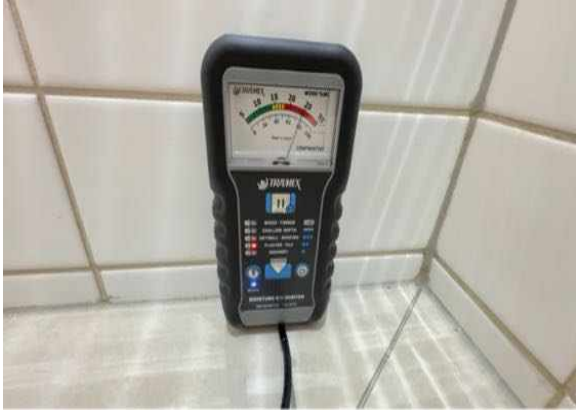
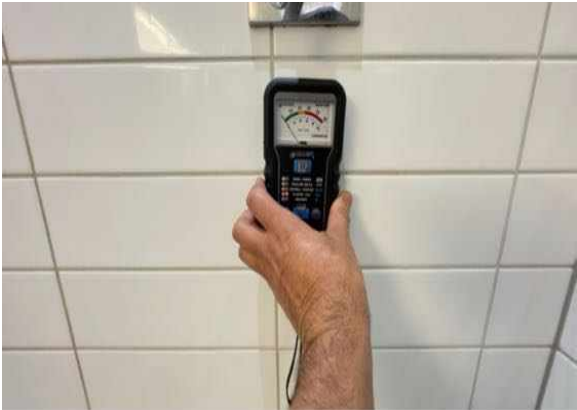
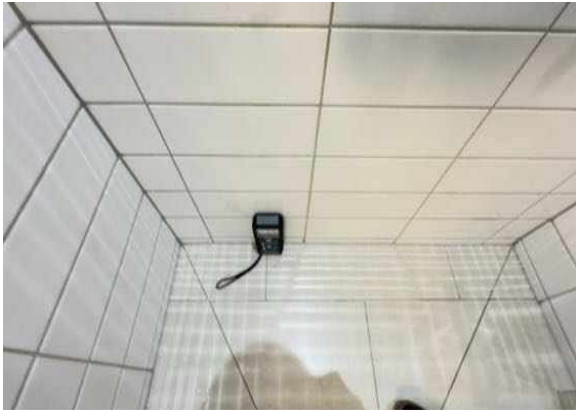
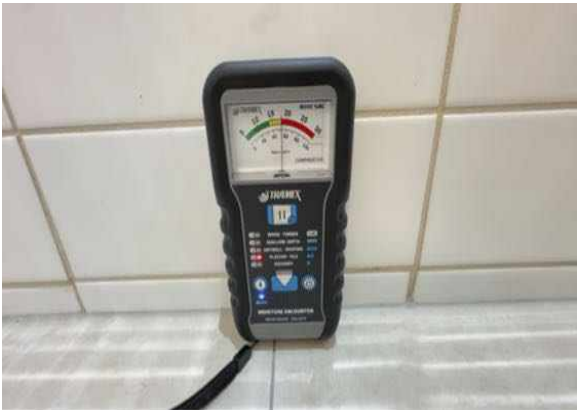
Noted Item

Building: Main Building
 Location: All Areas Interior & Exterior
 Finding: Moisture Levels - Advisory - No Elevated Moisture Levels Present
 Information: At the time of inspection, no elevated moisture levels were detected in these areas. Moisture readings were taken (using a Tramex Moisture Meter) and non-invasive testing methods and reflect conditions present at the time of inspection only. This item is noted for advisory purposes and should not be relied upon as a guarantee that moisture issues are not present elsewhere or may not occur in the future.

Ongoing monitoring of the property is recommended, and further investigation by a qualified tradesperson should be considered if signs of water ingress, dampness, staining, mould growth, or material deterioration become apparent.
