Building and Timber Pest Inspection Report

Inspection Date: Wed, 25 Mar 2026

Property Address: 1/34 Ayr St, Reservoir VIC 3073, Australia

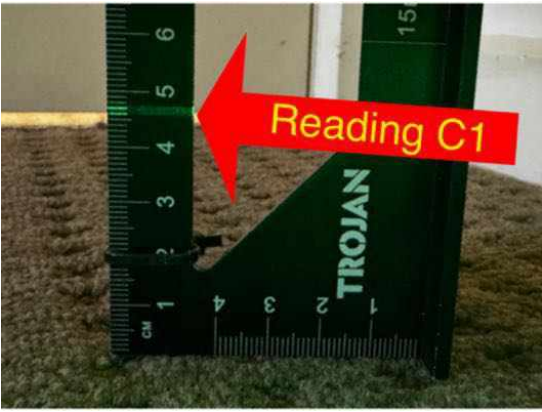
Building: Main Building
Location: All Areas > All Areas
Finding: Excessive Floor Level Deviation and Suspected Movement (Major Defect)
Information: Multiple floor level readings were taken using a laser level, which identified significant deviations across both ground and first floor levels. The ground floor recorded a variation of approximately 44 mm from the entry to the kitchen, while the first floor hallway to front bedroom recorded a variation of approximately 35 mm. A further reading within a first floor bedroom identified a variation of approximately 27 mm over a span of approximately 4 metres.

In addition to the floor level deviations, several doors throughout the dwelling were observed to self-close, including bedroom doors and the entry door, indicating that floors are not level and are sloping. The toilet door was also observed to be binding and scraping on the floor, further supporting evidence of movement or distortion within the structure.

The combination of significant floor level variation across multiple areas, along with functional issues such as door misalignment and binding, indicates that the building is experiencing structural movement or settlement, which may be related to subfloor conditions, footing movement, or differential settlement.

In accordance with AS 4349.1–2007 (Inspection of Buildings), defects involving significant movement or distortion affecting the serviceability of the building are classified as Major Defects.

Floor level variation of approx. 27mm

It is recommended that a structural engineer be engaged to assess the extent and cause of the movement. Further investigation of the subfloor, footings, and structural framing system is required. Remedial works may include re-levelling, structural repairs, or stabilisation of foundations, depending on findings.

Immediate – further investigation is required as soon as practicable to determine the cause and prevent further movement.

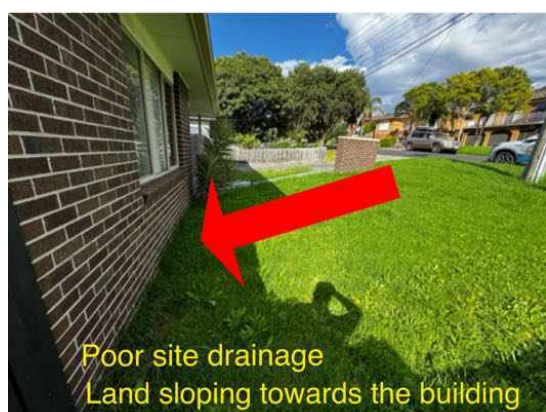
Finding 2.02

Building:	Main Building
Location:	Yard - Front, rear > Front,Rear
Finding:	Poor Site Drainage Around Building Perimeter (Major Defect)
Information:	Poor site drainage was observed to the property, with the front yard visibly sloping towards the building and no visible surface drainage installed along the perimeter. A similar condition was noted to the rear yard, where sections of the ground were also sloping towards the building.

At the time of inspection, no surface drainage systems were visible, and it could not be confirmed whether any subsurface drainage systems (such as agi drains) are installed around the property. The degree of fall towards the building at the front yard is considered significant, which increases the likelihood of surface water being directed toward the foundations.

Poor drainage conditions of this nature may lead to moisture ingress, soil movement, and potential impact on footings and structural elements over time, and may also contribute to other defects observed throughout the property.

In accordance with AS 4349.1–2007 (Inspection of Buildings), defects that may contribute to foundation instability, moisture ingress, or long-term deterioration are classified as Major Defects.

It is recommended that the site drainage be further investigated and verified, including determining whether any subsurface drainage exists. If inadequate or absent, a qualified drainage plumber should be engaged to install appropriate drainage systems around the building perimeter. The ground should also be regraded to ensure adequate fall away from the building.

Immediate – rectification is recommended as soon as practicable to prevent moisture-related issues and potential structural impact.

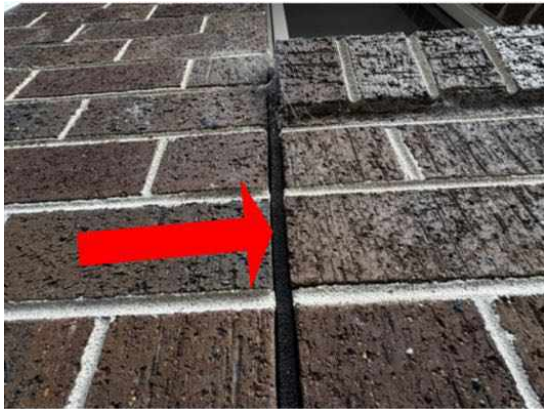
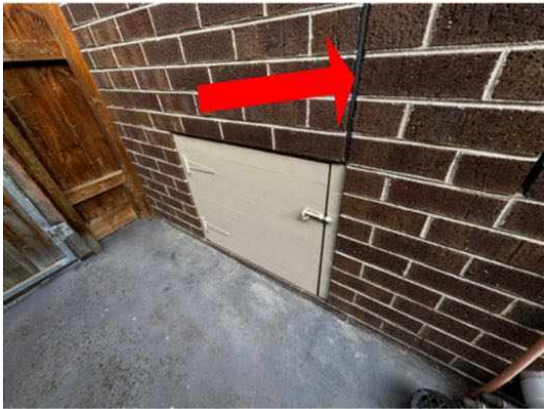
Finding 2.03

Building:	Main Building
Location:	Yard - Front, rear > Front,Rear
Finding:	External Defects Including Drainage, Movement and Maintenance Issues
Information:	The following external defects were observed during the inspection, comprising a combination of major defects and maintenance-related issues.

A damaged downpipe was observed to the external wall adjacent to the common driveway, and several brickwork articulation joints were missing sealant (caulking) throughout the building, which may allow moisture ingress and reduce the effectiveness of movement joints. A visible gap to the window infill above the front elevation window was also noted, indicating substandard installation, which may allow water penetration.

It is recommended that a licensed builder and/or relevant trades be engaged to address the identified defects. This should include rectification of displaced paving, sealing of articulation joints, repair of downpipes and drainage systems, correction of substandard installations, and stabilisation of leaning structures. Further investigation of ground conditions and drainage may also be required to prevent recurrence.

Immediate – rectification is recommended as soon as practicable to prevent further deterioration and potential structural impact.

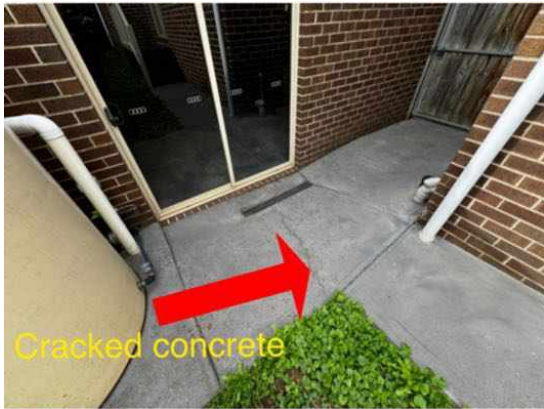
Significant defects were identified to the concrete driveway and paving adjacent to the garage, where substantial cracking and vertical displacement of up to approximately 25 mm was observed, with crack widths exceeding 5 mm, indicating movement within the paving and/or supporting ground conditions.

Cracked concrete

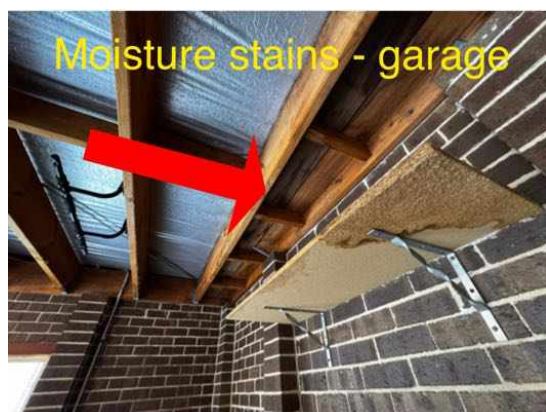
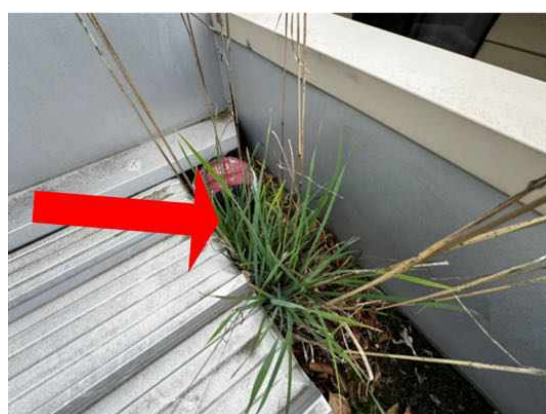
Finding 2.04

Building: Garage
 Location: Roof Exterior > Rear
 Finding: Moisture Damage to Garage Roof Framing from Blocked Box Gutter (Major Defect)
 Information: Moisture staining was observed to the timber members supporting the box gutter within the detached garage, which are visible due to the absence of ceiling linings. The staining indicates that the timbers have been subjected to moisture ingress over time.

Inspection of the roof area above identified that the box gutter was blocked with organic growth and debris, which is the likely cause of the issue. Blocked box gutters can lead to overflow during rainfall events, allowing water to back up and penetrate adjacent structural elements, including the supporting timbers.

Ongoing exposure to moisture may result in timber deterioration, decay, and reduced structural integrity if not addressed.

In accordance with AS 4349.1–2007 (Inspection of Buildings), defects involving moisture ingress affecting structural elements and requiring rectification to prevent further deterioration are classified as Major Defects.

It is recommended that the box gutter be cleaned immediately, and that a licensed roofing contractor inspect the gutter system, including falls, outlets, and waterproofing, to ensure proper function. The affected timbers should be assessed for any signs of decay or damage, and repaired or replaced if required.

Immediate – rectification is required as soon as practicable to prevent further moisture damage and potential structural deterioration.

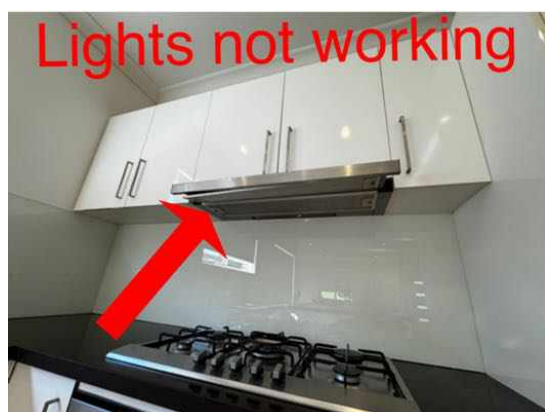
Finding 3.01

Building: Main Building
Location: All Areas > All Areas
Finding: Internal Maintenance and Minor Defects
Information: The following minor internal defects and maintenance-related issues were observed during the inspection. The kitchen range hood lights were not operational, and the oven door was not closing fully, affecting functionality of the appliance.

Additional defects included minor damage to kitchen cupboards and moisture damage to laundry cabinets, likely associated with general use and exposure to moisture. A minor leak was observed to the ensuite shower screen following a water test, which is likely due to deteriorated or failed sealant.

Damaged kitchen cabinets

It is recommended that these items be addressed as part of routine maintenance, including repair or replacement of faulty appliances, resealing of shower screens, and repair or replacement of damaged finishes and fixtures.

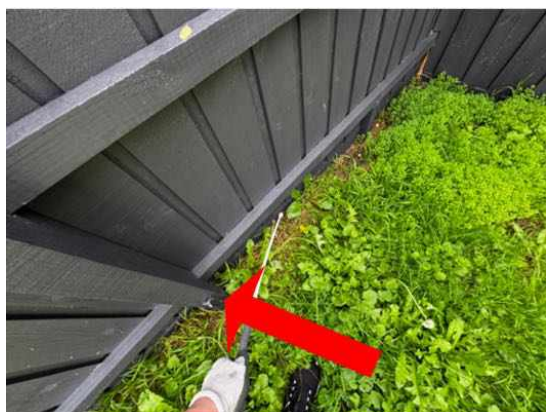
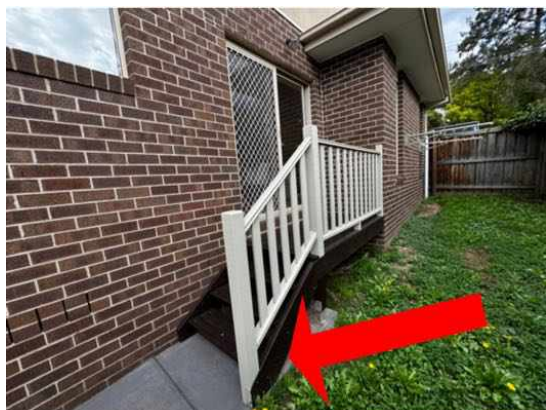
Building:	Main Building
Location:	All Areas > All Areas
Finding:	Inground timber contact (TP)
Information:	At the time of inspection, in-ground timber contact was observed to the front, side and rear yards, all in direct contact with the ground. These timber elements are positioned within the soil zone and in close proximity to the building and associated structures.

In accordance with AS 3660.2, conditions that facilitate termite access or provide a direct food source are recognised as increasing the risk of termite activity to existing

buildings. Timber elements in direct contact with the ground are particularly vulnerable, as they can attract subterranean termites and support concealed foraging activity, potentially allowing termite colonies to establish and migrate toward nearby structures without early detection.

As a result, the presence of in-ground timber elements is considered to increase the risk of termite activity to the property. It is recommended that a licensed termite management or pest control contractor be engaged to assess these conditions and provide advice on appropriate risk mitigation measures, which may include removal or replacement of timber elements with non-susceptible materials, isolation of timber from soil contact, and integration of suitable termite management measures to suit the existing site conditions.

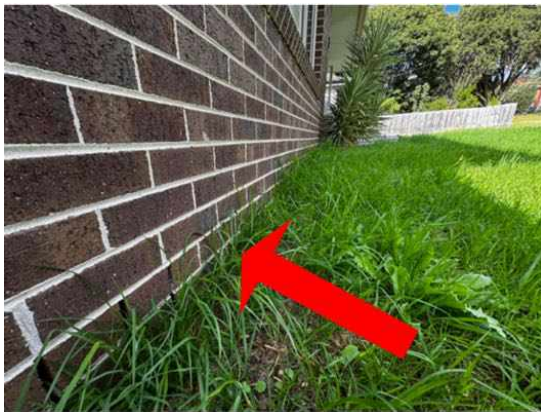
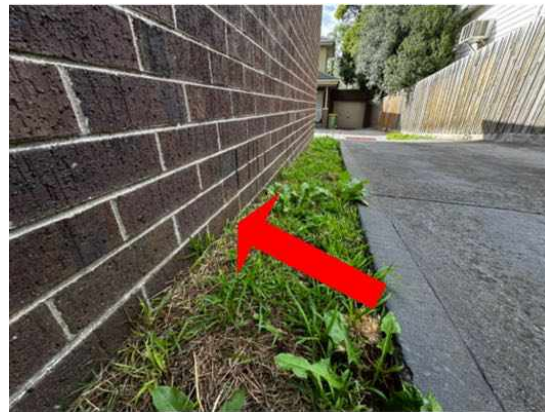
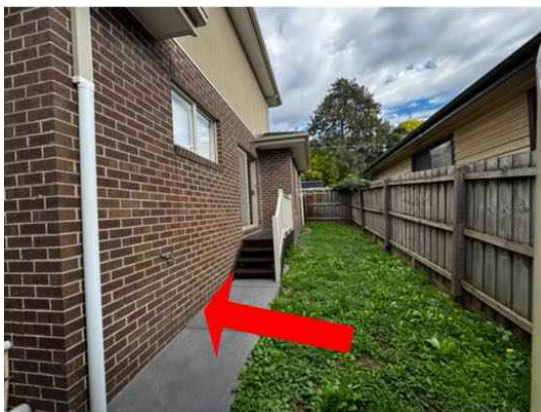
Finding 6.02

Building:	Main Building
Location:	All Areas > All Areas
Finding:	Building edge - concealed (TP)
Information:	At the time of inspection, the building edge to most areas of the building was observed to be concealed behind concrete paving, landscaping and timber decking. This condition restricts clear visibility of the slab perimeter and limits the ability to visually inspect critical inspection zones intended for the early detection of termite activity.

Where building edges and inspection zones are concealed, concealed termite entry paths may develop without early warning. In accordance with AS 3660.2, existing buildings are required to maintain conditions that allow for effective inspection and management of termite risk, noting that obstructions such as paving, paths, or landscaping can compromise the effectiveness of termite management measures. Where inspection zones are obstructed, the likelihood of undetected termite activity is increased. Although the building has a subfloor area for inspection, some areas of the subfloor are inaccessible.

As a result, the current configuration is considered to increase the risk of concealed termite entry to the building. It is recommended that a licensed termite management or pest control contractor be engaged to assess the extent of the concealed slab edges and provide advice on rectification options, which may include modifying paving or landscaping to reinstate suitable inspection access and integrating appropriate termite management measures to suit the existing conditions.

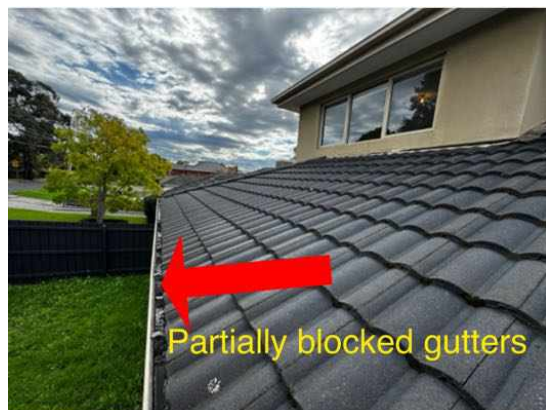
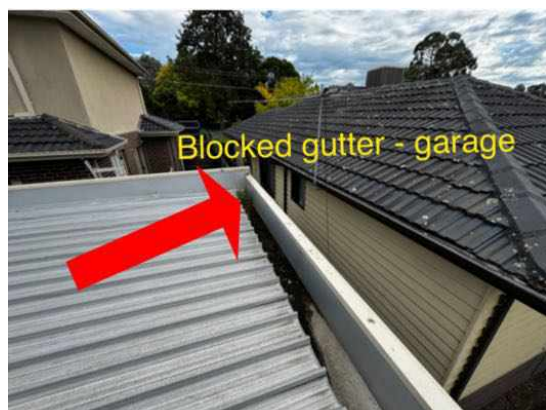
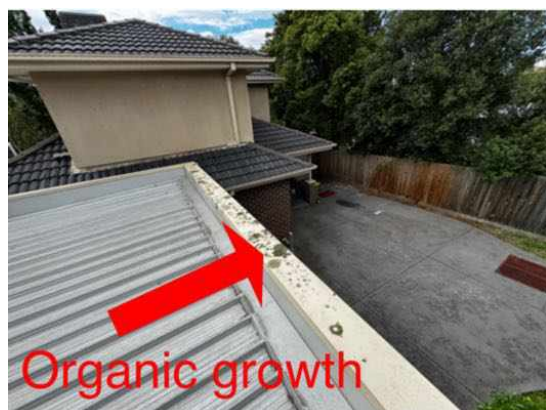
Finding 6.03

Building:	Main Building
Location:	Roof Exterior > Front,Rear
Finding:	Blocked gutters and organic growth (TP)
Information:	At the time of inspection, organic debris was observed to the roof areas, together with partially blocked gutters and downpipes. These conditions promote prolonged

moisture retention and reduced effectiveness of roof drainage, the issue is suspected to be associated with a lack of routine maintenance.

In accordance with AS 3660.2, conditions that promote ongoing dampness, moisture accumulation, or inadequate drainage are recognised as increasing termite risk to existing buildings, as elevated moisture levels can create environments conducive to termite foraging and concealed activity. Blocked gutters and downpipes may allow water to overflow or discharge against building elements, increasing moisture exposure to adjacent materials and reducing the effectiveness of termite risk management through visual inspection.

As a result, the observed organic debris and drainage issues are considered to increase moisture-related deterioration and elevate the overall risk of termite activity. It is recommended that an appropriately qualified roof plumber be engaged to clean and service the gutters and downpipes and that roof surfaces be maintained to reduce moisture retention, with ongoing monitoring and advice from a licensed termite management or pest control contractor where elevated termite risk is identified.

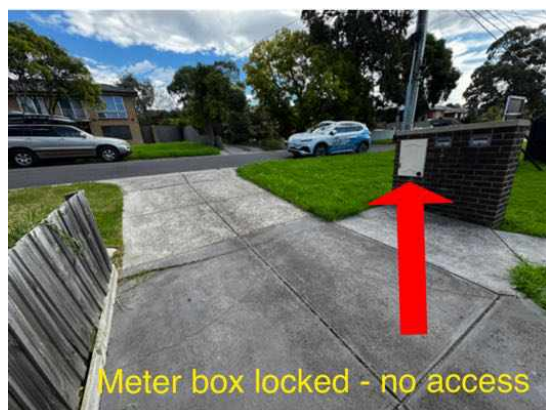
Finding 6.04

Building:	Main Building
Location:	Meter Box > Front
Finding:	Termite management system - no evidence of chemical installation (TP)
Information:	At the time of inspection, there was no visible evidence to suggest that a chemical termite management system has been installed or remains effective. In addition, no durable notice was observed within the electrical switchboard to identify the presence, type, or date of any termite protection measures.

For this reason, the installation of a post-construction chemical termite management system is highly recommended to reduce the risk of termite activity. A durable notice should also be installed within the electrical switchboard to clearly identify the treatment provided and support ongoing inspection and maintenance.

Engagement of a licensed termite management or pest control contractor is recommended as a matter of priority to assess the site conditions, consider local termite risk, and determine the most appropriate treatment method and procedures for this property.
