Building and Timber Pest Inspection Report

Inspection Date: Wed, 25 Feb 2026

Property Address: 10 Kanowna Ave, Cessnock NSW 2325,
Australia

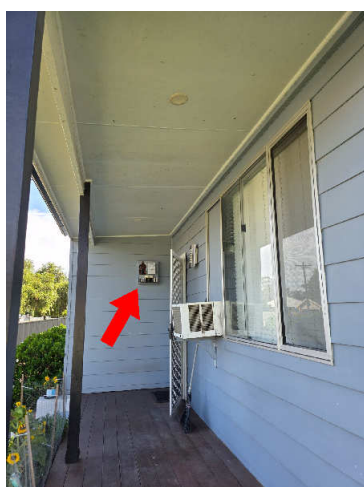
Finding: Electrical Board Condition – Front Verandah

Information: An outdated rewirable fuse board with mixed generations of circuit protection was observed at the external switchboard location. The installation includes older ceramic fuse carriers and does not appear to provide full modern RCD protection to all final subcircuits. The backing board also appears to be asbestos cement sheeting. This type of installation presents an increased risk of electric shock and fire compared to contemporary standards.

A licensed electrician should assess the switchboard, confirm the presence and adequacy of RCD protection, and upgrade the installation as required. If asbestos-containing material is confirmed, appropriate handling procedures will be required. This should be addressed without delay.

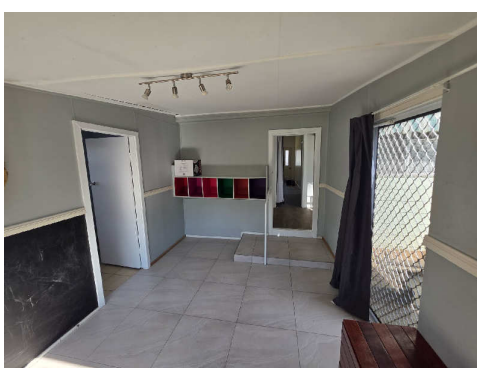
Finding 2.01

Finding: Missing External Door – Rumpus Room

Information: No external door is fitted to the rear doorway of the rumpus room, and no internal door is installed between the rumpus room and the adjacent kitchen and living areas. A flyscreen door is present and can be locked; however, this is not a weatherproof or secure barrier. This condition may be due to incomplete installation or removal of original doors. The absence of proper doors presents a weatherproofing issue, allowing wind and rain ingress, and also creates a safety and security risk due to inadequate physical separation and protection.

A licensed builder should be engaged to assess and rectify as required. This should be done without delay.

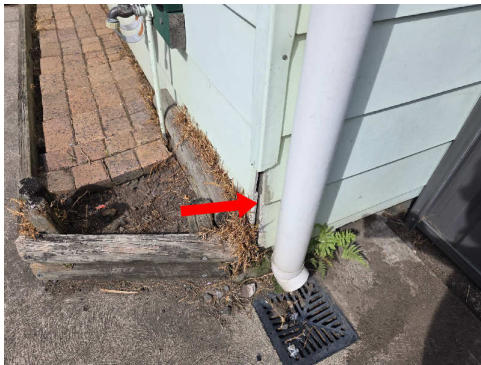
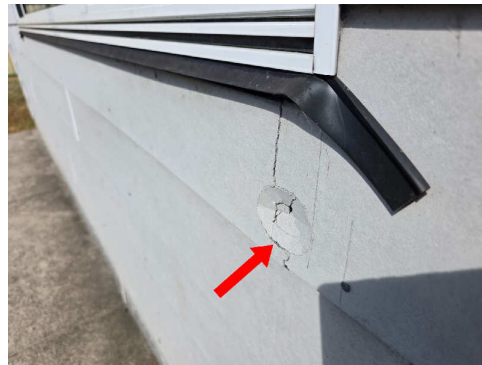
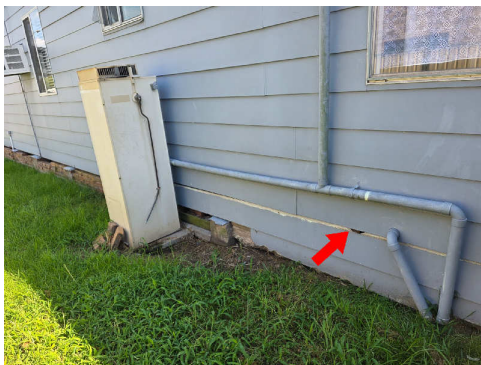
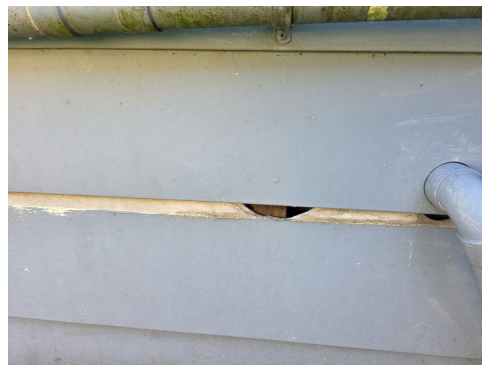
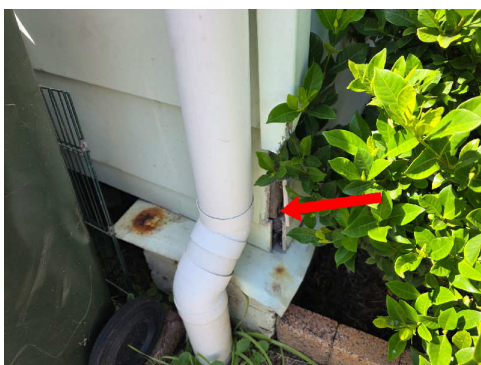
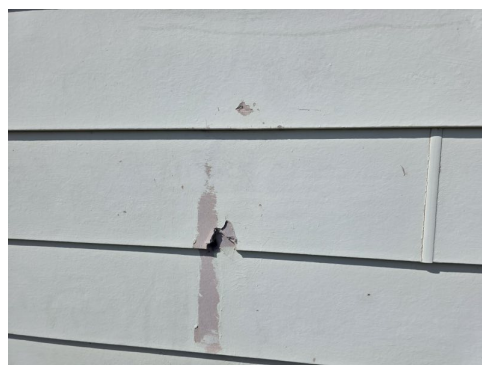
Finding 2.02

Finding: Damaged Weatherboards – External Walls

Information: External walls clad with weatherboards show areas of deterioration including slipped or broken boards, impact damage, missing or damaged corner trims and localised exposure of internal framing. Ongoing exposure may permit moisture ingress and further deterioration of cladding and framing elements.

A licensed builder should be engaged to assess and rectify as required. This should be done as soon as practicable.

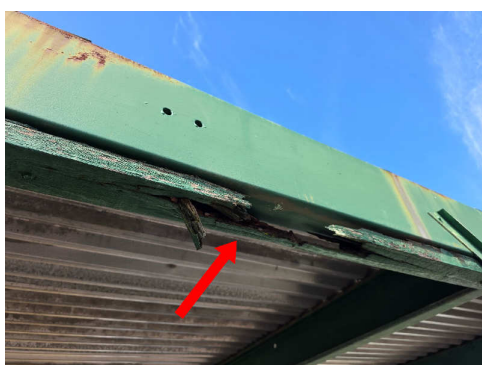
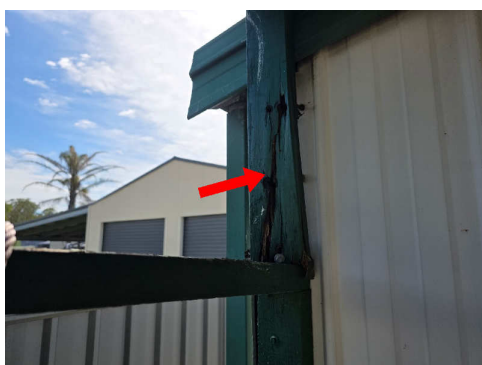
Finding 2.03

Finding: Carport Timber Decay and Roof Collapse – Carport

Information: Timber elements to the carport are extensively affected by fungal decay, with some sections completely deteriorated. A makeshift roof bridging the carport to the garage is supported by a timber member that has significantly rotted, resulting in the roof being in a state of collapse.

A licensed builder should be engaged to assess the cause and extent and rectify as required. This should be done without delay.

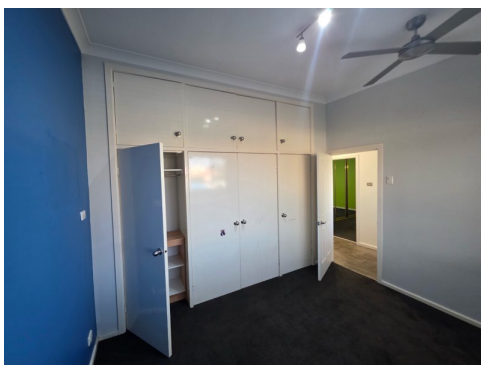
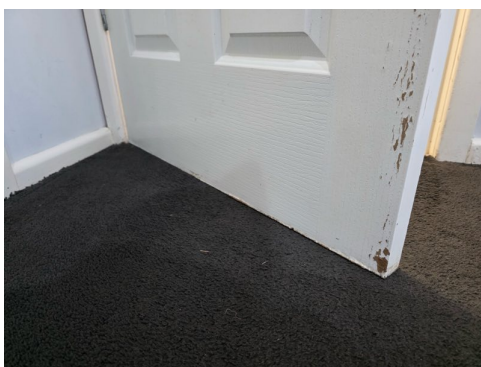
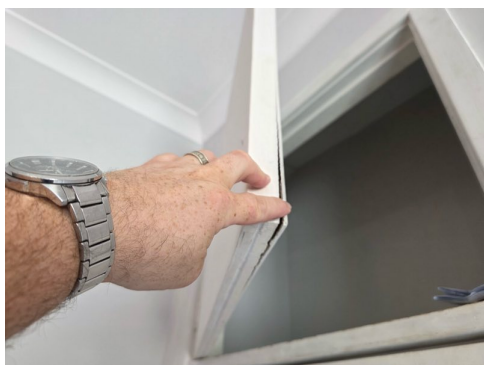
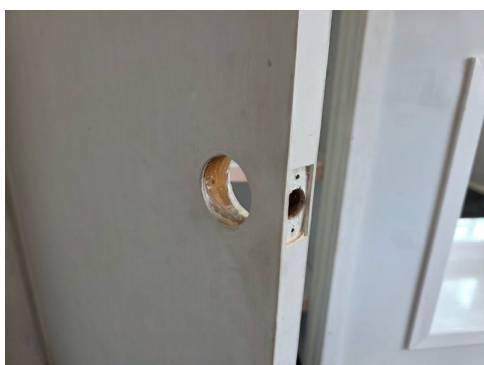
Finding 3.01

Wardrobe doors in Bedrooms 1 and 3 are binding and require adjustment. In Bedroom 1 the wardrobe doors are rubbing on the carpet and the entry door has minor damage to the lower edge with scratch marks to the internal face. In Bedroom 2 the door does not latch when closed. In Bedroom 3 the top wardrobe doors have sustained minor damage and have no hardware fitted, and the bedroom door has a loose top hinge causing it to bind on the jamb and rub on the carpet, requiring lifting to close. The bathroom door has not been painted or sealed to the top or bottom edges. Unsealed timber in wet areas is susceptible to moisture ingress.

These conditions appear consistent with misalignment, hinge wear or minor movement, and continued use may result in further damage to doors, hardware and adjacent finishes. A qualified carpenter should be engaged to assess and rectify as required. This should be done as soon as practicable.

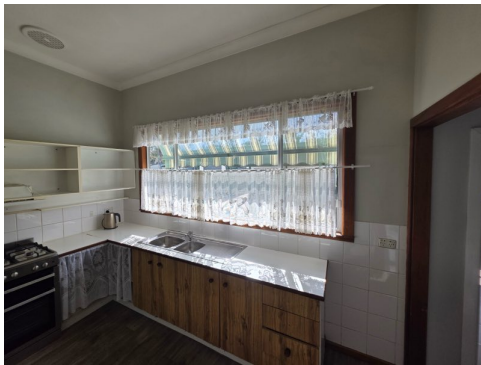
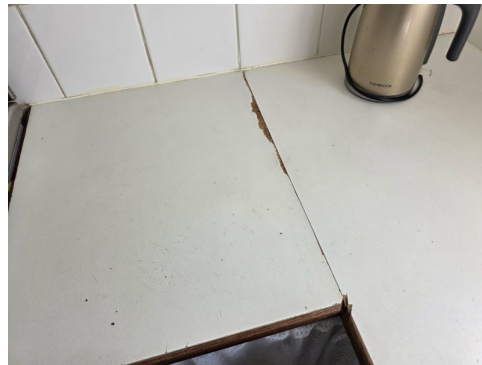
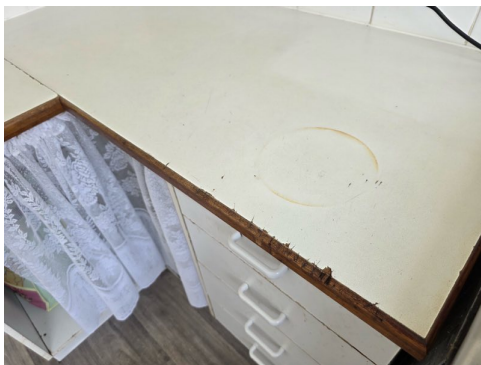
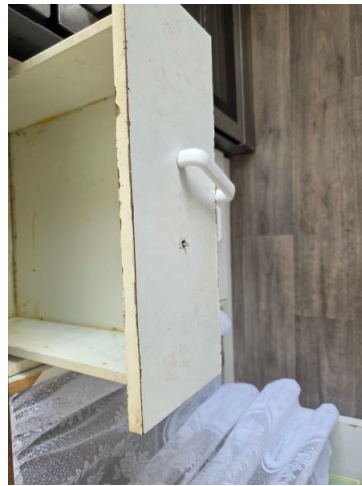
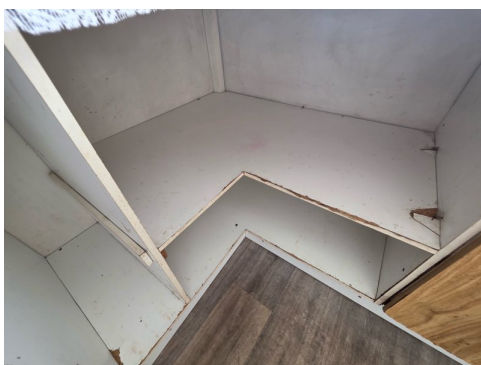
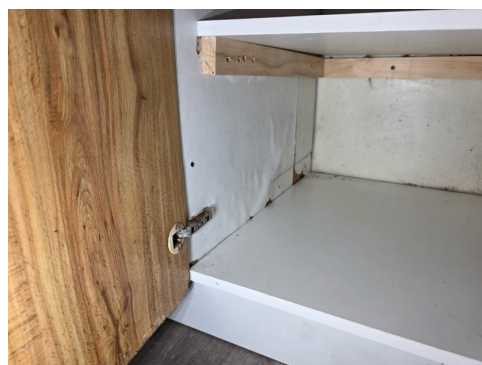
Finding 3.02

Finding: Deteriorated Kitchen Cabinetry and Moisture-Affected Joinery – Main Kitchen

Information: The kitchen is aged and in deteriorated condition. Overhead cupboards have no doors, drawers are missing handles and are difficult to operate, cabinet doors under the sink are binding, and a corner cupboard shelf has collapsed with fixings pulled through and associated edge damage. Blistering of laminate was also observed to the internal sides of the sink cabinet, which may be due to past moisture exposure; no elevated moisture was recorded at the time of inspection. Continued deterioration may result in further functional failure of cabinetry and progressive material breakdown.

A qualified carpenter should be engaged to assess and rectify as required. This should be done as soon as practicable.

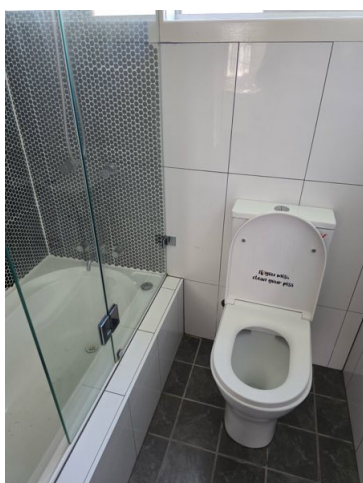
Finding 3.03

Finding: Cracked Wall Tiles – Main Bathroom

Information: Cracked tiles were observed in the main bathroom extending from a shower screen fixing point through an adjacent tile and continuing behind the toilet cistern. Cracking in wet areas may allow moisture ingress behind finishes, potentially leading to substrate deterioration.

A waterproofing contractor should be engaged to assess the cause and extent and rectify as required.

This should be done as soon as practicable.

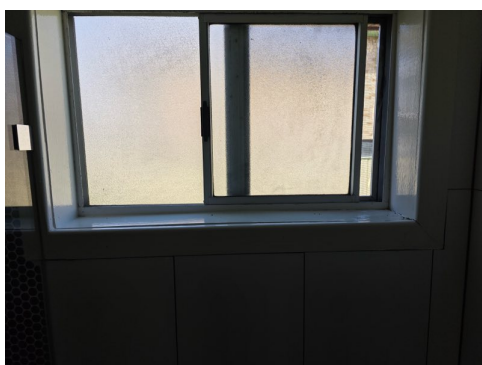
Finding 3.04

Location:	Bathroom
Finding:	Rotten Window Reveal – Bathroom
Information:	<p>The bathroom window reveal appears to be affected by fungal decay and has been painted over, limiting full assessment during a visual, non-invasive inspection. Timber decay in wet areas may compromise the integrity of the reveal and allow further moisture ingress into adjacent framing.</p> <p>A qualified carpenter should be engaged to assess the cause and extent and rectify as required. This should be done without delay.</p>

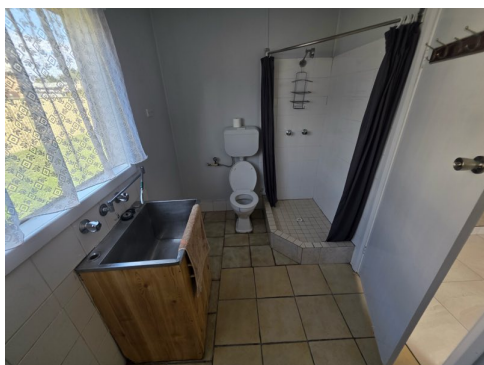
Finding 3.05

Building:	Main Building
Location:	Laundry
Finding:	Laundry Shower Tiling Defects – Laundry
Information:	<p>In the laundry shower, a vertical crack runs through approximately five tiles in line with the shower curtain, a tile is broken adjacent to the shower hob, and no sealant is present in the internal corner. These defects may allow moisture ingress into wall substrates, potentially resulting in concealed deterioration.</p> <p>A waterproofing contractor should be engaged to assess the cause and extent and rectify as required.</p> <p>This should be done as soon as practicable.</p>

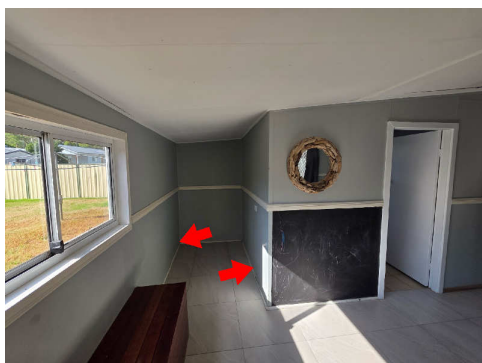
Finding 3.06

Finding: Elevated Moisture – Rumpus room and Laundry Wall

Information: High moisture readings were recorded to the back wall of the rumpus room, with readings around 500, and to the wall separating the rear of the laundry from the adjacent alcove, where readings reached 999. No visible mould, deterioration or discolouration was observed, and no obvious plumbing fixtures were noted on these walls that would clearly explain the source. The cause is undetermined and cannot be confirmed during a visual, non-invasive inspection. Given the elevated readings, further investigation may be required to rule out concealed moisture issues.

The moisture meter used operates on a scale from 0 to 999. Readings above 200 are considered elevated. Concealed damage could not be ruled out. More invasive inspection is recommended to determine the full extent of damage.

A licensed builder should be engaged to assess the cause and extent and rectify as required. This should be done as soon as practicable.

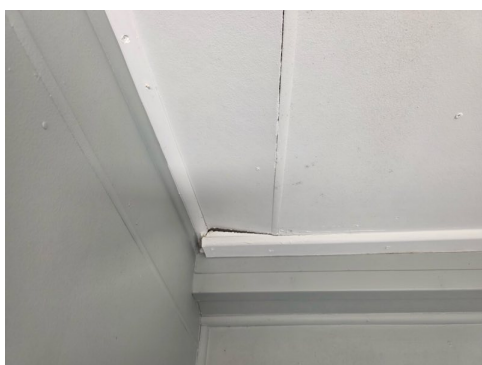
Finding 3.07

Information: The ceiling in the rear rumpus room has collapsed along one joint, with minor discolouration noted. No elevated moisture was detected at the time of inspection and the cause is unknown. The failure of ceiling linings may indicate underlying structural or fixing issues.

A licensed builder should be engaged to assess the cause and extent and rectify as required. This should be done as soon as practicable.

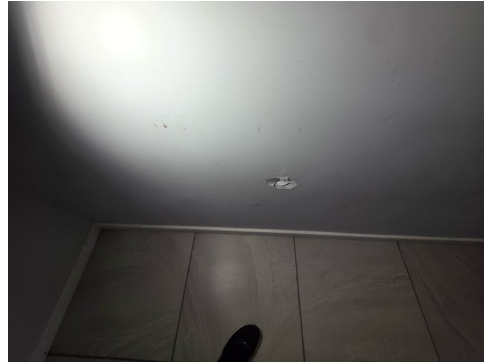
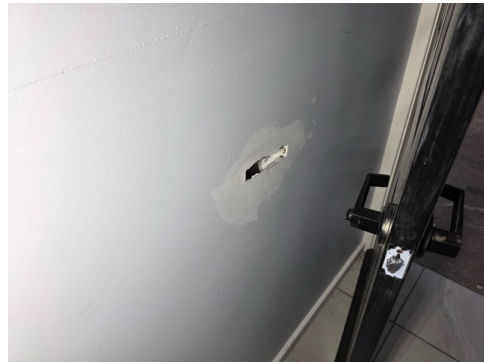
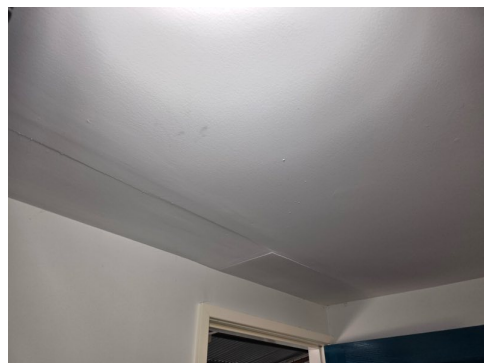
Finding 3.08

Information: The double garage has been partially converted into two makeshift rooms and a reduced garage space. Multiple cracks are present to ceilings and walls, with wall damage and poor-quality finishing observed. Substandard construction may conceal structural or moisture-related issues and may not perform as intended.

A licensed builder should be engaged to assess the cause and extent and rectify as required.

This should be done as soon as practicable.

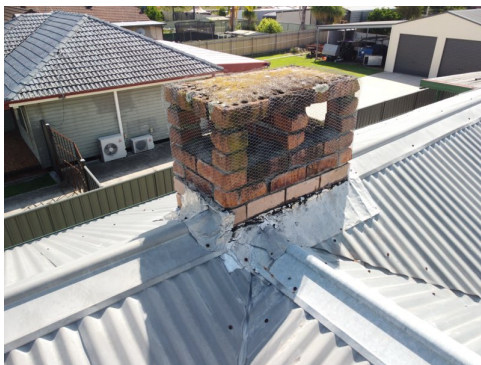
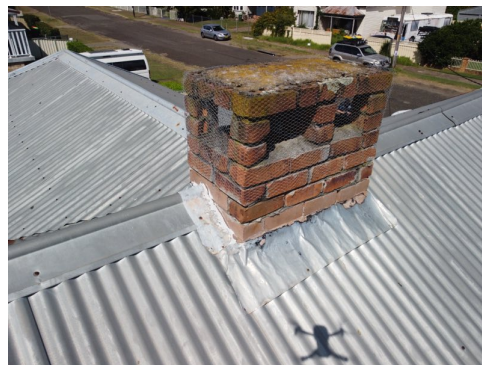
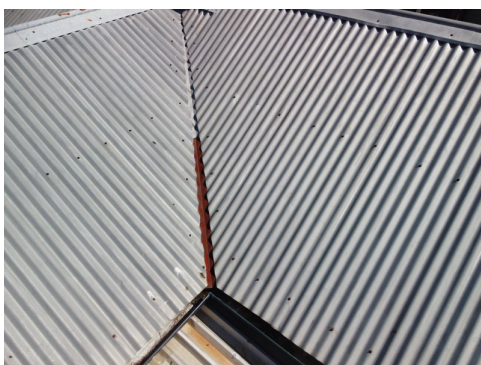
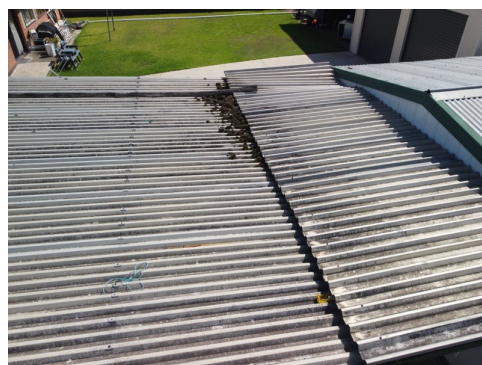
Finding 3.09

Finding: Roofing Defects – Roof Covering, Flashings and Drainage

Information: One valley pan at the rear of the roof is heavily rusted, numerous roof fixings are rusted with some sealed using silicone, one ridge cap is heavily rusted, and flashings around the chimney appear substandard. Gutters over the rumpus room and garage contain debris, with debris also present on the carport roof. These conditions may allow moisture ingress and reduce the serviceability of the roof covering system. A minor water stain was observed to the ceiling in Bedroom 3 in proximity to the chimney, which may indicate an intermittent leak in this area or may be related to another source; however, no elevated moisture was recorded at the time of inspection and the exact cause cannot be confirmed during a visual, non-invasive inspection.

A roofer should be engaged to assess the overall condition of the roof, including the chimney flashings, and carry out any necessary repairs as required. This should be done as soon as practicable.

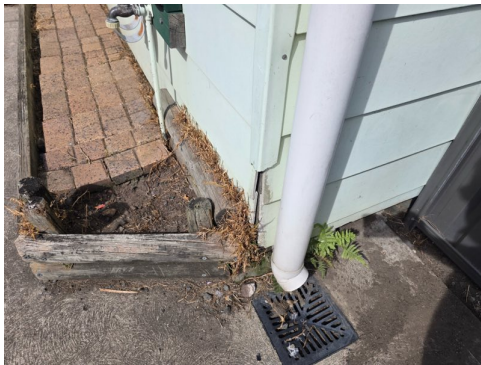
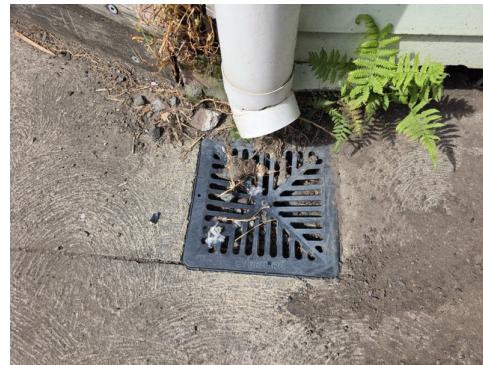
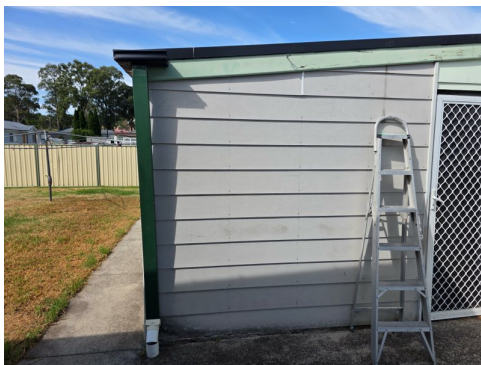
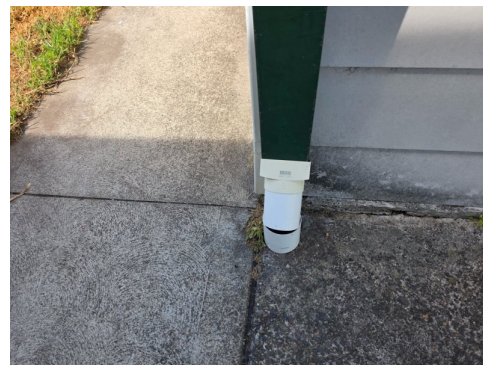
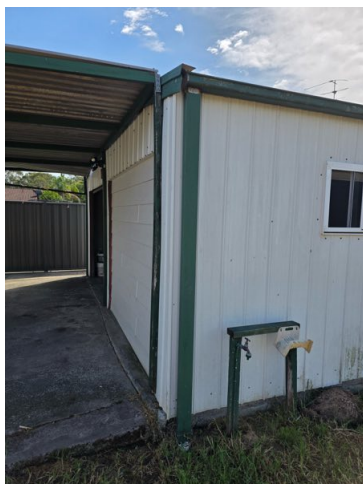
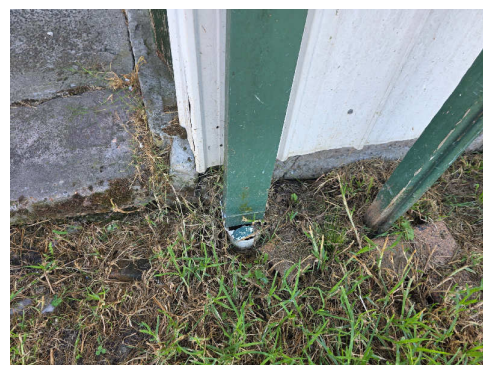
Information: Uncontrolled stormwater discharge was noted in one or more areas around the property, likely due to a damaged downpipe, missing gutter, blocked drains or disconnected stormwater component. This has resulted in water discharging directly onto the ground near the building perimeter, creating conditions conducive to timber pest activity and fungal decay.

A licensed plumber should be engaged to redirect stormwater away from the structure. If concealed timbers are exposed during repairs, a licensed pest controller should assess for potential termite risk. This issue should be rectified without delay to reduce future risk.

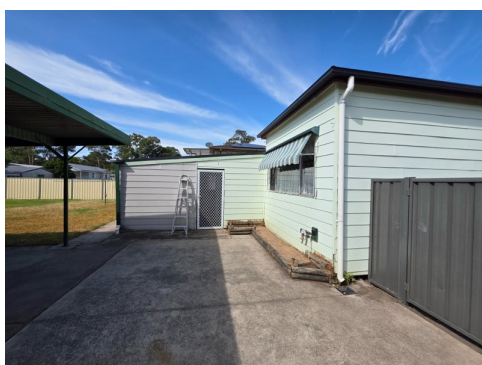
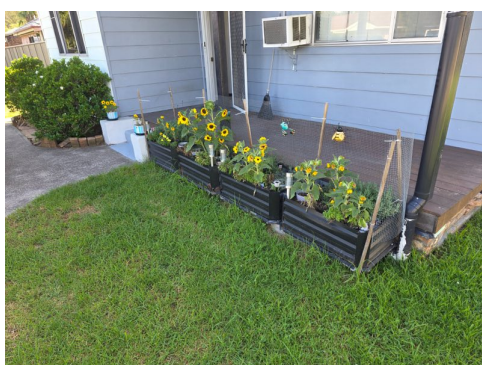
Bridging was observed at various locations around the external perimeter of the dwelling. Bridging occurs where materials or structures create a continuous path over or around the termite management system, allowing termites to bypass barriers and enter the dwelling undetected. Common examples include downpipes, fixed gates, hot water service units, air-conditioning units, garden beds, soil build-up, and paved surfaces installed hard against the slab or footing.

Bridging is a significant risk because it defeats the purpose of a physical or chemical termite barrier. Where practical, bridging elements should be modified or removed so that a clear and uninterrupted inspection zone remains around the entire perimeter.

Where it is not practical to remove or alter the bridging element, the risk of concealed termite entry remains. In these cases, a licensed pest controller should establish an ongoing termite management plan and carry out regular timber pest inspections every 6–12 months. This should be addressed without delay.

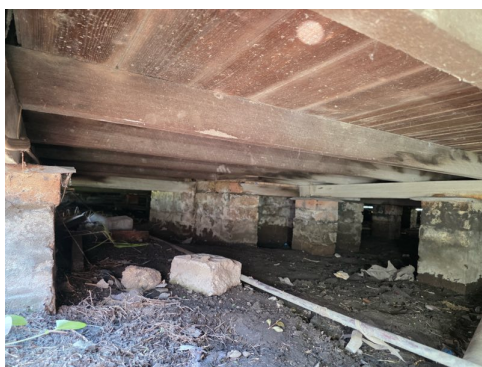
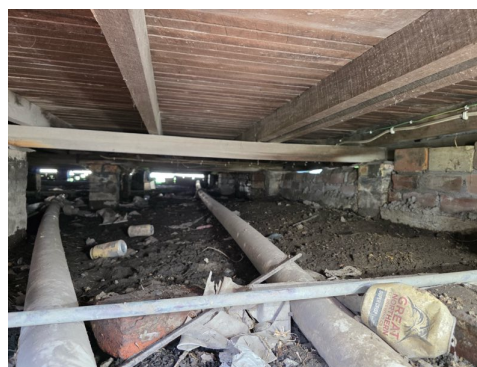
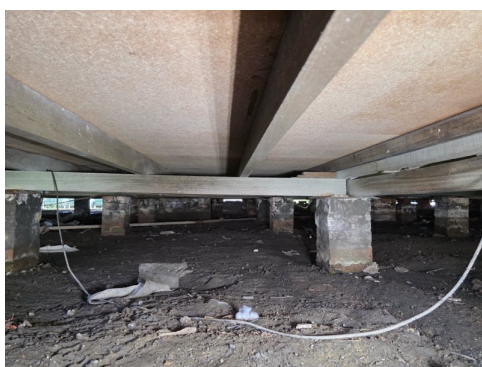
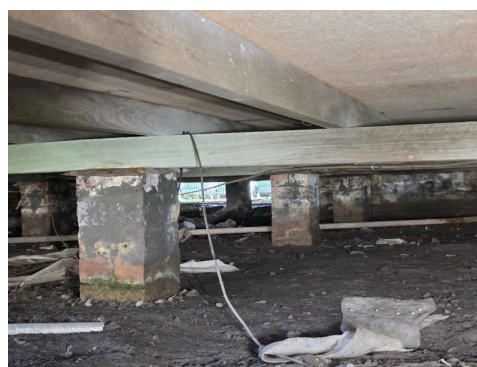
Finding 6.04

Building:	Main Building
Location:	Subfloor
Finding:	Damp - Damp conditions in subfloor area
Information:	Elevated moisture was observed in sections of the subfloor at the time of inspection. This may be due to inadequate drainage, poor ventilation, leaking plumbing, or water runoff from external areas. Damp subfloor conditions significantly increase the risk of timber decay and termite activity.

Although no active timber pests were identified, access to concealed areas beneath the flooring was not possible. A licensed builder or plumber should be engaged to identify and rectify the source of moisture. A licensed pest controller should also be consulted to assess whether further invasive inspection is required. This should be addressed as soon as practicable.

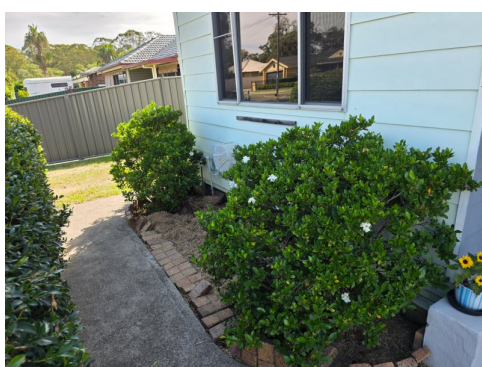
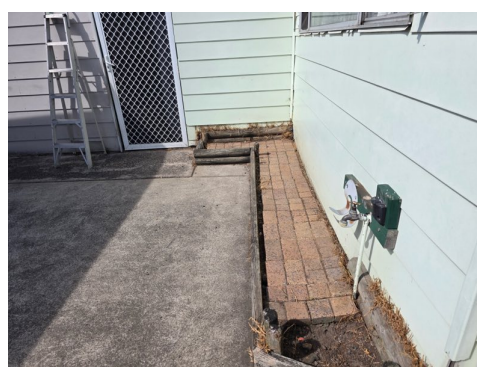
Finding 6.05

Location:	Yard
Finding:	Garden Beds - Conditions Conducive to Termites
Information:	Garden beds, particularly those constructed from untreated timber, were noted adjacent to the dwelling. These create a highly conducive environment for termite activity due to the combination of retained soil moisture from watering, direct soil contact, and the organic material in the soil and timber edging. Such conditions increase the risk of concealed termite ingress into the property, as termites can travel through the garden beds and enter the structure undetected.

Where practical, garden beds should be removed, relocated, or modified so that they do not abut the dwelling. Where this is impractical or undesirable, the risk of concealed termite activity remains. In these cases, a licensed pest controller should establish an ongoing termite management plan, and regular timber pest inspections should be carried out every 6–12 months to assist in protecting the property against infestation.

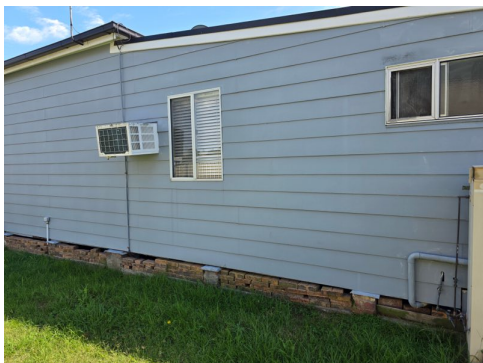
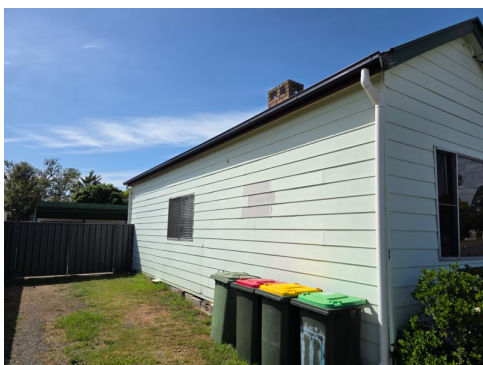
Finding 6.06

Building:	Main Building
Location:	Subfloor
Finding:	Ventilation - Inadequate subfloor ventilation
Information:	Subfloor ventilation appears to be inadequate in one or more areas beneath the dwelling. Poor airflow can result in elevated moisture levels, which in turn create conditions conducive to fungal decay and termite activity. Signs of dampness or musty odours may also indicate restricted air movement.

Improved cross-ventilation should be established to help manage moisture and reduce the risk of concealed timber pest attack. A licensed builder should assess the subfloor and install additional vents or mechanical ventilation as needed. This should be as soon as practicable.

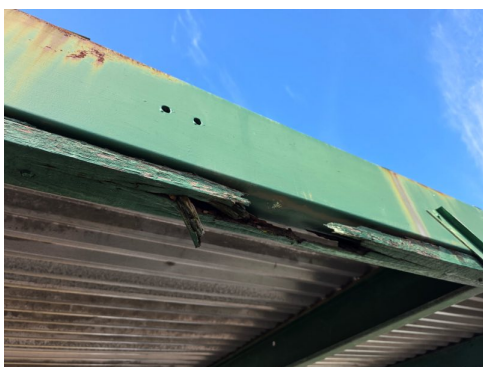
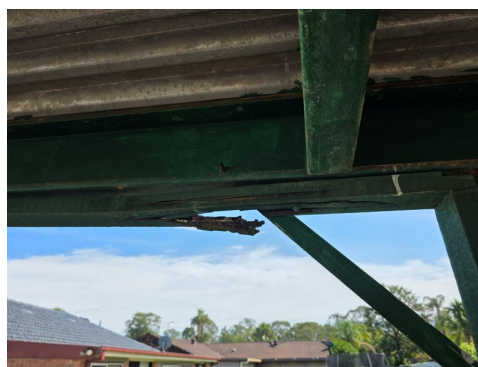
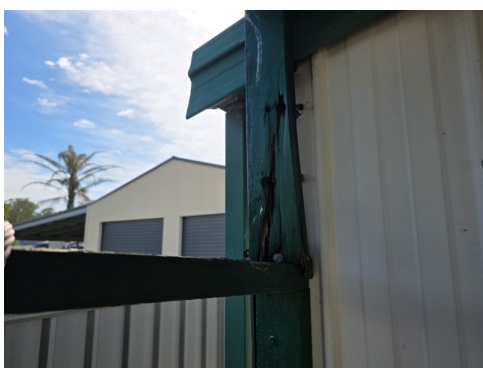
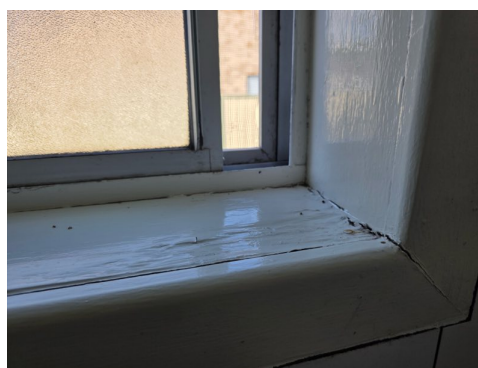
Finding 7.01

Building: Main Building
Location: Multiple Areas
Finding: Fungal decay observed in timber elements

Fungal decay was observed in timber elements in the carport, bathroom window reveal and the fascia boards at the front of the property. Fungal decay (commonly referred to as wood rot) occurs when timber remains damp for extended periods, allowing fungal spores to colonise and break down the wood fibres. This process reduces the strength, durability, and integrity of the timber.

Decay is typically caused by poor drainage, regular wetting, or direct contact with soil or saturated surfaces.

Recommend a licensed builder assess the extent of deterioration and replace or treat affected timbers as necessary. This should be done as soon as practicable. Regular timber pest inspections should be carried out every 6–12 months.

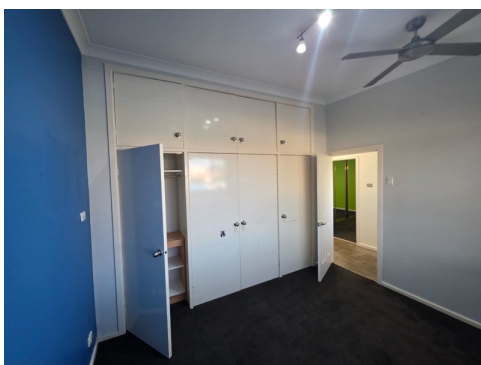
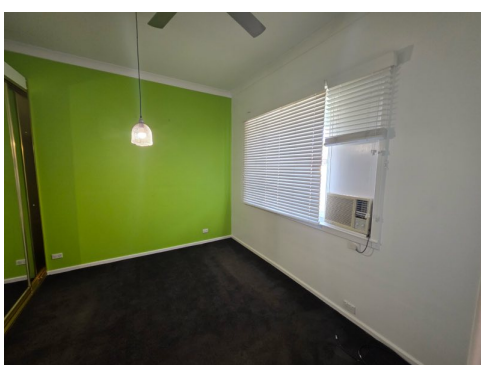
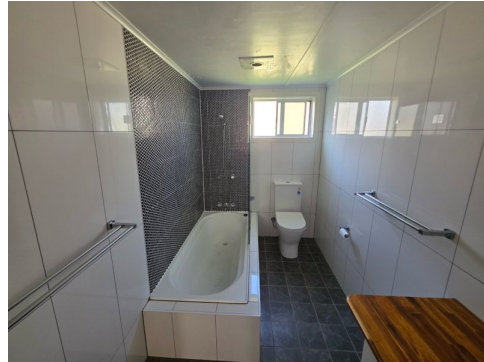
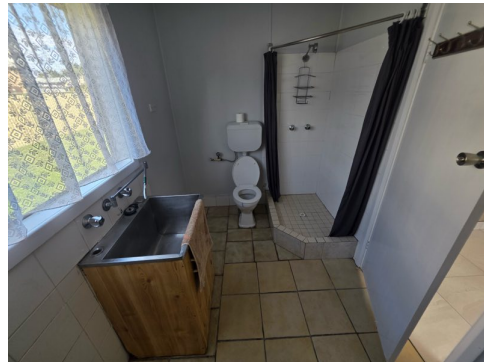
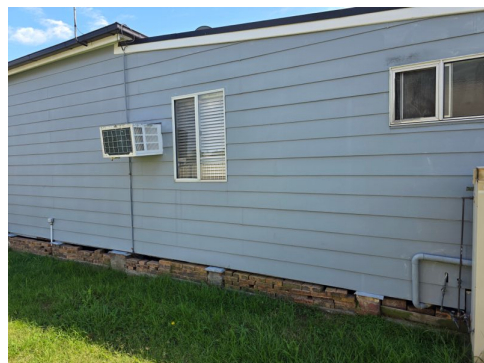
Finding: Additional Photos - Obstructions and Limitations

Information: These photographs are an indication of the obstructions and limitations which impeded full inspection of the property at the time of inspection. These obstructions can hide an array of defects and should be removed to allow full inspection to be carried out. A re-inspection is recommended once the areas are made accessible.

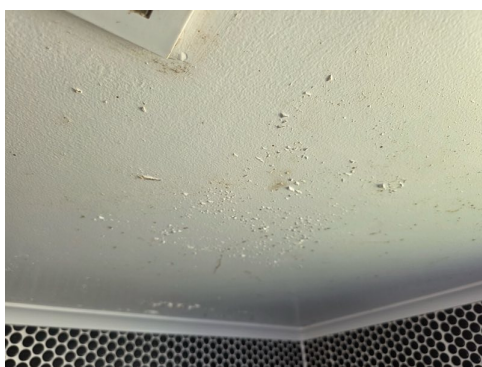
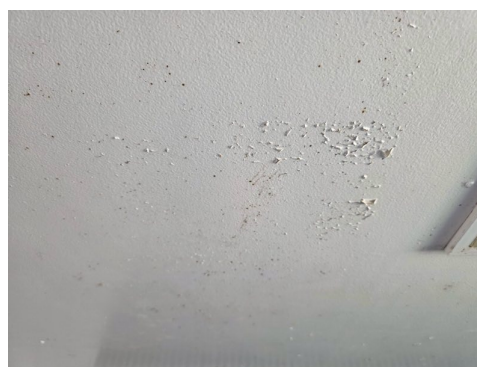
Information: Paint is peeling to the ceiling linings in the main bathroom. Given the ceiling lining is suspected to contain asbestos, disturbance during preparation or repair may present a health risk, as asbestos-containing materials should not be sanded or mechanically abraded. Inappropriate repair methods may result in fibre release.

An asbestos assessor should be engaged to assess and provide recommendations as required. This should be done prior to any disturbance or painting works.

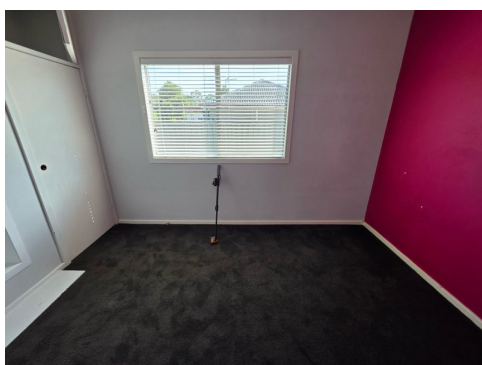
Finding: Low-Level Elevated Moisture

Information: Low-level elevated moisture readings were recorded beneath the window in Bedroom 3 and to the wall separating Bedroom 3 from the living room. No visible mould, deterioration or discolouration was observed at the time of inspection. The readings may not necessarily indicate active moisture ingress and could be influenced by environmental conditions; however, the source cannot be confirmed during a visual, non-invasive inspection. The area should be monitored, and if deterioration, discolouration or mould growth develops, further investigation may be required.

The moisture meter used operates on a scale from 0 to 999. Readings above 200 are considered elevated. Concealed damage could not be ruled out. More invasive inspection is recommended to determine the full extent of damage.

A licensed builder should be engaged to assess and provide further investigation if required. This should be done at the owner's discretion.

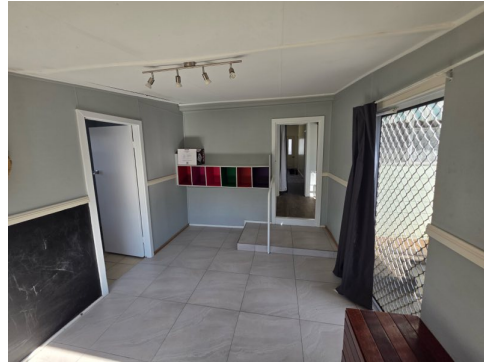
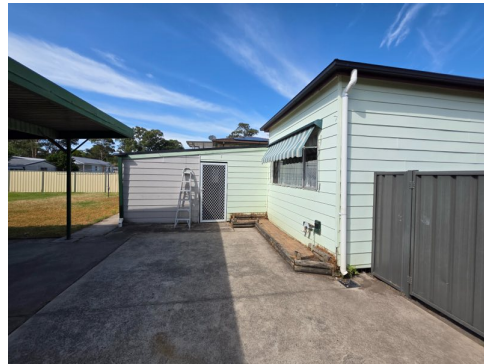
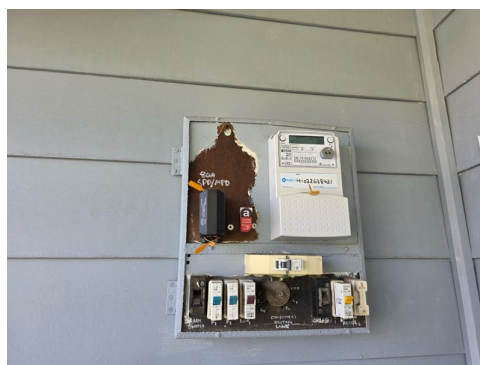
Information: Reporting on asbestos is outside the scope of this inspection. Suspected asbestos-containing material (ACM) was observed in the bathroom ceiling linings, rear rumpus room, external eaves, some wall linings and loose fill insulation within the roof void. Based on our experience in the building industry, there is a higher risk that the identified building elements contain asbestos, particularly given that any home constructed prior to 1990 may contain asbestos in various forms.

No sample testing has been undertaken to confirm the presence of asbestos. We strongly recommend a separate Asbestos Inspection and Condition Audit be carried out by a licensed assessor, which may include laboratory testing for definitive confirmation.

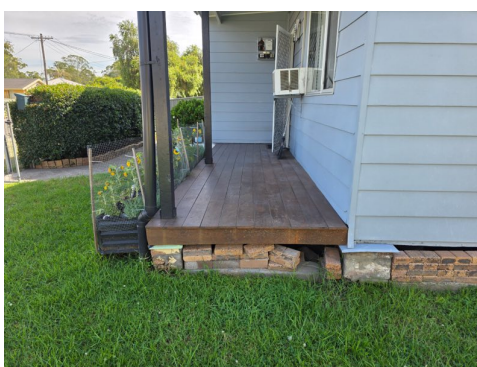
Location:	Verandah
Finding:	Verandah - Structural assessment required for elevated deck
Information:	<p>An elevated external deck was observed at the property. Even if the structure appears sound or recently built, it may still pose a safety risk if inadequately supported. A detailed structural assessment is required to confirm its stability and load-bearing capacity.</p> <p>A structural engineer should be engaged to carry out this assessment without delay. Until this has been completed and any necessary rectification works undertaken, users should take care not to overload the structure.</p>

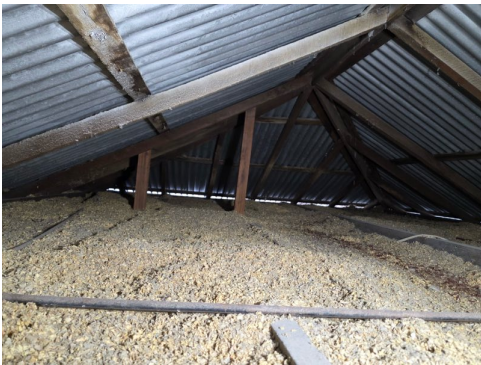
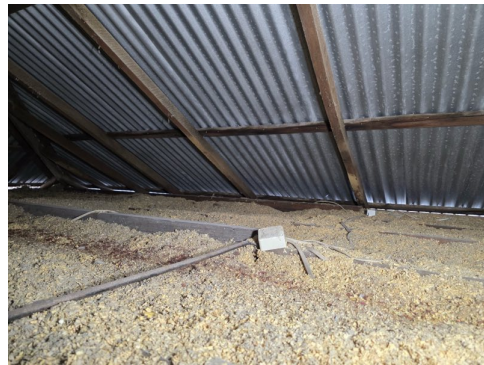
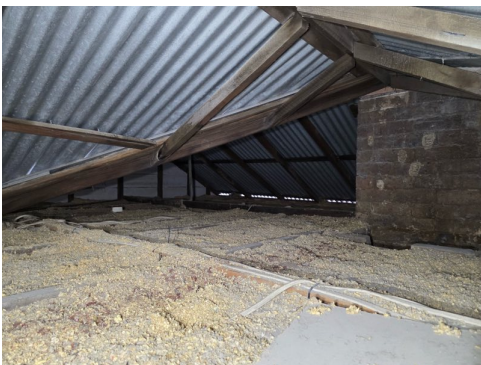
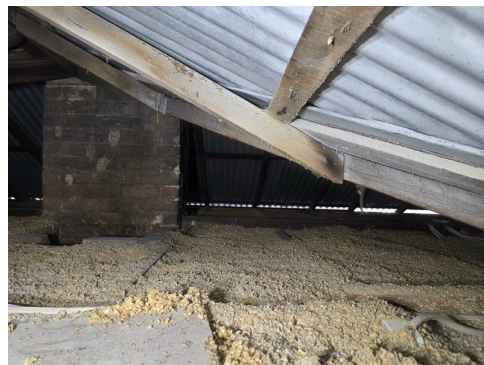
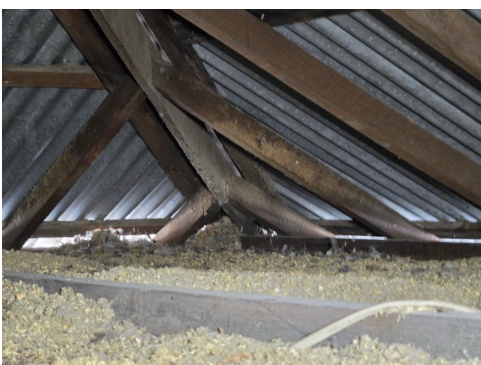
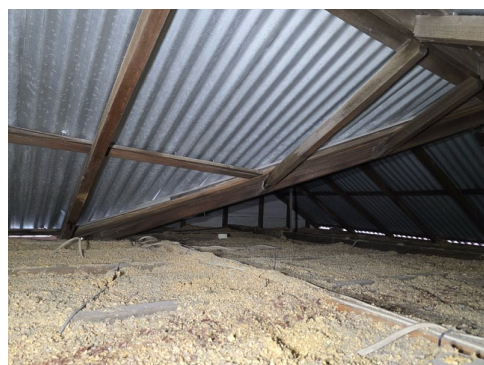
Building:	Main Building
Location:	Roof Void
Finding:	Roof Void Access
Information:	<p>Access to the roof void was not possible due to the presence of loose fill insulation. Loose fill insulation may contain asbestos, and the material cannot be confirmed during a visual, non-invasive inspection. Disturbance of insulation that contains asbestos may present a health risk through airborne fibre release.</p> <p>An asbestos assessor should be engaged to carry out testing and provide recommendations as required.</p> <p>This should be done at the owner's discretion.</p>
