Building and Timber Pest Inspection Report

Inspection Date: Mon, 22 Dec 2025

Property Address: 6 Lenne St, Mooroopna VIC 3629, Australia

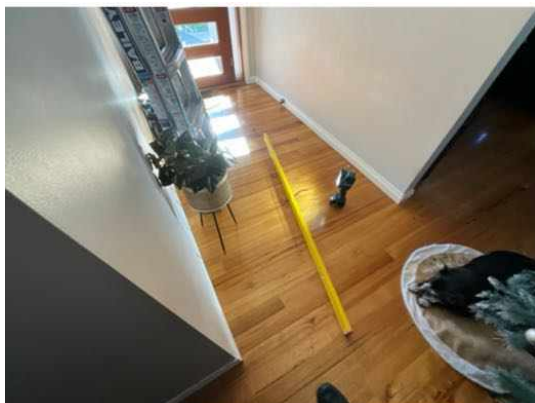
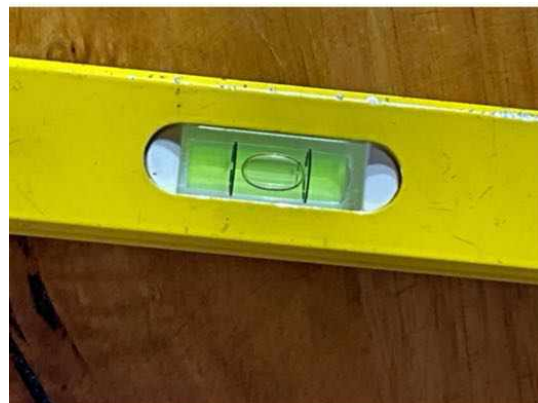
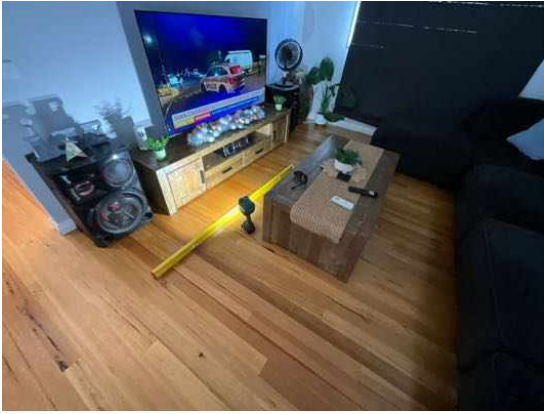
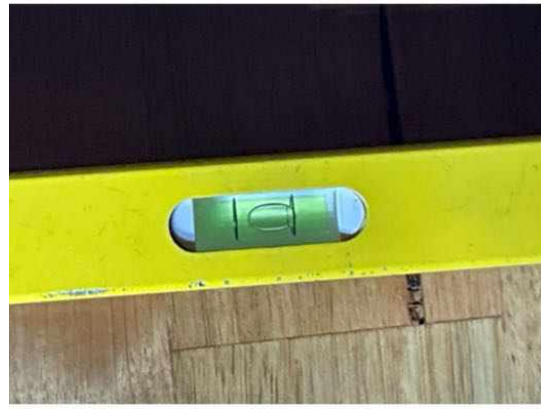
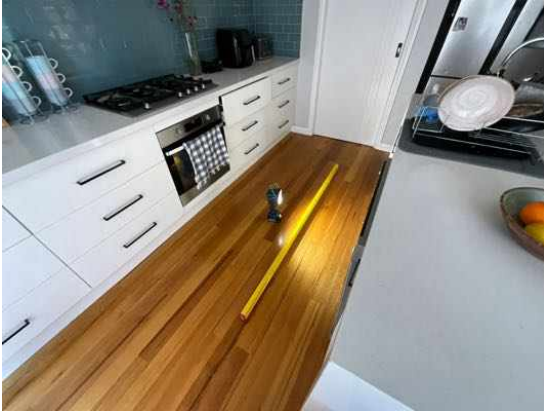
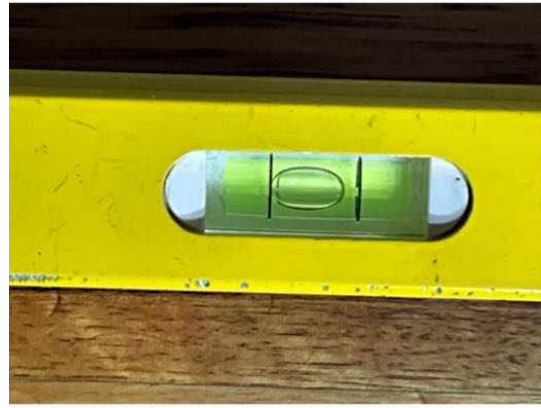
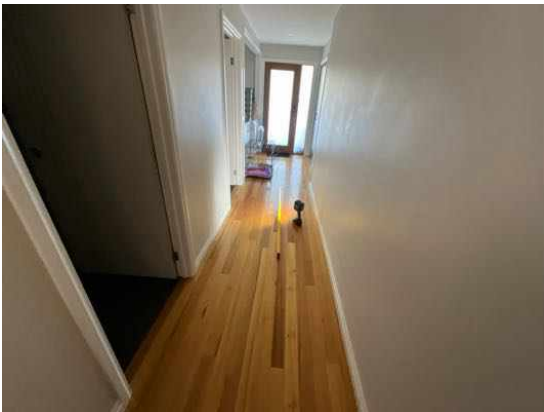
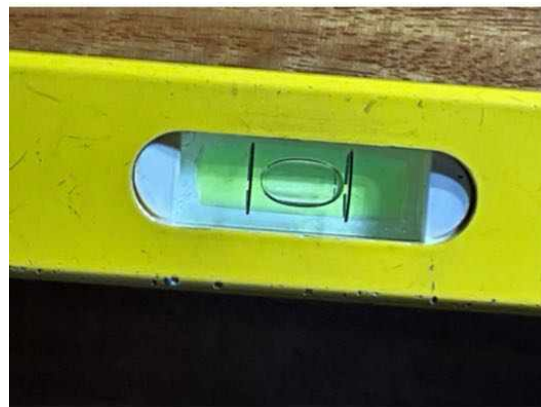
Finding 3.01

Building: Building 1
Location: All Internal Areas
Finding: Flooring - Uneven
Information: The internal flooring in this area is out of level and uneven. Uneven flooring is likely to indicate minor defects such as expected movement of the foundations of the property, but may also indicate subsidence of the associated subfloor stumps.

It is advised that the flooring be closely monitored to identify any further movement. Where flooring remains relatively unchanged for an extended period of time (i.e. several months), it is likely that this defect has been caused by expected movement of the foundations of the property.

However, where flooring is uneven further, potentially invasive inspection of the subfloor structures and stumps in this area is required. In this case, works to repair are likely to be required, and would be carried out by a registered builder specialising in re-stumping.

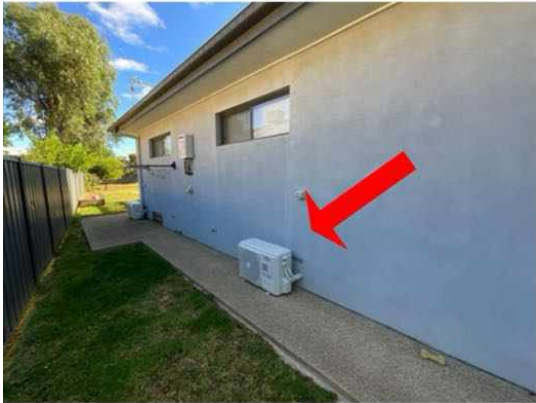
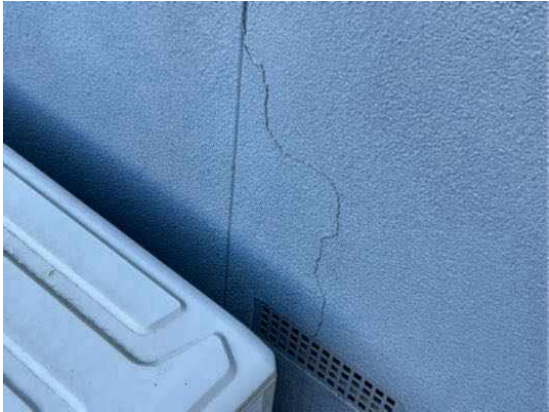
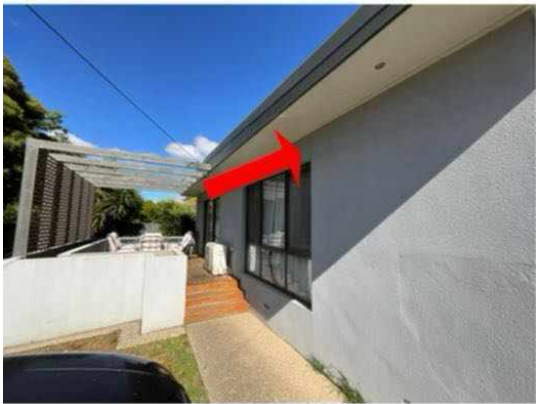
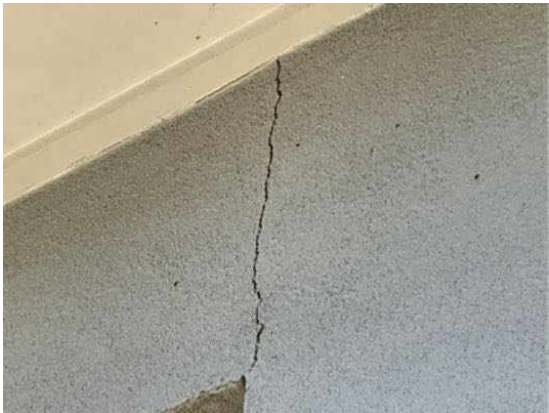
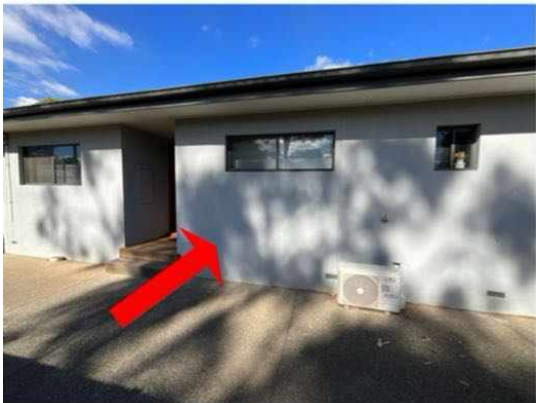
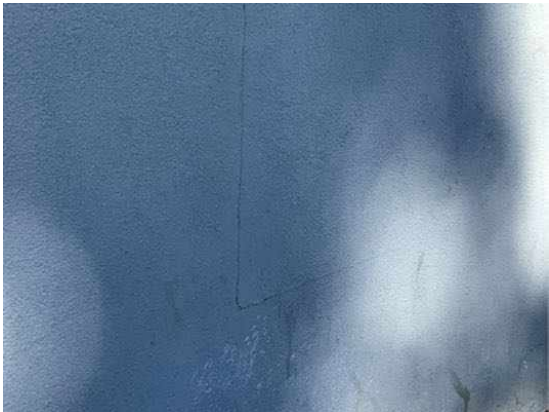
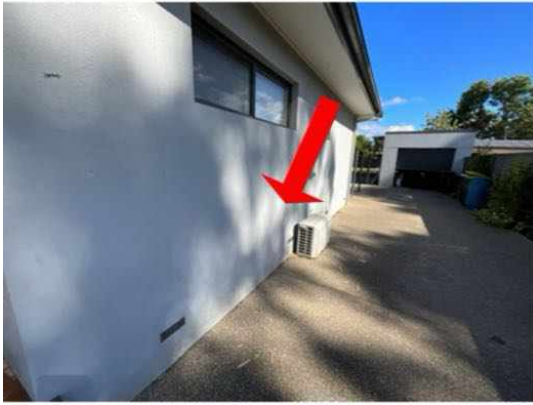
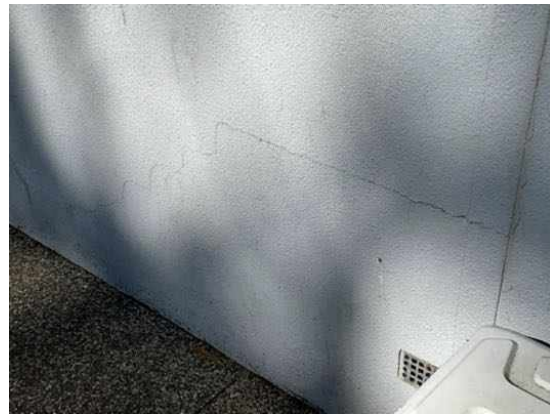
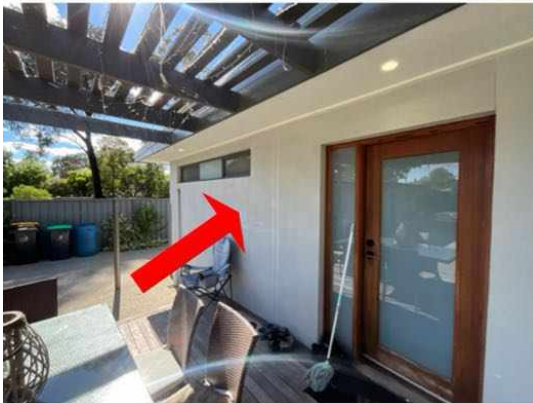
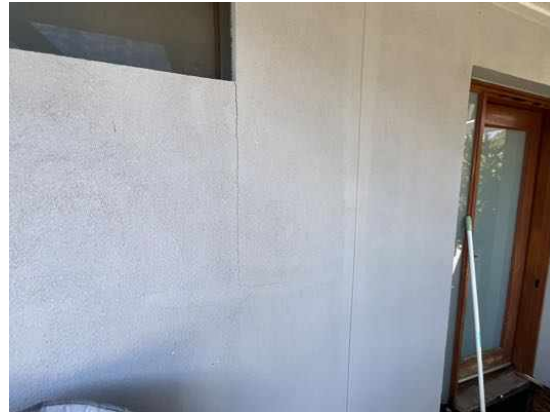
Finding 3.02

Building: Building 1
 Location: Yard - Side, front, driveway, alfresco
 Finding: Cracks to External Render
 Information: It has been observed that cracking to external rendered surfaces has occurred.

The extent of cracking would suggest that this is a Minor defect.

Monitoring for 12 months is recommended. If cracking increases in size or number, contact a Registered Builder to make all needed repairs and avoid further deterioration.

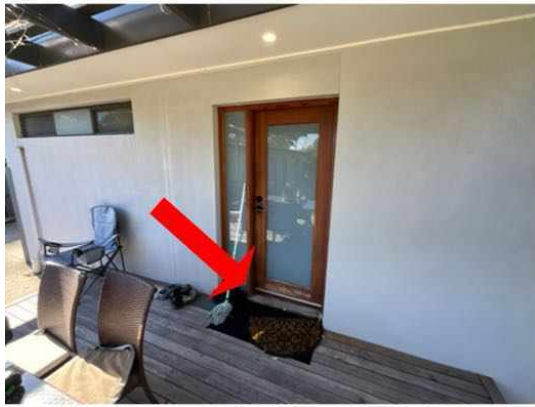
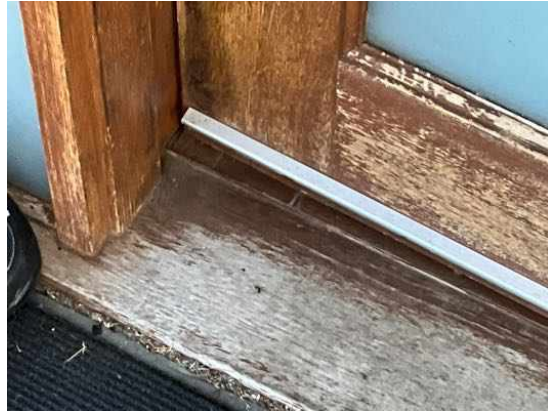
Finding 3.03

Building:	Building 1
Location:	Back door
Finding:	Door- Binding
Information:	Binding and/or jamming of this door is evident during standard operation. This defect inhibits the functionality of the affected door as well as creating potential for secondary defects to associated building elements, such as damage to the floor covering.

A door that binds to flooring or to the associated door frame may have several causes, ranging from minor defects, such as poor installation of the door or deteriorated hinges, through to major structural issues, such as damage to subfloor structures.

A qualified carpenter or general handyperson should be appointed to perform minor rectification works at client discretion.

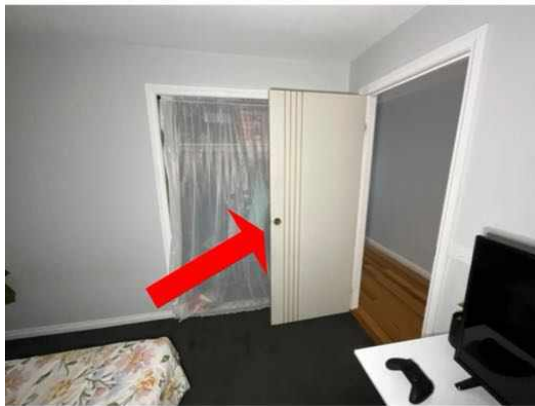
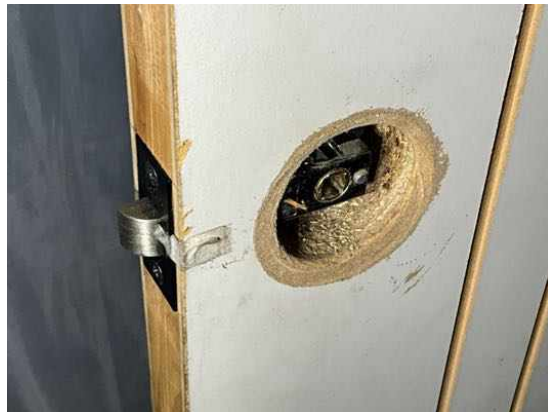
Finding 3.04

Building: Building 1
 Location: Bedroom 3
 Finding: Door handle- Not latching
 Information: It was noted that the door in this area was not latching during operation at the time of inspection.

It is suspected that this defect has occurred due to minor issues with the associated hinges. Such damage is identified as general wear and tear, which is expected for building elements of this age.

A qualified carpenter or general handyperson may be appointed to perform rectification works as necessary, at client discretion.

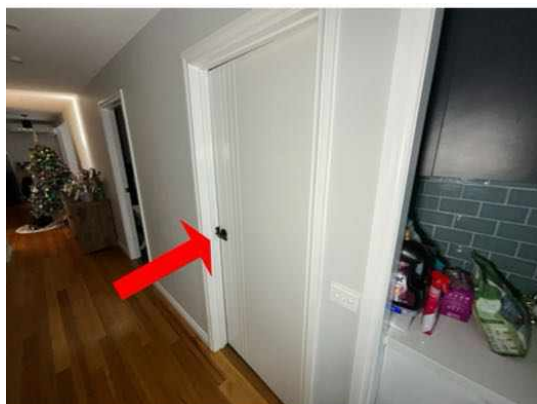
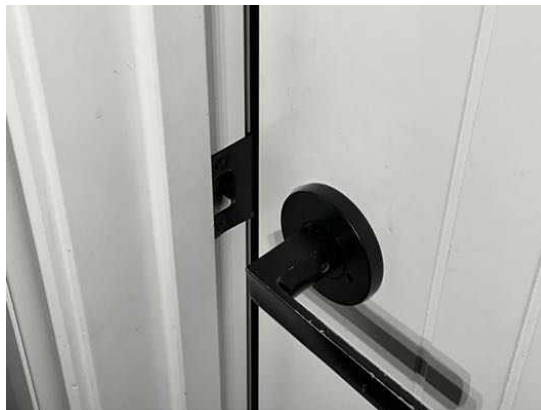
Finding 3.05

Building: Building 1
 Location: Bedroom 2
 Finding: Door - Striker plate misaligned
 Information: The striker plate to this door appears to have become misaligned and has consequently resulted in the door's operation being compromised.

This is a common defect and is expected in a property of this age, whether being due

to substandard installation or general deterioration of the door hardware.

Readjustment of the striker plate is recommended at client discretion. Works such as these can be completed by a general handyman or qualified carpenter.

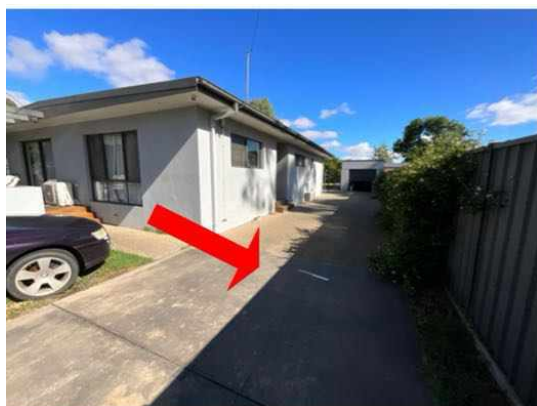
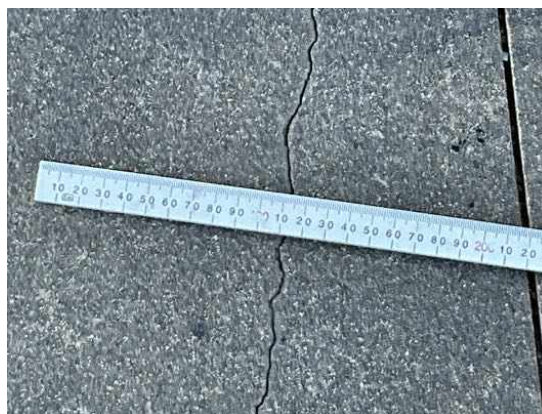
Finding 3.06

Building:	Building 1
Location:	Driveway
Finding:	Cracking - External Concrete Paving Damage Category 1 - Fine (less than 2mm)
Information:	Fine cracks were identified in external concrete paving. Although fine cracks are quite noticeable, they are often only considered to be an appearance defect, and usually do not indicate any structural damage. To be considered a Category 1 or fine crack, the crack is found to be less than 2mm in width.

Generally the cause of a hairline crack in existing concrete paving such as driveways and pathways is indicative of the expansion and contraction of the concrete. Such causes are generally due to environmental factors, such as moisture levels, weather conditions, root systems of nearby trees or the soil types on which they are laid.

Fine cracks may also be due to poor original installation of the concrete. Factors such as poor compaction of the sub surface and/or inadequate reinforcing of the slab may create cracking and other secondary defects.

Monitoring of all cracking should be conducted frequently. Always contact a building inspector should cracks widen, lengthen, or become more numerous.

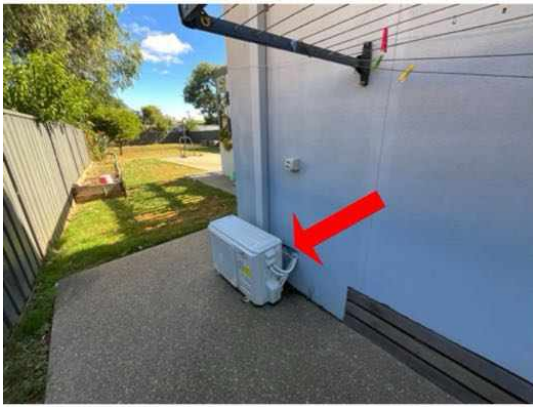
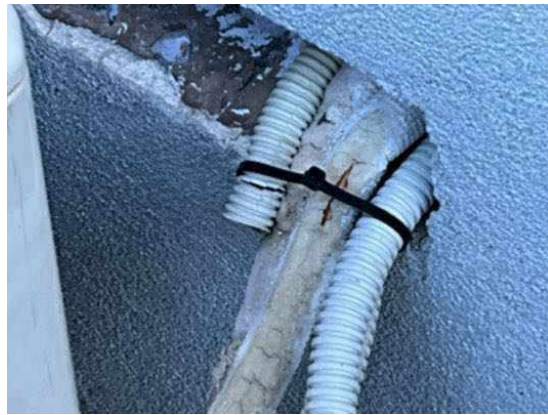
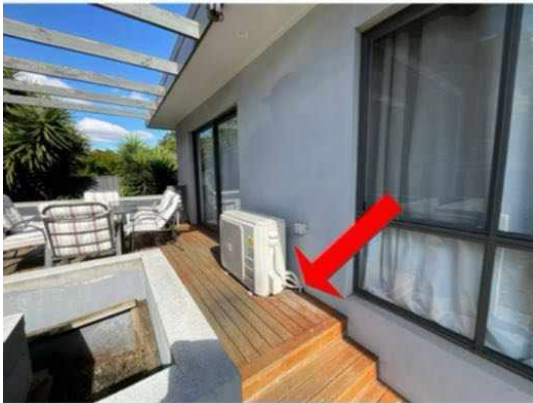
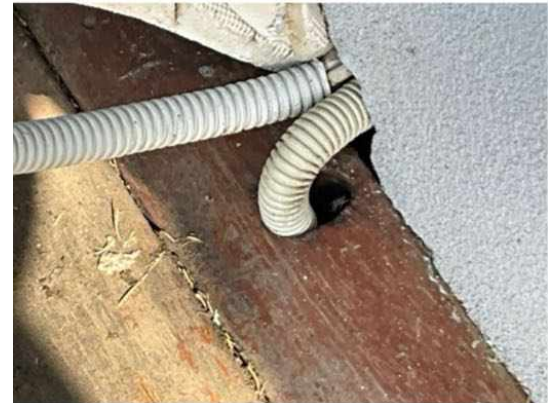
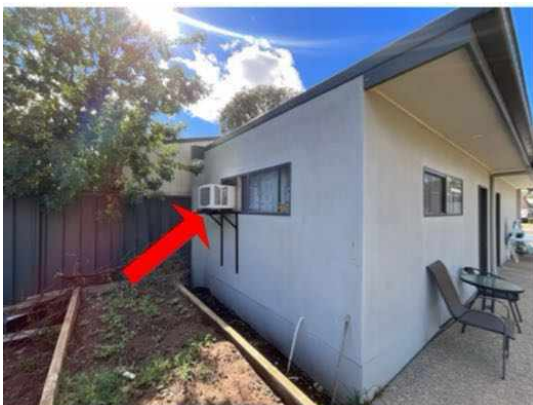
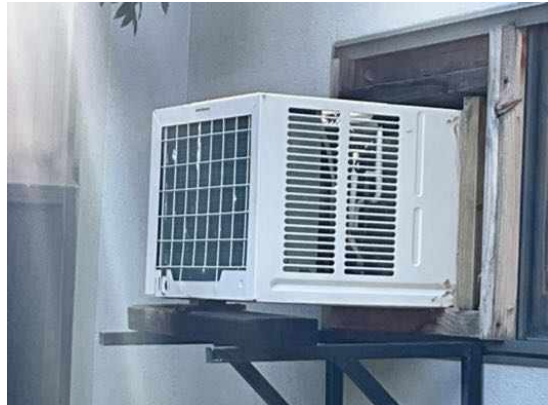
Finding 6.01

Building:	Building 1
Location:	Yard - Side, front
Finding:	Air conditioner - Disconnected overflow
Information:	The Air Conditioner (A/C) overflow was found to be disconnected from storm water drainage and is creating excessive moisture in the surrounding area.

Such leaking creates an environment which is conducive to an array of defects, including water damage to associated building elements and the attraction of termite or timber pest infestation.

It is highly recommended that a licensed plumber be appointed to connect the A/C overflow in order to prevent such an environment from being created. These minor works should be carried out as soon as possible.

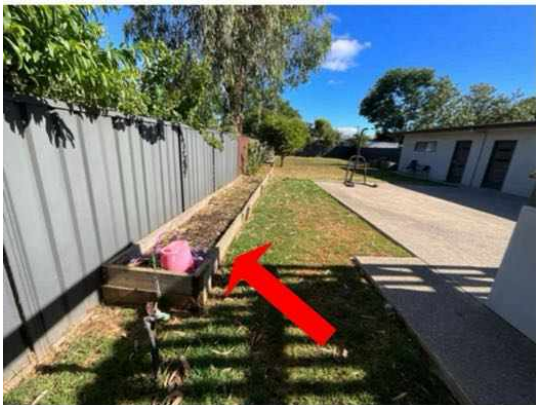
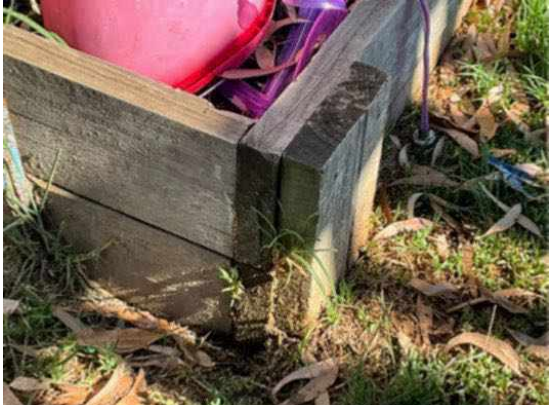
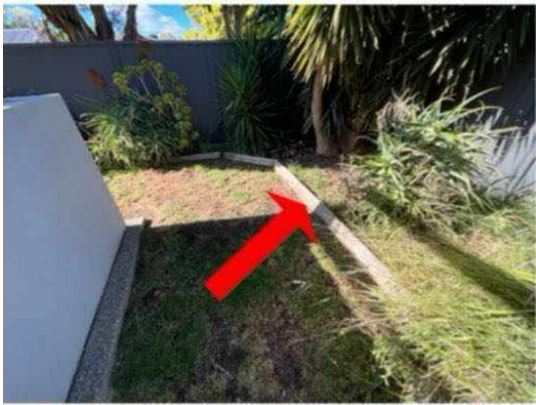
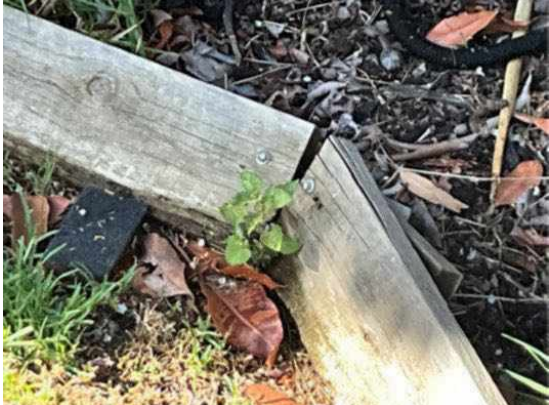
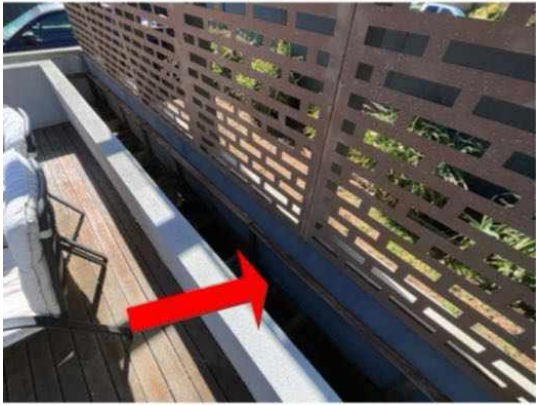
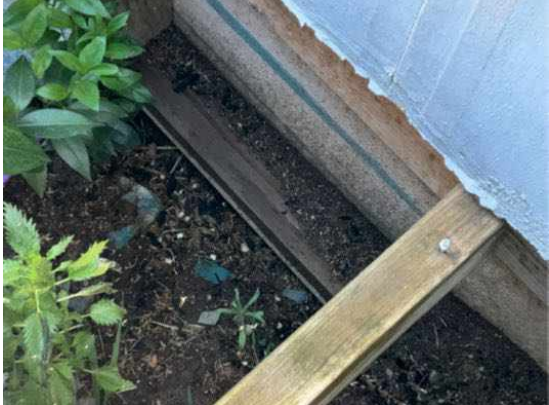
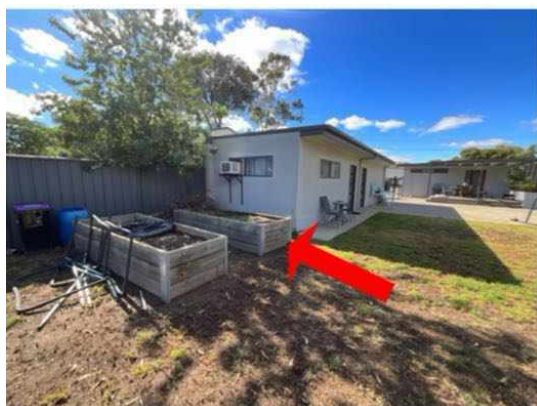
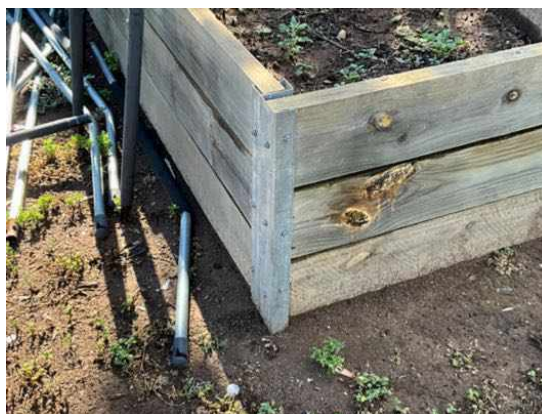
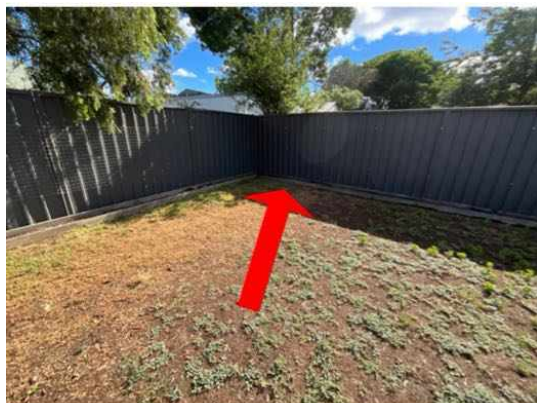
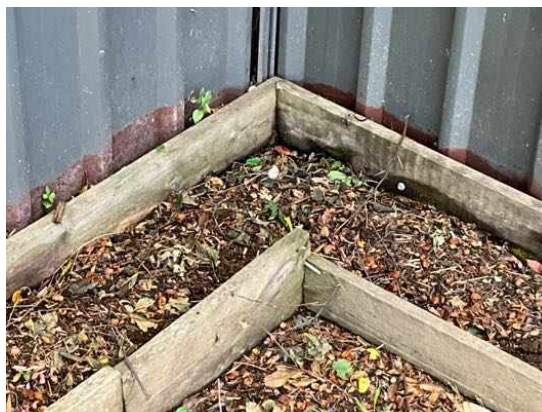
Finding 6.02

Building:	Building 1
Location:	Yard - Back, front
Finding:	Untreated or non-durable timbers in a hazardous environment
Information:	To reduce the risk of timber pest attack it is essential that timber used in a hazardous environment (e.g. in direct contact with the ground or frequently exposed to damp conditions) is of sufficient durability and/or is adequately preservative treated.

Untreated timbers in direct contact with the ground are likely to develop severe wood rot and/or fungal decay if left unattended creating attraction for subterranean termites to infest the timbers from surrounding areas.

If untreated or non-durable timbers are found to be in a hazardous environment it is highly advised that replacement of these building elements be performed as soon as possible to aid the protection of the property against termite / timber pest attack.

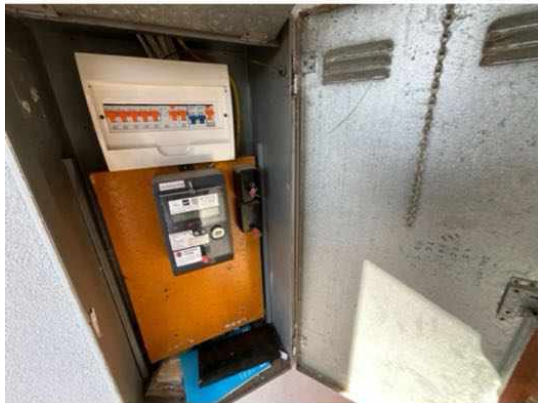
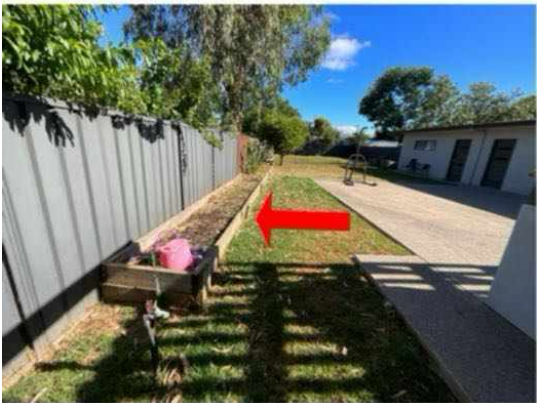
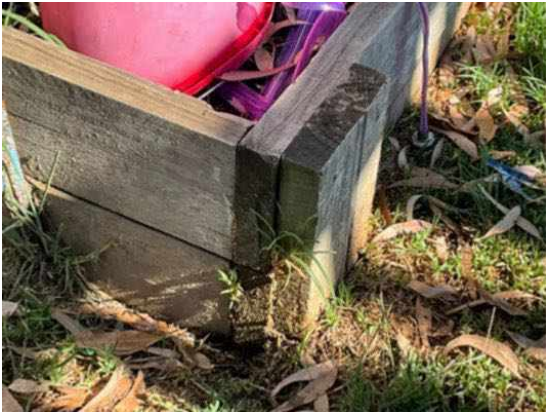
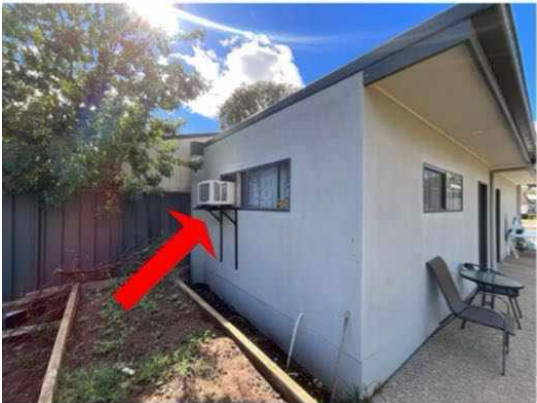
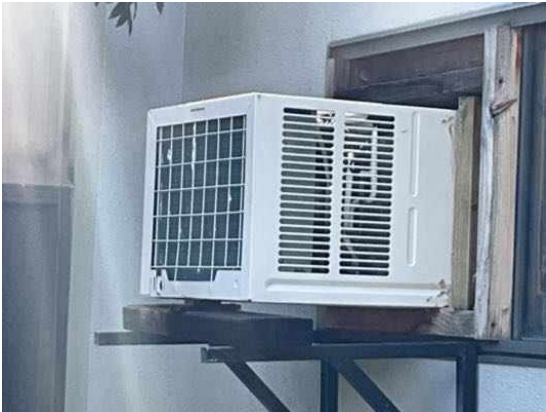
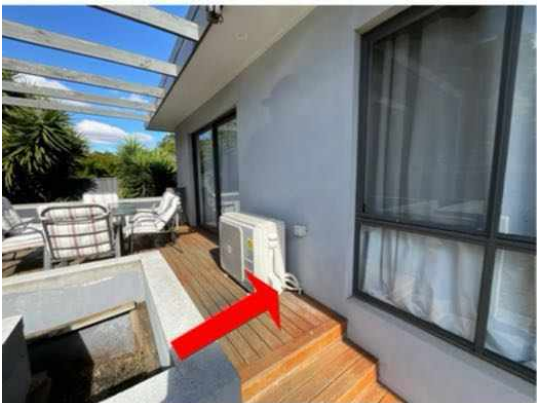
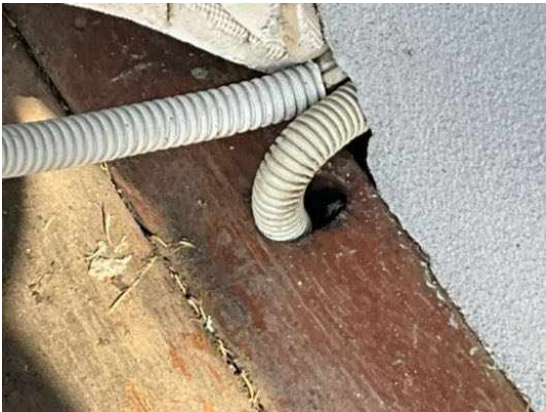
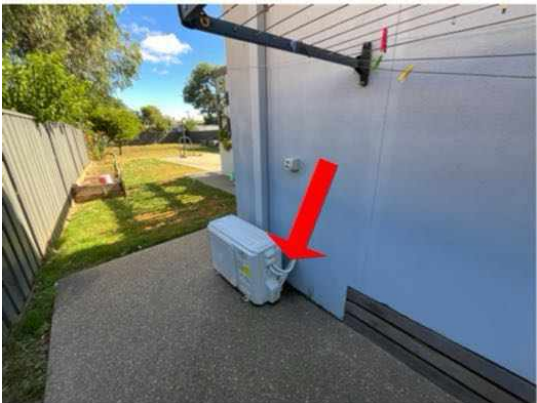
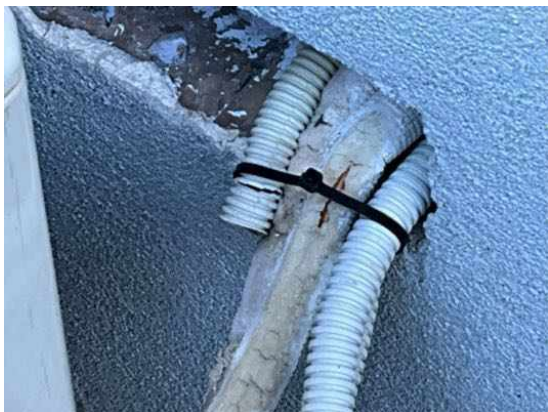
Finding 6.03

Building:	Building 1
Location:	All External Areas
Finding:	Termite Management System - no evidence of a chemical installation
Information:	The application of a post-construction chemical termite barrier is highly recommended for all properties, particularly if live termite activity has been found on the site previously. Such barriers are highly effective in preventing termite attack on any timber building elements throughout the property.

A durable notice should be placed in the switchboard unit to indicate current termite barriers. At the time of inspection, it appeared as though no termite management system has been installed, with no evidence to suggest preventative works taking place.

The client may consider gaining further advice from a pest controller as to the costs and procedures involved with this application. It is recommended that obtaining such advice be a short-term priority.

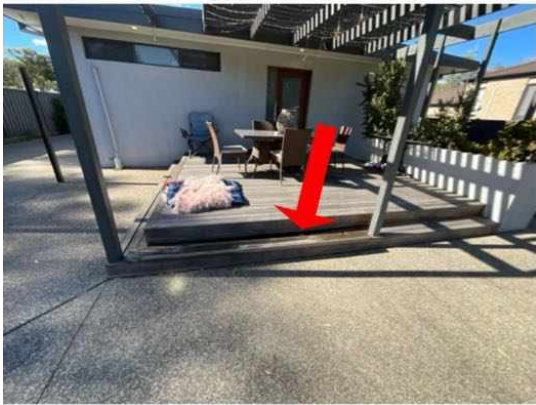
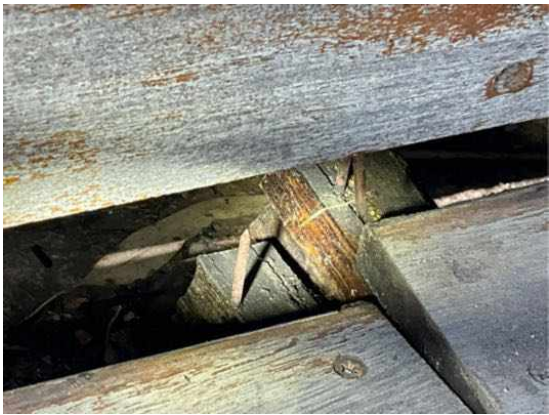
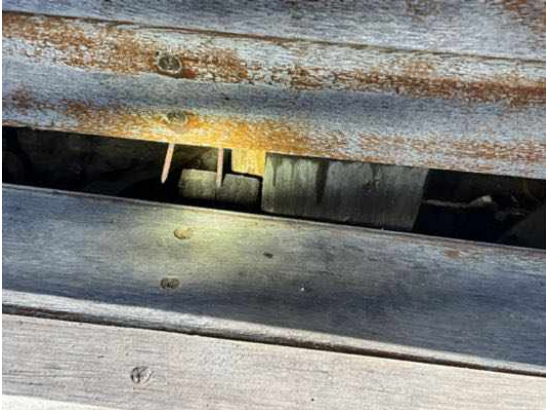
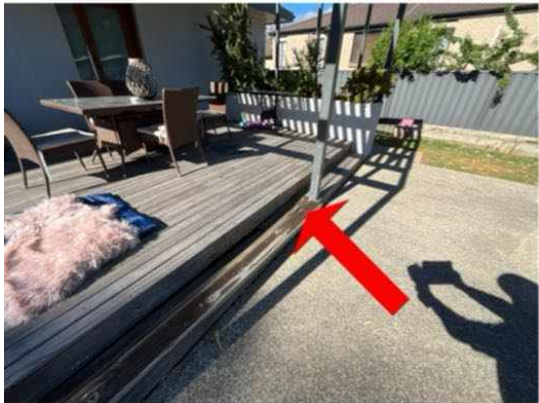
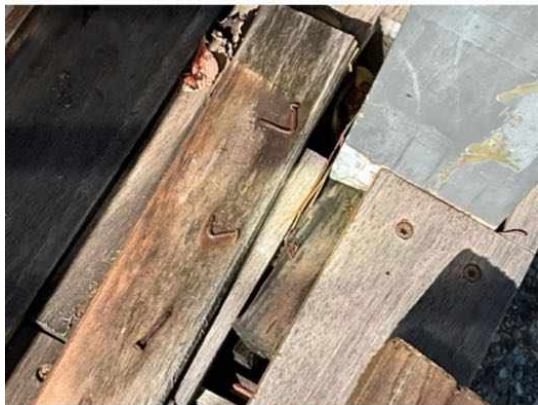
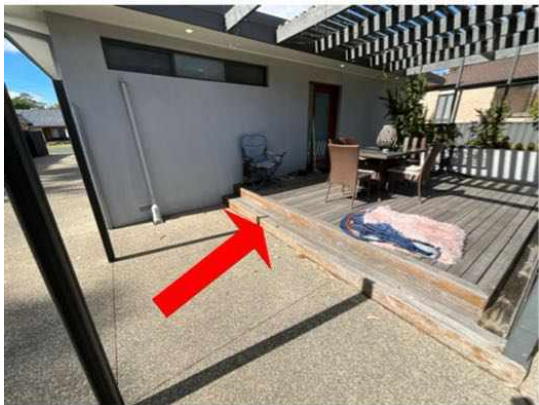
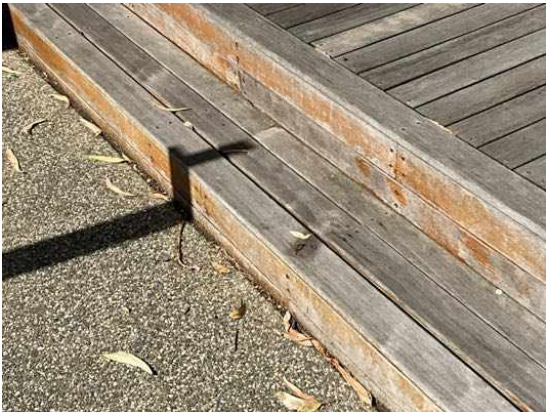
Finding 7.01

Building:	Building 1
Location:	Deck
Finding:	Fungal decay - present (localised)
Information:	Fungal decay also known as wood decay or wood rot generally refers to the deterioration of timber elements when in contact with excessive levels of moisture for a prolonged period of time.

The development of fungal decay is accelerated by temperatures in the range of 5degreeC to 40degreeC as well as the presence of oxygen. Generally fungal decay develops on timber elements that are in use in an external environment which are exposed to rain penetration.

In this case although the affected timber element is in a decaying state the extent of any visible damage appears to be localised to a specific area and is yet to spread to other parts of the building element or affect adjoining structures. The fungal decay is therefore likely to be of a relatively superficial nature with minimal impact on the structural integrity or tensile strength of the timber element.

Monitoring is recommended. If any further movement occurs a registered builder or carpenter should be consulted immediately to restore the area and prevent further deterioration.

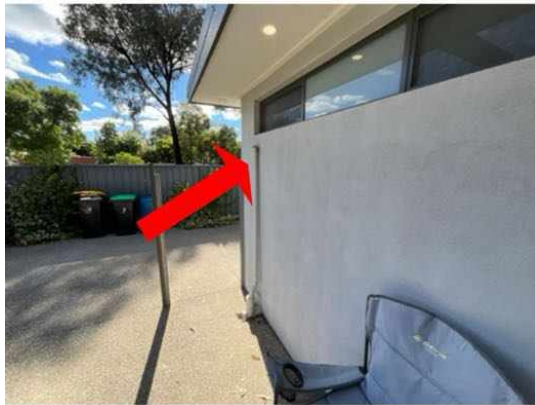
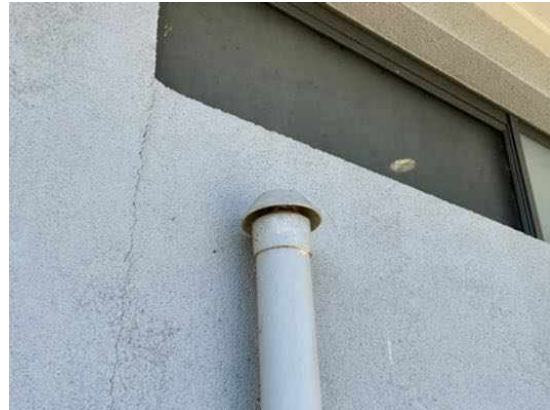
Building: Building 1
 Location: Yard - Back
 Finding: Vent
 Information: This appears to be the sewer vent for the property. This pipe should vent to the outside air at least 150 mm above the roof surface.

A plumber should be contacted soon to improve this installation and prevent a potential health hazard.

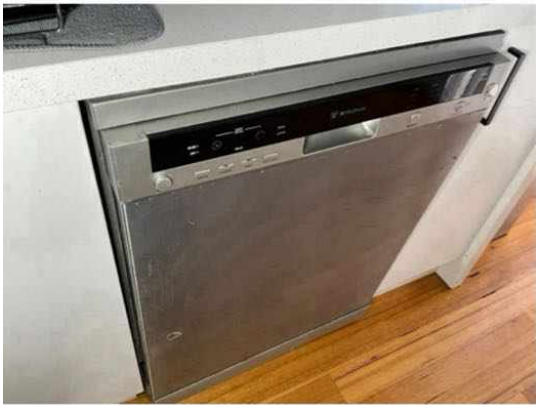
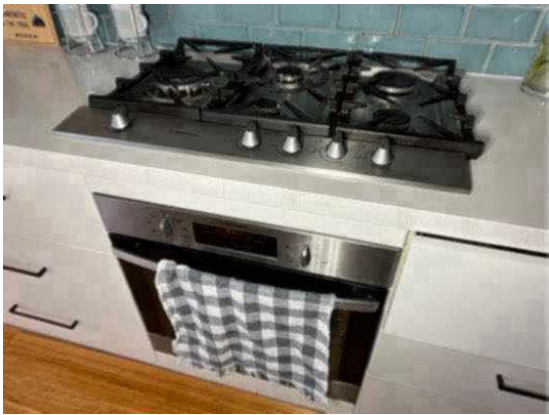
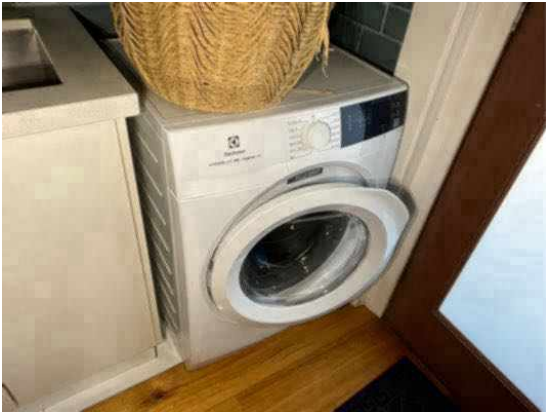
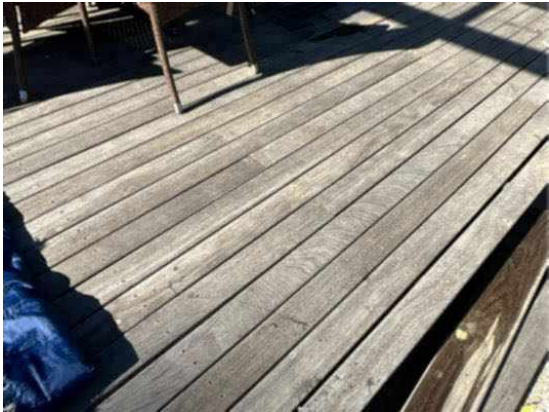
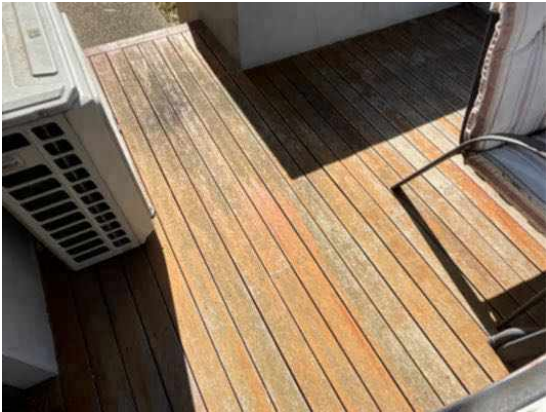
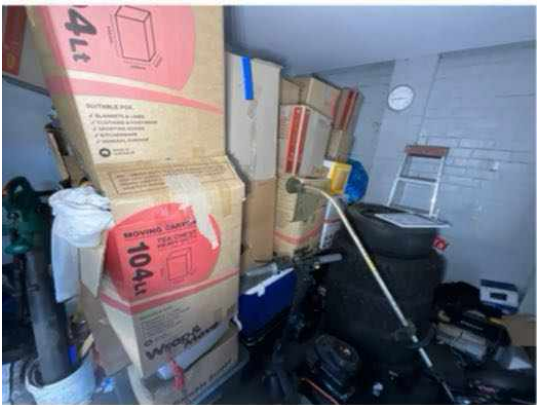
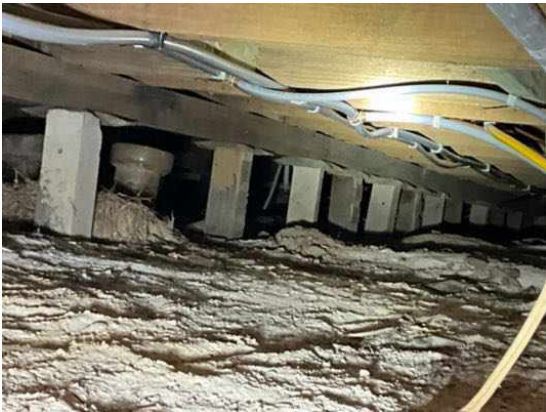
Building: Building 1
 Location: All Areas
 Finding: Additional Photos - Obstructions and Limitations
 Information: These photographs are an indication of the obstructions and limitations which impeded full inspection of the property at the time of inspection. These obstructions can hide an array of defects and should be removed to allow full inspection to be carried out. A re-inspection is recommended once the areas are made accessible.
