Building and Timber Pest Inspection Report

Inspection Date: Thu, 2 Apr 2026

Property Address: 5/23-25 Fontainebleau St, Sans Souci NSW
2219, Australia

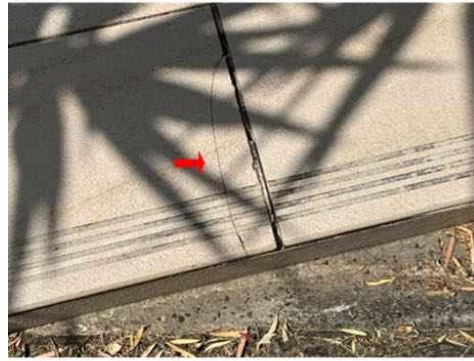
Building:	Main Building
Location:	All Areas
Finding:	Tiles - Cracked or Damaged
Information:	At the time of inspection cracking or damage was evident to the tiling in several areas throughout the property.

If left unmanaged, water penetration to these areas may lead to subsequent water damage, which is likely necessitate repair work to affected building elements.

A tiling contractor should be appointed to replace cracked or damaged tiles ensure that no further water damage occurs.

The re-application of silicone and grouting throughout remaining tile work is also advised, to further protect the area against water penetration.

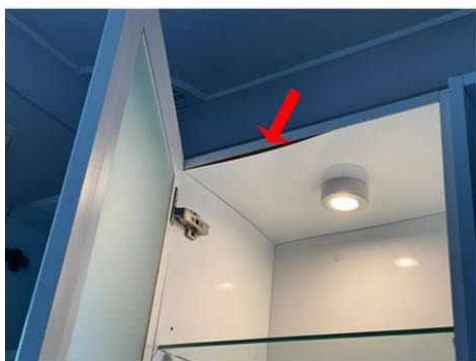
Finding 3.19

Building:	Main Building
Location:	Kitchen
Finding:	Door binding
Information:	Binding of this door is evident during standard operation.

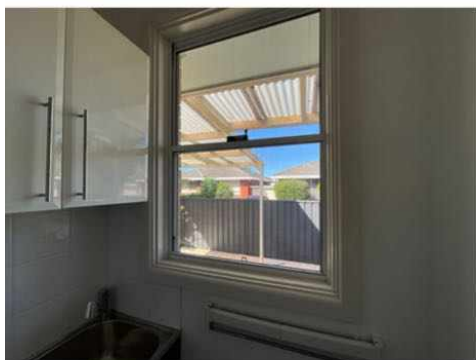
Finding 3.21

Building:	Main Building
Location:	Laundry
Finding:	Laundry tub - Rusted or corroded
Information:	The laundry tub was observed to have visible rusting and surface deterioration. This condition is typically the result of prolonged exposure to moisture and general wear over time and may lead to further corrosion or eventual failure of the fixture if left unaddressed.
