Building and Timber Pest Inspection Report

Inspection Date: Wed, 11 Mar 2026

Property Address: 43A Welwyn Rd, Hebersham NSW 2770,
Australia

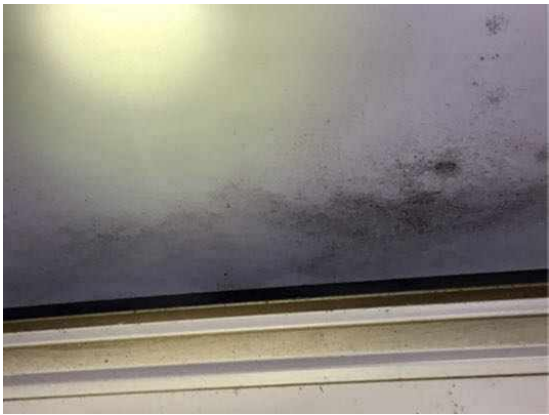
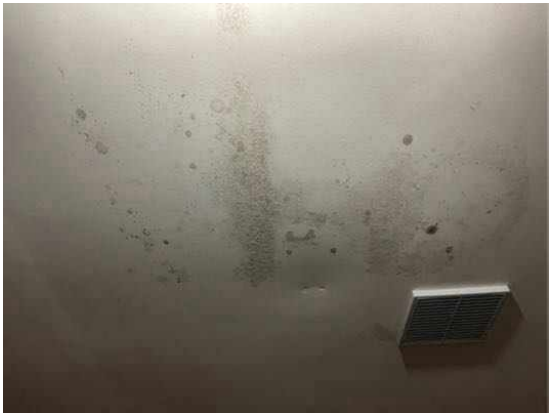
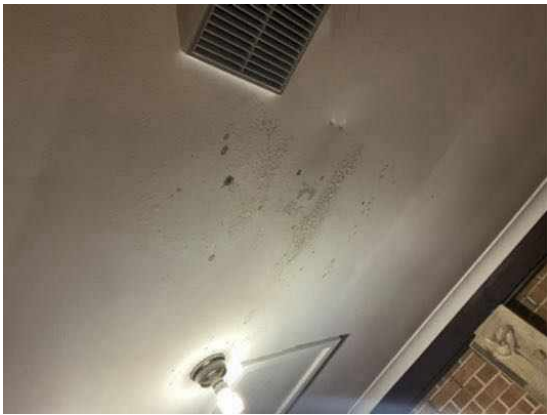
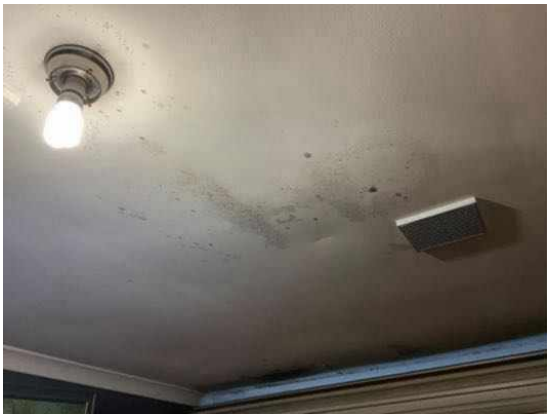
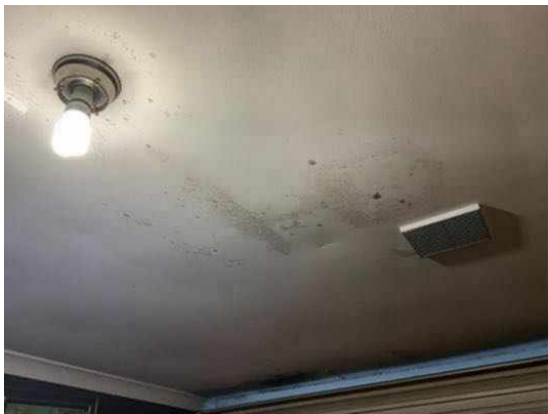
Building: Main Building
Location: Garage
Finding: Mould - Present
Information: Mold growth is present throughout the property, primarily due to inadequate ventilation. Poor airflow and moisture accumulation within the house have created ideal conditions for mold to thrive.

- **Health Hazards**: Mold growth can pose serious health risks to occupants, particularly those with allergies, asthma, or other respiratory conditions. Prolonged exposure to mold spores can cause respiratory issues, skin irritation, and other allergic reactions.
- **Structural Damage**: Mold can degrade building materials over time, leading to rot and weakening of the structural components such as timber, drywall, and insulation, which can result in costly repairs.
- **Decreased Property Value**: The presence of mold can significantly reduce the value of the property, as it indicates underlying moisture and ventilation issues that need addressing.

A licensed mold remediation specialist should be engaged to remove the mold and treat affected areas. In addition, a ventilation expert or builder should assess and improve the house's ventilation system, possibly installing exhaust fans, vents, or mechanical ventilation systems to ensure adequate airflow and prevent future mold growth.

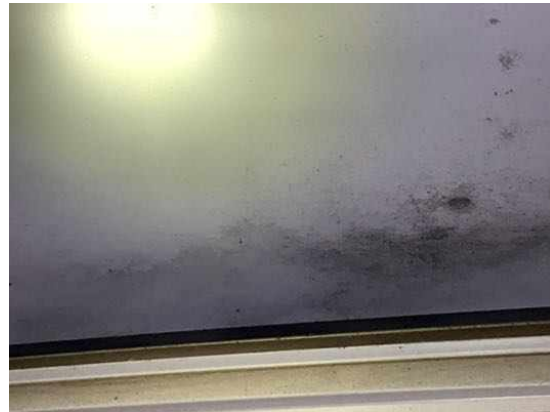
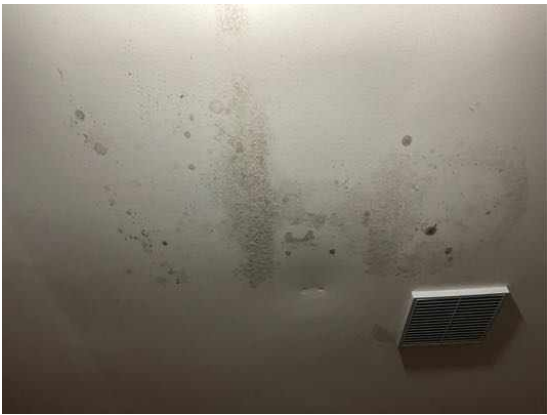
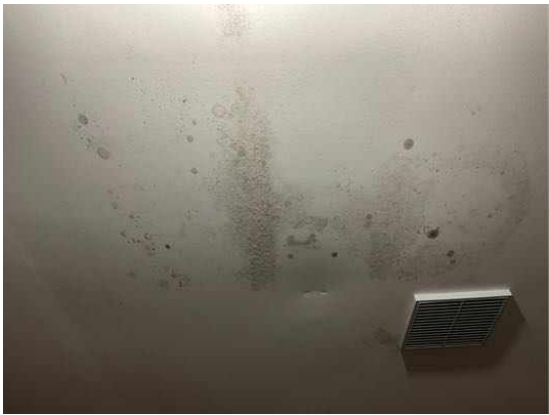
Building:	Main Building
Location:	Garage
Finding:	Roof void - Suspected water leak
Information:	Suspected water leak in the roof void, as evidenced by the presence of water stains, indicating potential gaps or holes.

- Structural Damage: Continuous water leakage can weaken the structural integrity of

- Mold and Mildew: Persistent moisture can promote the growth of mold and mildew, posing health risks such as respiratory problems and allergic reactions.
- Electrical Hazard: Water intrusion near electrical wiring can create a risk of short circuits, fires, or electrical shocks.
- Insulation Damage: Prolonged exposure to moisture can damage insulation, reducing its effectiveness and increasing energy costs.

A licensed roofing contractor should be contacted immediately to inspect, diagnose, and repair the source of the leak to prevent further damage.

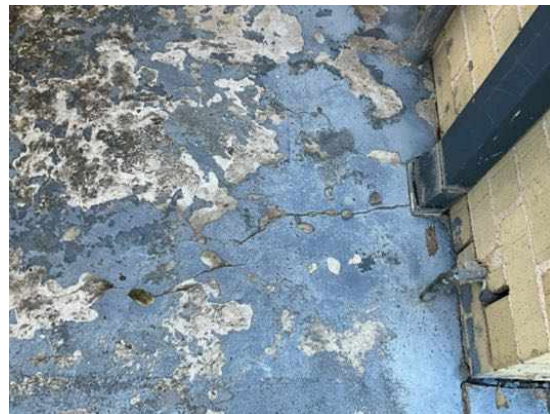
Finding: Crack in concrete slab - Category 0

Information: A crack coded as Category 0 was identified in the slab. A Category 0 crack is described as a hairline crack, representing insignificant movement of slab from level.

The approximate width of the crack to be considered Category 0 is 0.3mm, or change in offset of less than 8mm when a 3m straight edge is placed over the defect.

No rectification is required at this time. However, all cracking should be monitored over a 12 month period to identify any further damage in the area.

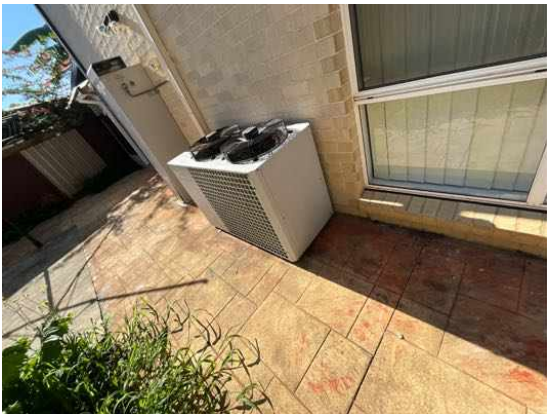
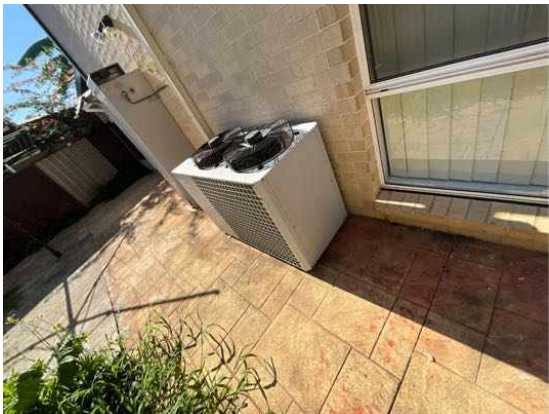
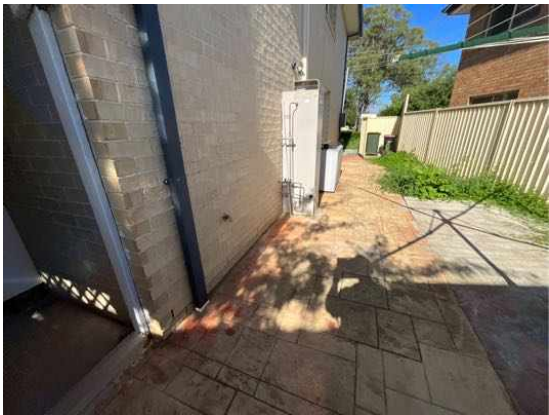
Finding 3.02

Building:	Main Building
Location:	All Areas
Finding:	Bridging or Obstruction Conducive environment for Termites
Information:	Bridging of termite barriers occurs when termites bridge (usually by building a mud tunnel) a termite barrier or inspection inspection zone or where termites have a passage, allowing them to bridge the barrier.

property in a concealed or undetected manner.

Recommended moving obstructions away from the external walls for further and future inspections.

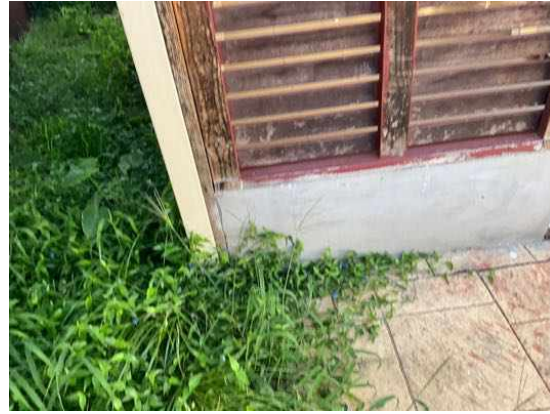
Finding 3.03

Building: Main Building
Location: Pergola
Finding: Timber - exposed to weather
Information: External timbers that are frequently exposed to harsh weather conditions require adequate protection in order to maintain their condition. Where timbers have not been

painted or treated adequately, general deterioration is likely to occur at an accelerated rate.

If left unattended, replacement of these timbers is likely to be necessary in the short-term future. Adequate treatment of these timbers is required as soon as possible by a painting contractor or general handyman.

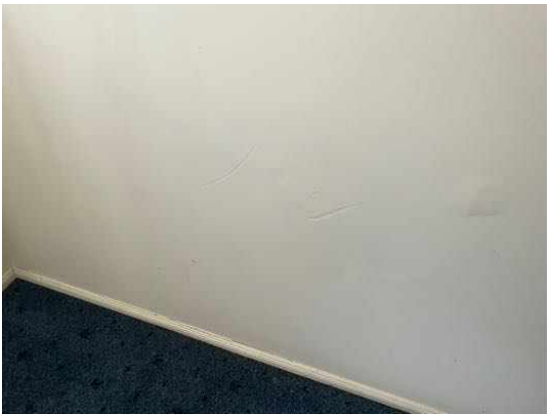
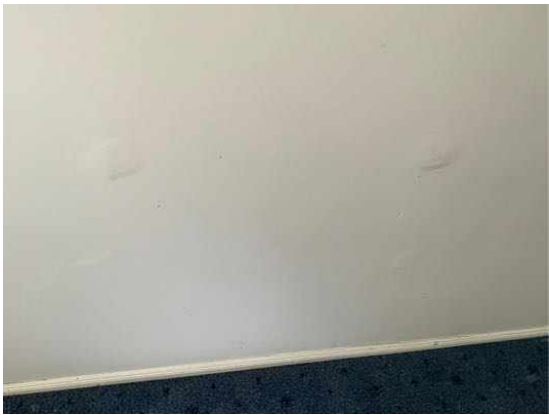
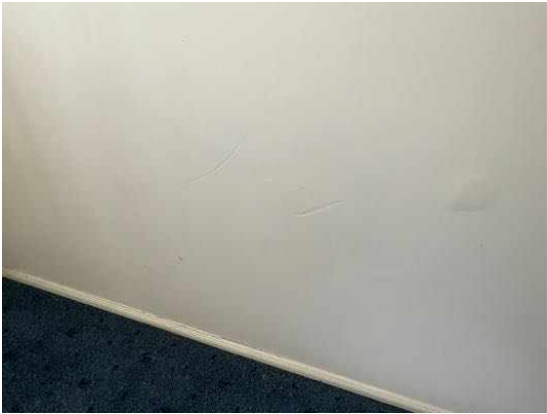
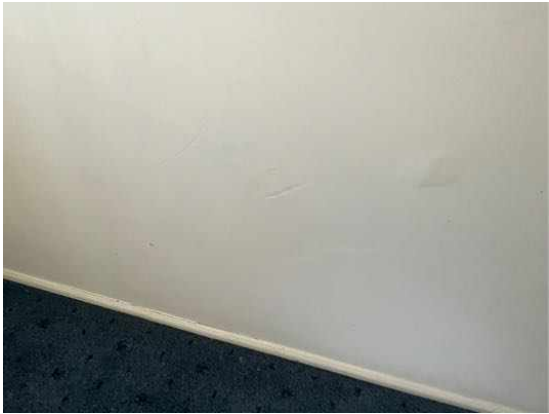
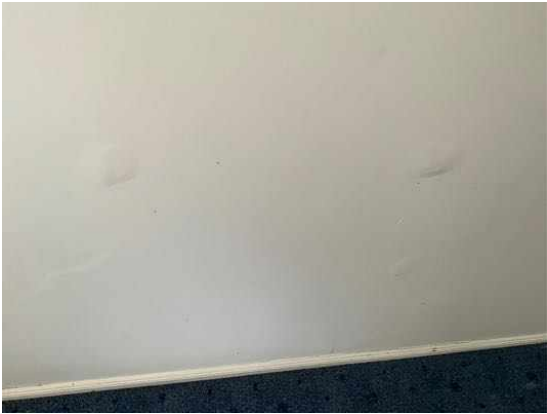
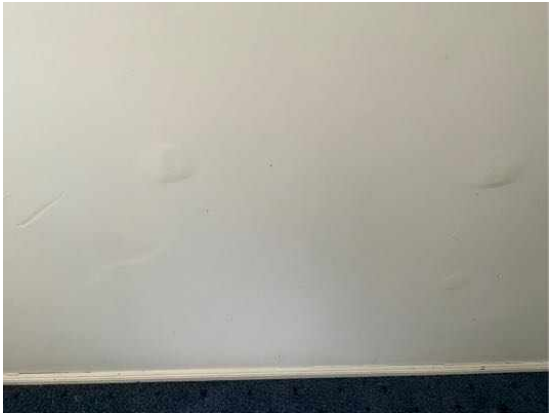
Finding 3.04

Building: Main Building
 Location: All Areas
 Finding: Poor workmanship
 Information: The structure exhibits signs of poor workmanship, evident in various aspects of construction and finishing.

Risk: Poor workmanship poses a range of risks, including compromised structural integrity, potential safety hazards, and a decreased lifespan of the structure. It may also lead to aesthetic and functional issues.

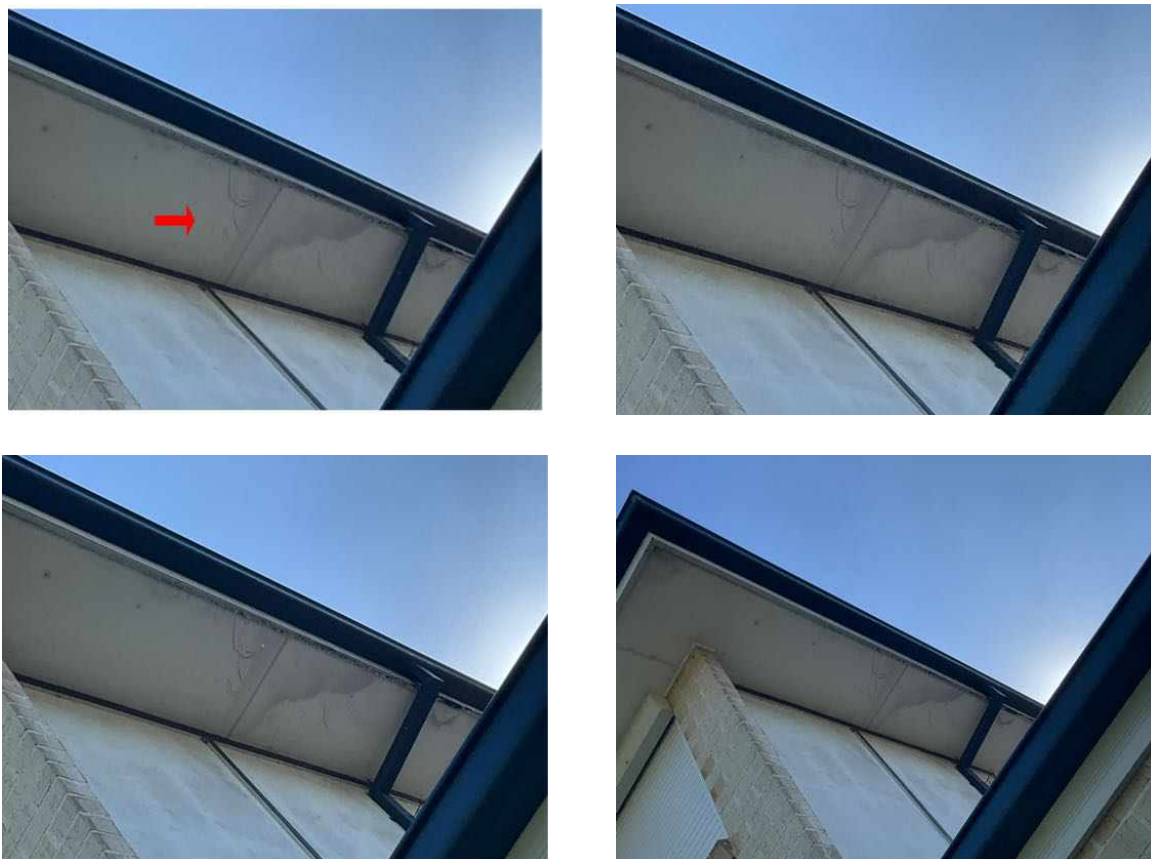
Finding 3.05

Building: Main Building
Location: All Areas
Finding: Eaves - water Stained
Information: Water stains are present on eaves, indicating a potential water leak or seepage issue.

Prolonged water exposure can lead to structural damage, mold growth, and compromise the aesthetic appeal of the affected area. Additionally, it may indicate underlying issues that, if unaddressed, can escalate and result in more extensive damage.

A qualified plumber or water damage restoration specialist should investigate and

address the source of the water stains. Repairing leaks, improving waterproofing, and, if necessary, restoring the affected surfaces are crucial to preventing further damage and maintaining the integrity of the space.

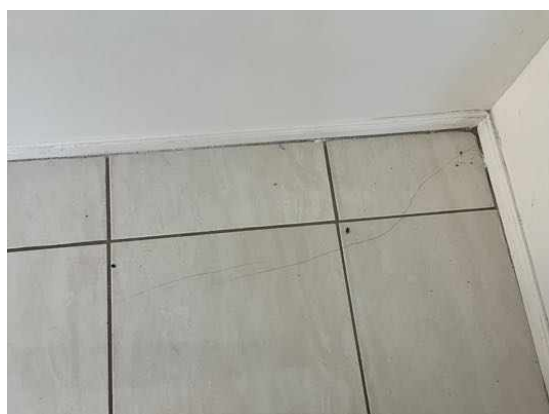
- Building: Main Building
- Location: Living Room
- Finding: Floor Tile crack
- Information: A floor tile has a visible crack on the surface.
- Risk / Implication:

The damaged tile presents a trip hazard, may lead to cuts if stepped on barefoot, and can allow moisture ingress into the substrate, which may cause further deterioration or loosening of adjacent tiles. It also affects the overall appearance of the floor.

A licensed tiler should be engaged to remove the damaged tile and install a matching replacement. If spare tiles are unavailable, additional remedial work may be required to blend the repair with surrounding finishes.

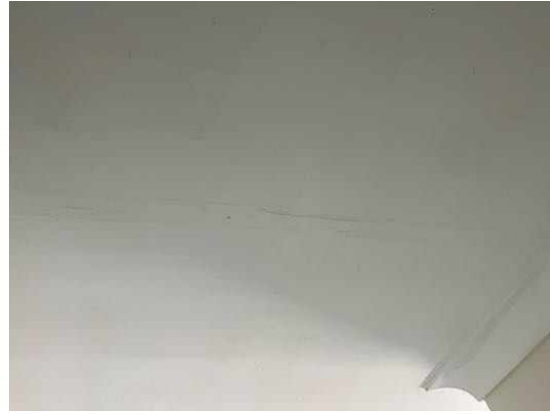
Building:	Main Building
Location:	Dining Room
Finding:	Ceilings - Crack (Fine)
Information:	Fine cracks are observed in the ceiling, suggesting potential structural issues or settling.

The presence of fine cracks in the ceiling poses a risk of further structural damage, compromising the integrity of the building. Additionally, it may indicate underlying issues such as foundation problems or insufficient support.

A structural engineer or a qualified contractor should be consulted to assess the cause of the cracks and recommend appropriate repairs. Addressing the underlying issues is crucial to prevent further damage and maintain the safety and stability of the structure.

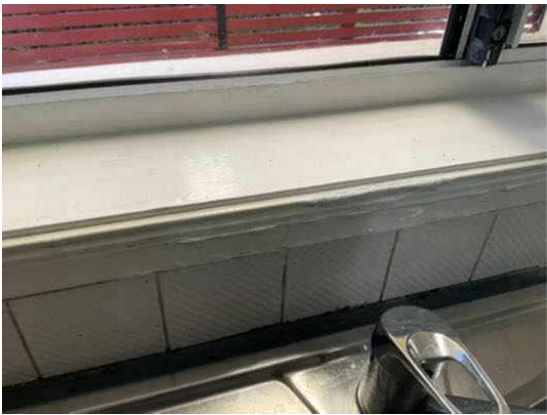
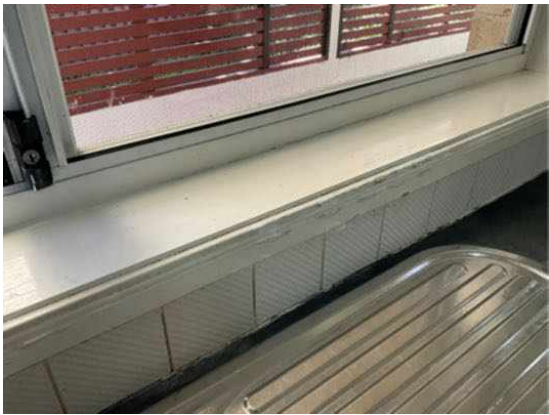
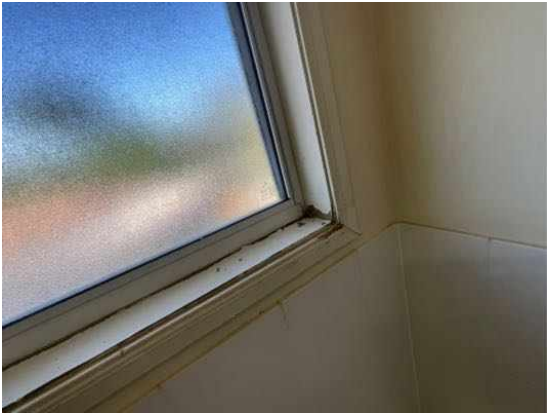
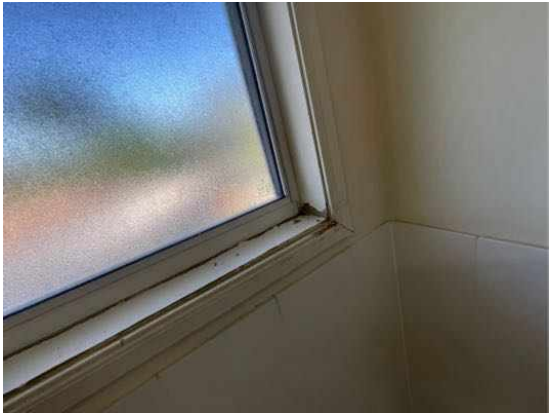
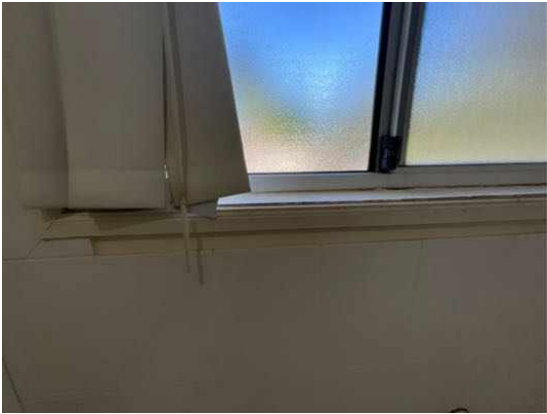
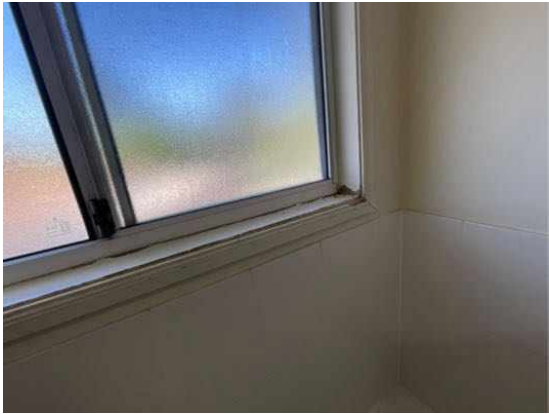
Finding 3.16

Finding: Water staining

Information: Water staining was evident in this area at the time of inspection. Water staining indicates that surfaces have been exposed to excessive moisture over time. The minerals and other elements in the water lead to staining, which may graduate to corrosion and deterioration if left unmanaged.

While mostly an appearance defect, water staining can be indicative of more serious defects, which may be currently concealed by other building elements.

Conversely, where water staining is old and inactive, affected building materials may be repaired or replaced at client discretion. A qualified carpenter or registered builder may be appointed to perform these works.

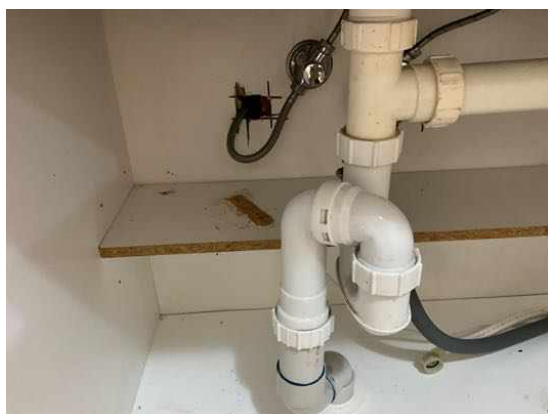
Building: Main Building
 Location: Kitchen
 Finding: Damaged cabinetry
 Information: A damaged cabinetry poses a risk of functional issues, reduced aesthetics, and potential further deterioration if left unaddressed.

Seeking assistance from a skilled carpenter or cabinet repair specialist is advisable to assess and repair the damaged cabinet door, ensuring proper restoration and maintaining the functionality and appearance of the cabinetry.

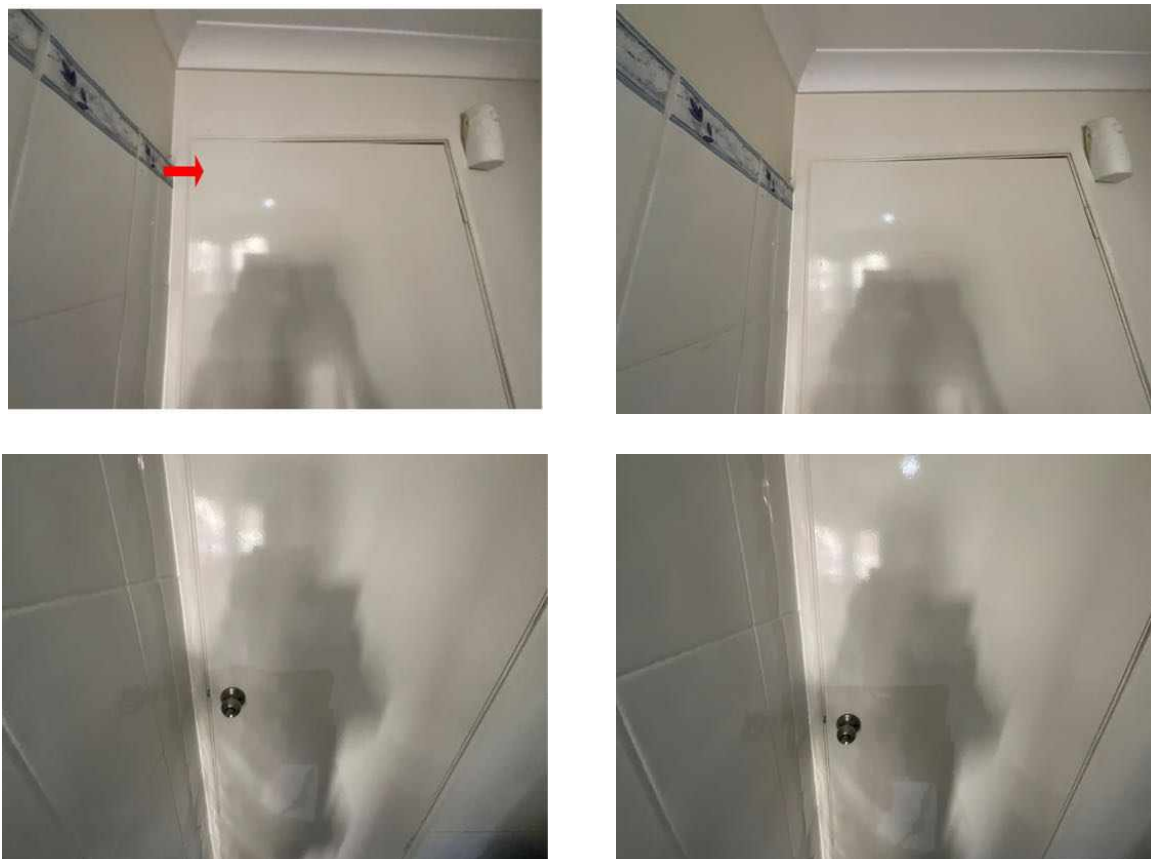
Finding 3.19

Building:	Main Building
Location:	Laundry
Finding:	Door - Binding/jamming
Information:	Binding and/or jamming of this door is evident during standard operation. This defect inhibits the functionality of the affected door as well as creating potential for secondary defects to associated building elements.

A door that binds to flooring or to the associated door frame may have several causes, ranging from minor defects, such as poor installation of the door or deteriorated hinges, through to major structural issues. For minor causes, a qualified carpenter or general handyperson should be appointed to perform minor rectification works at client discretion.

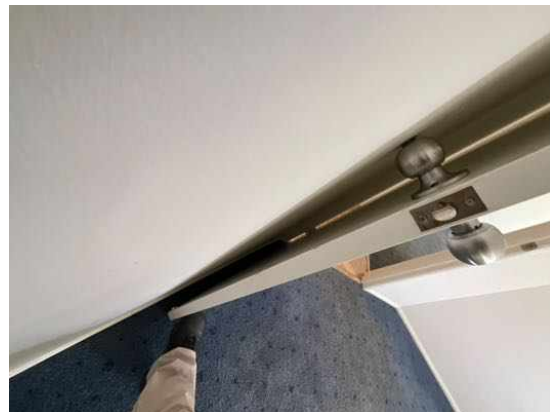
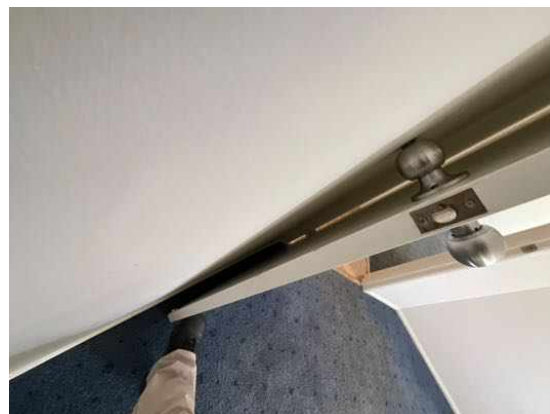
- **Engage a Handyperson or Carpenter:** A handyperson or carpenter should install a suitable door stopper to prevent excessive door movement. This could be a floor-mounted or wall-mounted stopper depending on the space and door design.

This issue is a minor defect but should be addressed to prevent potential damage and maintain the integrity of the door and surrounding areas.

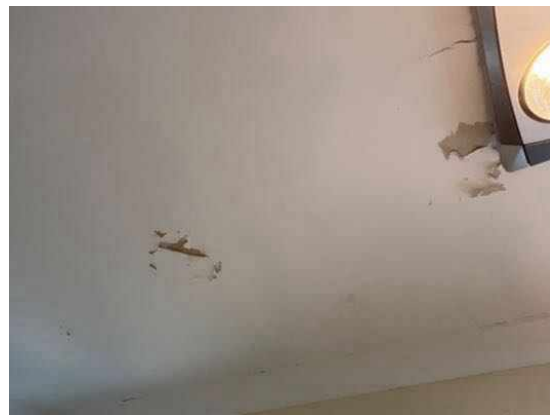
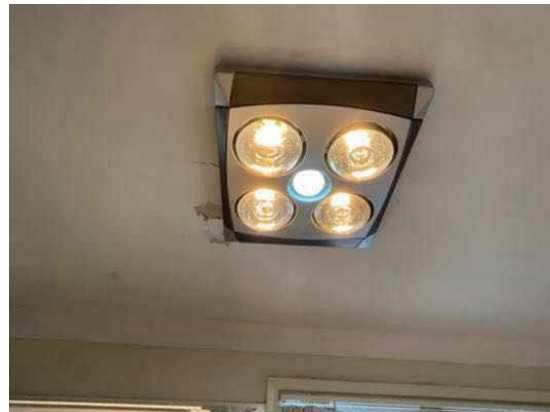
Finding 3.24

Building: Main Building
Location: Bathroom
Finding: Flaky Paint

The presence of excessive moisture can have major implications on associated building elements if left unattended. While only seemingly minor at this stage, the damage cannot be determined due to the paint, obstructing any further inspection of the damage.

It is highly advised that the affected paint to be cleaned to allow a further, more invasive inspection by a licensed builder/painter. Failure to act on this defect may necessitate major works in the future.

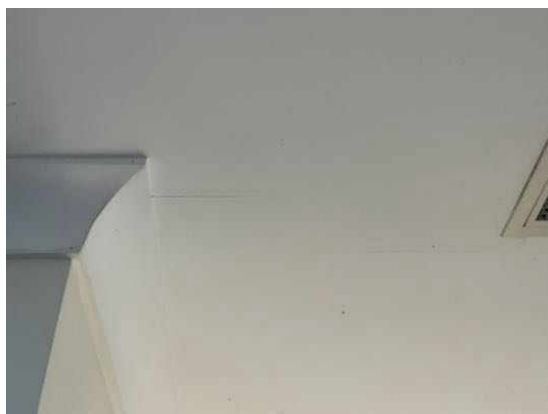
A structural engineer or a qualified contractor should be consulted to assess the cause of the cracks and recommend appropriate repairs. Addressing the underlying issues is crucial to prevent further damage and maintain the safety and stability of the structure.

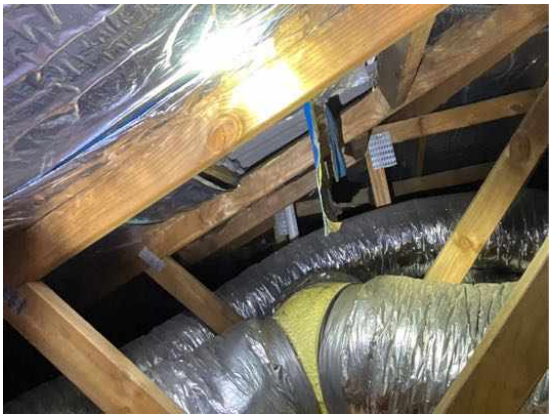
Finding 3.32

Building:	Main Building
Location:	Roof Void
Finding:	Sarking - Damaged
Information:	Sarking, a laminated aluminium foil applied to the interior of the roof covering, assists in insulating the property and acting as a vapour-barrier to the roof void and, subsequently, to the household.

It is important to repair any holes or damaged sections of sarking to ensure that the building material is fully functional. A registered builder or qualified carpenter should be consulted to provide further advice on this defect and to perform rectification works at client discretion.

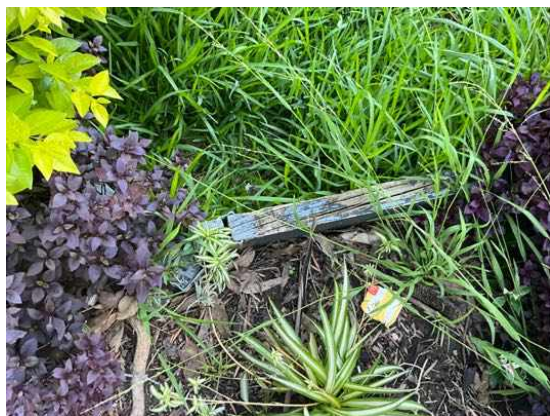
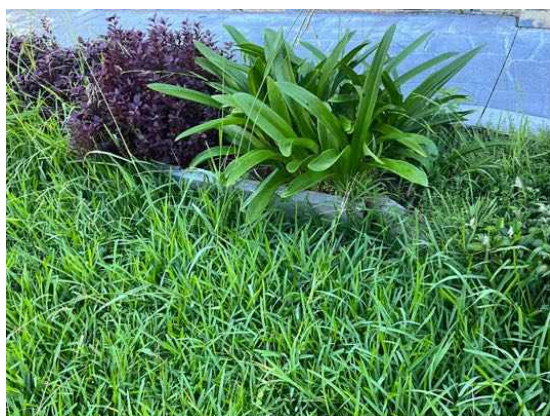
To prevent this, it's important to keep timber elevated and away from direct ground contact. Regular inspections and proper termite control measures are also essential to protect your wooden structures from termite damage.

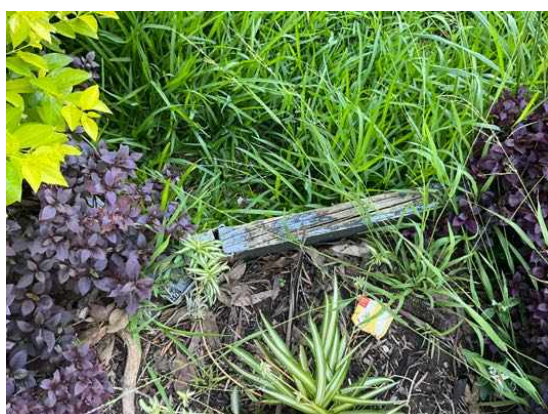
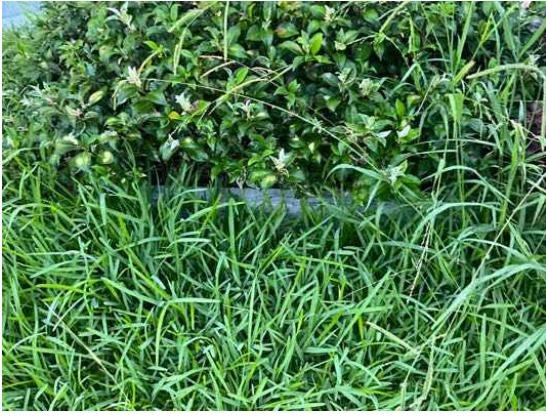
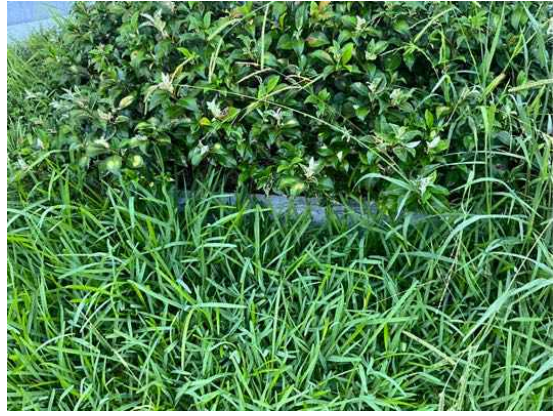
Finding 7.01

Early intervention and regular maintenance, particularly of exterior timbers, will prolong the useful life of these building elements. Prior to any works being performed, the cause of the moisture that has created the visible wood rot should be identified and addressed in a suitable manner. Replacement of affected timbers may then be a necessary step in protecting surrounding building elements from such deterioration.

A qualified plumber may be appointed to assess the cause of excessive moisture and to provide advice on any remedial works as required. A qualified carpenter or registered builder may also be required to replace affected building materials.
