## Building Inspection Report

Inspection Date: Tue, 17 Feb 2026

Property Address: 12/21-31 Parman Ave, Pakenham VIC 3810,  
Australia

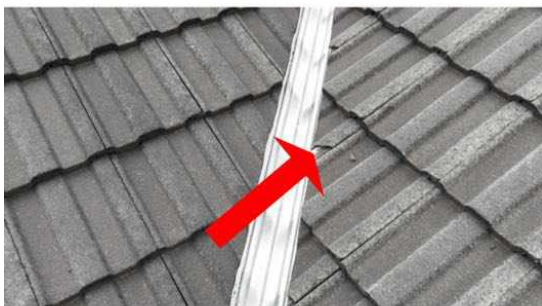
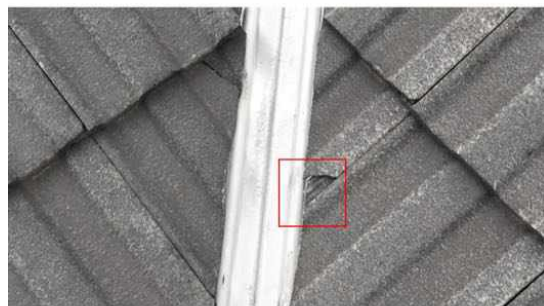
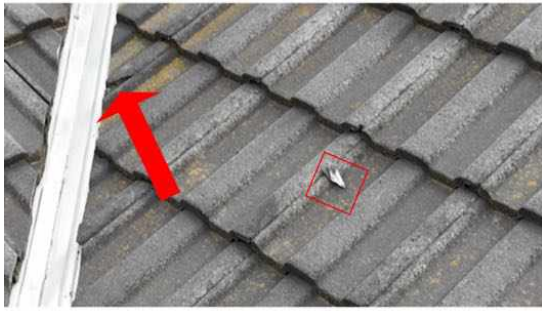
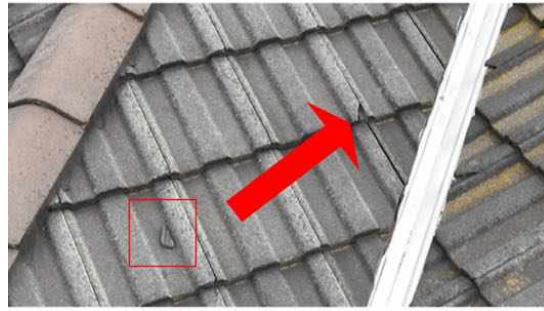
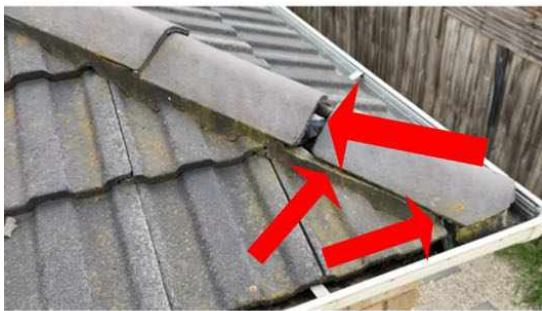
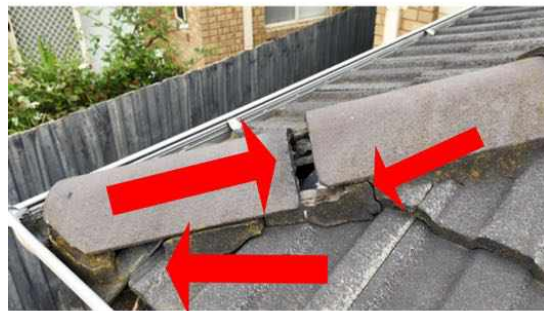
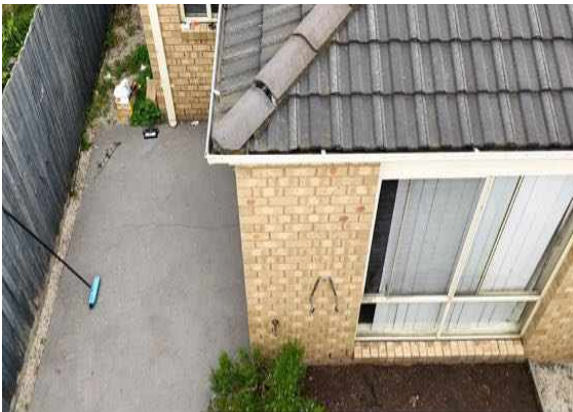
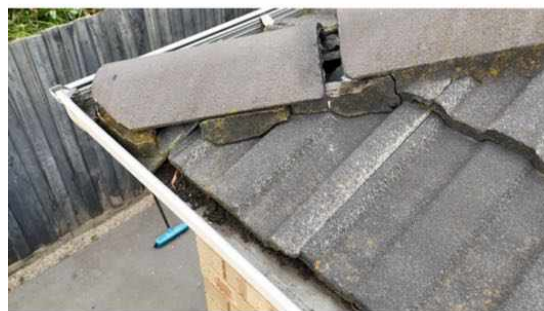
#### Defects 3.01

Building:	Main Building
Location:	Roof Exterior
Finding:	Broken Roof Tiles and Damaged Ridge Capping - urgent attention required
Information:	Multiple broken and chipped roof tiles were identified at the time of the inspection, consistent with general ageing and weather exposure. In addition, at the rear side of the roof, a section of ridge capping was observed to be broken, creating a visible gap within the ridge line.

Broken tiles and compromised ridge capping may allow rainwater penetration into the roof space, particularly during wind-driven rainfall events. Moisture ingress may result in deterioration of roof battens, insulation, and other timber roof framing elements, potentially leading to further damage if not addressed promptly.

In particular, damage to the roof ridge tiles was identified. The affected ridge sections require re-bedding and re-pointing to restore the integrity of the roof covering. This matter requires urgent attention, as compromised ridge capping may allow water ingress into the roof space during rainfall events. A licensed roofing contractor should be engaged without delay to rectify the ridge tiles and ensure the roof is fully weatherproof.

It is recommended that a licensed roofing contractor be engaged without delay to replace all broken and chipped roof tiles and to repair the damaged ridge capping. The affected ridge section should be properly re-bedded and re-pointed as required to restore weatherproof integrity. A comprehensive roof inspection should also be undertaken at the same time to identify and rectify any additional defective tiles or ridge sections to ensure the roof covering is fully watertight.

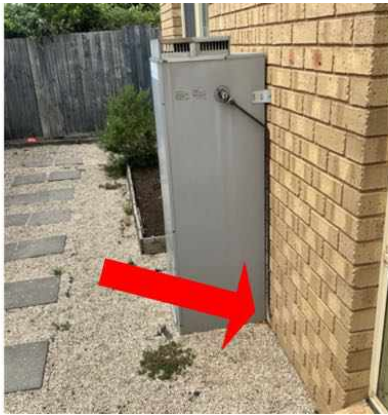
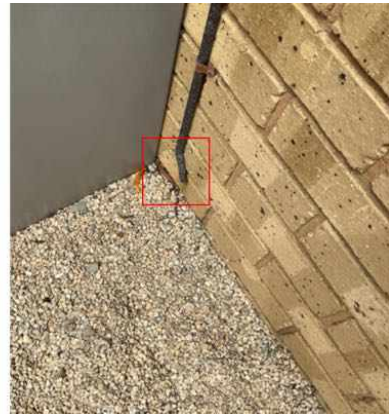
### Defects 3.02

Building: Main Building  
 Location: Yard - Side  
 Finding: HWS not plumbed to drainage  
 Information: Upon visual inspection, we found that the hot water system is not plumbed for proper drainage. This issue may create conditions conducive to water accumulation around the building, potentially leading to moisture-related problems such as wood rot or fungal decay. The stagnant water could also attract termites, creating an environment where they may thrive and cause damage to timber components of the property.

We recommend that a licensed plumber be engaged to ensure that the hot water system is properly connected to a drainage system to prevent any moisture buildup

around the area. This will help avoid any future risks of structural damage, pest infestations, or deterioration of the building's materials. Immediate attention is advised to mitigate any potential issues and protect the property from long-term damage.

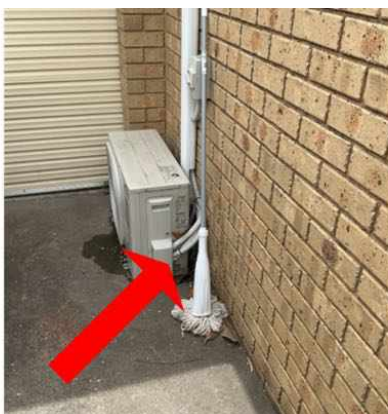
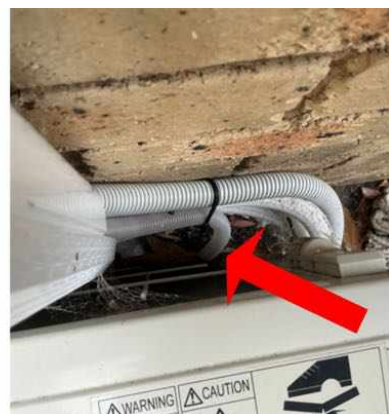
### Defects 3.03

Information: Upon inspection, it was found that the AC overflow is not plumbed or connected to suitable drainage. This could lead to the surrounding area becoming excessively damp, which in turn may cause secondary defects such as rot, rust, corrosion of associated building elements, and the formation of fungal decay. In addition, prolonged damp conditions could create potential slip hazards. Poor site drainage may exacerbate the issue, potentially attracting termite activity to the area.

We recommend that a licensed plumber be appointed to properly plumb the AC overflow and connect it to suitable drainage. This will help ensure that the area remains dry and free from secondary defects.

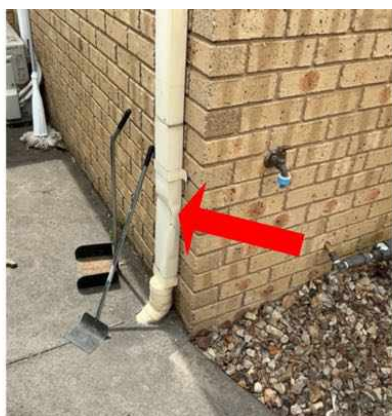
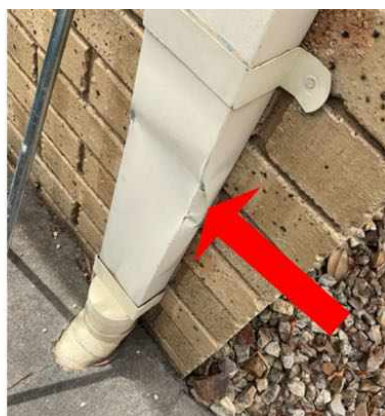
### Defects 3.04

Location: LHS elevation  
 Finding: Damaged Downpipe at Left-Hand Elevation  
 Information:

The downpipe located to the left-hand side elevation of the dwelling was observed to be dented and deformed, consistent with impact damage. The physical deformation has compromised the original profile of the downpipe and may restrict the effective discharge of roof water during rainfall events.

If left unrectified, the damaged section may lead to reduced hydraulic performance, potential overflow during heavy rain, and localised moisture accumulation at the base of the wall. Prolonged exposure to uncontrolled water discharge may contribute to deterioration of adjacent wall finishes, footings, and may create conducive conditions for timber pest activity.

It is recommended that a licensed plumber remove and replace the damaged downpipe section with a new matching component to restore proper stormwater drainage functionality. The connection to the stormwater system should be checked at the time of replacement to ensure compliant and effective discharge.

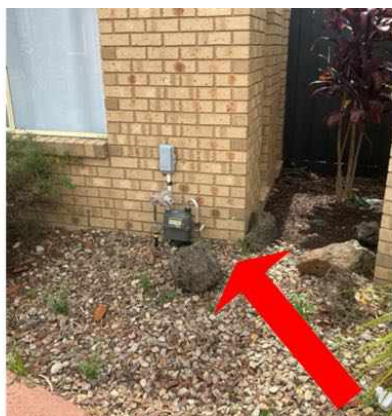
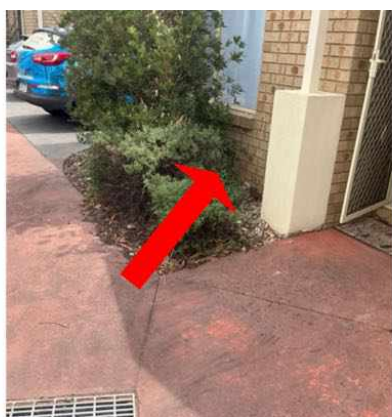
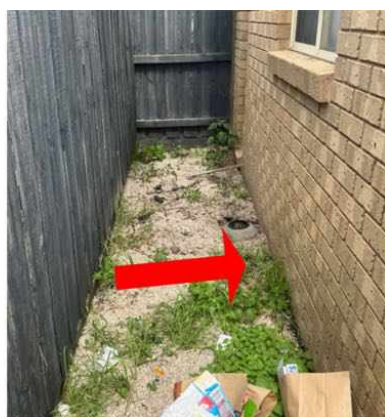
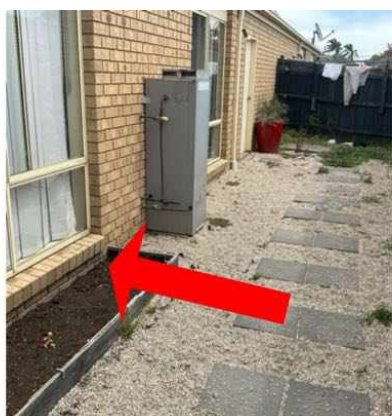
### Defects 3.05

Building: Main Building  
 Location: All External Areas  
 Finding: Site drainage - Inadequate  
 Information:

The site drainage in this area was found to be inadequate at the time of inspection, creating potential for subsequent water damage to associated building elements.

Where site drainage is inadequate, installation of an Agricultural (Aggie) Drain may be required. A qualified plumber should be appointed to further inspect the property and

perform any remedial works as necessary. Water damage and secondary defects are likely to occur if left unmanaged.

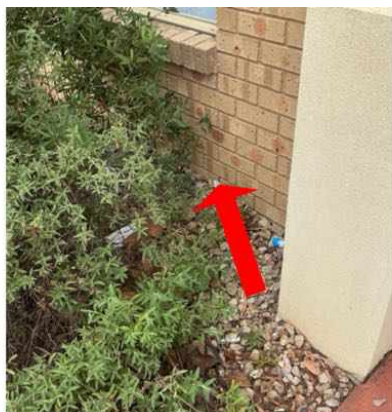
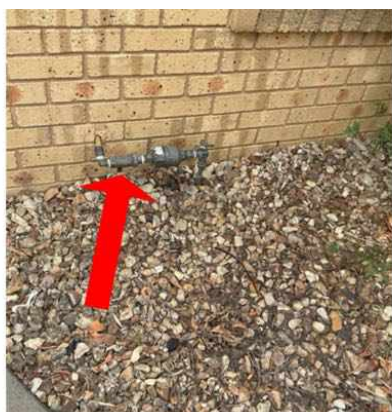
### Defects 3.06

Building:	Main Building
Location:	All External Areas
Finding:	Insufficient Clearance to External Weep Holes
Information:	Inspection revealed that the external weep holes around the base of the external walls have insufficient clearance, with landscaping materials such as soil or stones positioned directly beneath or against them. Weep holes are essential for allowing moisture within the wall cavity to escape and for enabling ventilation of the internal wall

When weep holes are obstructed or have inadequate clearance, their function is compromised. This can result in moisture being trapped within the wall cavity, leading to potential structural deterioration, rising damp, or even termite ingress—especially in timber-framed dwellings.

It is recommended that the landscaping be adjusted to ensure a minimum vertical clearance of at least 75mm below the lowest part of the weephole. This will allow for proper drainage and ventilation and help protect the structural integrity of the property.

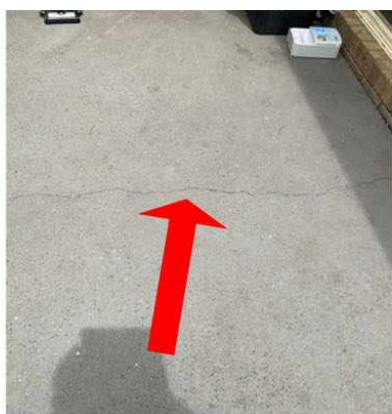
### Defects 3.07

Building:	Main Building
Location:	Yard - Side
Finding:	Cracking - External Concrete Paving Damage Category 1 - Fine (less than 2mm)
Information:	Fine cracks were identified in external concrete paving. Although fine cracks are quite noticeable, they are often only considered to be an appearance defect, and usually do not indicate any structural damage. To be considered a Category 1 or fine crack, the crack is found to be less than 2mm in width.

Generally the cause of a hairline crack in existing concrete paving such as driveways and pathways is indicative of the expansion and contraction of the concrete. Such causes are generally due to environmental factors, such as moisture levels, weather

conditions, root systems of nearby trees or the soil types on which they are laid.

Fine cracks may also be due to poor original installation of the concrete. Factors such as poor compaction of the sub surface and/or inadequate reinforcing of the slab may create cracking and other secondary defects.

Monitoring of all cracking should be conducted frequently. Always contact a building inspector should cracks widen, lengthen, or become more numerous.

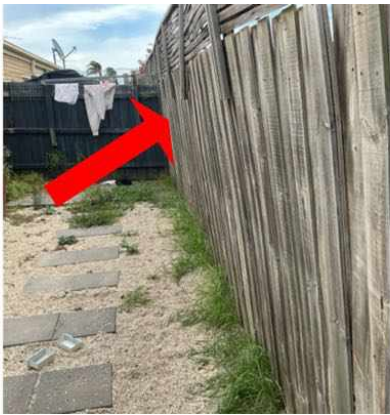
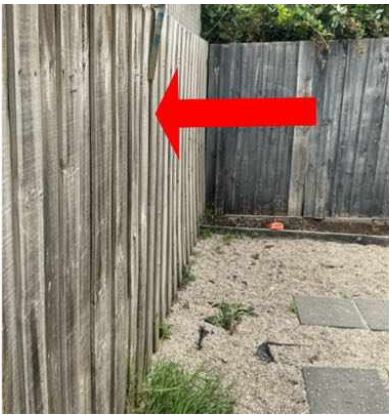
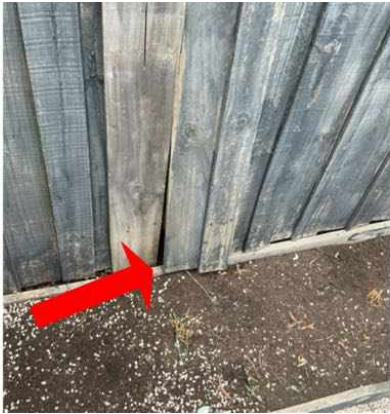
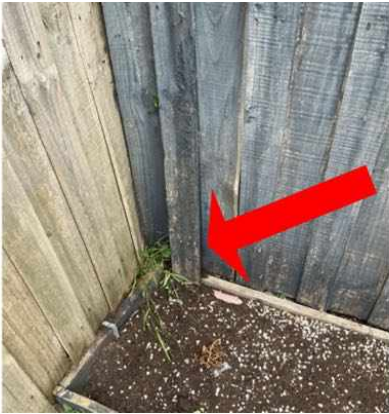
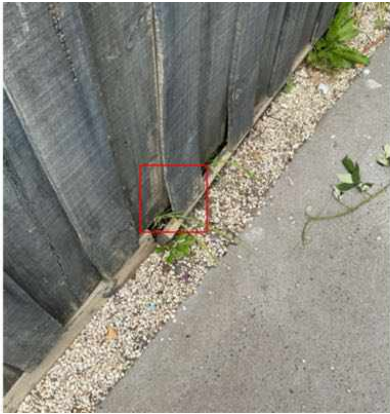
### Defects 3.08

Building:	Main Building
Location:	Fencing
Finding:	Fencing - Deteriorated
Information:	It was noted at the time of inspection that sections of the fencing throughout the property have deteriorated. Typically fencing deteriorates due to age and or wear, rot and or rust which is generally expected for a structure of this age, due to prolonged exposure to weather conditions. Sometimes inadequate installation or maintenance can be to blame.

If left unattended, it is likely that further damage will occur. It is suspected that repair of several elements of the fencing may be required however replacement may be a consideration of the client also.

A licensed fencing contractor should be appointed to provide further advice and perform rectification works as necessary.

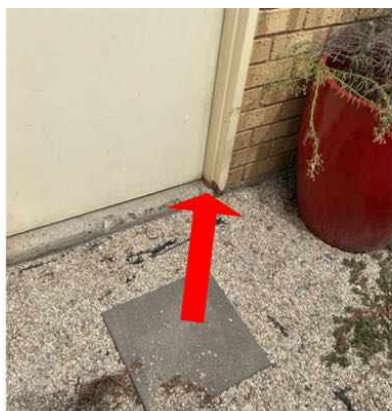
**Defects 3.09**

Building: Main Building  
Location: Garage  
Finding: Minor Rusting to Rear Garage Access Door Frame  
Information:

Minor surface rust was observed at the base of the door frame to the garage rear access door. The corrosion appears to be localised at the lower section, likely due to prolonged moisture exposure at the base of the frame.

If left untreated, surface rust may progressively deteriorate the metal substrate, leading to further corrosion, paint failure, and potential weakening of the door frame over time.

It is recommended that the affected area be mechanically cleaned to remove corrosion, treated with an appropriate rust-inhibiting primer, and repainted with a suitable exterior-grade protective coating to prevent further deterioration.

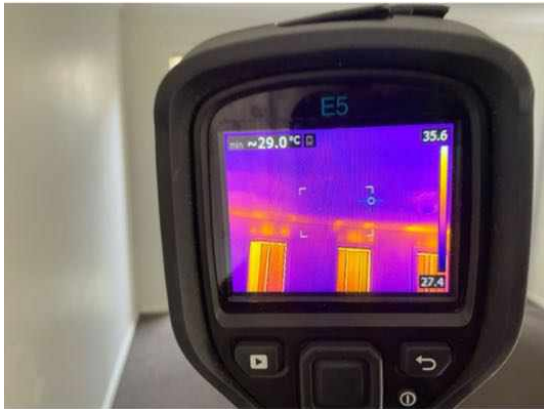
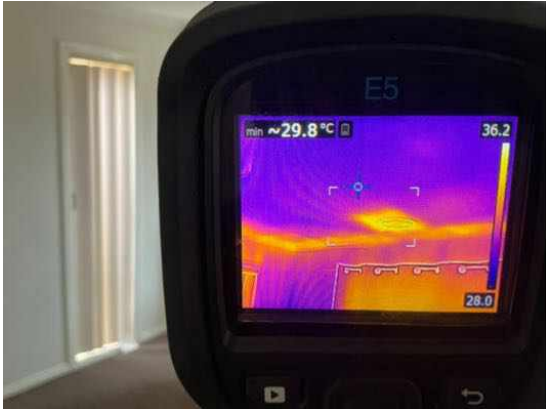
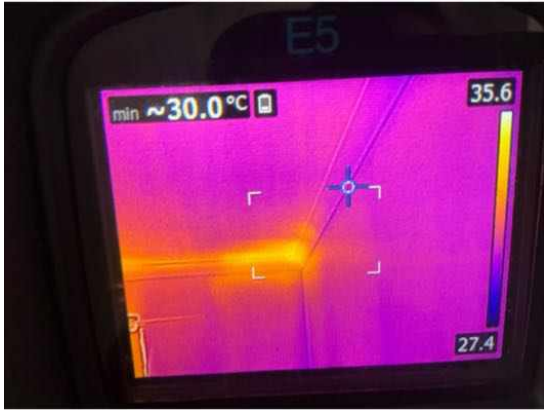
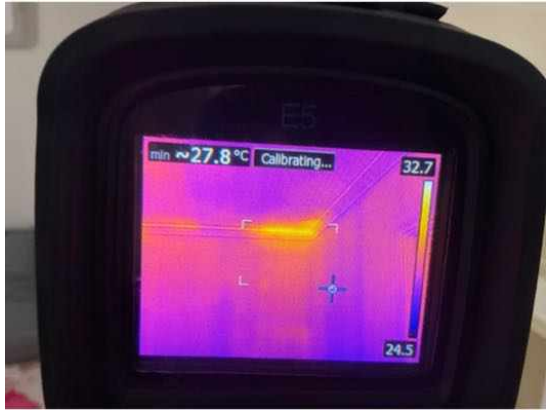
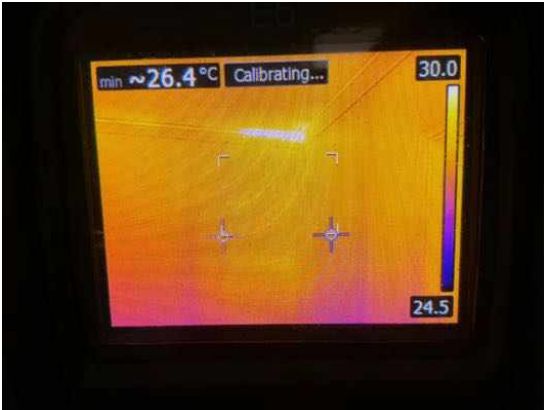
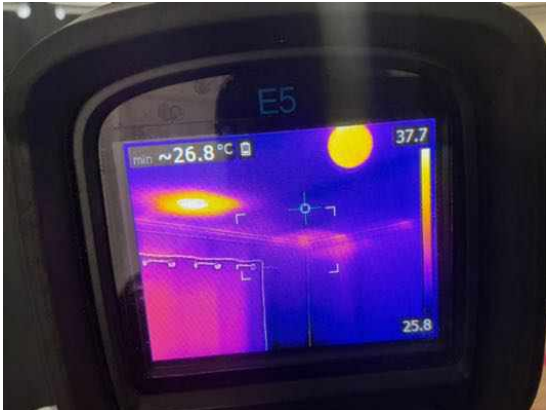
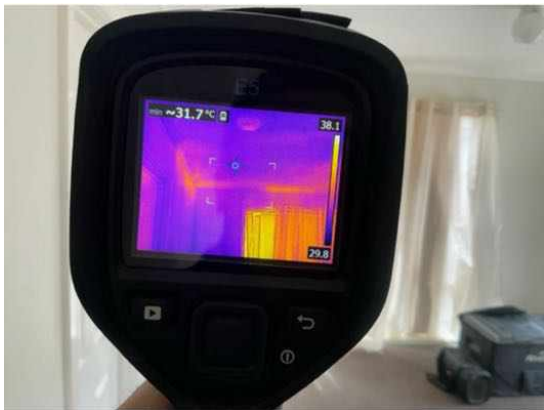
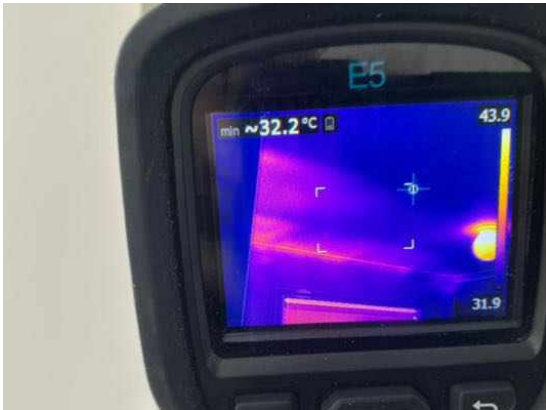
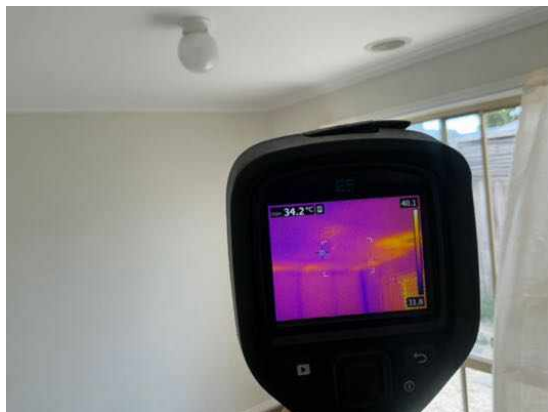
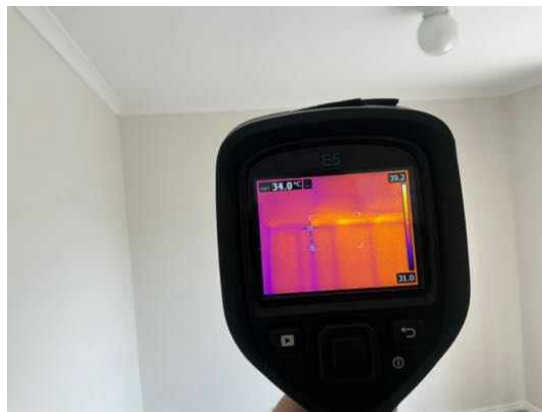
### Defects 3.10

Building:	Main Building
Location:	All Internal Areas
Finding:	Inconsistent Thermal Performance to Ceiling Areas – Suspected Insulation Deficiencies
Information:	Thermal imaging conducted to internal ceiling areas at the time of inspection identified inconsistent heat patterns, which are indicative of variations in thermal performance across the roof space. These patterns are commonly associated with areas of missing, displaced, or insufficient insulation above the ceiling linings.

Inadequate or uneven insulation coverage can reduce the energy efficiency of the dwelling, contribute to heat loss in cooler periods and heat gain in warmer conditions, and may result in reduced occupant comfort and increased heating and cooling costs. Due to the non-invasive nature of the inspection, the exact extent and condition of insulation could not be confirmed visually in all affected areas.

It is recommended that a qualified insulation contractor inspect the roof space, assess insulation coverage and condition, and top up or reinstate insulation where required to achieve consistent thermal performance throughout the property.

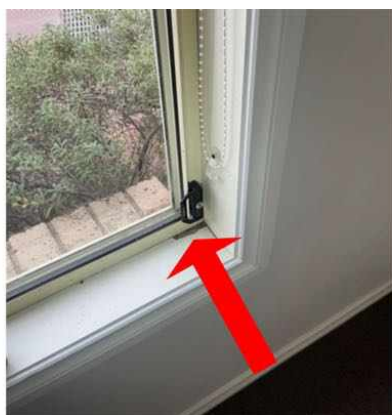
### Defects 3.11

Building:	Main Building
Location:	Lounge Room
Finding:	Minor Historical Water Damage to Lounge Window Sill
Information:	The internal window sill to the lounge room was observed to exhibit signs of previous minor water staining and localised deterioration at the lower section. Non-invasive moisture testing was conducted using a calibrated moisture meter, and readings were within normal parameters at the time of inspection, with no evidence of active moisture ingress detected.

Although no elevated moisture levels were recorded, previous water exposure may have resulted from wind-driven rain penetration or inadequate external sealing. If external junctions are not properly sealed and maintained, future moisture ingress may occur, leading to deterioration of internal finishes and potential timber decay.

It is recommended that the affected sill area be sanded, prepared, and repainted to restore the surface finish. In addition, all external window perimeters and junctions around the dwelling should be inspected and, where required, sealed with an appropriate exterior-grade sealant to prevent wind-driven rain penetration and future moisture-related damage.

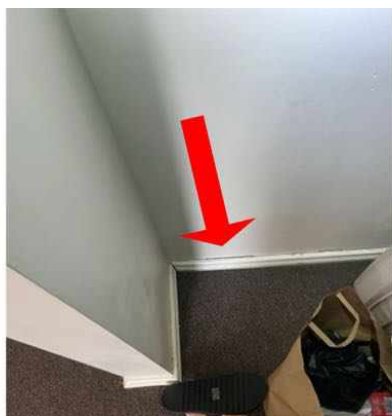
### Defects 3.12

Building: Main Building  
 Location: Lounge Room  
 Finding: Loose Skirting Boards to Lounge Room  
 Information:

The skirting boards in the lounge room were observed to be slightly detached from the wall lining in sections. Non-invasive moisture testing was undertaken to the affected areas, with readings within normal parameters at the time of inspection and no evidence of active moisture ingress detected.

Detached skirting boards are commonly associated with minor shrinkage movement, inadequate fixing, or settlement over time. If left unaddressed, continued movement may result in widening gaps, cosmetic deterioration, and potential damage to adjacent finishes.

It is recommended that the skirting boards be re-secured using appropriate mechanical fixings to ensure firm attachment to the wall framing. Any visible gaps should be filled with a suitable flexible sealant or gap filler, followed by preparation and repainting to achieve a uniform and durable finish.

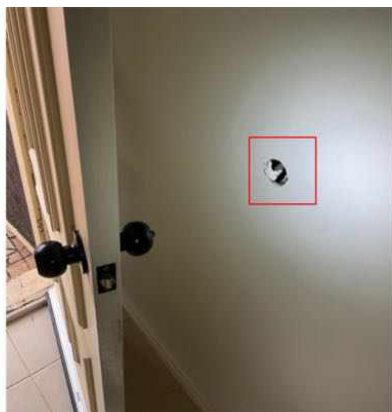
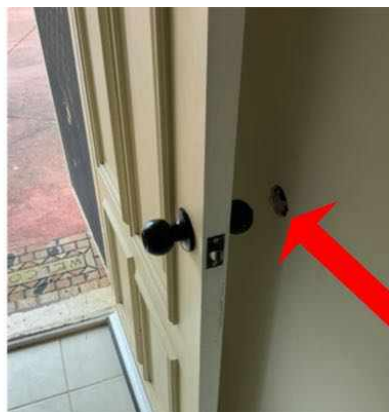
### Defects 3.13

Building: Main Building  
 Location: Entry  
 Finding: Impact Damage to Wall Behind Entry Door  
 Information:

Damage was observed to the internal wall lining behind the entry door, consistent with repeated impact from the door handle. No door stopper has been installed, allowing the handle to strike the plasterboard surface and cause localised indentation and surface damage.

Ongoing impact may result in progressive deterioration of the wall lining, including cracking, delamination of plaster, and damage to paint finishes. If left unrectified, this may lead to more extensive repairs being required over time.

It is recommended that the damaged wall area be properly repaired by patching the

affected section, sanding smooth, and repainting to match the surrounding finish. In addition, a suitable door stopper (wall-mounted or floor-mounted) should be installed to prevent further impact and protect the wall lining from future damage.

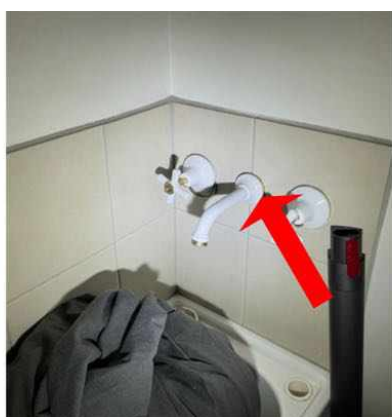
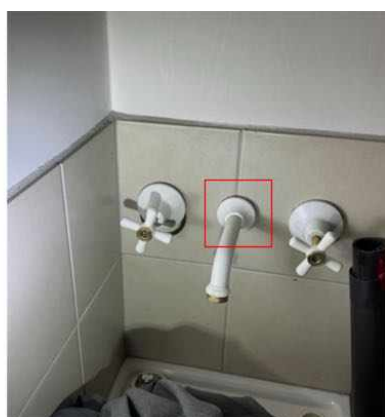
### Defects 3.14

Finding: Tap - Loose

Information: The tap in laundry area has deteriorated with age, and is consequently loose. This tap being loose creates potential for water leaks and subsequent water damage to the surrounding area.

Where taps or spouts are loose, a qualified plumber should be appointed to re-fix the plumbing fitting.

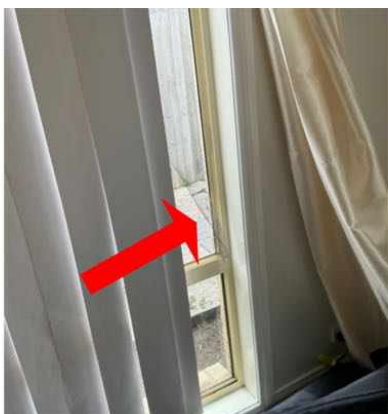
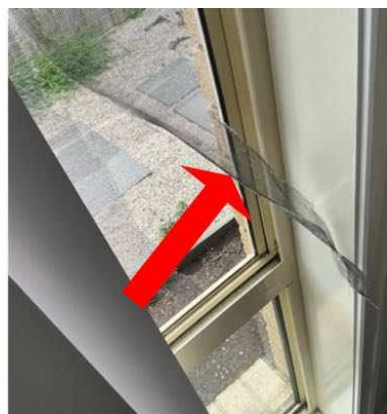
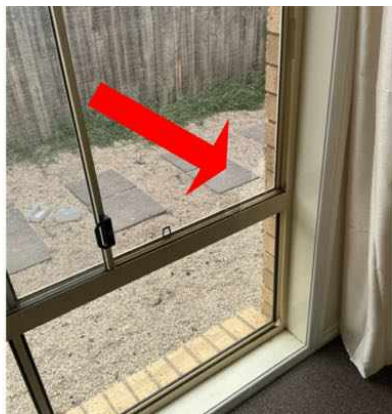
### Defects 3.16

Finding: Flyscreens - damaged

Information: Upon visual inspection, we found that the flyscreen in bedroom 2 and the living room is damaged. This condition could compromise insect protection and allow pests to enter through the open window, potentially affecting indoor comfort and hygiene. We recommend engaging a qualified tradesperson to repair or replace the damaged flyscreen at the earliest convenience to restore its functionality.

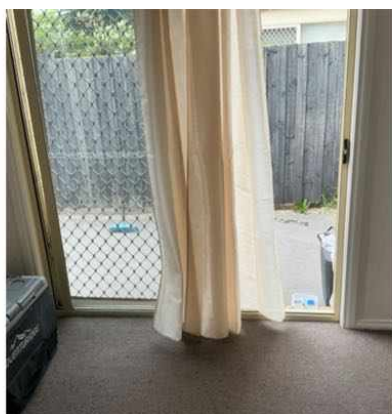
### Defects 3.17

Building: Main Building  
 Location: Living Room  
 Finding: Misaligned Flyscreen Sliding Door  
 Information:

The flyscreen sliding door to the living room external door was observed to have come out of its tracks and does not slide freely. The door is stiff in operation and does not open and close smoothly.

A misaligned or displaced flyscreen door may lead to further damage to the rollers, track system, or frame if forced during operation. Continued improper use may result in permanent distortion of components and reduced serviceability.

It is recommended that the flyscreen door be removed, rollers and tracks inspected, and the door realigned and repositioned correctly within the track system. Any worn or damaged rollers should be replaced to ensure smooth and proper operation.

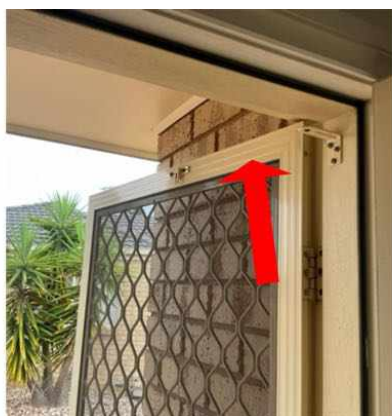
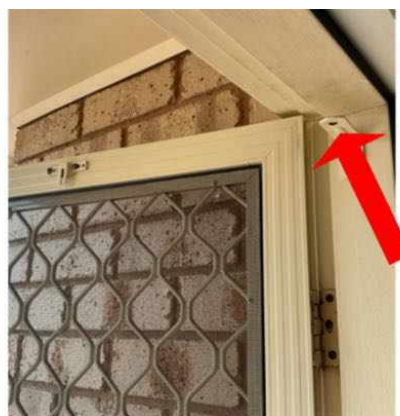
### Defects 3.18

Building: Main Building  
 Location: Entry  
 Finding: Missing Door Closer to Entrance Security Door  
 Information:

The entrance security door was observed to have its upper door closer (automatic closing mechanism) removed and detached. As a result, the security door does not self-close and does not latch automatically when released.

The absence of a functional door closer may compromise security, reduce weather sealing performance, and allow uncontrolled door movement during windy conditions, potentially leading to damage to hinges, frame, or adjacent wall surfaces.

It is recommended that a suitable door closer mechanism be reinstalled and securely fixed to the security door and frame. The unit should be properly adjusted to ensure smooth self-closing action and correct latching upon closure.

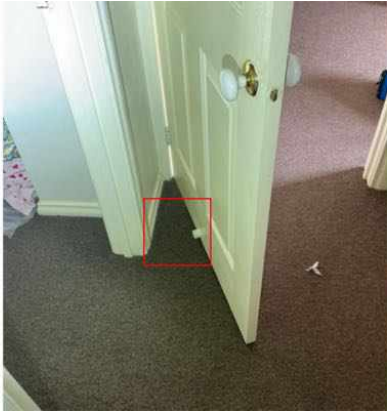
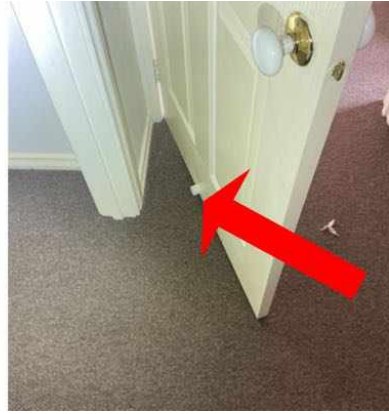
### Defects 3.19

Building:	Main Building
Location:	Bedroom - Master
Finding:	Door stop - Missing
Information:	The door stop is missing or is inadequate to stop the door handle from damaging the wall. Although some building elements may seem irrelevant or unnecessary, all building elements play a key role in the operation and function of the overall structure and its performance.

Re-installation or replacement of the door stop is advised as soon as possible to prevent any subsequent damage to the door or associated structures. A general handyman may be appointed to perform these works at client discretion.

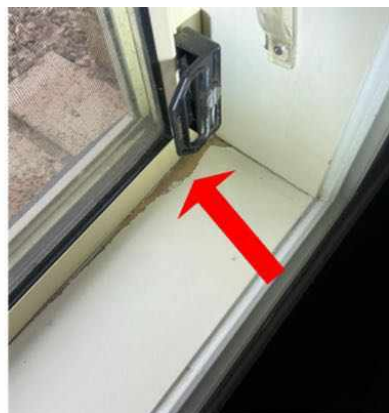
### Defects 3.20

Building:	Main Building
Location:	Bedroom - Master
Finding:	Minor Historical Water Damage to master bedroom Window Sill
Information:	The internal window sill to the master bedroom was observed to exhibit signs of previous minor water staining and localised deterioration. Non-invasive moisture testing was conducted using a calibrated moisture meter, and readings were within normal parameters at the time of inspection, with no evidence of active moisture ingress detected.

Although no elevated moisture levels were recorded, previous water exposure may have resulted from wind-driven rain penetration or inadequate external sealing. If external junctions are not properly sealed and maintained, future moisture ingress may occur, leading to deterioration of internal finishes and potential timber decay.

It is recommended that the affected sill area be sanded, prepared, and repainted to restore the surface finish. In addition, all external window perimeters and junctions around the dwelling should be inspected and, where required, sealed with an appropriate exterior-grade sealant to prevent wind-driven rain penetration and future moisture-related damage.

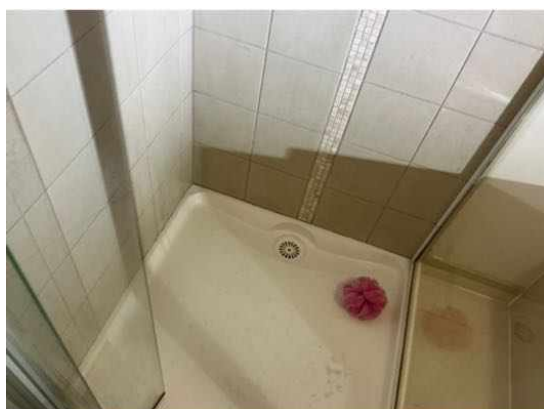
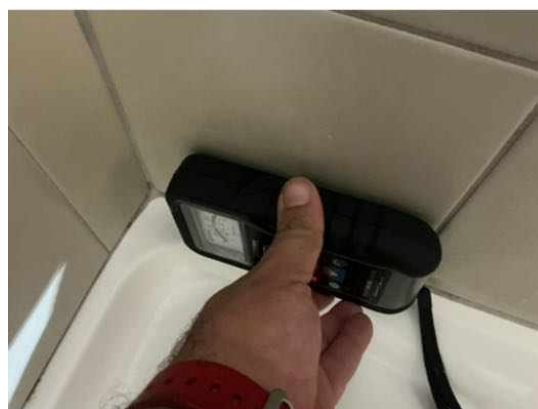
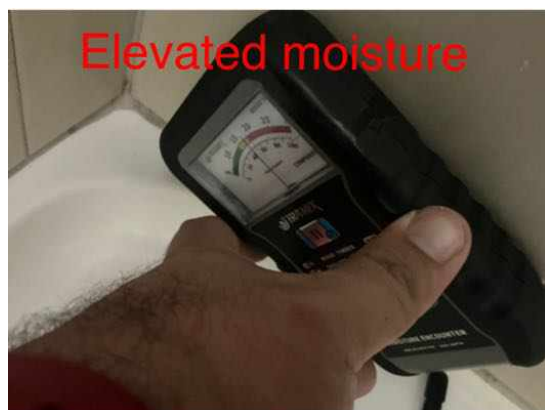
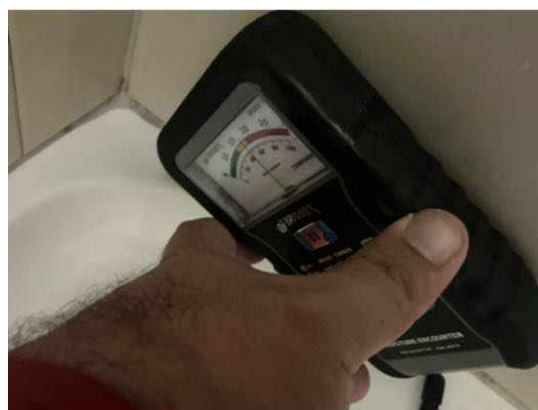
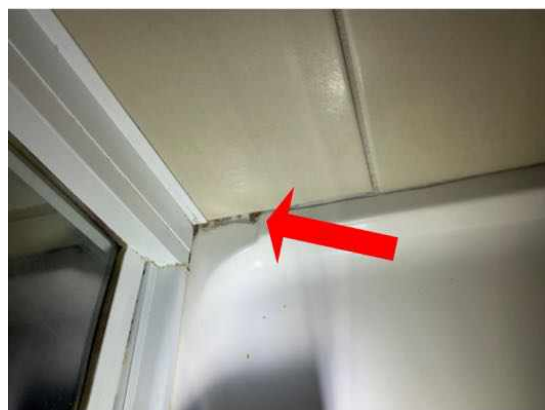
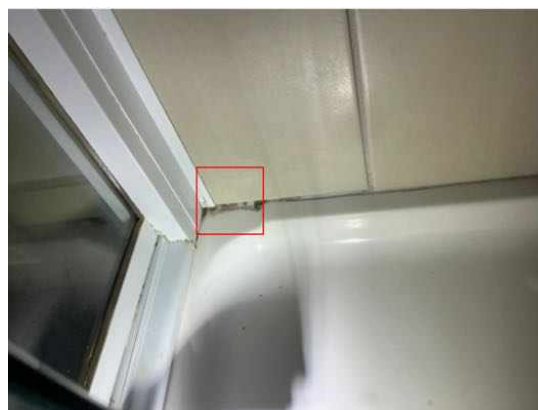
### Defects 3.21

Building:	Main Building
Location:	Bathroom
Finding:	Shower damp - Sealant and grout
Information:	Damp is evident to the lower 400mm of wall to the shower alcove. This defect is quite common, and is suspected to have been caused by moisture permeating or leaching through the grouting and sealant in this area, which shows evidence of deterioration. Leaking pipes within the wall is also a possible cause however this seems unlikely in this instance as there is no moisture build up around the taps or transferring to the other side of the wall. There appears to be no sealant around the tap spindles which may be a small contributing factor.

Damp (or structural damp) refers to the presence of unwanted moisture in the structure of a building, either as the result of intrusion from outside, or condensation from within the structure. In the shower area, internal water leaks, degraded materials or other sources of excessive moisture are generally the cause of damp.

Unmanaged damp in the shower recess is likely to facilitate the formation and development of mould and fungi growth, decaying associated building materials and compromising their structural integrity of associated elements. It is important to address damp conditions, as the World Health Organisation notes that excess moisture leads - on almost all indoor materials - to growth of microbes such as moulds, fungi and bacteria, which subsequently emit spores and other matter into the indoor air. Exposure to these contaminants is associated with a wide range of respiratory and other health-related problems. Damp conditions also create a conducive environment for termite infestation.

Consultation with a bathroom sealant specialist is advised immediately to identify the cause of damp and to perform remedial works as required.

Always ensure that sealant and grout is in good condition to prevent any moisture issues occurring in the future.

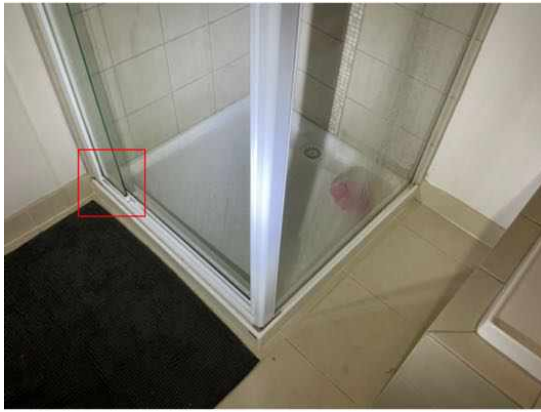
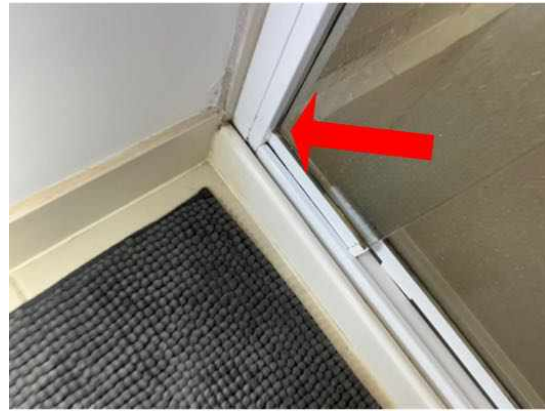
### Defects 3.22

Building:	Main Building
Location:	Bathroom
Finding:	Shower screen - sealing required
Information:	Leaking was evident to the shower screen at the time of inspection. It is suspected that the leaking has occurred as a result of deteriorated or missing caulking to the shower or general ageing of the building elements.

Leaking from the shower where left unattended, is likely to lead to water damage to adjoining flooring and walls. Such damage can lead to water damage and necessitate extensive remedial works being required. Active water leaks may also create an environment that is susceptible to the formation and development of mould.

Appointment of a caulking contractor is required to repair or replace the caulking to the shower area. Such works should be performed as soon as possible to ensure that no further damage occurs.

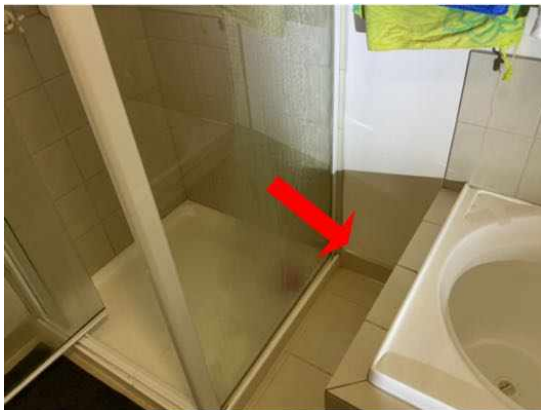
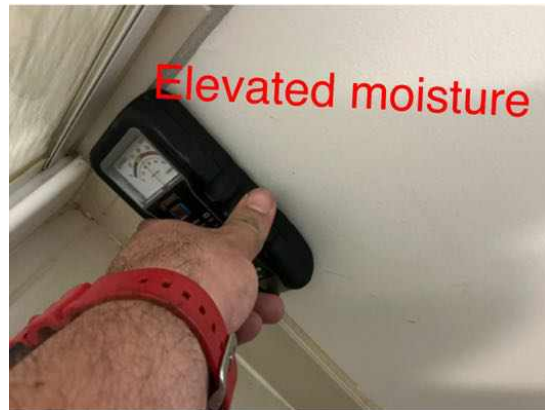
### Defects 3.23

Building:	Main Building
Location:	Bathroom
Finding:	Evidence of elevated moisture was present at the time of inspection
Information:	Excessive moisture can attract termites and produce conditions that promote termite attack, fungal growth and wood decay. Excessive moisture is generally caused by deteriorated, inadequate or missing roof drainage, leaking plumbing pipes or fixtures, poorly plumbed HWS overflows or condenser units and poor site drainage. It is highly recommended that all plumbing and drainage fixtures and fittings be maintained regularly in order to prevent excessive moisture being present in the external / internal property.

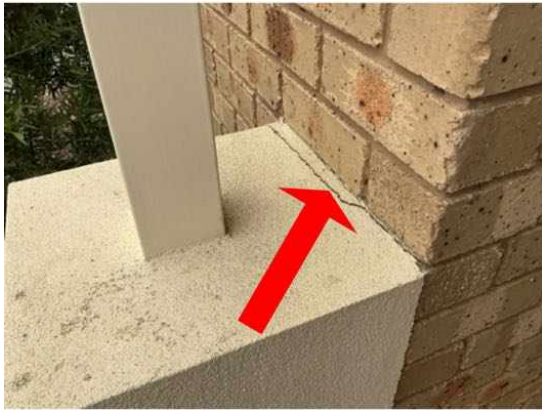
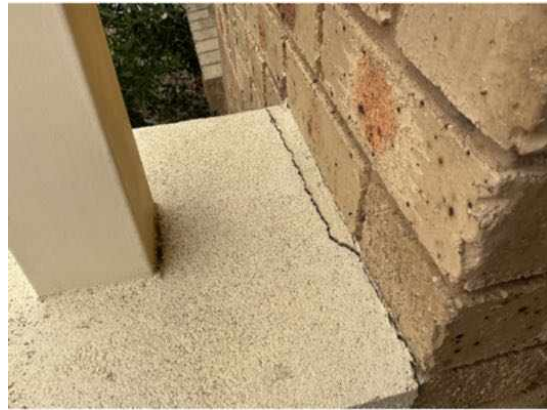
### Defects 3.24

Building:	Main Building
Location:	Exterior walls - front
Finding:	Minor Cracking to Rendered Front Brickwork Post
Information:	Minor cracking was observed to the rendered brickwork post at the front elevation of the dwelling. The cracking appears consistent with typical building movement and shrinkage over time.

Movement-related cracking to rendered surfaces is generally cosmetic in nature; however, if left unsealed, it may allow moisture penetration behind the render, which can contribute to further surface deterioration.

It is recommended that the affected cracks be properly prepared, filled with a suitable exterior-grade flexible crack filler, and refinished to match the surrounding render. Where necessary, localised re-rendering may be undertaken to achieve a uniform and durable finish.

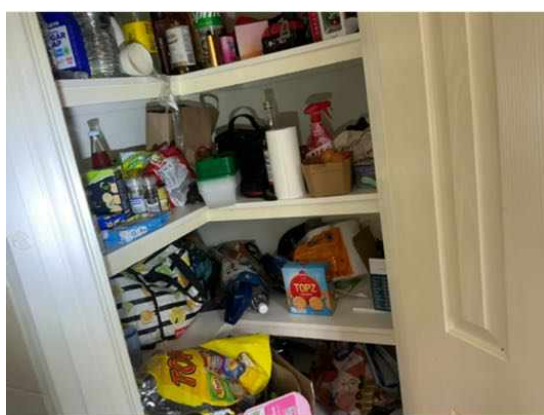
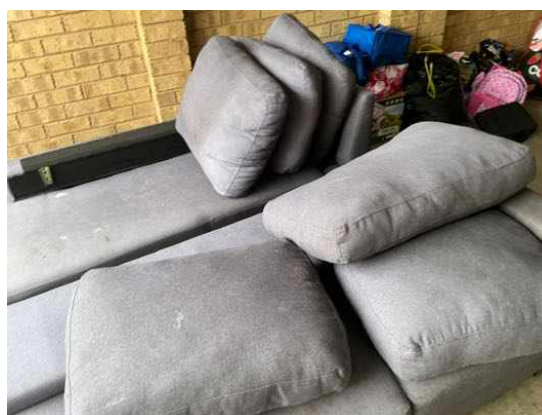
#### Noted Item

Building: Main Building  
Location: All Areas  
Finding: Obstructions and Limitations - Interior  
Information: These photographs are an indication of the obstructions and limitations which impeded the inspection of the internal areas of the property at the time of inspection. These obstructions can hide an array of defects and should be removed to allow full inspection to be carried out. A re-inspection is recommended once the areas are made accessible.

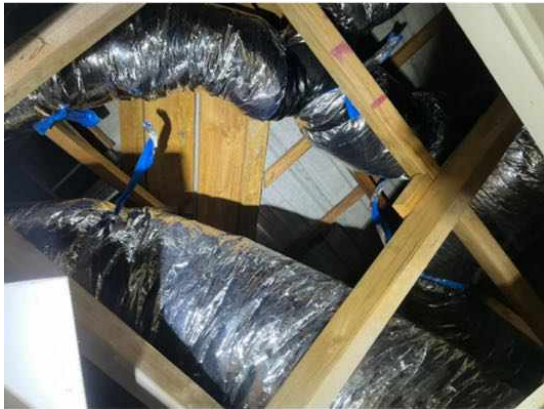
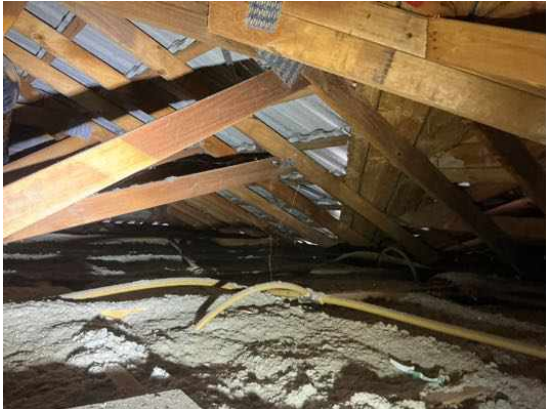
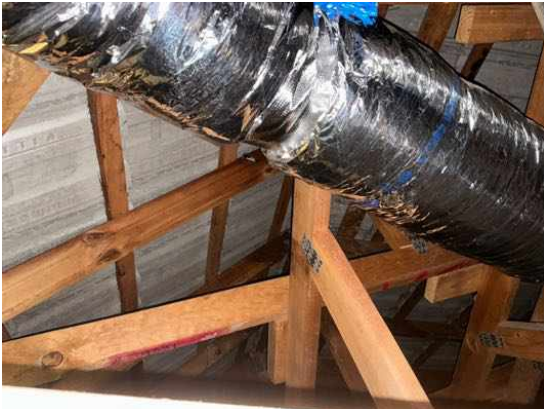
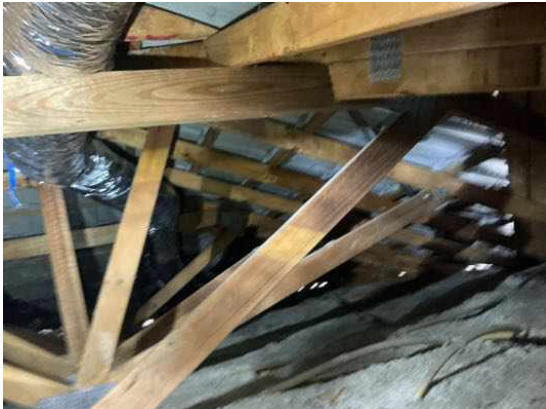
#### Noted Item

Building: Main Building  
Location: Roof Void  
Finding: Obstructions and Limitations - roof cavity  
Information: These photographs are an indication of the obstructions and limitations which impeded the inspection of the roof cavity area of the property at the time of inspection. These obstructions can hide an array of defects and should be removed to allow full inspection to be carried out. A re-inspection is recommended once the areas are made accessible.
