Building Inspection Report

Inspection Date: Wed, 28 Jan 2026

Property Address: 14 Delhuntly Rise, Narre Warren South VIC
3805, Australia

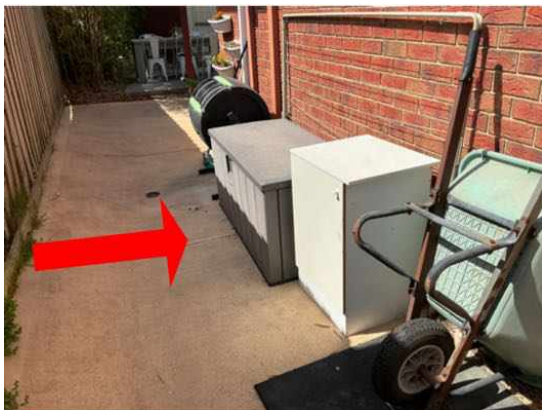
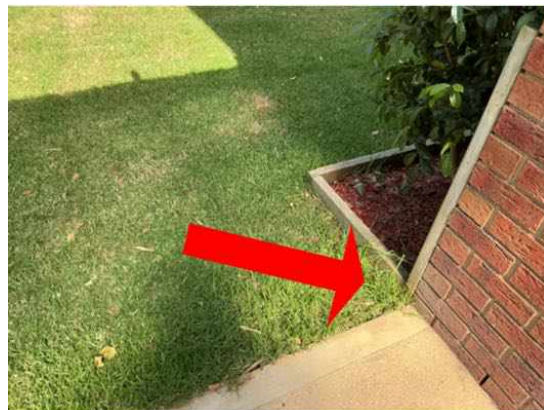
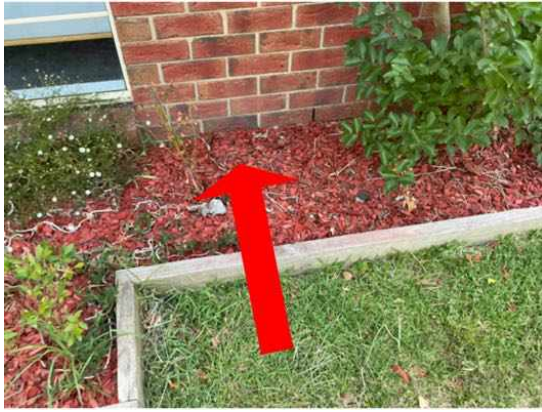
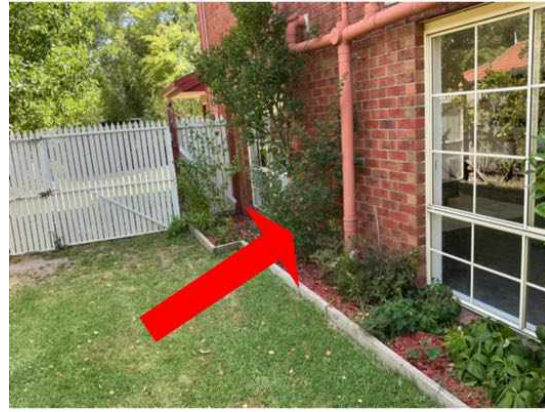
Defects 3.01

Building: Main Building
 Location: All External Areas
 Finding: Site drainage - Inadequate
 Information: Upon visual inspection, we found that all yards exhibited poor site drainage, with surface water observed to drain toward the rear exterior wall of the dwelling. This condition increases the risk of water accumulating near the base of the wall, potentially leading to moisture ingress or deterioration of adjacent building materials over time.

To prevent water from lying against the wall, surrounding ground levels should be regraded to ensure surface runoff flows away from the structure. Downpipes should not discharge stormwater onto lower walls or plinths, and water should be managed through appropriate drainage systems. If the damp-proof course (DPC) is buried, ground levels may need to be lowered to expose it.

We recommend either installing an agricultural (Aggie) drain to intercept and redirect surface water away from the affected area, or constructing a concrete path with adequate slope to channel rainwater away from the dwelling. A qualified plumber should be engaged to assess the site and carry out the most suitable remedial works. If not addressed, this issue may contribute to ongoing water-related damage and secondary building defects

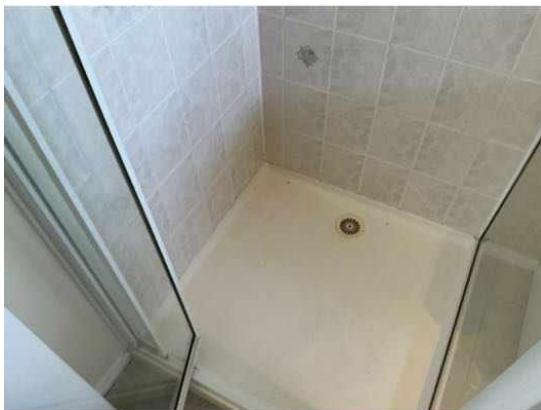
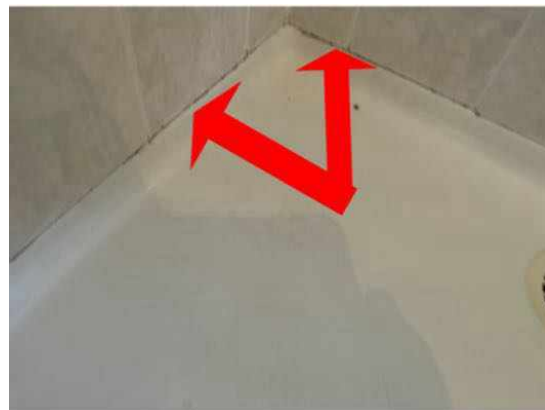
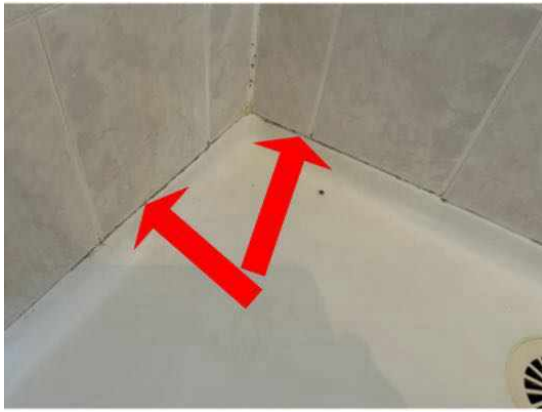
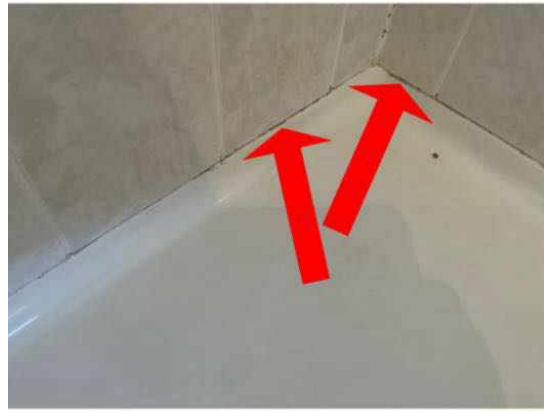
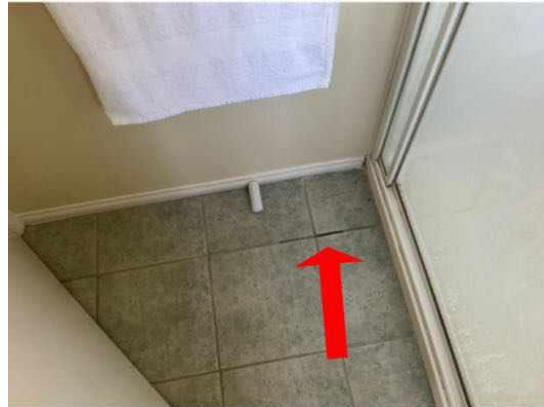
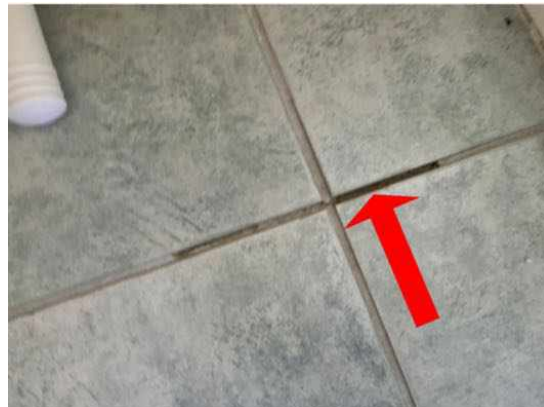
Defects 3.04

Building:	Main Building
Location:	Ensuite - Master
Finding:	Sealant and grouting - Deteriorated
Information:	It was noted on inspection that sealant or grout is degraded to the tiled shower alcove and or other areas of the bathroom.

Different materials and floor areas move at different rates, generally causing cracking to grout or sealant at this point. A flexible sealant is required to allow for expected expansion and contraction, while keeping the joint water tight and protective of all associated building materials.

Flexible and mould resistant materials should be applied to affected areas to prevent any subsequent water damage that is likely to occur. Regular maintenance and replacement of damage or missing or damaged sealant and grout is highly recommended to the wet areas, as this is a regular wear and tear defect. Sealant and grouting in areas that come into regular contact with water should be maintained for the long term care of your property.

A sealant specialist or tiling contractor should be appointed to complete these works as soon as possible

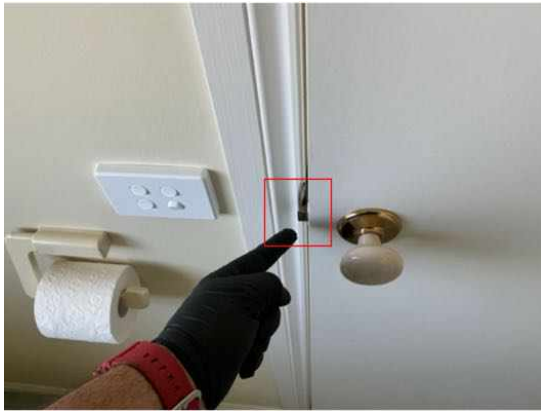
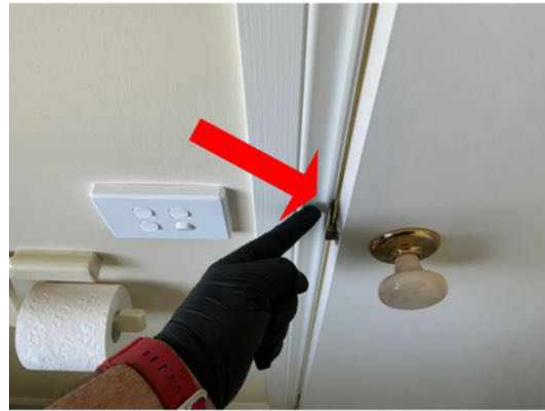
Defects 3.05

Building: Main Building
 Location: Ensuite - Master
 Finding: Door handle - Not latching
 Information: It was noted that the door in this area was not latching during operation at the time of inspection. Whilst detracting from the functionality of this building element, this minor defect may also be a security risk, and may therefore have serious implications if left unattended.

It is suspected that this defect has occurred due to minor issues with the associated hinges. Such damage is identified as general wear and tear, which is expected for building elements of this age.

A qualified carpenter or general handyperson may be appointed to perform rectification works as necessary, at client discretion. If left unattended, further functional impairment is likely to occur.

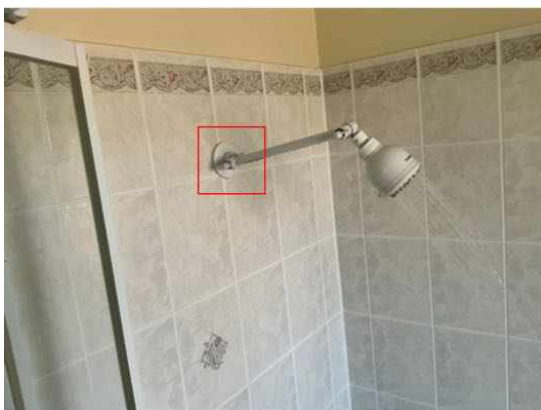
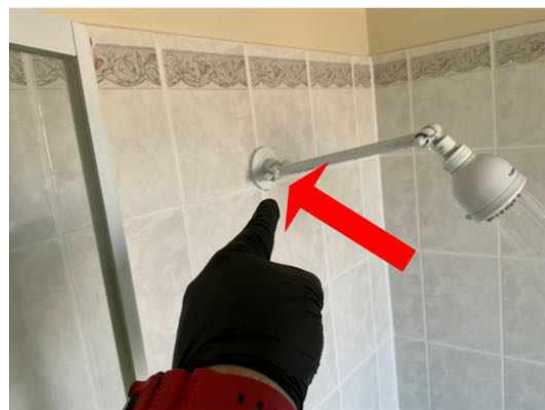
Defects 3.06

Building: Main Building
 Location: Ensuite - Master
 Finding: Shower head- leaking
 Information: Upon visual inspection, we found that the shower head in the master ensuite is leaking, with continuous dripping observed even after the tap is fully closed. The persistent leakage may indicate worn-out internal components within the shower head or tap, potentially contributing to unnecessary water wastage and increased water bills. This issue can also lead to further deterioration of surrounding materials due to prolonged exposure to moisture, potentially causing mould growth or damage to bathroom fixtures and surfaces over time.

To address this issue, we recommend that a licensed plumber be engaged to inspect and repair or replace the shower head and any associated fittings as necessary. Timely repairs are advised to prevent further water loss and potential moisture-related damage to the bathroom area.

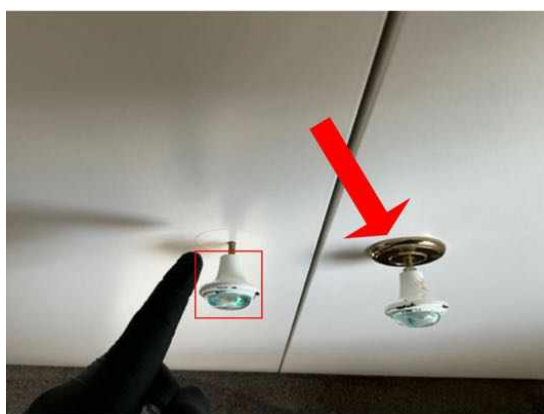
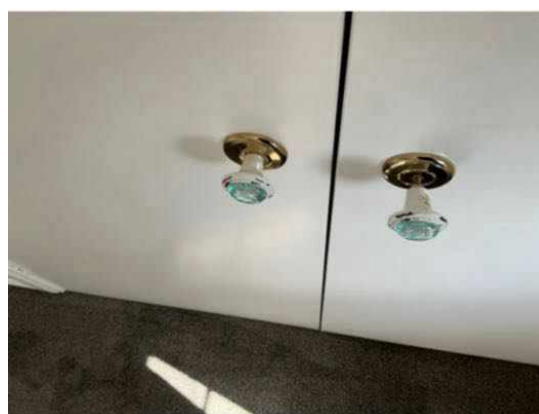
Defects 3.07

Building: Main Building
 Location: Bedroom 3
 Finding: Loose Door Handles – Bedroom 3 Wardrobes
 Information:

At the time of inspection, the door handles to the linen cupboard and the wardrobe cupboards in Bedroom 3 were observed to be loose and, in some instances, coming away from the doors. This is likely due to worn fixings or inadequate fastening.

This is considered a maintenance issue rather than a structural defect; however, continued use in their current condition may result in further damage to the doors or hardware.

It is recommended that a qualified handyman or carpenter be engaged to refix, realign, and secure the affected handles, replacing screws or hardware where necessary to ensure proper and durable operation.

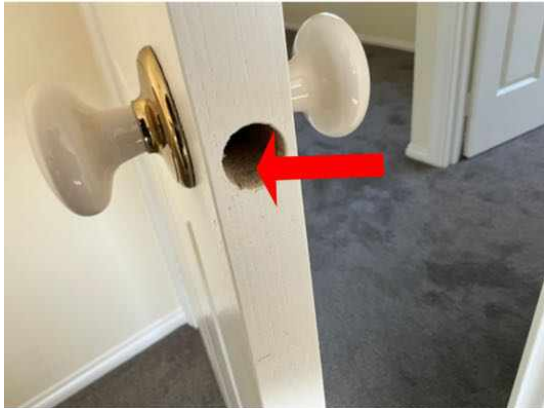
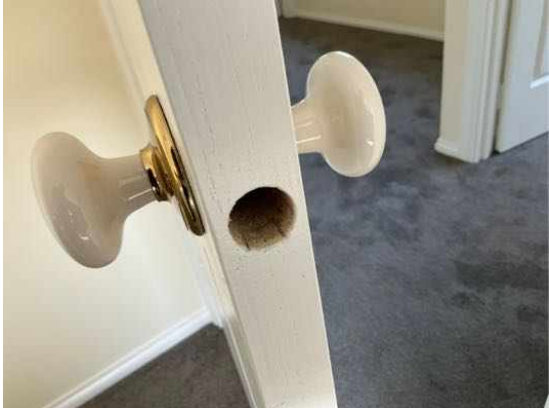
Defects 3.08

Building: Main Building
 Location: Bedroom 3
 Finding: Bedroom 3 Door – No Functional Latching/Lock Mechanism
 Information:

At the time of inspection, the door to Bedroom 3 was observed to not latch or lock properly. The door does not engage with a strike plate and there is currently no functional locking mechanism installed, meaning the door cannot be secured in its closed position.

This affects the functionality and privacy of the room and may lead to further wear to the door or frame if operated in its current condition.

It is recommended that a qualified carpenter be engaged to install an appropriate door lock and strike mechanism, and to adjust or realign the door as required to ensure it latches and operates correctly.

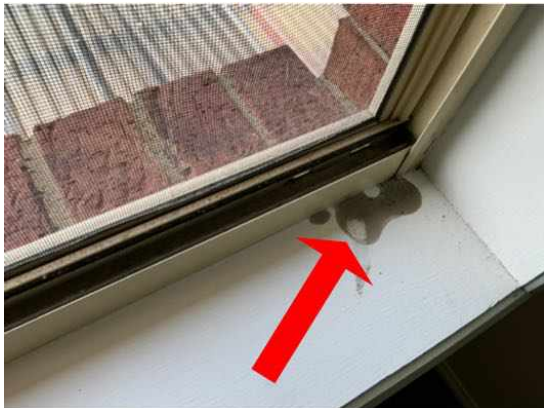
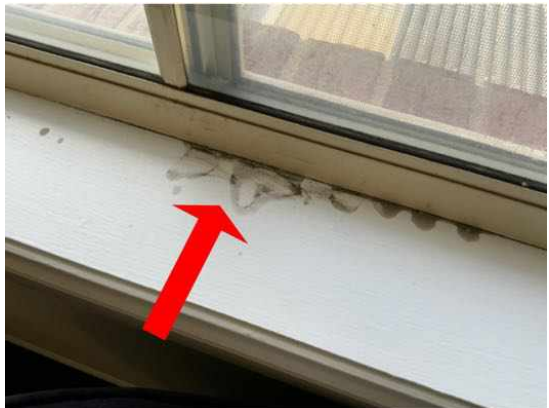
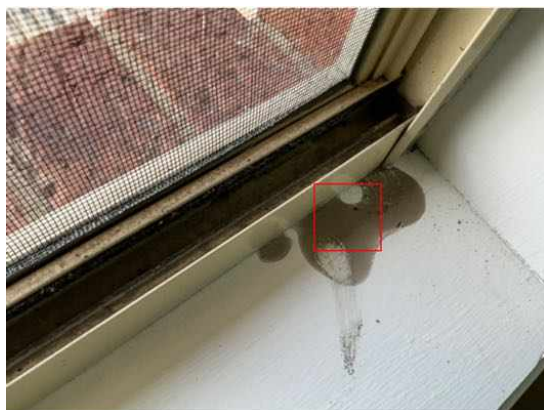
Defects 3.09

Building: Main Building
Location: Retreat
Finding: Water Ingress Evidence – Retreat Window (Upstairs)
Information:

At the time of inspection, evidence of past water residue was observed around the retreat window upstairs, indicating that water may have been entering through or around the window assembly during rainfall. This suggests that the existing external seals may be inadequate or deteriorated.

If left unaddressed, continued water ingress could lead to staining, deterioration of surrounding finishes, and potential moisture-related damage to framing or linings over time.

It is recommended that a qualified glazier, window installer, or suitably experienced tradesperson inspect and re-seal the window externally, including all perimeter joints and flashings as required, to prevent further water entry.

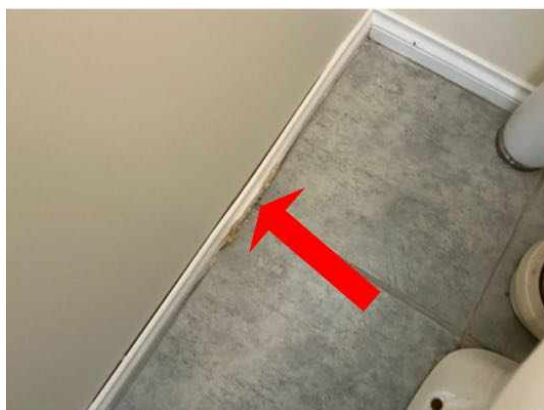
Defects 3.10

Building: Main Building
 Location: WC - Upstairs
 Finding: Water Damage to Skirting Board – Upstairs WC
 Information:

At the time of inspection, the skirting board on the left-hand side inside the upstairs WC was observed to be swollen and distorted, consistent with previous water exposure or moisture contact. The damage appears localised to this section of the skirting and does not indicate any visible structural failure at the time of inspection.

If left unaddressed, the affected skirting may continue to deteriorate, which could impact adjacent finishes and overall appearance.

It is recommended that a qualified painter, handyman, or carpenter assess the damaged section and either replace the affected skirting board or sand, repair, and repaint it as appropriate to restore appearance and durability

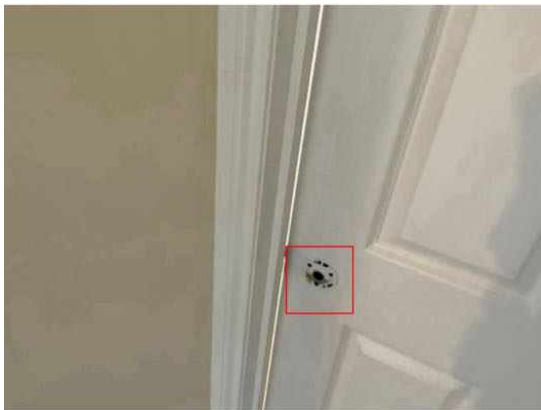
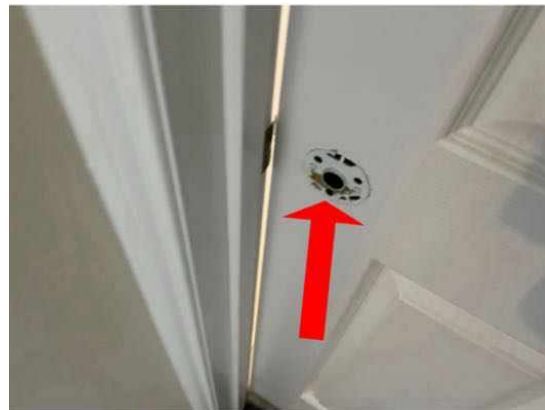
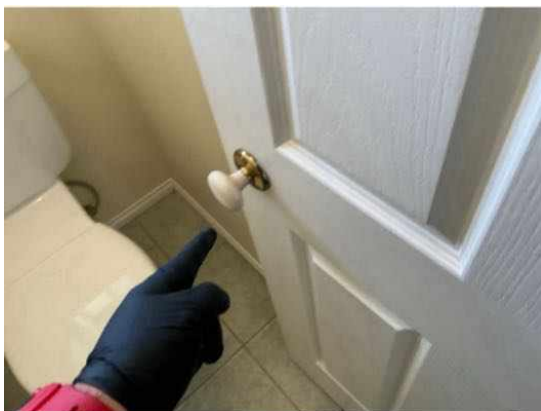
Defects 3.11

Building: Main Building
 Location: Upper level
 Finding: Loose Door Handles – Upper Level
 Information:

Several internal door handles on the upper level, including those to the WC, bathroom and bedrooms, were observed to be loose and in some instances partially detached from the doors. This indicates inadequate fixing or wear to the existing fittings.

Loose or poorly secured handles can continue to deteriorate over time, may fail completely during use, and could cause damage to the door surface or locking mechanisms.

It is recommended that a qualified handyman or carpenter inspect all upper-level door handles and refix, tighten, or replace fixings as required to ensure secure and proper operation.

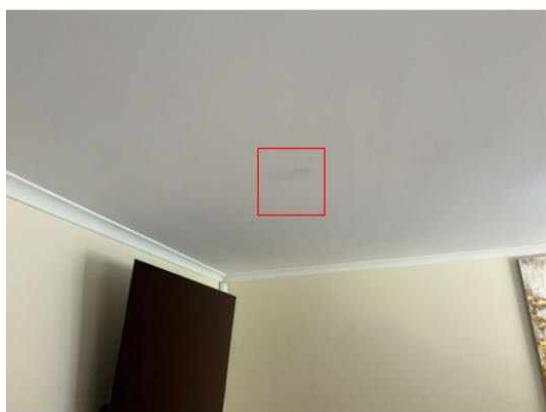
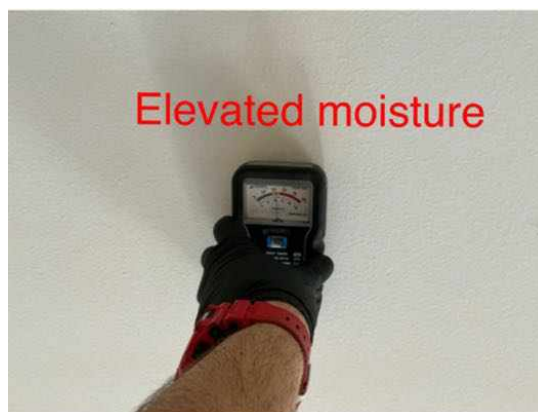
Defects 3.12

Building:	Main Building
Location:	Dining room
Finding:	Elevated Moisture Readings – Dining Area Ceiling (Downstairs)
Information:	At the time of inspection, elevated moisture readings were detected to the ceiling in the downstairs dining area adjacent to the kitchen using a moisture meter. No bathroom or obvious wet area is located directly above this section of ceiling, and no clear visual source of water ingress could be identified during the inspection.

The presence of elevated moisture in this location indicates that there may be an

active or intermittent leak within the ceiling cavity, roof space, or concealed plumbing, which could lead to further water damage, mould growth, or deterioration of ceiling linings and framing if left unaddressed.

A licensed plumber should be engaged without delay to investigate the source of the moisture, undertake any necessary invasive testing where required, and carry out appropriate rectification works to prevent ongoing water ingress.

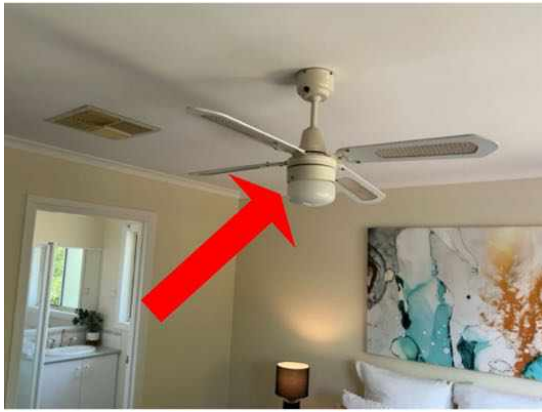
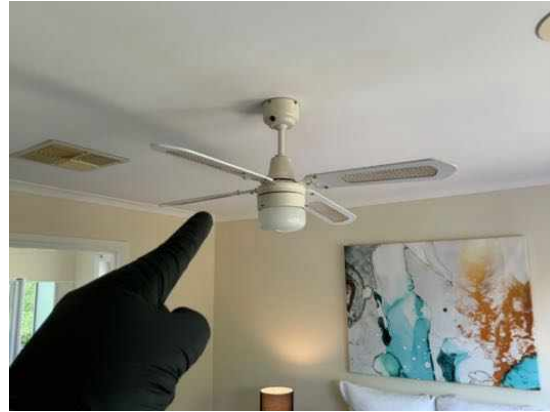
Defects 3.13

Building:	Main Building
Location:	Bedroom - Master
Finding:	Ceiling Fan Not Operating – Master Bedroom
Information:	At the time of inspection, the ceiling fan in the master bedroom was not operating when switched on. No further testing was undertaken and the exact cause of the fault could not be determined during the visual inspection.

A non-operational ceiling fan may indicate an electrical fault, defective motor, faulty switch, wiring issue, or failed components, which could affect ventilation, comfort, and safe operation of the fixture.

A licensed electrician should attend the property to inspect, test, and repair or replace the ceiling fan as required to restore safe and proper operation.

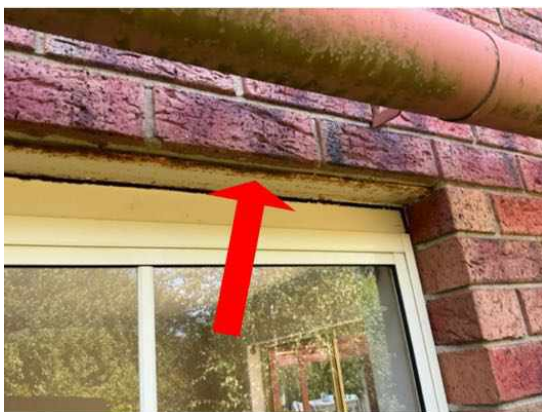
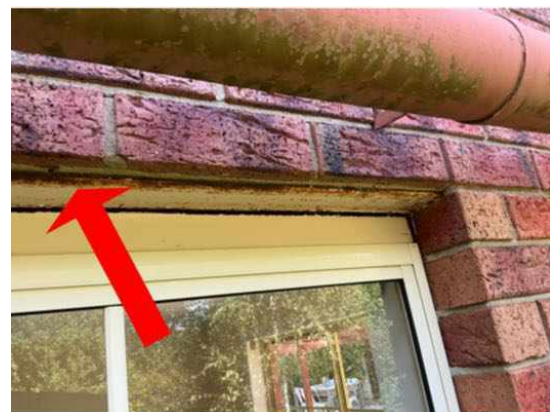
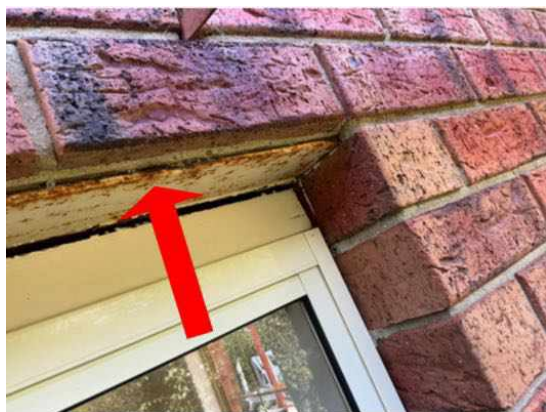
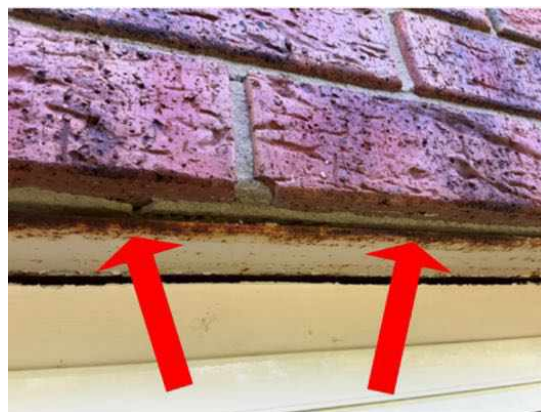
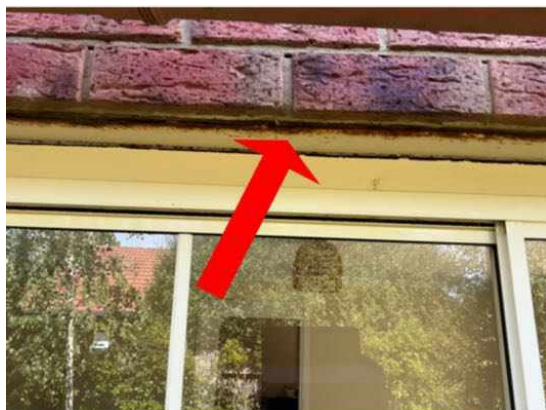
Defects 3.14

Building: Main Building
 Location: All External Areas
 Finding: Corrosion to Steel Lintels Around Windows
 Information:

At the time of inspection, rusting was observed to several steel lintels above windows and openings around the dwelling. The corrosion appears to be developing progressively, rather than being an isolated localised issue.

Steel lintels are structural members that support masonry above window openings, and ongoing corrosion can weaken their load-bearing capacity, potentially leading to cracking, movement, or further deterioration of surrounding brickwork if left untreated.

A registered builder should be engaged as soon as practicable to assess the extent of corrosion and carry out appropriate rust treatment, protection, and repair works to prevent further structural degradation.

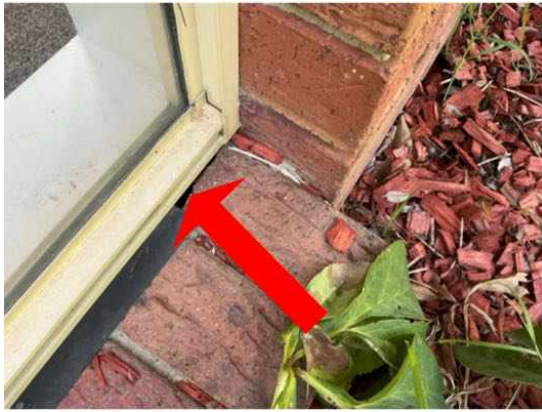
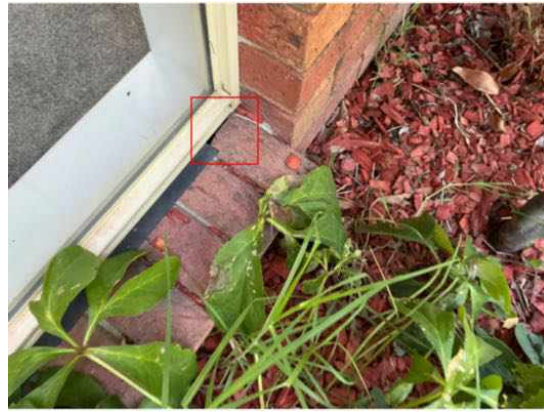
Defects 3.15

Building:	Main Building
Location:	All External Areas
Finding:	Gaps Around External Window Frames
Information:	Multiple gaps were identified between the external window frames and the adjoining brickwork across several elevations. These gaps appear to be the result of either poor or inconsistent sealant application during installation, or deterioration of the original sealant over time.

Unsealed or poorly sealed gaps can allow moisture ingress, wind-driven rain, draughts, and provide potential entry points for pests. Ongoing exposure to moisture may also contribute to internal dampness and premature deterioration of surrounding building elements.

A qualified handyman or registered builder should apply a consistent, waterproof, flexible exterior-grade sealant around all affected windows to ensure adequate weatherproofing and protection against moisture and pest entry.

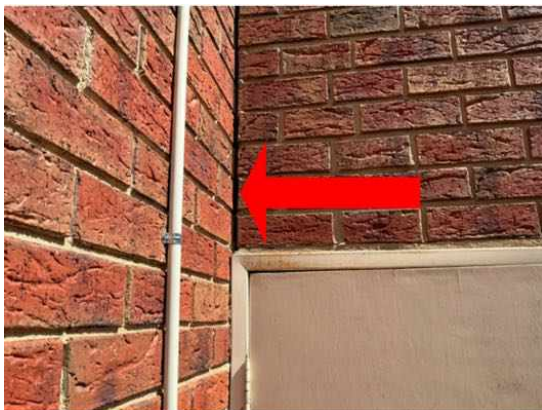
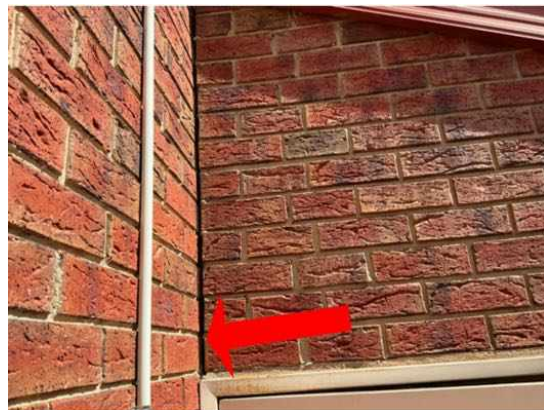
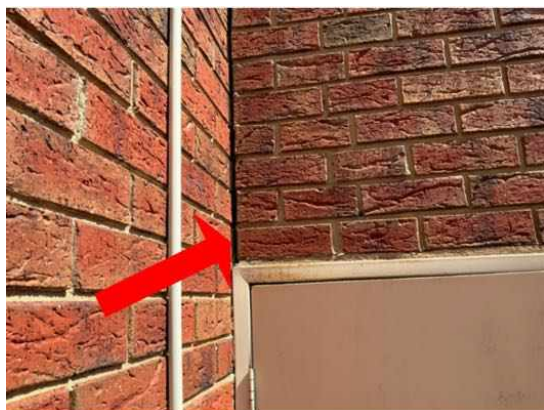
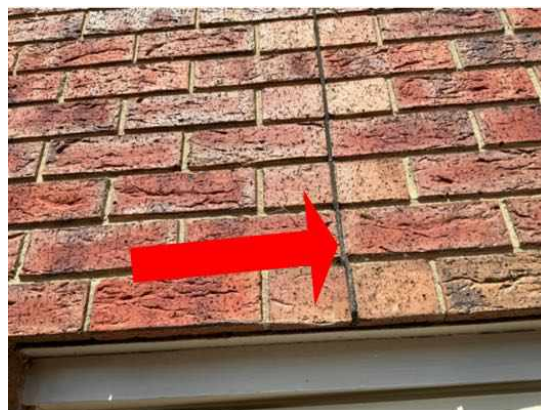
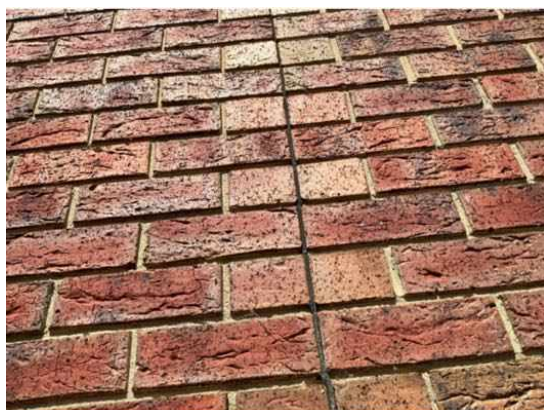
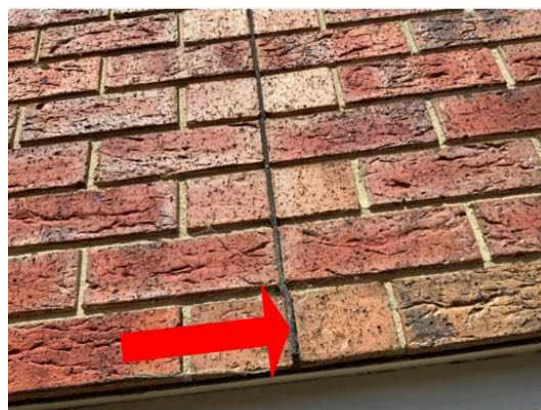
Defects 3.16

Finding: Brickwork expansion joint - Seal missing.

Information: During the inspection, it was noted that the seal for the brickwork expansion joint is missing on all exterior walls. Expansion joints in brickwork are critical as they accommodate the natural movement of building materials caused by thermal expansion, contraction, and other environmental factors. The absence of a proper seal in these joints can lead to several issues:

- Water Penetration: Without a seal, water can penetrate the expansion joint, potentially leading to water damage within the wall cavity and interior spaces. This can result in dampness, mold growth, and deterioration of building materials.

- Energy Efficiency: Gaps in the expansion joints can affect the building's insulation properties, leading to increased energy consumption for heating and cooling.

To address this issue, it is recommended that a qualified handyman, caulking specialist, or bricklayer be engaged to inspect and reseal the expansion joint. This will help maintain the integrity, durability, and appearance of the brickwork, as well as prevent potential water ingress and structural problems.

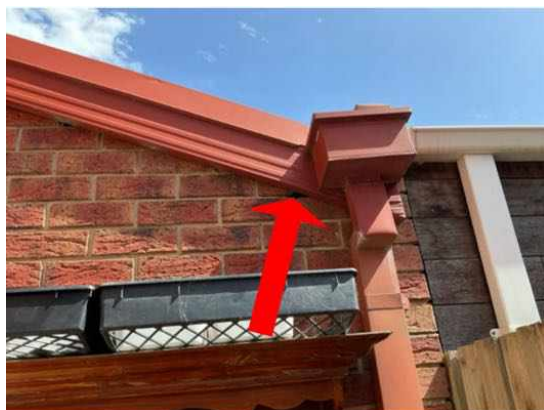
Defects 3.17

Building: Main Building
 Location: Garage rear access door
 Finding: Gap in Brickwork Above Garage Access Door
 Information:

At the time of inspection, a visible gap was observed in the brickwork above the rear garage access door, located directly beneath the fascia board. The opening appears to be the result of incomplete detailing or deterioration of mortar at this junction.

This gap allows potential water ingress into the wall cavity and roof junction, which may lead to staining, moisture-related damage, or deterioration of framing and surrounding materials over time if left unsealed.

A suitably qualified tradesperson (bricklayer or qualified caulking specialist) should be engaged to clean, fill, and seal the gap with an appropriate weather-resistant flexible sealant to prevent water entry and protect the surrounding structure.

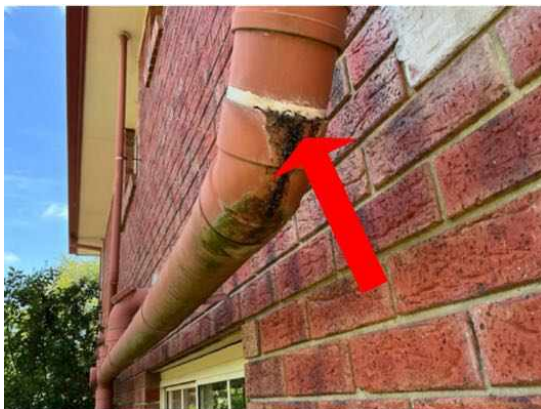
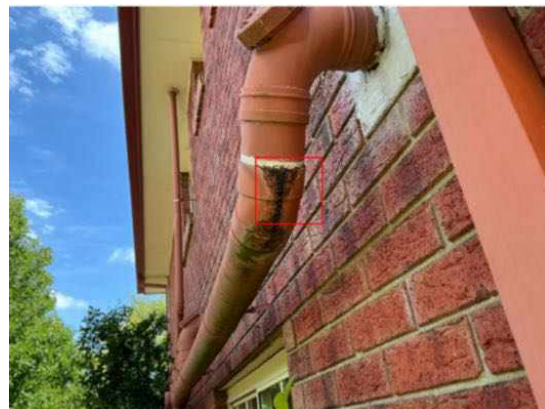
Defects 3.21

Building: Main Building
 Location: Right hand side yard
 Finding: Defective Downpipe Connection – External Brick Wall
 Information:

At the time of inspection, staining, algae growth, and evidence of water leakage were observed around the external downpipe where it connects to the brickwork.

This indicates that the joint is likely not adequately sealed or that water is escaping from the pipe or its connection, which may lead to ongoing moisture damage to the brickwork and surrounding materials if left unaddressed.

A licensed plumber should be engaged to inspect, reseal, repair, or realign the downpipe connection and ensure stormwater is properly contained and discharged away from the wall.

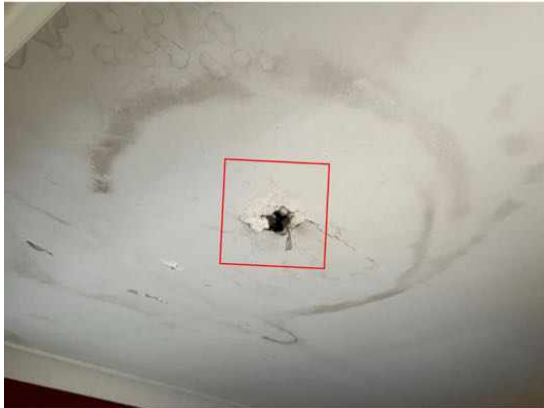
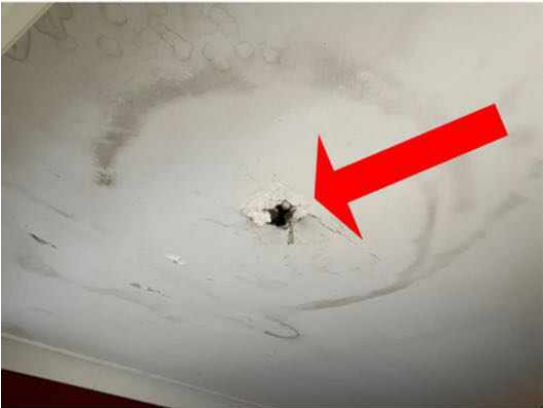
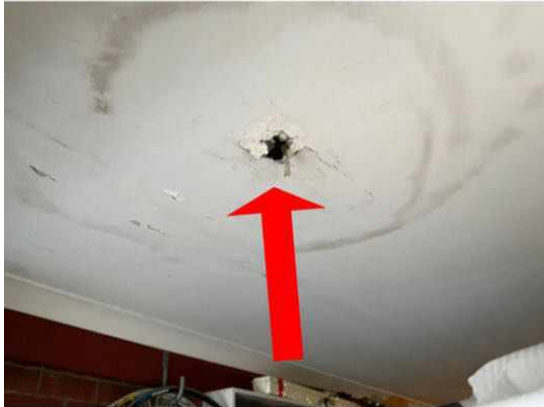
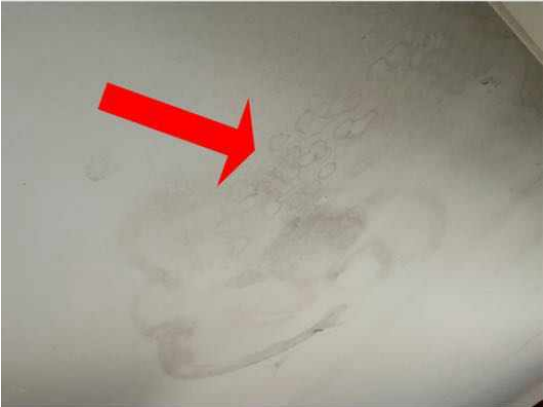
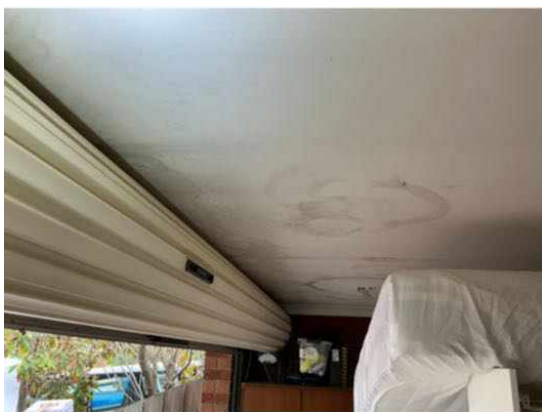
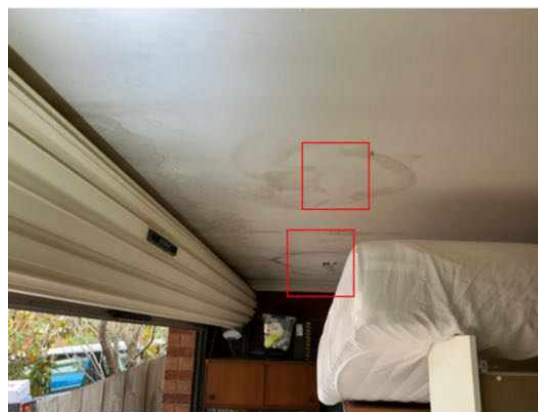
Defects 3.22

Building: Main Building
 Location: Garage
 Finding: Damage and Sagging to Garage Ceiling
 Information:

At the time of inspection, multiple areas of damage were observed to the garage

ceiling, including holes, water staining, and slight sagging of the plasterboard. Moisture testing was undertaken using a moisture meter and no elevated moisture readings were detected in the areas tested; however, inspection of the ceiling was limited due to stored furniture and restricted access within the garage.

A qualified plasterer should be engaged to fully inspect the ceiling once the garage is cleared, provide additional fixing or support where required, and repair the affected plaster by patching, sanding, and repainting the damaged areas to restore its condition and appearance.

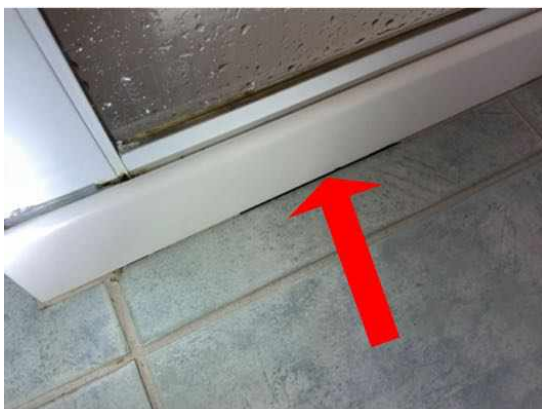
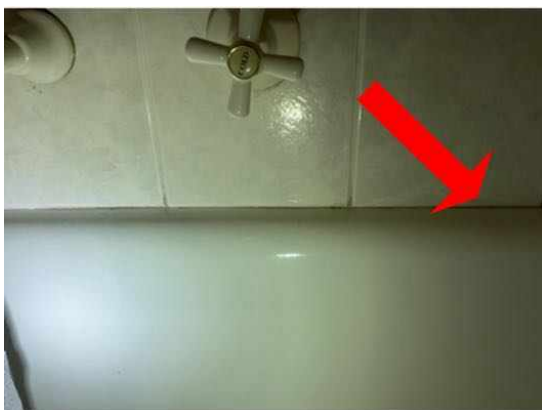
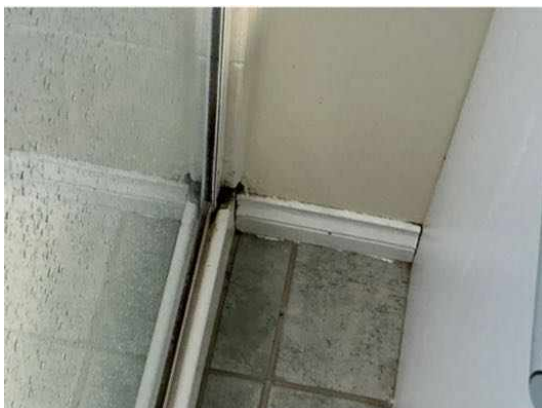
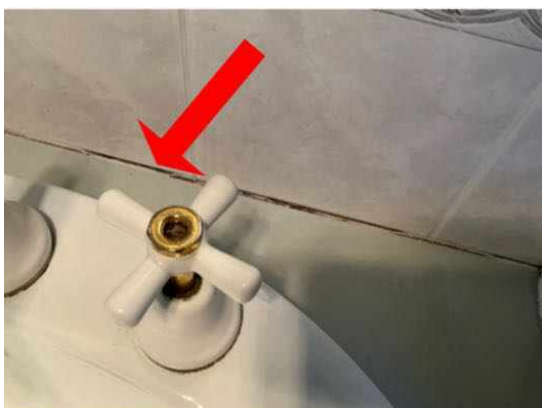
Defects 3.23

Building:	Main Building
Location:	Bathroom 2
Finding:	Sealant and grouting - Deteriorated
Information:	It was noted on inspection that sealant or grout is degraded to the tiled shower alcove and or other areas of the bathroom.

A sealant specialist or tiling contractor should be appointed to complete these works as soon as possible

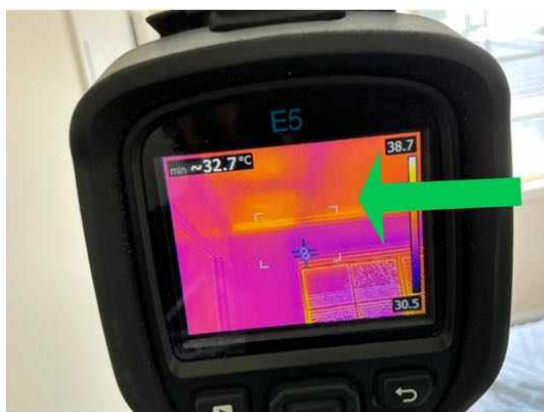
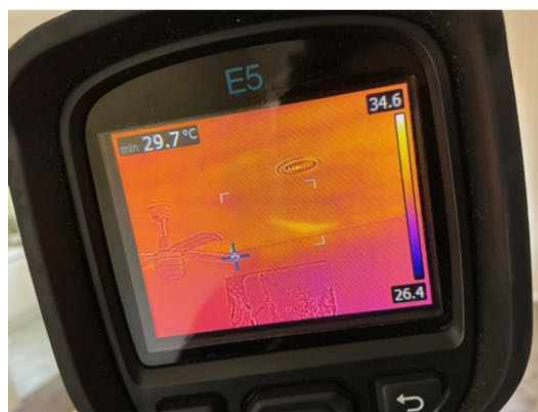
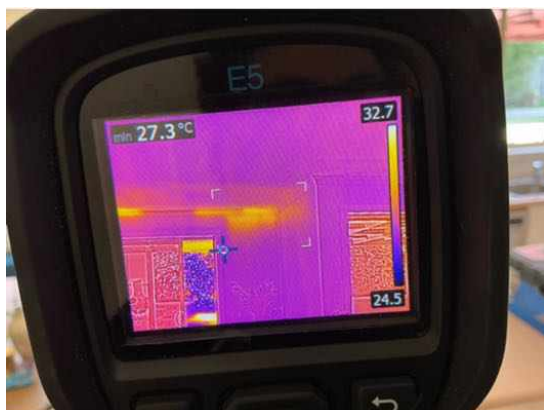
Defects 3.24

Building:	Main Building
Location:	All Internal Areas
Finding:	Inconsistent Thermal Performance to Ceiling Areas – Suspected Insulation Deficiencies
Information:	<p>Thermal imaging conducted to internal ceiling areas at the time of inspection identified inconsistent heat patterns, which are indicative of variations in thermal performance across the roof space. These patterns are commonly associated with areas of missing, displaced, or insufficient insulation above the ceiling linings.</p> <p>Inadequate or uneven insulation coverage can reduce the energy efficiency of the dwelling, contribute to heat loss in cooler periods and heat gain in warmer conditions,</p>

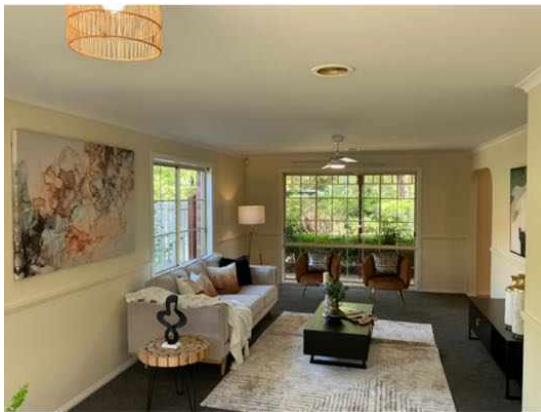
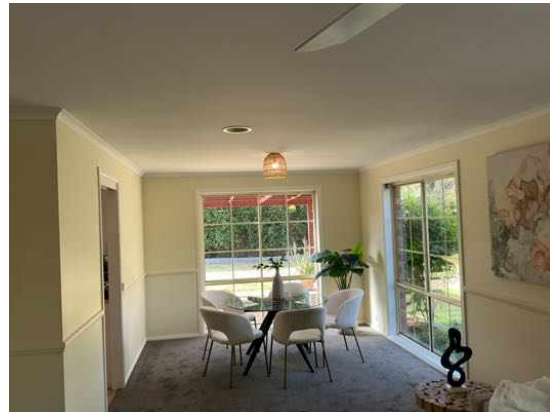
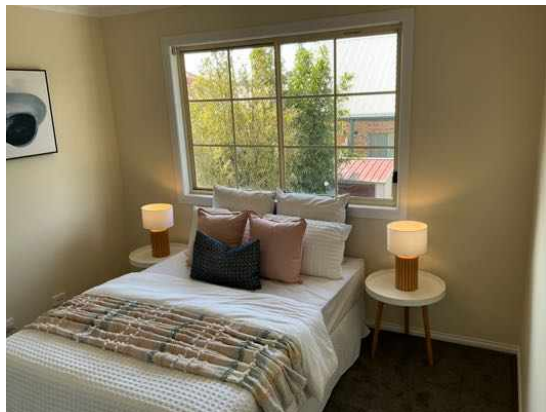
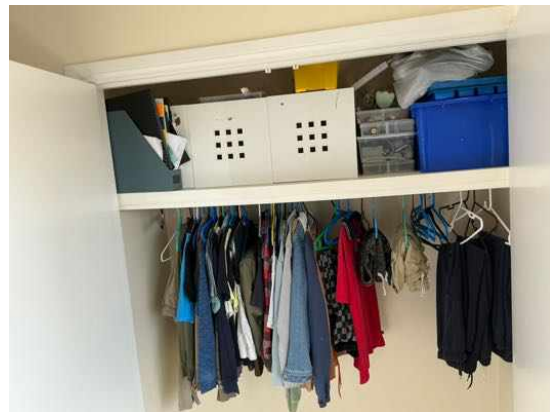
Building: Main Building
 Location: All Internal Areas
 Finding: Obstructions and Limitations - Interior
 Information: These photographs are an indication of the obstructions and limitations which impeded the inspection of the internal areas of the property at the time of inspection. These obstructions can hide an array of defects and should be removed to allow full inspection to be carried out. A re-inspection is recommended once the areas are made accessible.

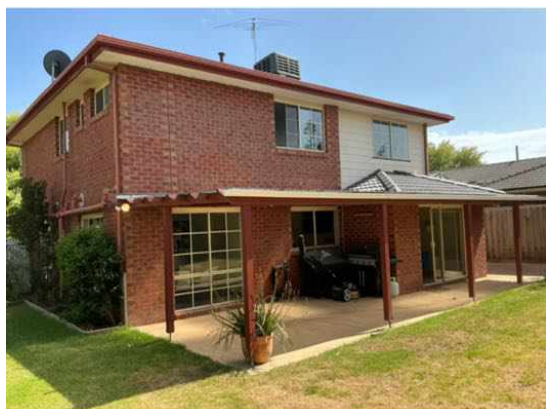
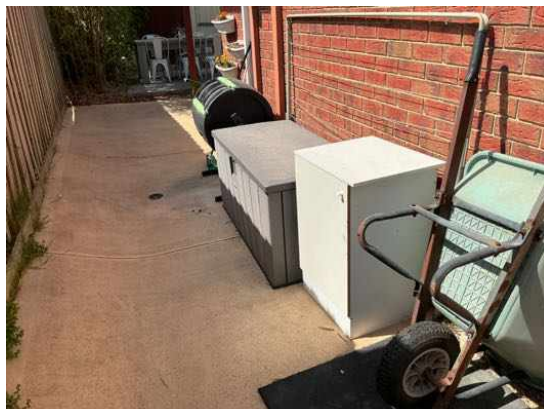
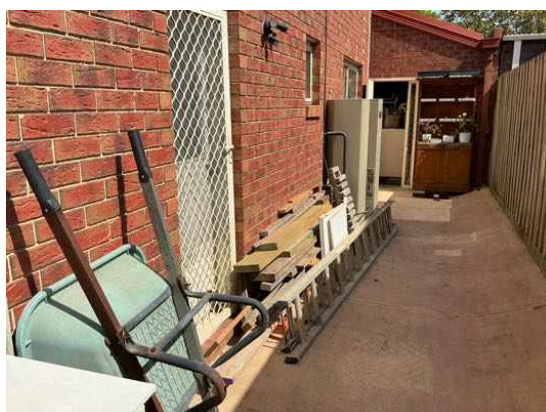
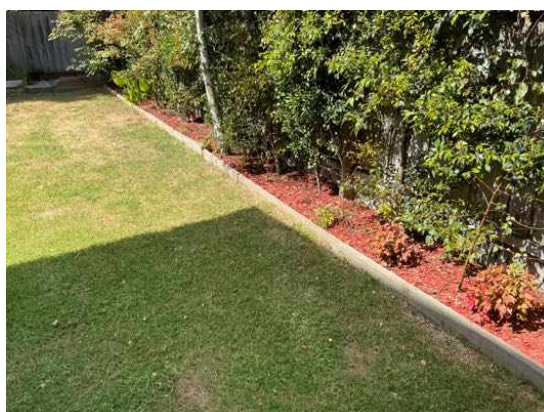
Building: Main Building
 Location: All External Areas
 Finding: Obstructions and Limitations - Exterior
 Information: These photographs are an indication of the obstructions and limitations which impeded the inspection of the external areas of the property at the time of inspection.

These obstructions can hide an array of defects and should be removed to allow full inspection to be carried out. A re-inspection is recommended once the areas are made accessible.

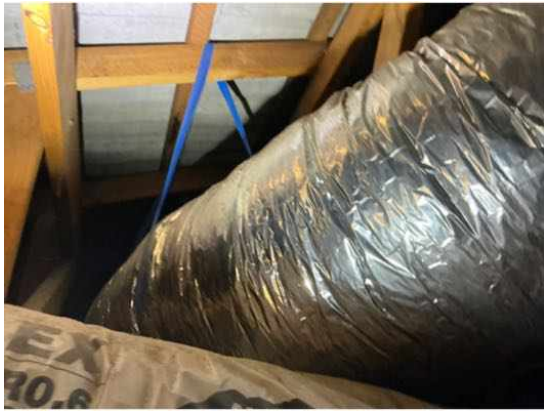
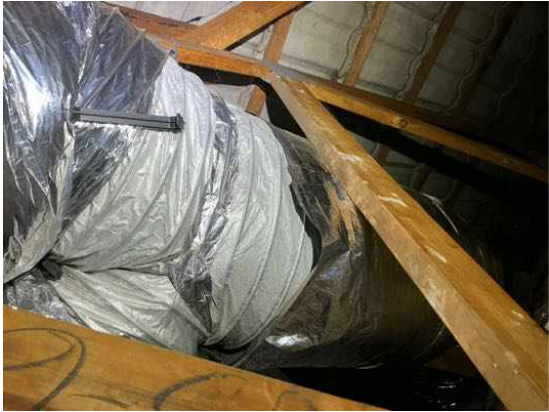
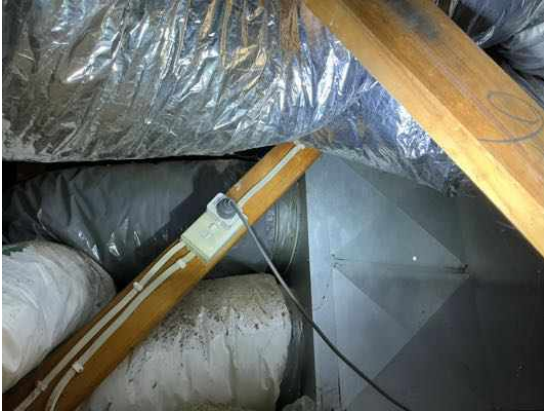
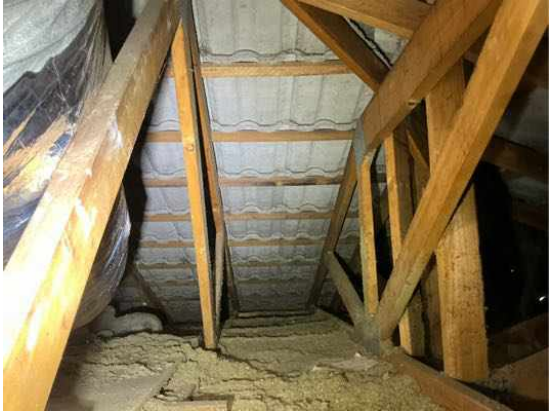
Building:	Main Building
Location:	Roof Void
Finding:	Obstructions and Limitations - roof cavity
Information:	These photographs are an indication of the obstructions and limitations which impeded the inspection of the roof cavity area of the property at the time of inspection. These obstructions can hide an array of defects and should be removed to allow full inspection to be carried out. A re-inspection is recommended once the areas are made accessible.
