## Building and Timber Pest Inspection Report

Inspection Date: Thu, 5 Mar 2026

Property Address: 102/3 Balmoral St, Blacktown NSW 2148,  
Australia

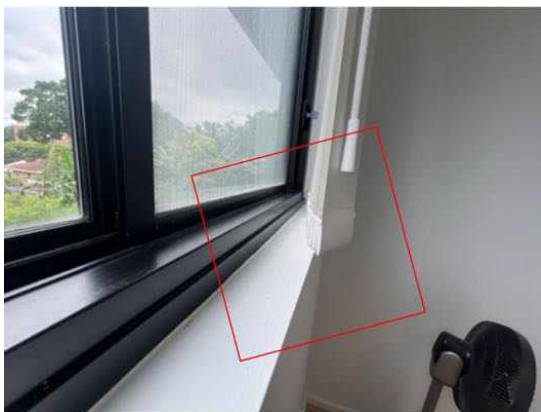
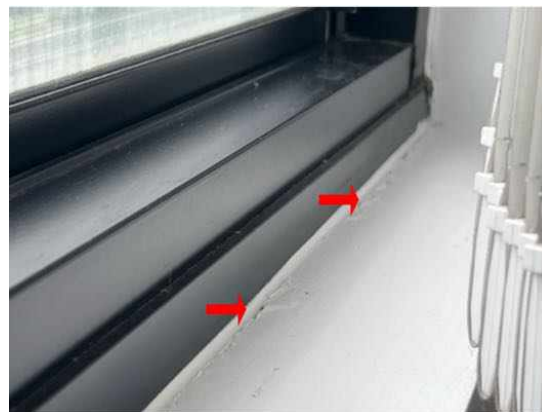
#### Finding 3.01

Building:	Main Building
Location:	Bedroom
Finding:	Painted surface - Bubbling (window)
Information:	Minor paint bubbling was observed along the internal window sill. This type of condition can occur due to minor moisture exposure, condensation, or deterioration of sealing around the window frame over time. Maintenance of the paint finish and further inspection of the window sealing is recommended to reduce the potential for moisture ingress.

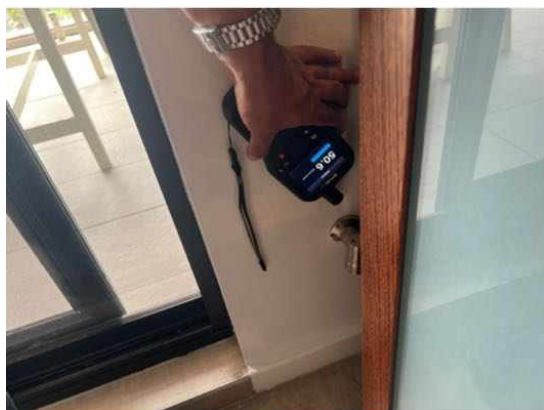
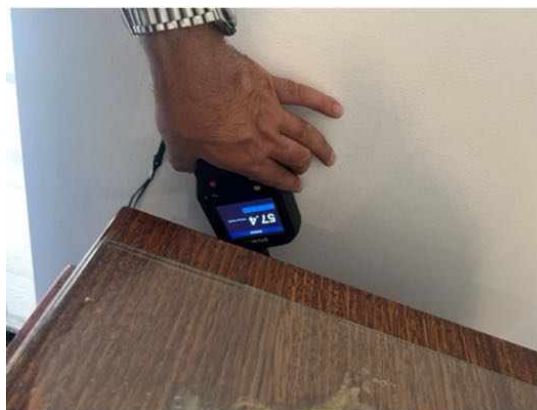
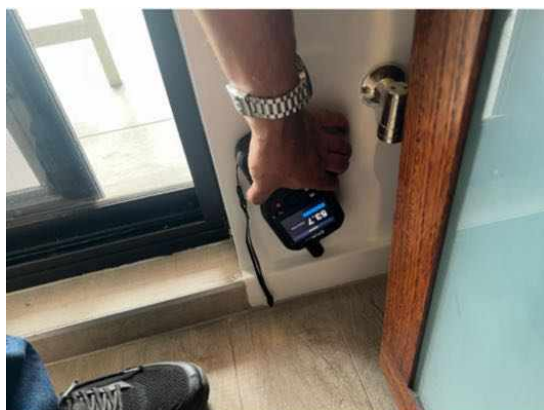
#### Finding 3.02

Building:	Main Building
Location:	All Internal Areas
Finding:	Elevated Moisture Detected - Strata (No visible deterioration)
Information:	Elevated moisture was recorded at the base of the balcony tiles and adjacent walls. While no internal damage was visible at the time of inspection, balconies in multi-unit dwellings are high-risk areas for waterproofing failure, which can lead to leaks into adjoining units and significant rectification costs. Further investigation by a licensed waterproofing contractor is recommended.

Depending on the strata plan, this area may form part of the common property, in which case remedial responsibility may rest with the owners corporation (strata). Purchasers should seek clarification from the strata manager and legal adviser prior to purchase.

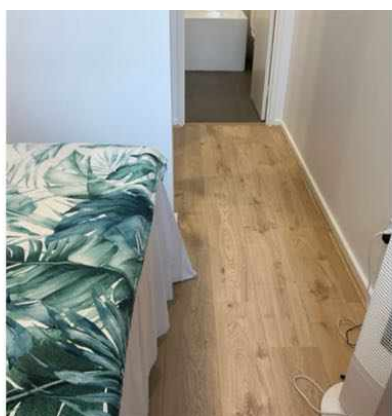
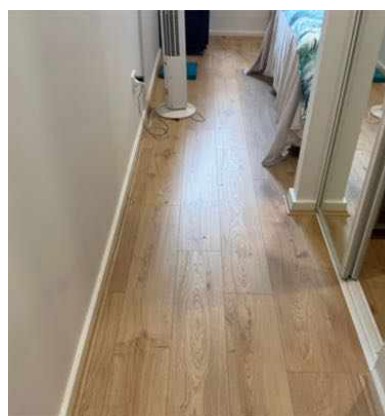
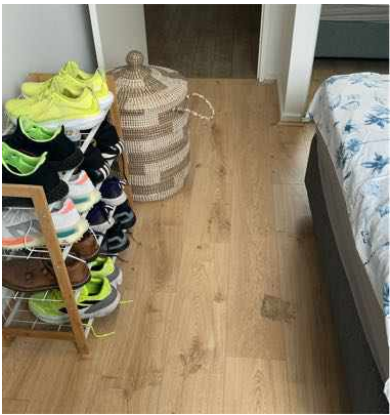
Finding: Laminate Flooring Movement / Creaking

Information: Minor creaking and movement were noted when walking over sections of the laminate flooring. This condition is commonly associated with floating floor systems where slight movement occurs between boards or between the flooring and the underlying substrate, particularly if the subfloor is uneven or expansion clearances are limited. While this does not generally indicate a structural issue, ongoing movement may cause wear to the flooring over time. Monitoring is recommended, and rectification may involve lifting and reinstalling affected boards or improving subfloor preparation if the condition worsens.

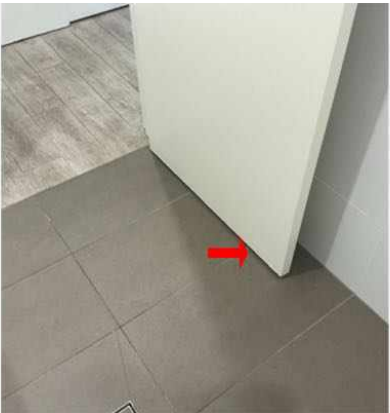
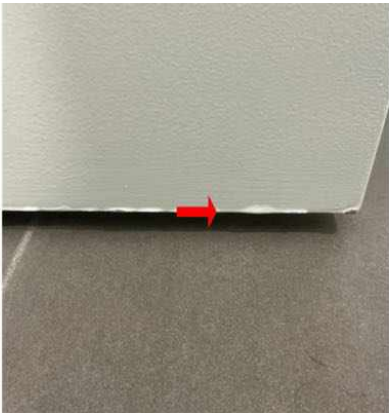
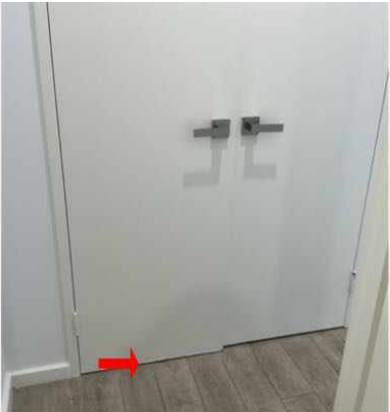
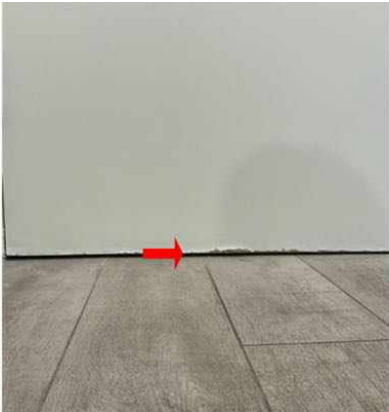
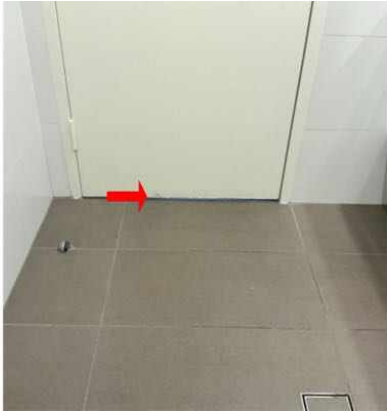
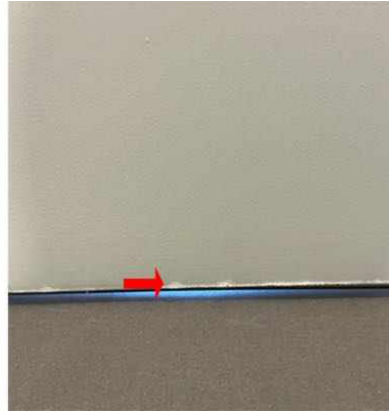
**Finding 3.05**

Building: Main Building  
Location: Bathroom, hallway, ensuite  
Finding: Delamination of timbers  
Information: Localised delamination and surface deterioration were observed to sections of laminated joinery panels. This condition commonly occurs where moisture exposure or wear causes separation of laminate finishes from the underlying substrate. The defect is generally cosmetic in nature but may worsen over time if moisture exposure continues. Repair or replacement of affected joinery components may be considered as part of routine maintenance.

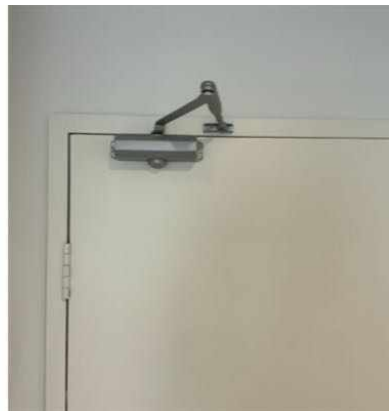
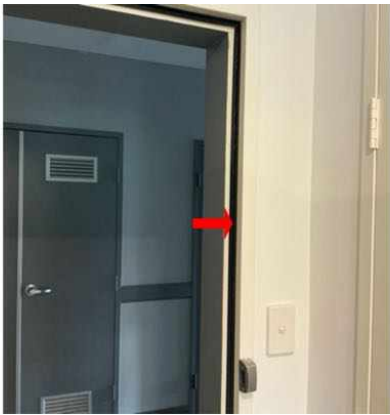
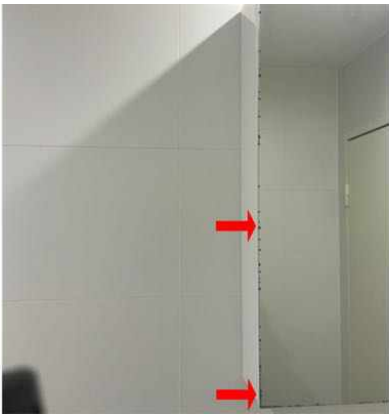
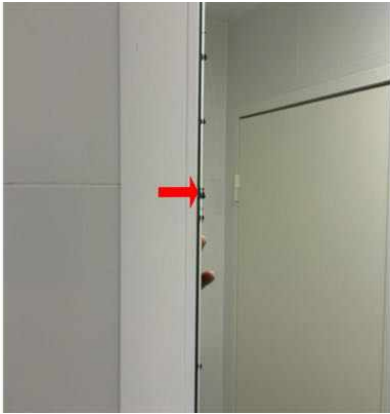
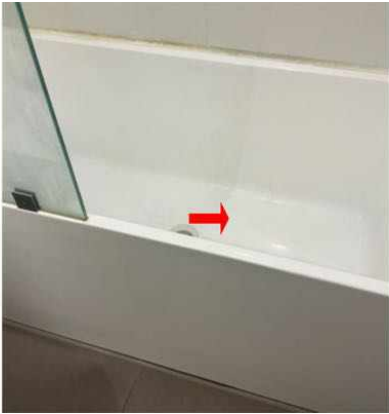
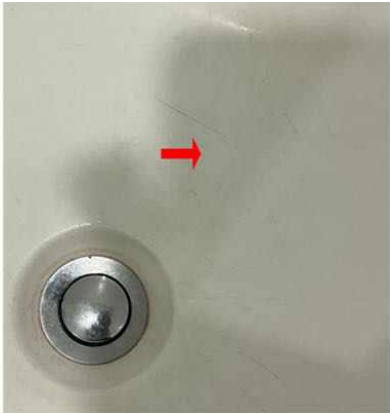
### Finding 3.06

Building:	Main Building
Location:	All Internal Areas
Finding:	Building element - Damaged - main door not closing by itself , mirror desilvering bathrooms , bathtub minor surface scratches , kitchen top minor chips
Information:	Breakage occurs generally when the building materials have either aged and decayed, or as a result of damage (accidental or deliberate).

Repair and/or replacement of broken elements is advised to ensure that additional secondary defects do not arise as a consequence. Such works are necessary, as all building elements play a key role in the operation and function of the overall structure and its performance.

A relevant tradesperson should be appointed to repair or replace the affected building element prior to any subsequent damage being caused.

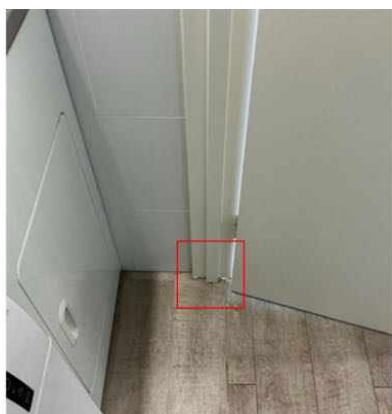
Finding 3.07

Building: Main Building  
 Location: Laundry  
 Finding: Building element - Rusted or corroded - Door Jamb  
 Information: This building element shows evidence of rusting and corrosion, which is likely to have developed as a result of excessive exposure to moisture and or inadequate coatings.

As surface rust provides no protection to the underlying iron, the deteriorating condition is likely to worsen if not addressed in the short-term future.

Where possible, the use of galvanized (treated) metals or aluminium coated metals aid in rust prevention, as does regular general maintenance. Rust formation can be controlled with coatings, such as paint, that isolate the iron from the environment.

Rusting and corrosion should be managed by ideally removing or limiting the affected surface from exposure to moisture. A registered builder may be appointed to replace any building elements that have been severely affected by rust or water damage.

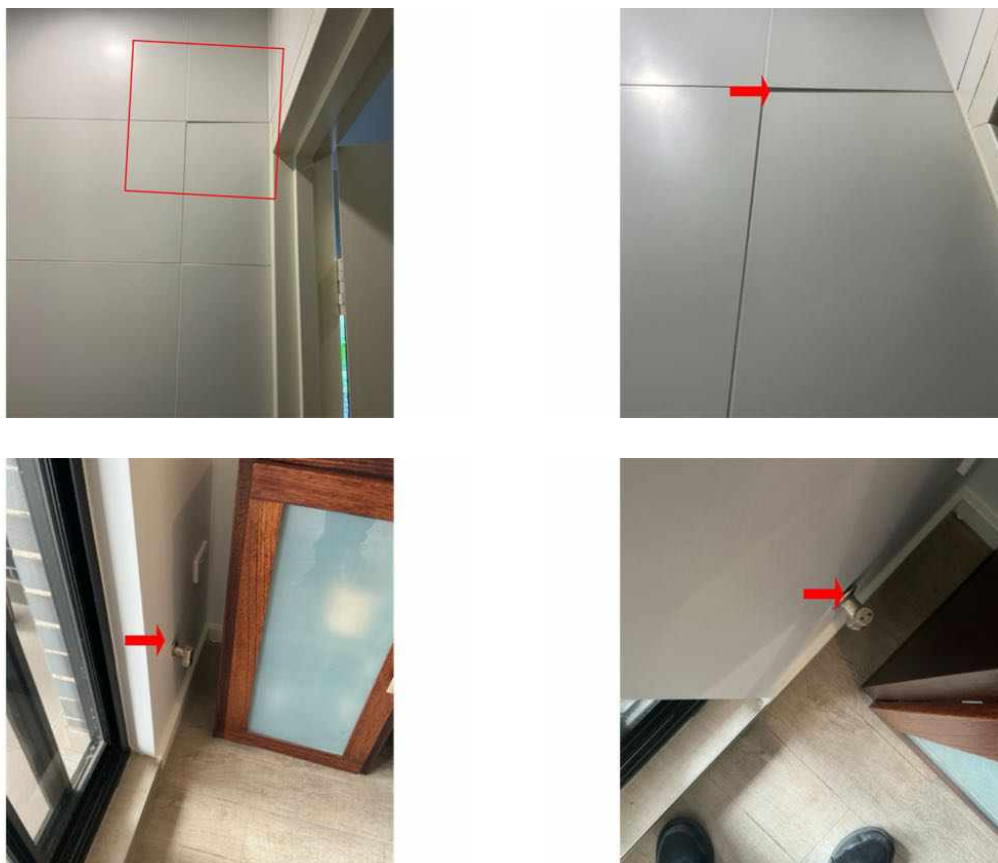
### Finding 3.08

Building: Main Building  
 Location: Laundry  
 Finding: Installation - substandard or incomplete - uneven tiling laundry , fixing not flush lounge  
 Information: The installation of this building element appears to have been completed to a substandard level of workmanship or is incomplete. Generally substandard repairs or installation are related to poor workmanship, the use of inappropriate materials, or a failure to complete installation to a suitable standard.

Where installation is substandard and/or incomplete, the client should contact the responsible trade to undertake rectification. Unfinished and substandard building works are likely to degrade more quickly and may create potential for secondary defects to associated building elements.

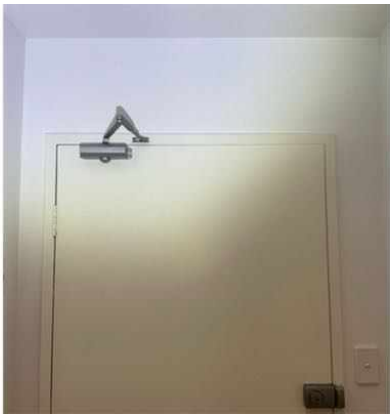
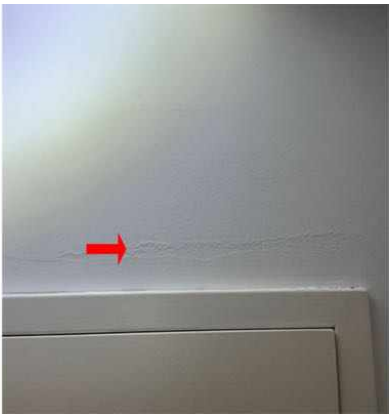
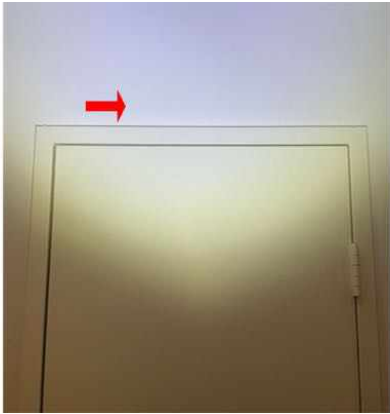
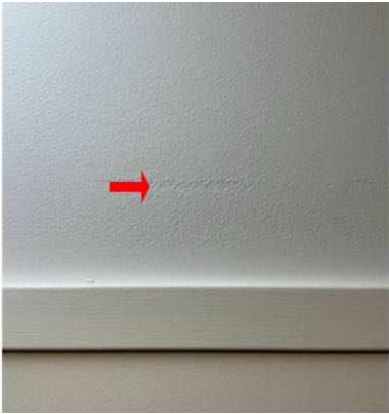
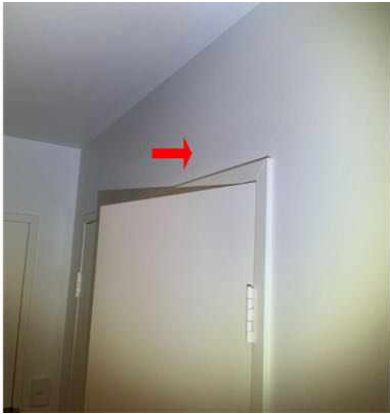
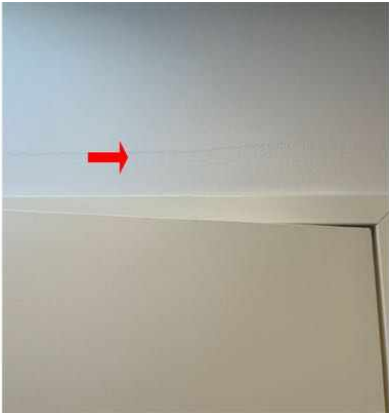
### Finding 3.09

Building:	Main Building
Location:	All Internal Areas
Finding:	Paint finish and hairline cracking
Information:	The paint finish in this area was identified as being incomplete at the time of inspection including some hairline minor cracking.

Whilst incomplete or missing paint finish is generally an appearance defect, it can also lead to the development of secondary building defects over time. Incomplete areas of paint finish expose the area to moisture, potentially accelerating the deterioration of underlying building materials.

Incomplete paint finishes should be sanded back, filled, leveled and painted, as applicable. Where inadequate or missing paint protection has led to the deterioration of the associated building element, repair and/or replacement of this building element may be required.

A painting contractor should be appointed as soon as possible to perform necessary works to aid the appearance of the affected area and to ensure the area is protected against further deterioration. Alternatively, the homeowner following manufacturer instructions may perform these works.

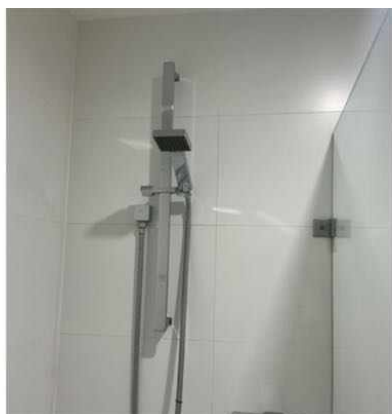
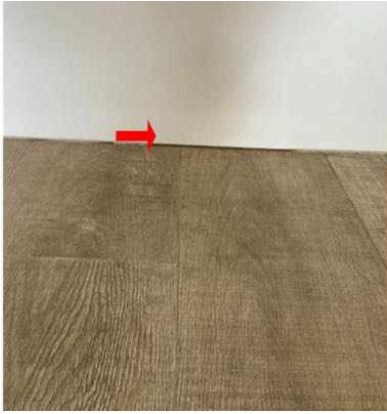
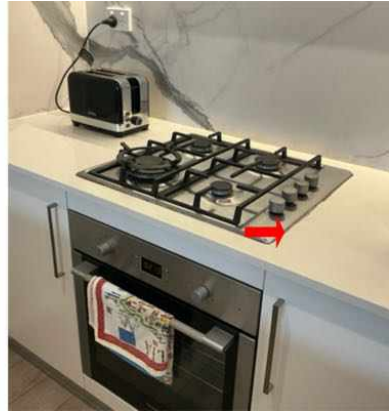
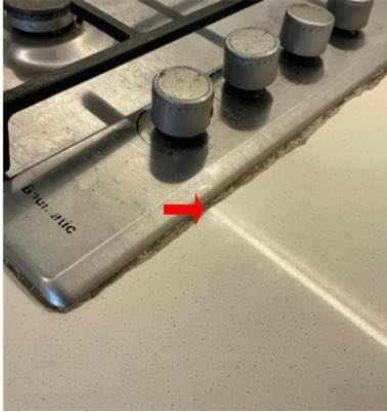
Finding 3.10

Building: Main Building  
Location: All Internal Areas  
Finding: Sealant and grouting - Missing or degraded  
Information: It was noted on inspection that sealant or grout is degraded. There is also evidence of poor workmanship and excessive use of sealant. Silicone should never be used as a first line of defence against waterproofing. Further inspection by a licensed waterproofing contractor is highly recommended.

Different materials and floor areas move at different rates, generally causing cracking to grout or sealant at this point. A flexible sealant is required to allow for expected expansion and contraction, while keeping the joint water tight and protective of all associated building materials.

There appears to be excessive mould to the sealant and grout which will likely require scraping out and replacement.

Flexible and mould resistant materials should be applied to affected areas to prevent any subsequent water damage that is likely to occur. Regular maintenance and replacement of damage or missing or damaged sealant and grout is highly recommended to the wet areas, as this is a regular wear and tear defect. Sealant and grouting in areas that come into regular contact with water should be maintained for the long term care of your property.

A sealant specialist or tiling contractor should be appointed to complete these works as soon as possible.

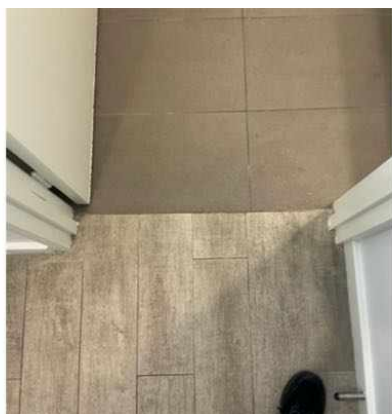
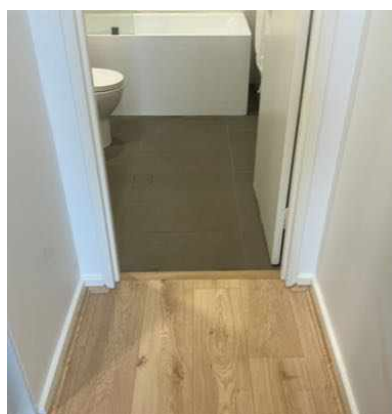
Building: Main Building  
Location: Bathroom, ensuite  
Finding: Bathroom & external floor threshold  
Information: The bathroom floor is at the same level as the adjoining timber flooring. This configuration is typical in modern apartments and is permitted where compliant waterproofing and floor falls are provided. No evidence of moisture damage was observed at the time of inspection; however, waterproofing performance cannot be confirmed without invasive inspection.

Care should be taken to avoid excessive water migration beyond the bathroom during use.

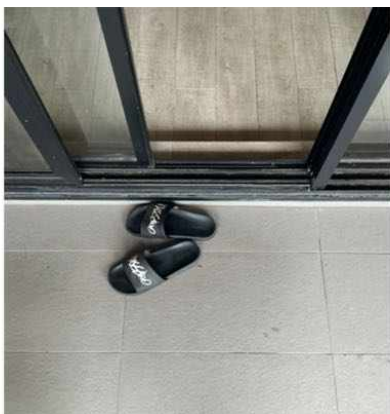
Building: Main Building  
Location: Balcony  
Finding: Balcony Floor Level Differential

Information: The balcony finished surface appears to be close to, or at the same level as, the internal floor. Standard construction practice requires a step-down of approximately 50 mm unless a fully engineered threshold drainage system is provided. No such drainage features were visible during inspection. This configuration increases the risk of water ingress, and confirmation of the balcony waterproofing detail through strata/building management is recommended.
